**Chevron U.S.A. Inc.
A.C. Mclaughlin 44A
Location #311854**

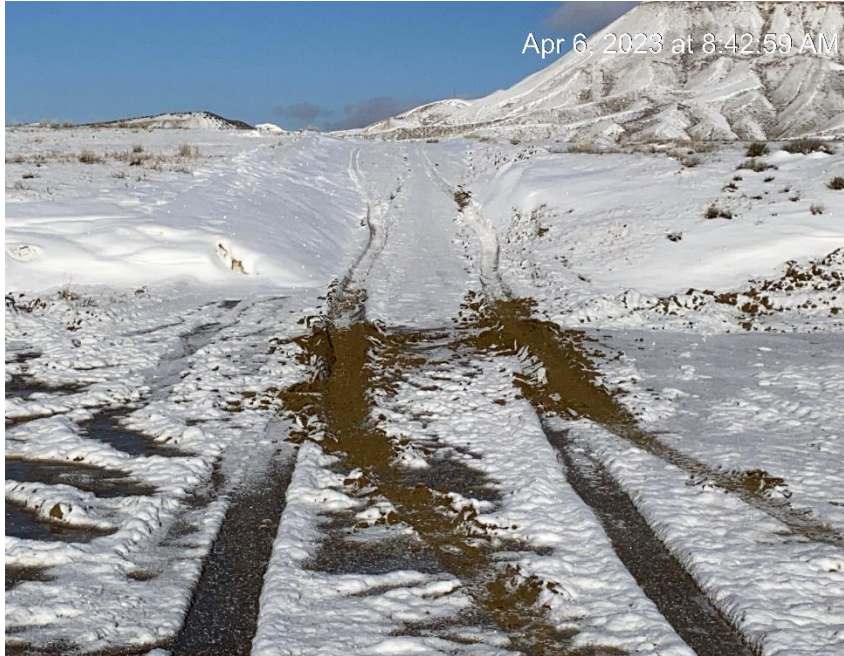
West side access entrance to location

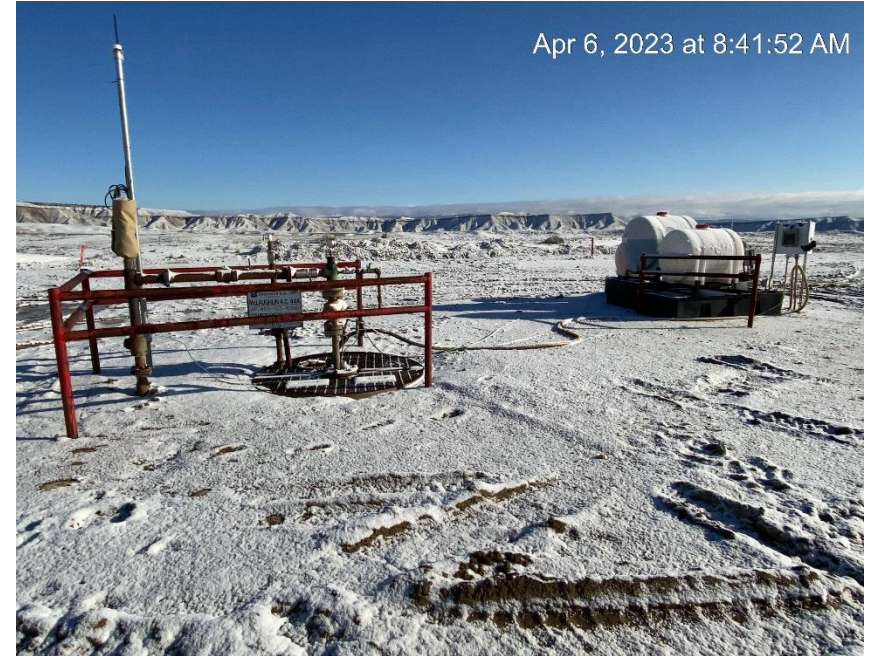
Looking North

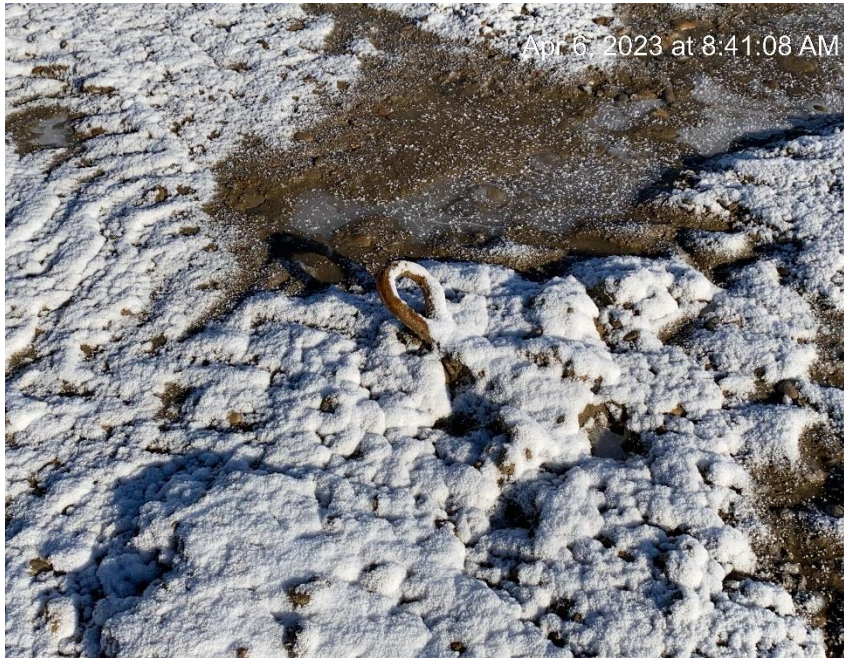
Unmarked anchor on SE corner

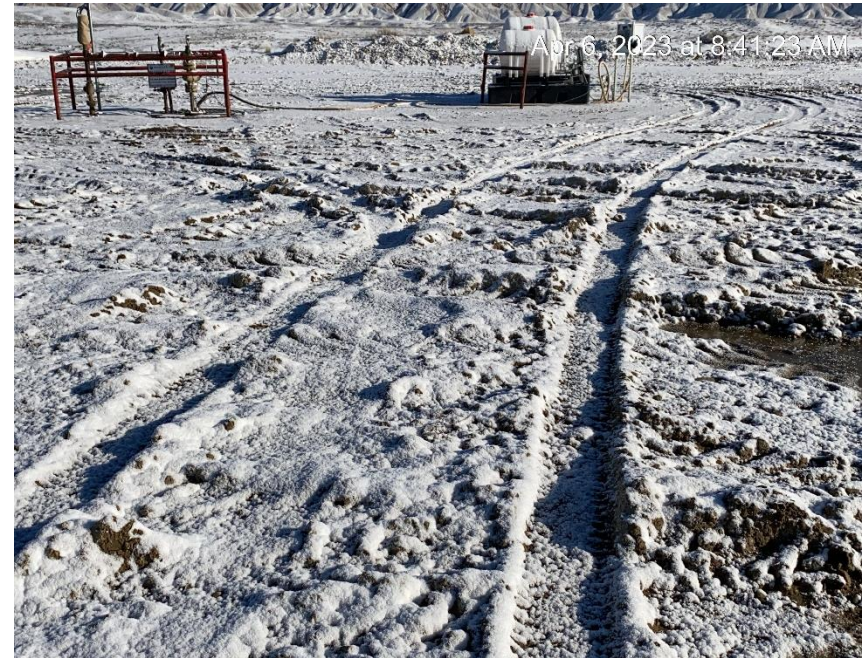
Location lack of stabilization

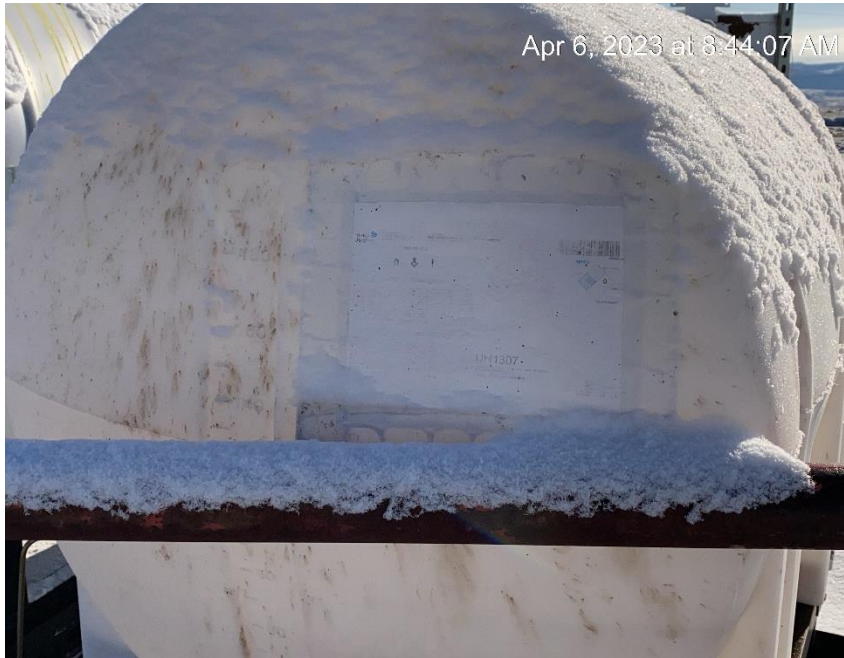
Faded chemical tank label needs replaced

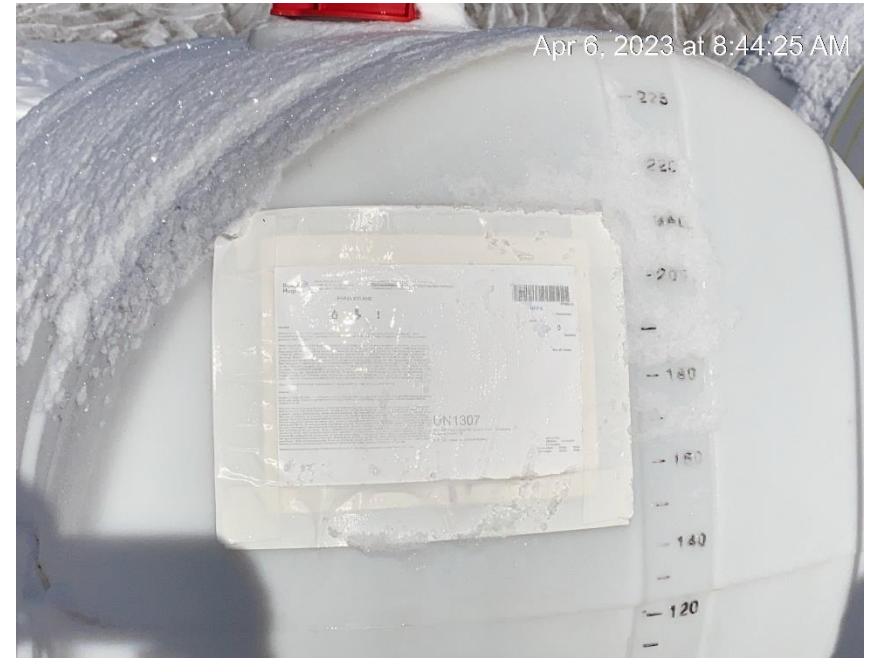
Faded chemical tank label needs replaced

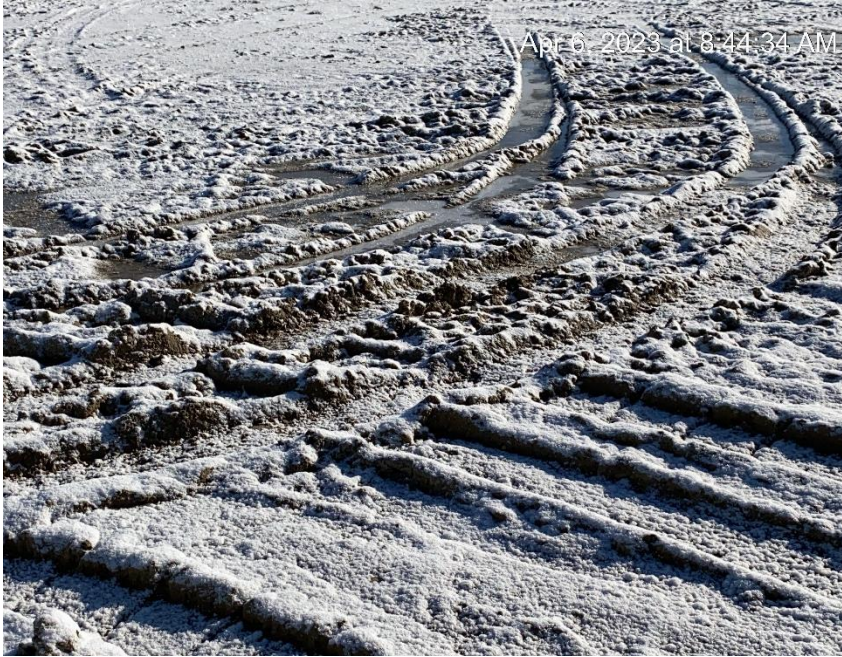
Location lack of stabilization

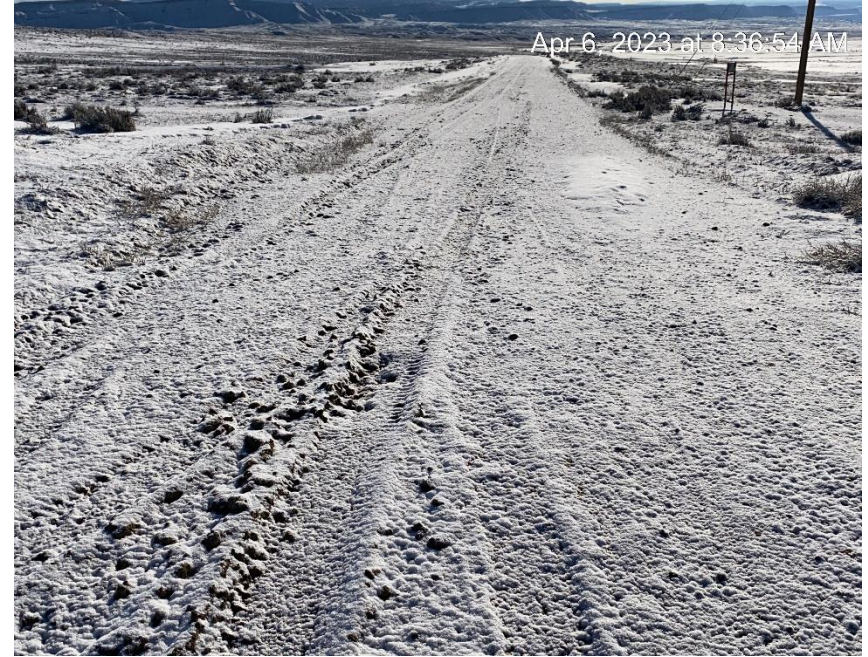
Access road from the East into location
