Inspection Photos

Location Name: TEP ROCKY MOUNTAIN LLC CLOUGH RMV 32-21 pad

Location ID: 323916

COLORADO
Oil & Gas Conservation
Commission
Department of Natural Resources

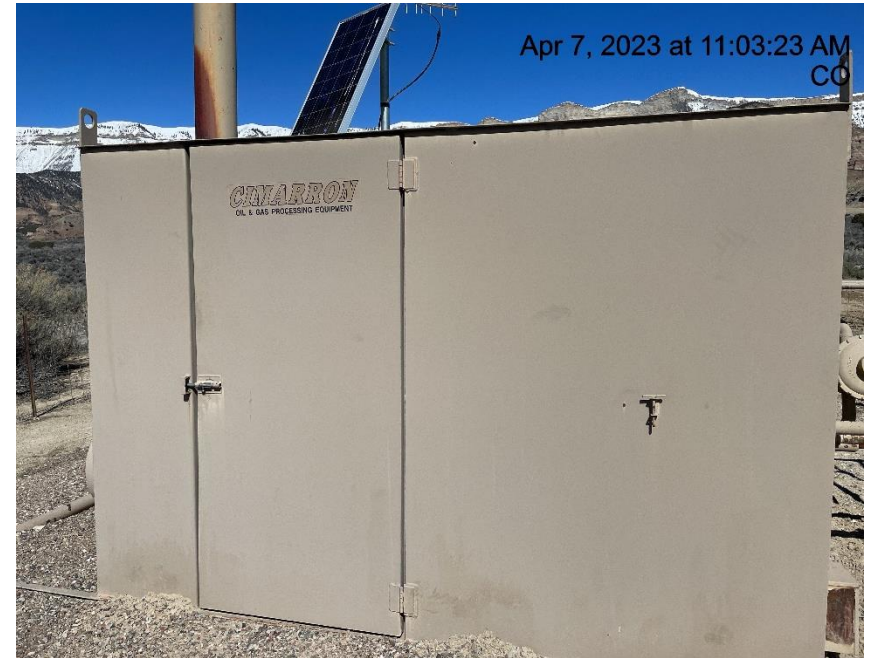
Photo # 4584 Meter calibration info not conspicuously posted

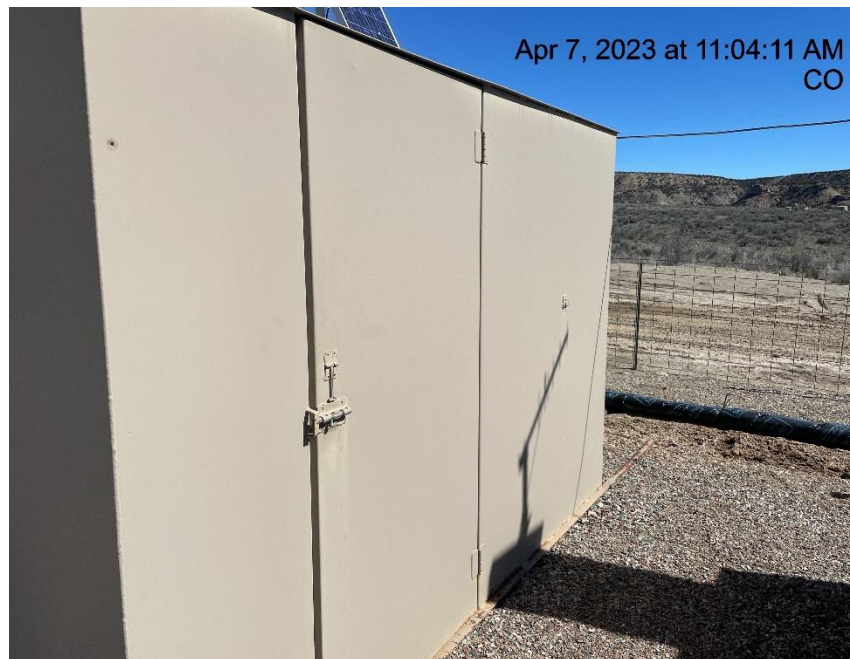
Photo # 4585 Meter calibration info not conspicuously posted

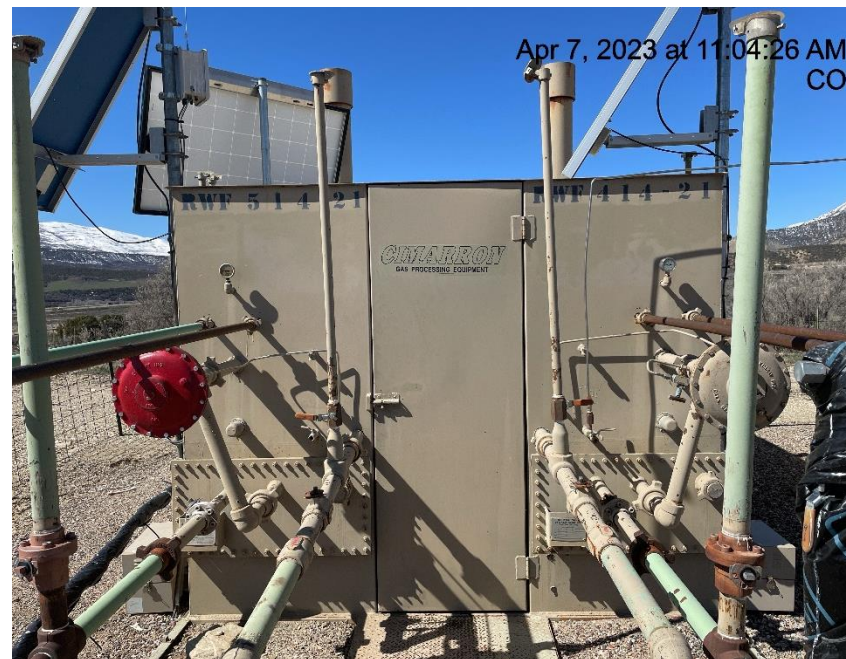
Photo # 4586 Meter calibration info not conspicuously posted

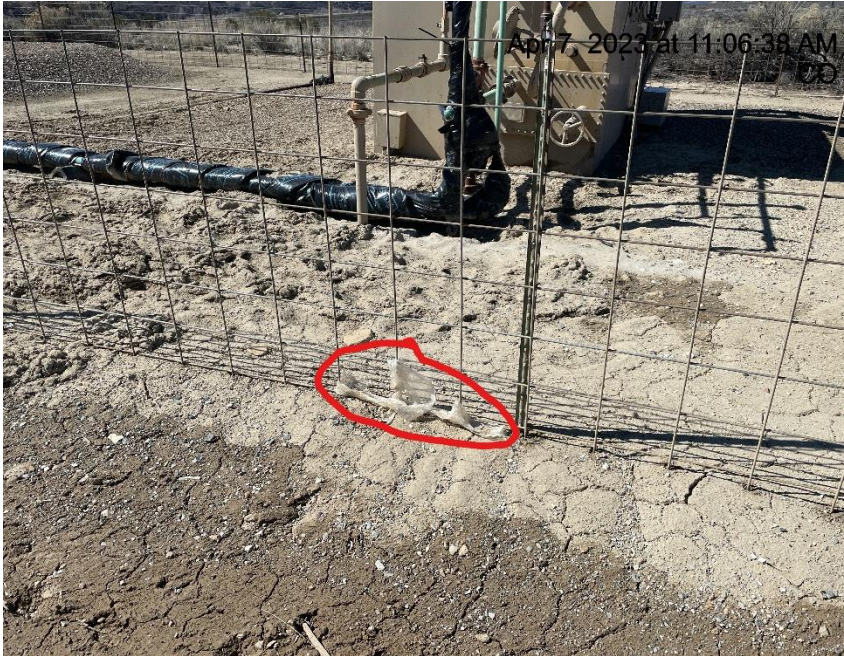
Photo # 4587 Debris

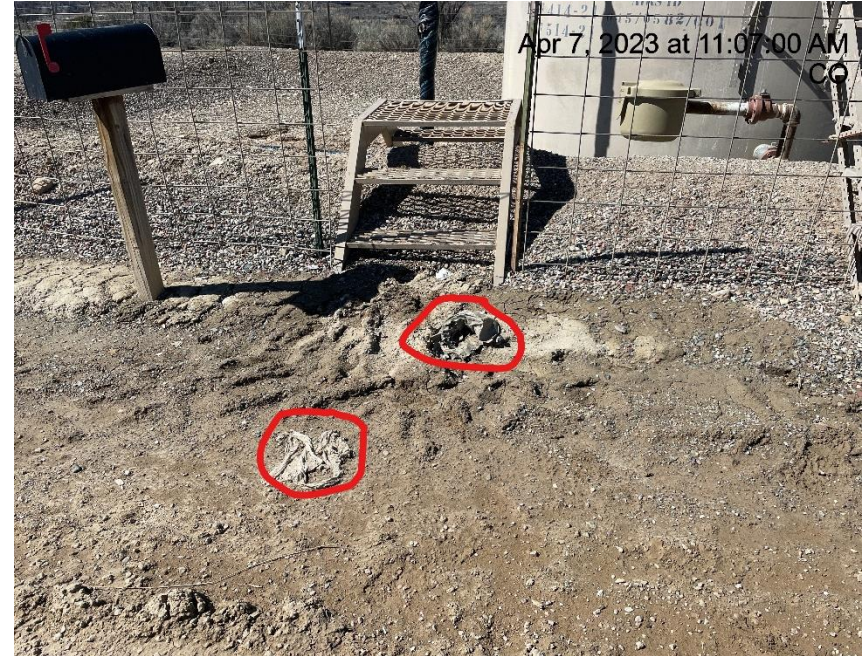
Photo # 4588 Debris

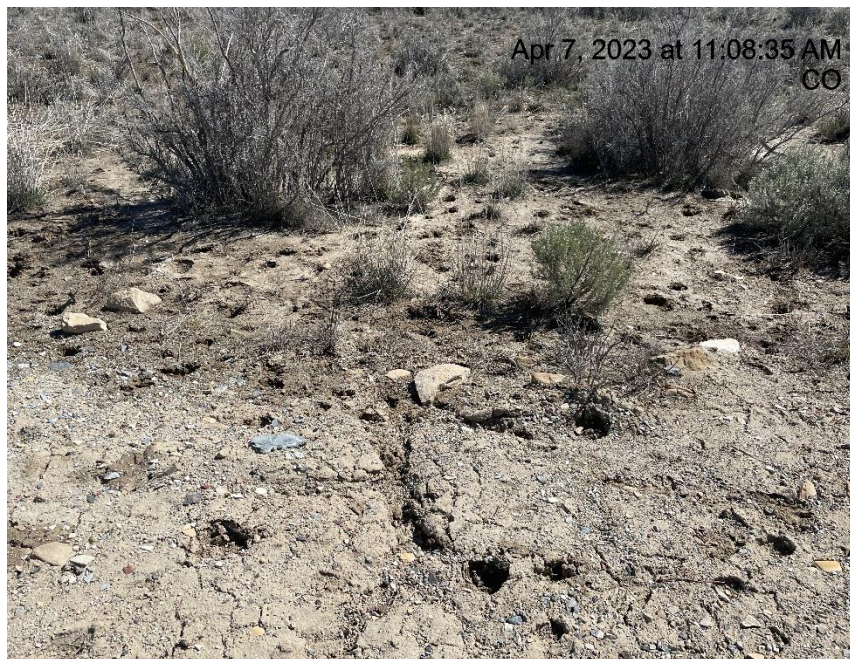
Photo # 4589 Rill erosion (East side of location)

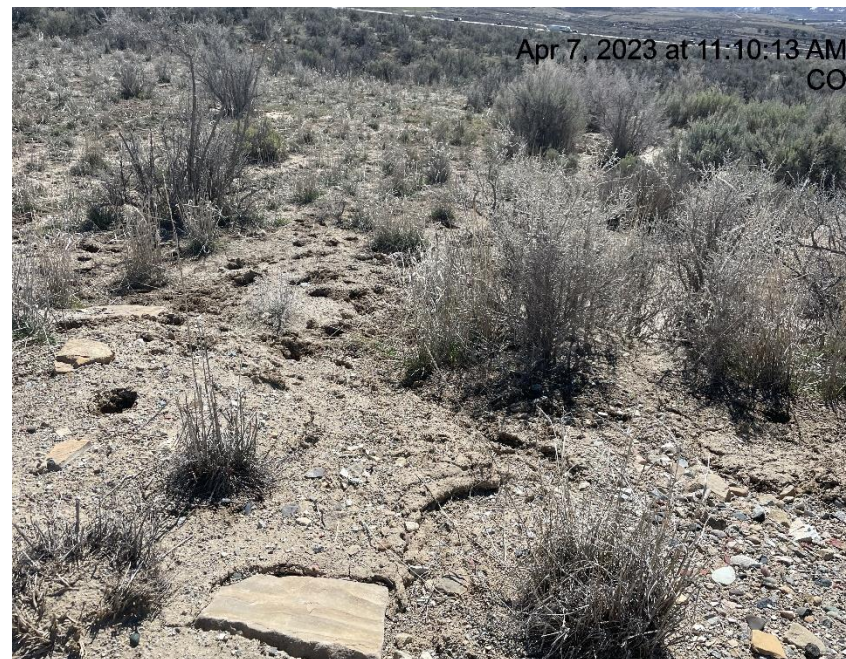
Photo # 4600 Rill erosion (East side of location)

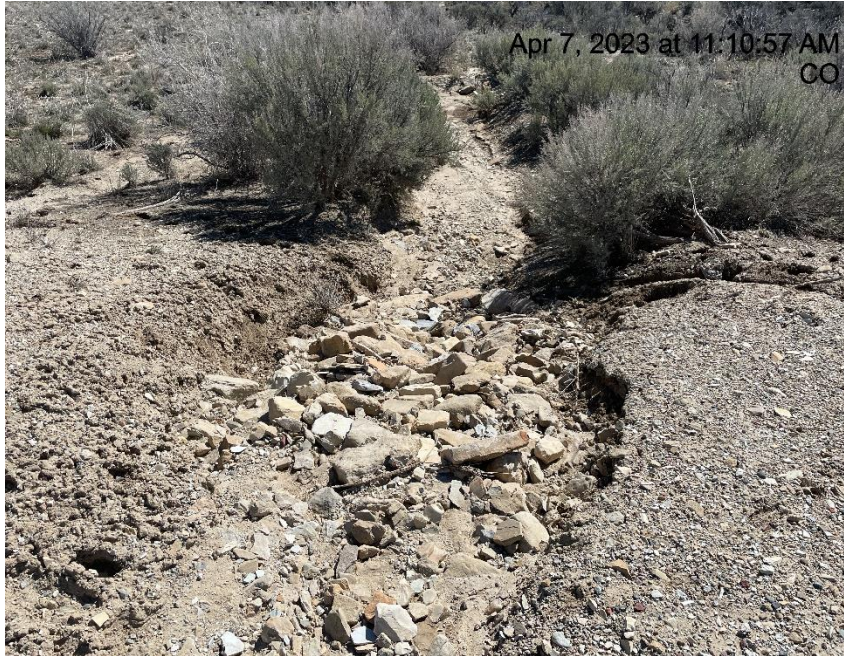
Photo # 4605 Rip Rap run needs maintenance (SE area of location)

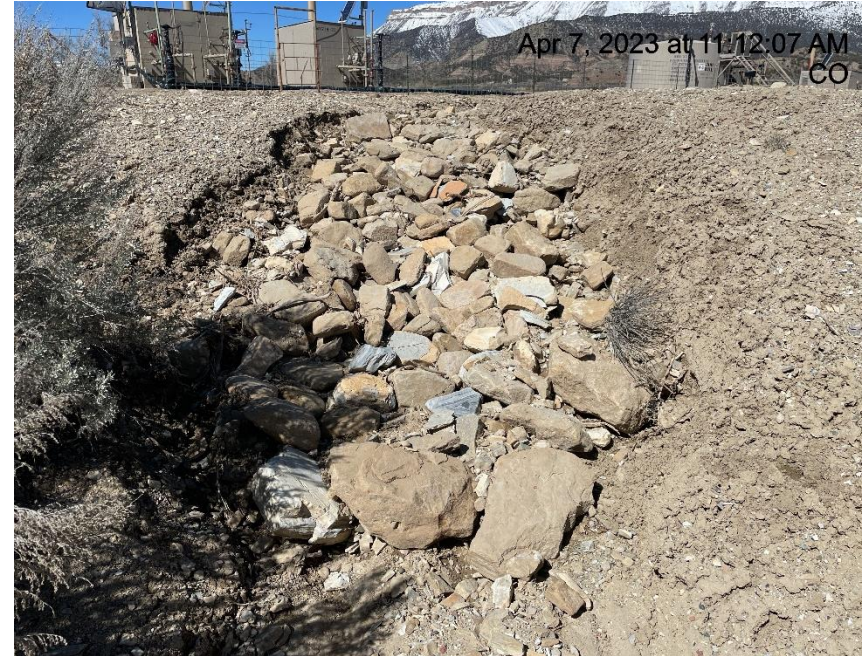
Photo # 4607 Rip Rap run needs maintenance (SE area of location)

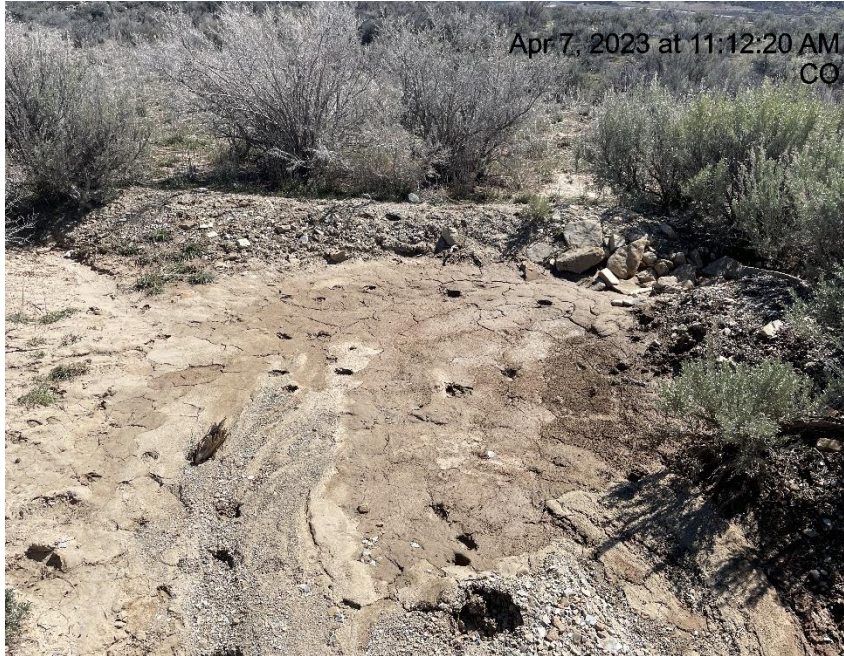
Photo # 4608 Sediment trap needs maintenance

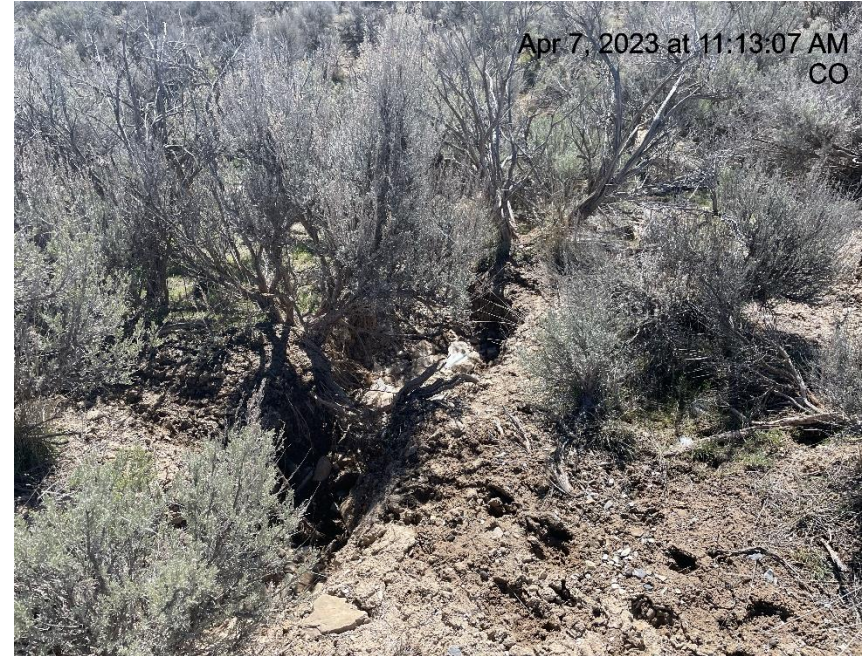
Photo # 4612 Area coming out of sediment trap needs maintenance/insufficient BMP's

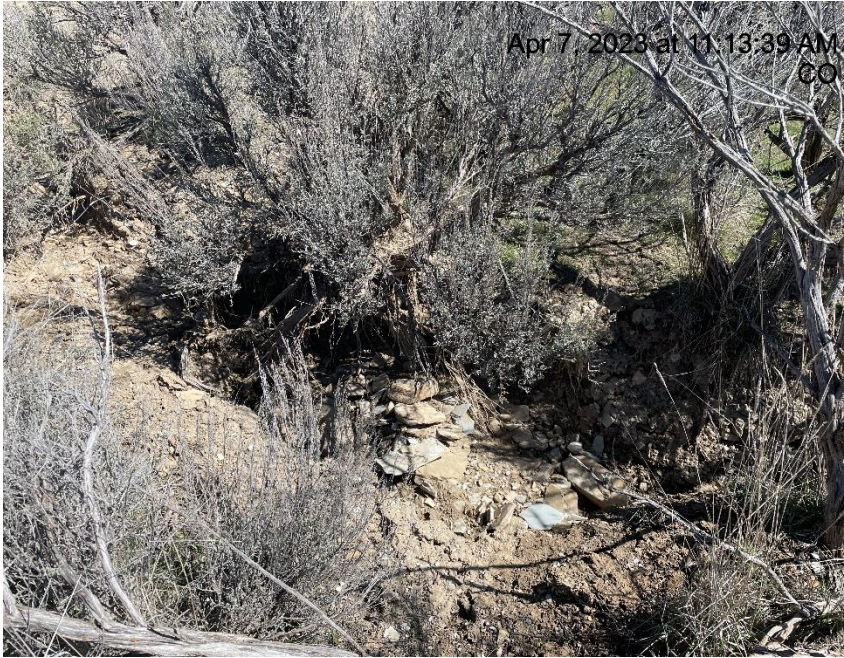
Photo # 4614 Area coming out of sediment trap needs maintenance/insufficient BMP's

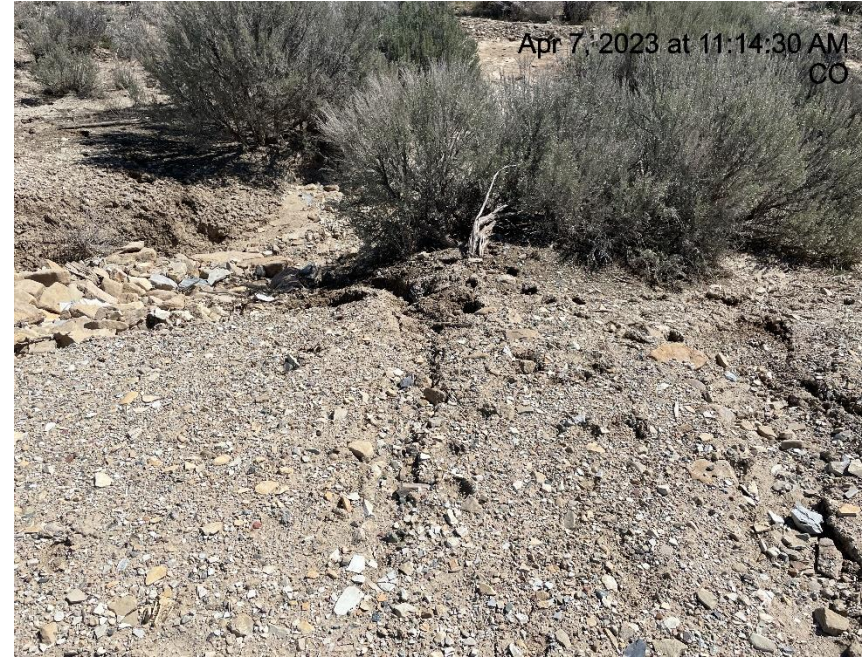
Photo # 4617 Rill erosion & transport of sediment (Multiple spots near rip rap run)

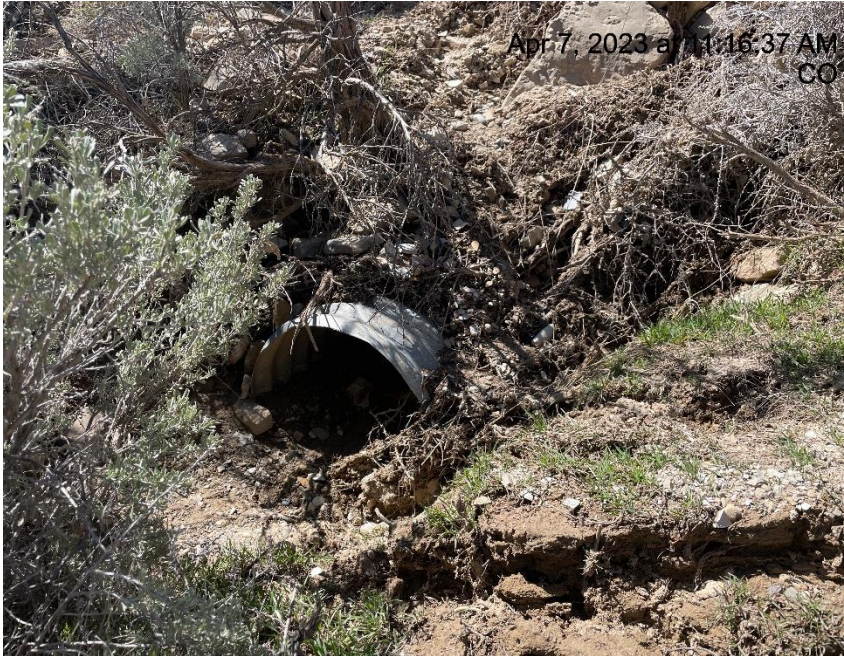
Photo # 4625 Culvert needs maintenance (on lease road 10-20 yards from entrance to location)

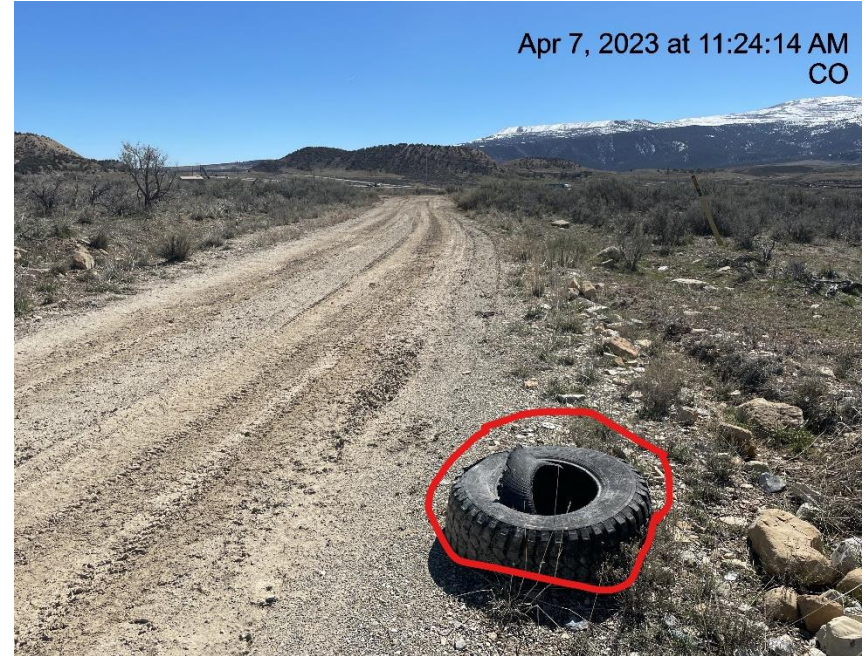
Photo # 4645 Debris (on lease road less than 1/10th of a mile after the CLOUGH 111 pad)

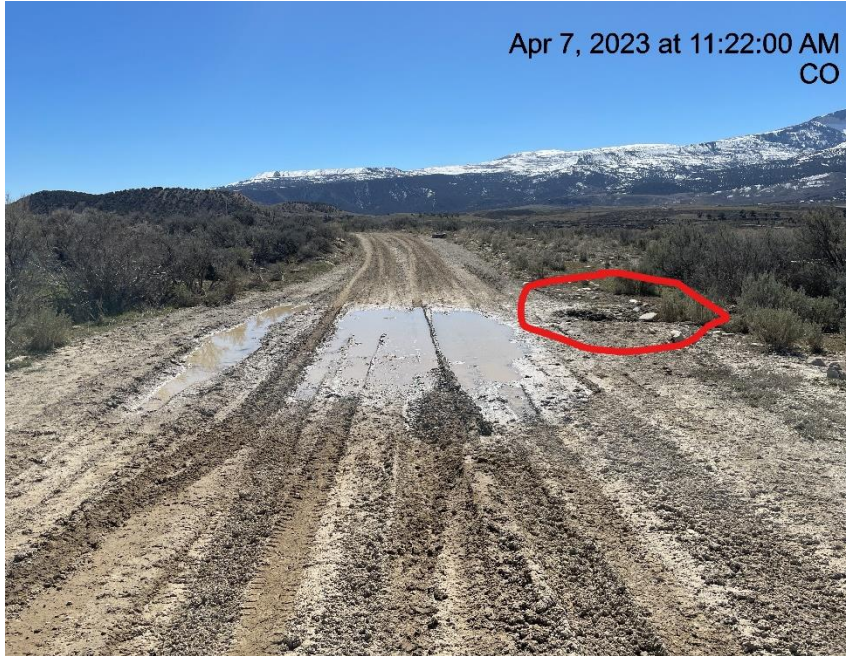
Photo # 4636 Erosion & transport of sediment off lease road/insufficient BMP's (approximately 1/10th of a mile after the CLOUGH 111 pad)

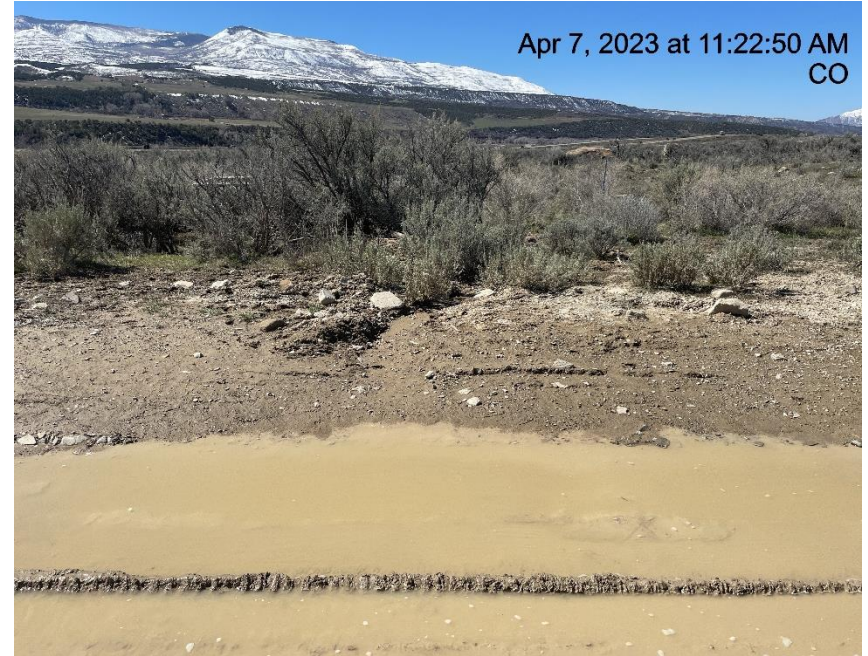
Photo # 4638 Erosion & transport of sediment off lease road/insufficient BMP's (approximately 1/10th of a mile after the CLOUGH 111 pad)

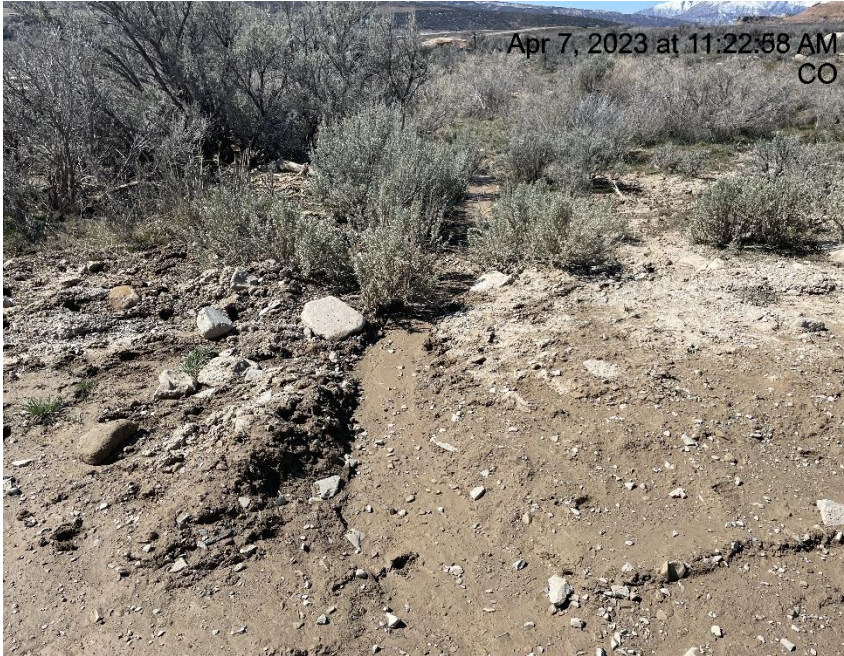
Photo # 4639 Erosion & transport of sediment off lease road/insufficient BMP's (approximately 1/10th of a mile after the CLOUGH 111 pad)

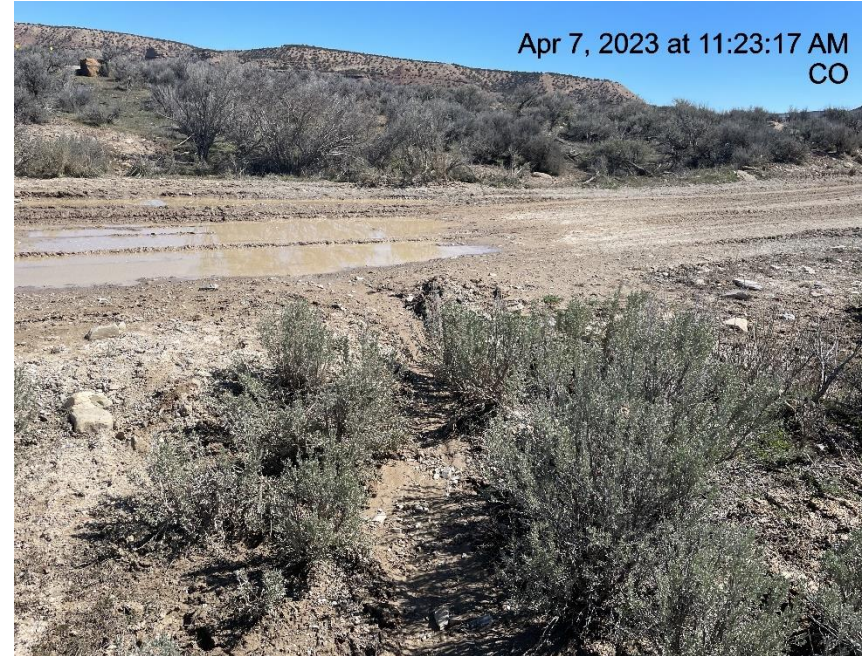
Photo # 4640 Erosion & transport of sediment off lease road/insufficient BMP's (approximately 1/10th of a mile after the CLOUGH 111 pad)

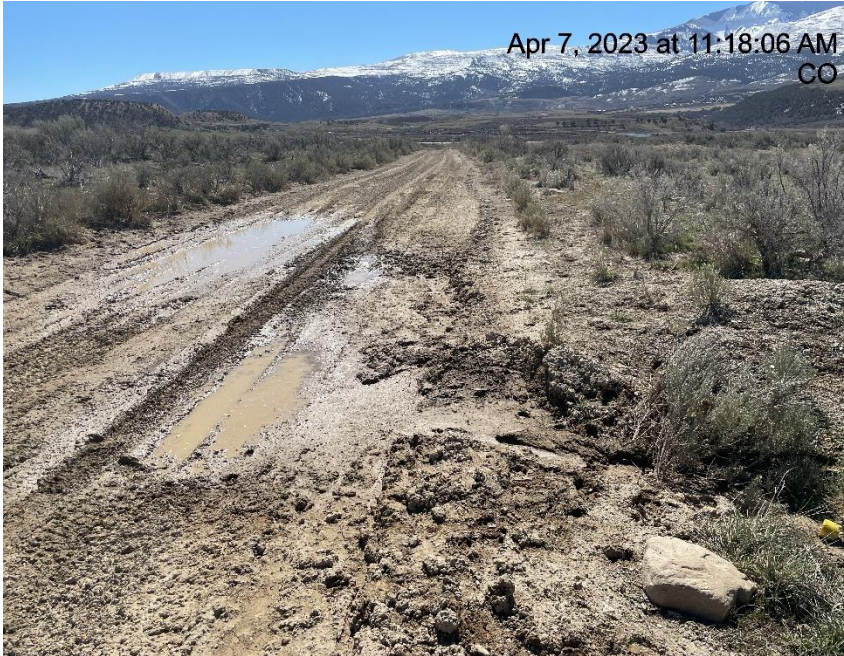
Photo # 4630 Erosion & transport of sediment off lease road/insufficient BMP's (approximately 2/10th of a mile after the CLOUGH 111 pad)

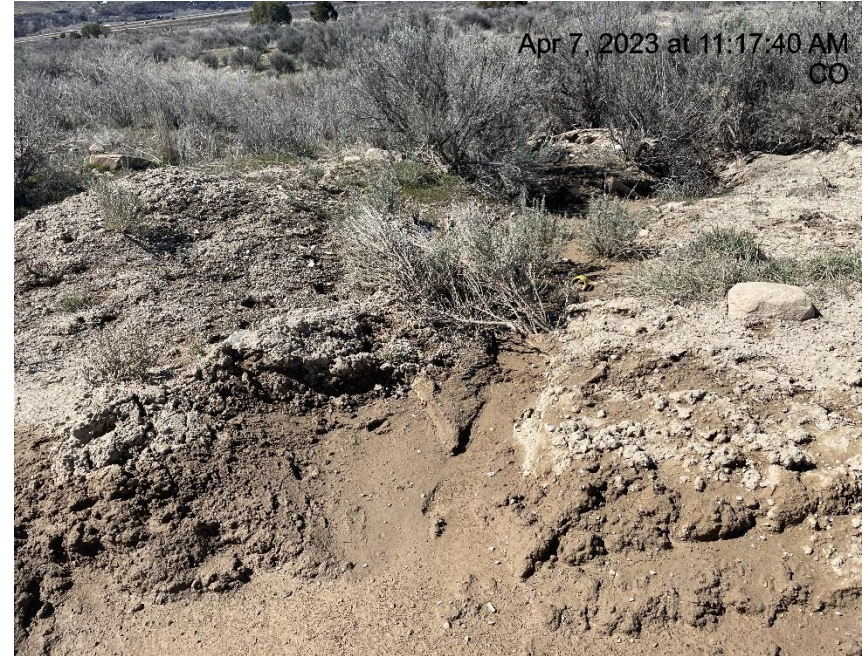
Photo # 4627 Erosion & transport of sediment off lease road/insufficient BMP's (approximately 2/10th of a mile after the CLOUGH 111 pad)

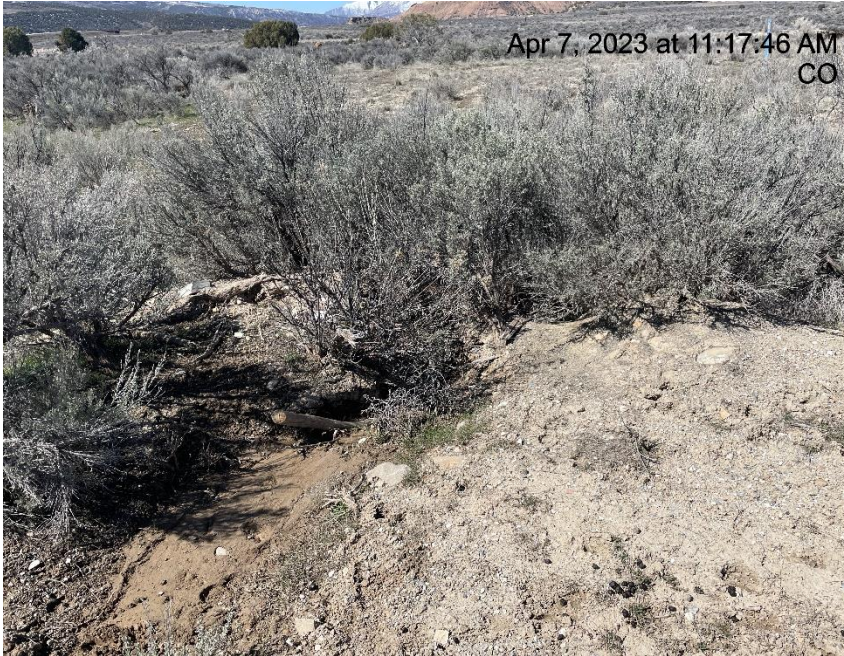
Photo # 4628 Erosion & transport of sediment off lease road/insufficient BMP's (approximately 2/10th of a mile after the CLOUGH 111 pad)

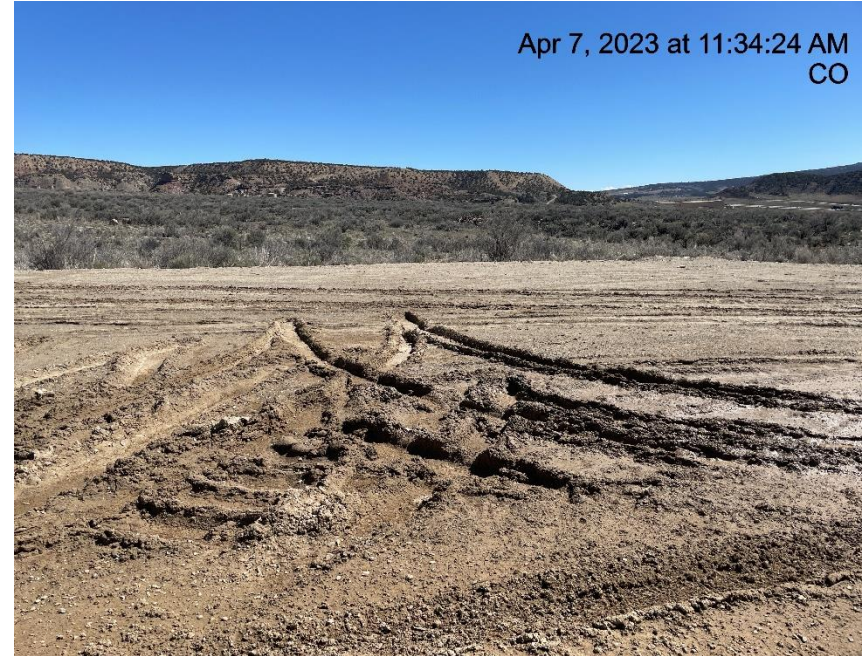
Photo # 4663 Lack of stabilization/compaction on location

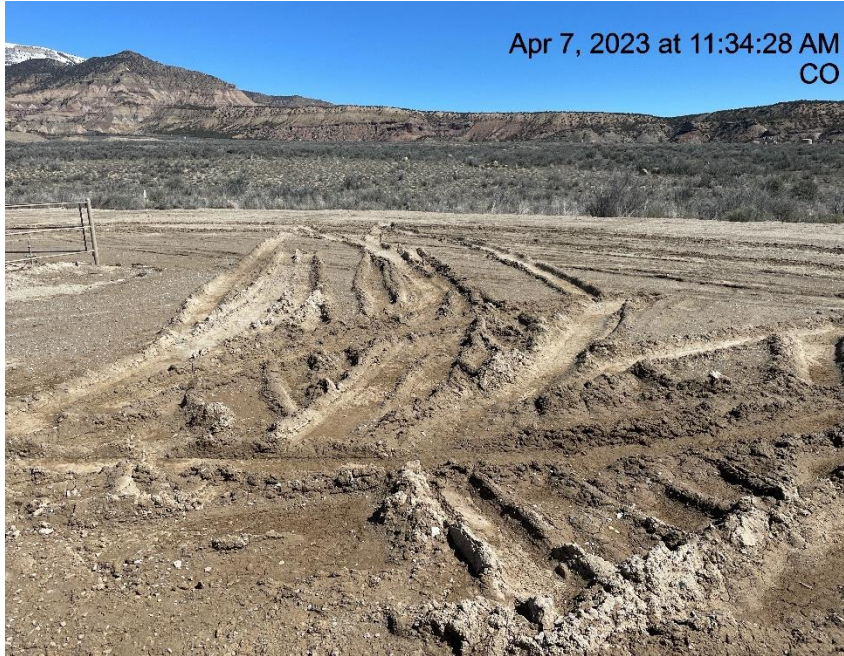
Photo # 4664 Lack of stabilization/compaction on location

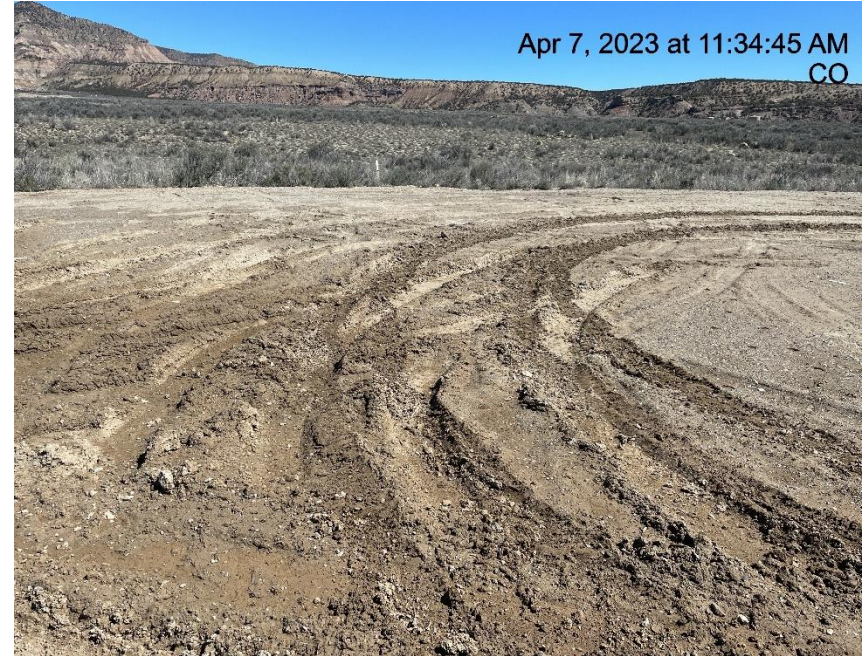
Photo # 4665 Lack of stabilization/compaction on location

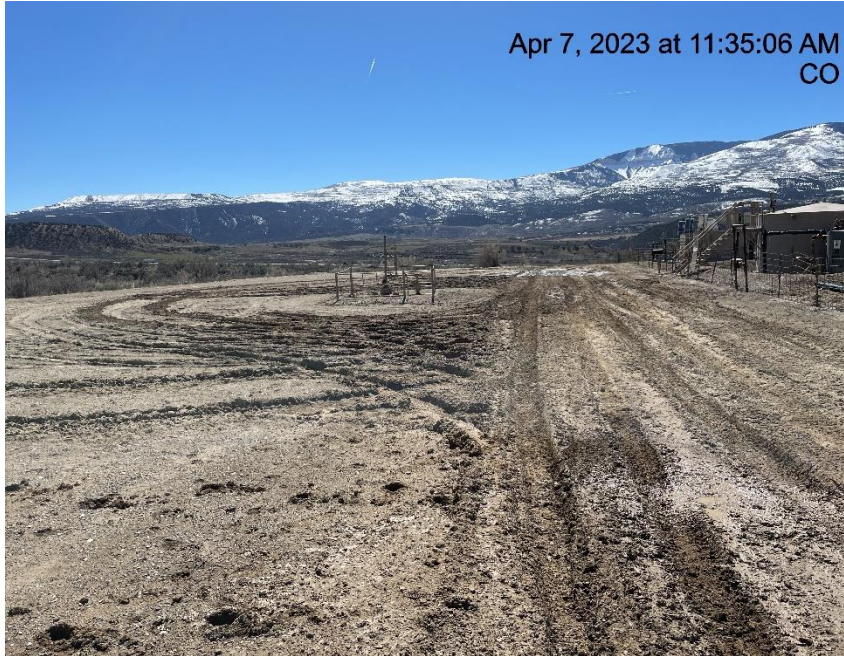
Photo # 4666 Lack of stabilization/compaction on location
