## Inspection Photos

Location Name: TEP ROCKY MOUNTAIN LLC CLOUGH RMV 217-21 pad

Location ID: 335213

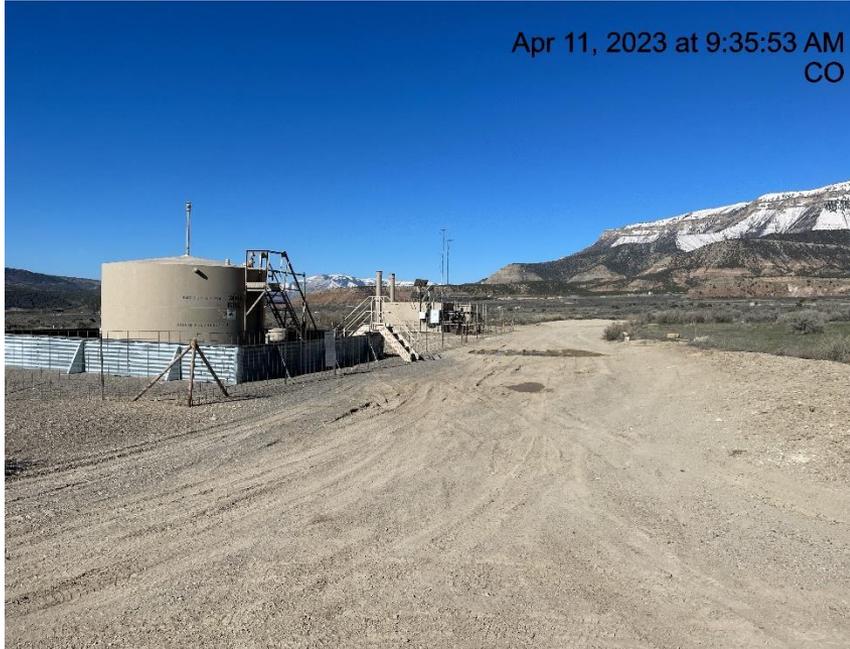
Photo # 4953 From entrance to location

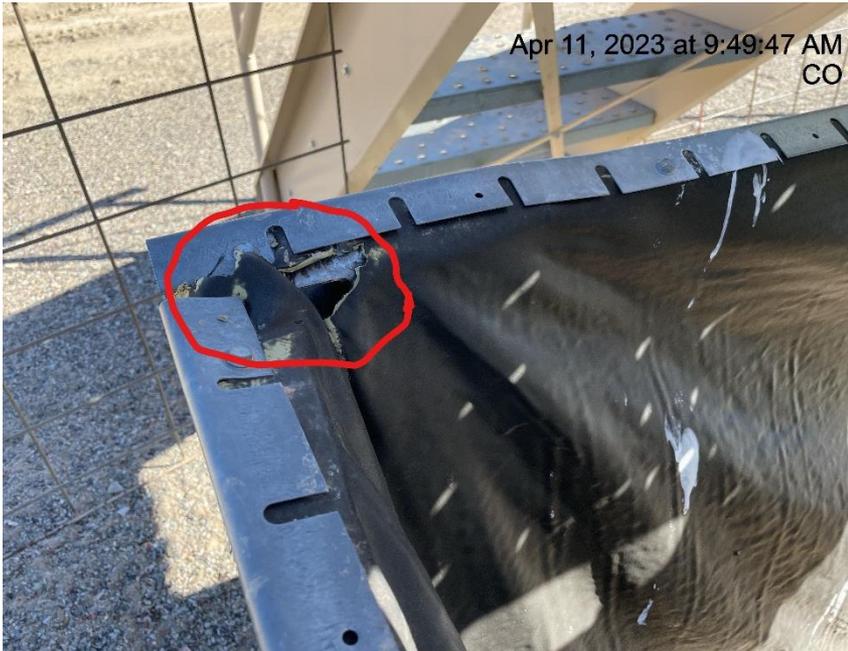
Photo # 4958 Containment liner needs maintenance

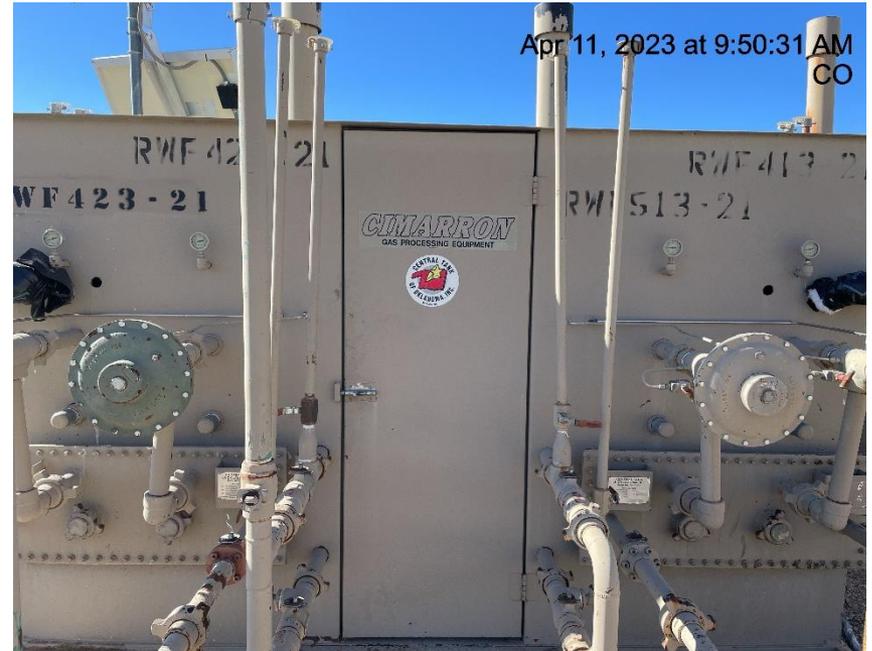
Photo # 4959 Meter calibration info not conspicuously posted

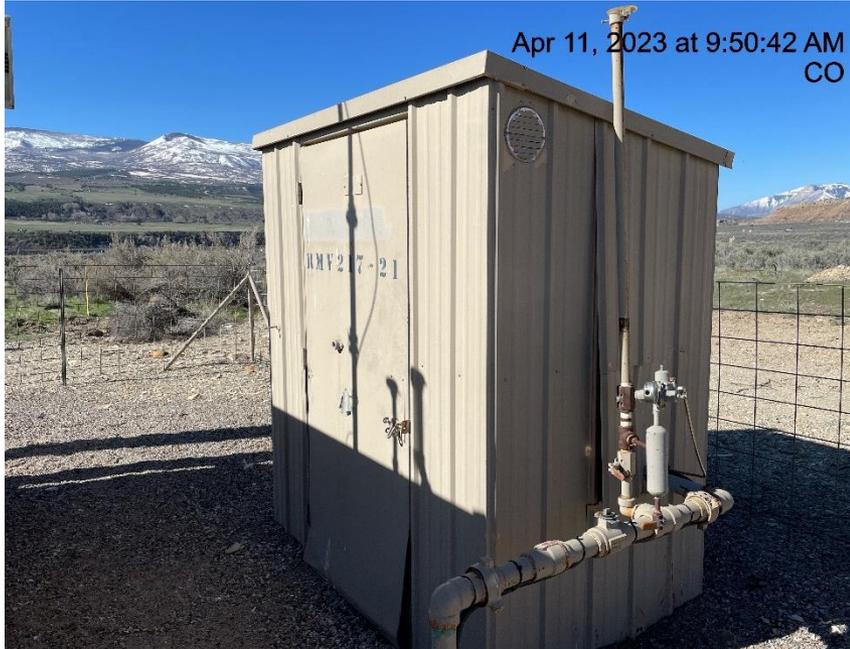
Photo # 4960 Meter calibration info not conspicuously posted

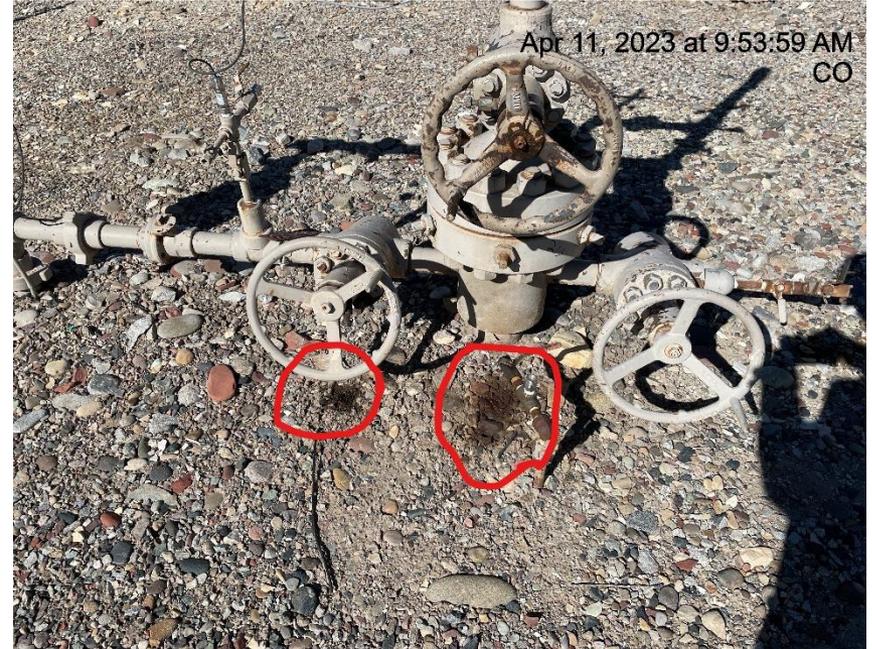
Photo # 4961 Stained soils & gravel

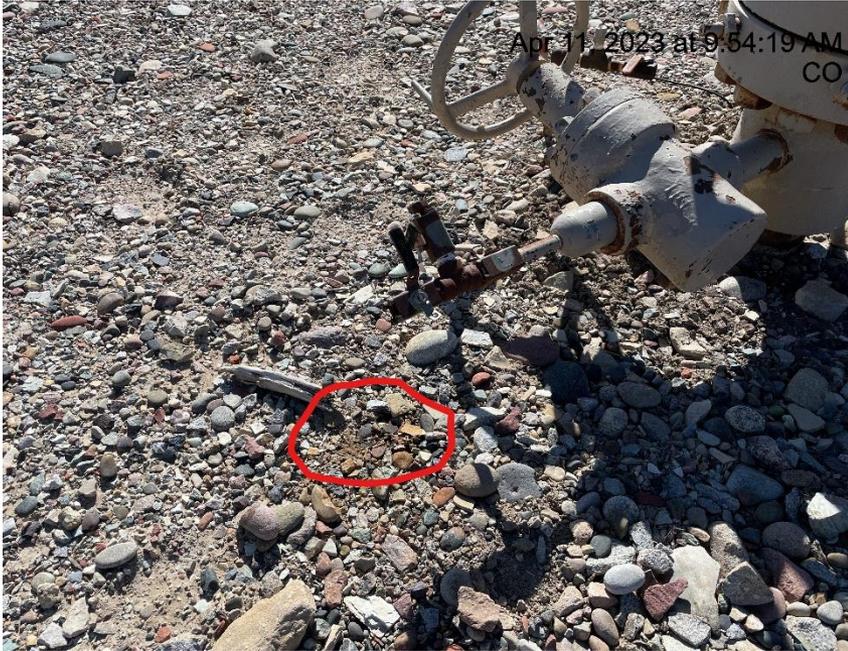
Photo # 4963 Stained soils & gravel

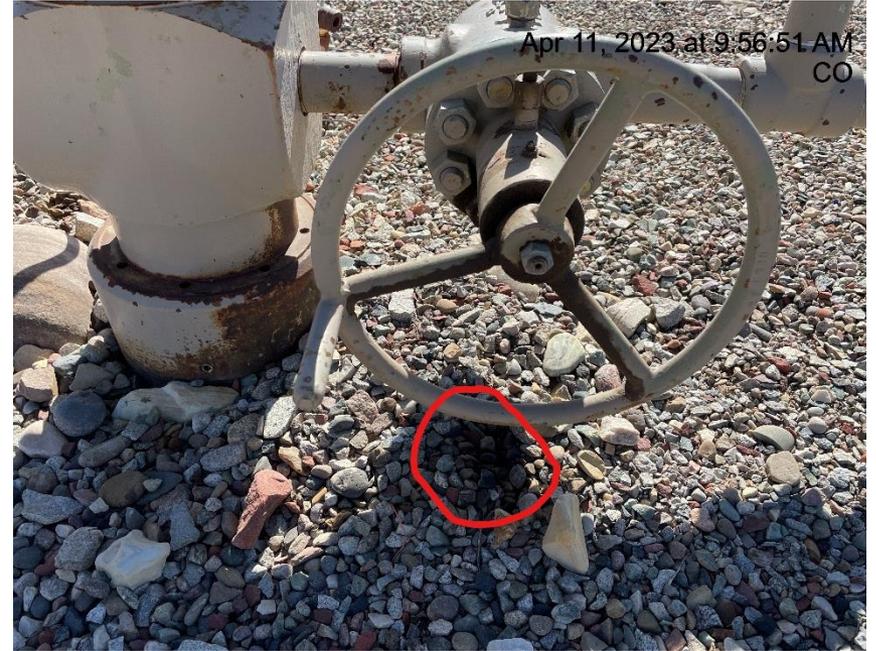
Photo # 4965 Stained soils & gravel

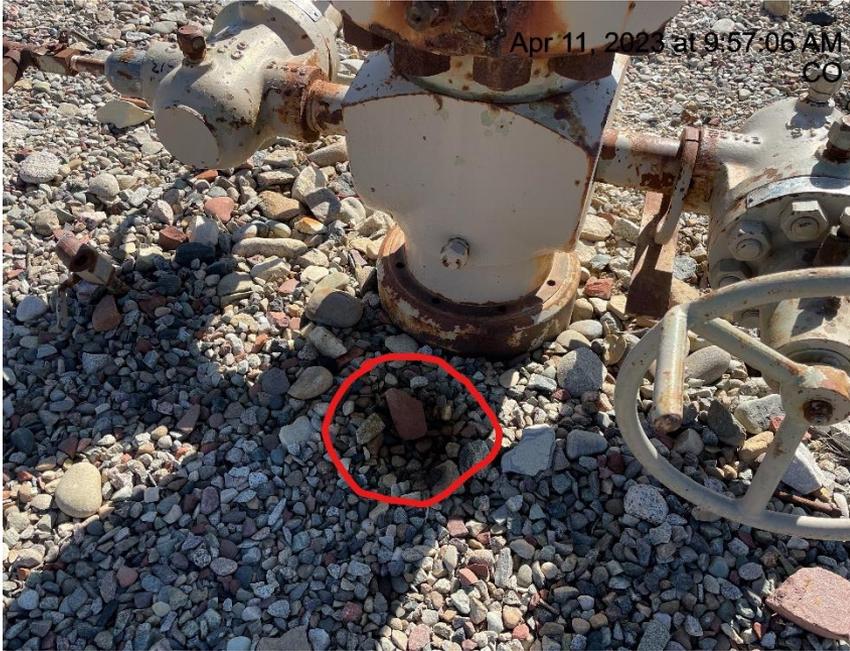
Photo # 4966 Stained soils & gravel

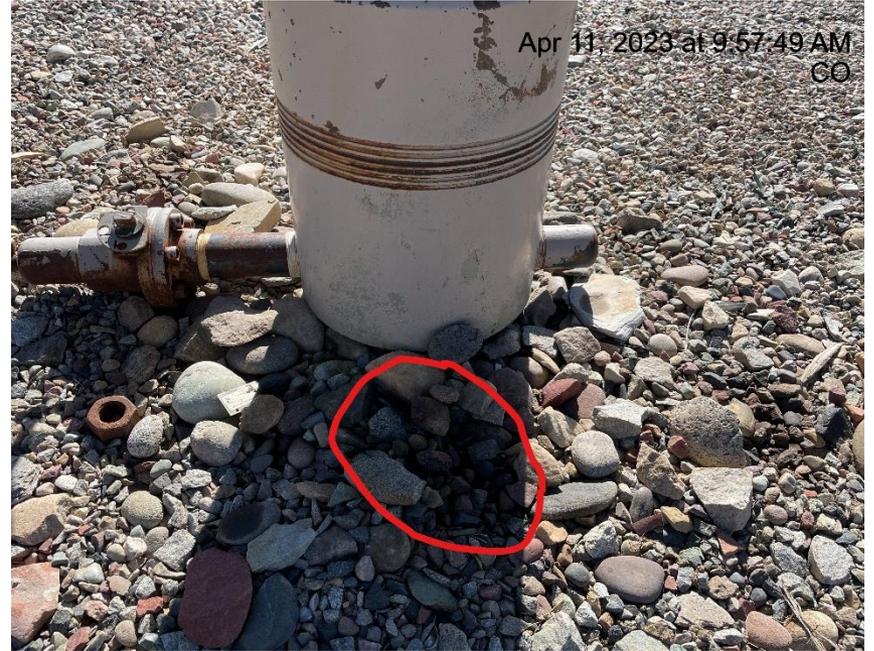
Photo # 4968 Stained soils & gravel

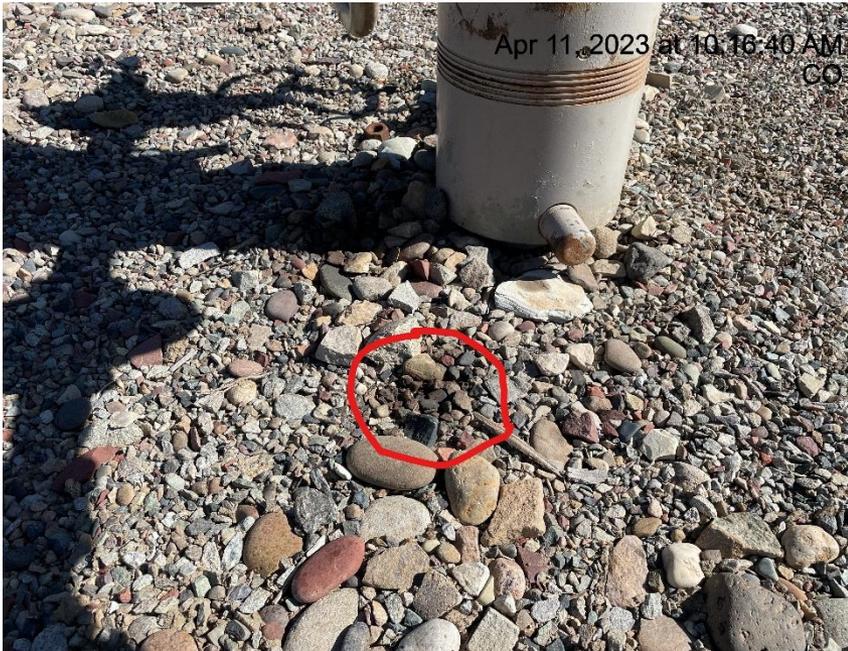
Photo # 4989 Stained soils & gravel

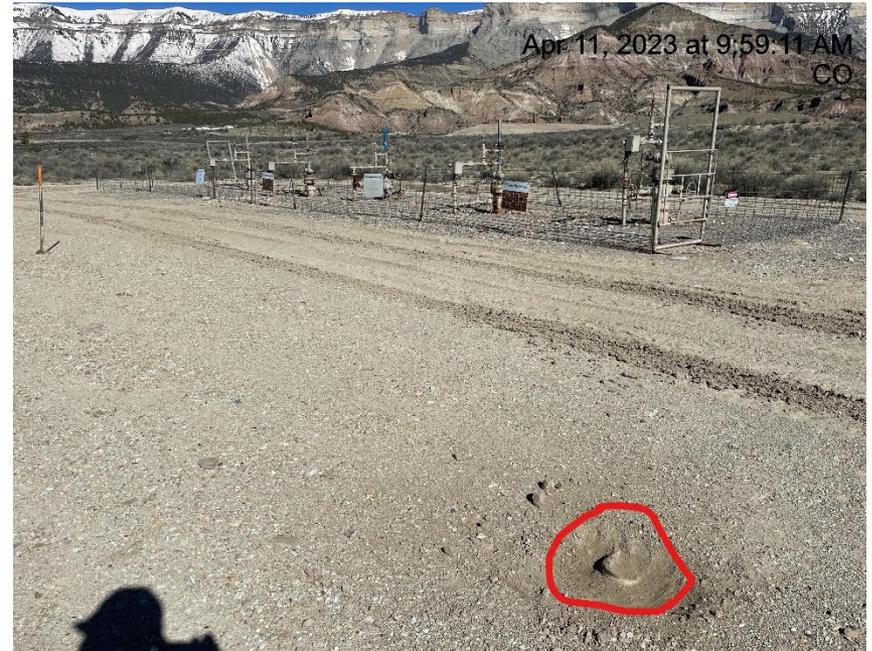
Photo # 4971 Unmarked deadman

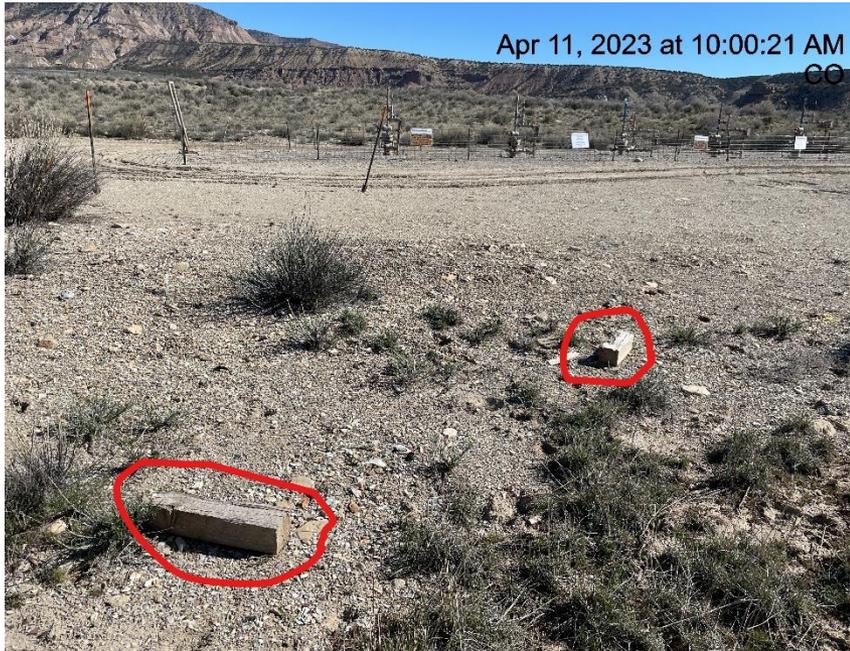
Photo # 4973 Debris

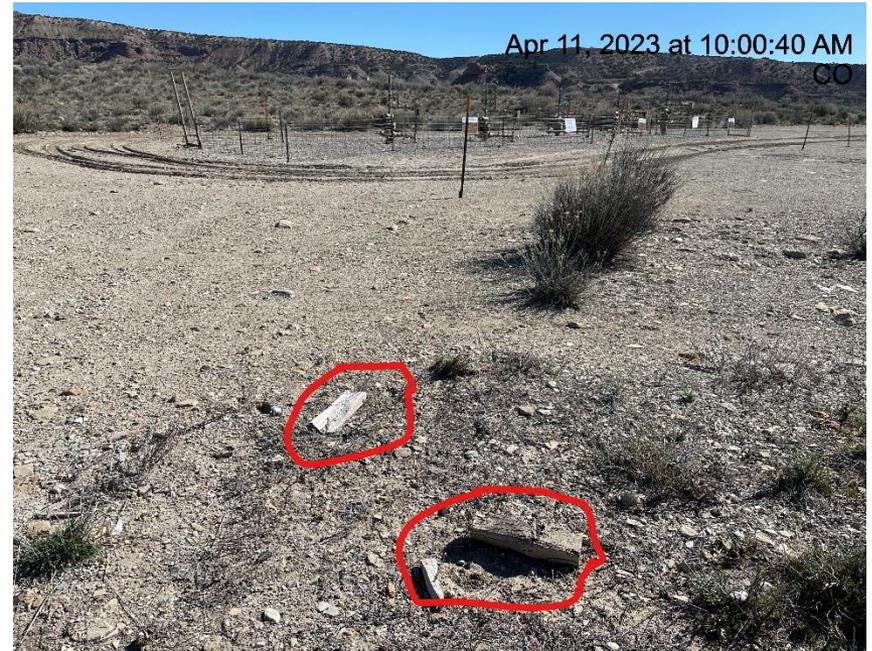
Photo # 4974 Debris

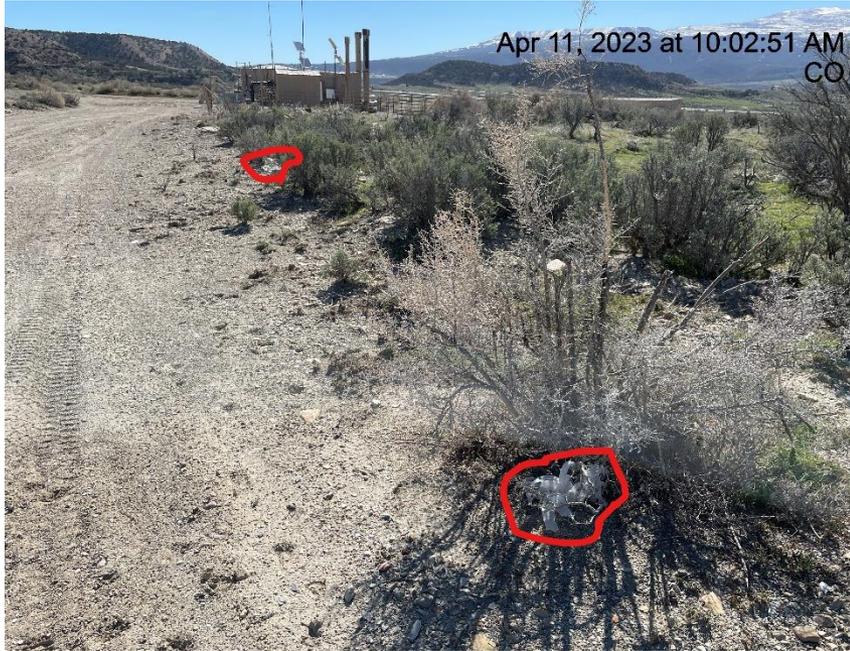
Photo # 4975 Debris

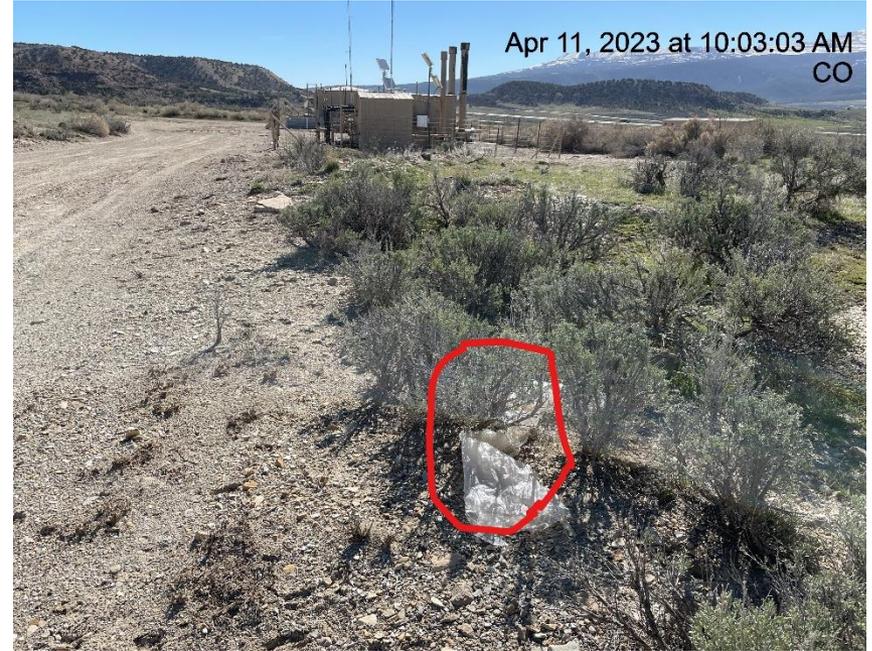
Photo # Debris

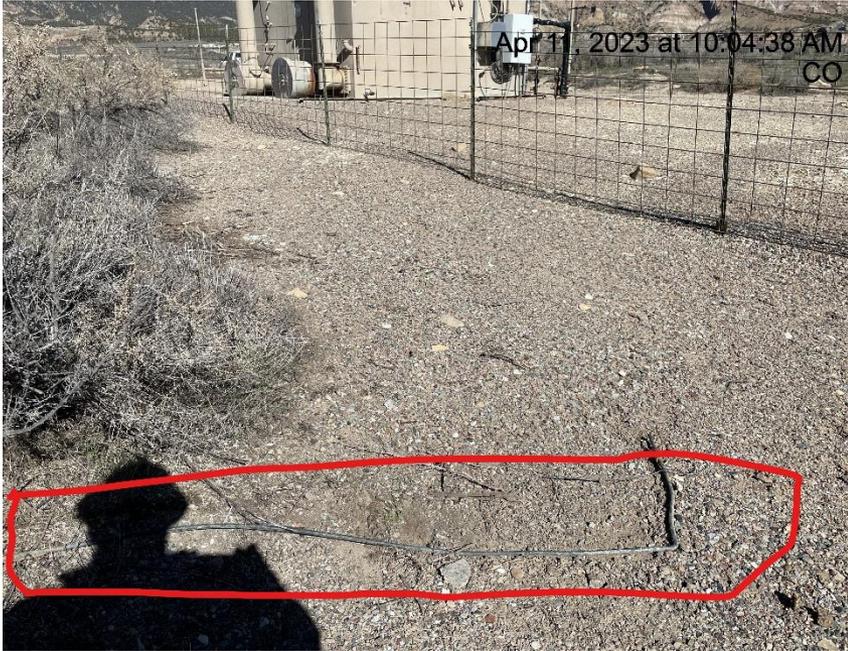
Photo # 4977 Debris

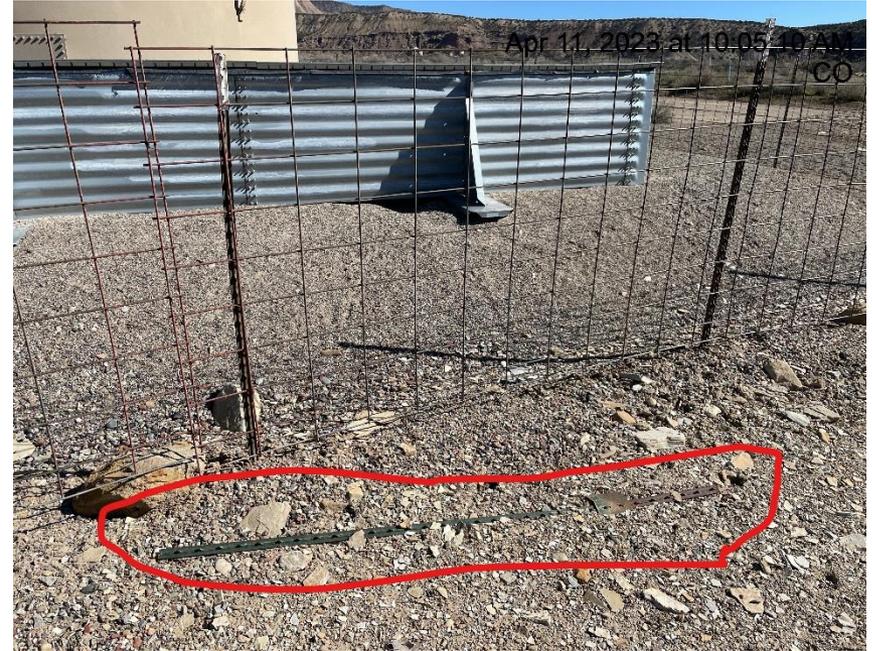
Photo # 4978 Debris

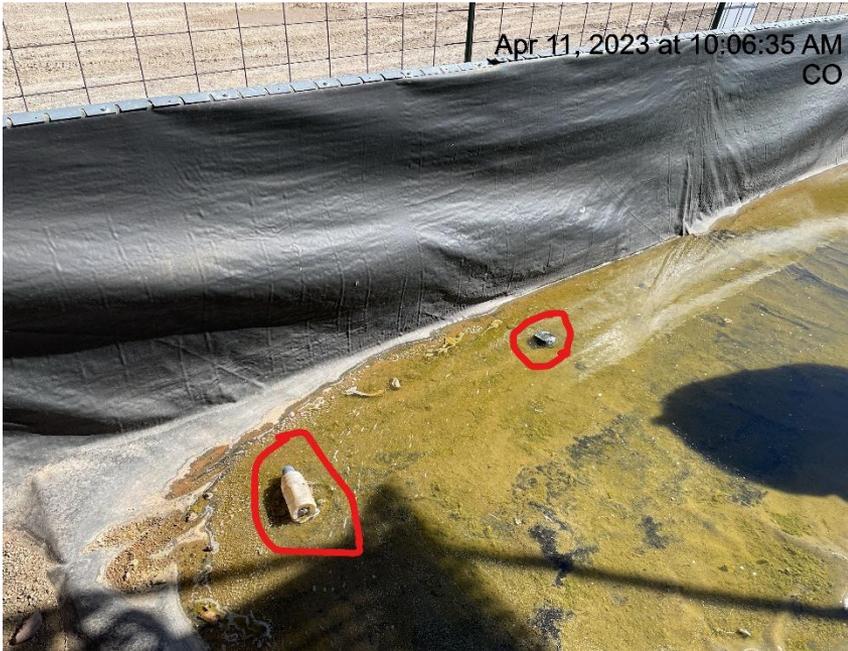
Photo # 4980 Debris

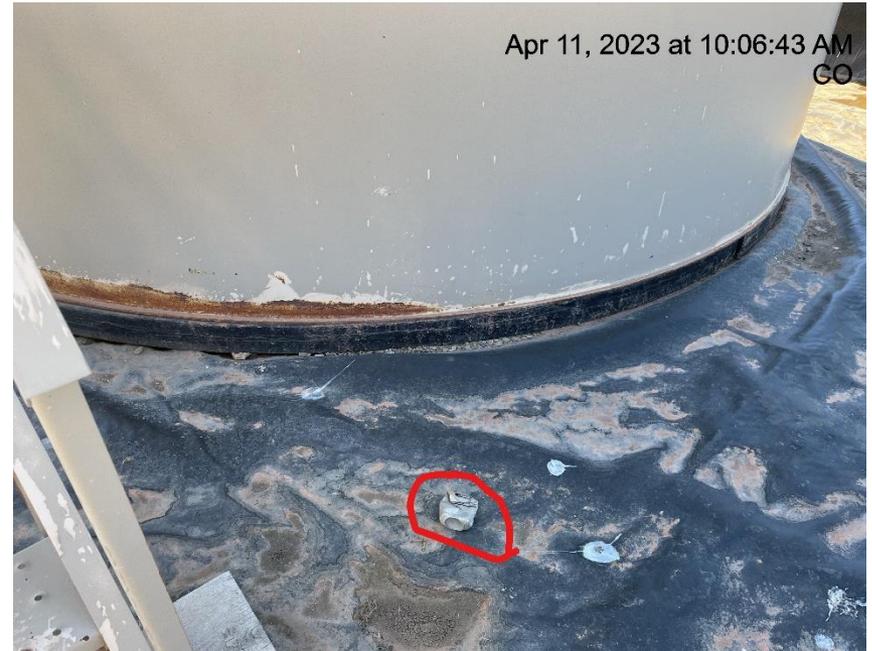
Photo # 4982 Debris

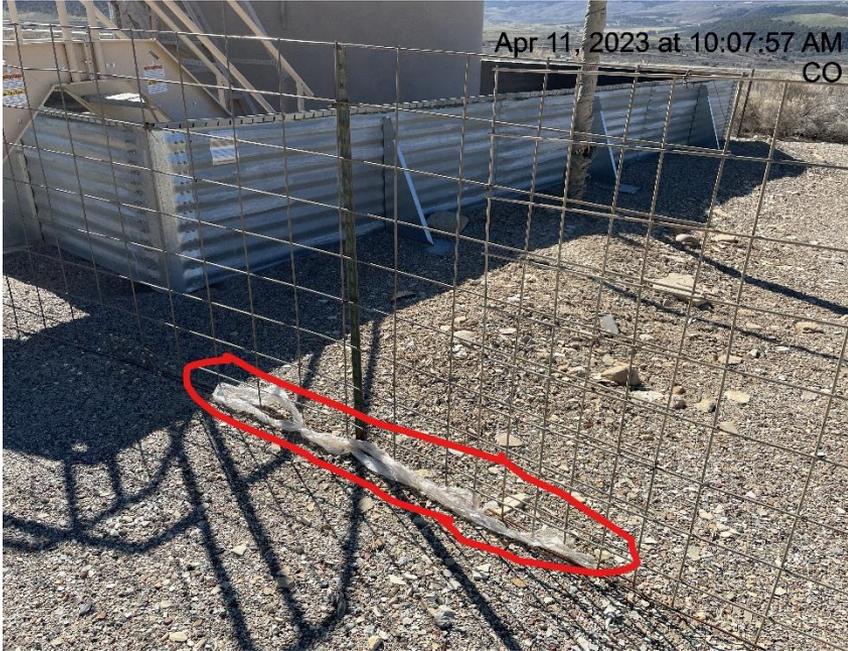
Photo # 4983 Debris
