Inspection Photos

API: 055-06105

Operator: OXY USA INC

Inspection Date: 4/10/2023

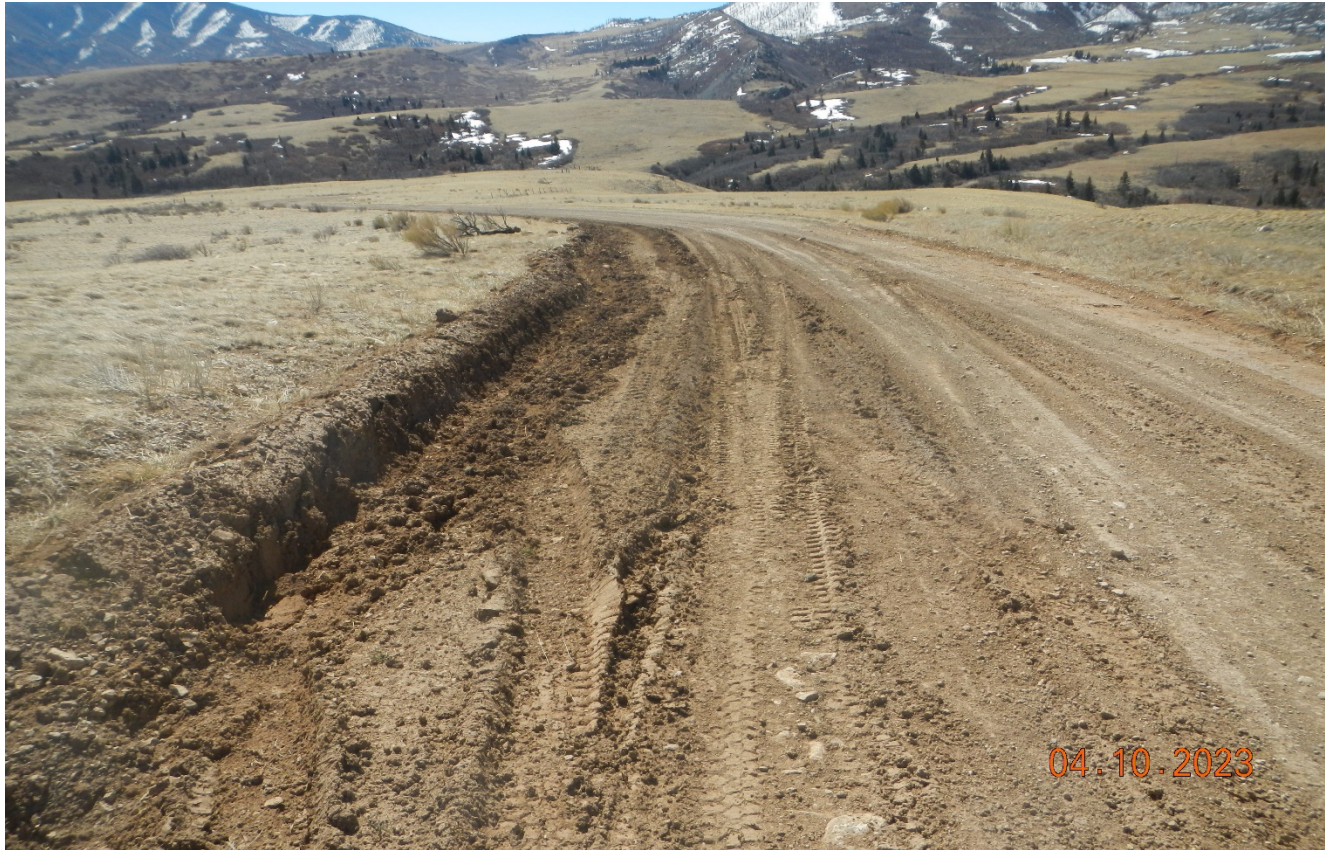
Photo 1. Facing south along the main road. It appears a vehicle slid off the road causing rutting disturbance that will need to be repaired.

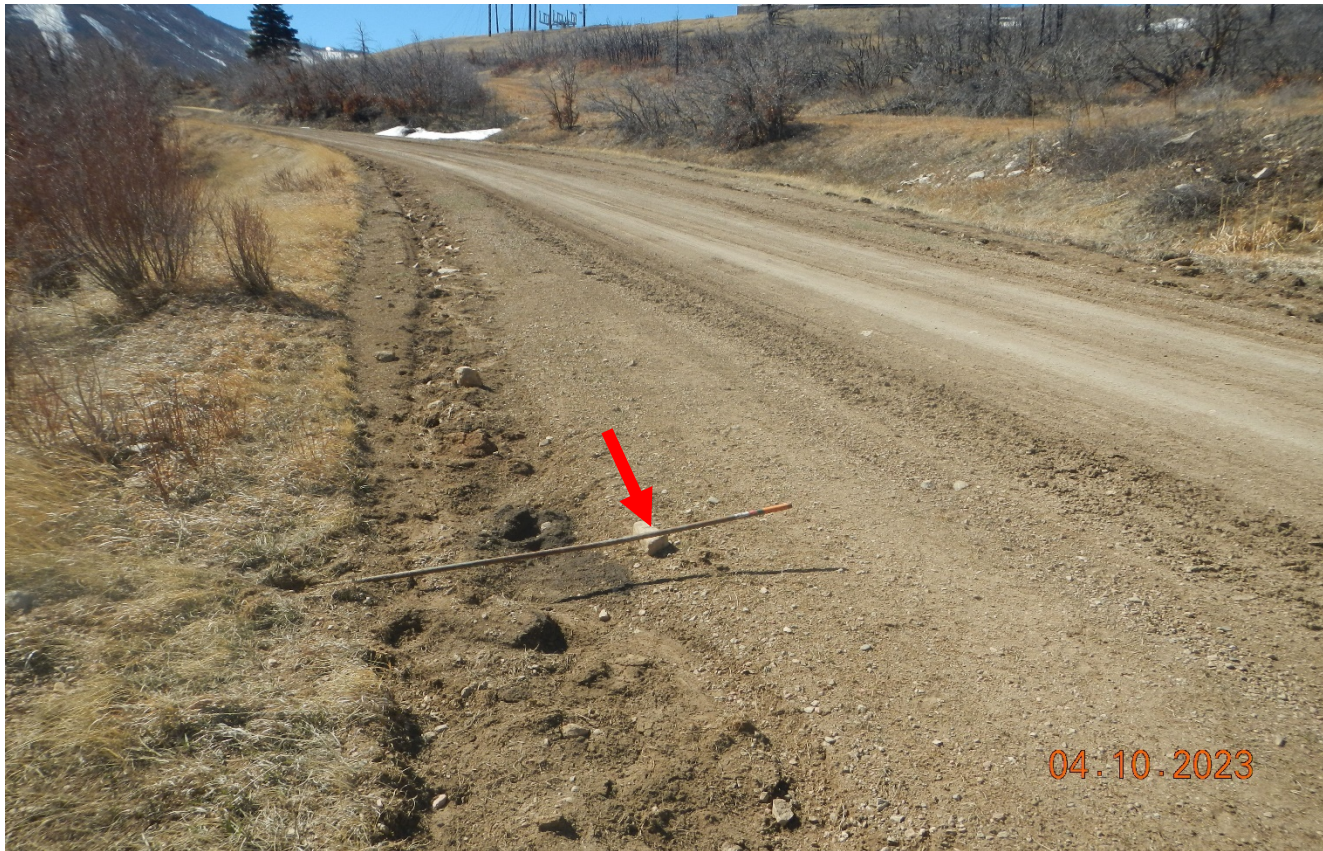
Photo 2. Facing southeast ascending the hill toward the location. There has been grading performed which has widened the road and pulled up the metal rebar which needs to be removed or repaired and made more visible.

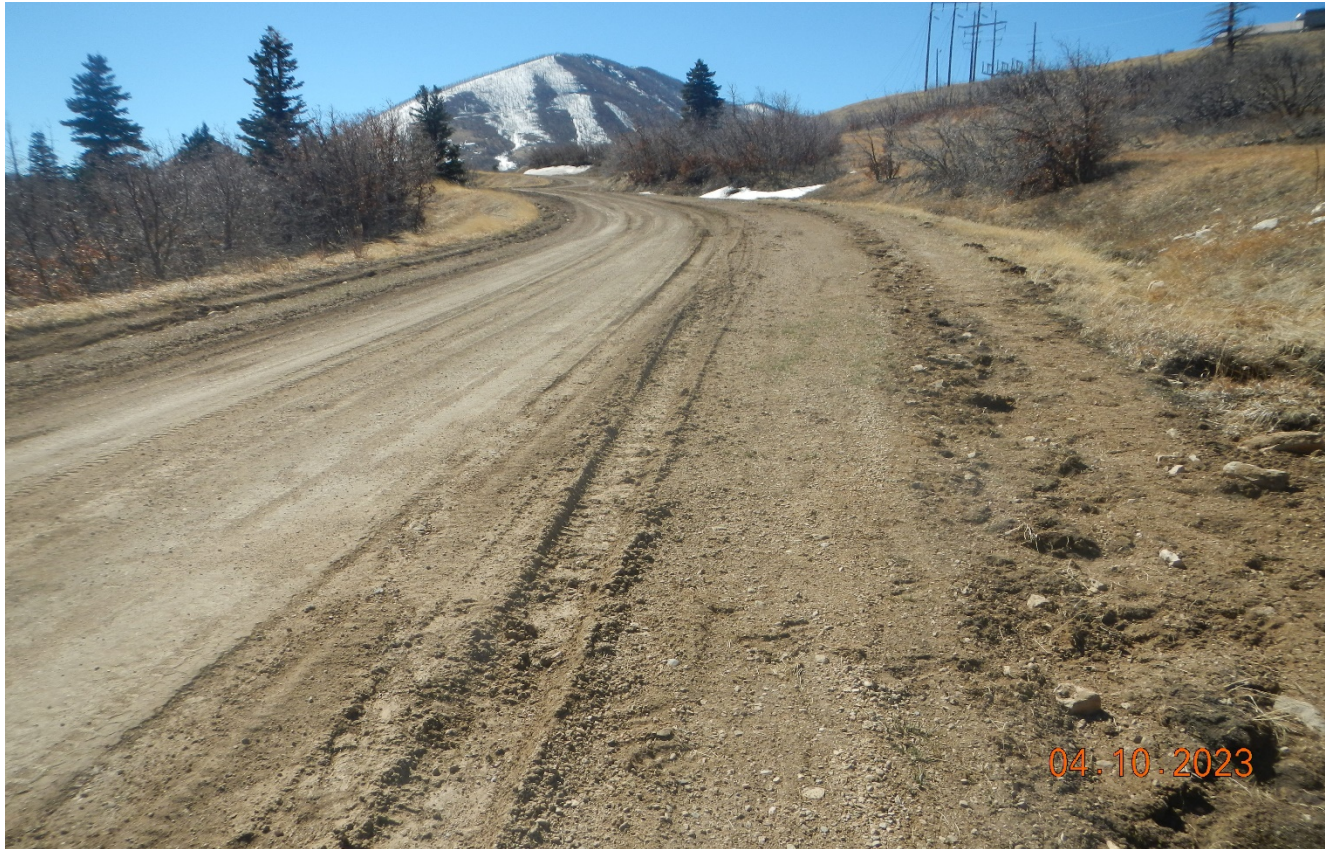
Photo 3. Facing southeast ascending the hill toward the location. The road has been widened along this area which will create more stormwater impact. Disturbance area of the road should be minimized.

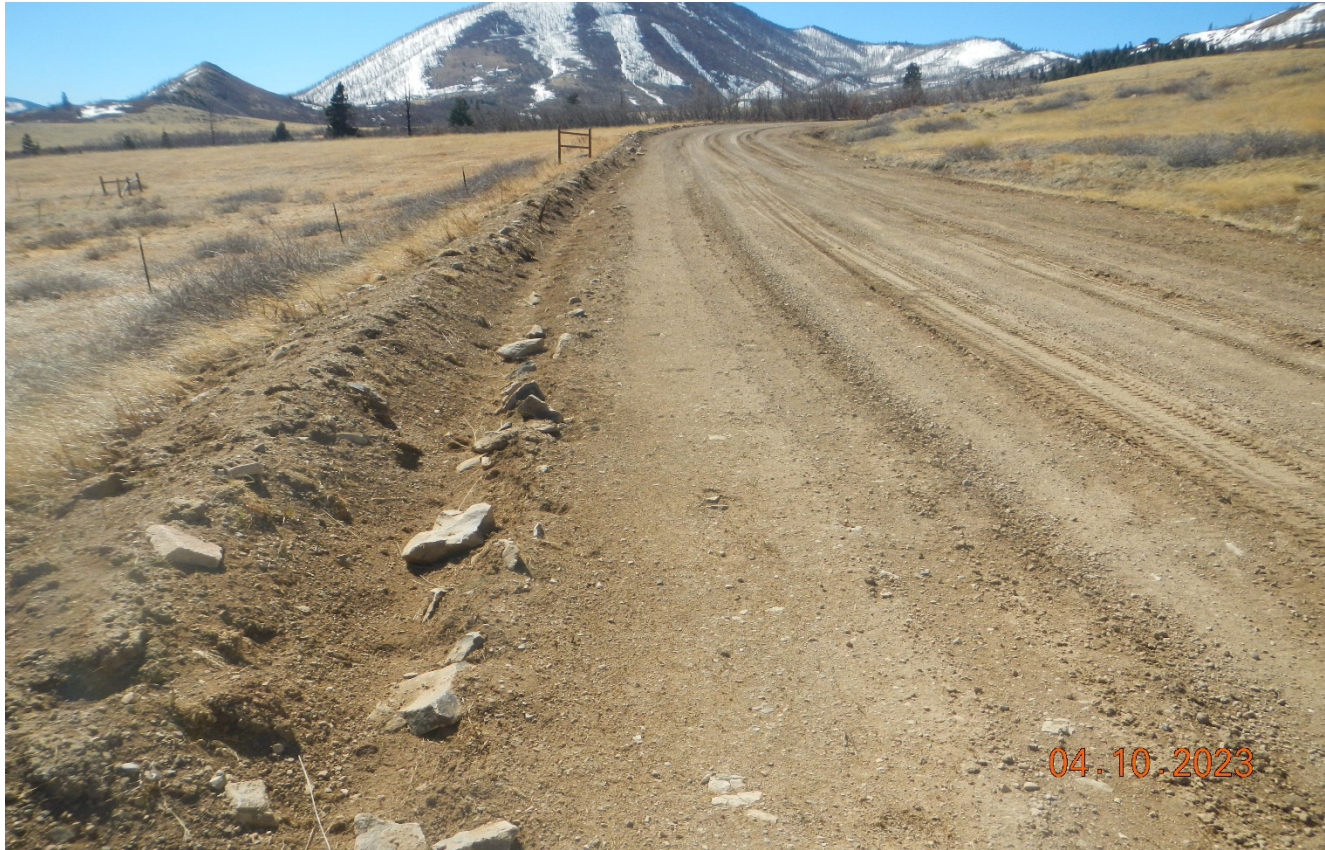
Photo 4. Facing southeast ascending the hill toward the location. Grading has pushed out material into a berm which is creating more of a disturbance and not allowing stormwater to be diverted off the road. There is a long stretch of the road where stormwater will be directed down the road which will cause erosion.

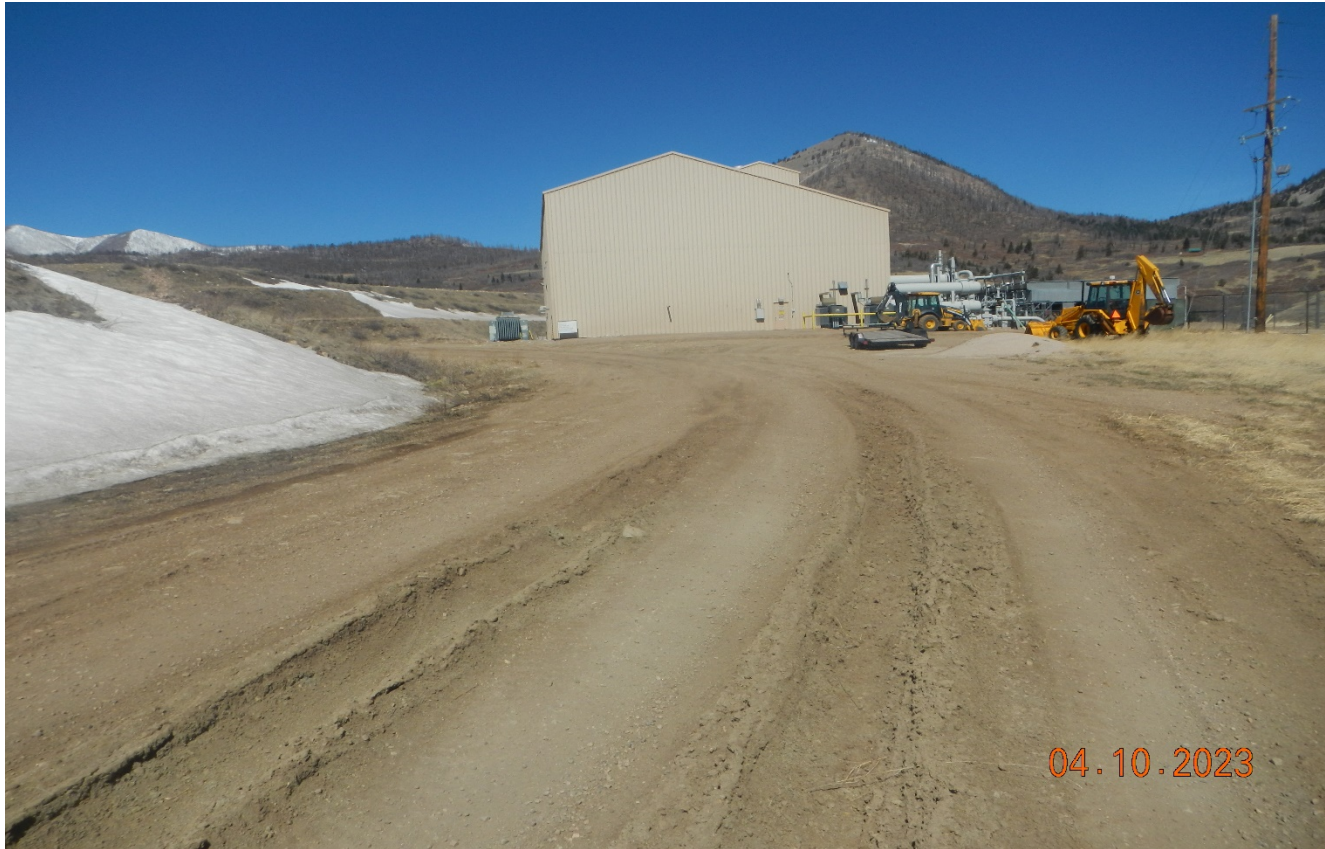
Photo 5. Facing northwest toward the compressor facility. There is vehicle ruts in this area that need to be repaired.

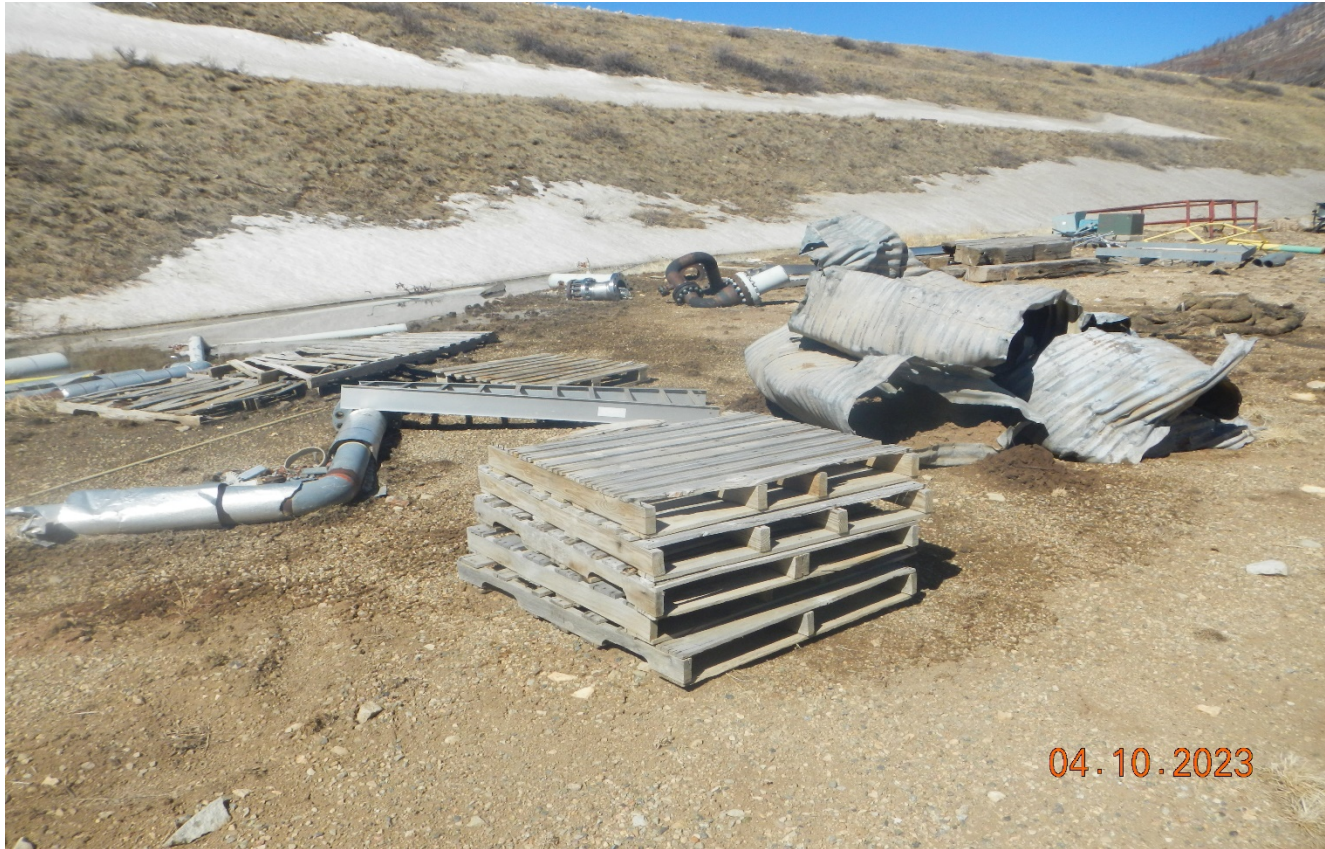
Photo 6. Facing northwest at the location. There is various unused equipment and trash debris stored in this area. The damaged culverts and degraded wattle are now stored in this area and need to be removed. Previous corrective action has not been completed.

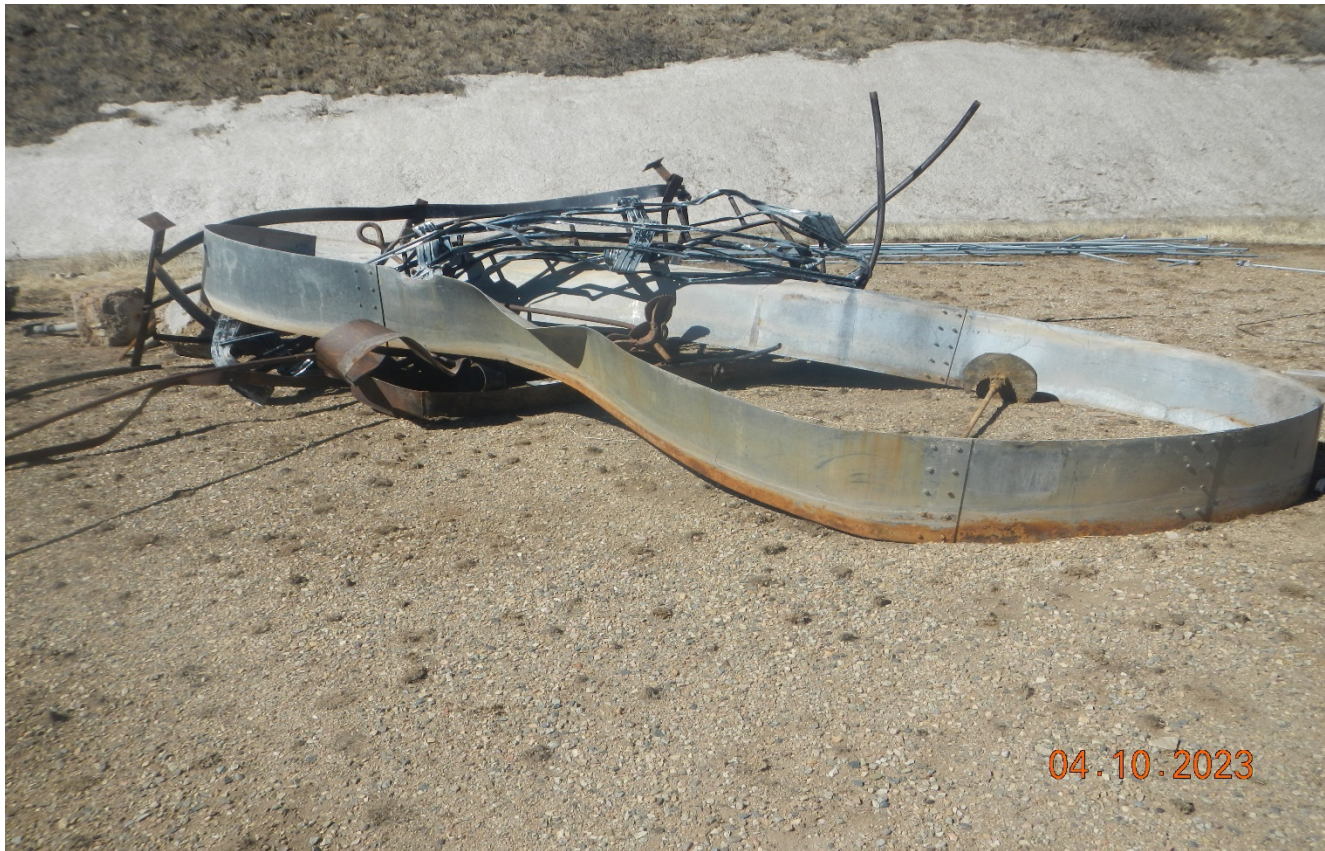
Photo 7. There is bent up metal stored in this area that needs to be removed.

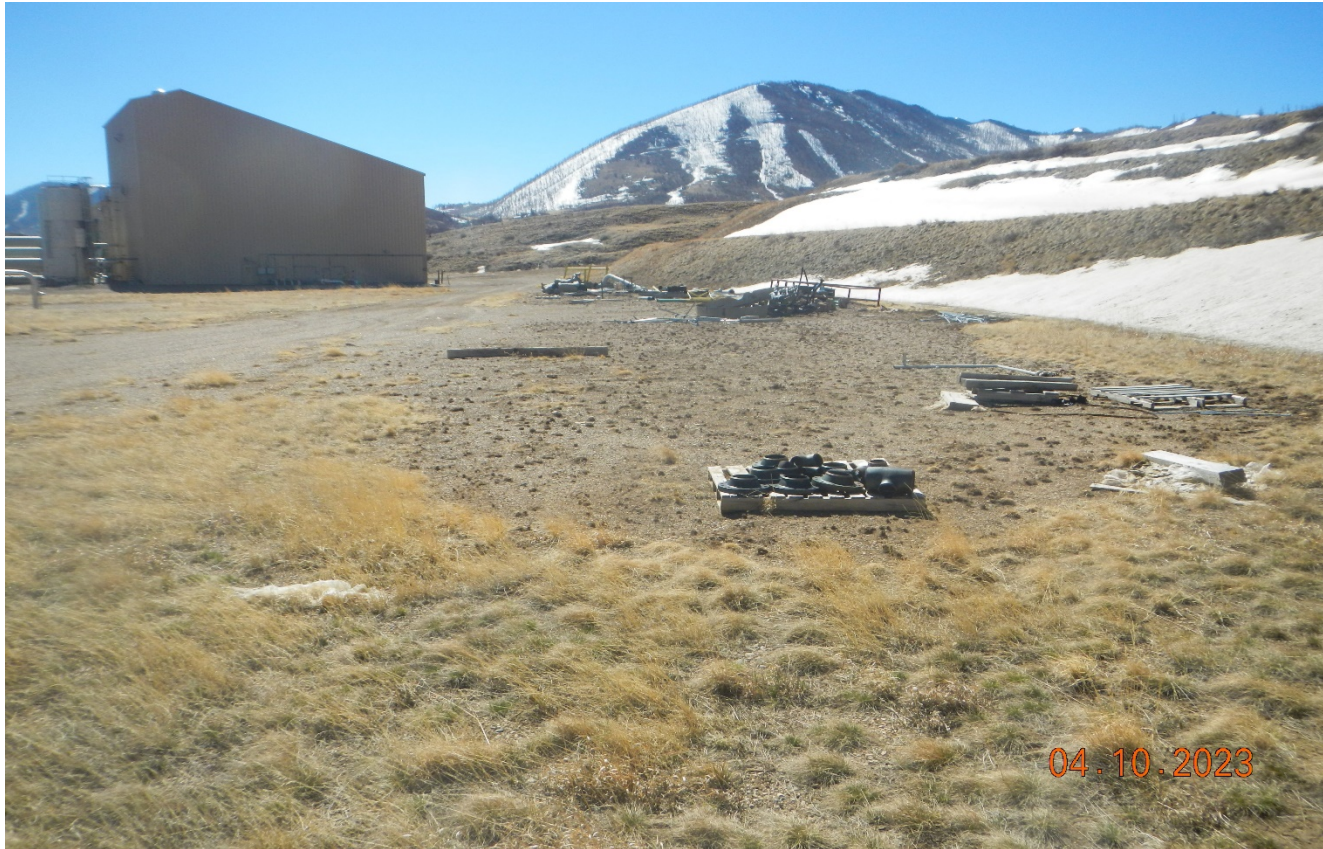
Photo 8. Facing back southeast at the location. The area of equipment storage needs to be reduced and disturbance area reclaimed.
