Interim Reclamation and Stormwater Inspection

April 7, 2023

Operator: UPLAND EXPLORATION LLC- #10701

Location ID: 456651

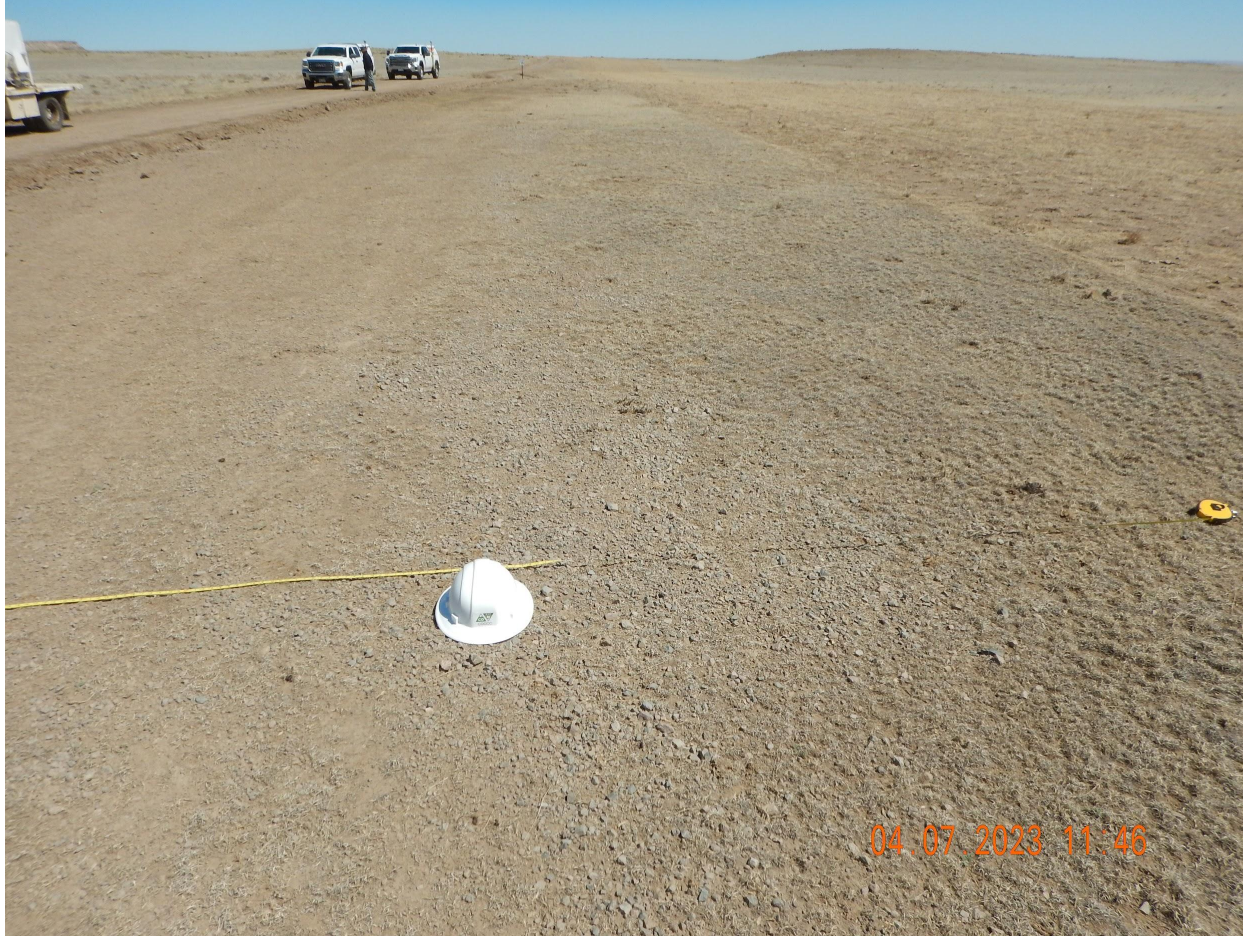
Photo 1. Photo taken from a section of the access road, facing East. Photo illustrates a section of the access road where rock remains, vehicle traffic and vegetation has been impacted. From the edge of the access road to the furthest disturbance point measured 30 feet. Refer to Photo 2 for a close up.

Note- At the time of this inspection, Operator believed no further work was required to remove rock outside of the access road. COGCC staff communicated to the Operator that more work was still required.

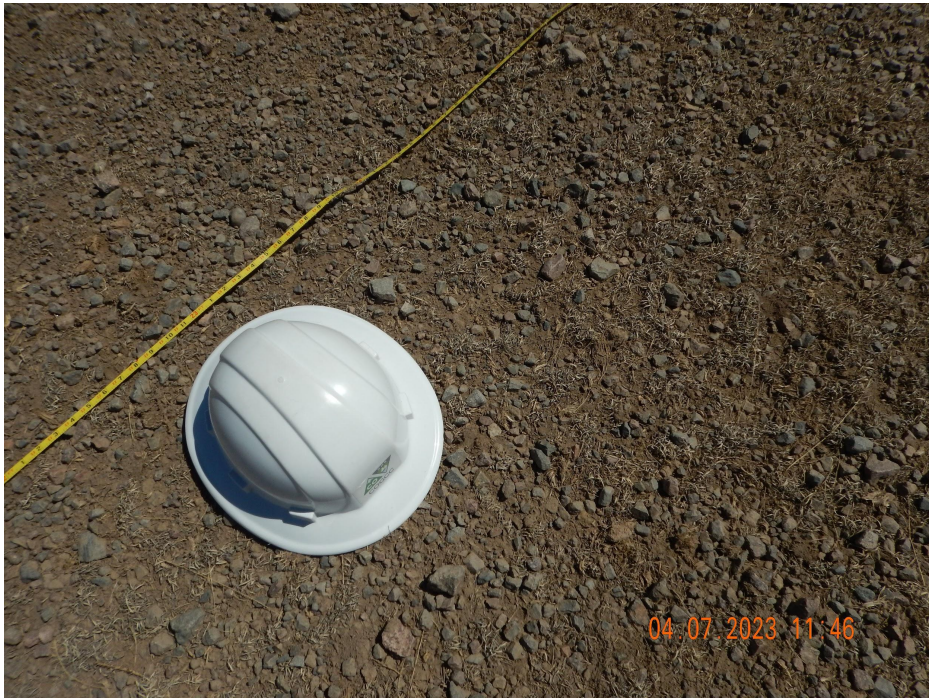
Photo 2. Close up photo taken from the 23 foot mark on the tape documenting rock that was pushed off the access road onto pasture land that still needs to be removed and will require additional seeding.

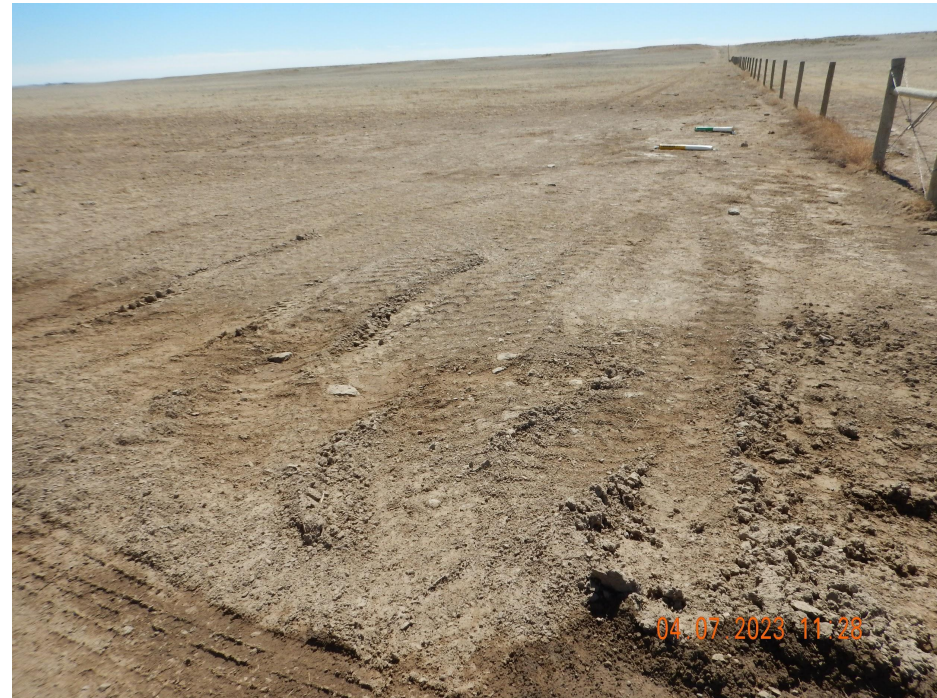
Photo 3. Photo taken from a section of the access road, facing South. Photo illustrates unauthorized vehicle traffic off the access road.
Note- COGCC staff witnessed more vehicle traffic off the access road than the previous inspection.

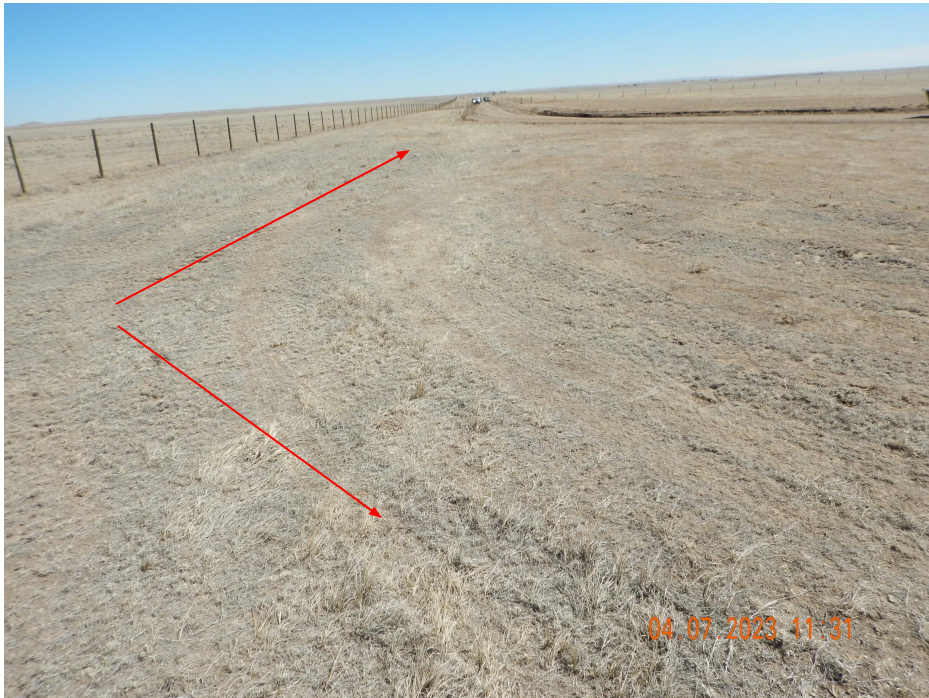
Photo 4. Photo taken from a section of the access road, facing East. Photo illustrates unauthorized vehicle traffic off the access road. It appears vehicles have been turning around at this area.

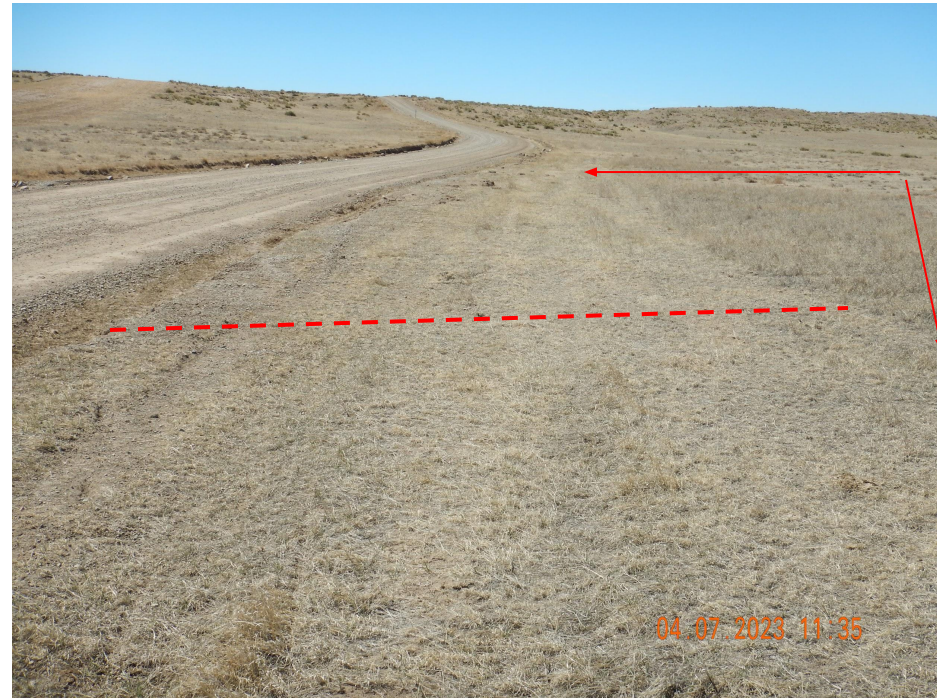
Photo 5. Photo taken from a section of the access road, facing West. See comments under Photo 4.

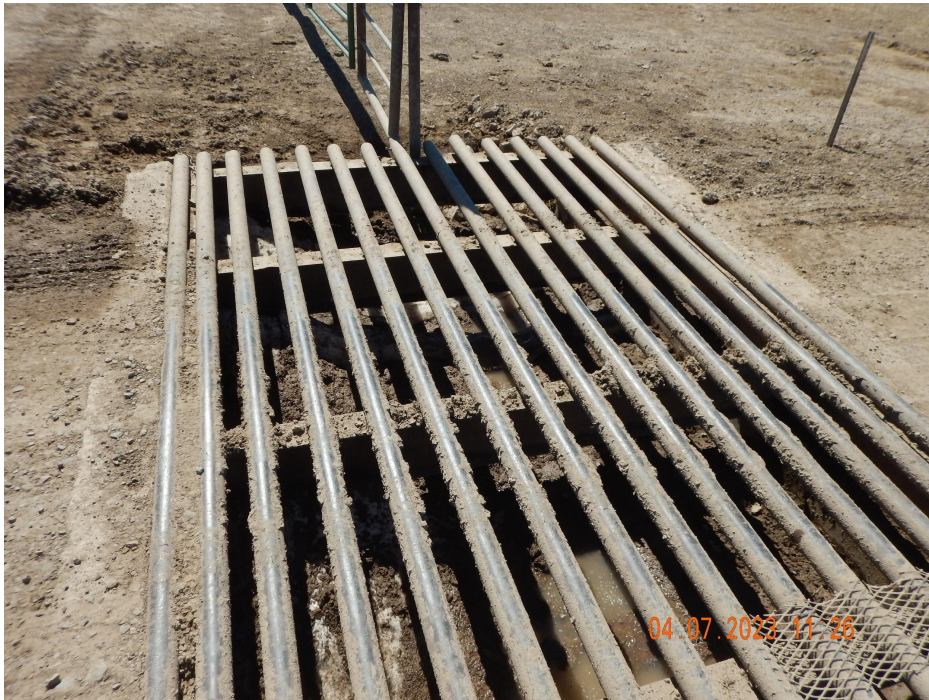
Photo 6. Photo taken from a section of the access road, facing South. Photo illustrates the cattle guard has been cleaned out.

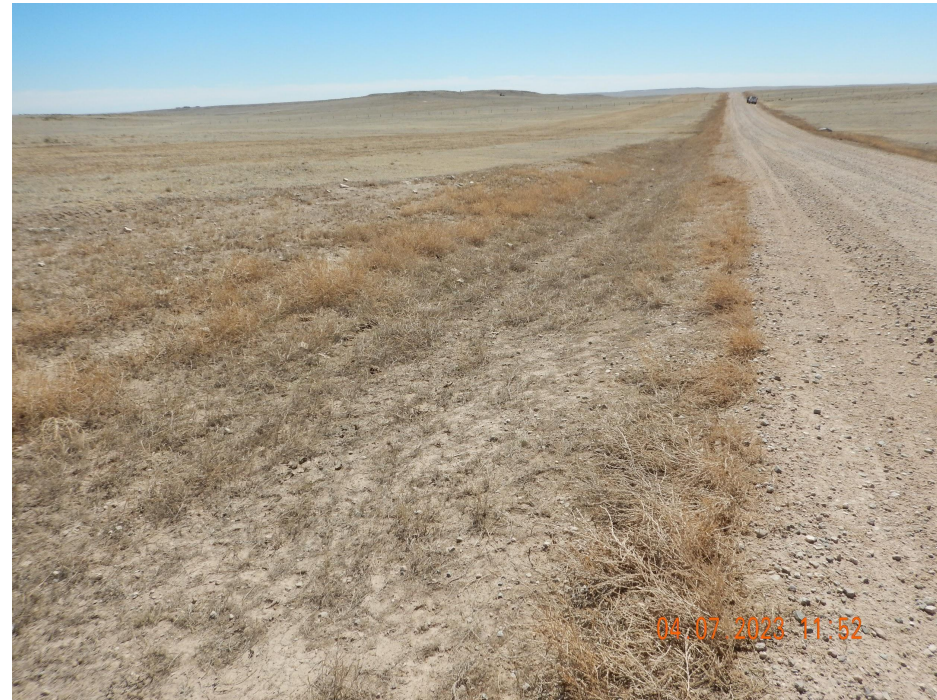
Photo 7. Photo taken from a section of the access road, facing South. Photo illustrates the weed establishment along the access road ditch. Operator was in process of raking out the weeds. Refer to Photo 8.

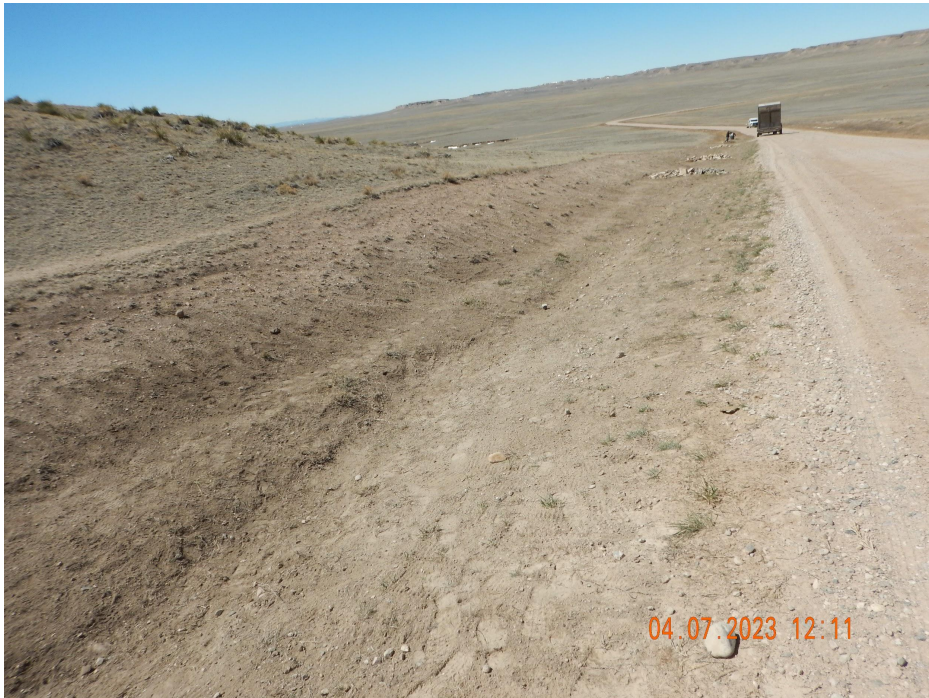
Photo 8. Photo taken from a section of the access road, facing Northwest. Photo illustrates weed debris is being raked out and put into a covered trailer.

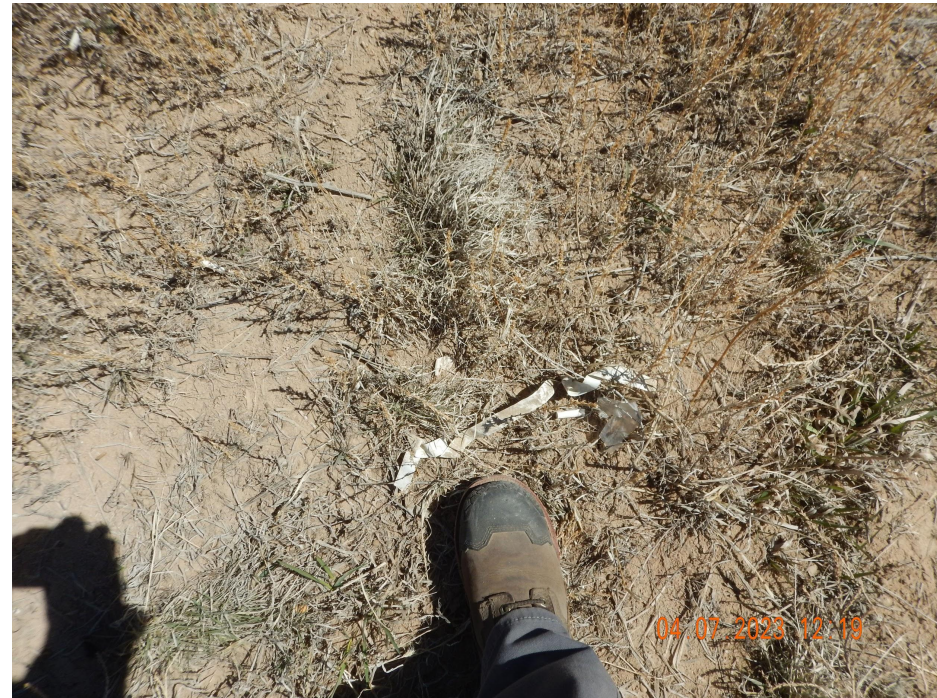
Photo 9. Photo taken from a section of the stormwater BMP area illustrating trash. COGCC staff had a total of four photos of trash outside of containment.

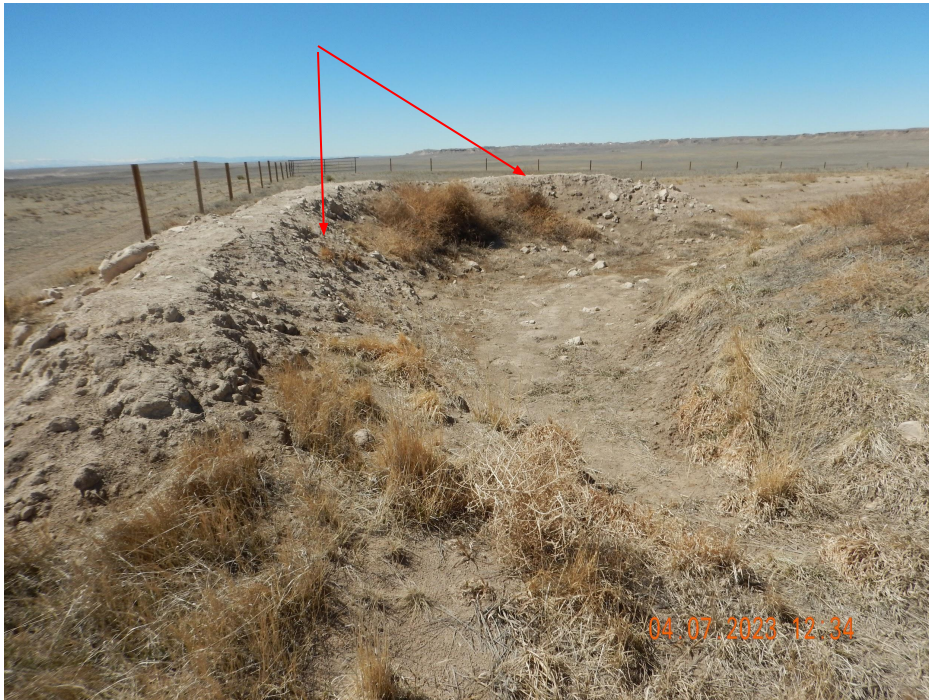
Photo 10. Photo taken from the southwestern location, facing West. Photo illustrates weed establishment (weed debris) within the sediment trap area.

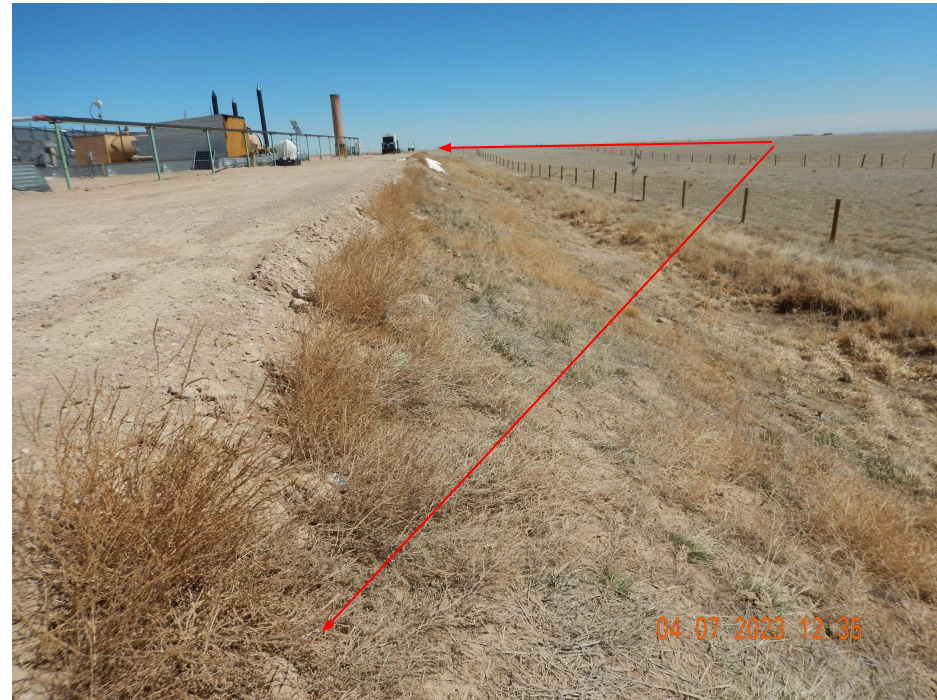
Photo 11. Photo taken from southern fill slope, facing East. Photo illustrates weed establishment (weed debris) along the top fill slope.

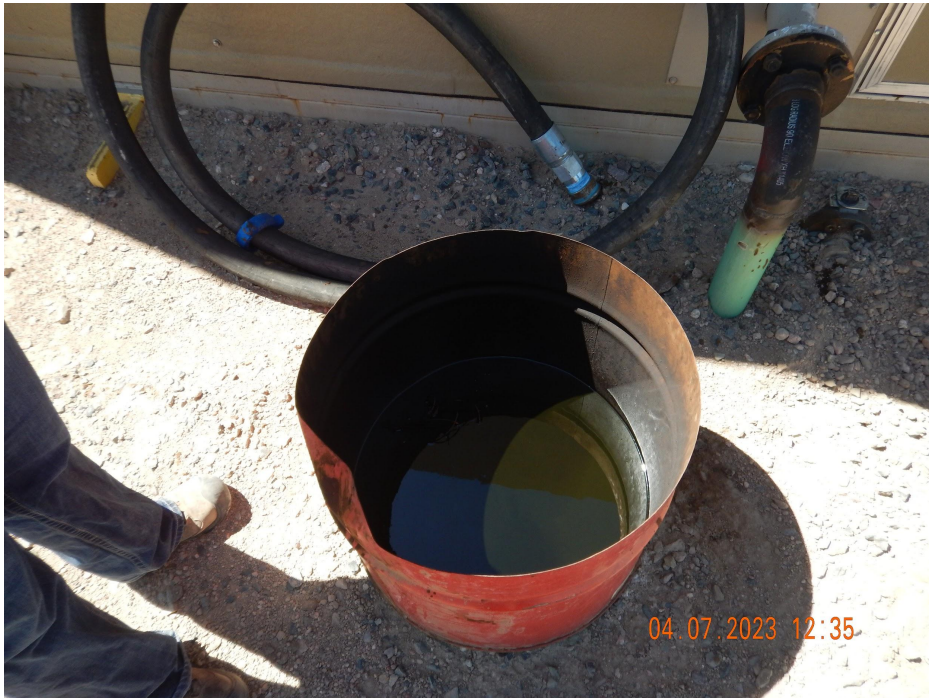
Photo 12. Photo taken from the production areas illustrating an open bucket with oil without wildlife netting.

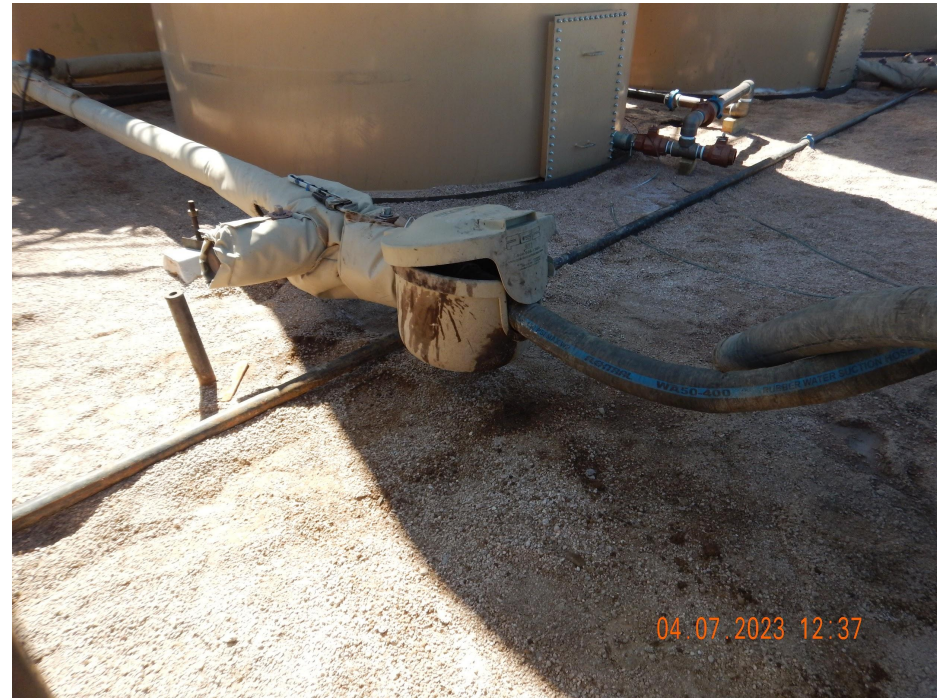
Photo 13. Photo taken from the production area illustrating a load out line hooked up. Oily waste underneath the load out shall also be cleaned up.

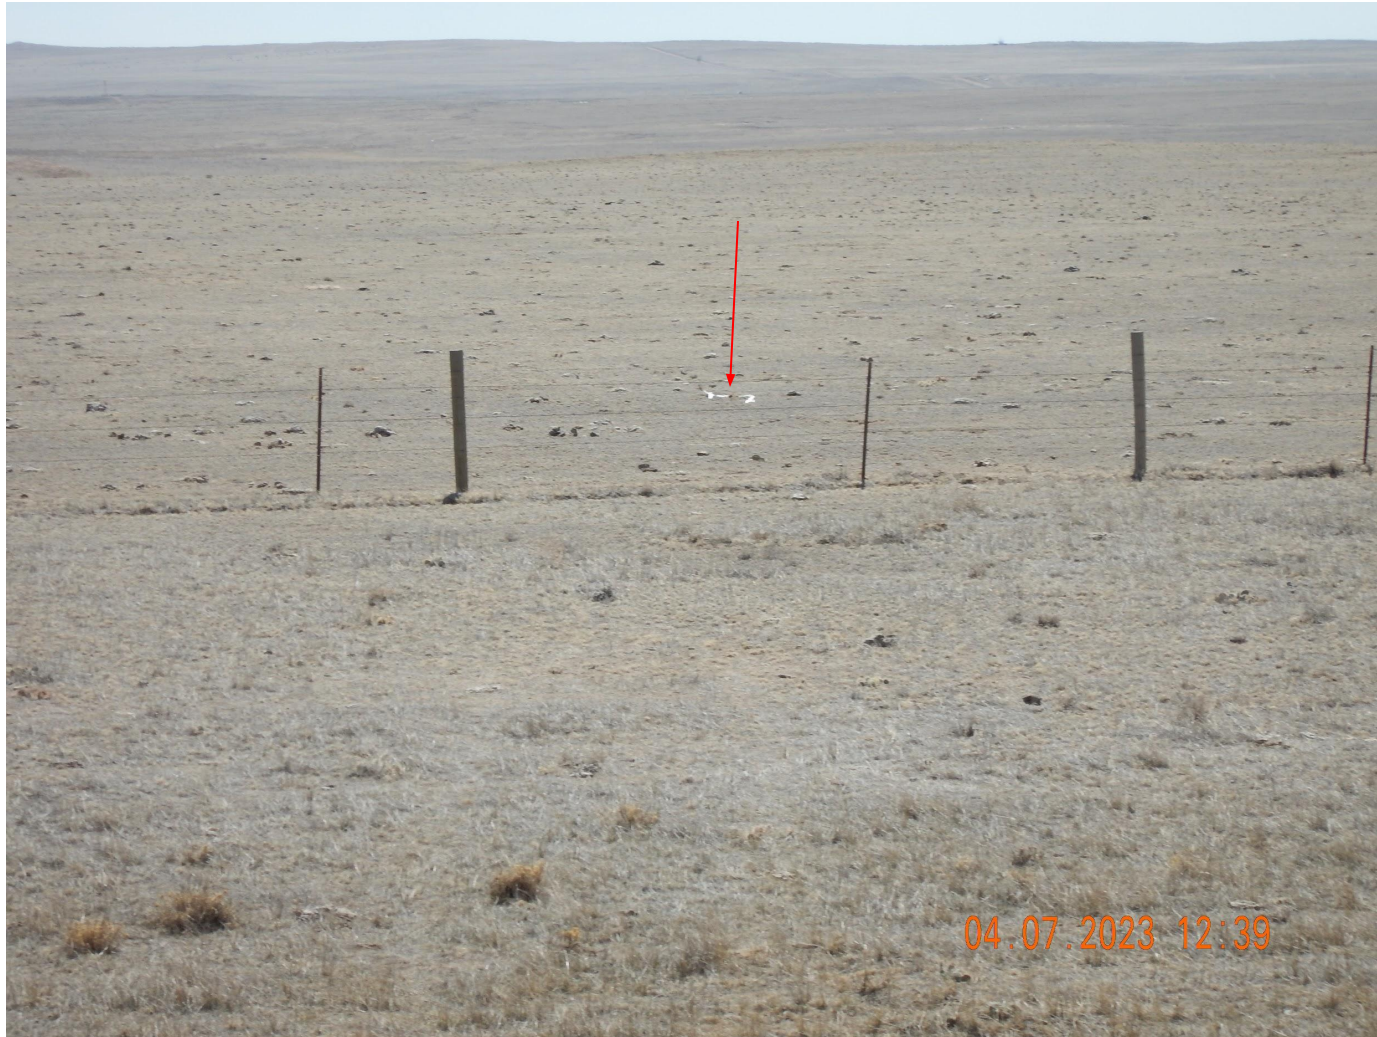
Photo 14. Photo taken from the southern location, facing South. Photo illustrates trash that has blown off location.

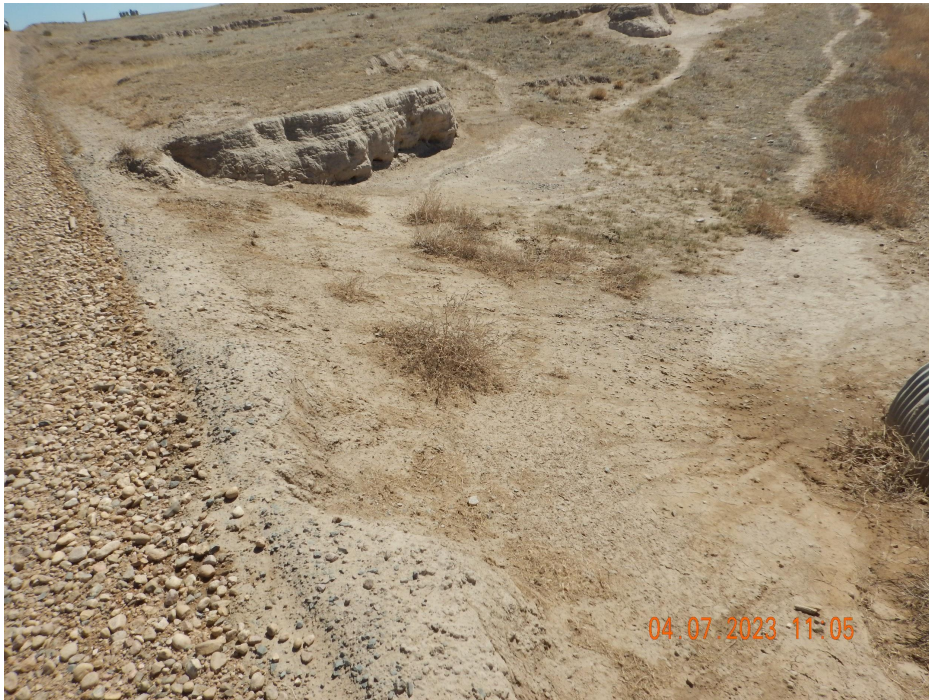
Photo 15. Photo taken from Geary Creek, facing East. Photo illustrates the Operator has imported additional road base to stabilize the road but the remainder of the other work to install additional BMPs is planned.

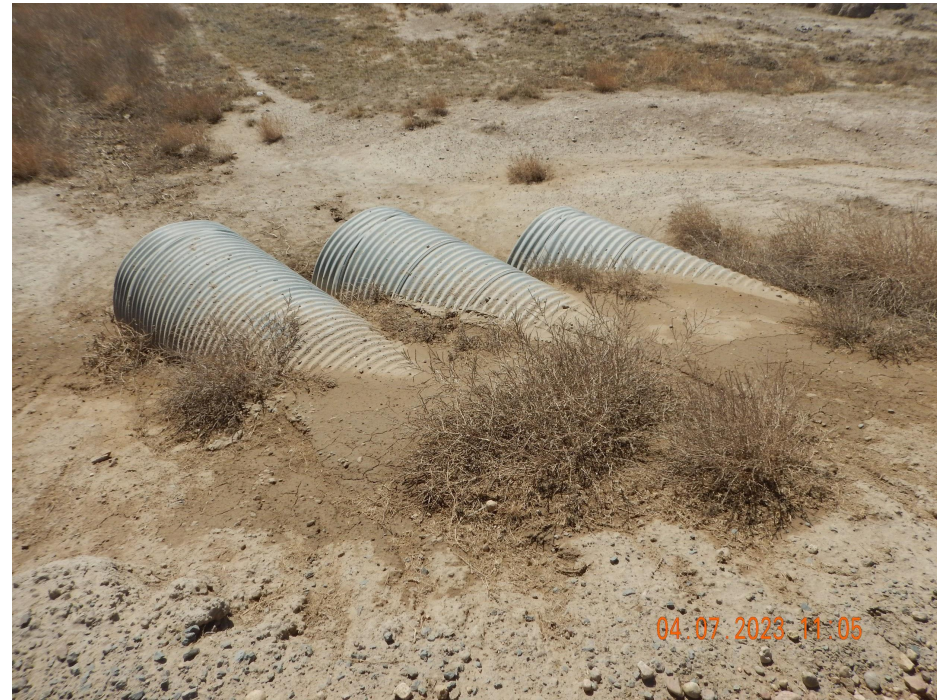
Photo 16. Photo taken from Geary Creek, facing South. See comments under Photo 15.

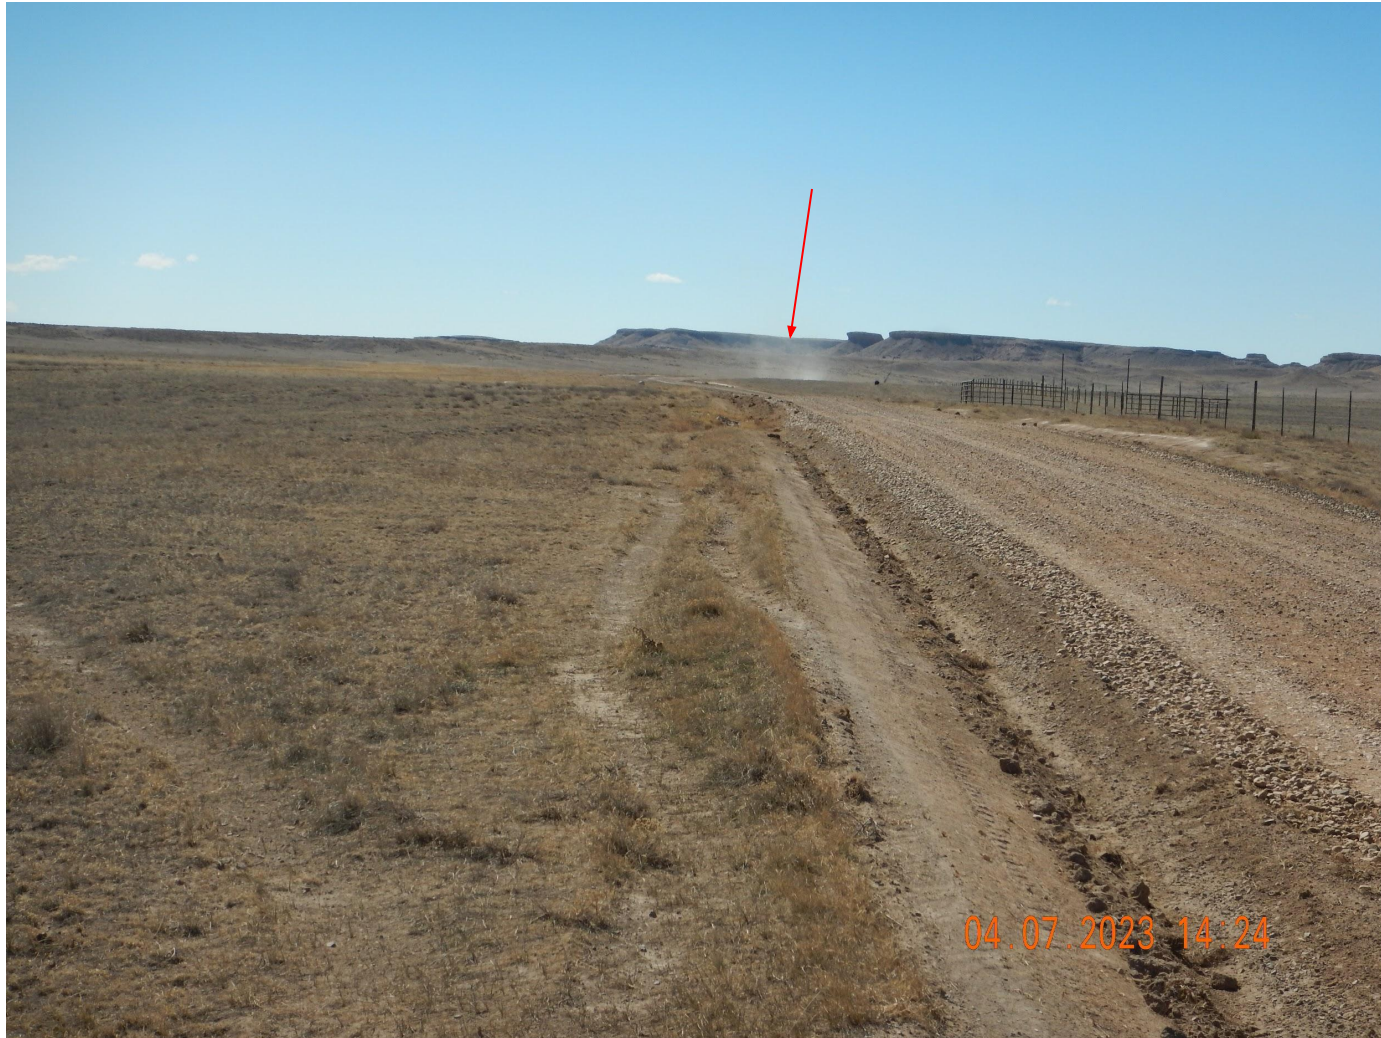
Photo 17. Photo taken from a portion of the access road, facing West. Photo illustrates fugitive dust from the water truck.

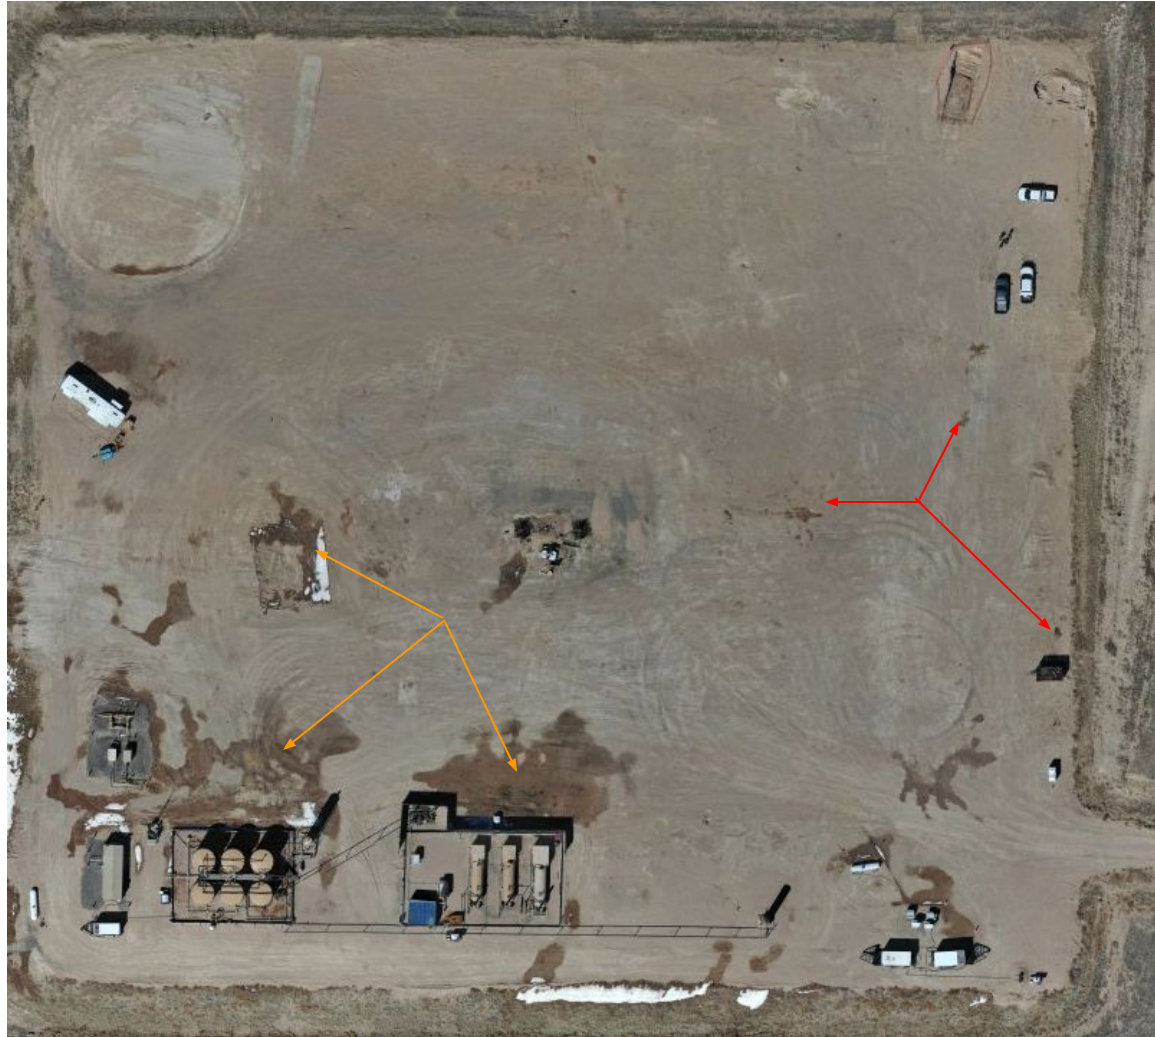
Photo 18. Drone aerial imagery illustrates some surface spills (red arrows); orange arrows are examples of snowmelt.
