KT Resources
DOW 20-22
Location # 316310

COLORADO
Oil & Gas Conservation
Commission
Department of Natural Resources

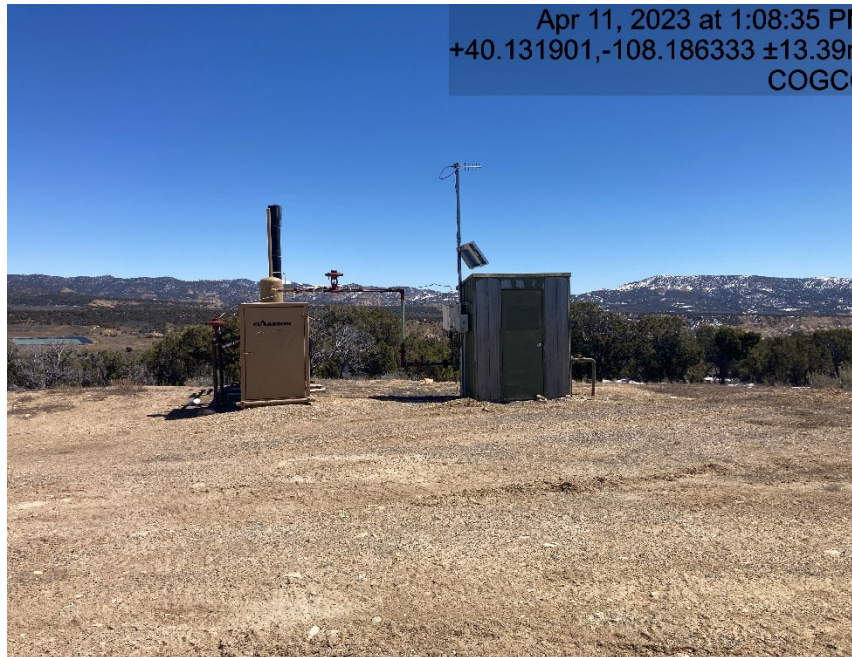
location

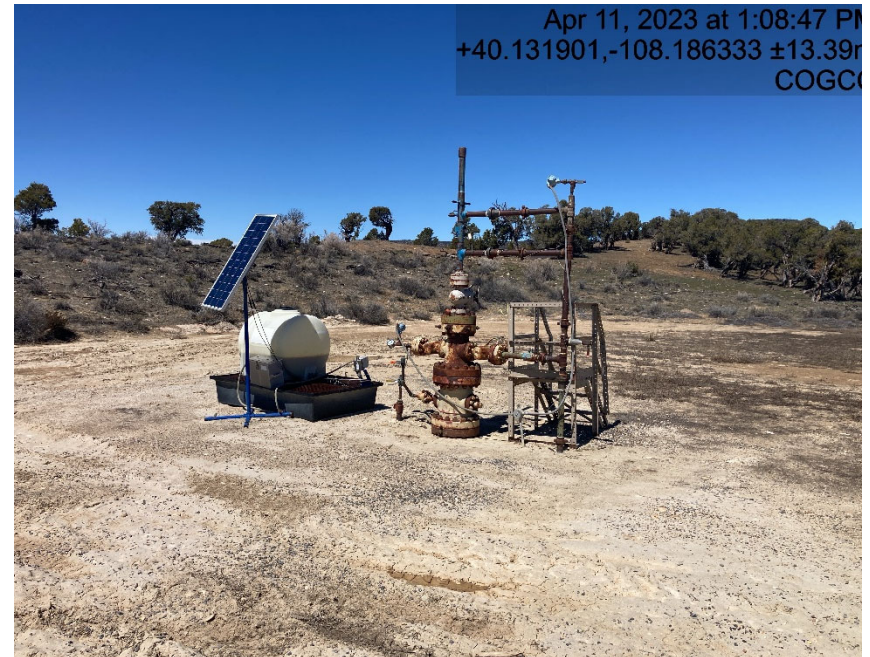
Well head signage lacking information

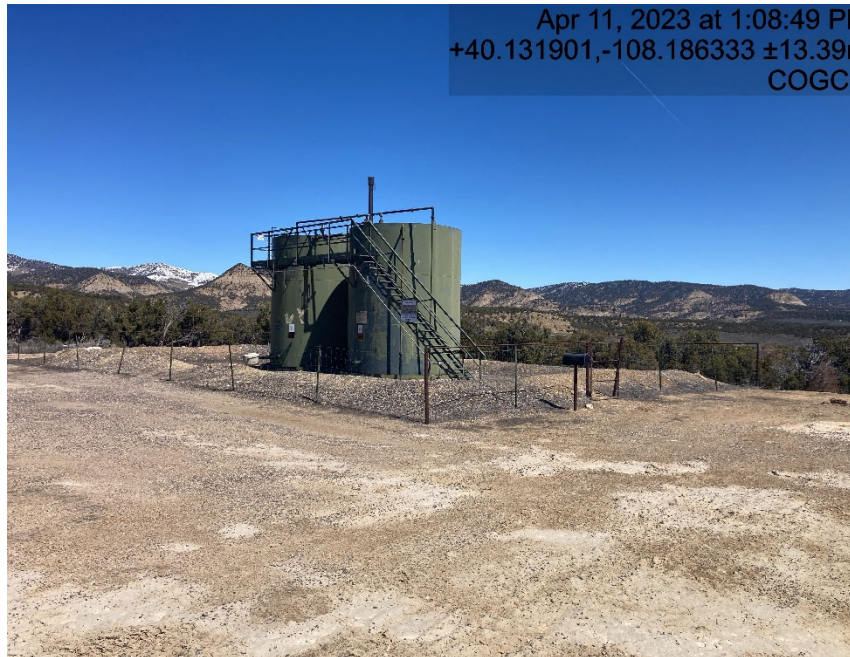
location

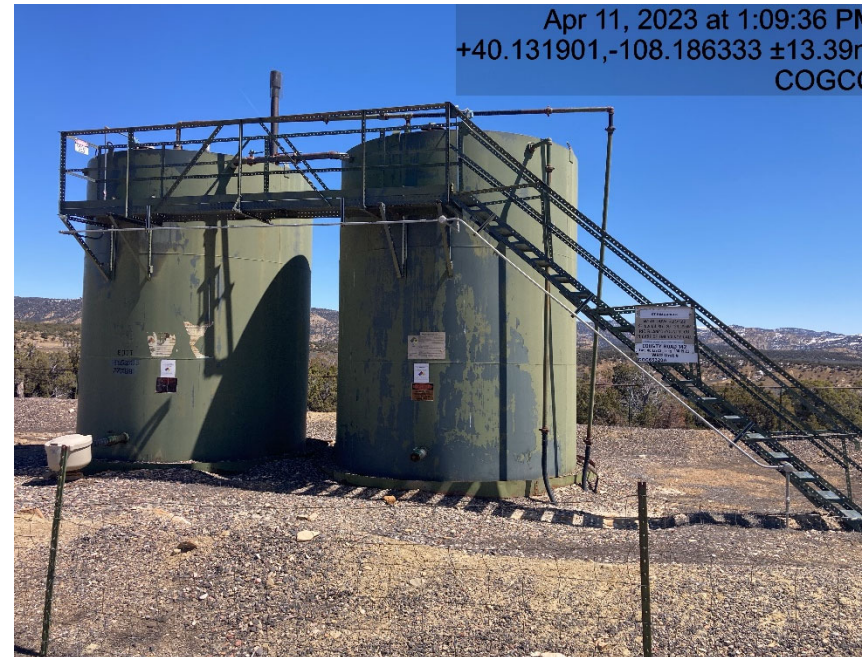
location

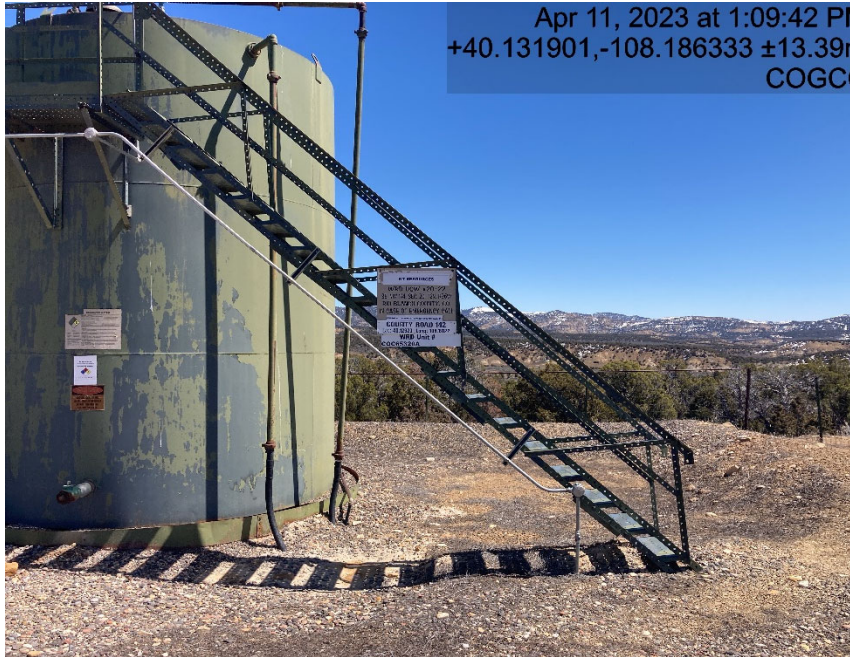
Tank battery signage lacking information

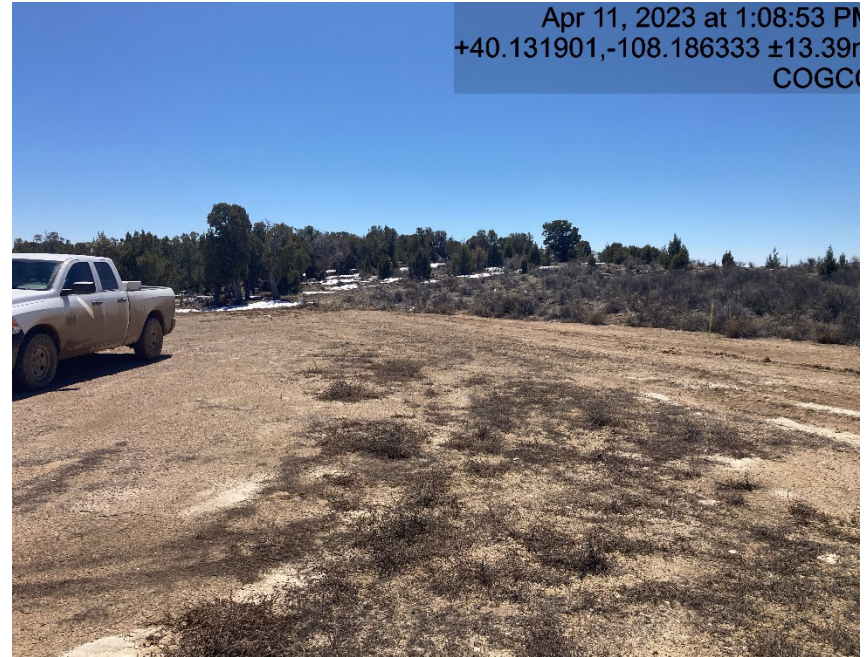
Lack of BMP's to prevent sediment migration from location

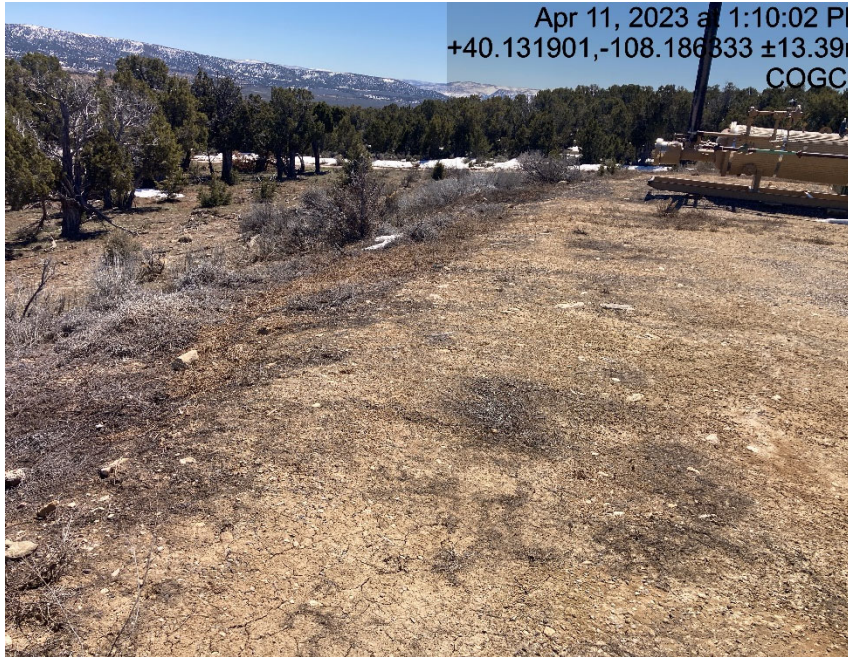
Lack of BMP's to prevent sediment migration from location

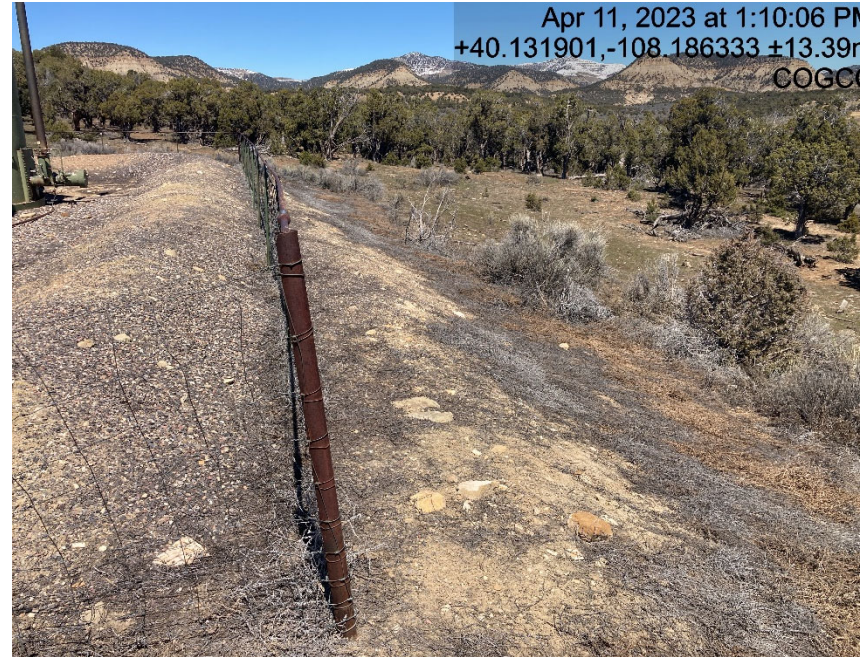
Lack of BMP's to prevent sediment migration from location

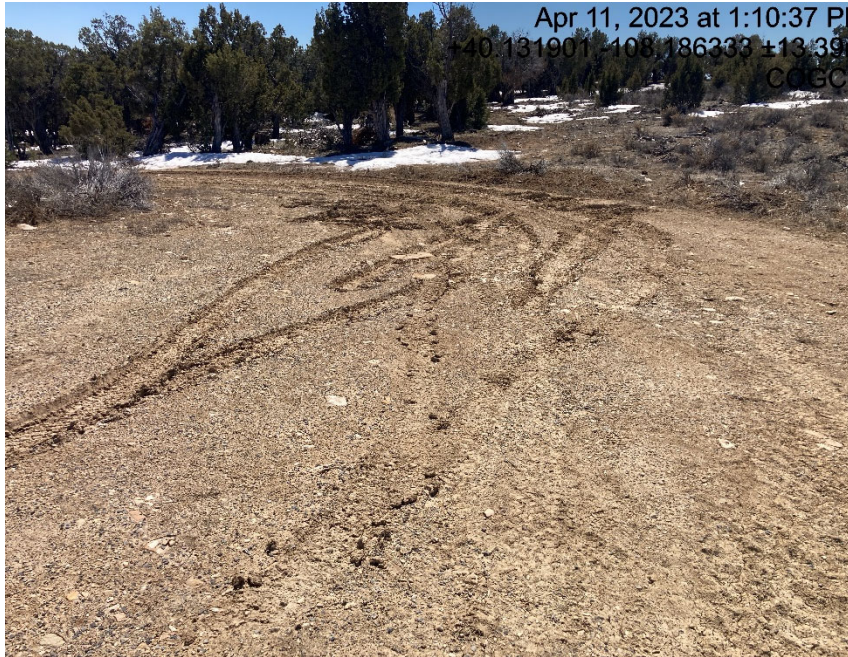
Lack of stabilization/compaction

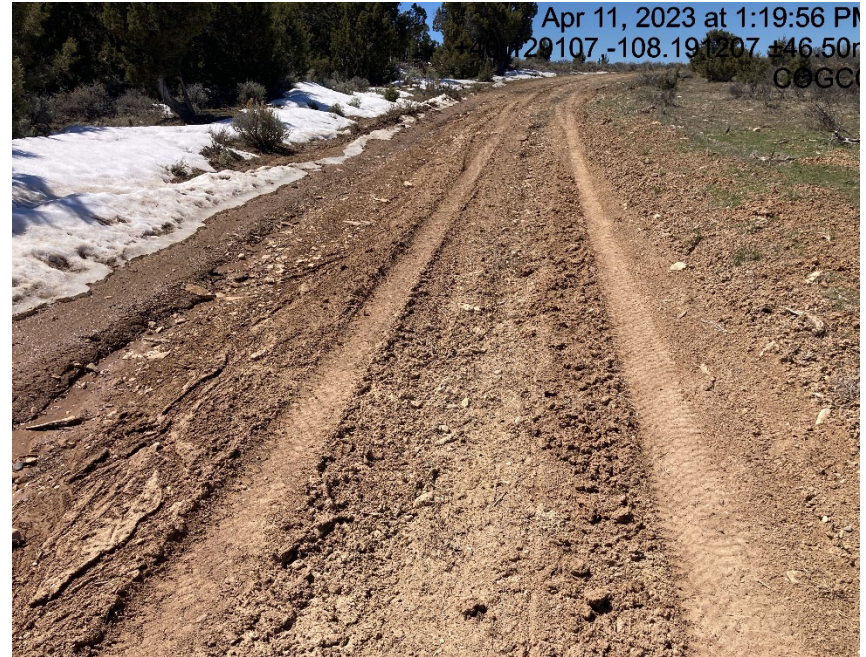
Access road erosion/ lack of stabilization

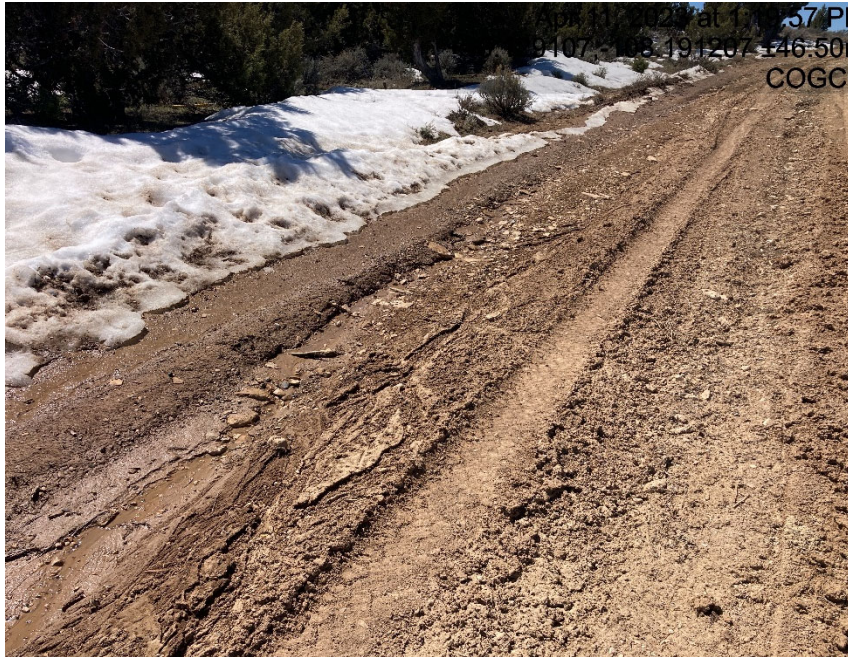
Access road erosion/ lack of stabilization

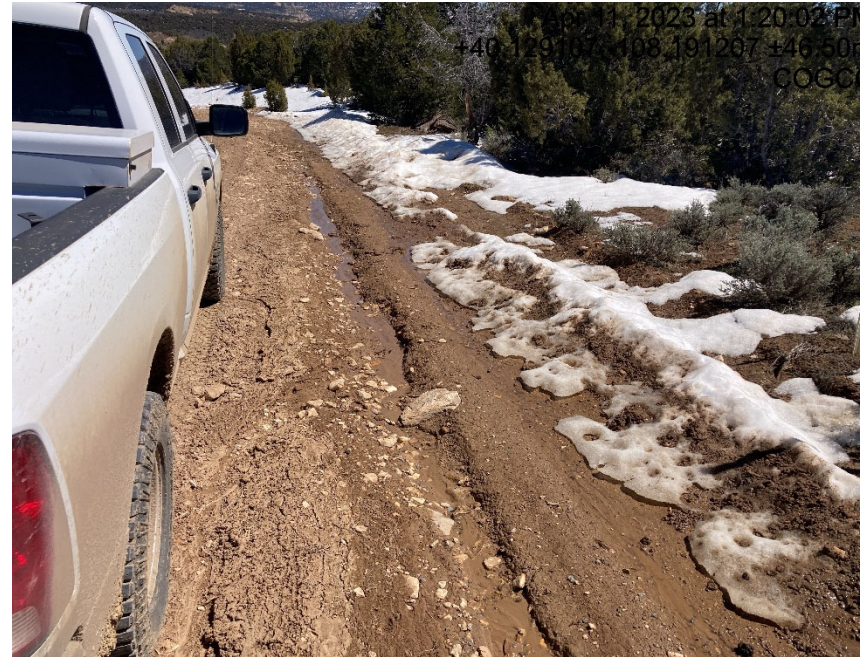
Access road erosion/ lack of stabilization

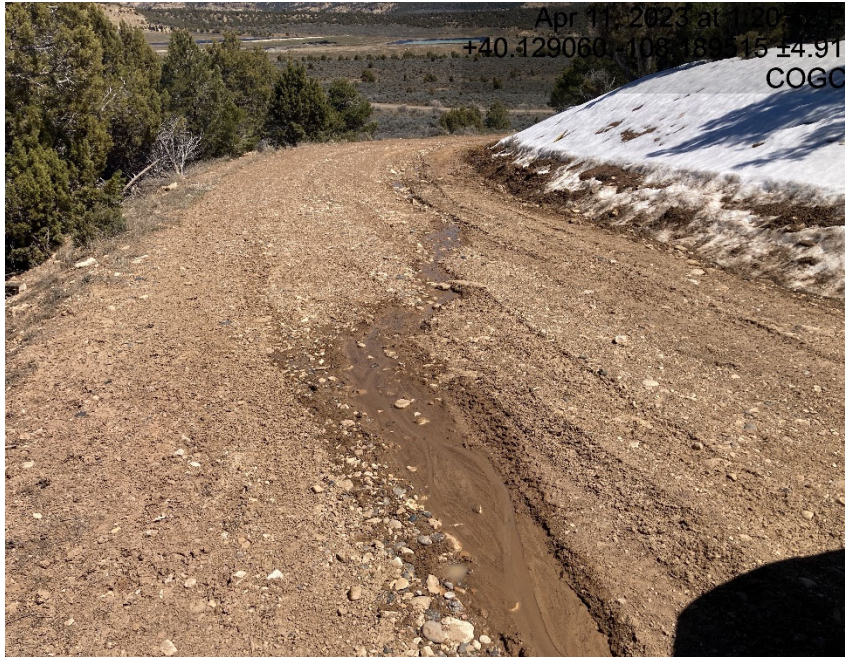
Access road erosion

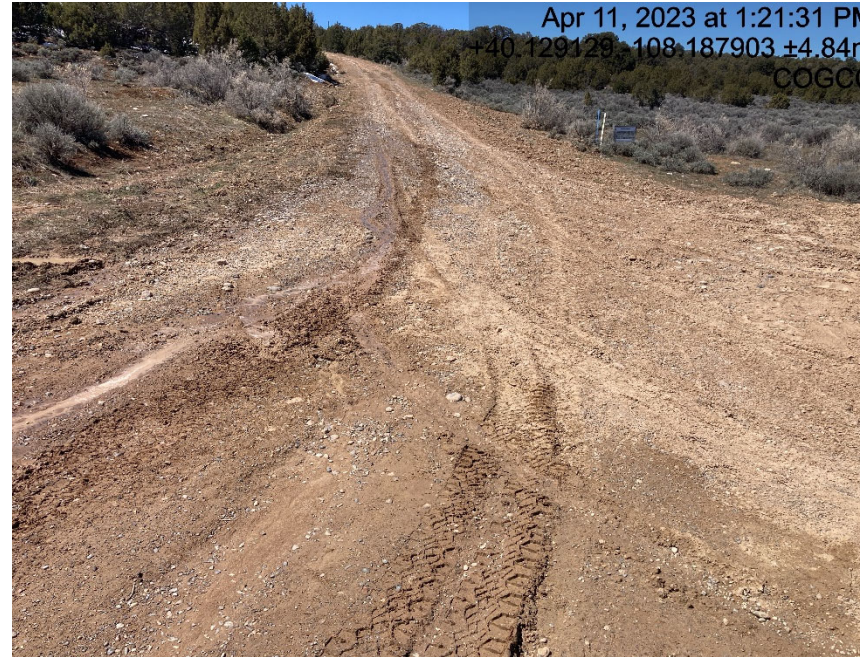
Access road erosion/ lack of stabilization

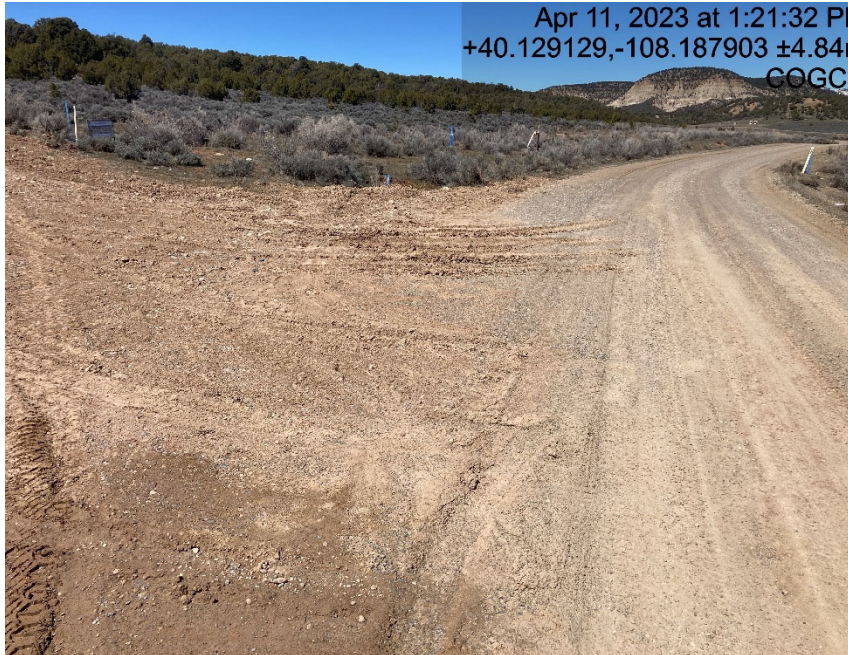
Tracking from access road to lease road

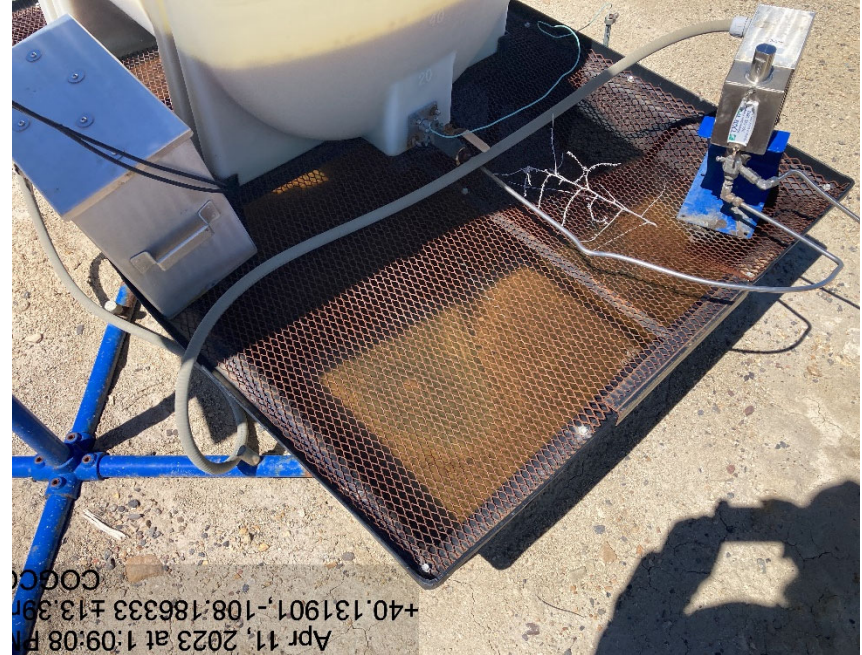
Containment is full

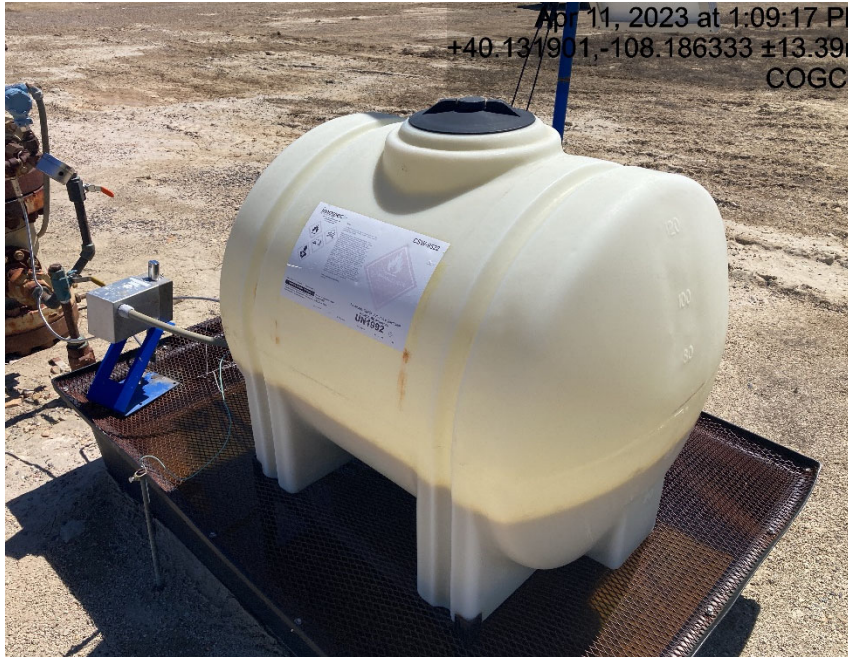
Tank labeling is fading
