Inspection Photos

Location Name: TEP ROCKY MOUNTAIN LLC CLOUGH 112 Pad

Location ID: 335221

COLORADO
Oil & Gas Conservation
Commission
Department of Natural Resources

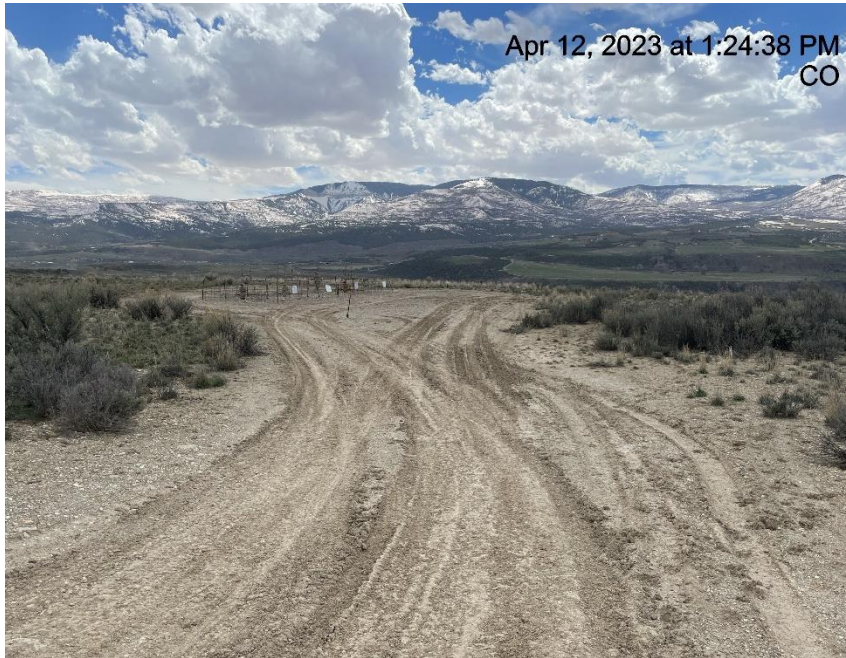
Photo # 5243 From entrance to location

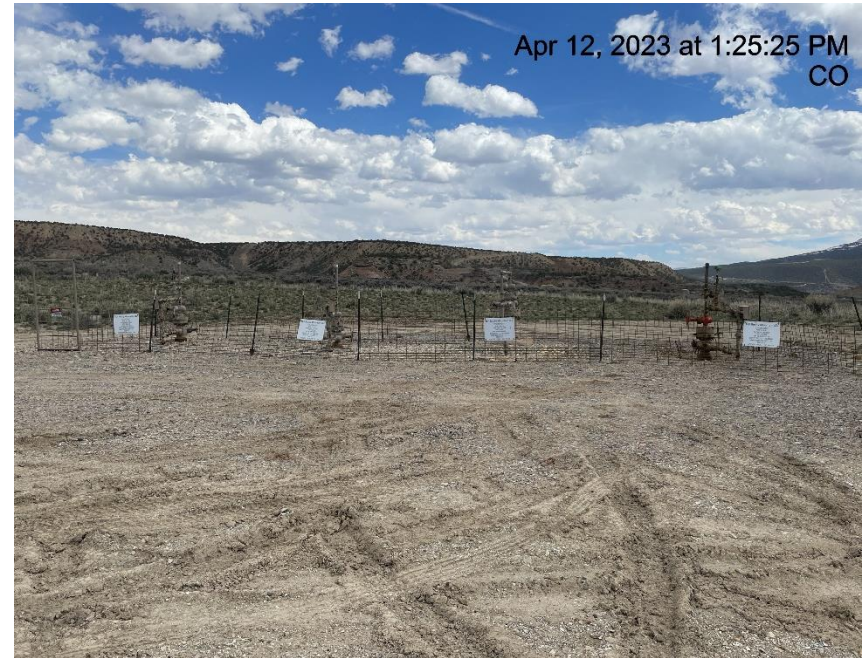
Photo # 5244 Location

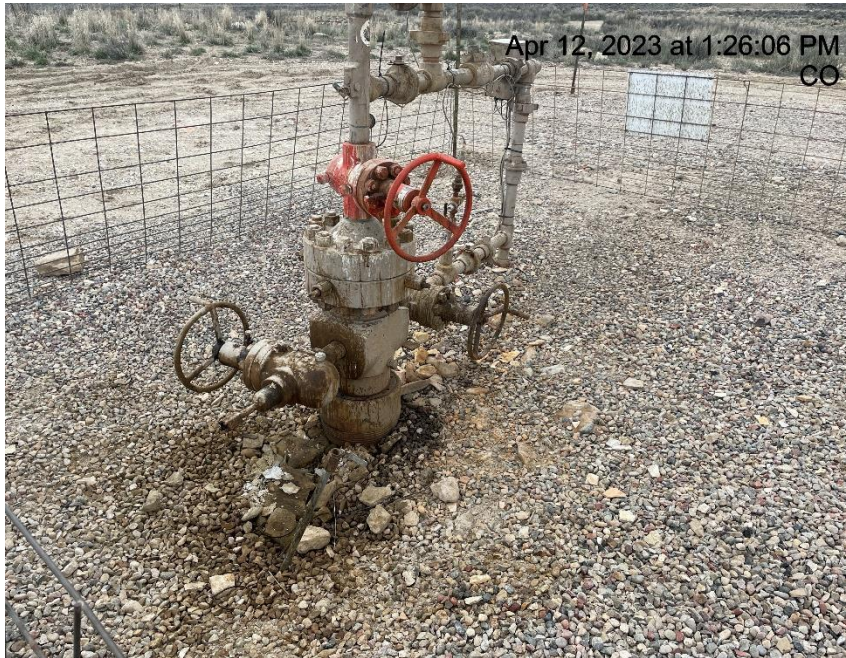
Photo # 5246 Stained soils & gravel around wellhead

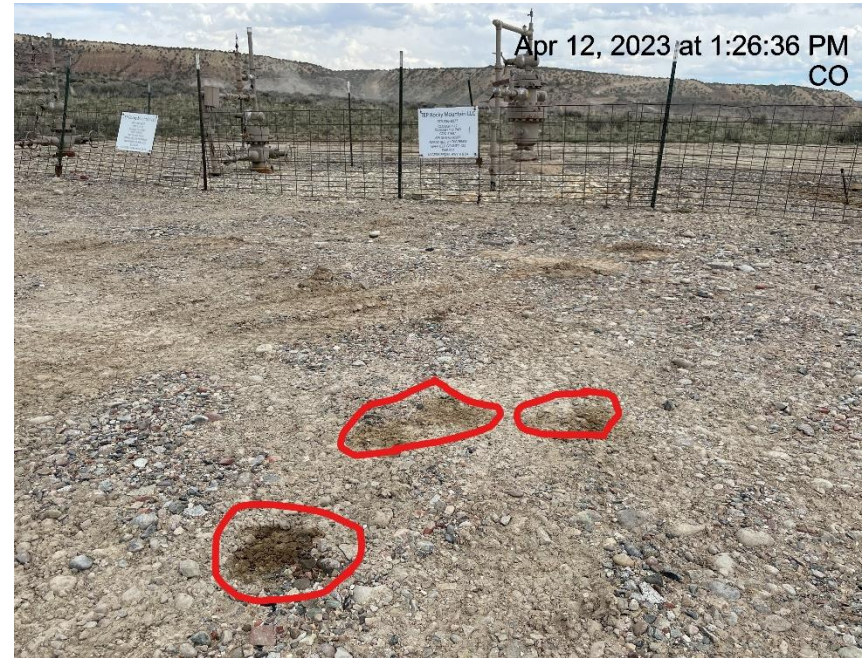
Photo # 5249 Stained soils & gravel

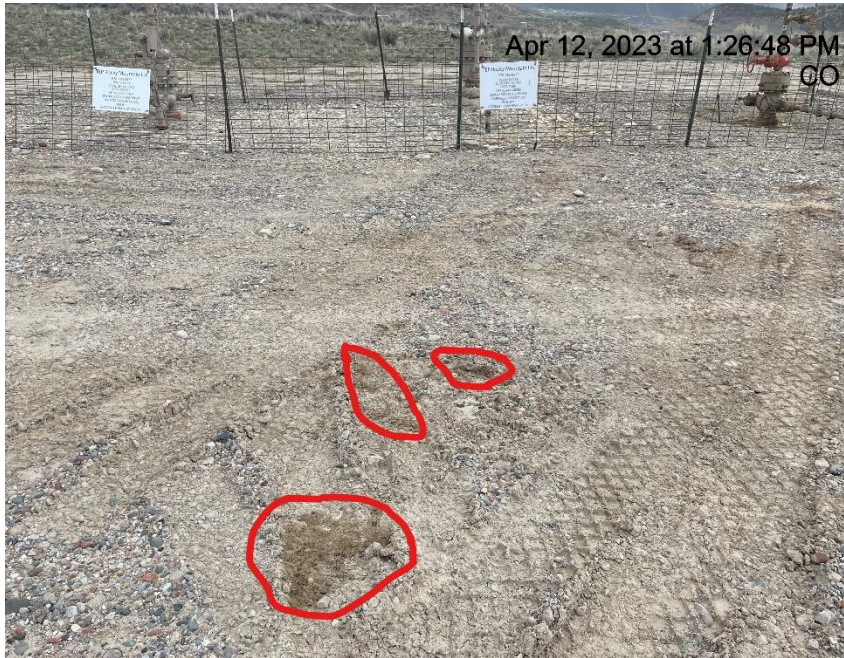
Photo # 5250 Stained soils & gravel

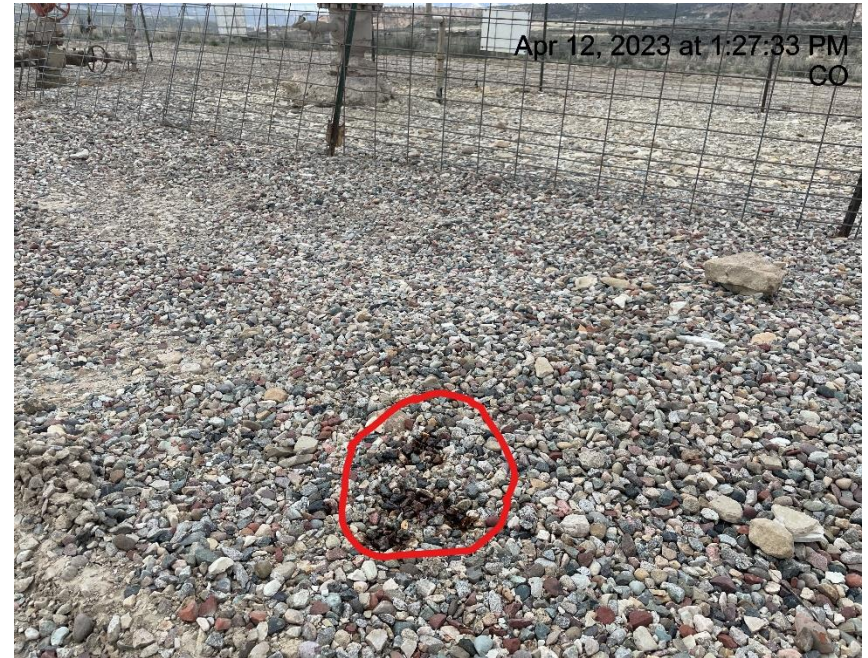
Photo # 5253 Stained soils & gravel

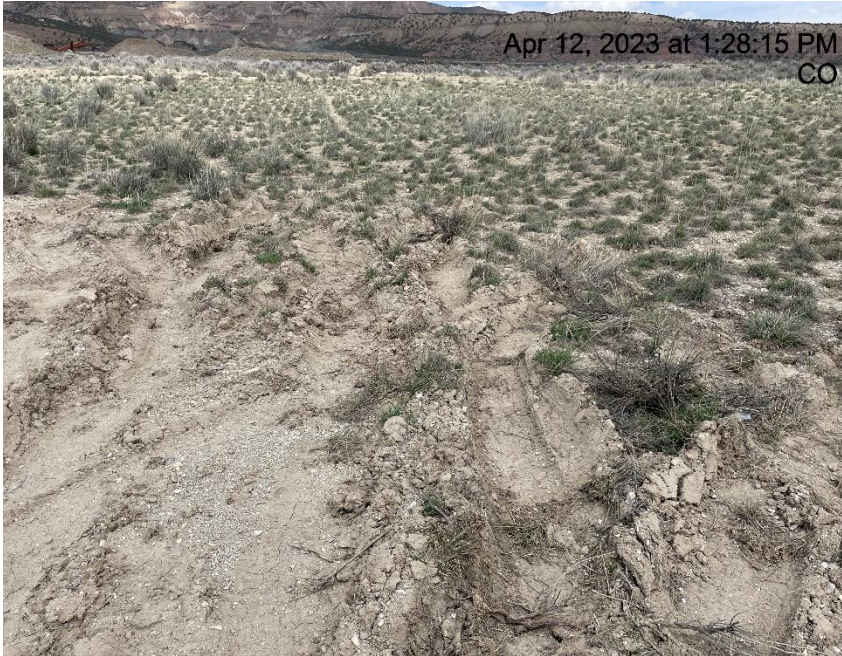
Photo # 5257 Failure to minimize surface disturbance

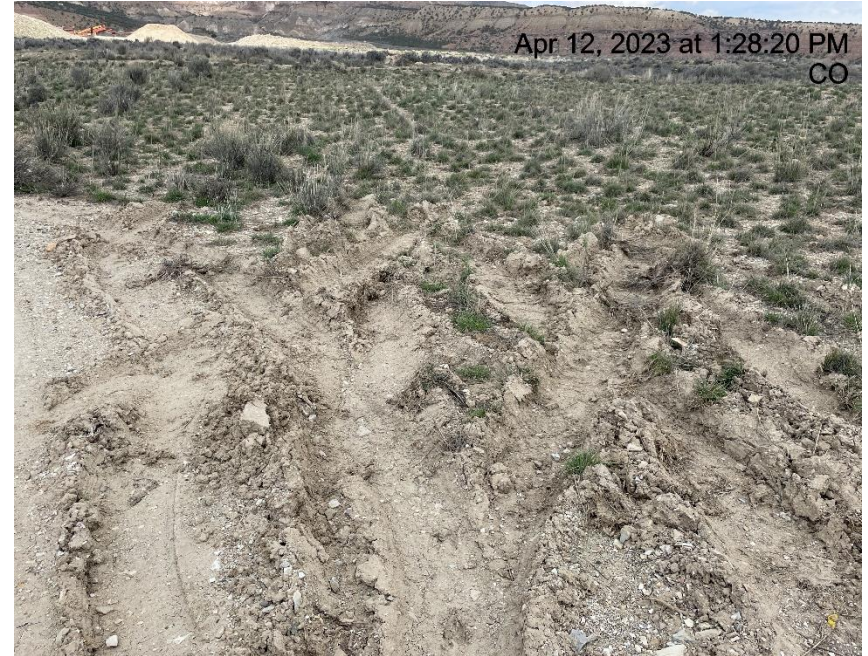
Photo # 5258 Failure to minimize surface disturbance

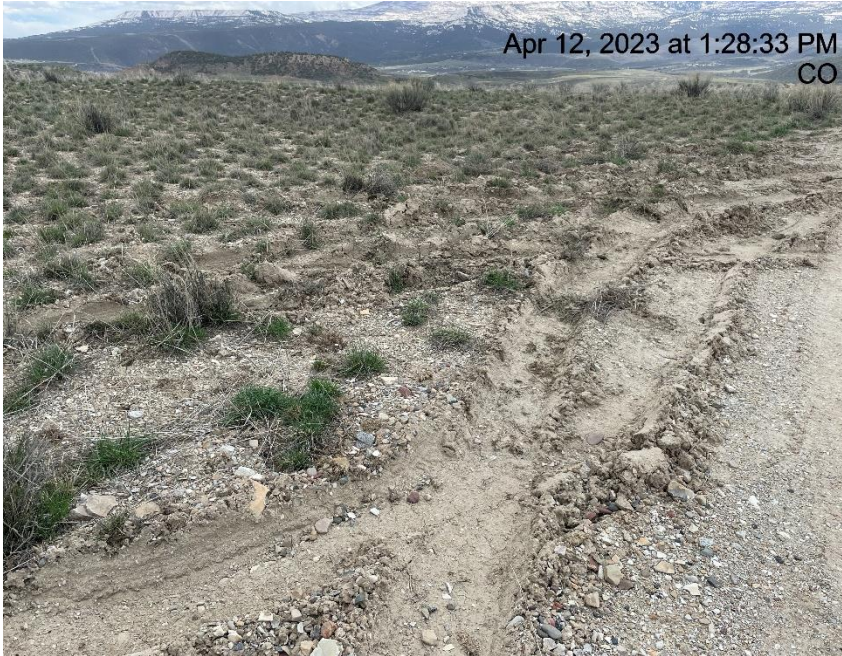
Photo # 5259 Failure to minimize surface disturbance

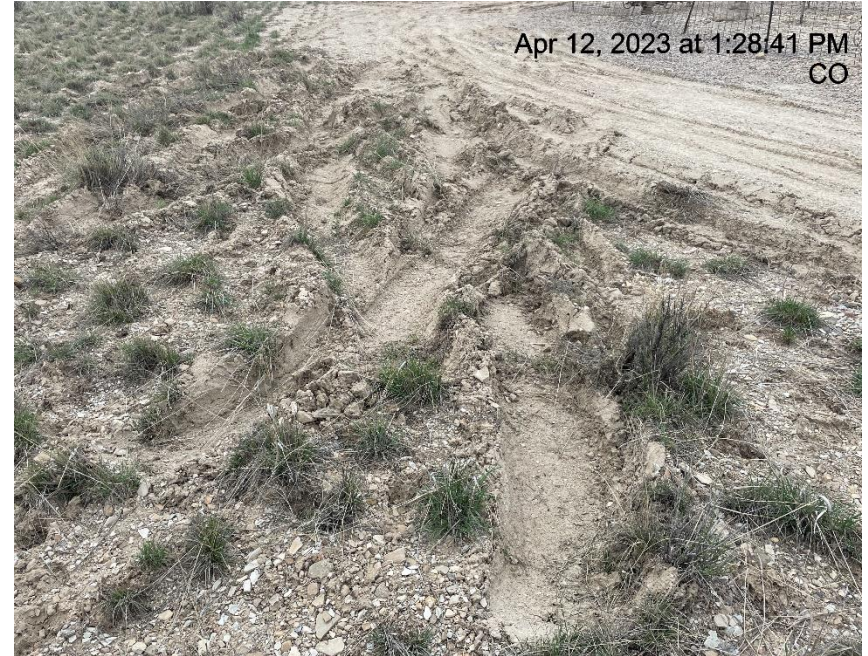
Photo # 5260 Failure to minimize surface disturbance

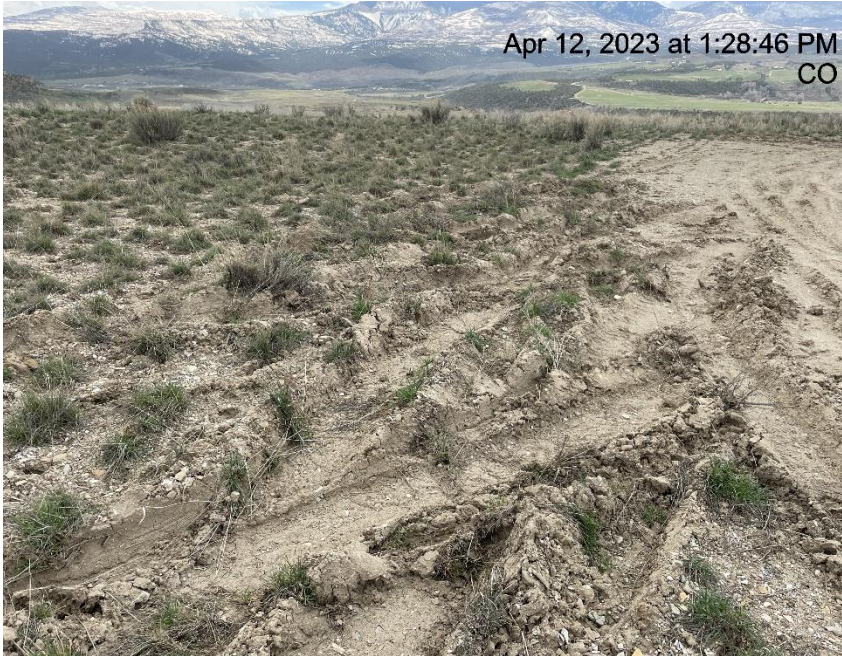
Photo # 5261 Failure to minimize surface disturbance

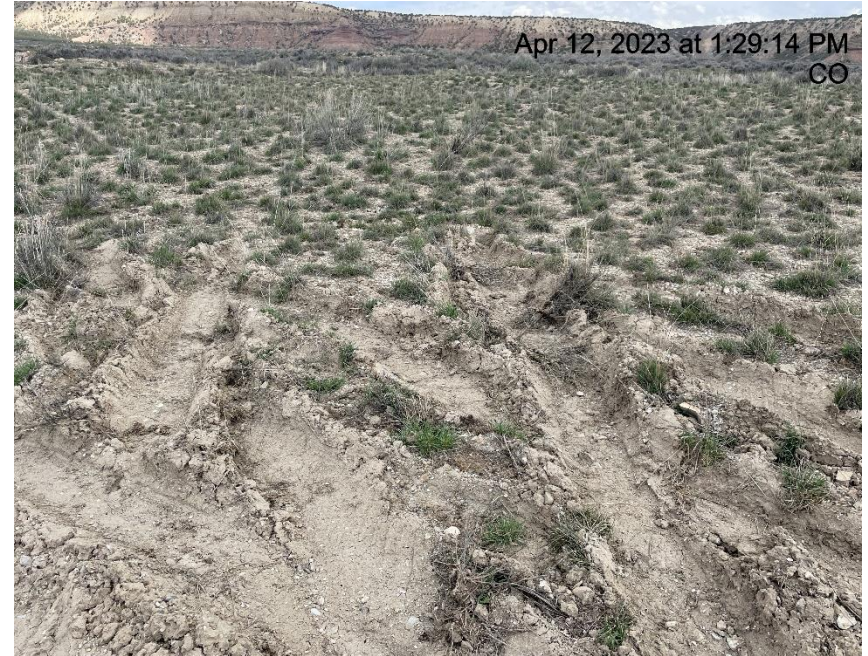
Photo # 5264 Failure to minimize surface disturbance

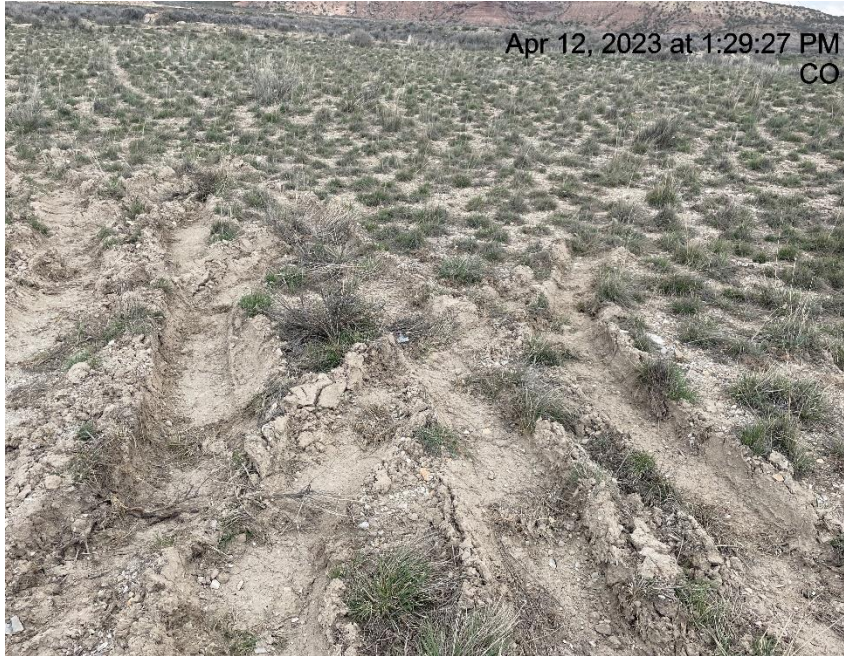
Photo # 5267 Failure to minimize surface disturbance

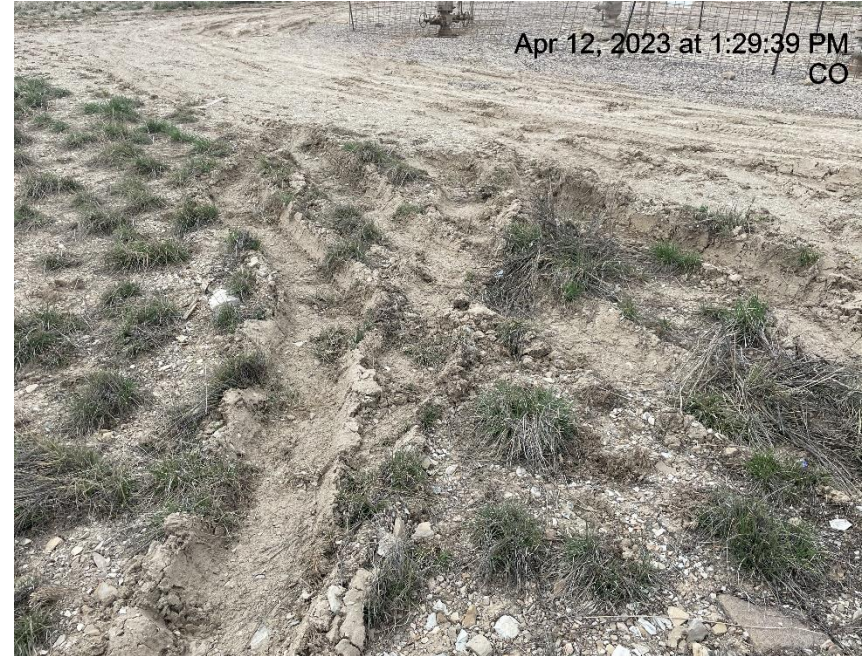
Photo # 5268 Failure to minimize surface disturbance

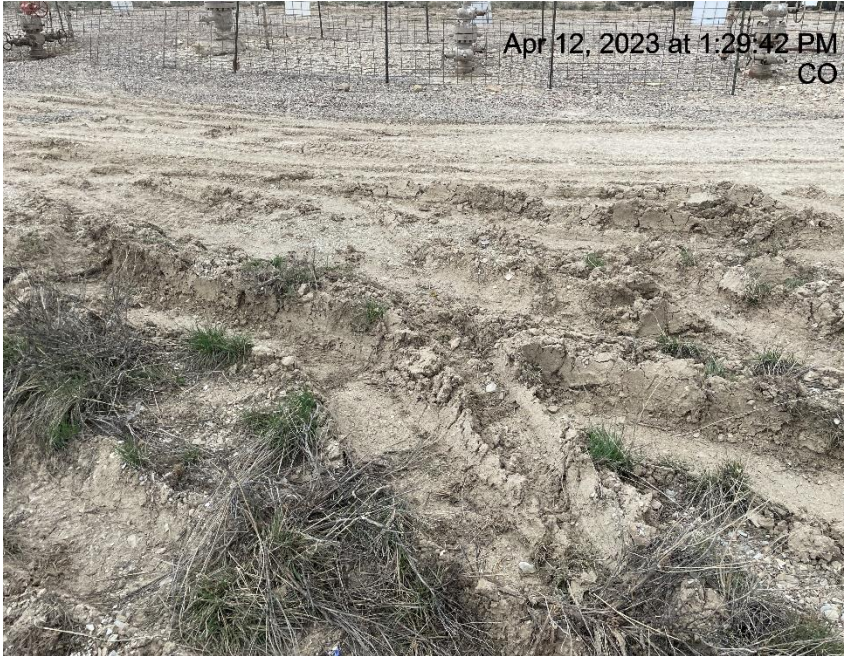
Photo # 5269 Failure to minimize surface disturbance

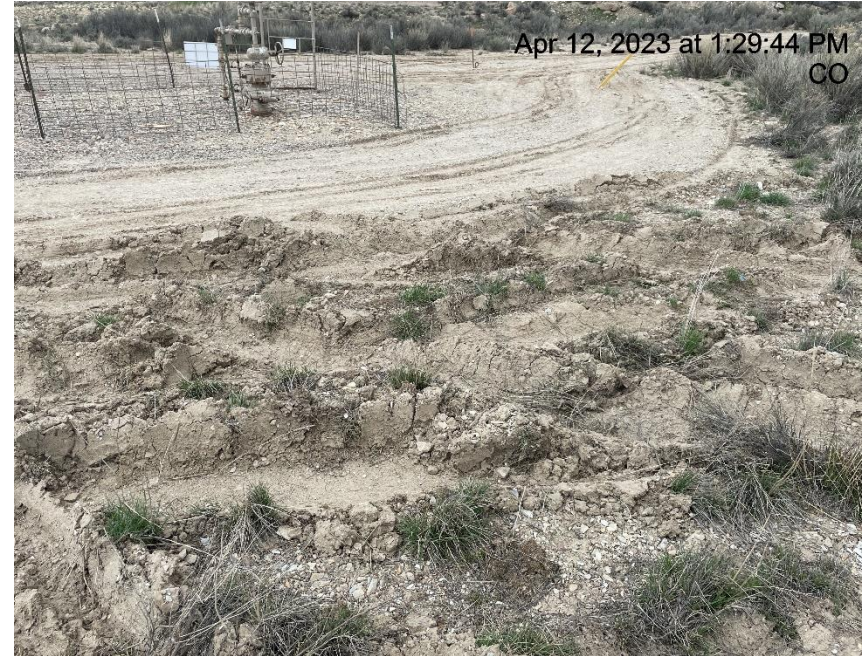
Photo # 5270 Failure to minimize surface disturbance

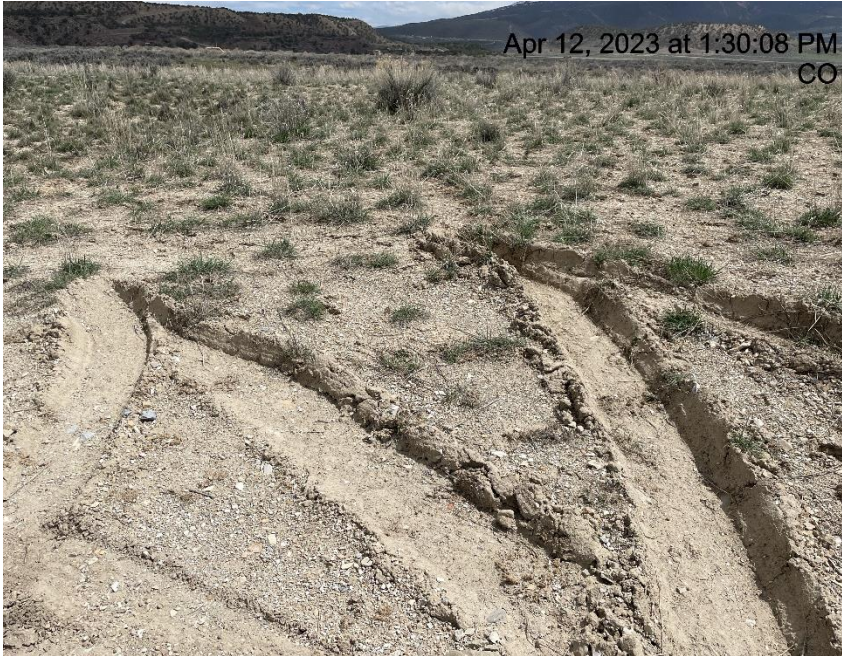
Photo # 5272 Failure to minimize surface disturbance

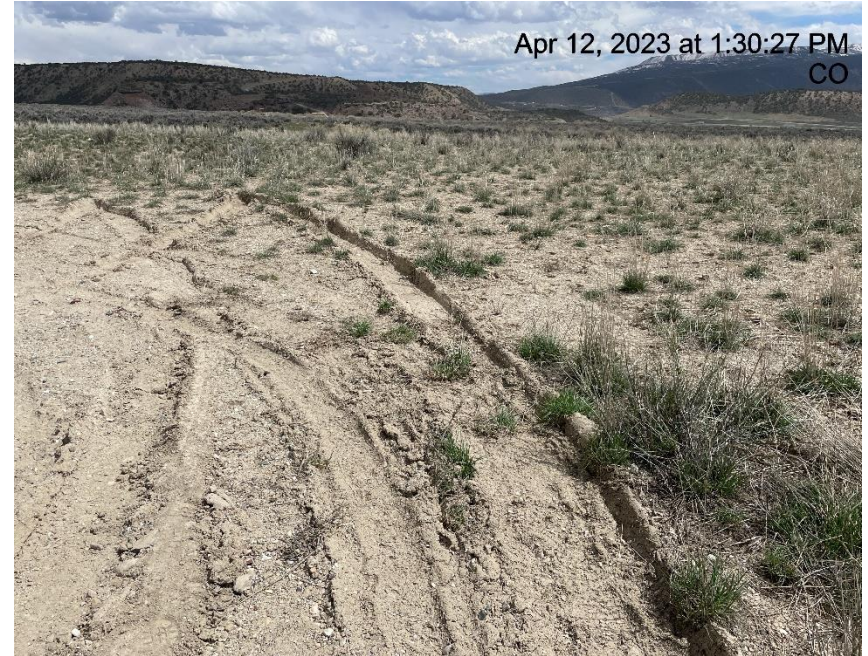
Photo # 5275 Failure to minimize surface disturbance
