Inspection Photos

Operator: GORDON ENGINEERING INC -
34720

Location #312560
Mesa County, CO

Aaron Trujillo
NW Reclamation Specialist
COGCC

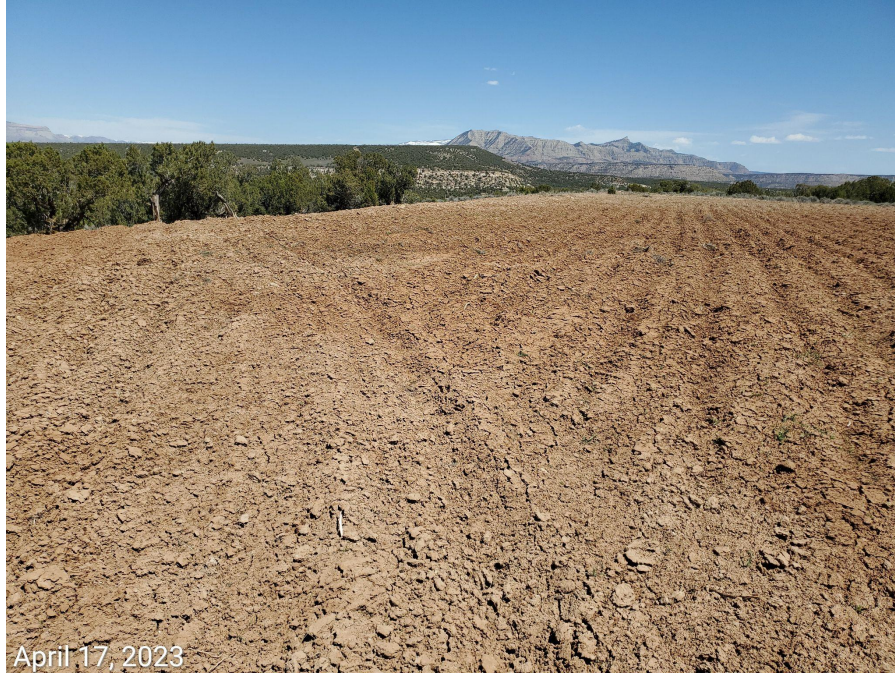
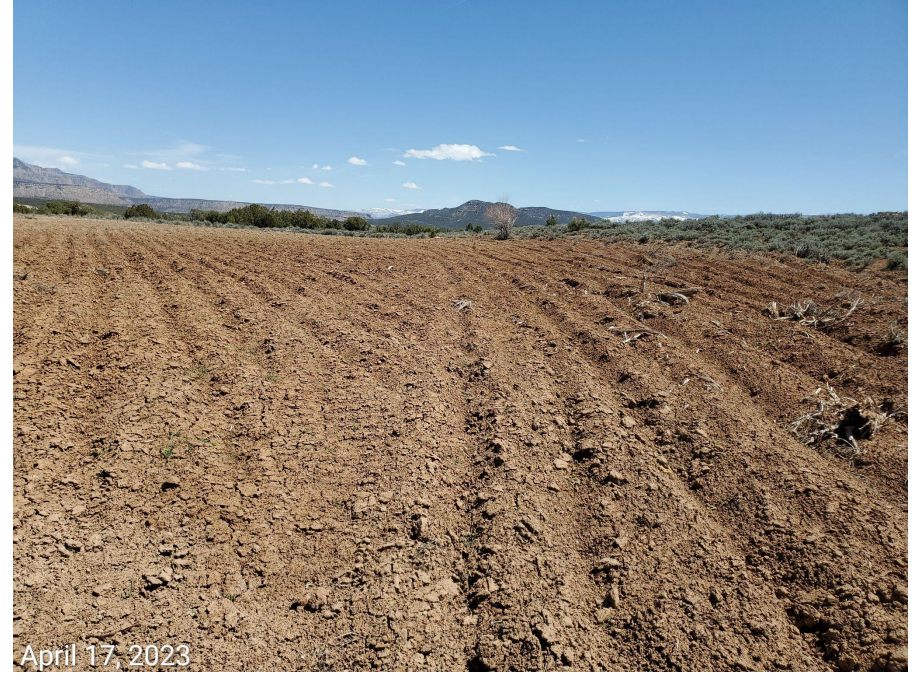
Photo 1: Photos taken from the west end of the Location, facing northeast and southeast. Photos shows Location has been recontoured, soils replaced, and decompacted.

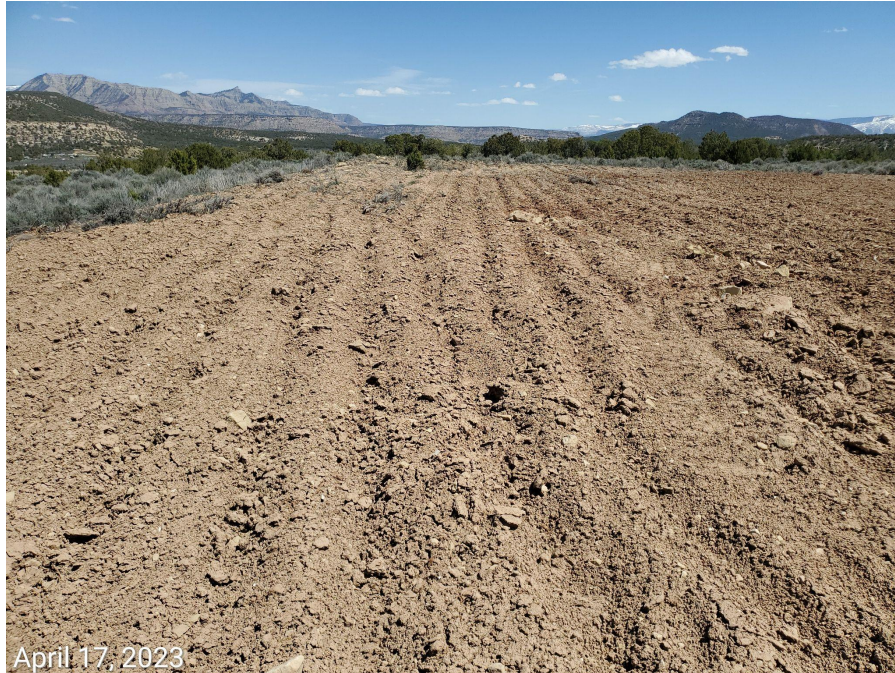
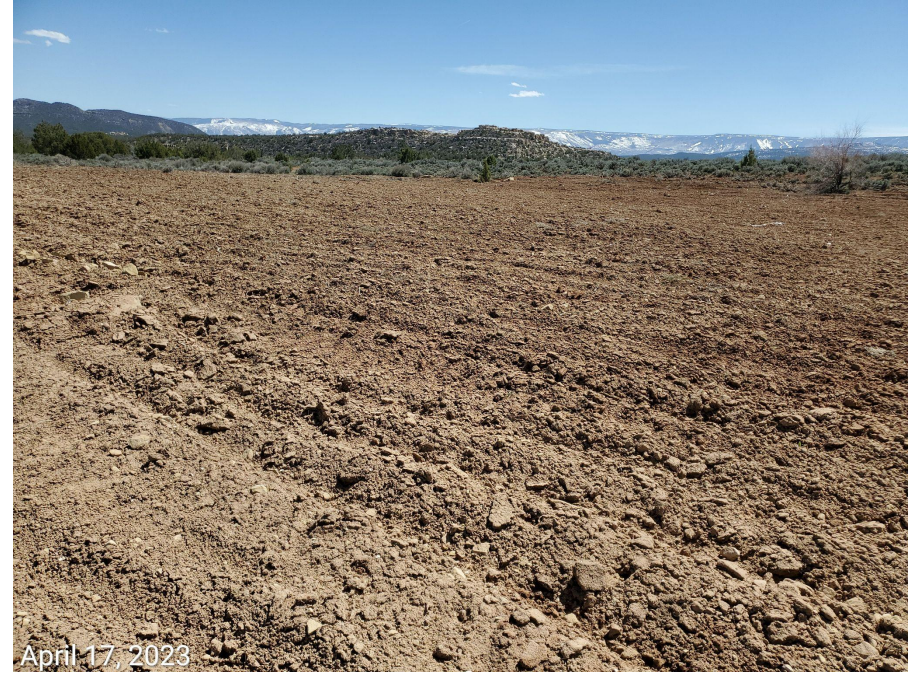
Photo 2: Photos taken from the north end of the Location. Photos 2-3 provide an overview of the Location from east, southeast, southwest to west. Photos show Location has been recontoured, soils replaced, and decompacted. Photos also show stormwater and erosion control BMPs, and BMPs to stabilize the soils remain missing or insufficient; soils left exposed and at risk to wind and water erosion; surface roughening alone inadequate.

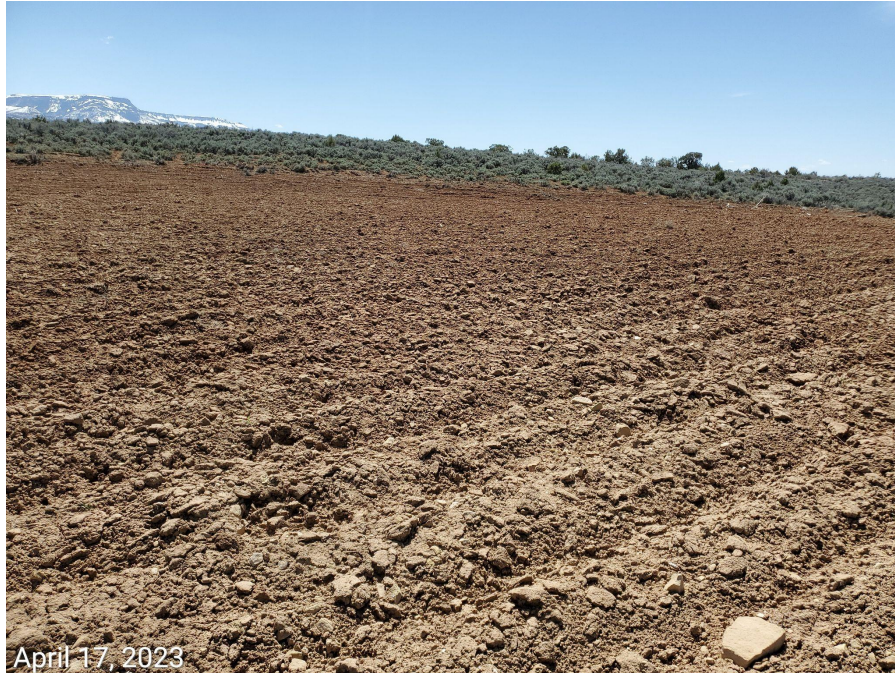
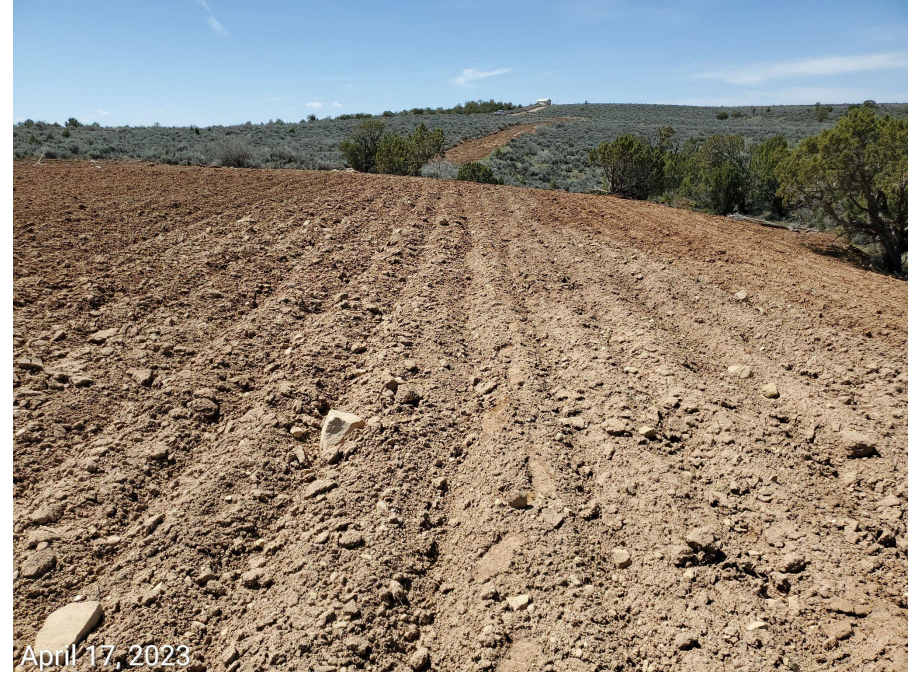
Photo 3: See comments under photo 2.

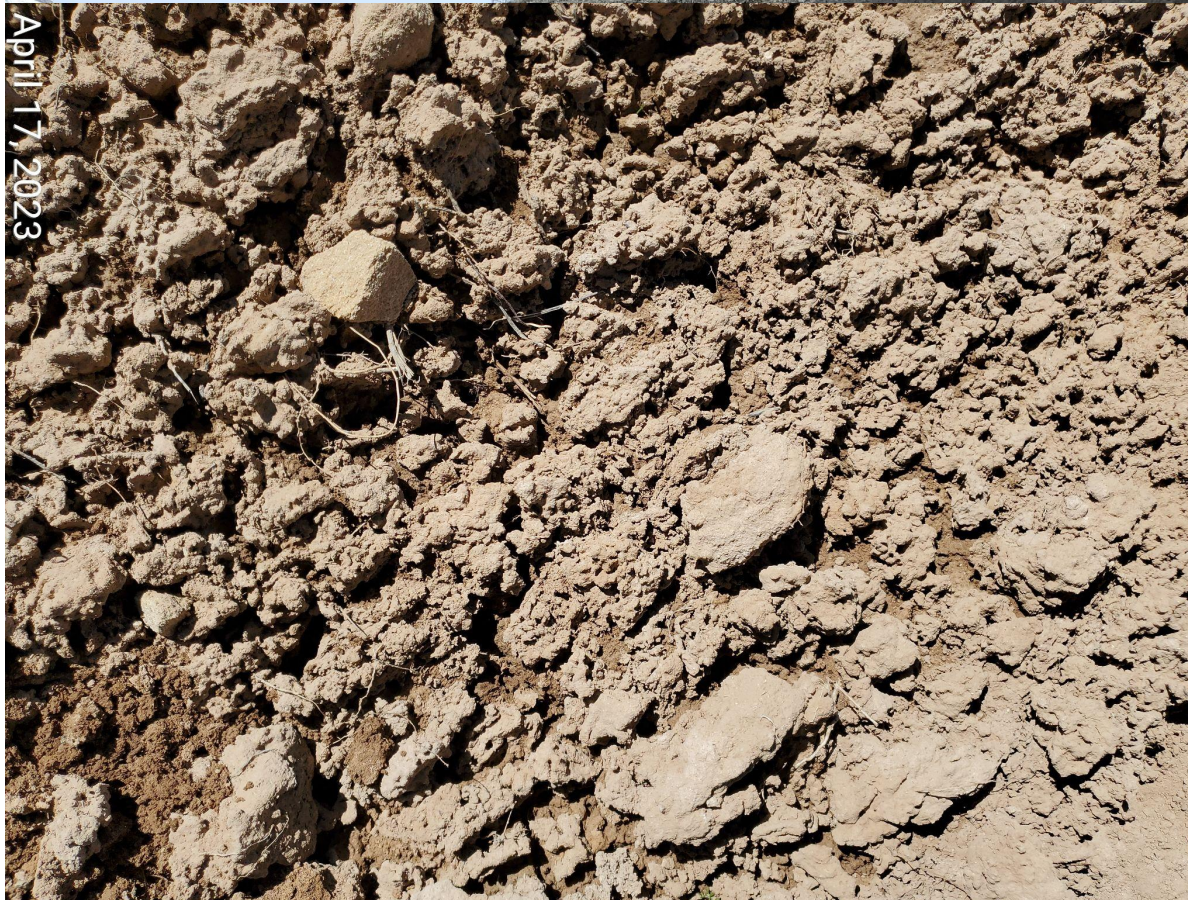
Photo 4: Photo shows an example of the soils surface, taken from the reclamation areas of the Location. Reclamation Specialist was unable to observe seed within the soil surface and subsurface; seeding activities not apparent, and do not appear to have been conducted.

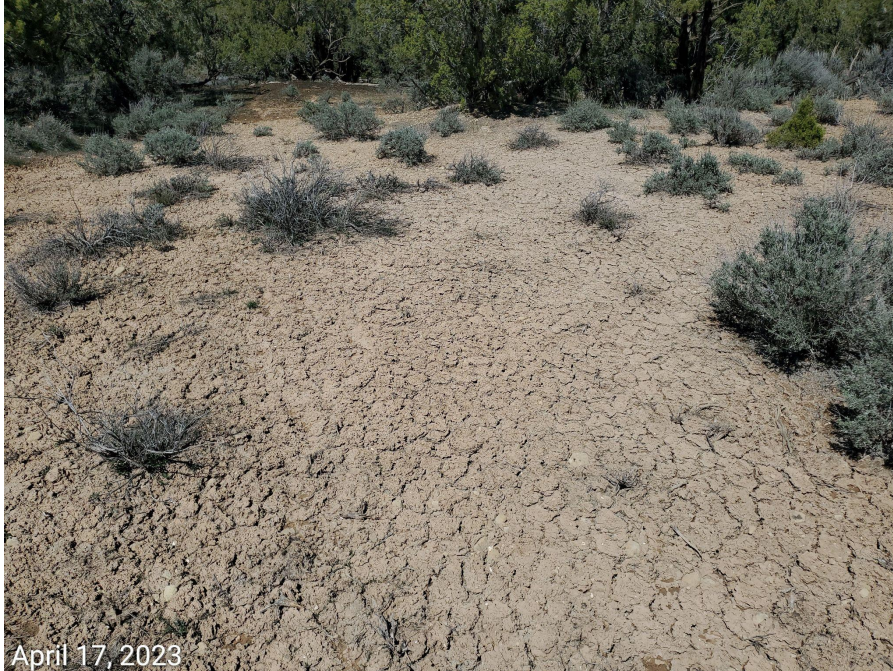
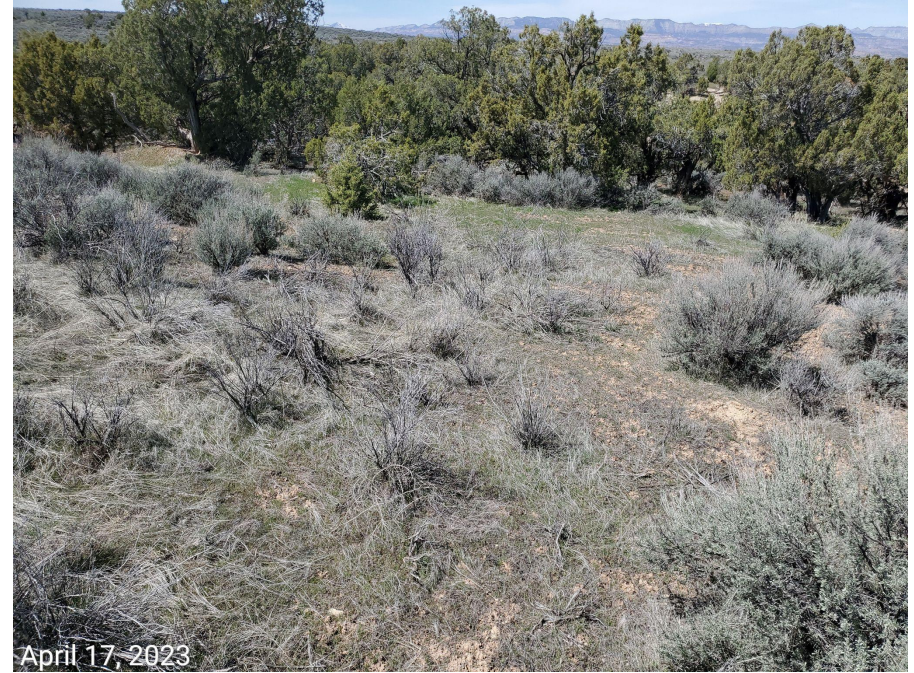
Photo 5: Photo left taken from the spill area north of the Location. Photo right taken from areas immediately adjacent to the spill that were not impacted. Photo shows spill areas remain bare- unable to find evidence that spill area has been remediated and reclaimed.

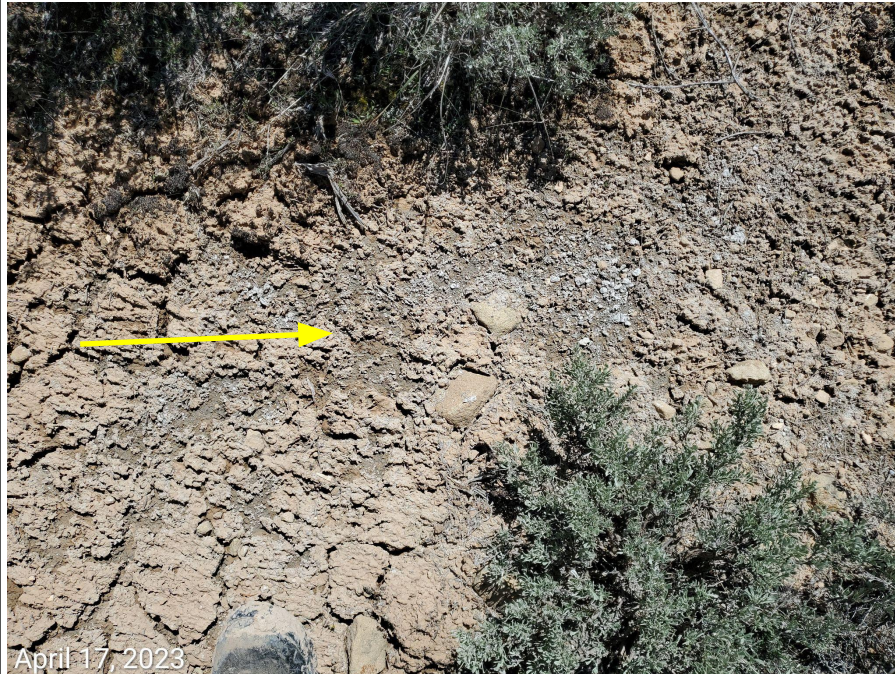
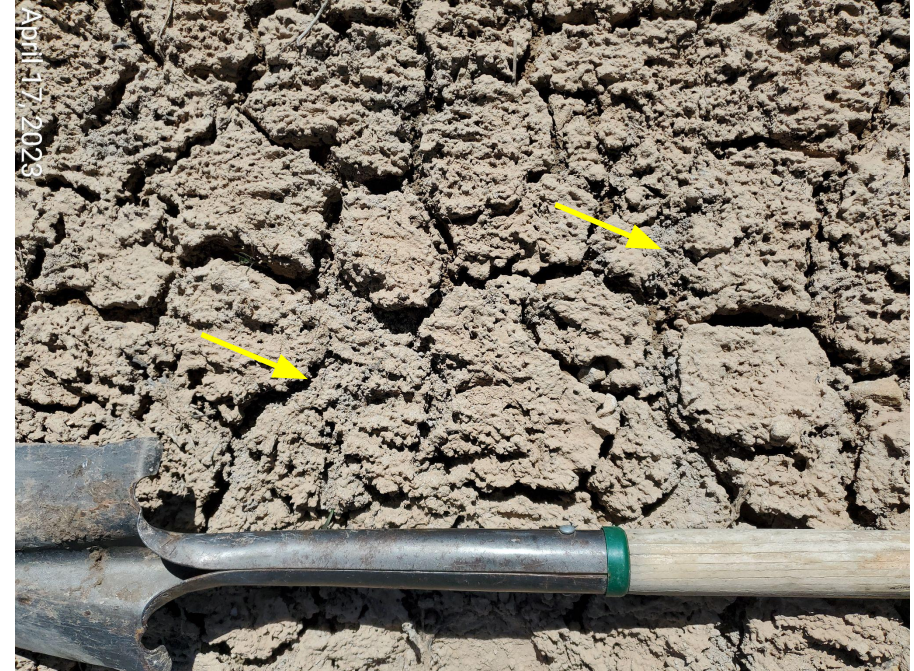
Photo 6: Photos taken from the spill area north of the Location. Photos show waste material remains at spill; spill area has not been remediated or reclaimed.

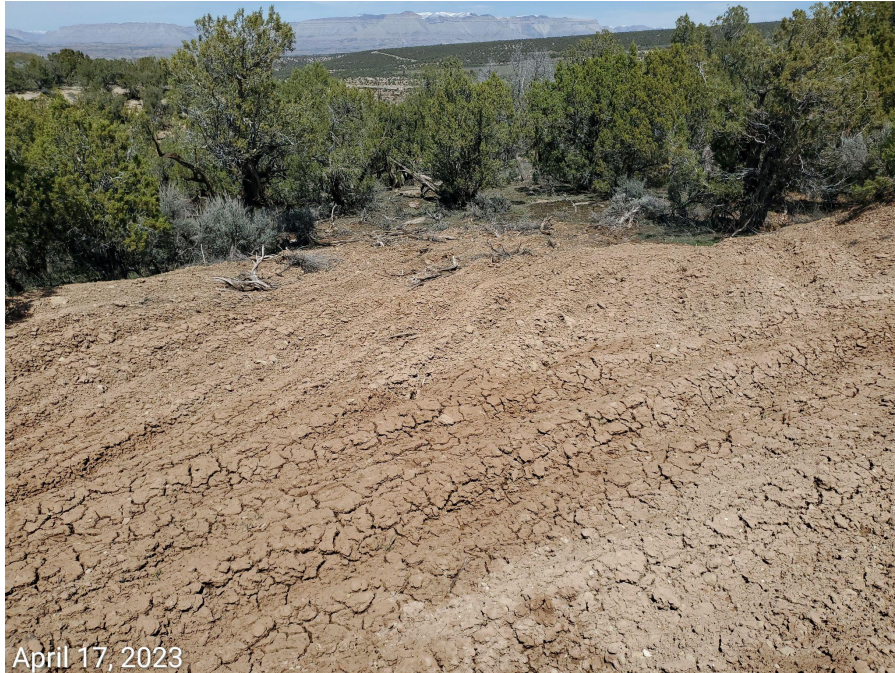
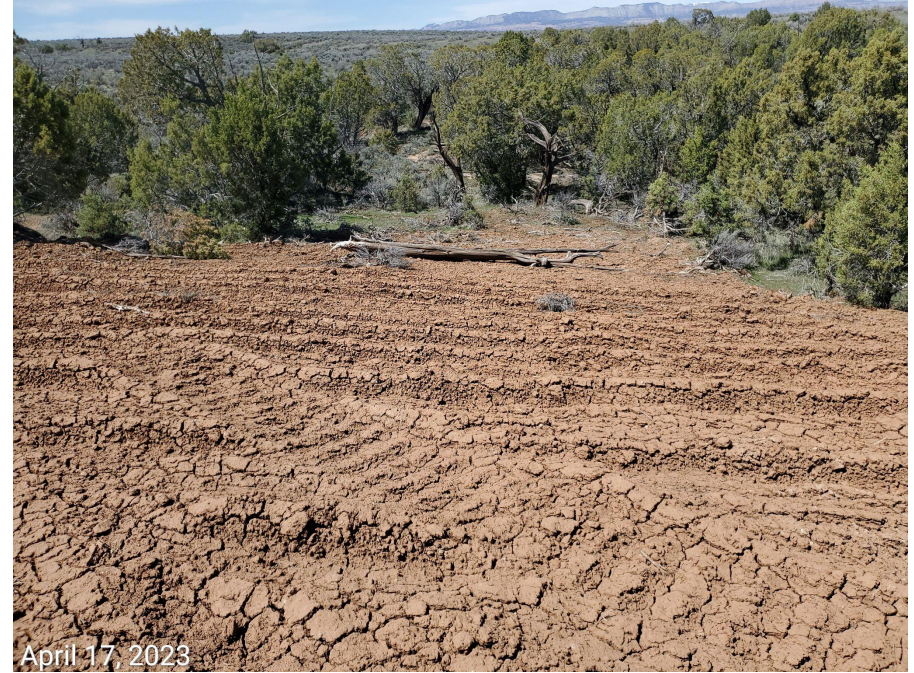
Photo 7: Photos taken from the Location. Photos examples showing stormwater and erosion control BMPs remain missing or insufficient; soils have been left exposed, unstabilized and at risk to wind/water erosion. BMPs to manage runoff and minimize off-site sediment transport along the perimeter also missing or insufficient; surface roughening alone inadequate.

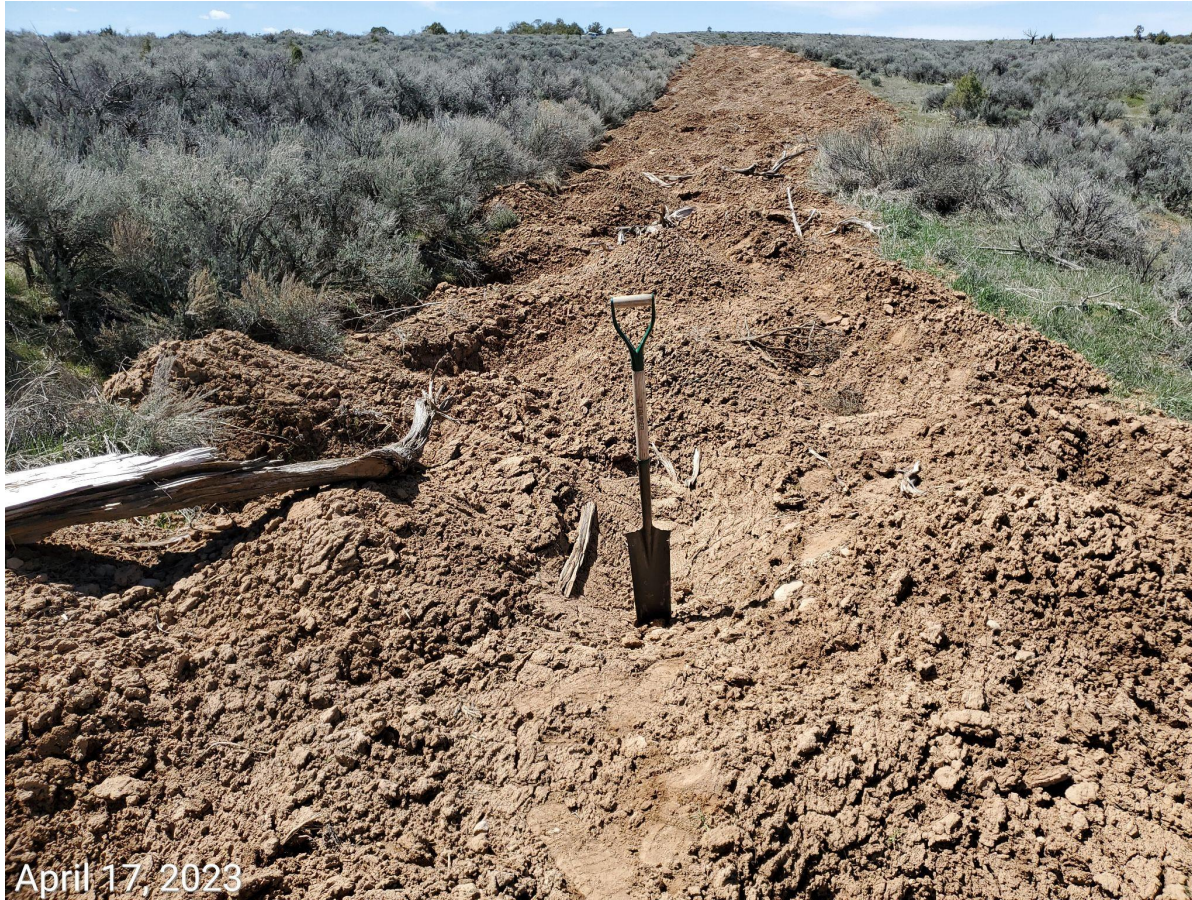
Photo 8: Photo taken from the access road. Photo shows Operator has re “pot-holed” the access road, resulting in large holes and soil piles; soils have been left unstabilized; access road has not been properly contoured and stabilized; seeding activities at access road not apparent.

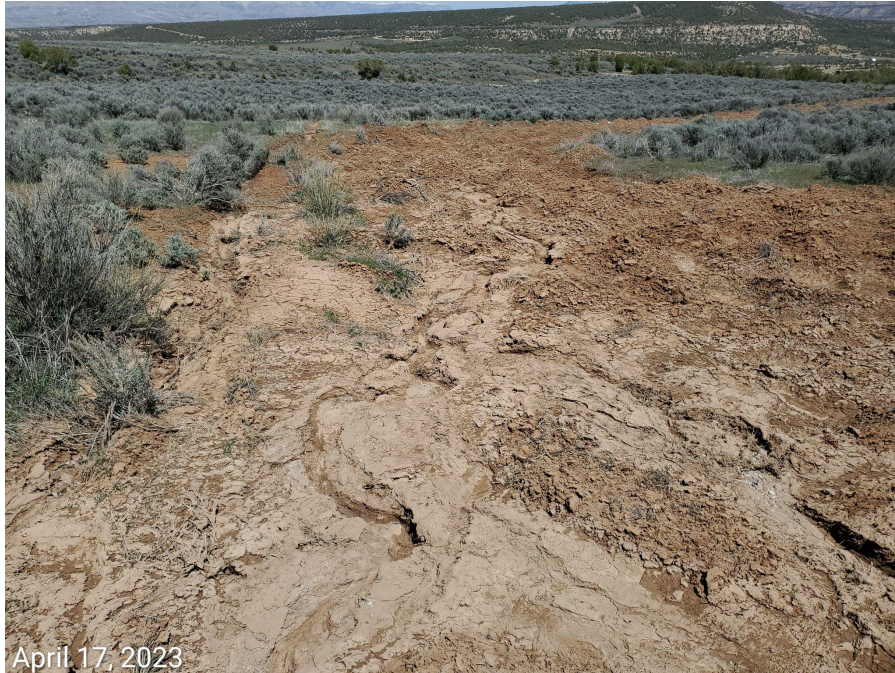
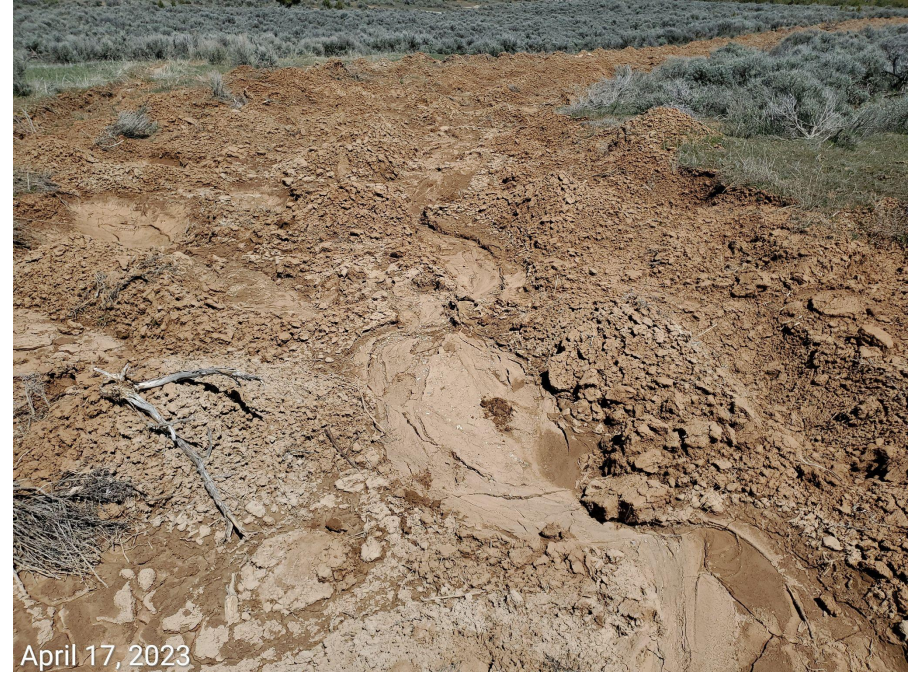
Photo 9: Erosion degradation, sediment deposition observed along access road; stormwater and erosion control BMPs missing or insufficient.

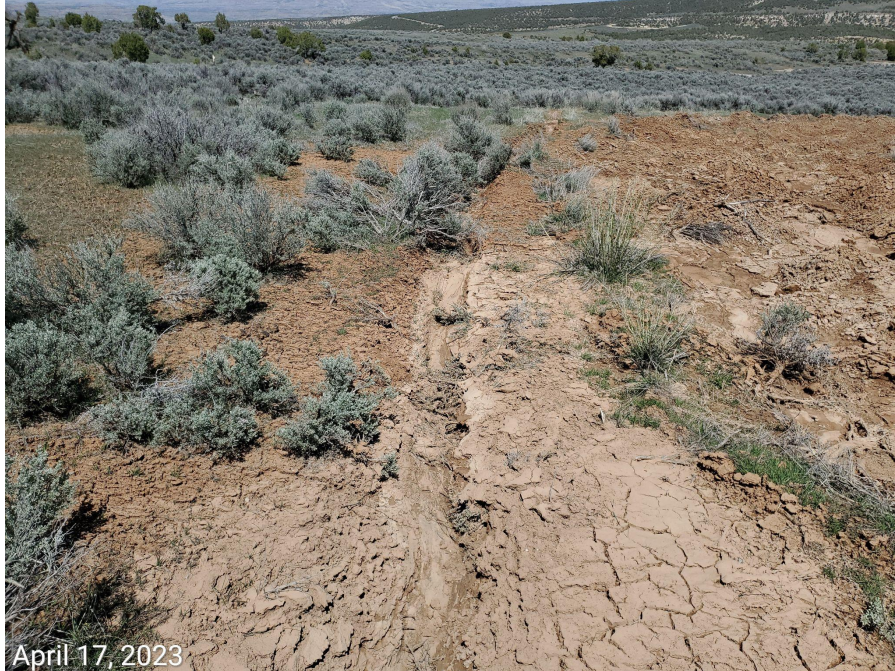
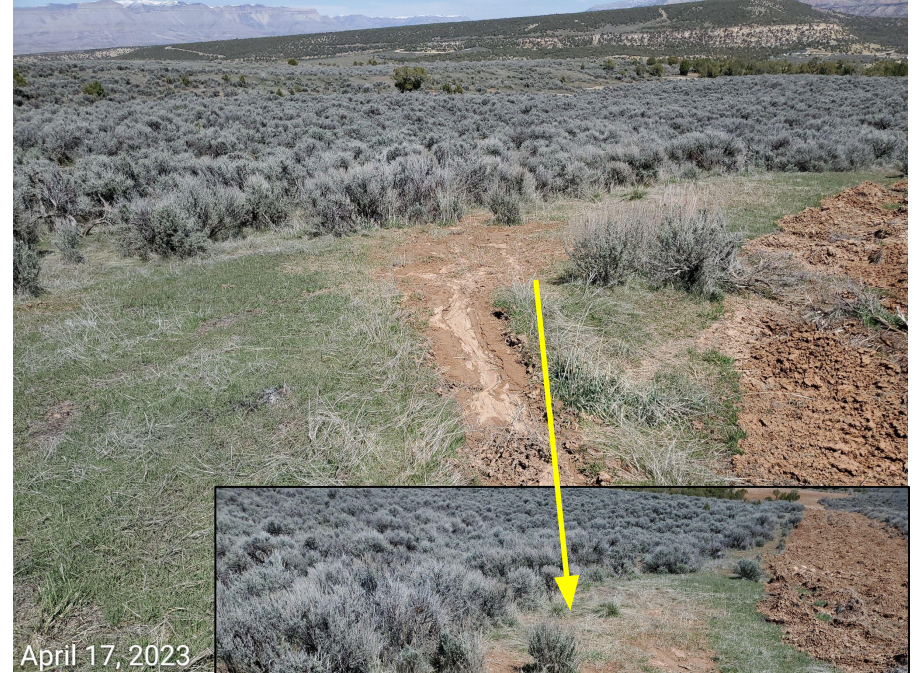
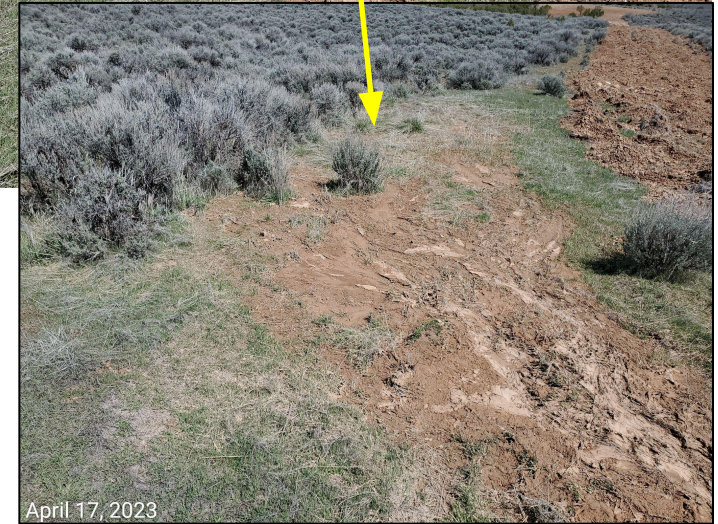
Photo 10: Stormwater and erosion control BMPs at the access road remain missing or insufficient. Photos right show sediment transport/deposition on undisturbed adjacent areas.
