**KT Resources LLC
Ant Hill Unit RBC WG 31-42
Location #316335**

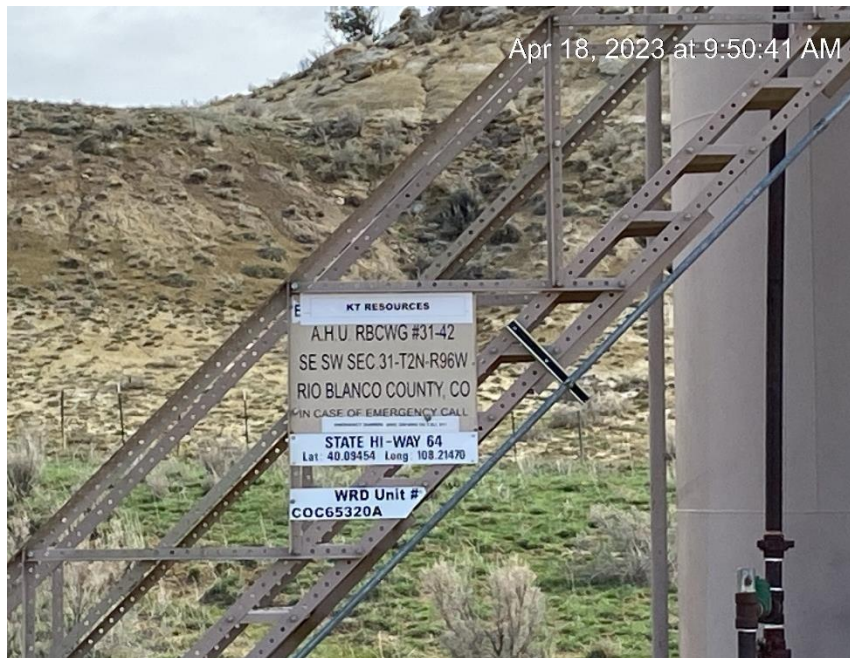
Tank sign missing well API Number

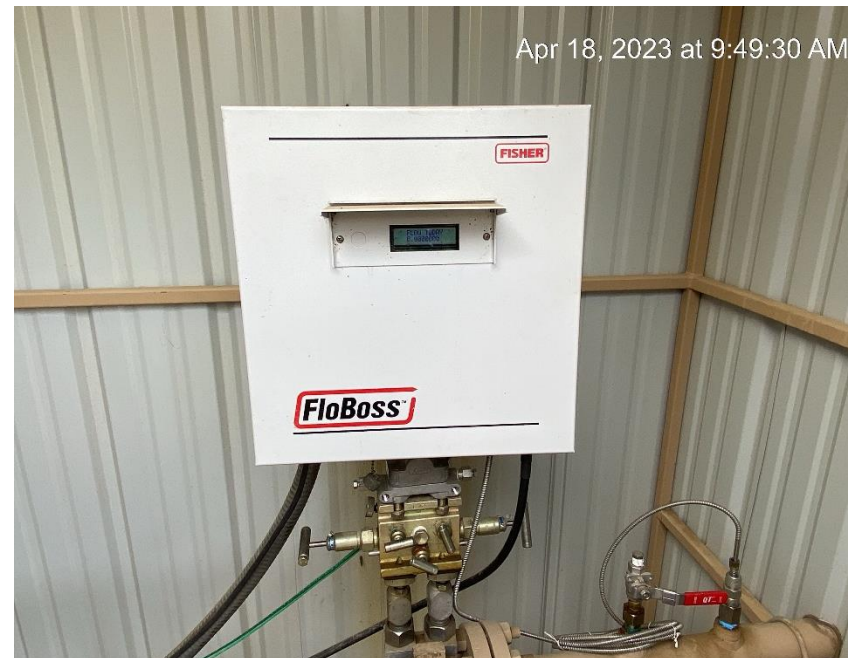
No gas meter calibration card visible

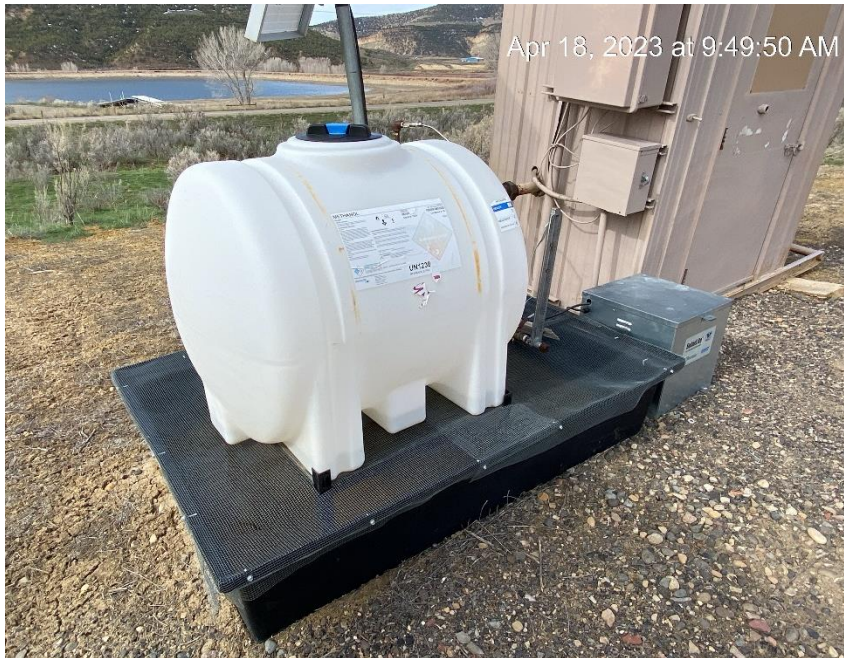
Labels fading and becoming illegible

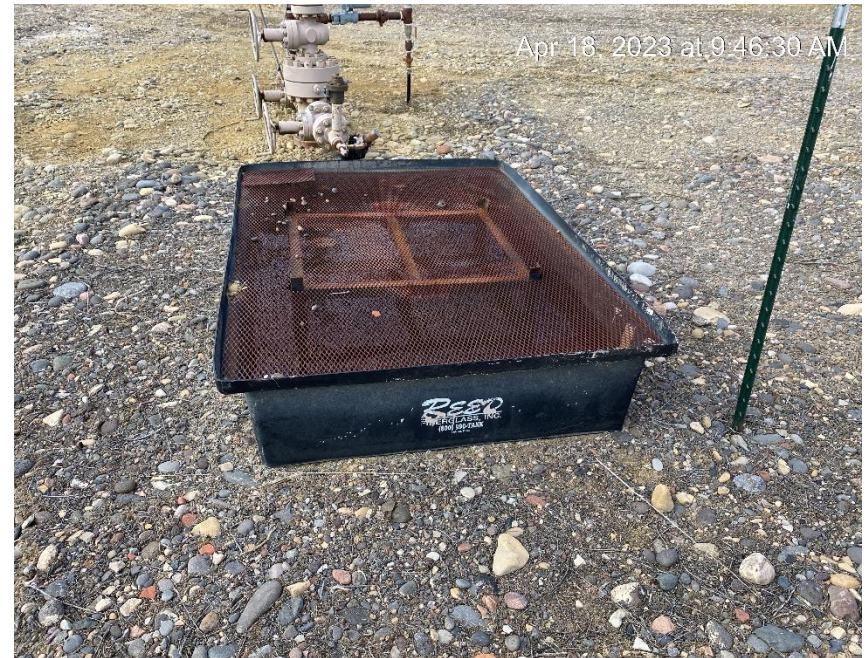
Unused equipment

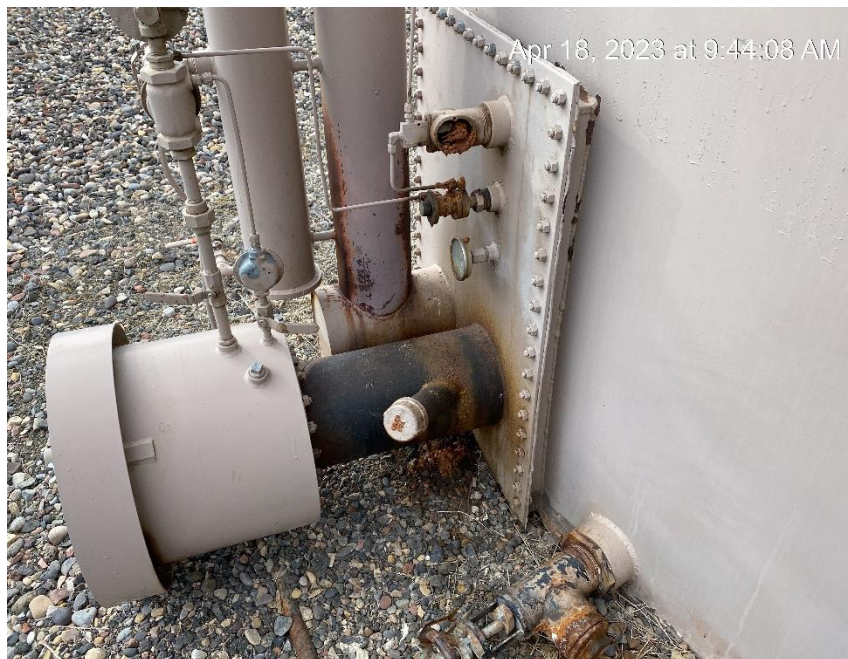
Leaking equipment and soil staining

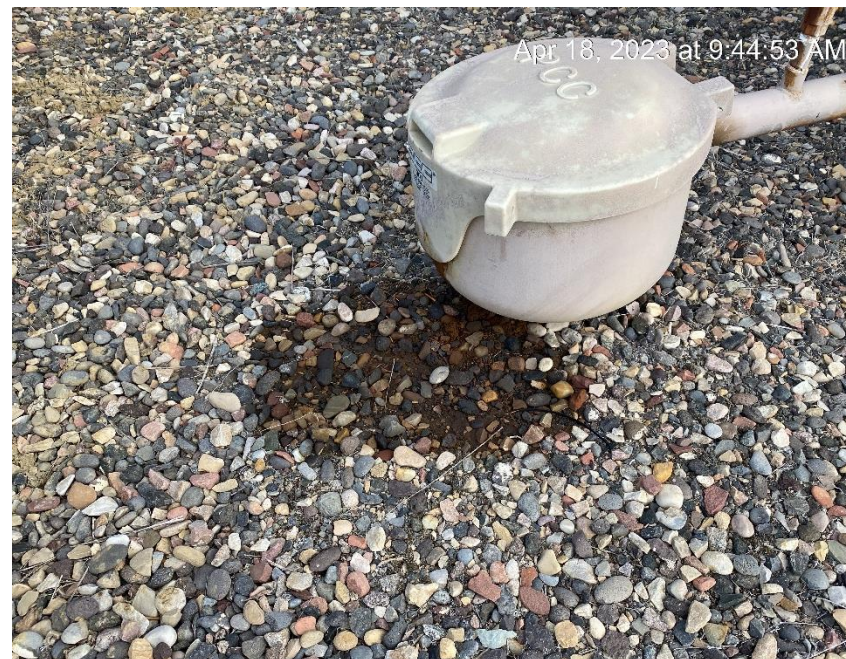
Crude oil loadline soil staining

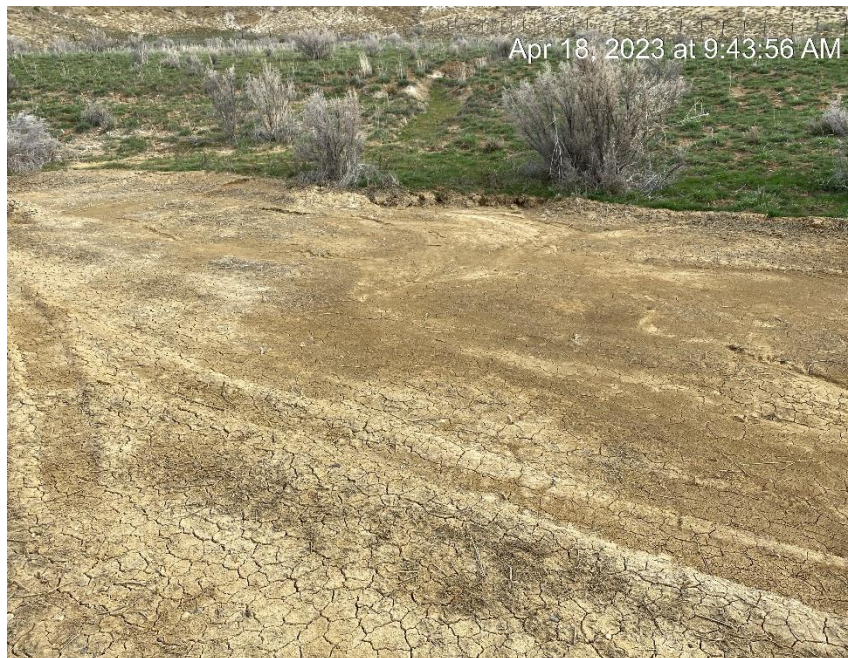
Sediment migration entering location

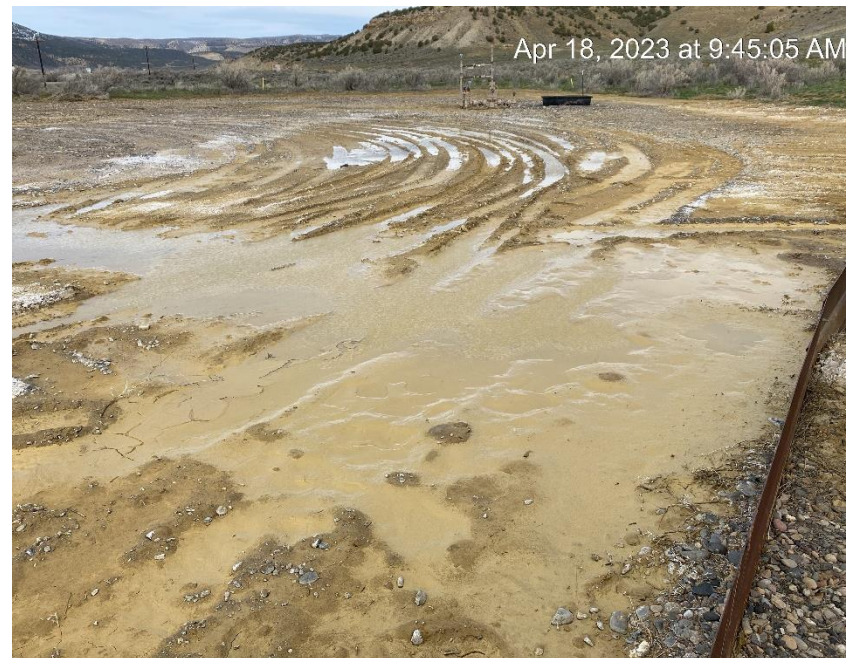
Lack of stabilization and vehicle tracking

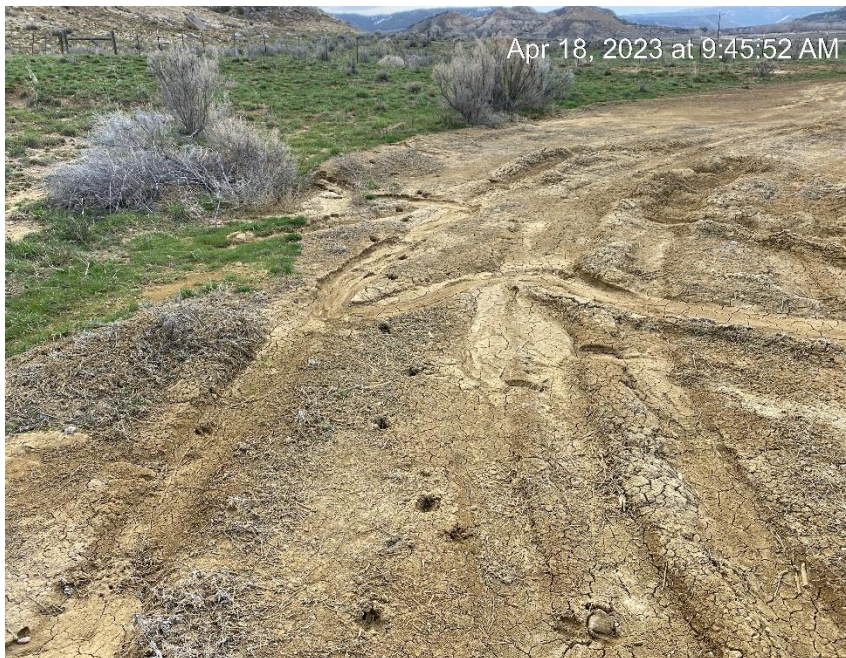
Sediment migration exiting location and vehicle tracking

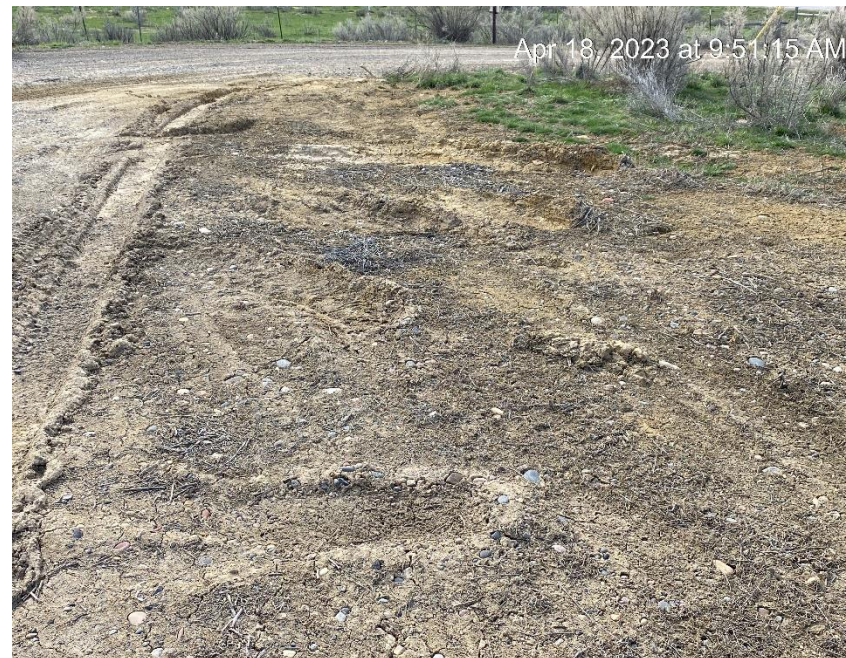
Sediment migration and vehicle tracking leaving location
