**KT Resources LLC**  
**Fee M-31-2-96-N, Ant Hill Unit 6-11D**  
**Location #336391**

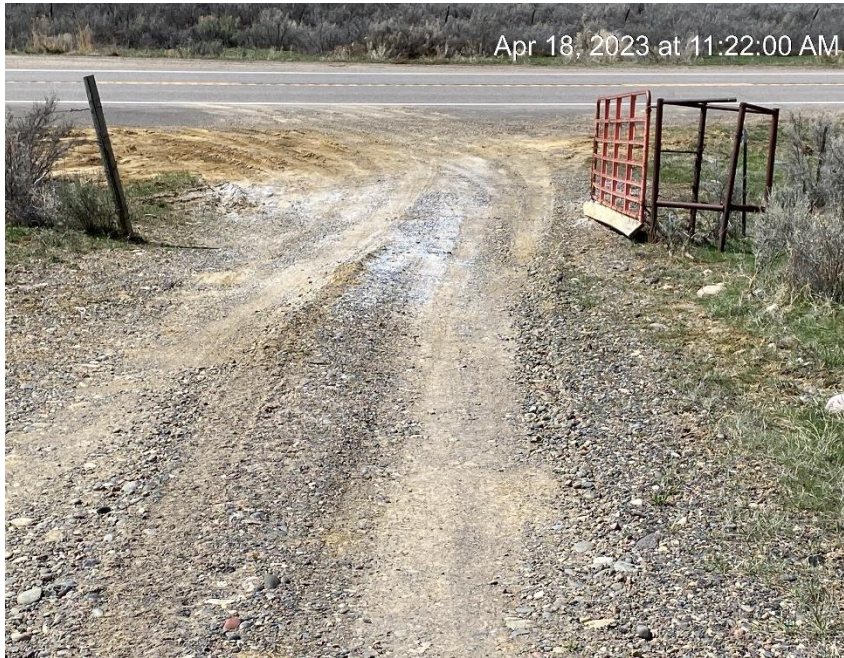
**Access off highway 64**

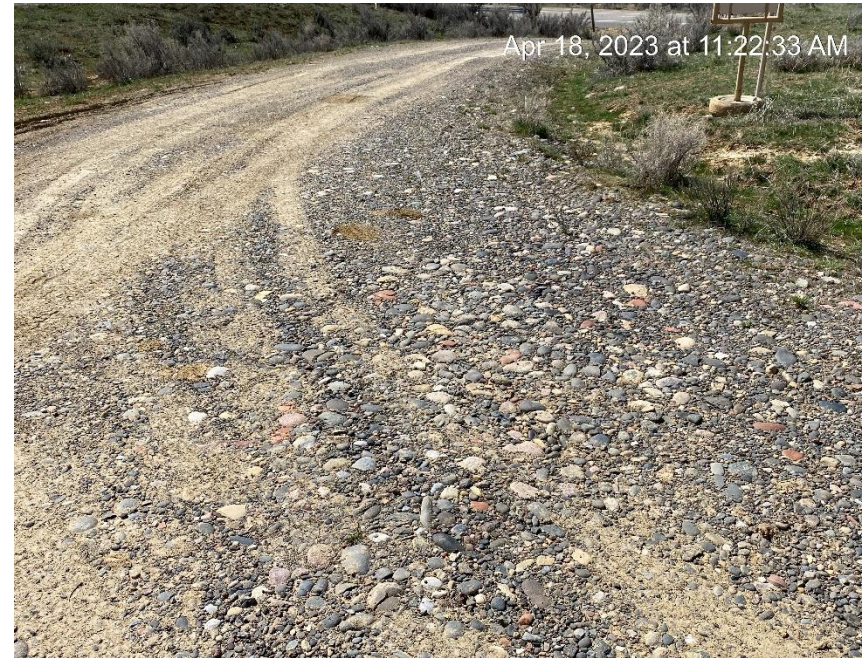
**Access road from highway 64 to location**

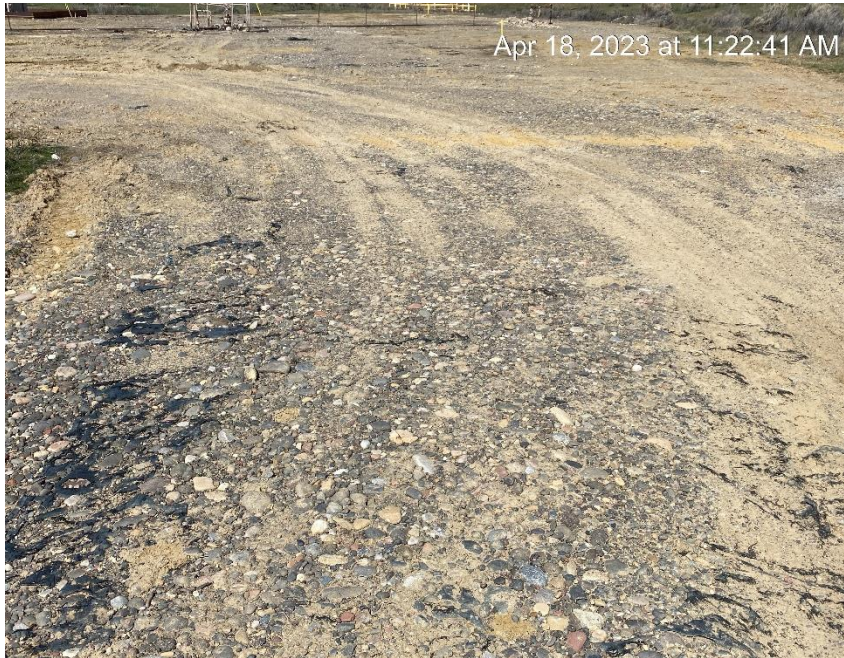
**Access road entrance to location**

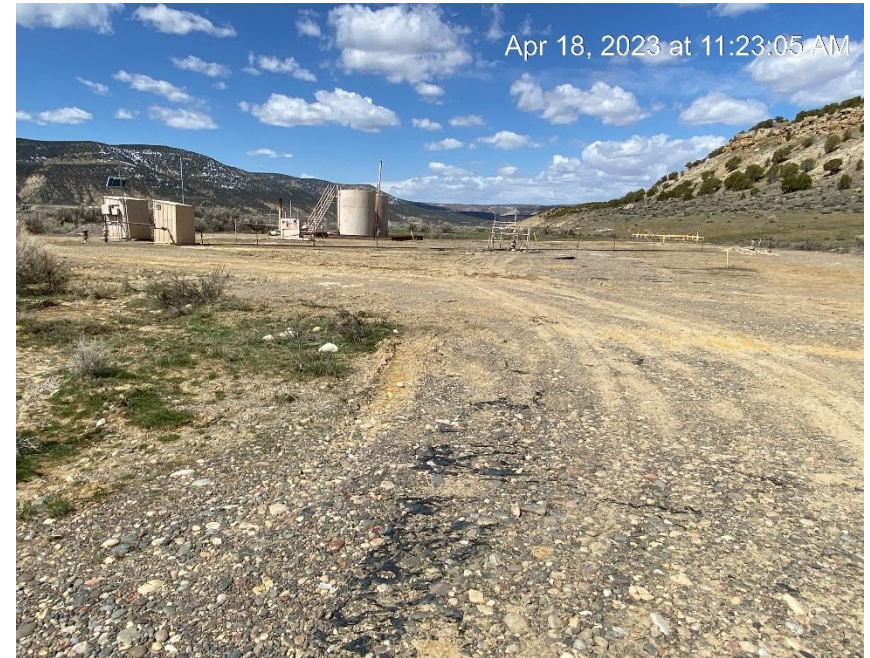
**Entrance to location**

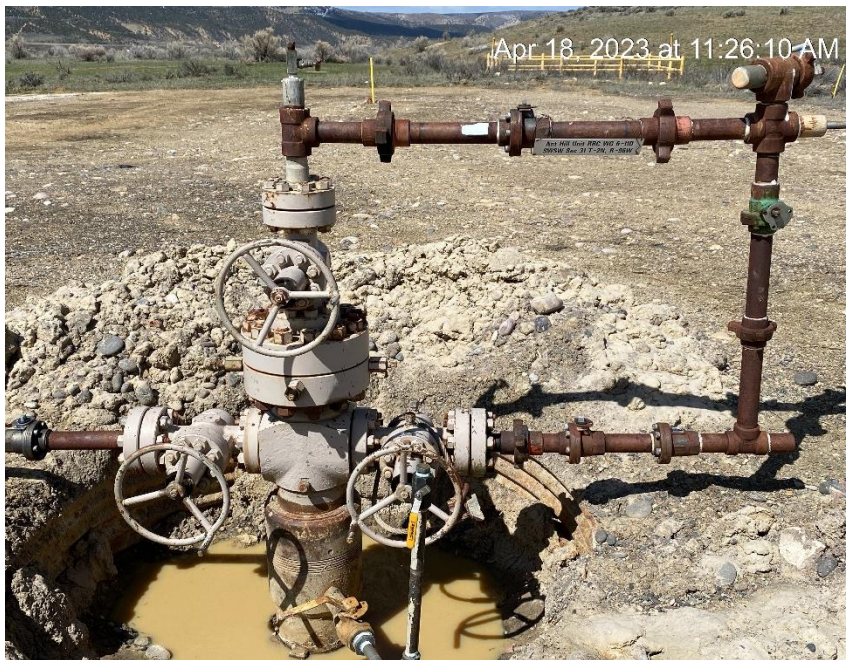
**Open cellar**

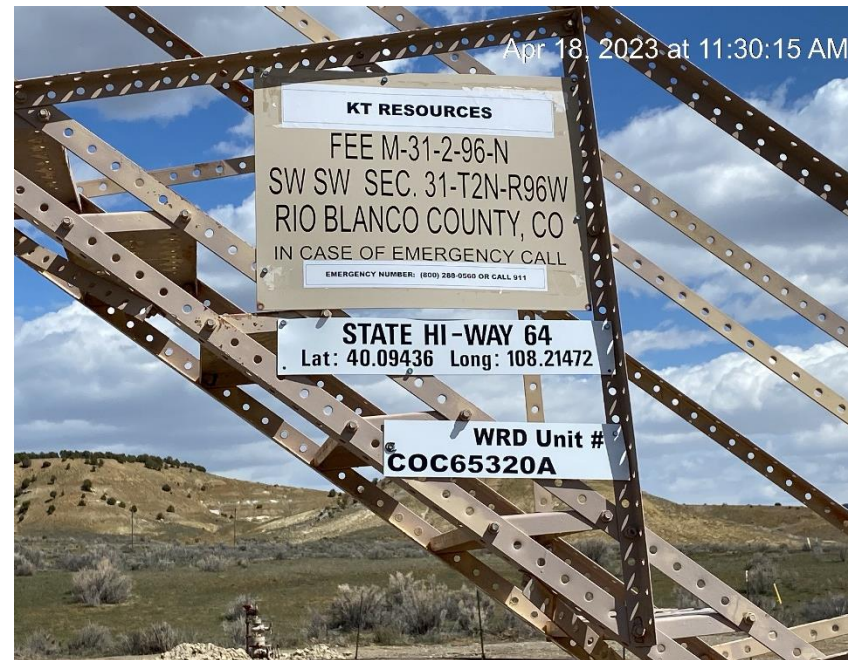
**API Number missing from tank battery sign**

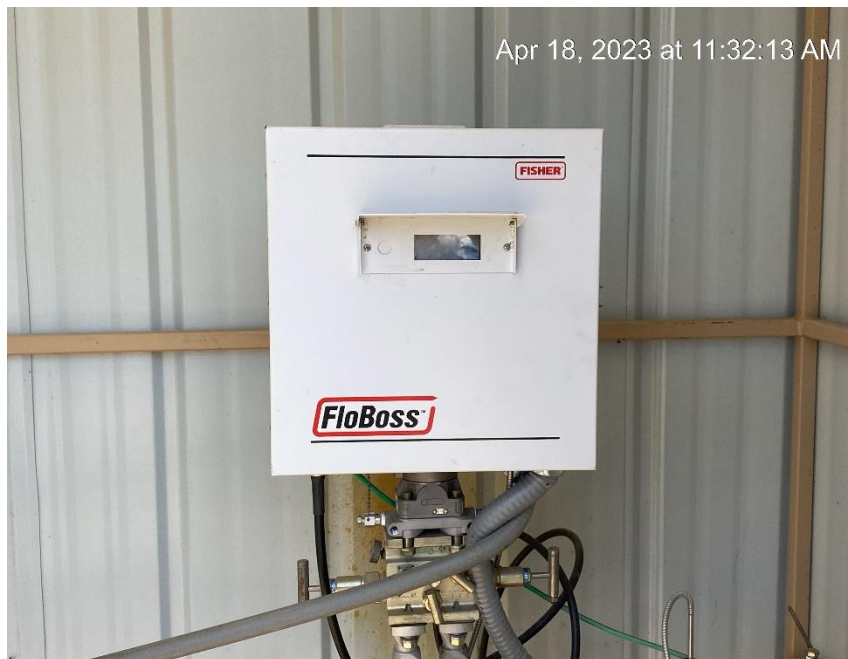
**No gas meter calibration card visibly displayed**

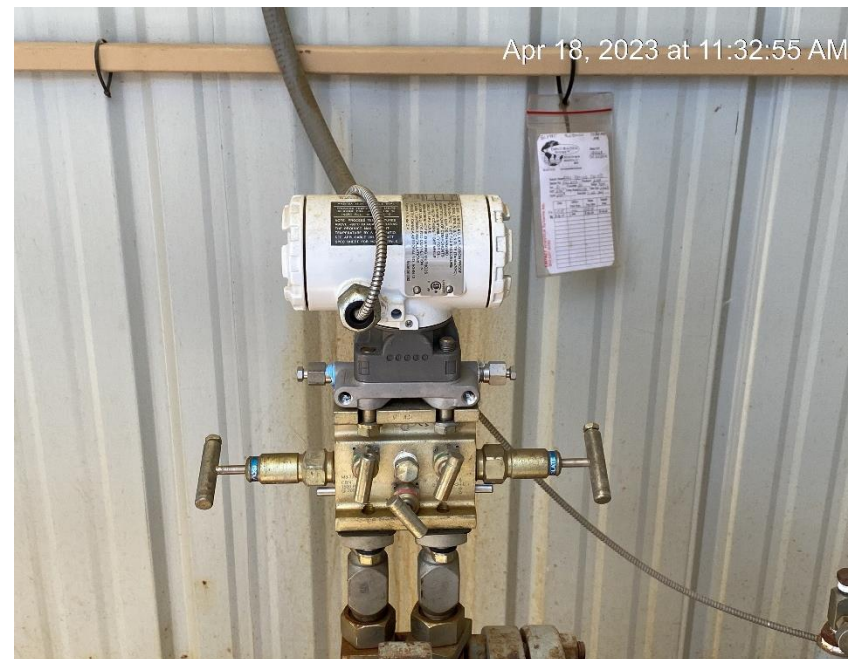
**Calibration card visibly displayed**

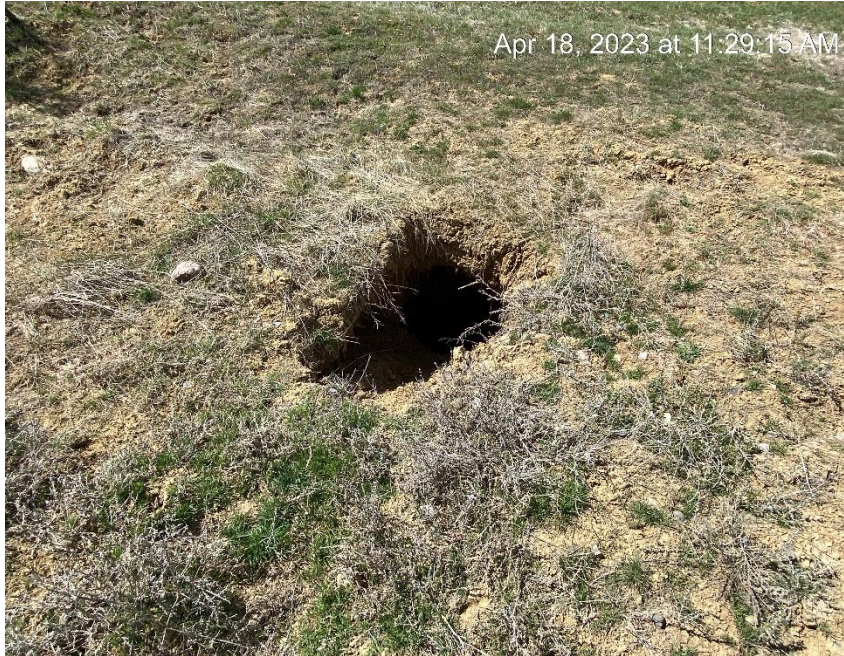
**Edge of location sinkhole**

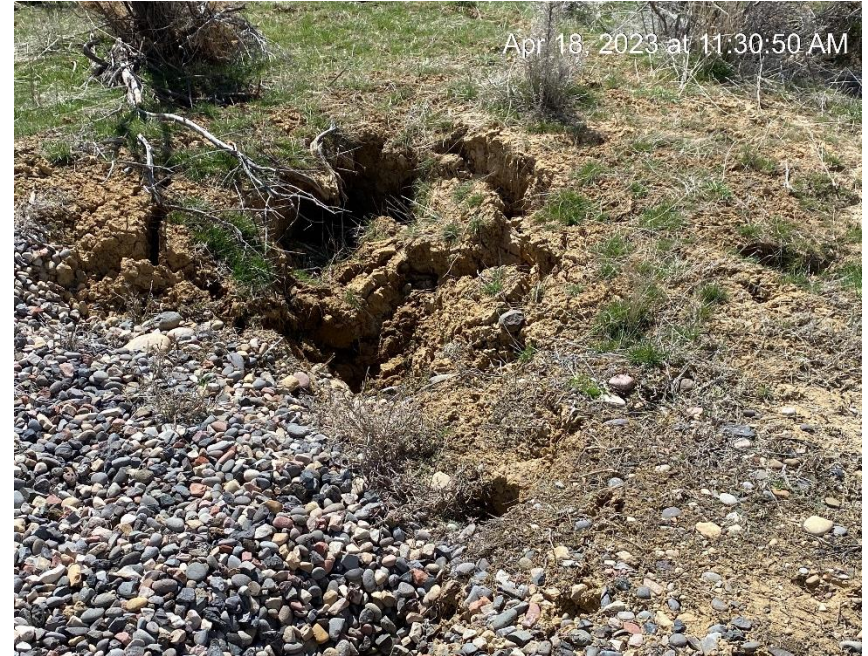
**Sinkhole at edge of location**

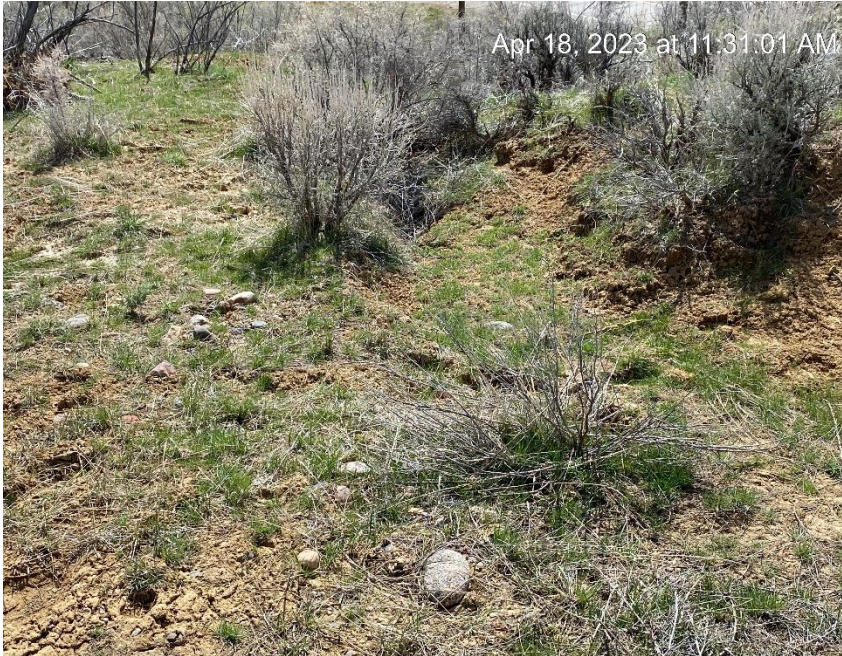
**Erosion ditch off location**

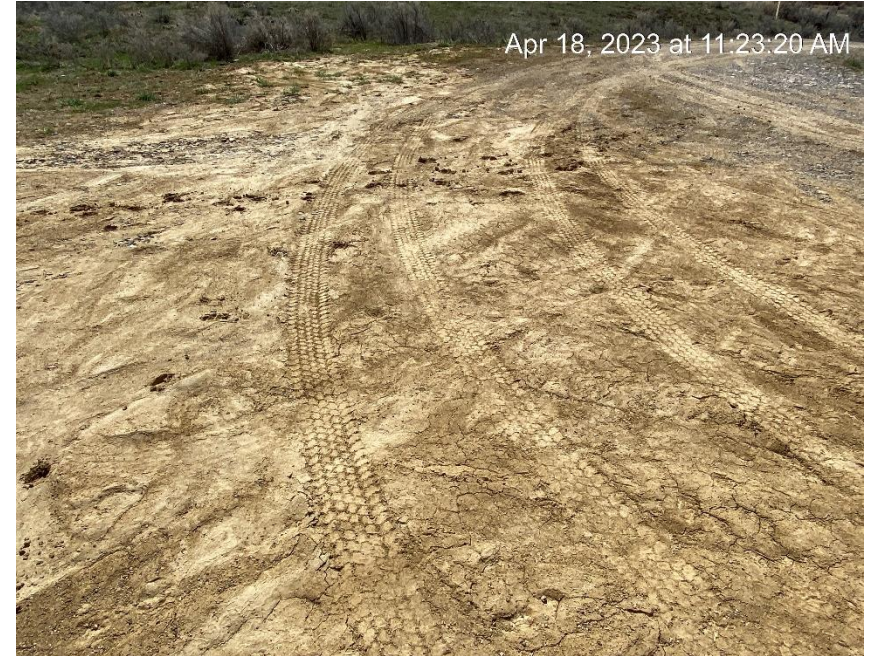
**Sediment migration from location and hillside**

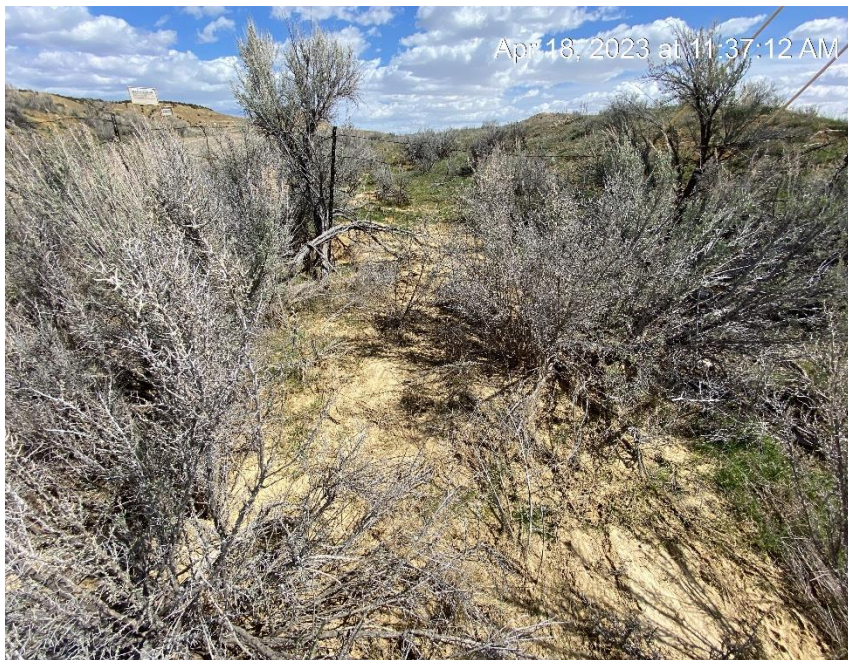
**Sediment migration ditch from location to highway 64**

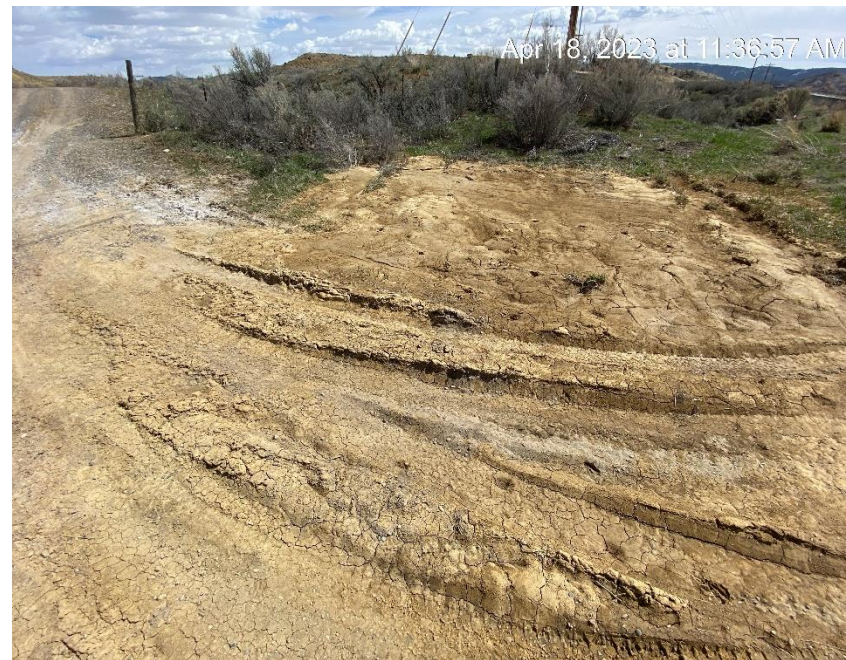
**Sediment migration from location to highway 64**
