# Inspection Photos

4/17/2023

Operator: CAERUS PICEANCE LLC #10456

Location #334103

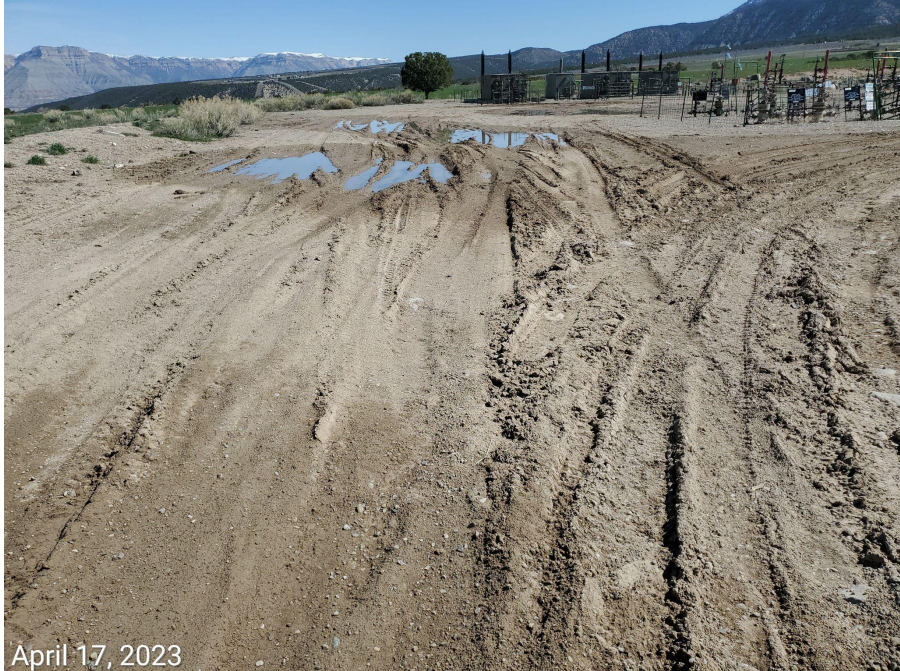
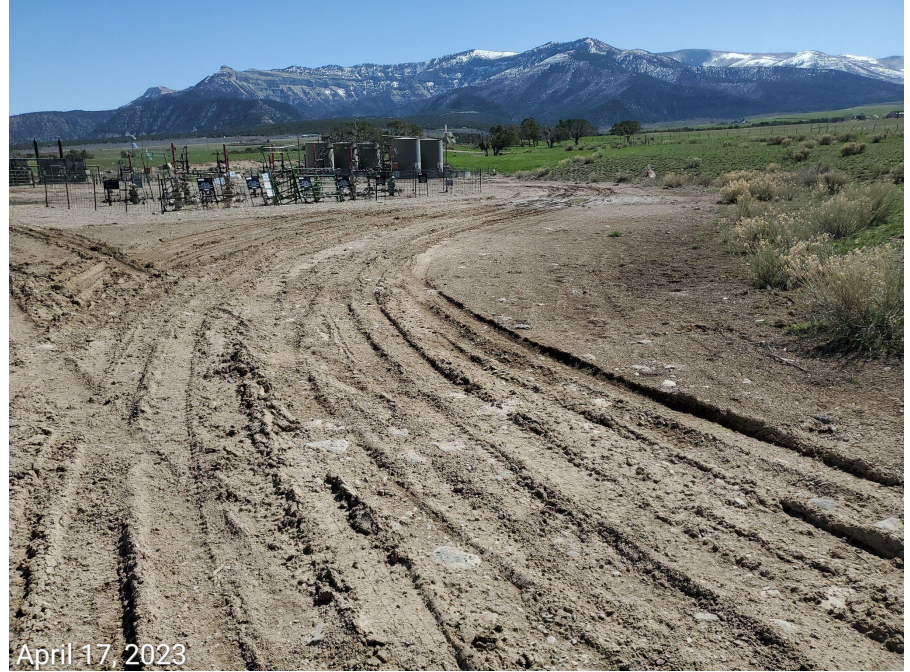
**Photo 1:** Photo taken from the Location entrance facing north and northeast. Photos examples showing BMPs to stabilize, as well as to minimize erosion, degradation and off-site sediment transport are missing or insufficient; pad lacks stabilization. Tracking controls not observed.

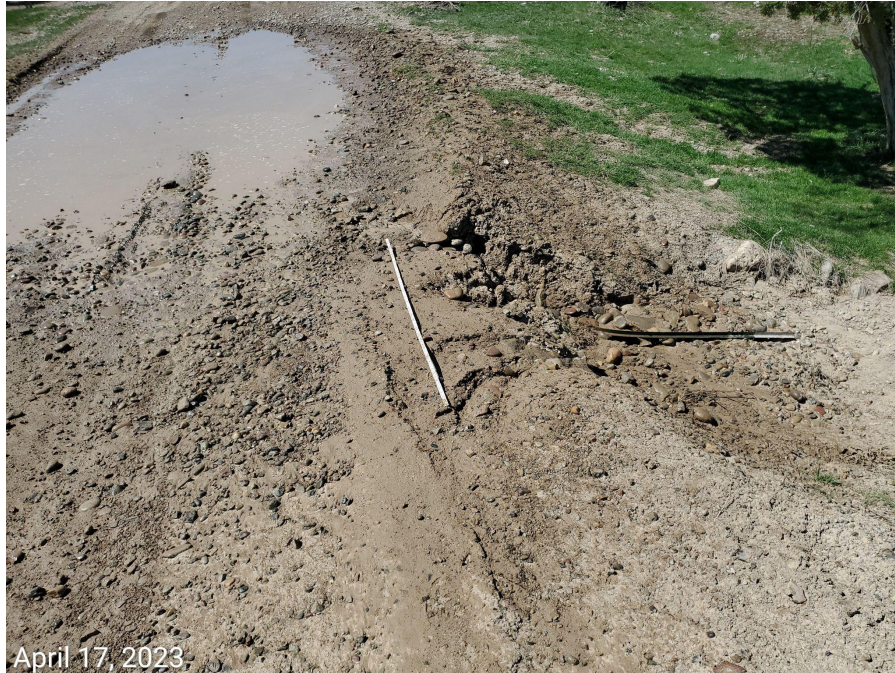
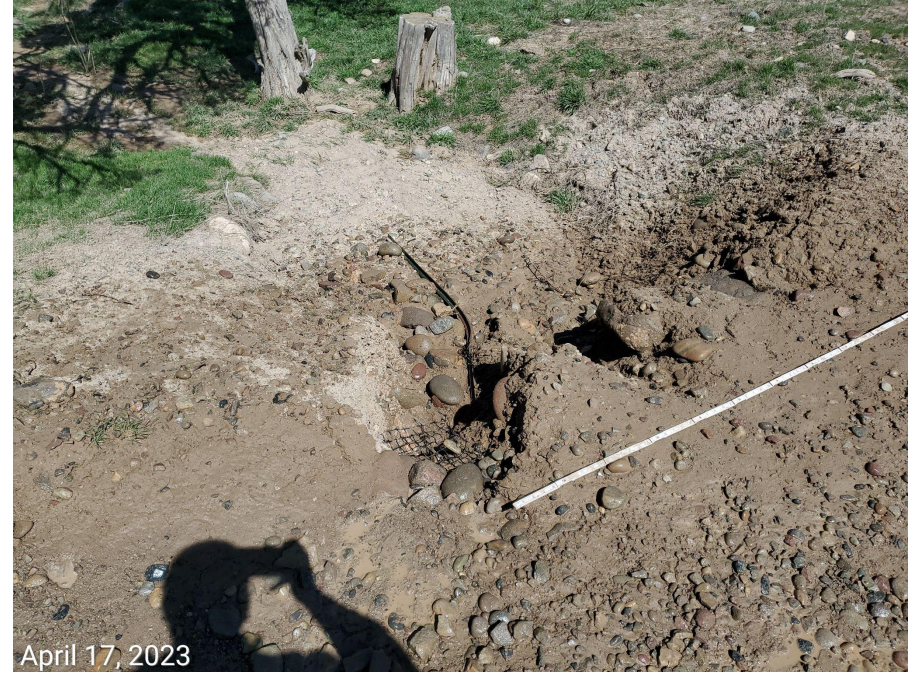
**Photo 2:** Photo taken from culvert along access road. Ponding shows BMPs to allow for proper stormwater discharge at road are missing or insufficient; culvert has not been installed or maintained in accordance with good engineering practices; culvert has been pinched at outlet and filled with sediment; culvert lacks proper armoring at and above the inlet/outlet. 6 foot measuring stick for reference.

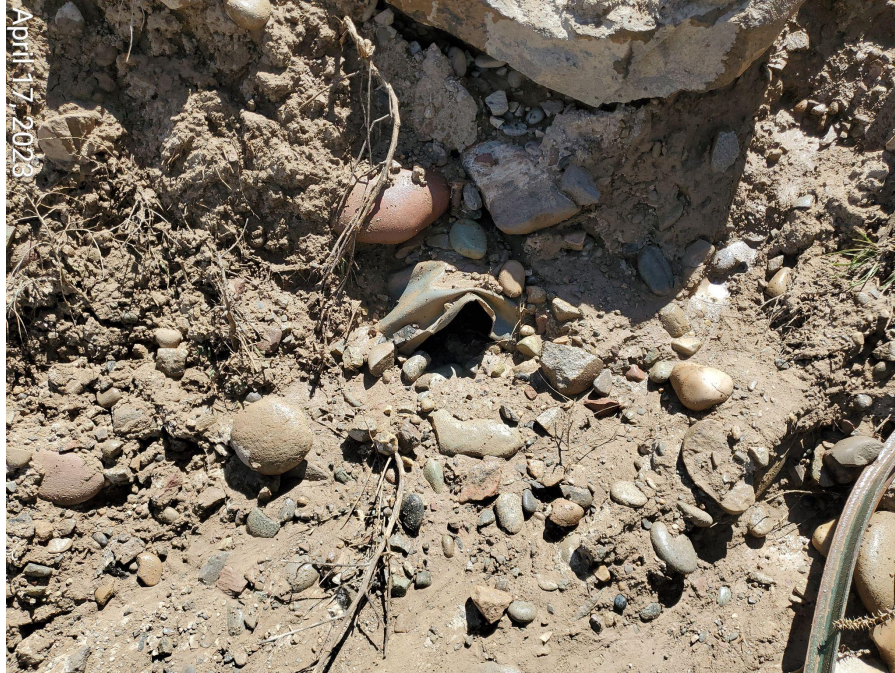
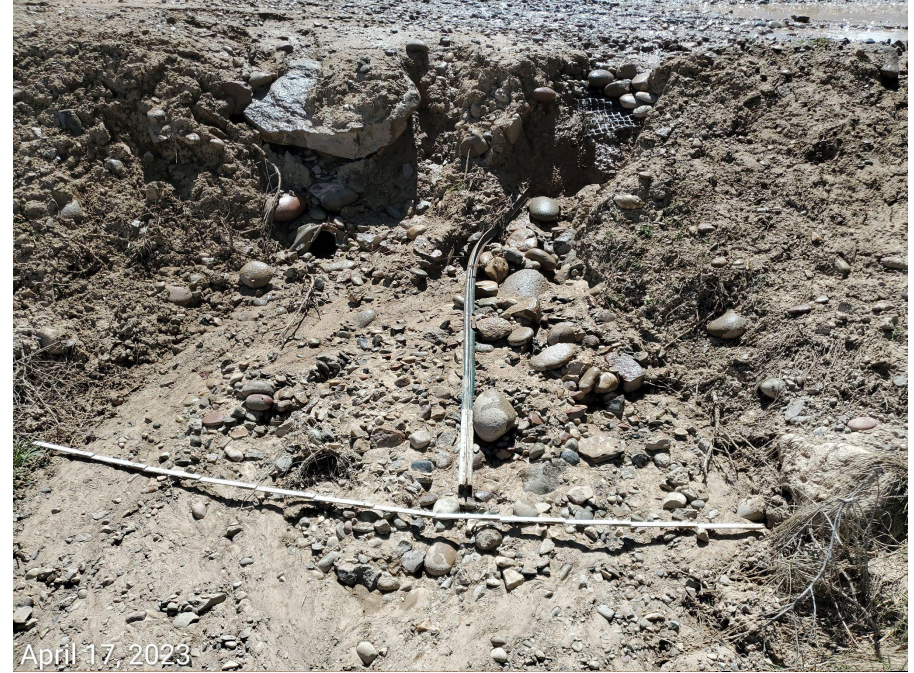
**Photo 3:** See comments under photo 2.

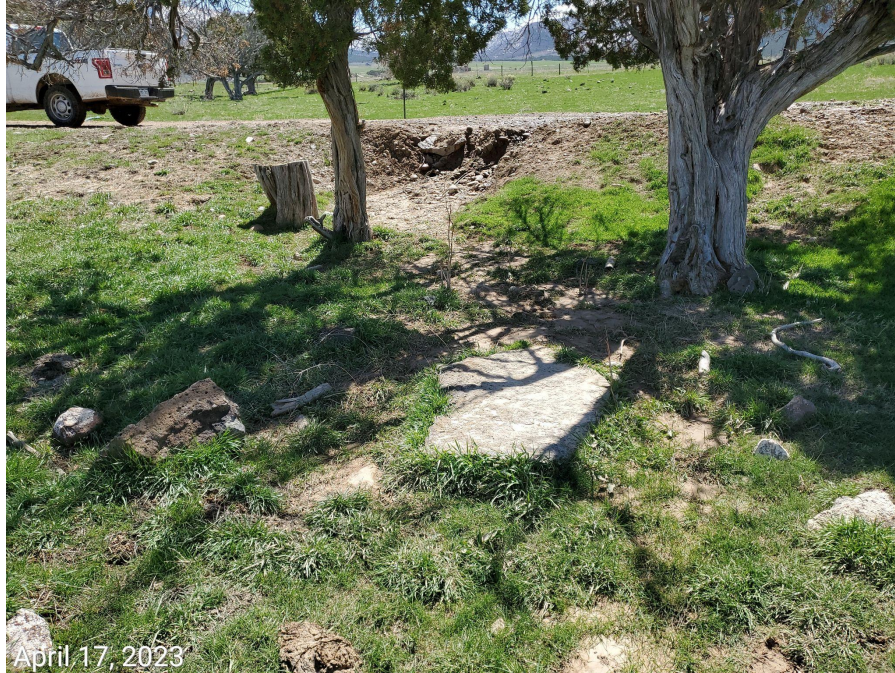
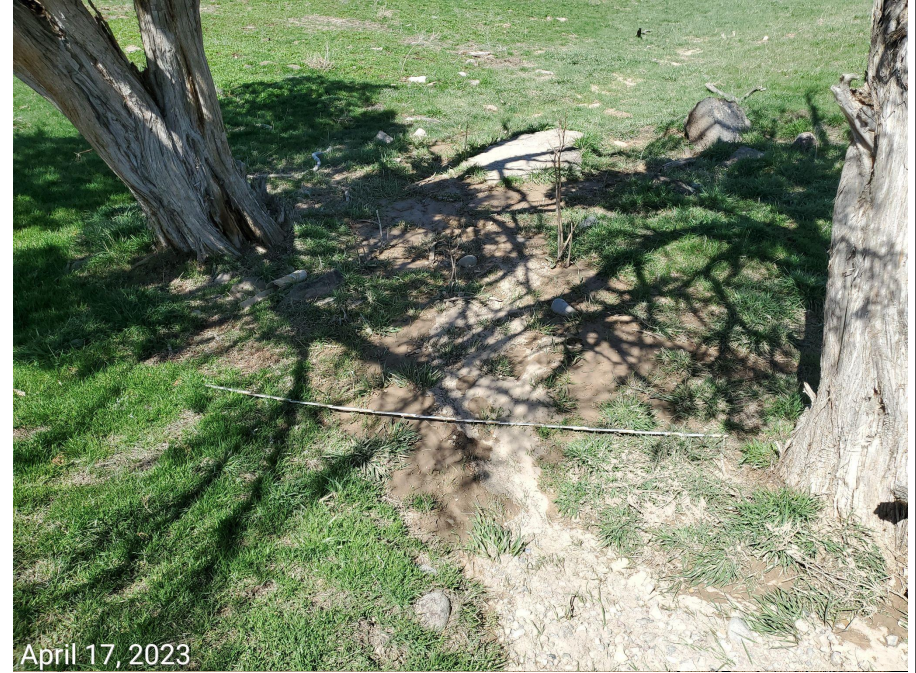
**Photo 4:** Photos show sediment transport/deposition due to improper stormwater management. 6 foot measuring stick for reference.

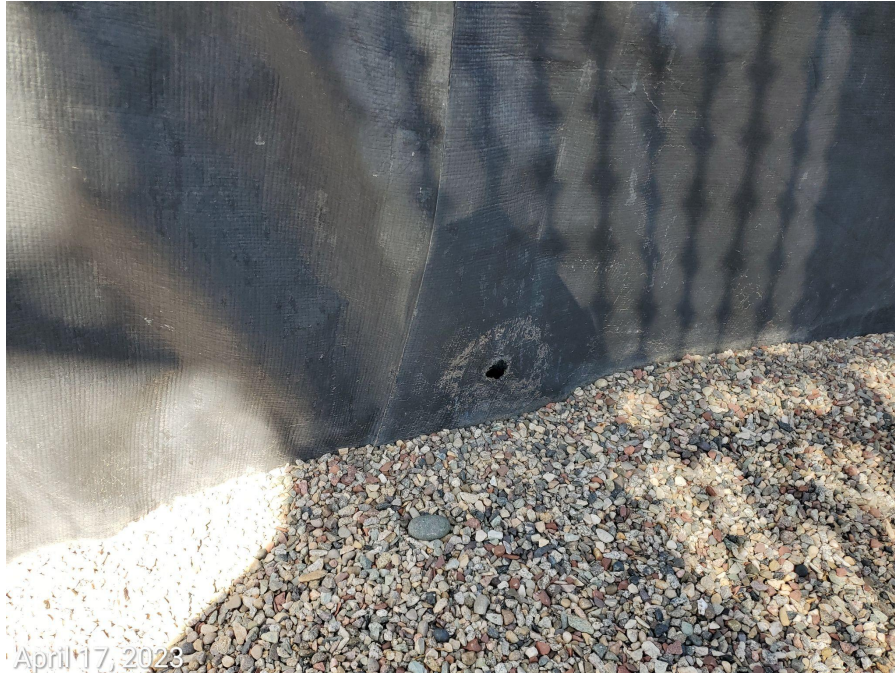
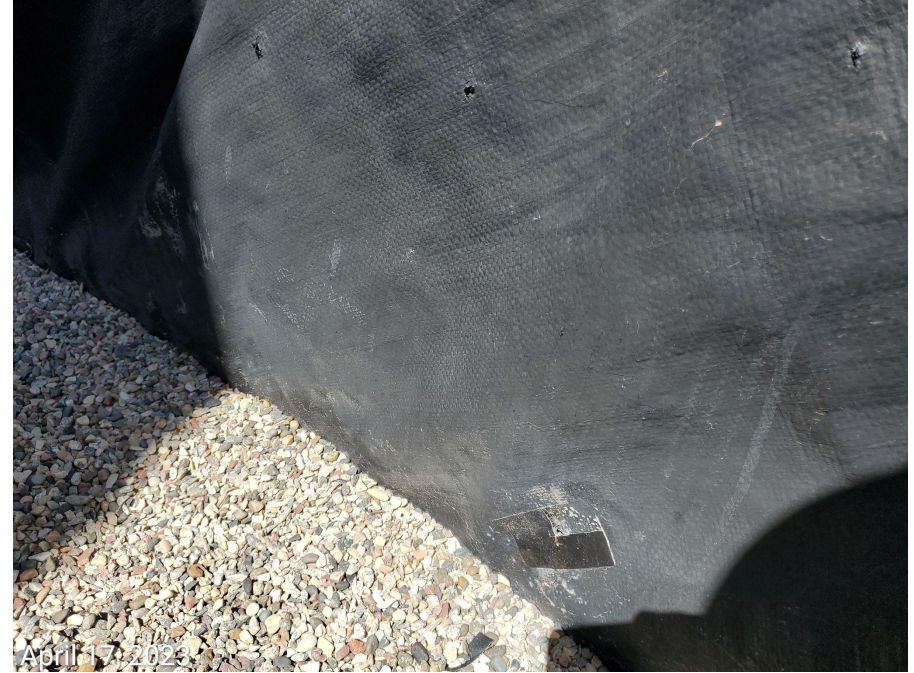
**Photo 5:** Photos examples showing various holes observed throughout the secondary containment liner.

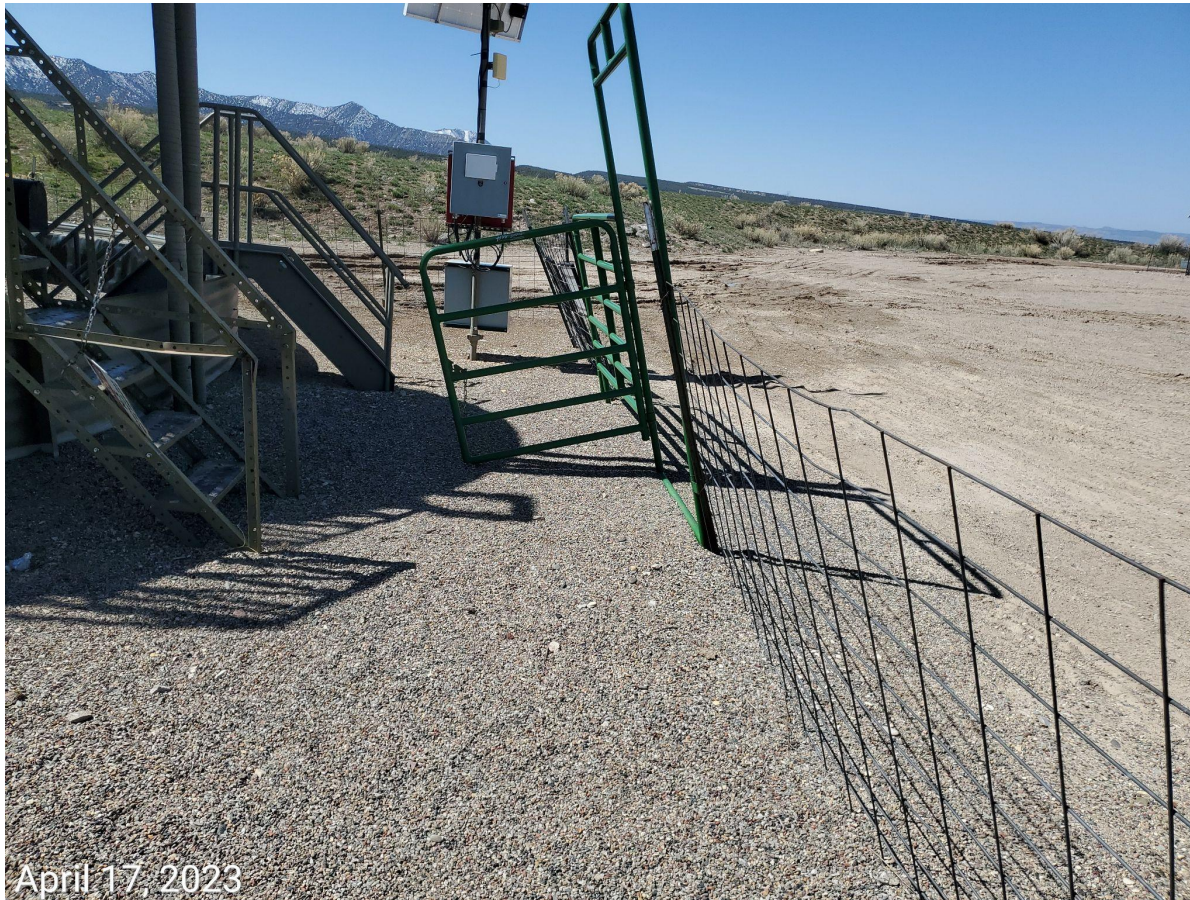
**Photo 6:** Fence appears to only be supported by the gate- many t-post supports observed to be unanchored.

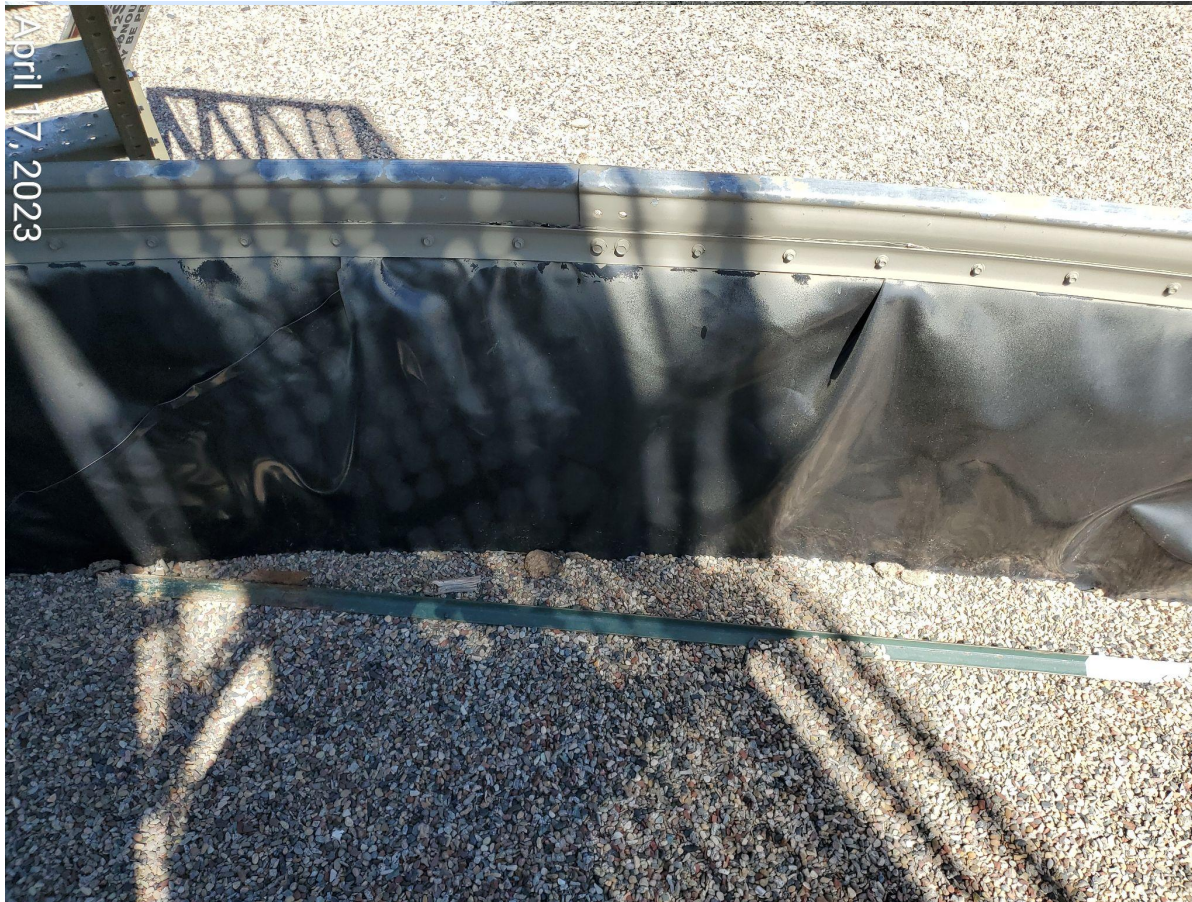
**Photo 7:** Unused t-post improperly stored within secondary containment of battery.

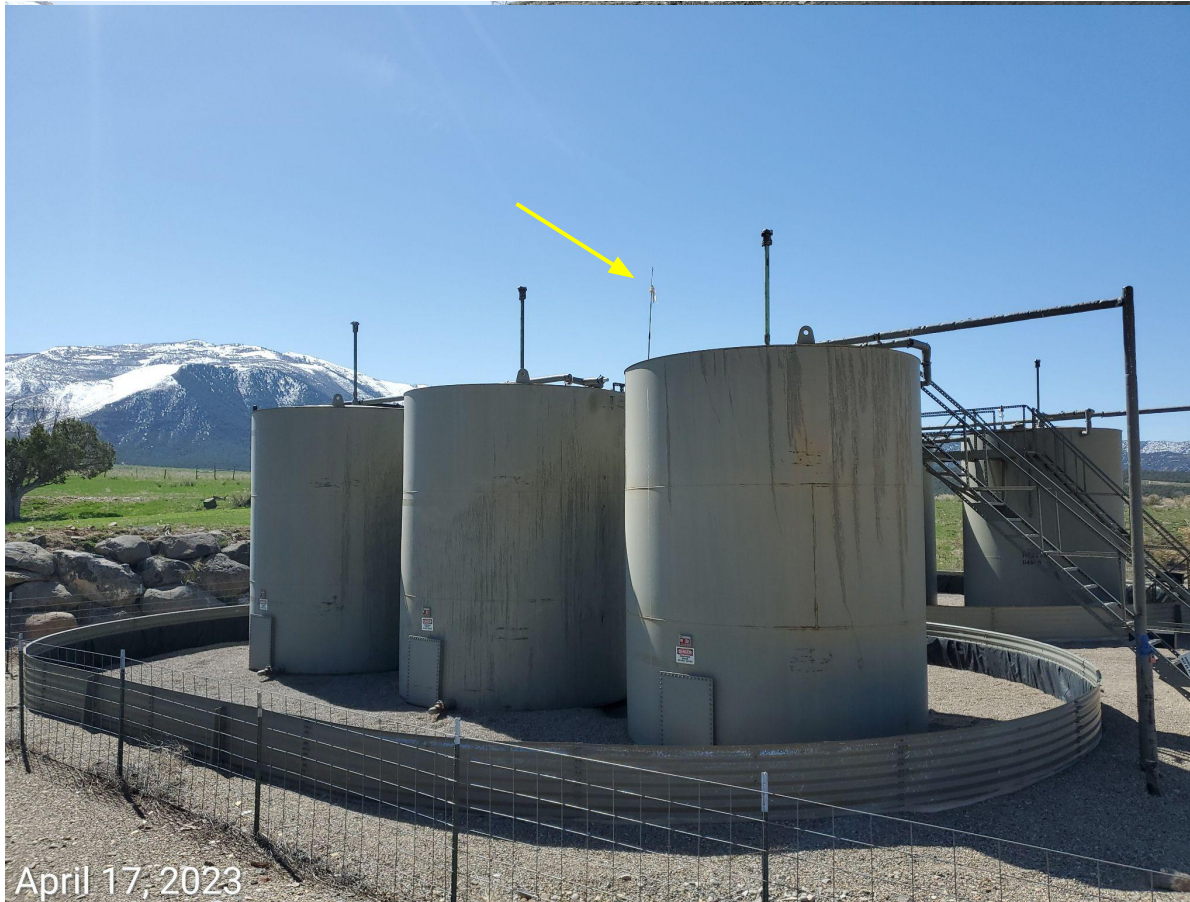
**Photo 8:** Wind indicator safety equipment not in proper functioning condition.

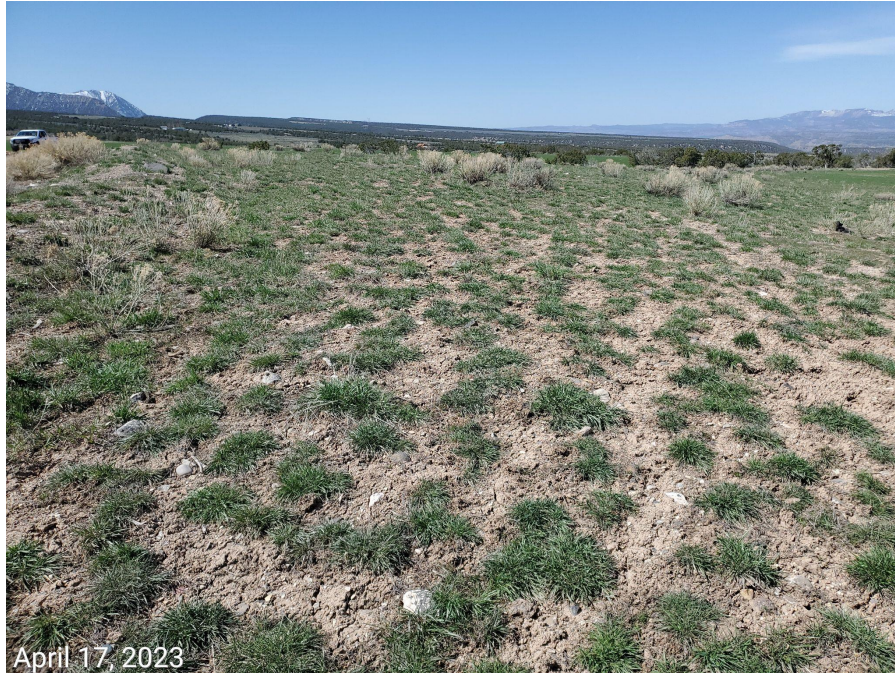
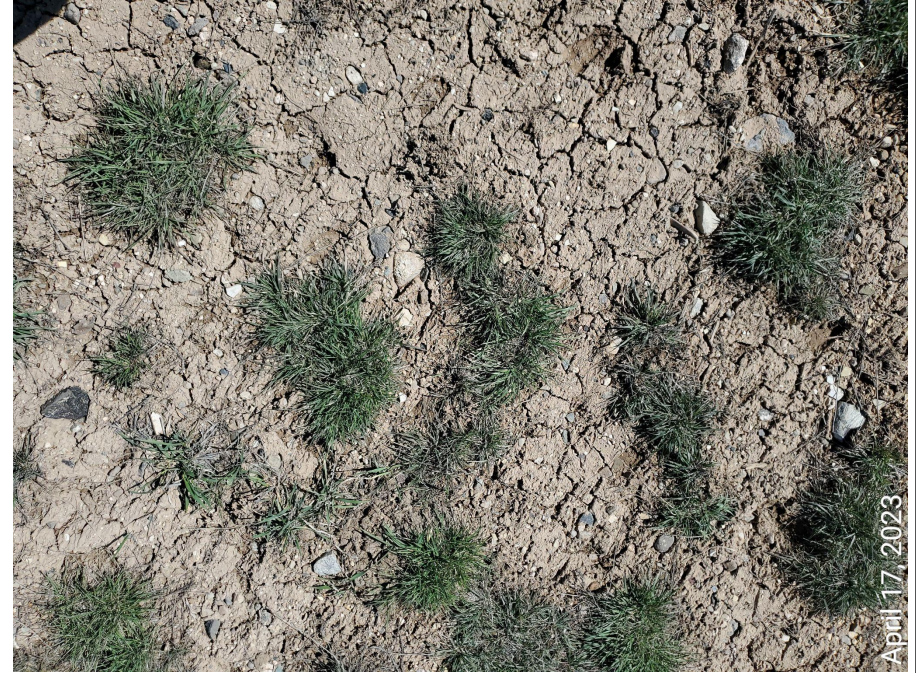
**Photo 9:** Photo taken from the interim areas of the Location. Photo shows areas appear to be progressing towards 1003 standards, though uniform establishment compared to the reference does not appear to have been achieved within many areas of the interim.

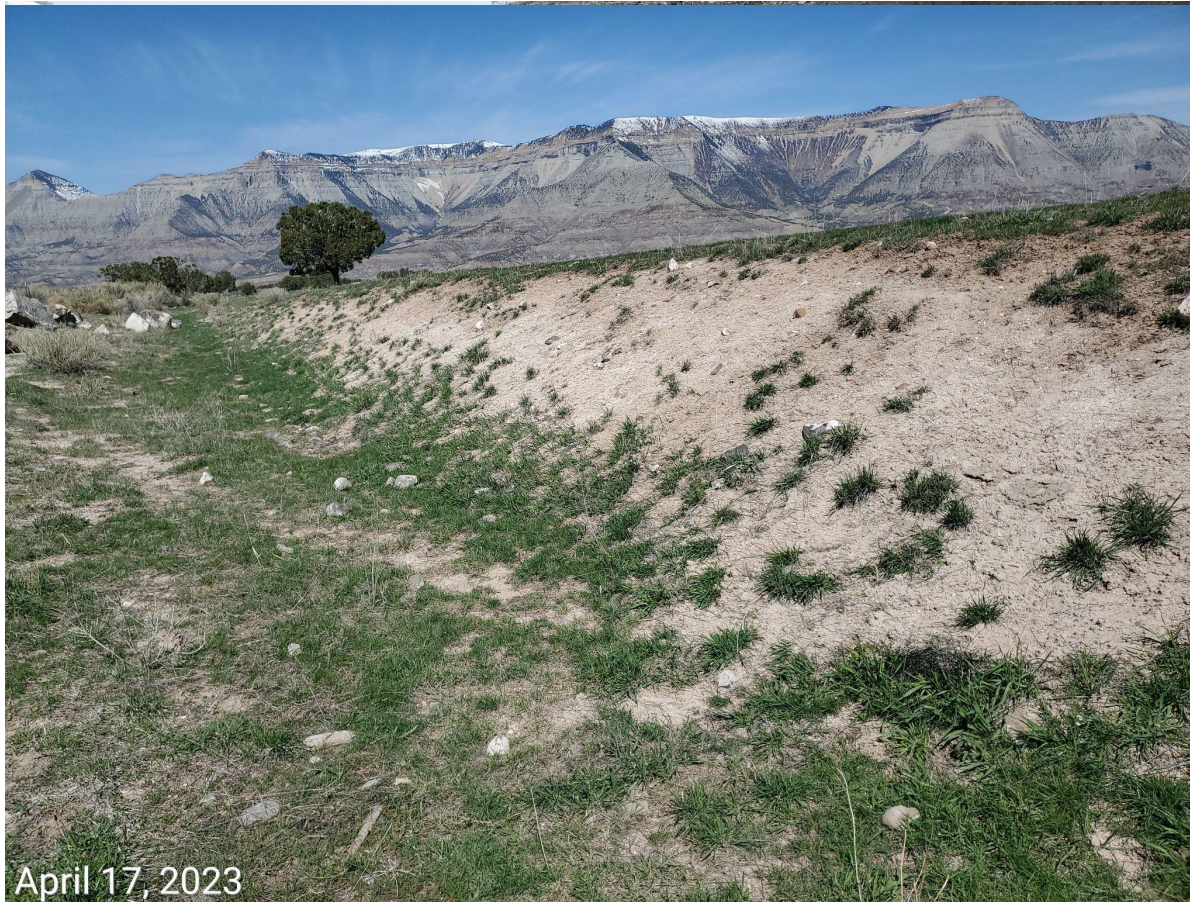
**Photo 10:** Photo shows interim areas of the Location that have not achieved uniform vegetative establishment. Addition revegetation activities will likely be required.

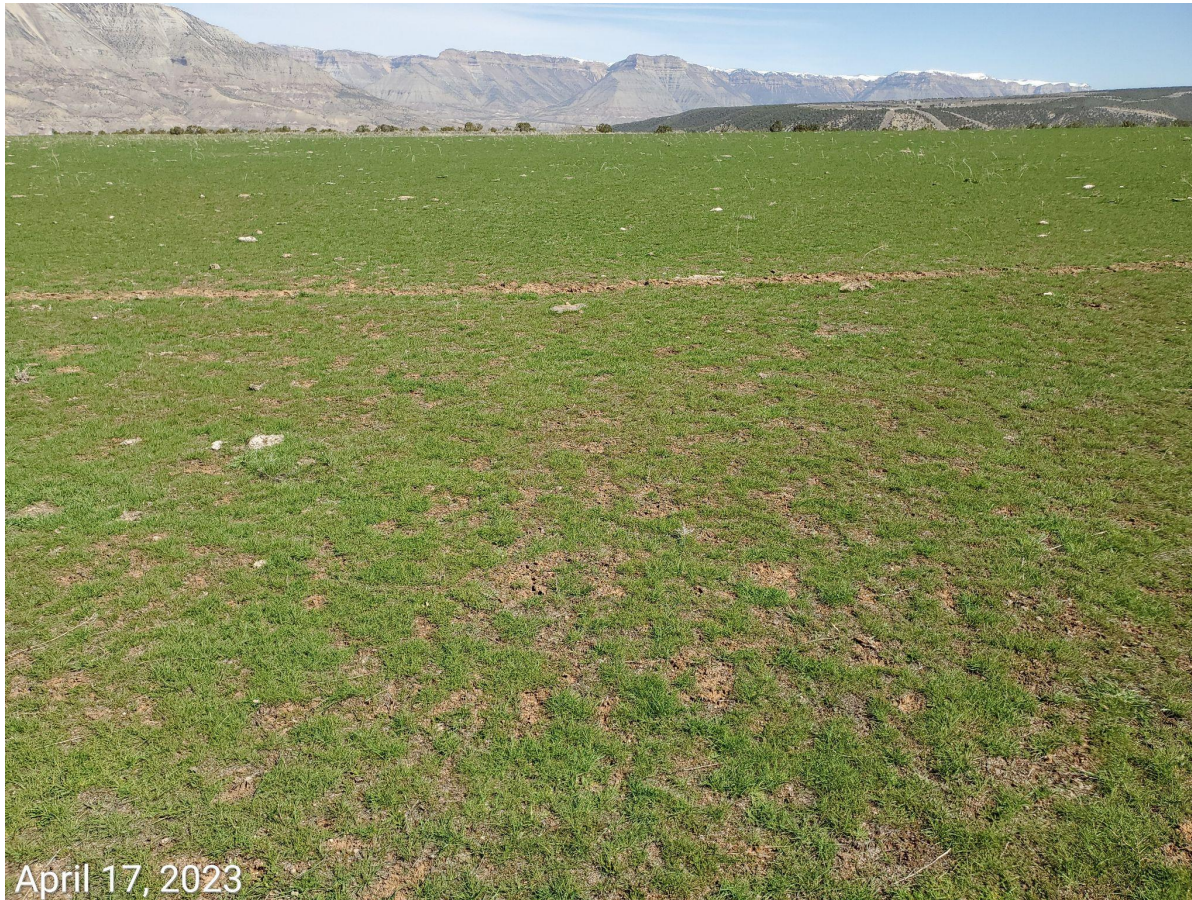
**Photo 11:** Adjacent reference area for comparison to the interim areas; reference appears to be an irrigated perennial cropland.
