# Inspection Photos

4/17/2023

Operator: CAERUS PICEANCE LLC #10456

Location #334158

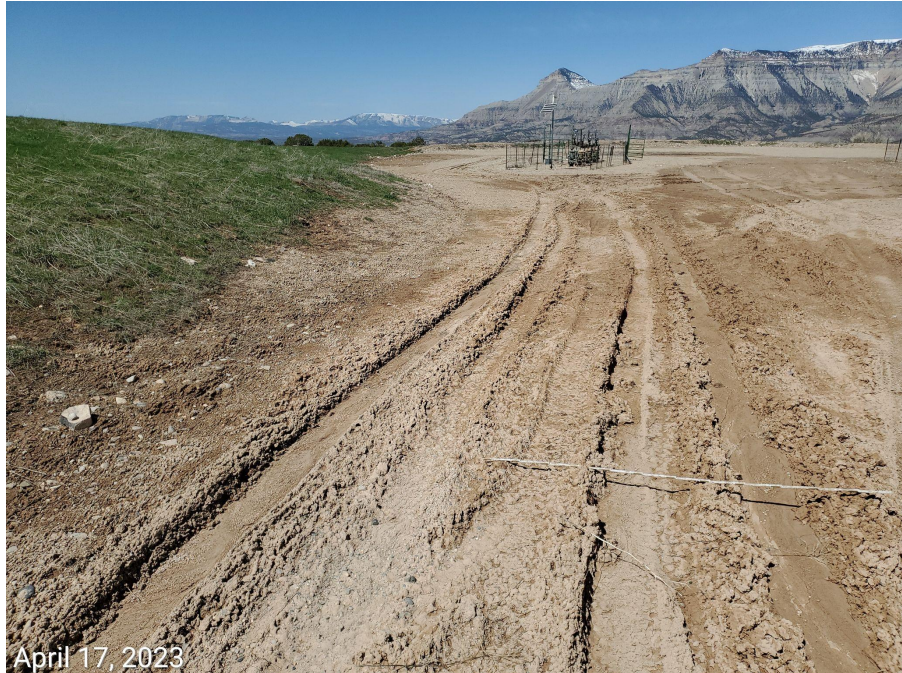
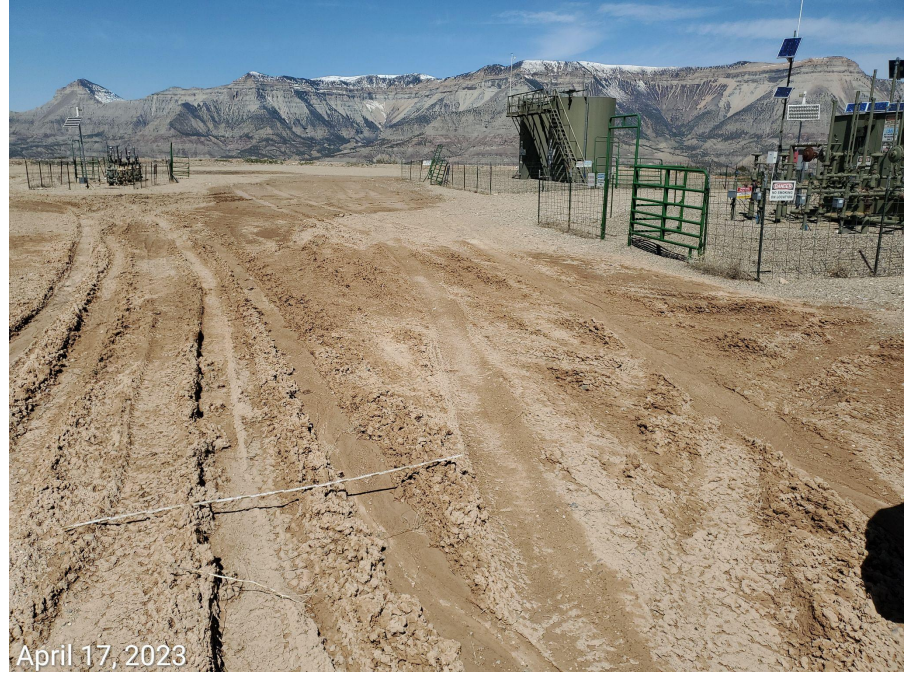
**Photo 1:** Photos taken from the Location entrance. Photos also examples showing BMPs to stabilize, as well as to minimize erosion, degradation and off-site sediment transport are missing or insufficient; pad lacks stabilization. Tracking controls not observed. 6 foot measuring stick for reference.

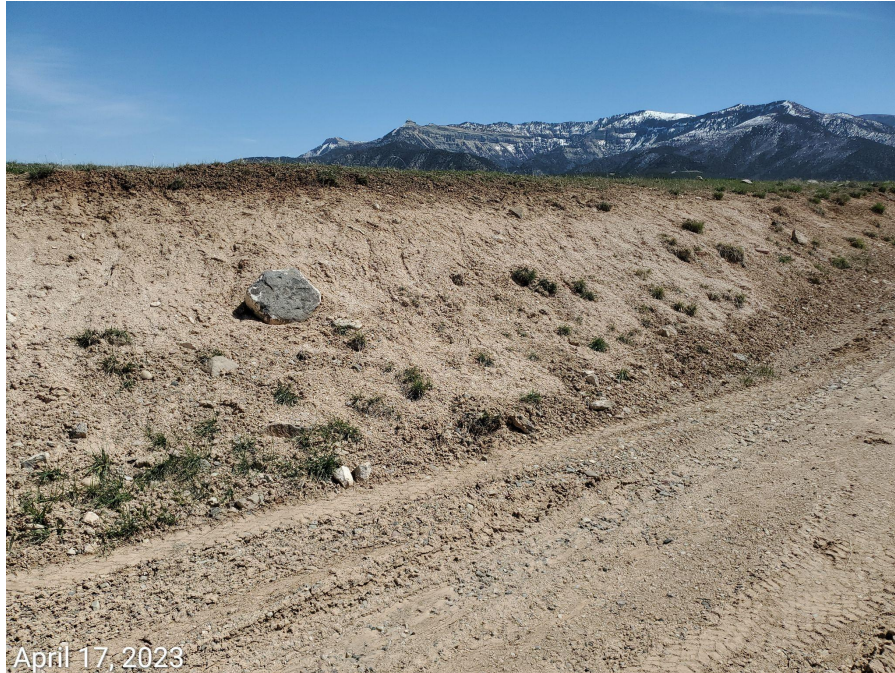
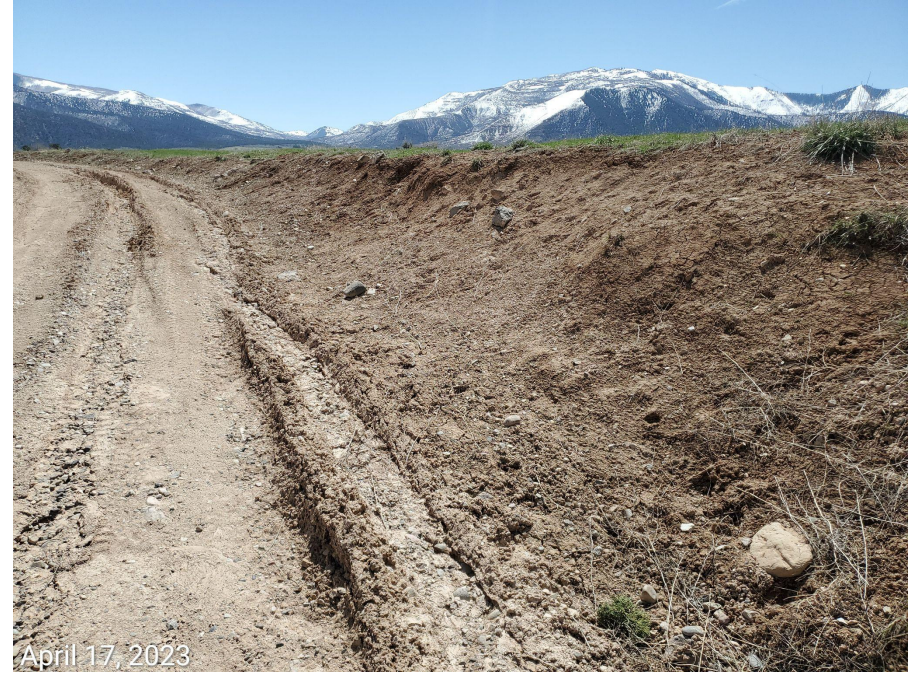
**Photo 2:** BMPs at cut slopes along access road are missing or insufficient; erosion degradation evident. Slopes lack stabilization.

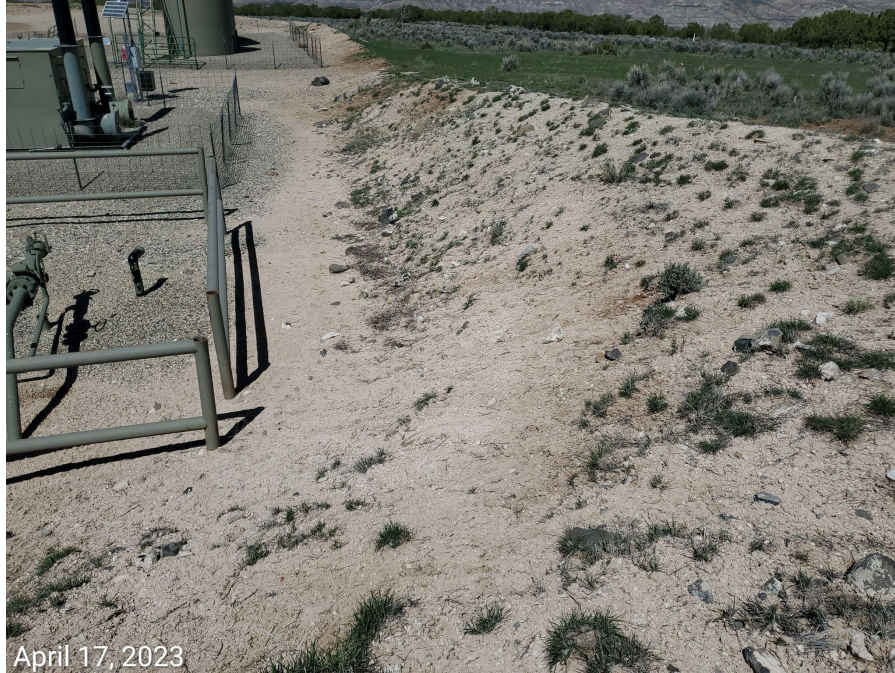
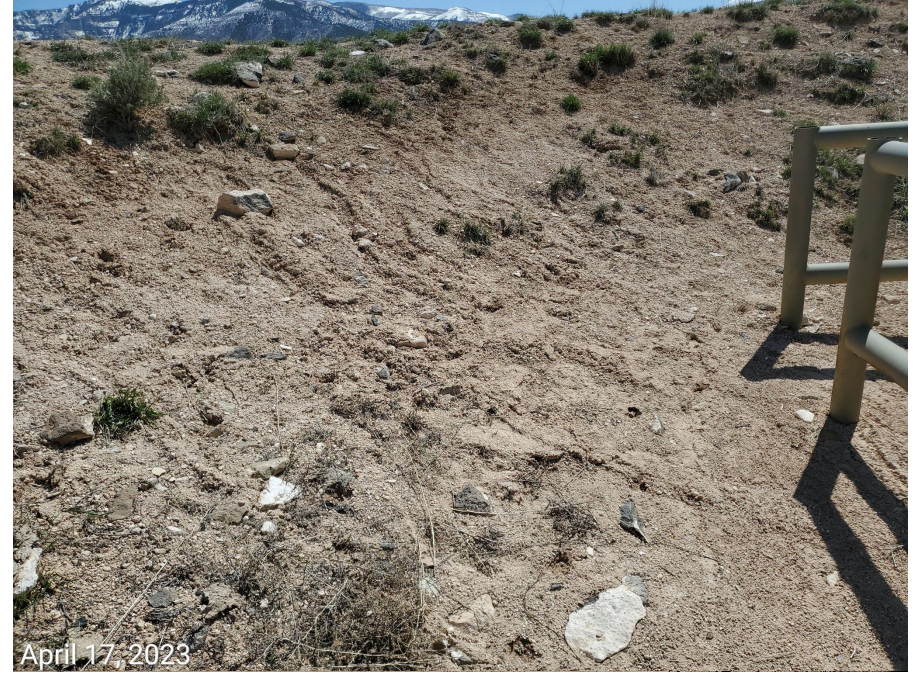
**Photo 3:** BMPs at cut slopes along access road are missing or insufficient; erosion degradation evident. Slopes lack stabilization.

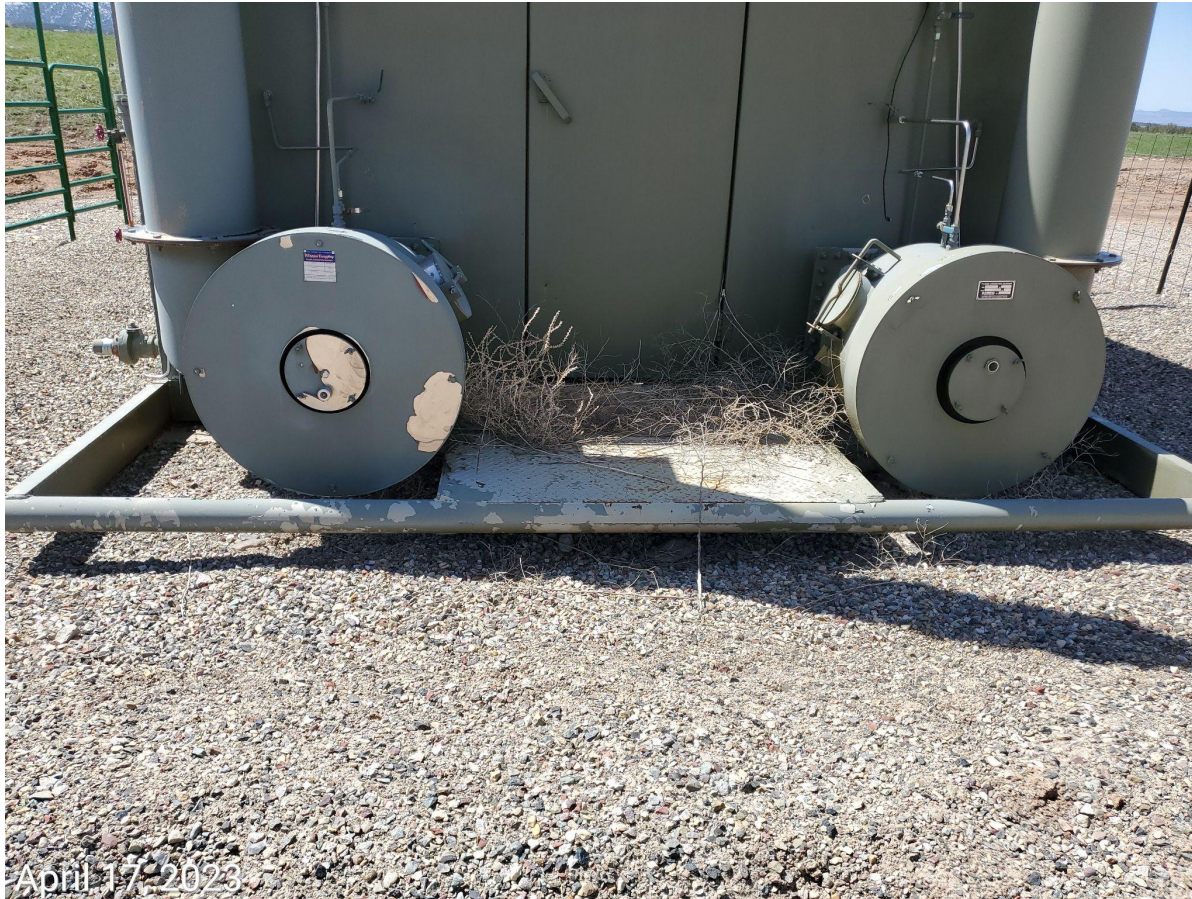
**Photo 4:** Weed debris at separator equipment.

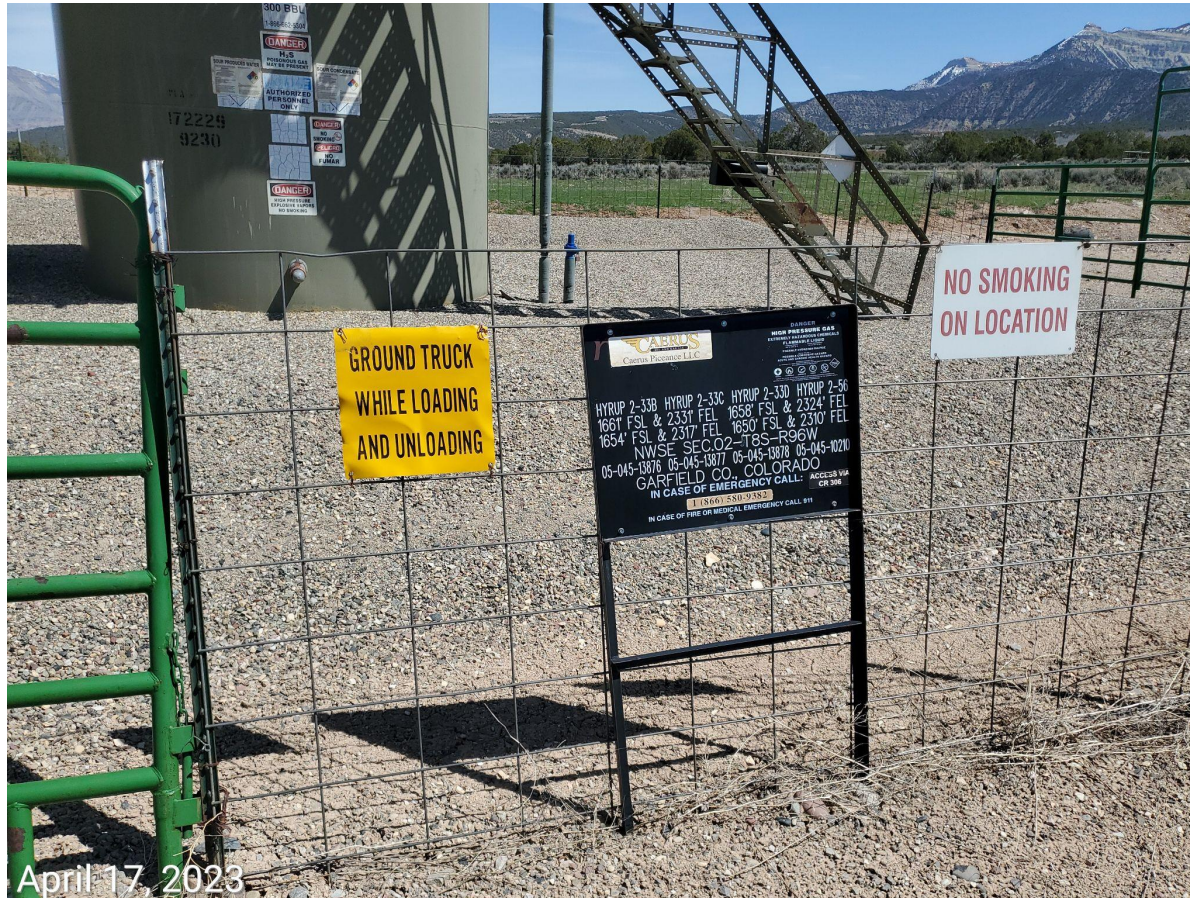
Photo 5: Tank battery.

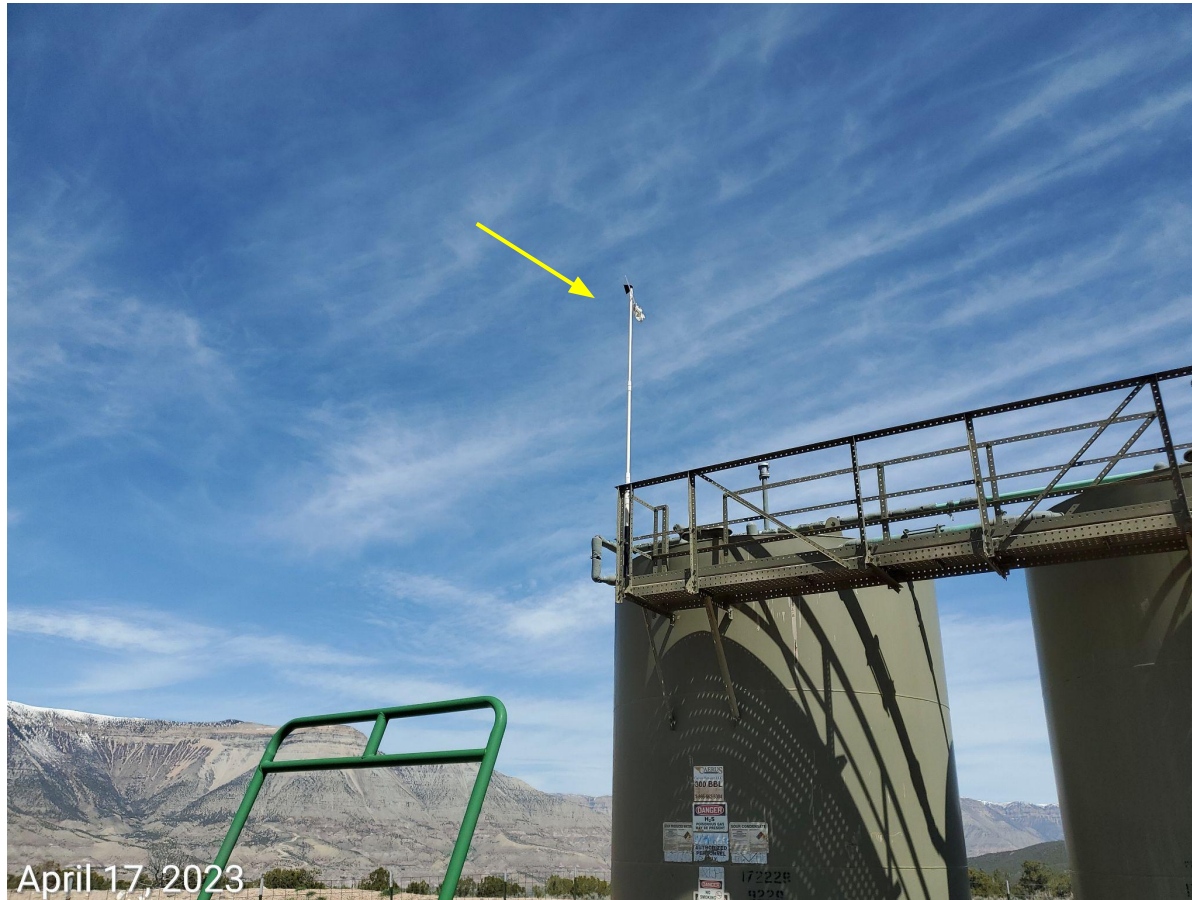
**Photo 6:** Wind indicator safety equipment not in proper functioning condition.

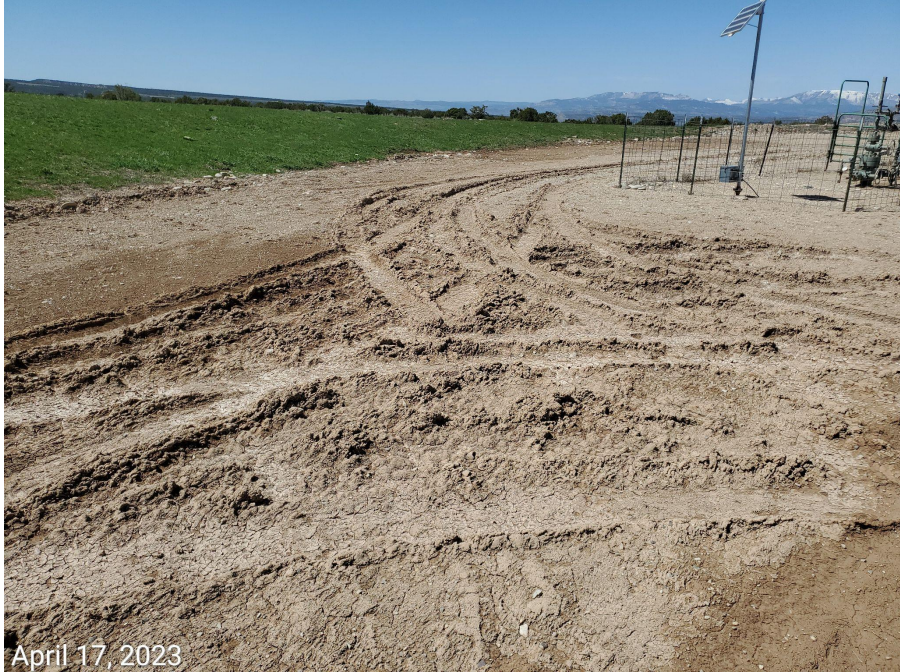
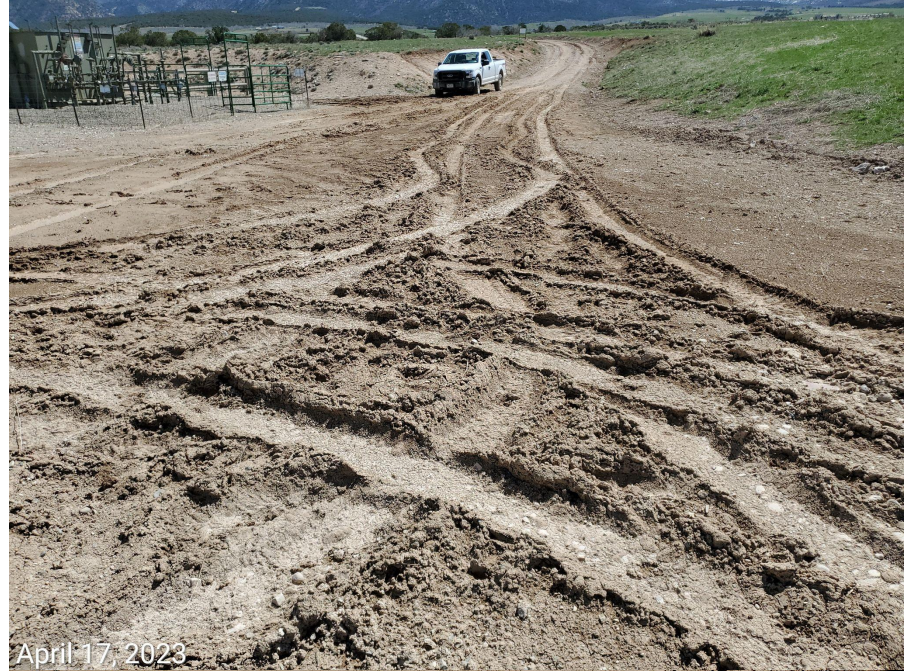
**Photo 7:** Photos examples showing BMPs to stabilize, as well as to minimize erosion, degradation and off-site sediment transport are missing or insufficient; pad lacks stabilization. Tracking controls not observed.

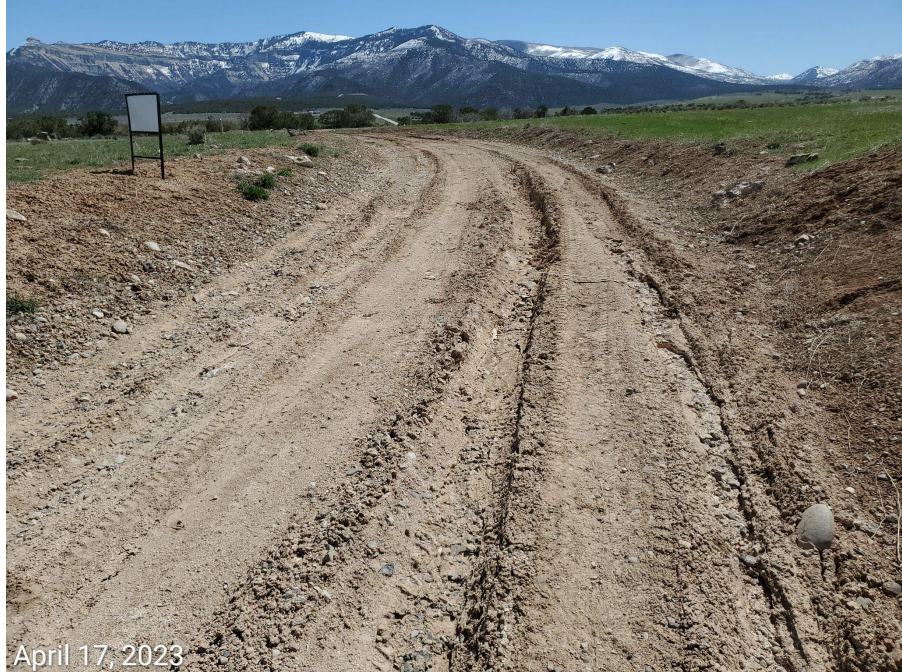
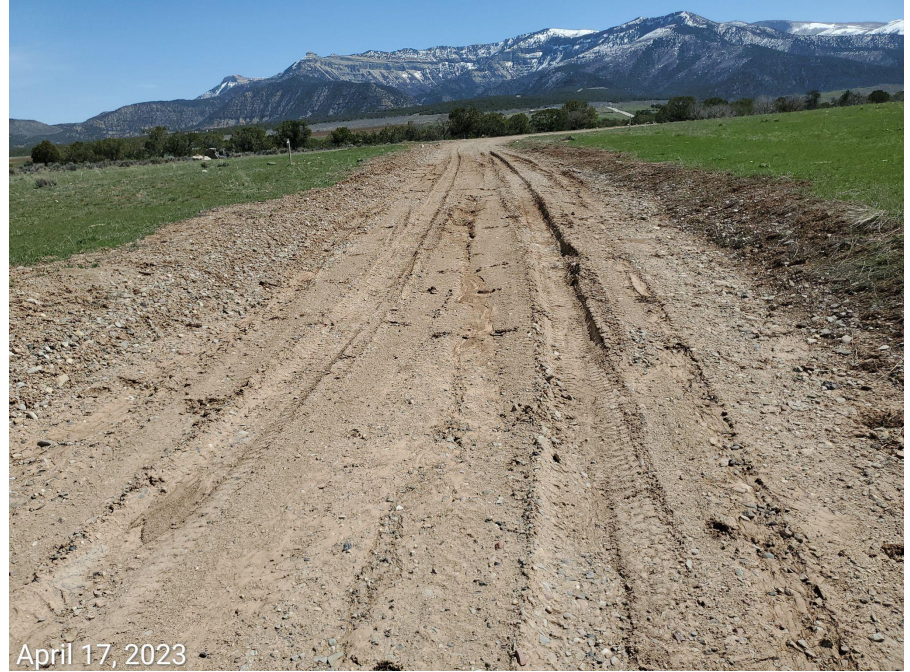
**Photo 8:** Photo examples showing BMPs at access road are missing or insufficient during wet conditions.
