# TEP ROCKY MOUNTAIN LLC, ARCO-66S96W/31NWSE

Location # 323813

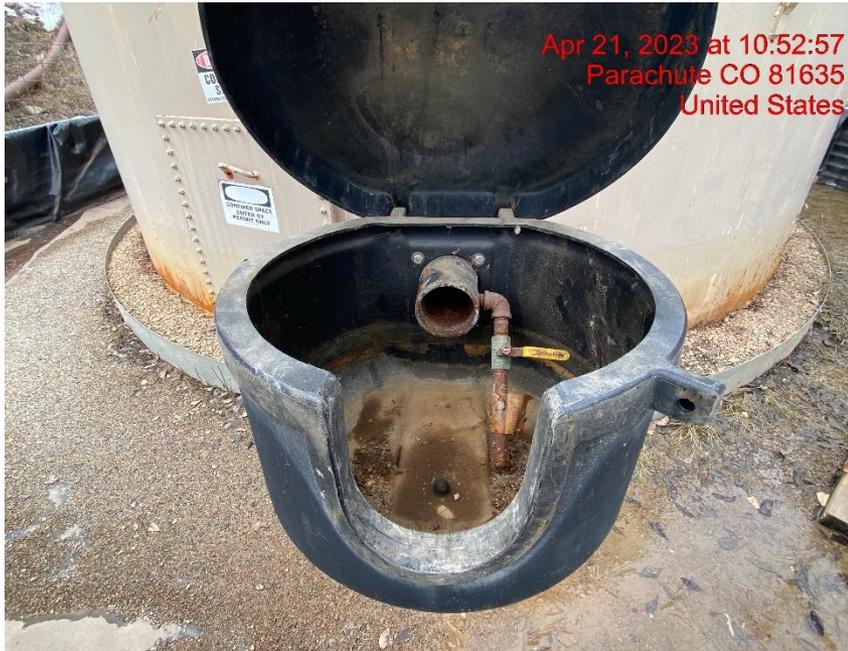
Open-Ended Load Line – Photo #02459

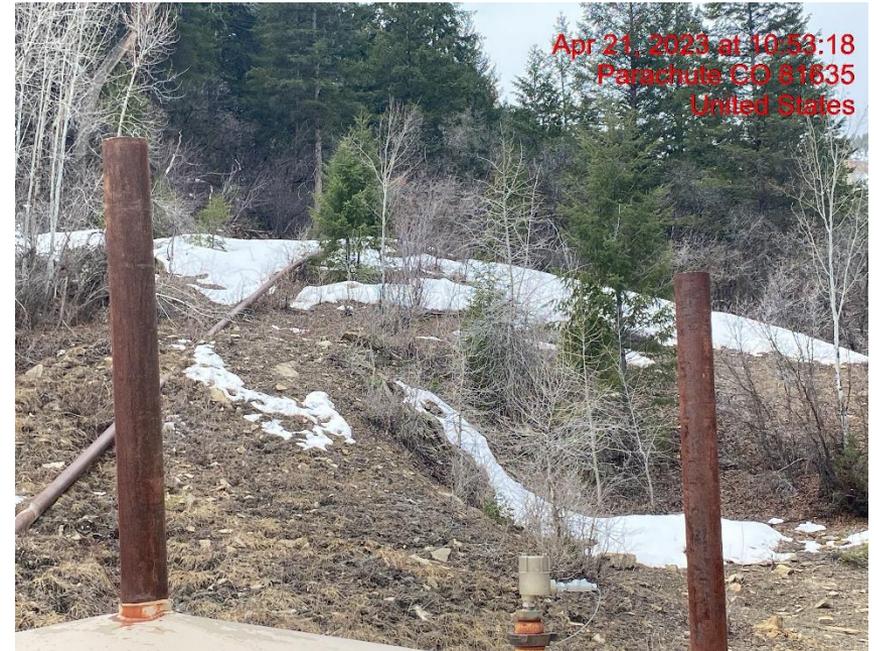
No Wildlife Protection Equipment – Photo #02461

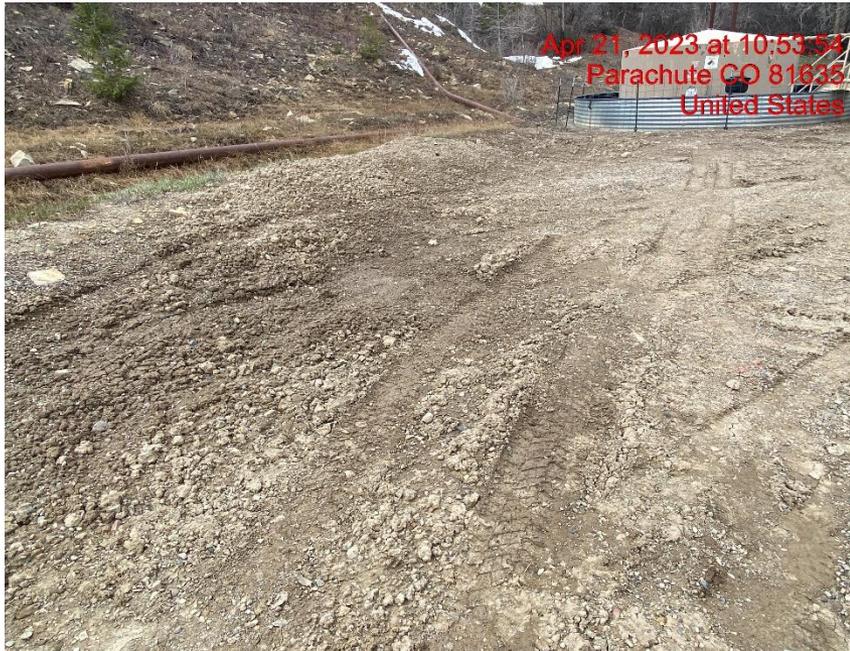
**Lack of Stabilization/Transportation of Sediment –  
Photo #02462**

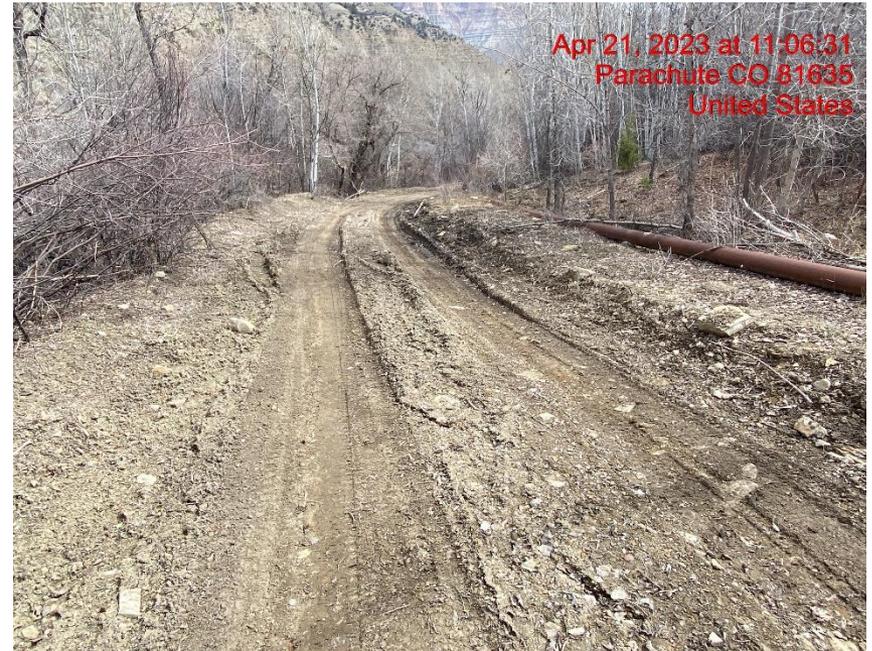
**Access Road: Lack of Stabilization/Transportation of  
Sediment – Photo #02464**

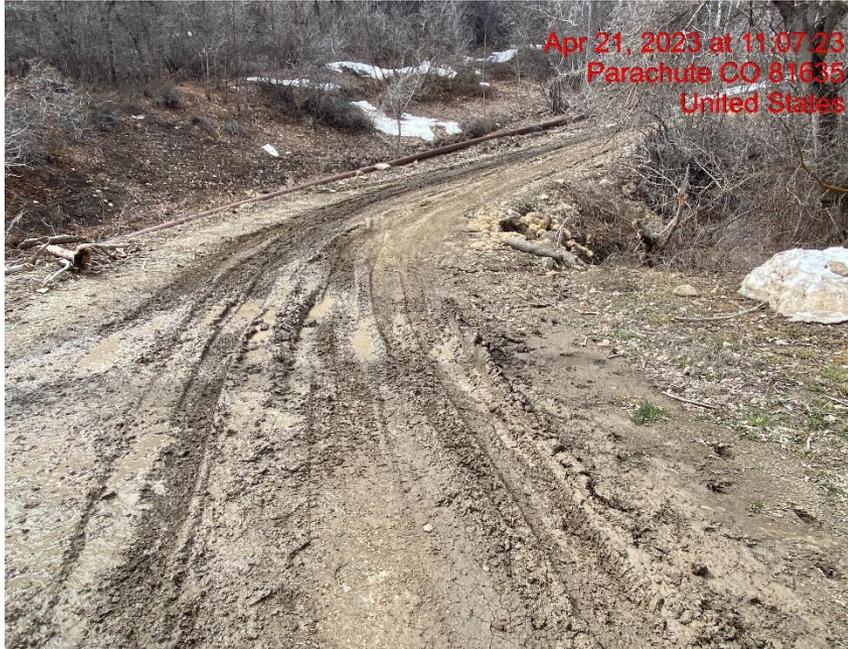
**Access Road: Lack of Stabilization/Transportation of Sediment – Photo #02465**

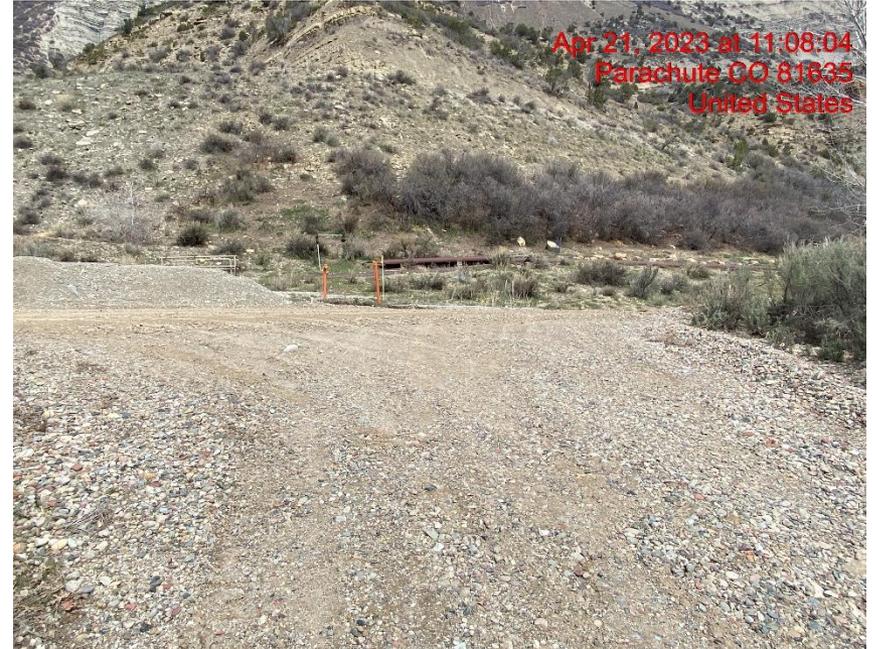
**Inadequate Vehicle Tracking BMPs – Photo #02466**
