# Inspection Photos

Loc: 312051

Operator: SIMCOE LLC  
LOGOS OPERATING LLC

Inspection Date: 4/16/2023

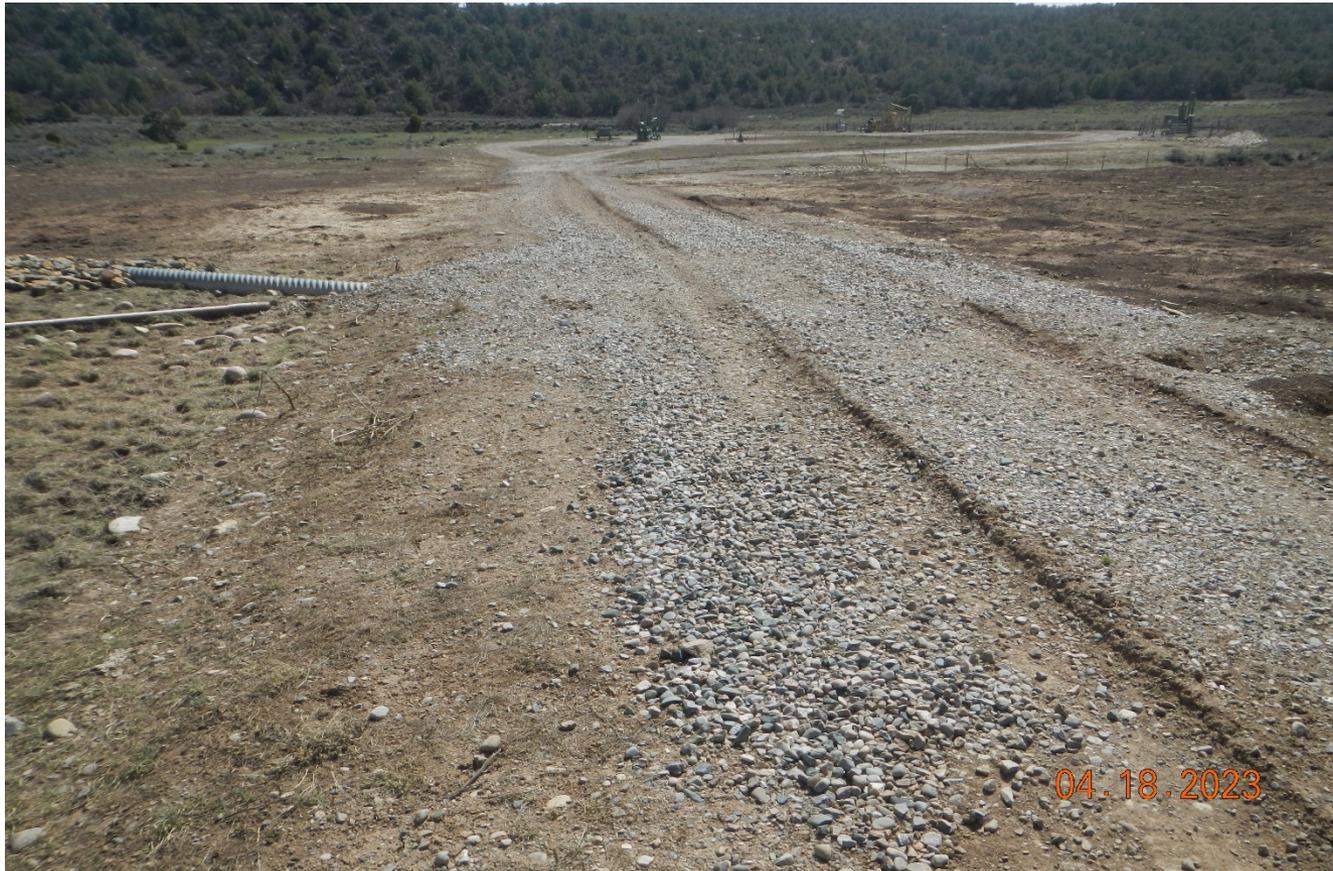
**Photo 1.** Facing southeast along the access road toward the location.

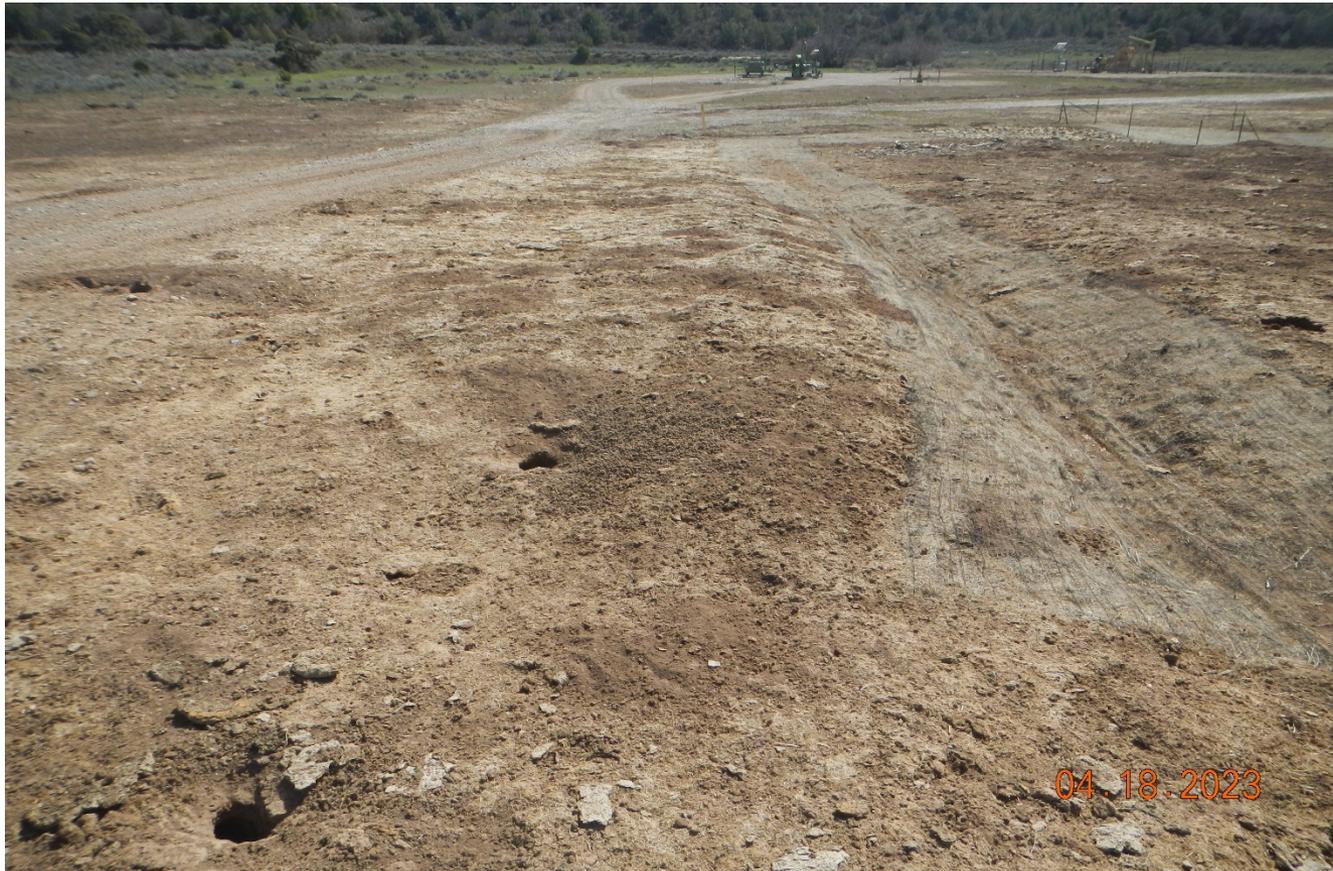
**Photo 2.** This area along the access road was seeded and hydromulched. The swaled area has straw blanket installed. Seeded areas need to be monitored for vegetation establishment and reseeded if needed.

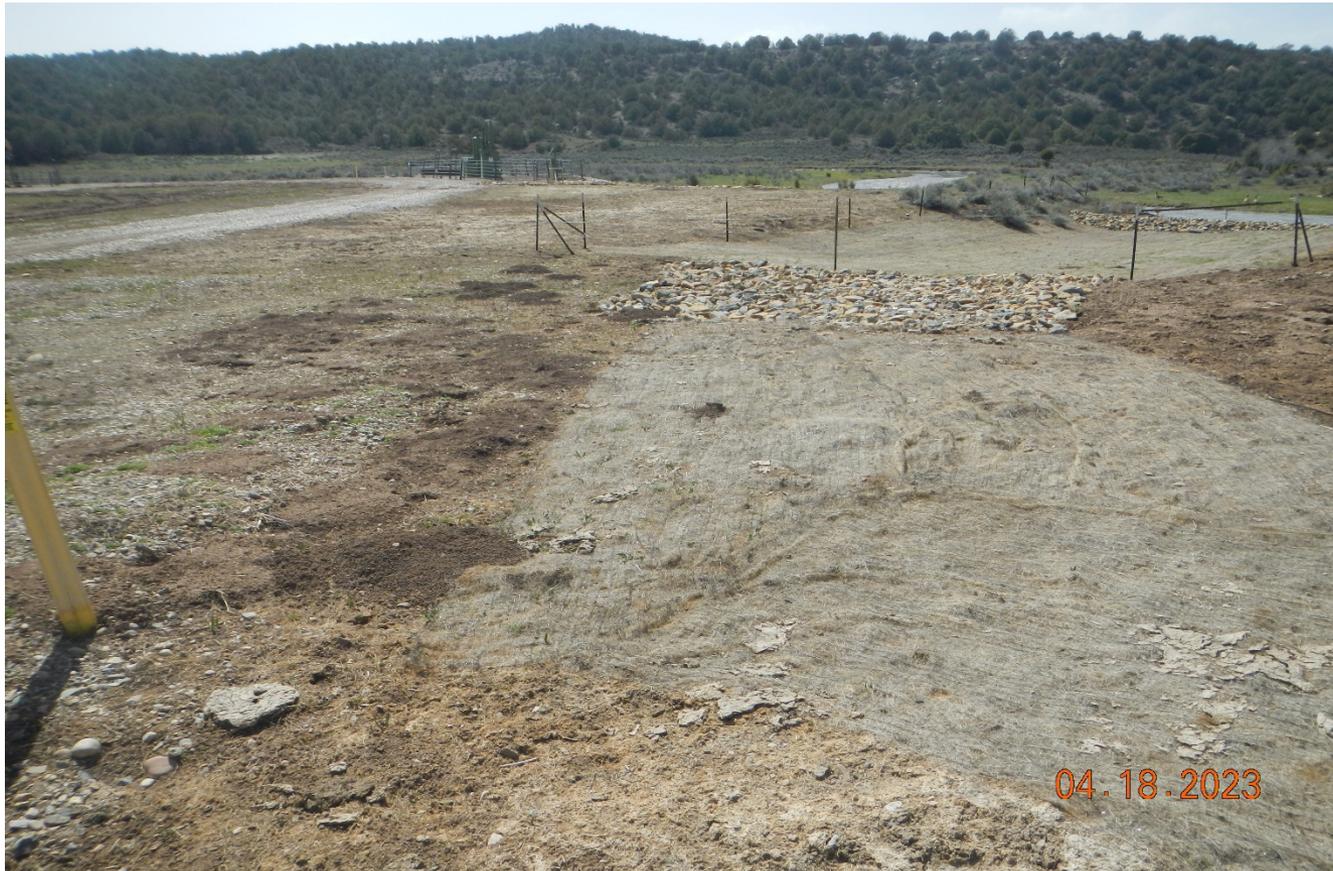
**Photo 3.** Facing southwest toward the swaled area which has been seeded and stabilized with rip/rap and straw blanket.

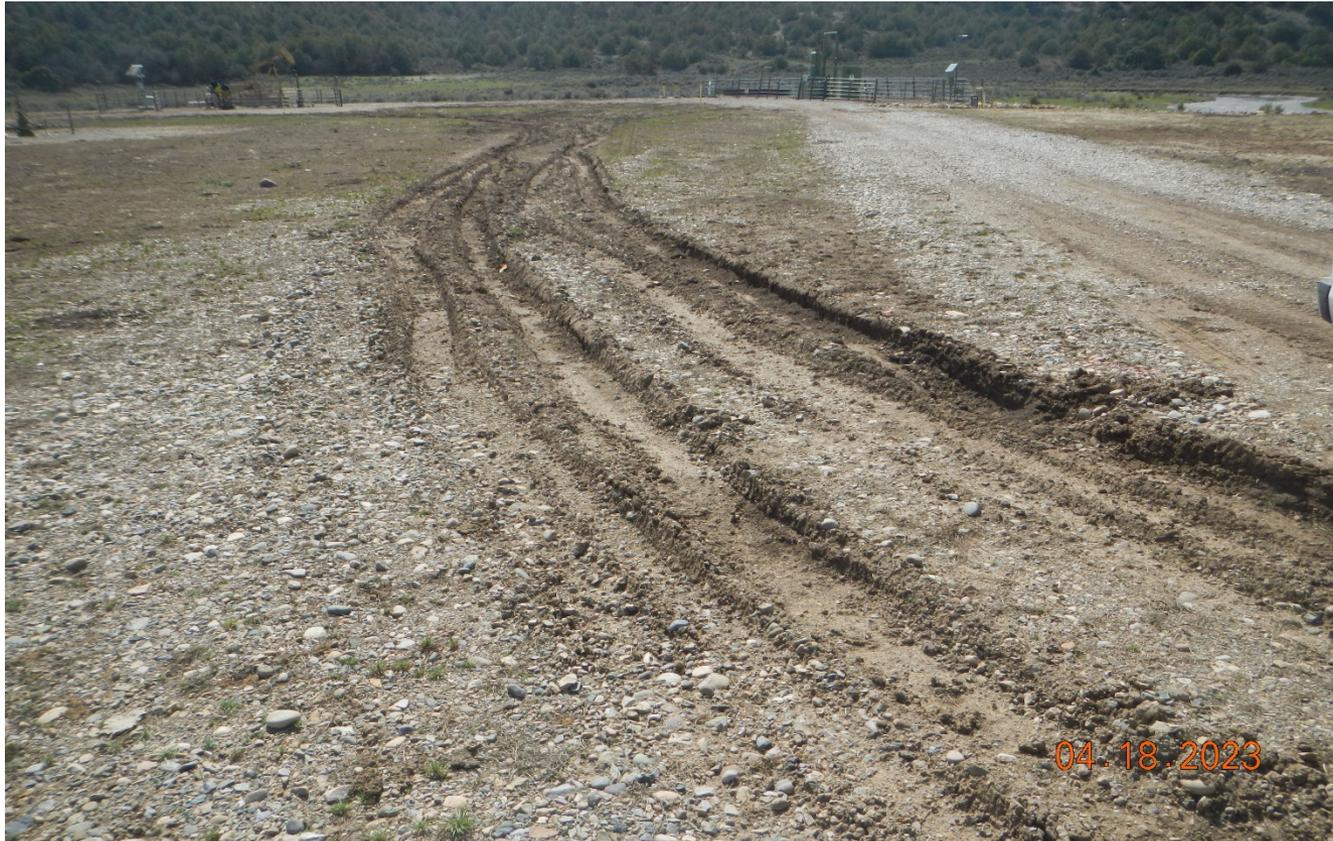
**Photo 4.** Facing southwest at the location. There is vehicle rutting off the access road and across the location that needs to be repaired and reclaimed

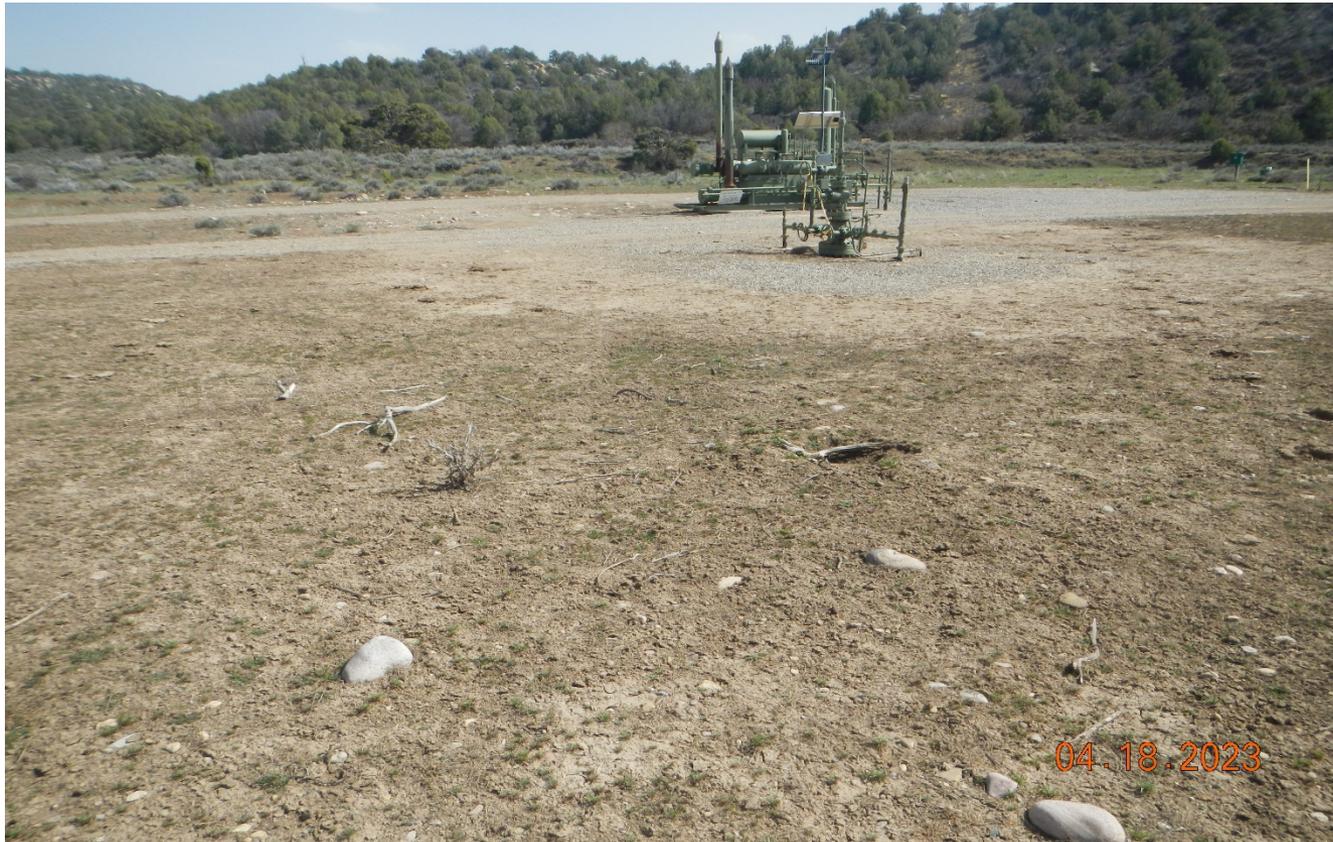
**Photo 5.** Facing southeast towards the BONDAD 33-9 #22A TA well. All interim reclamation areas will need to be monitored and reseeded as needed to ensure perennial desirable vegetation establishes for long term stabilization.

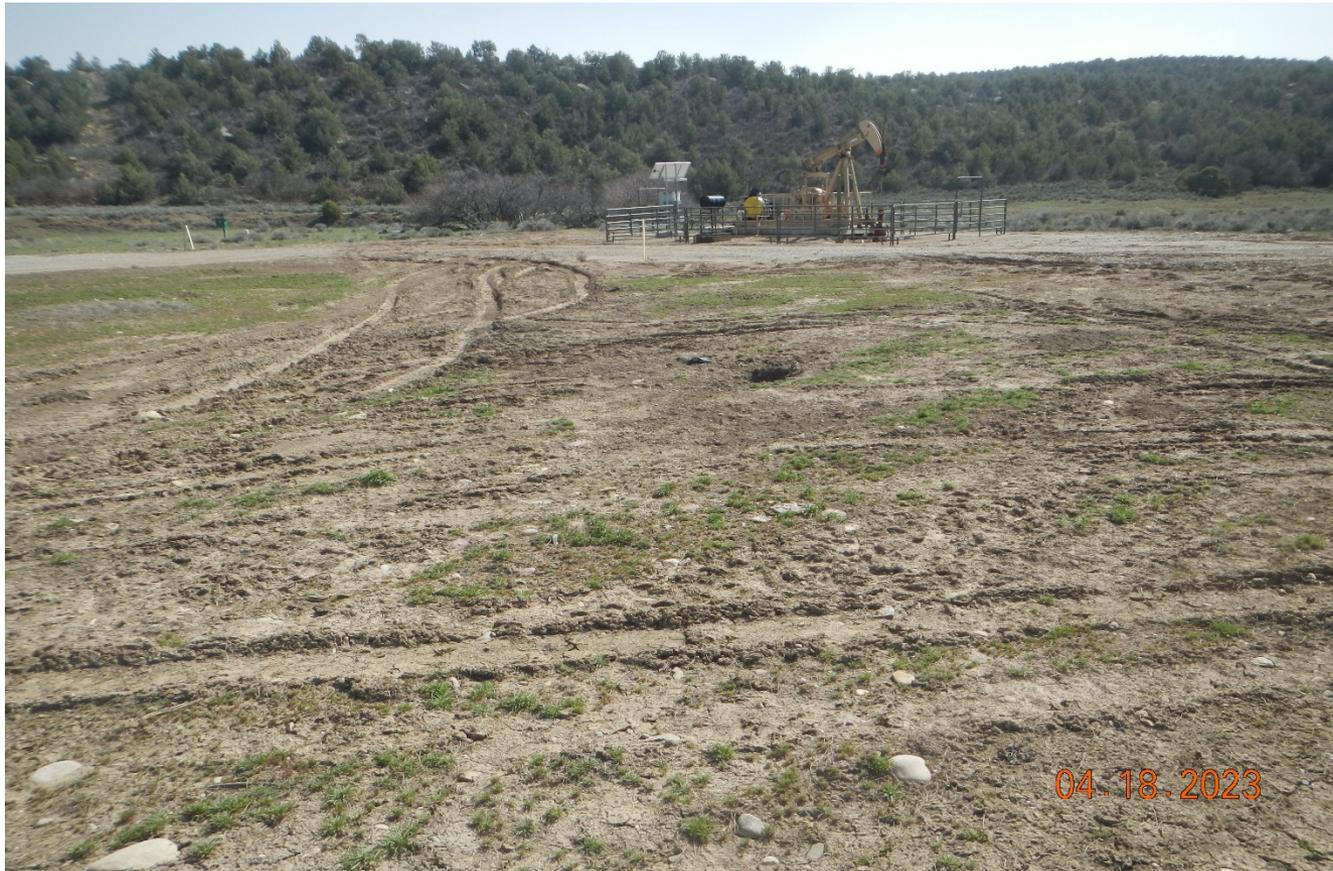
**Photo 6.** Facing southeast at the location. There is vehicle rutting across the location that needs to be repaired and reclaimed

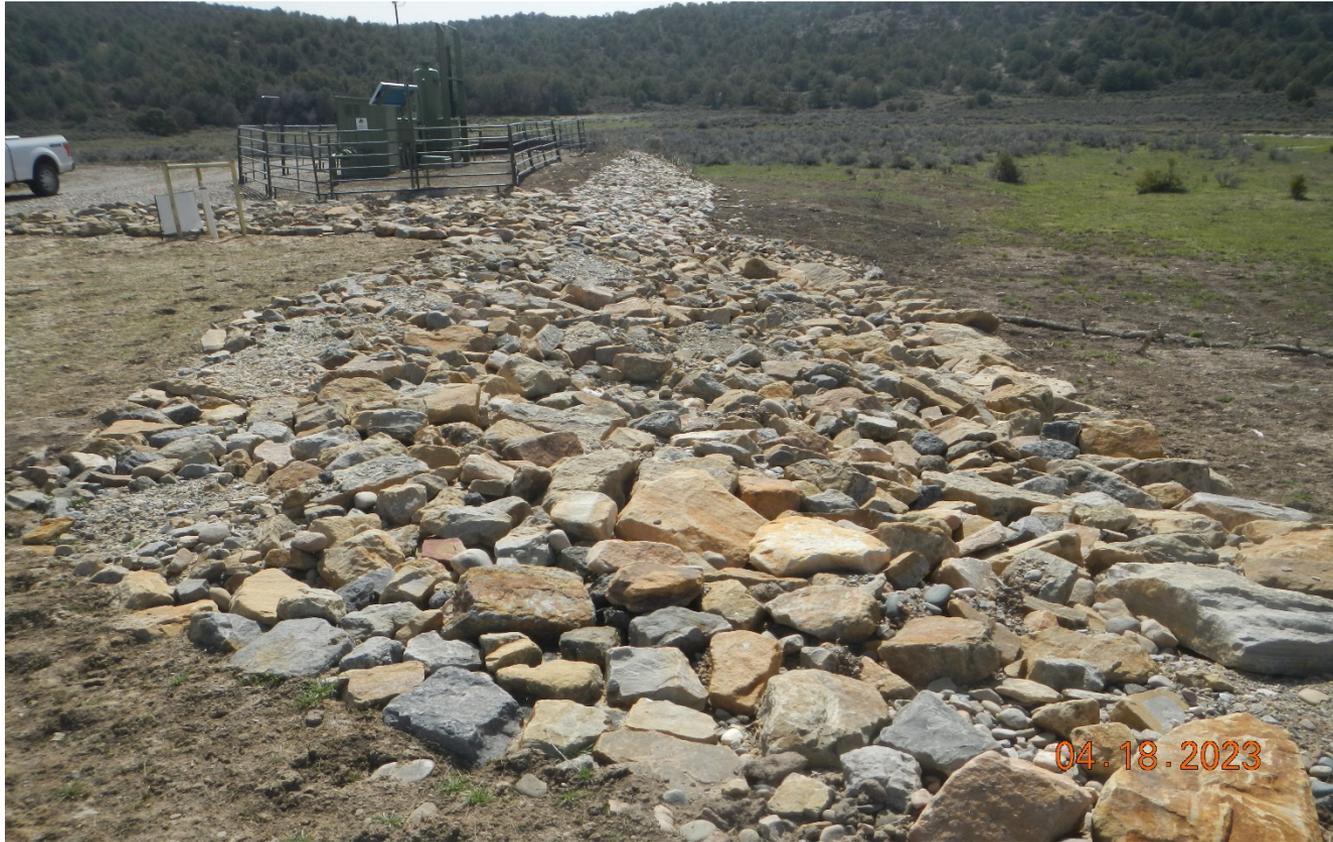
**Photo 7.** Facing southwest at the west side of the location. This area adjacent to the Florida River has been rock rip/raped. Angular rock was used part of this area which hold together much better than round rock which can become displaced.

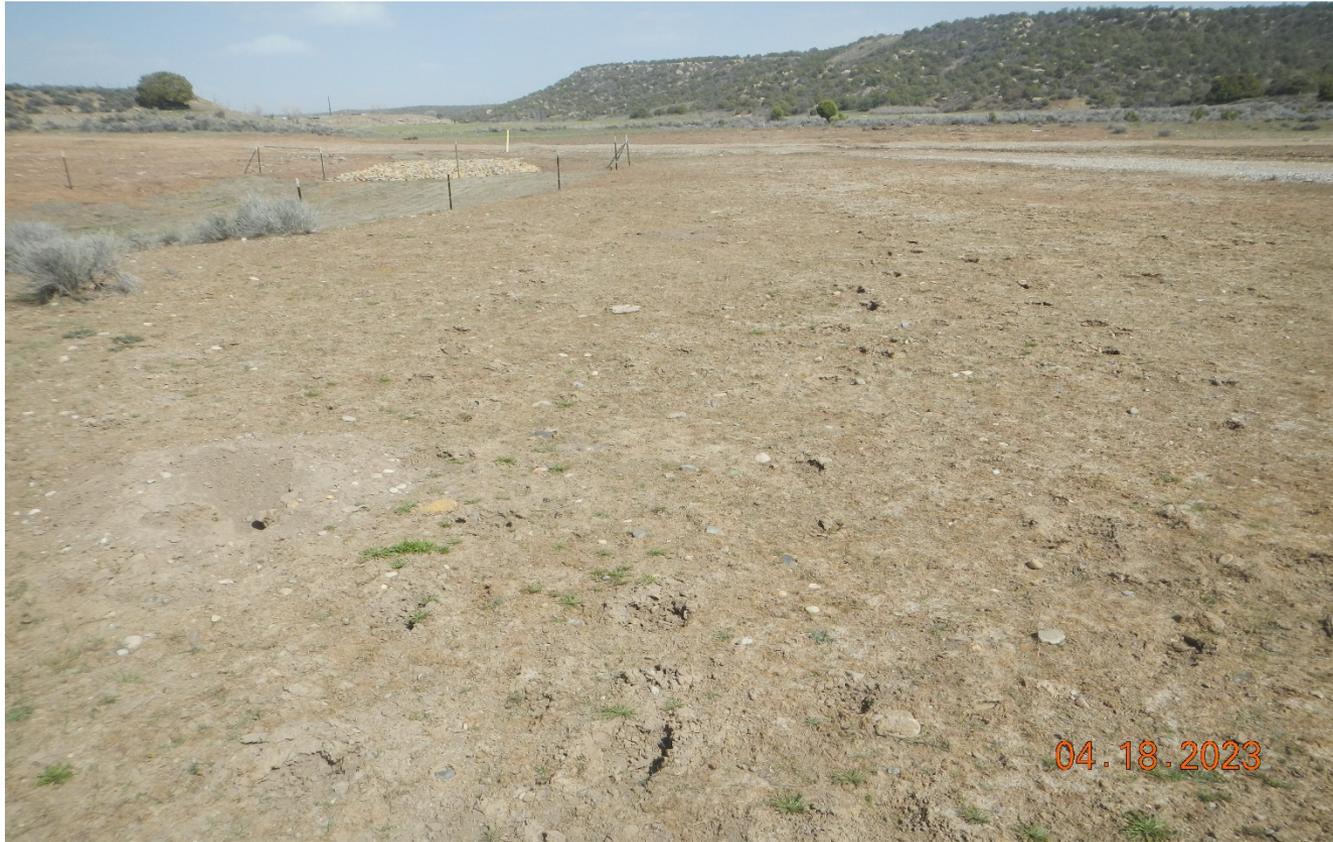
**Photo 8.** West side of the location facing east. This area was seeded and hydromulched. There was some vegetation germination observed however, seeded areas will need to be monitored to ensure the vegetation establishment progresses.
