Inspection Photos

Loc: 333710

Operator: MARALEX RESOURCES INC

Inspection Date: 4/18/2023

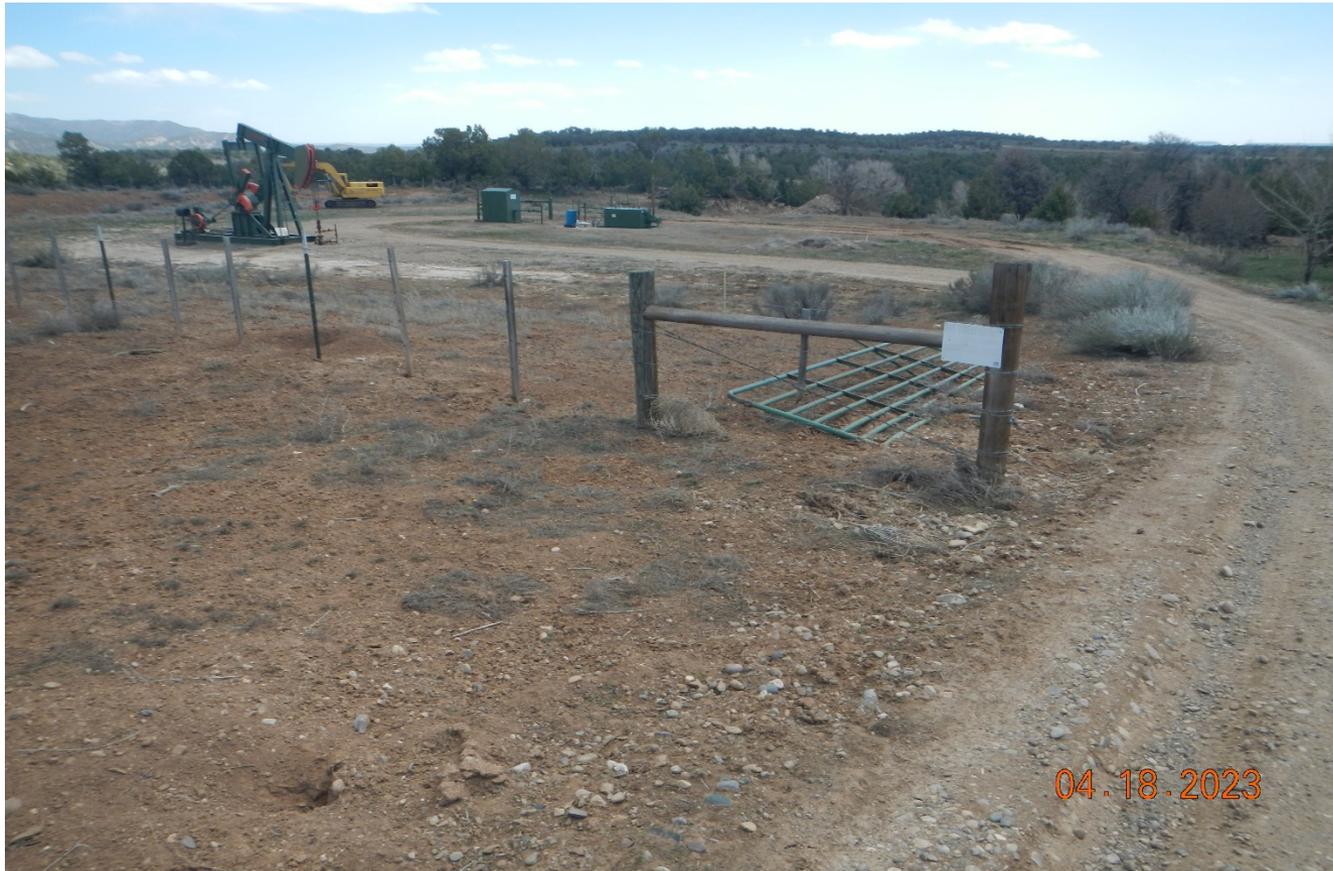
Photo 1. Facing southeast toward the location. The gate has fallen off the hinges and needs to be re hung.

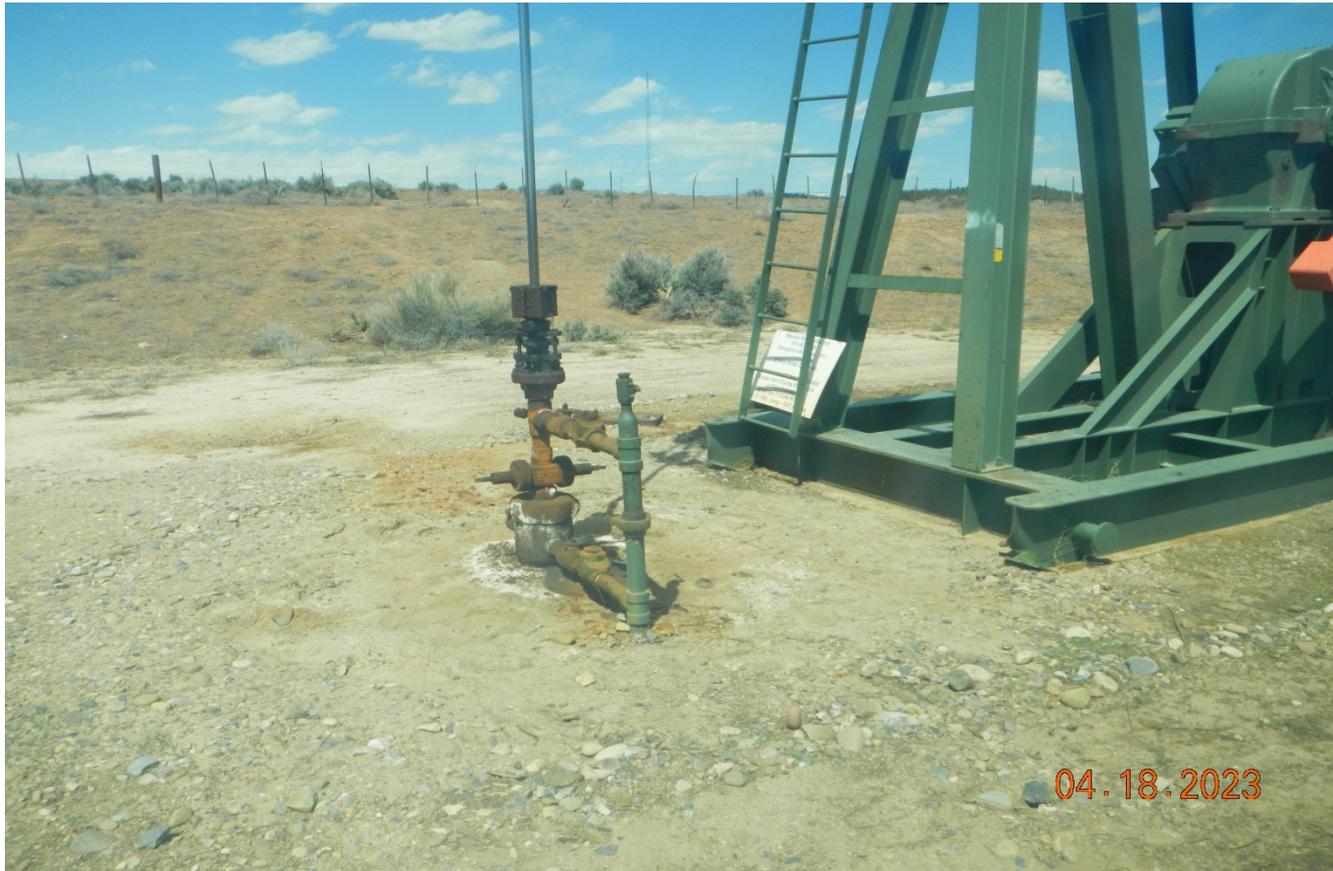
Photo 2. There is impacted soil at the wellhead that needs to be cleaned up. This issue previously cited and has not been cleaned up.

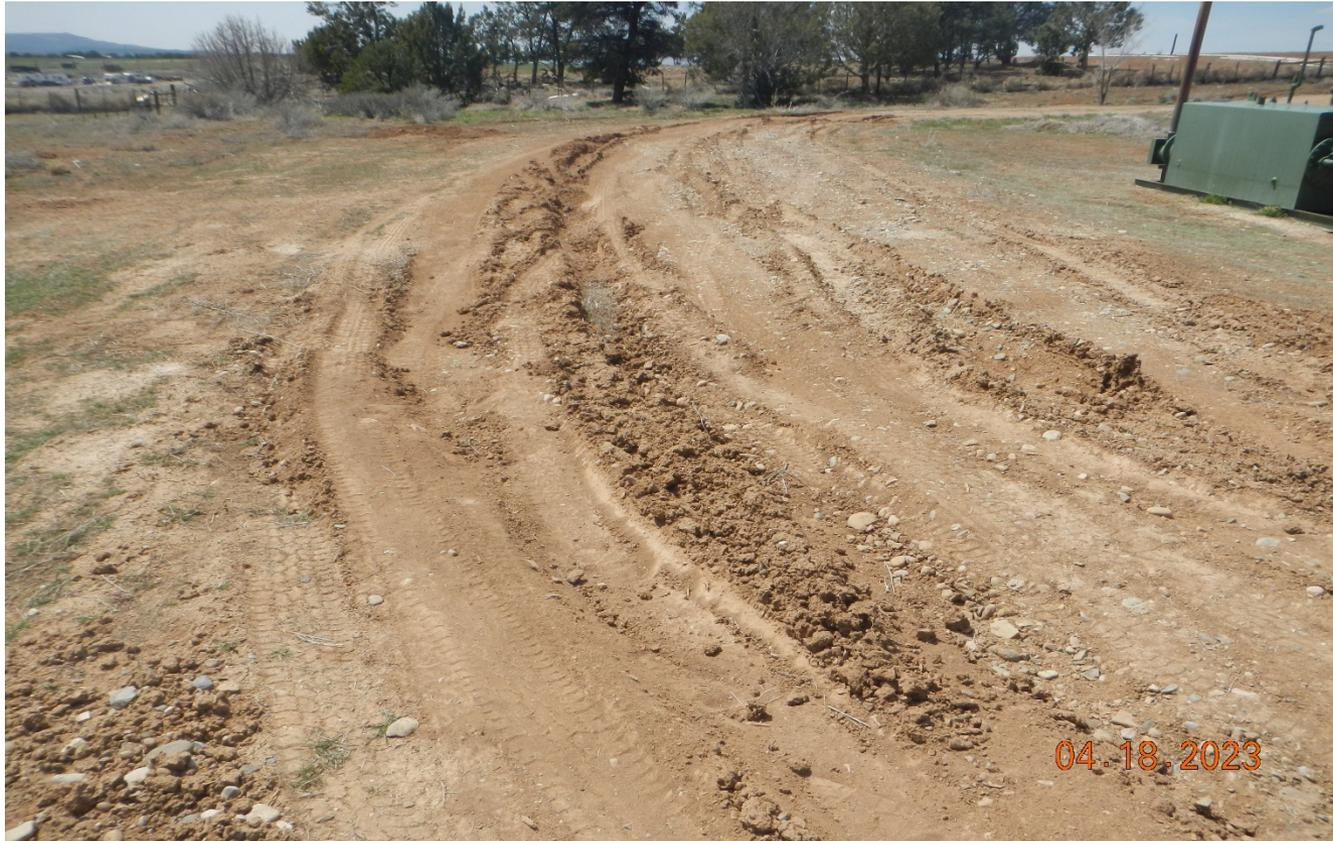
Photo 3. There is vehicle rutting and track at the location that needs to be repaired and stabilized.

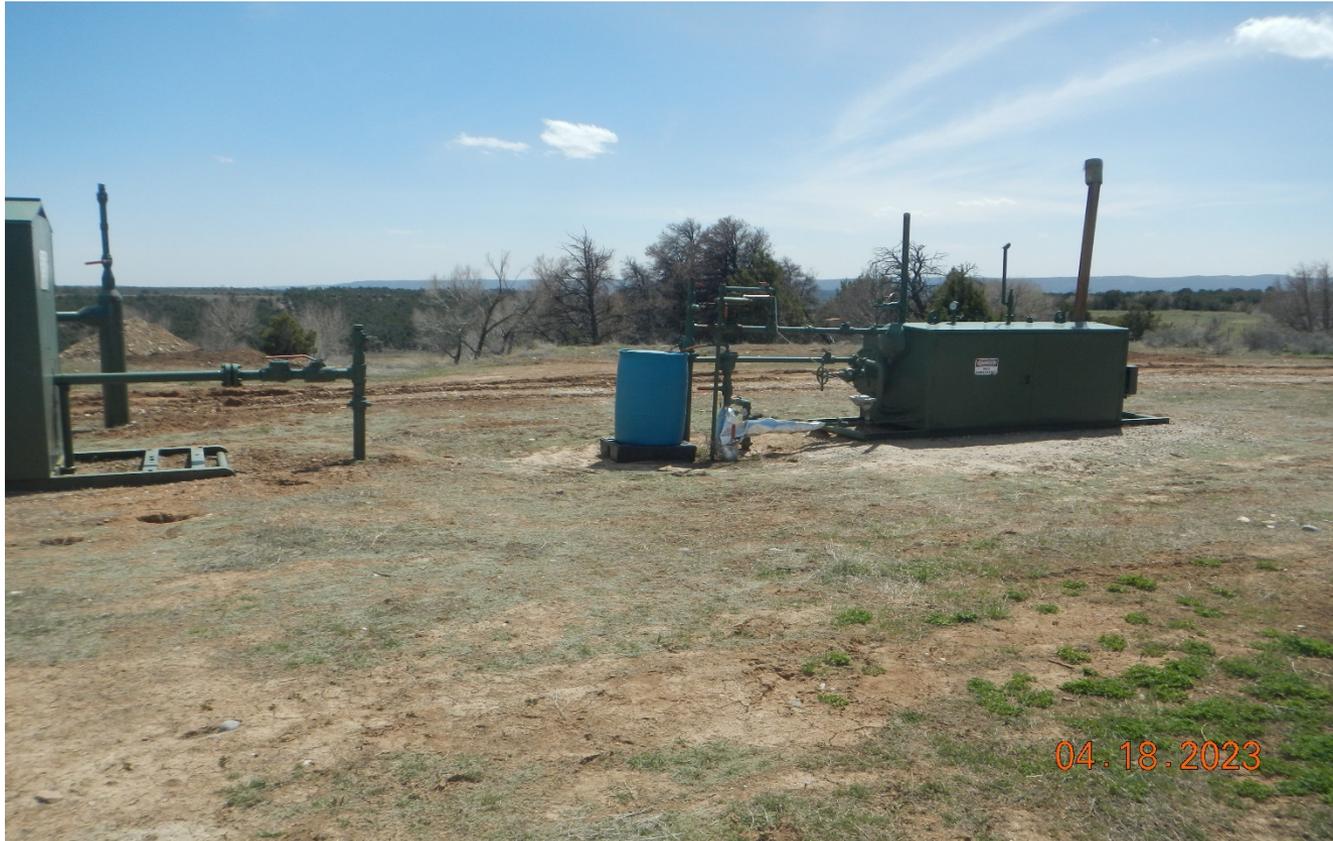
Photo 4. There is no labeling on the blue chemical drum which was previously cited.

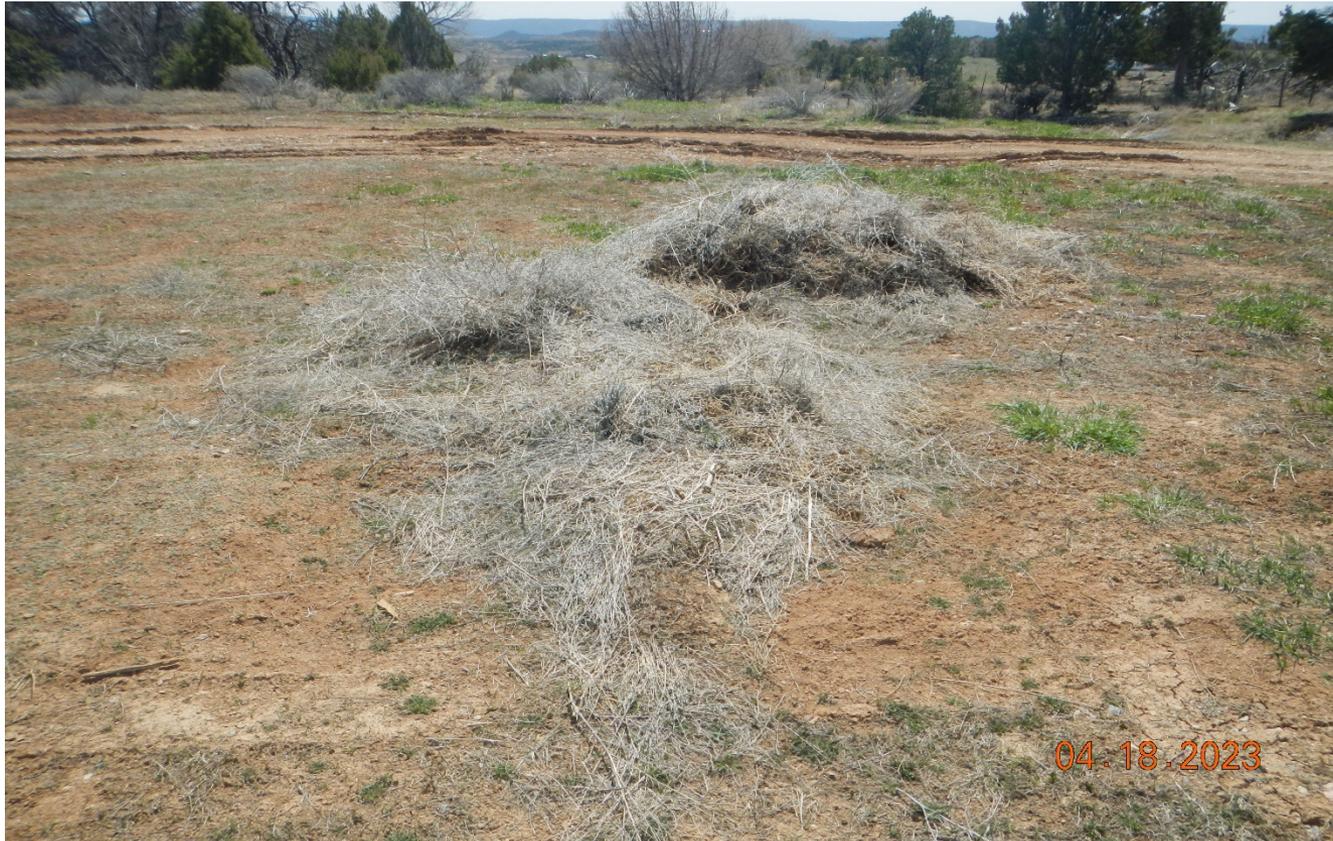
Photo 5. There is a pile of weed debris at the location that needs to be removed.
