Inspection Photos

Location Name: TEP ROCKY MOUNTAIN LLC RMV 56-21 Pad

Location ID: 335062

COLORADO
Oil & Gas Conservation
Commission
Department of Natural Resources

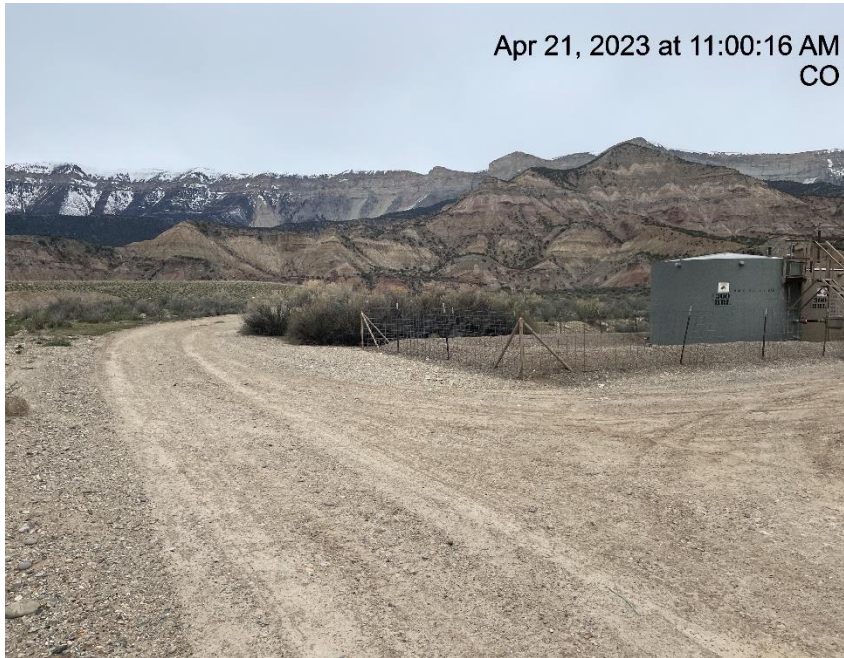
Photo # 6010 From entrance to location

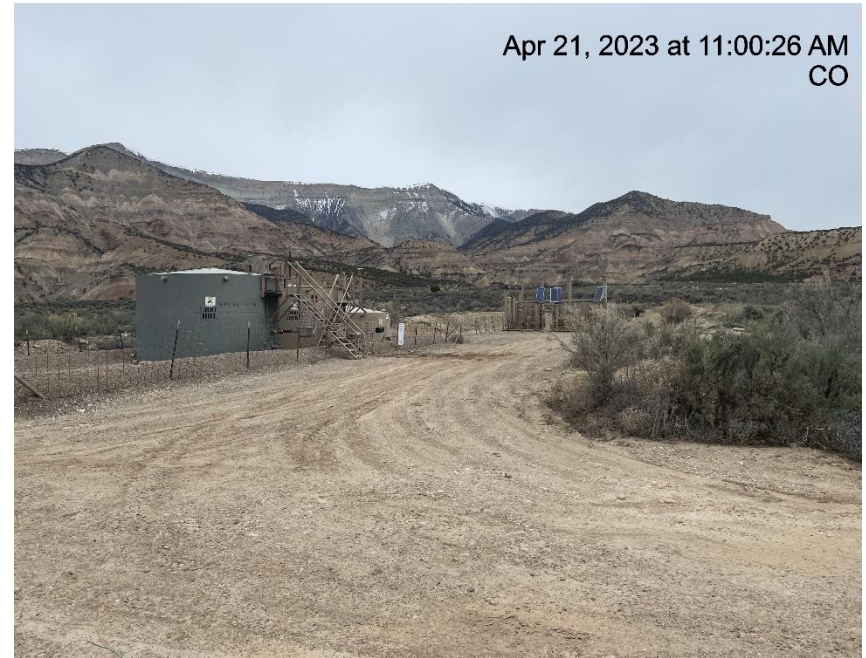
Photo # 6011 From entrance to location

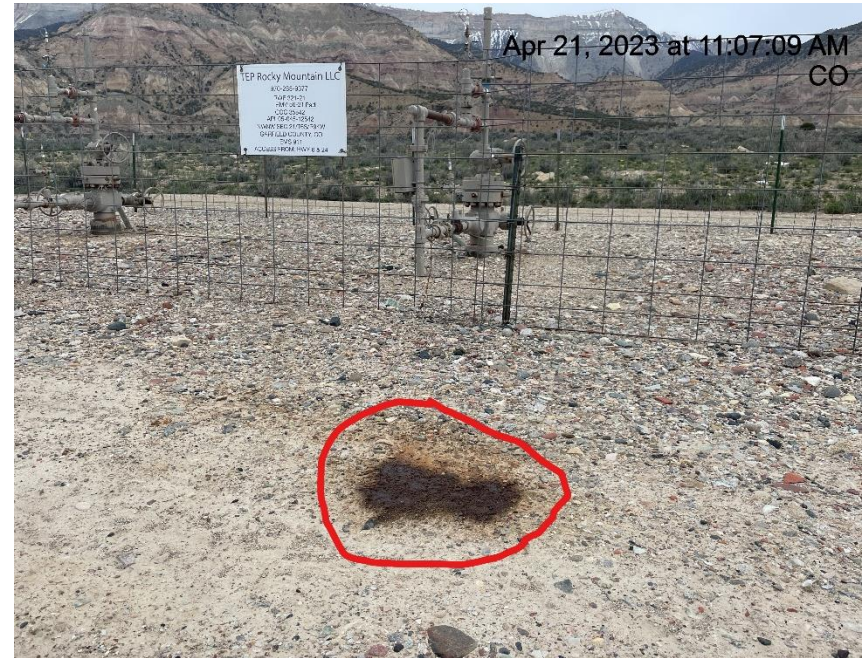
Photo # 6017 Stained soils & gravel

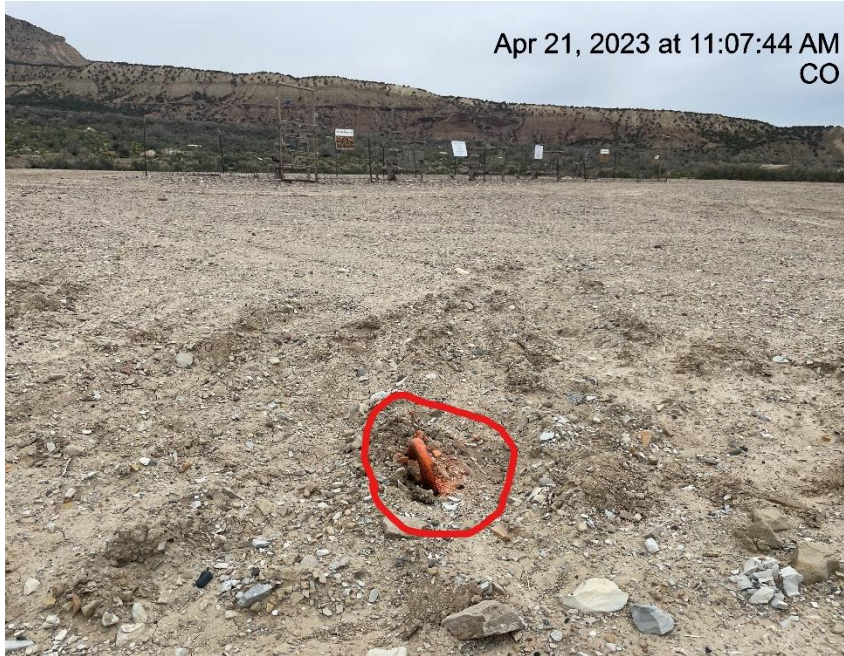
Photo # 6018 Unmarked deadman

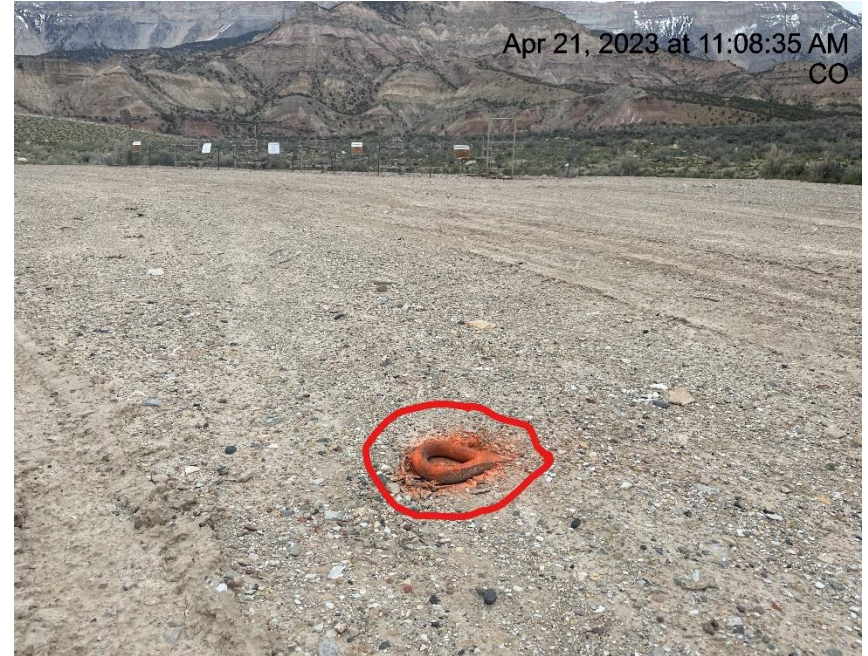
Photo # 6019 Unmarked deadman

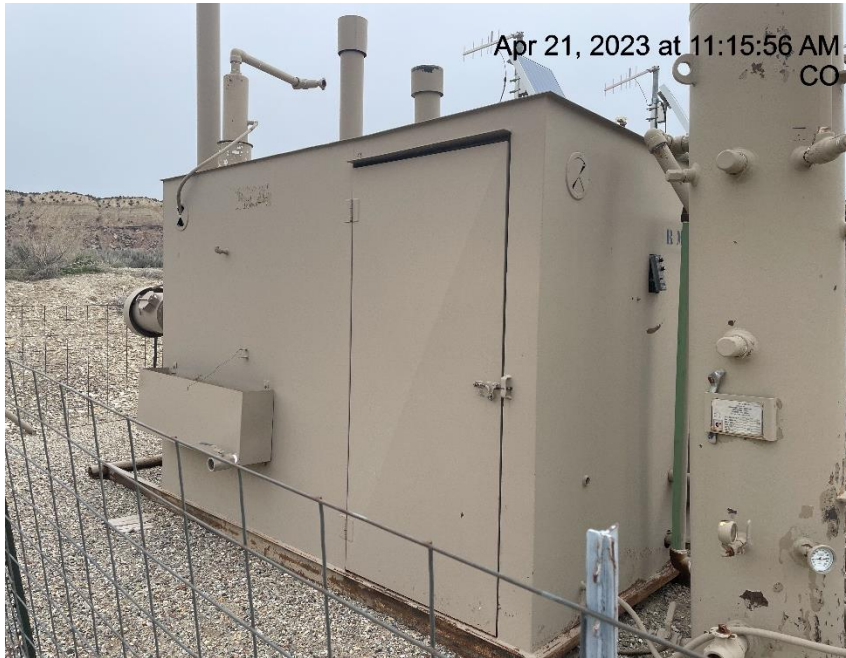
Photo # 6031 Meter calibration info not conspicuously posted

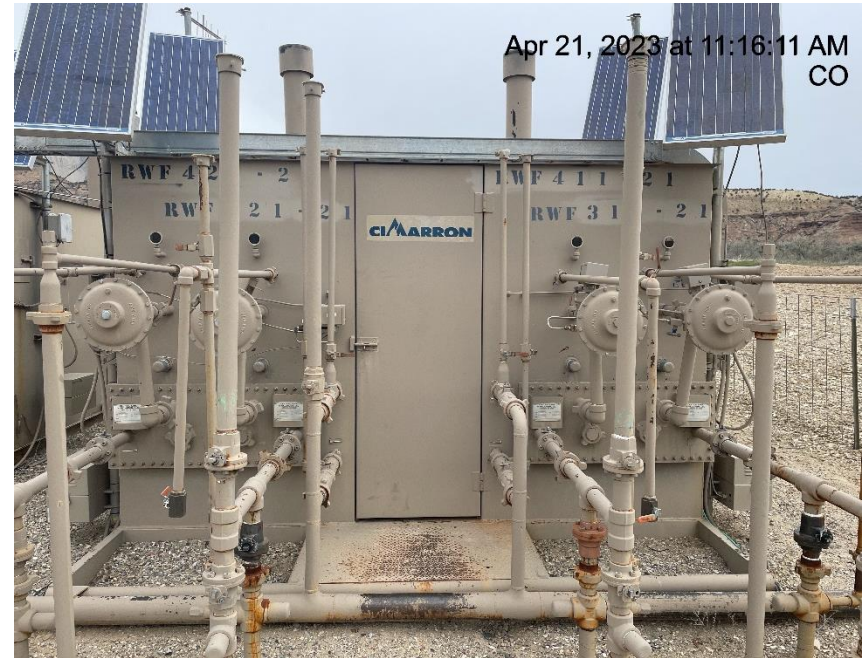
Photo # 6032 Meter calibration info not conspicuously posted

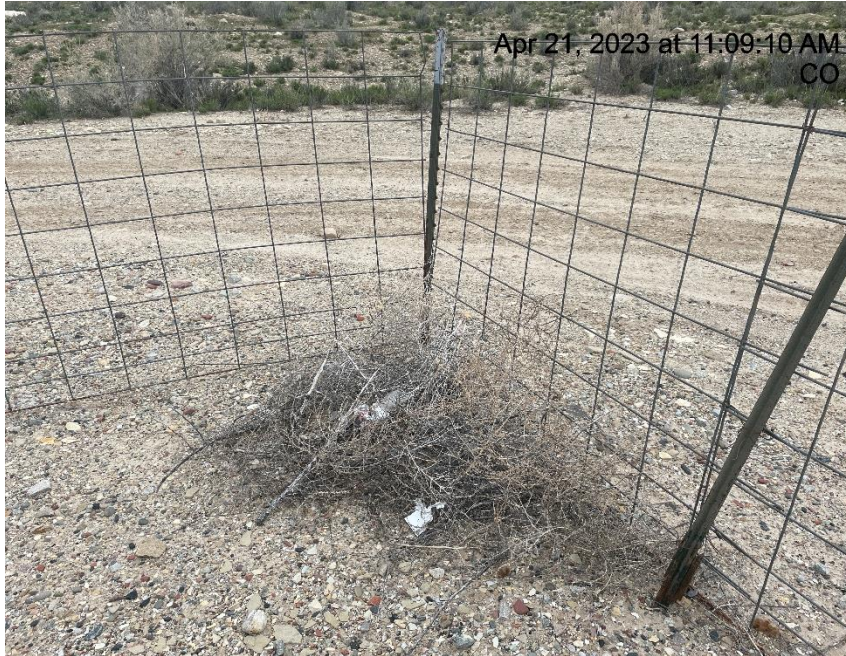
Photo # 6020 Debris

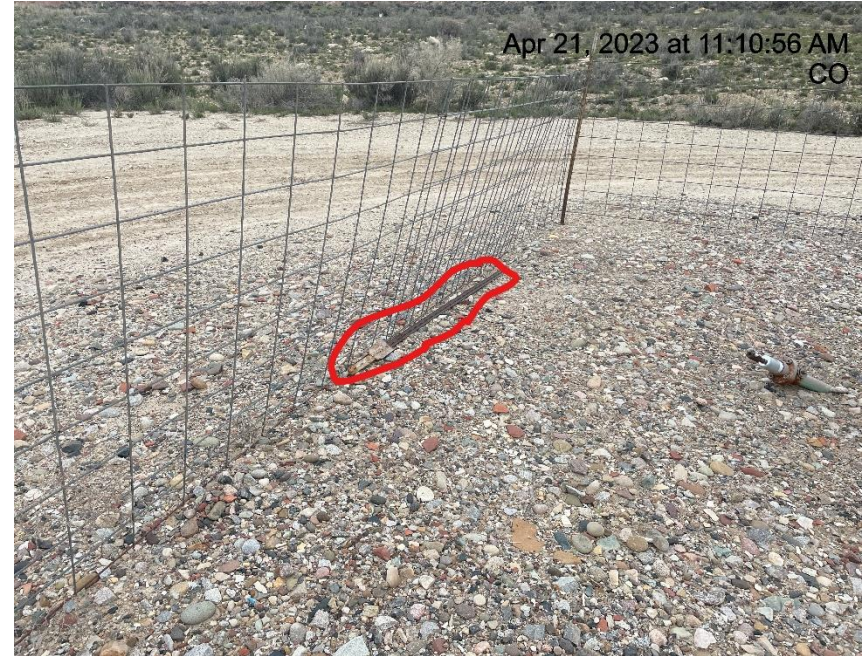
Photo # 6022 Debris

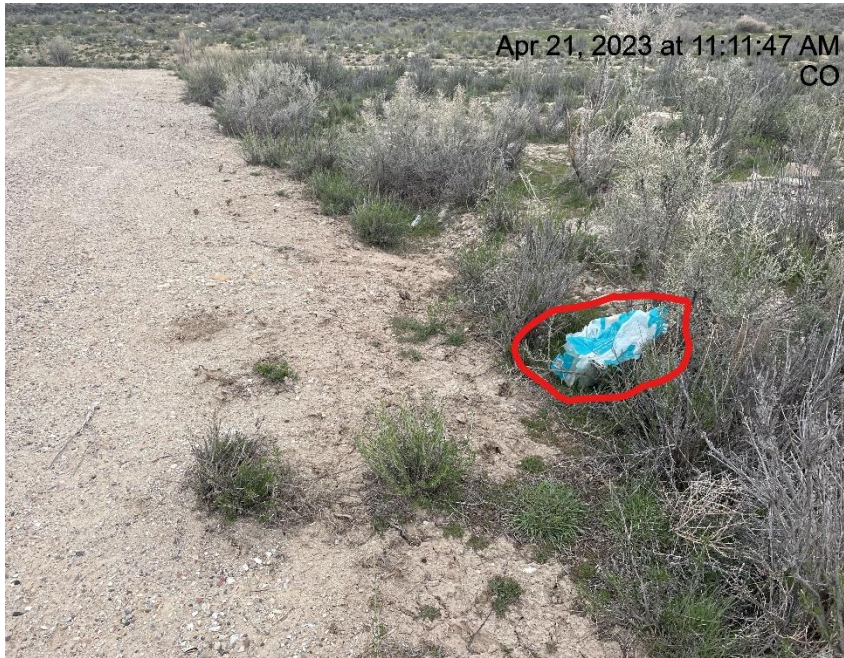
Photo # 6023 Debris

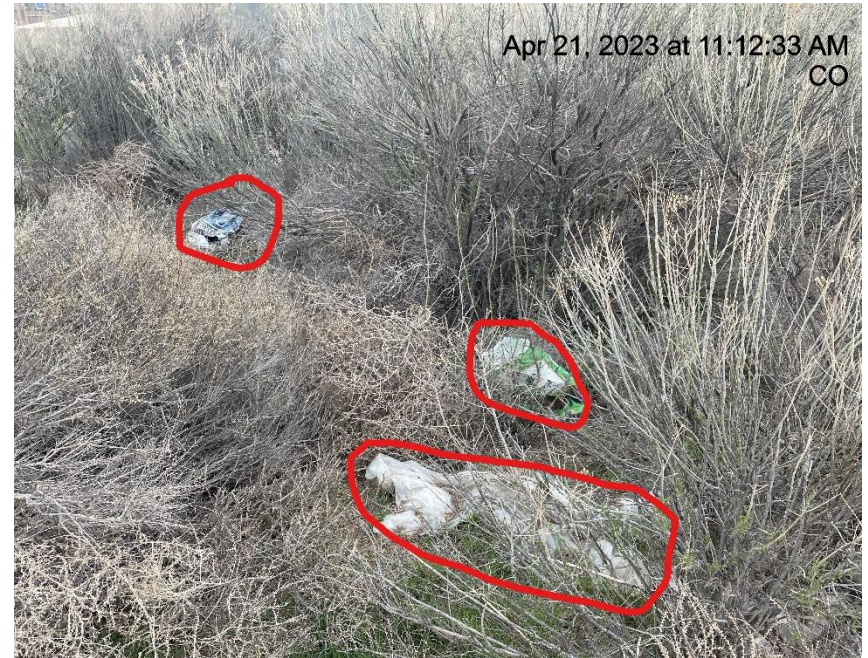
Photo # 6024 Debris

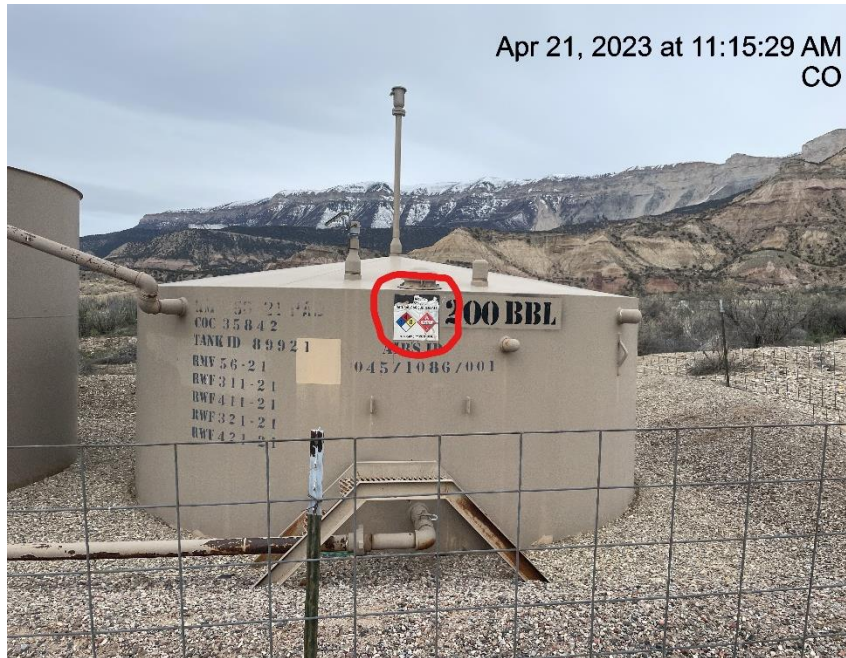
Photo # 6029 Tank label damaged & some info is missing
