# TEP ROCKY MOUNTAIN LLC, PUCKETT-67S96W/6SWNW

Location # 334811

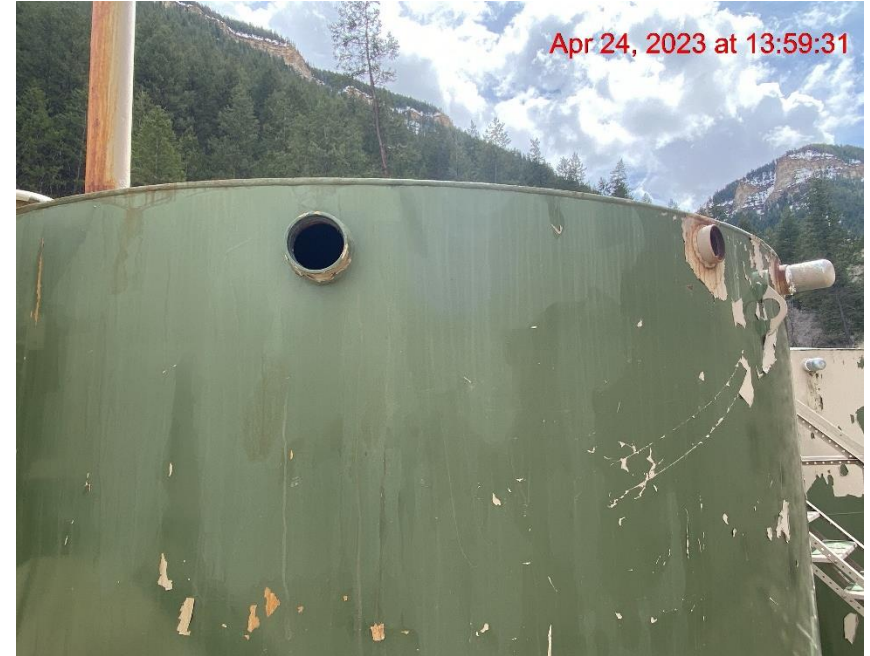
Wildlife Entry Hazard – Photo #02517

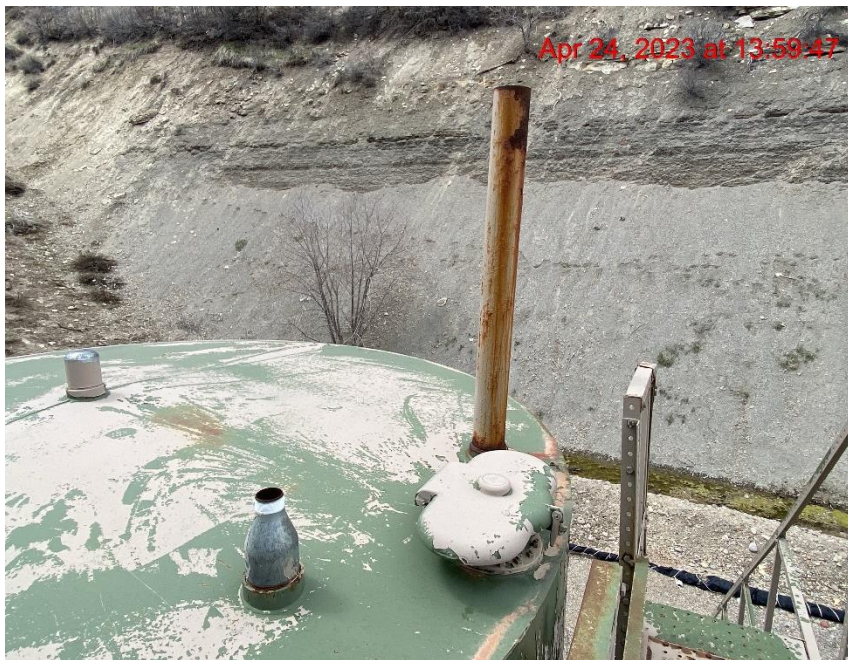
**No Wildlife Protection Equipment Installed – Photo #02518**

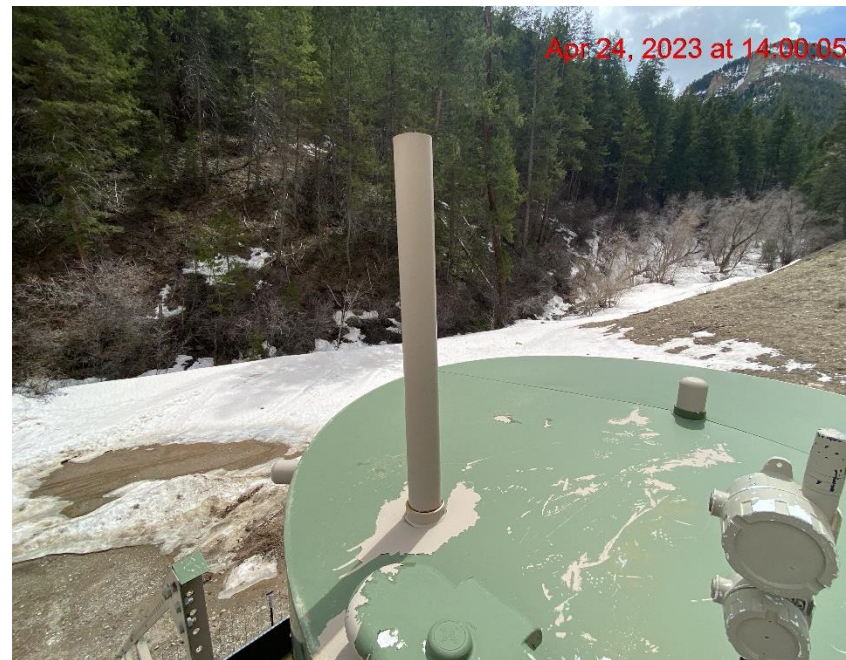
**No Wildlife Protection Equipment Installed – Photo #02519**

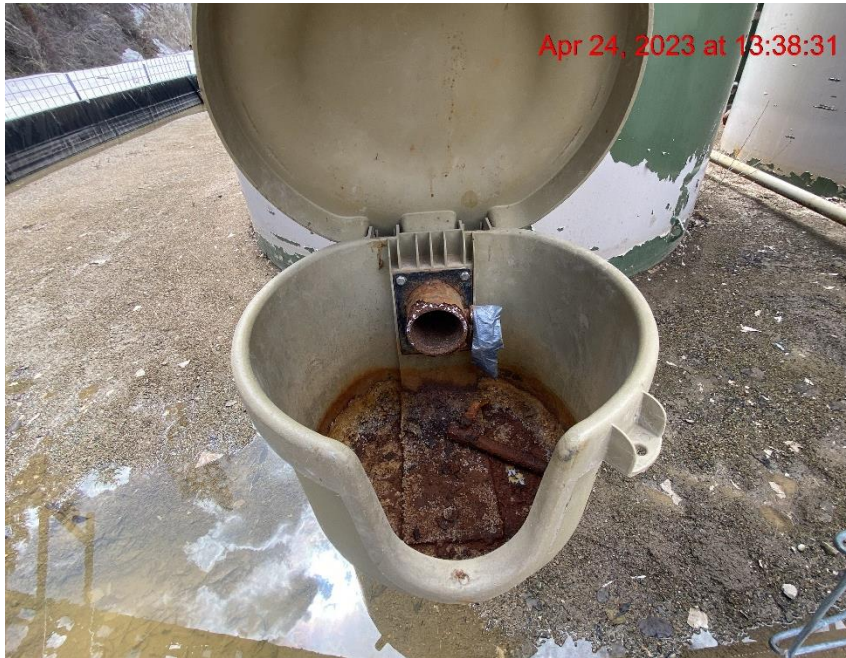
Open-Ended Load Line – Photo #02504

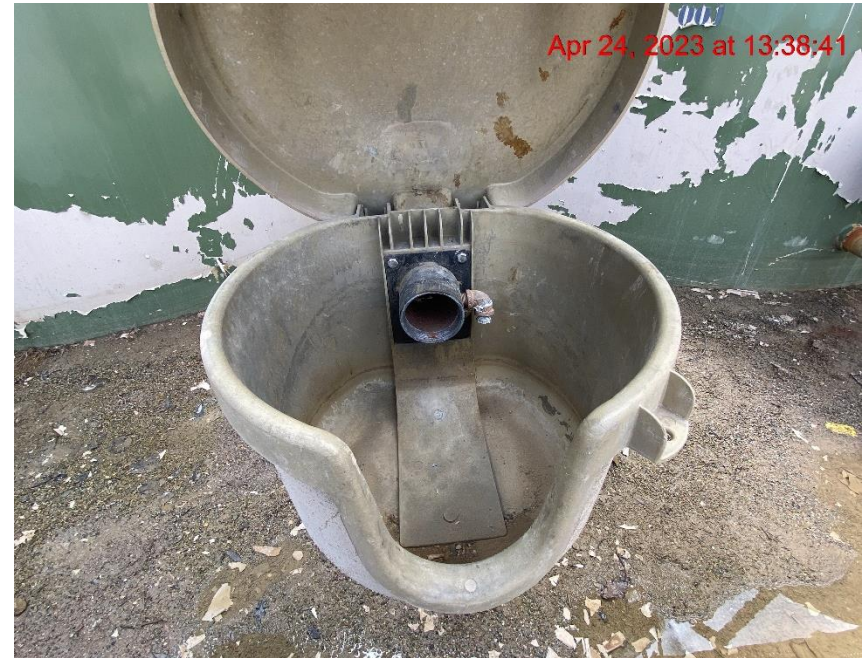
Open-Ended Load Line – Photo #02505

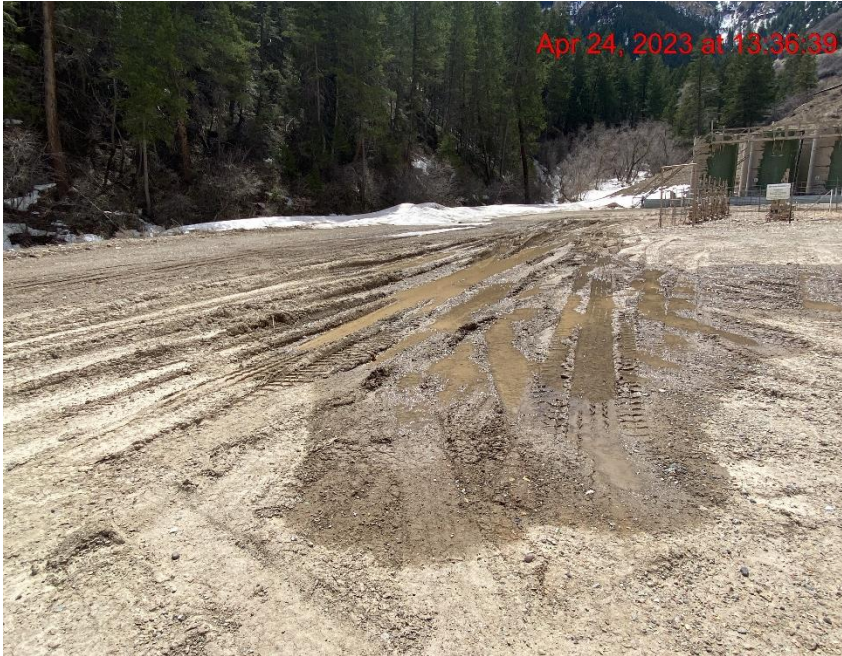
**Lack of Stabilization – Photo #02500**

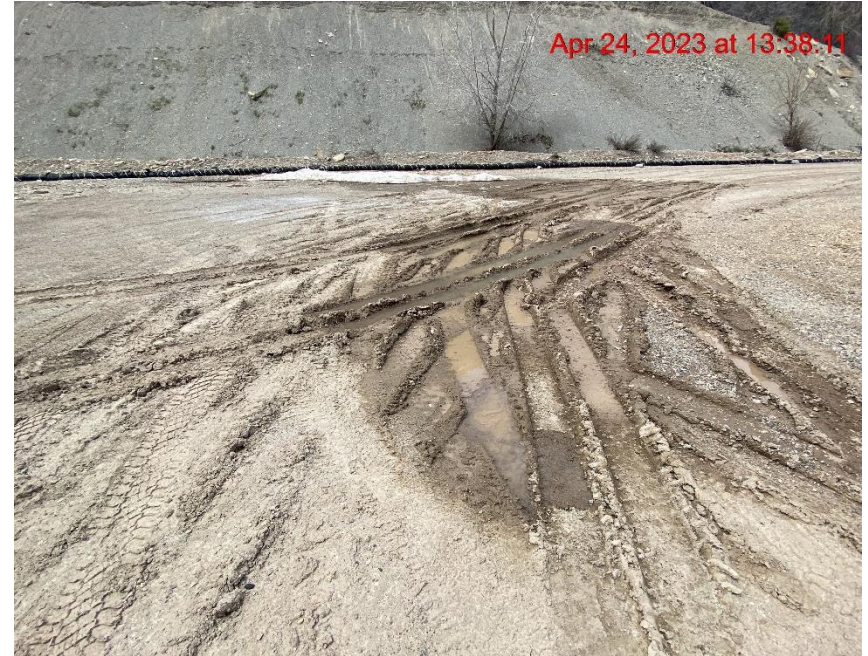
**Lack of Stabilization – Photo #02502**

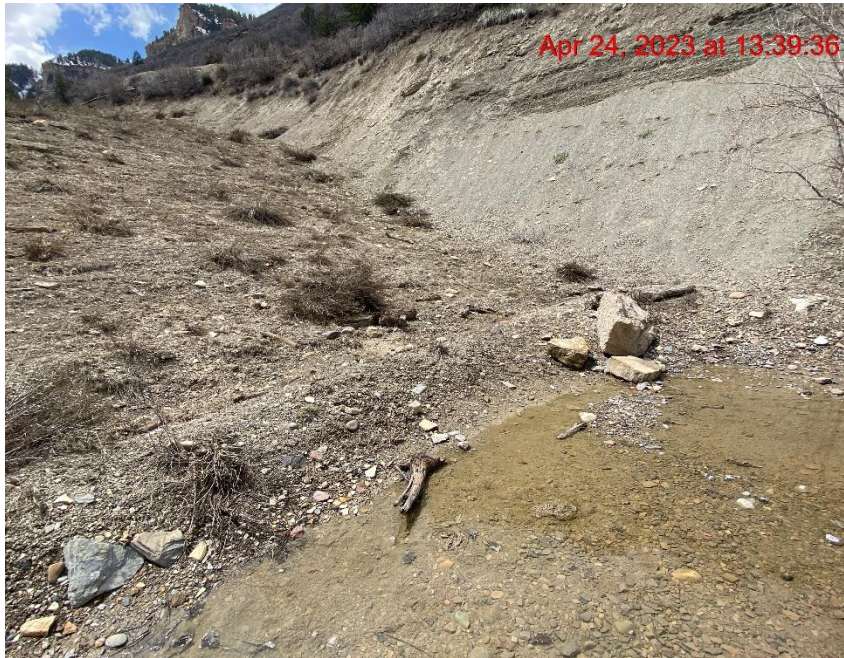
**Slope Erosion onto Location – Photo #02506**

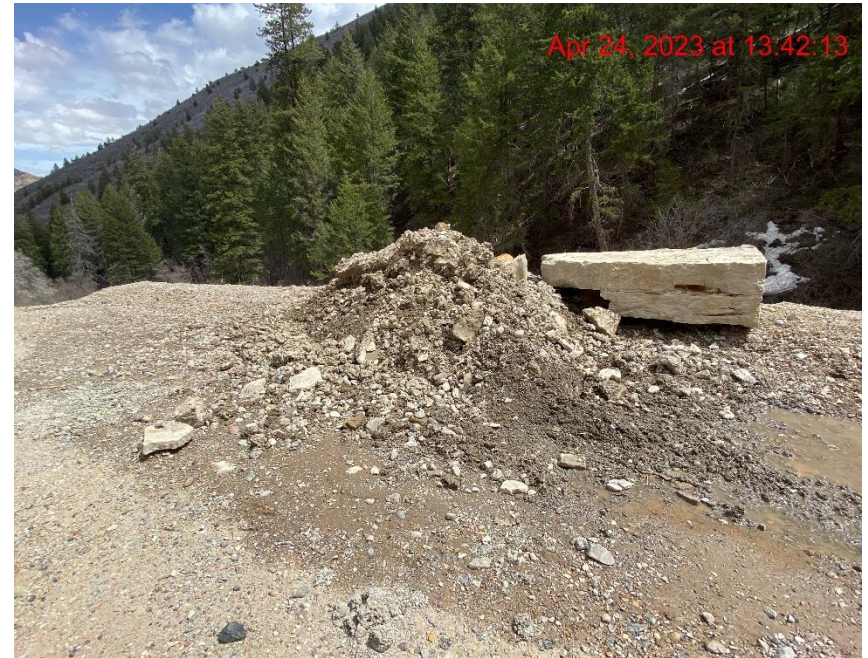
**Degradation/Transportation of Sediment – Photo #02511**

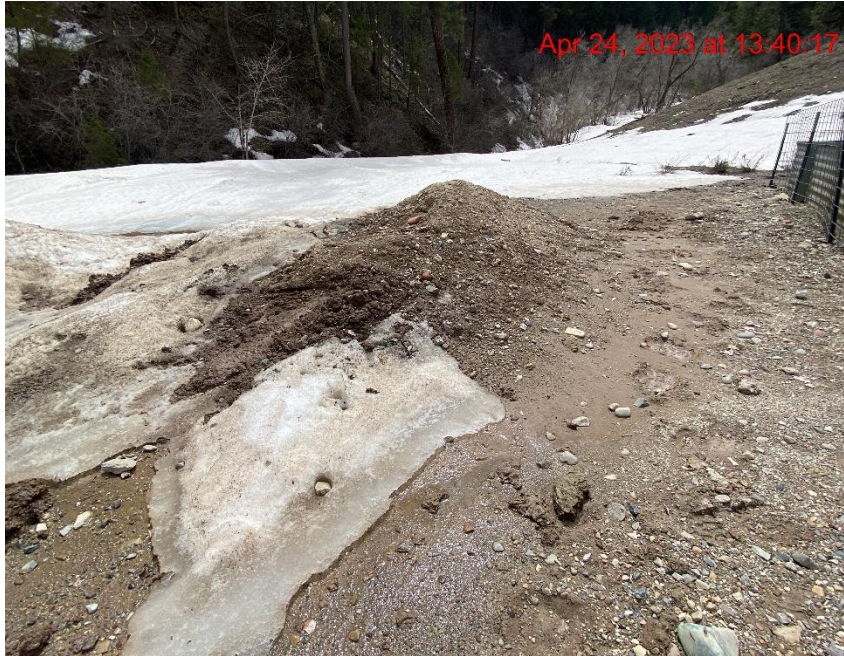
**Degradation/Transportation of Sediment – Photo #02507**

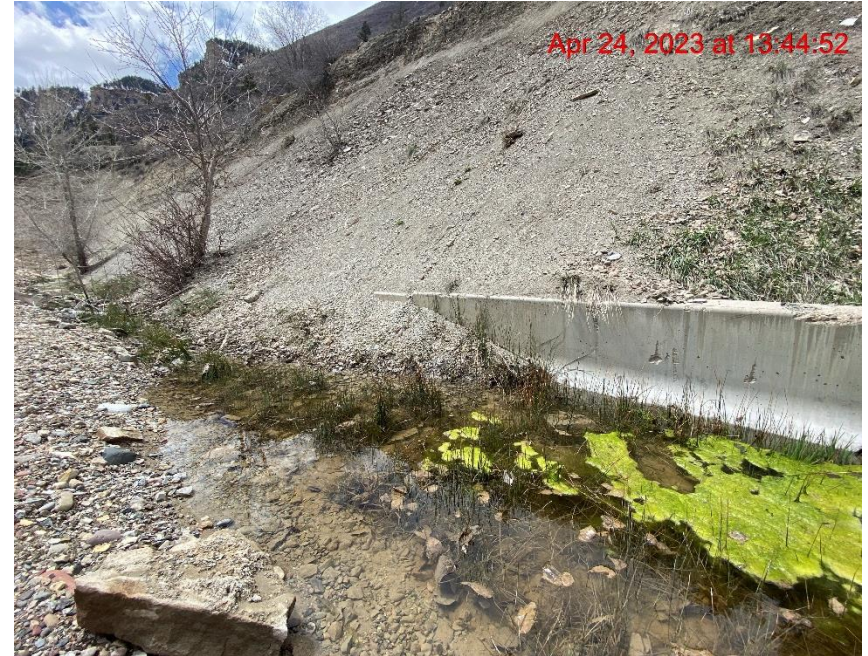
**Slope Erosion has Overrun Retaining Wall – Photo #02514**

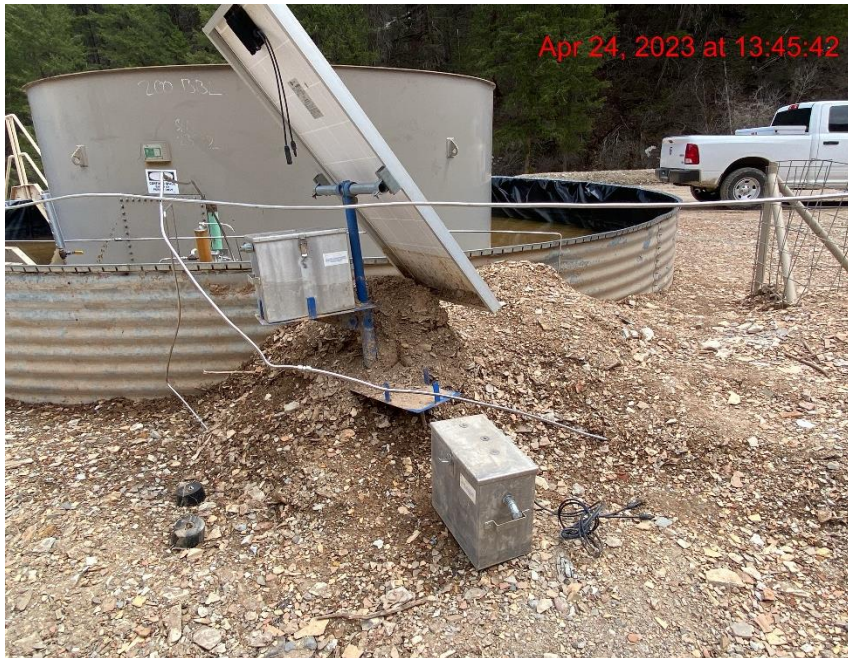
**Transportation of Sediment onto  
Location/Encroachment on Equipment – Photo #02515**

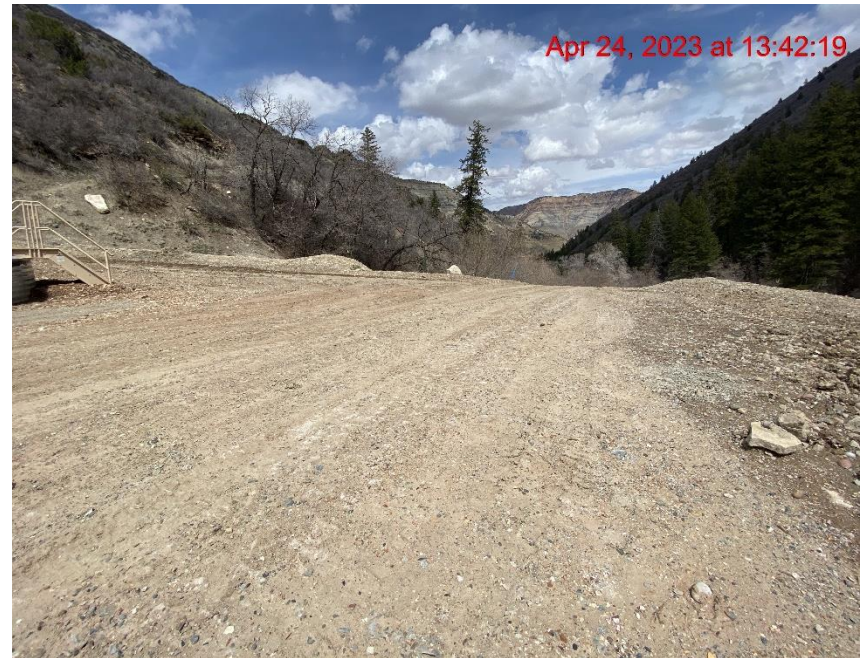
**Inadequate Vehicle Tracking BMPs at Location  
Entrance – Photo #02512**

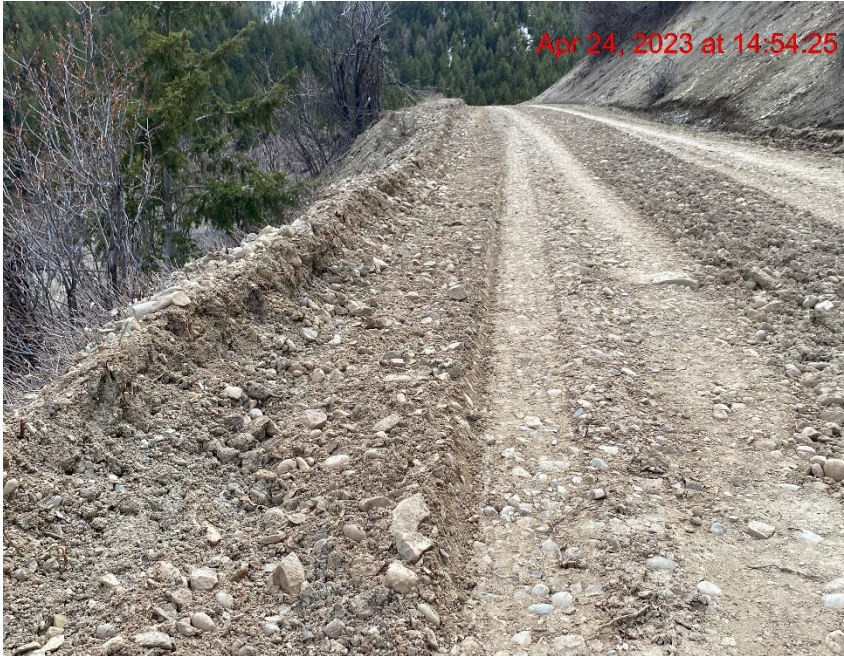
**Access Road Degradation/Transportation of  
Sediment – Photo #02540**
