# CAERUS PICEANCE LLC, PUCKETT-67S96W/6SWNW

Location # 334977

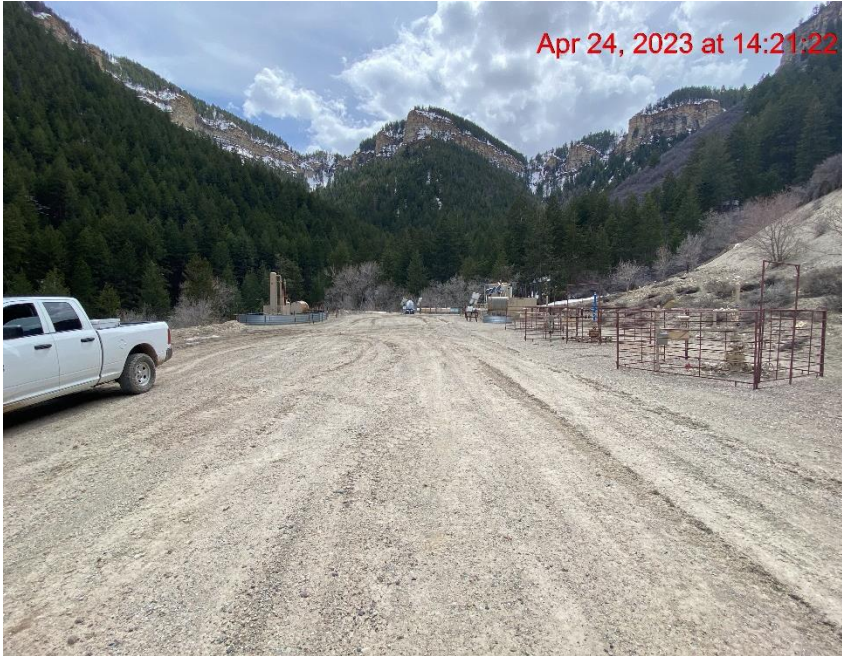
Location Entrance – Photo #02521

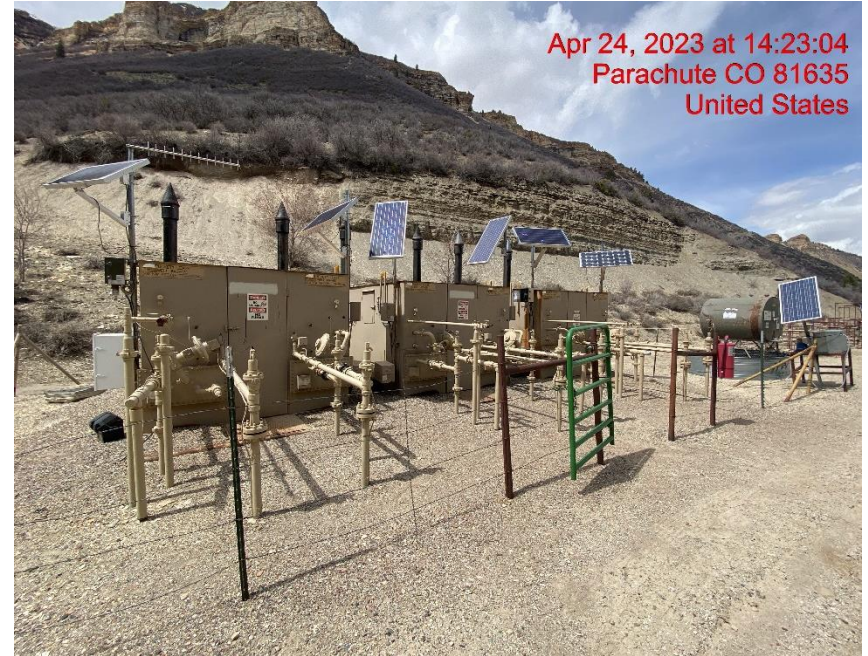
Separators – Photo #02527

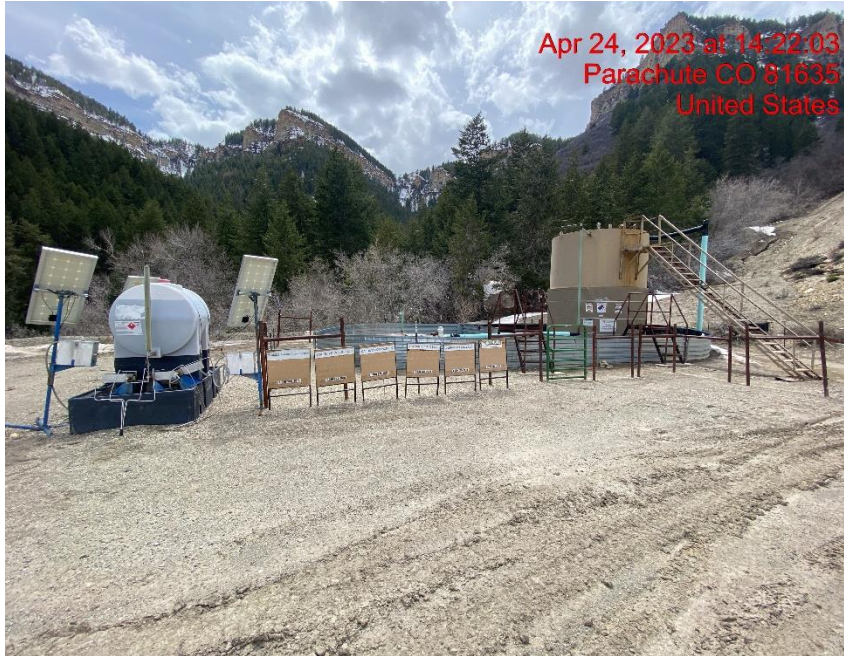
**Tank Battery – Photo #02522**

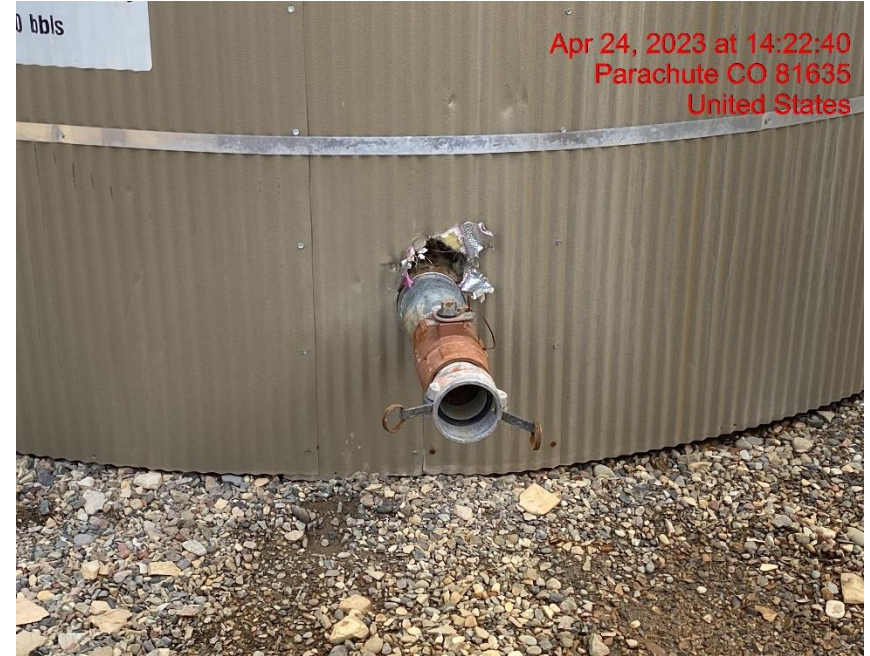
**Open-Ended Load Line – Photo #02525**

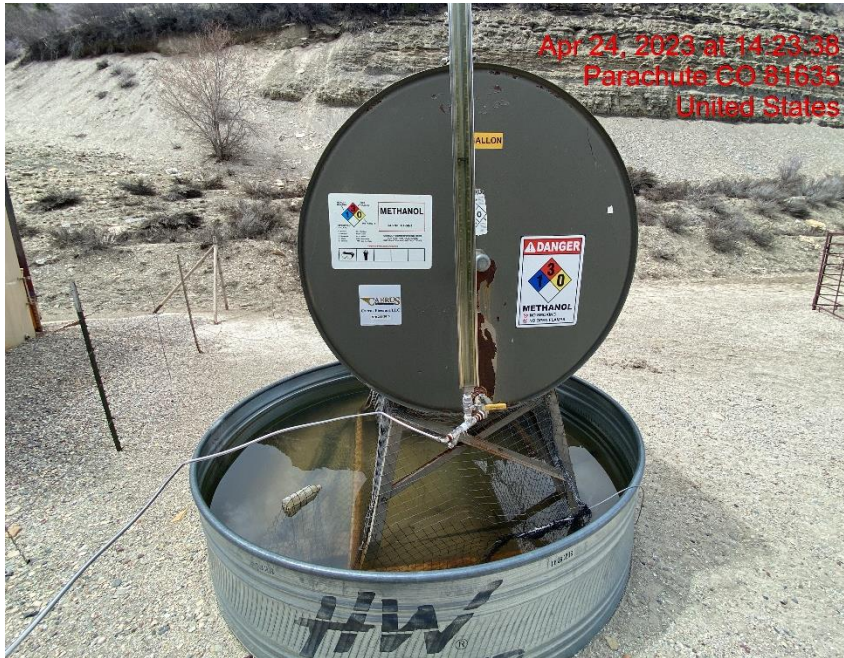
Inadequate Containment Capacity – Photo #02529

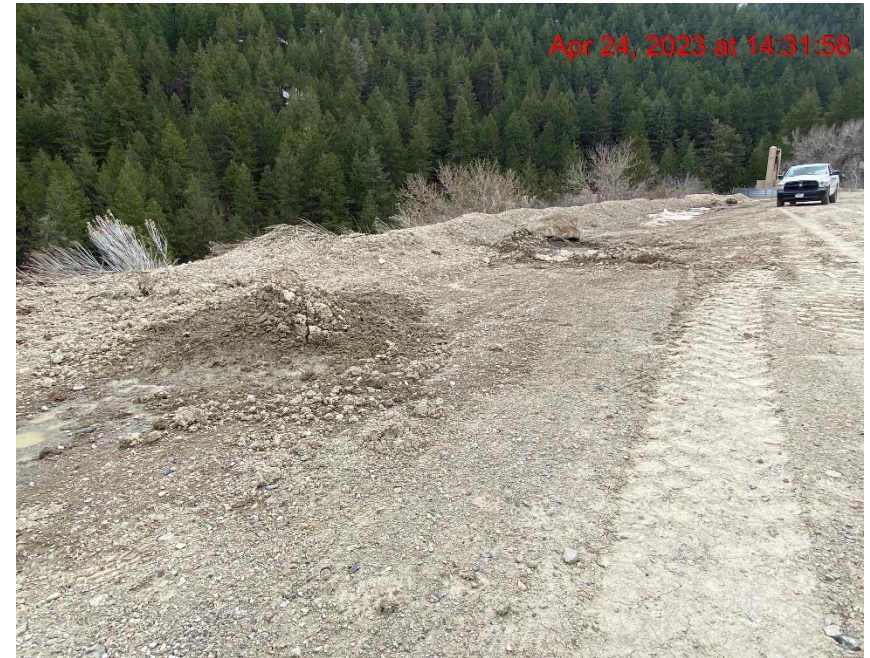
Degradation/Lack of Stabilization – Photo #02530

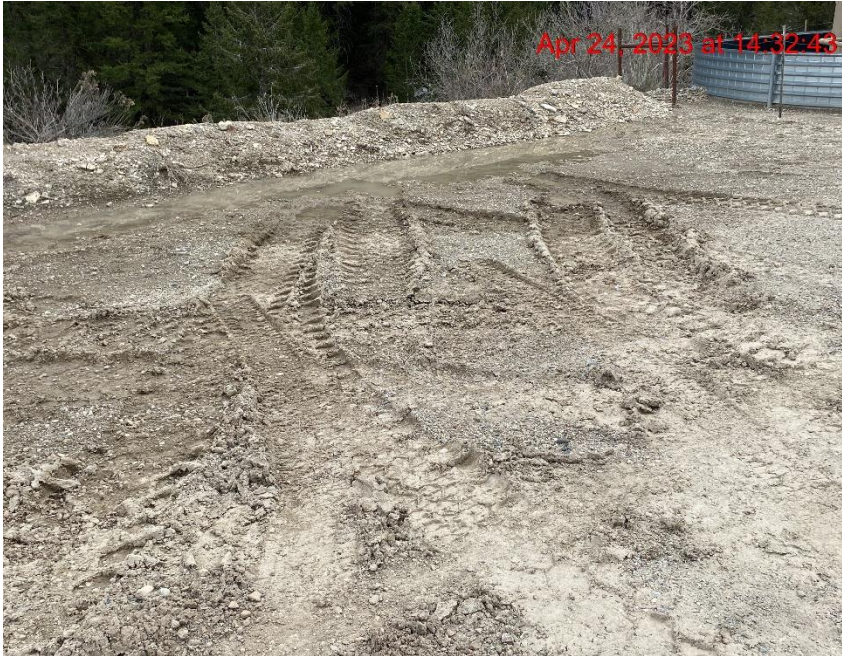
**Lack of Stabilization – Photo #02532**

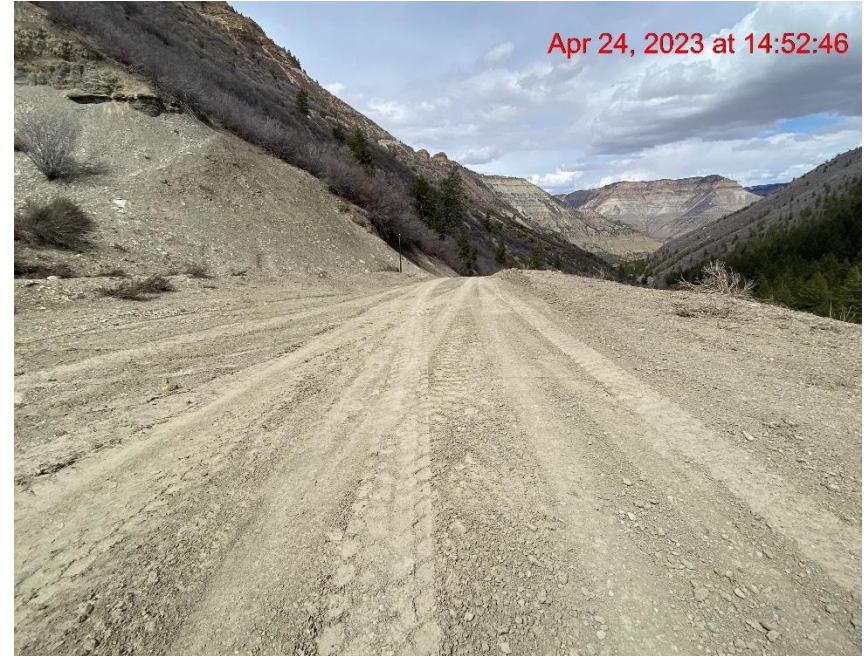
**Inadequate Vehicle Tracking BMPs at Location Entrance – Photo #02536**

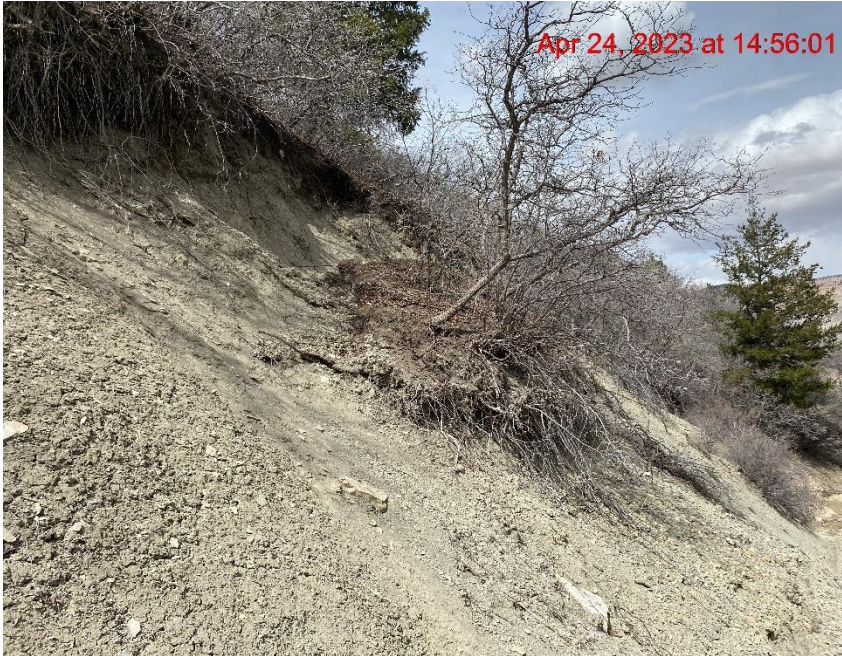
**Slope Erosion onto Access Road – Photo #02544**

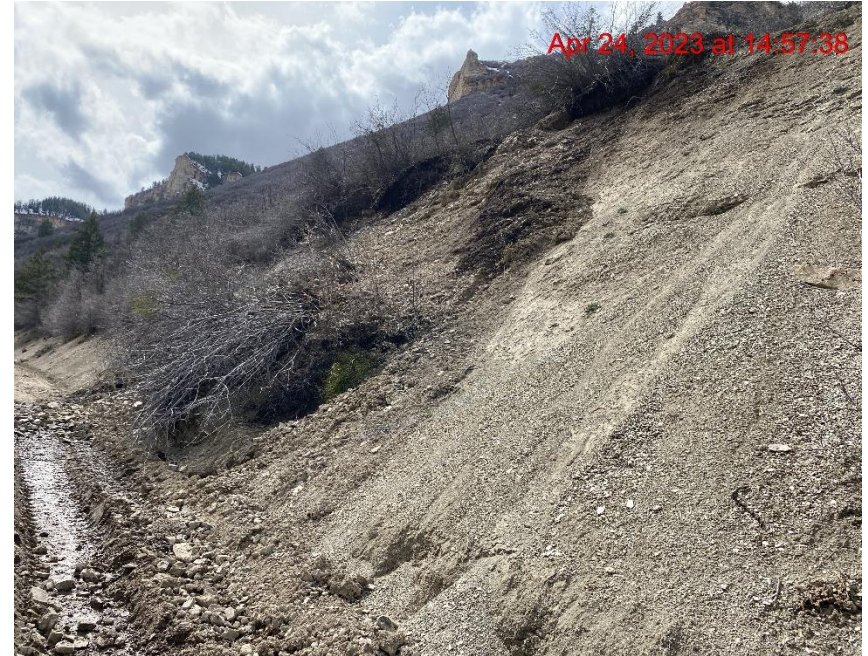
**Slope Erosion onto Access Road – Photo #02546**
