Inspection Photos

Location Name: TEP ROCKY MOUNTAIN LLC RWF 314-16 Pad

Location ID: 324148

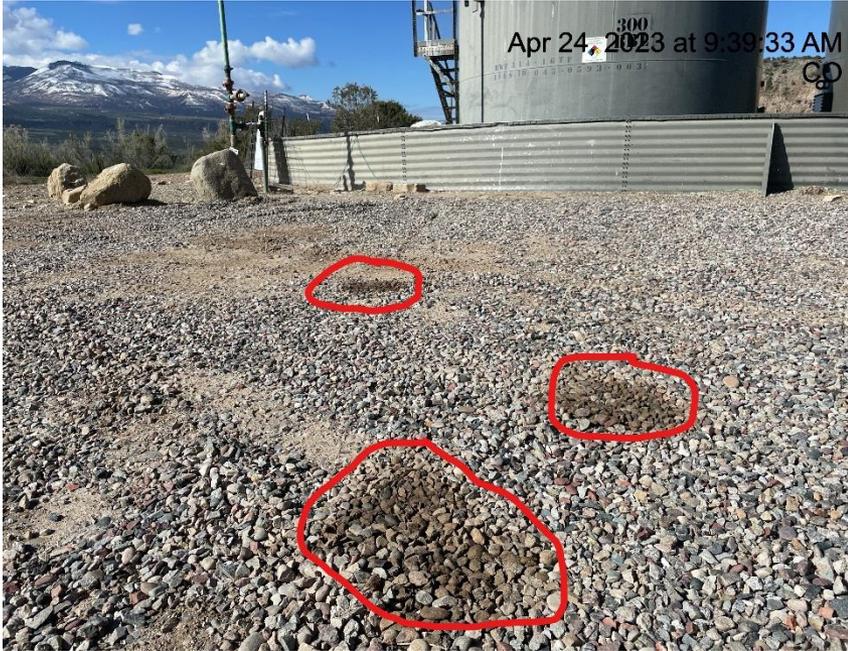
Photo # 6124 Stained soils & gravel

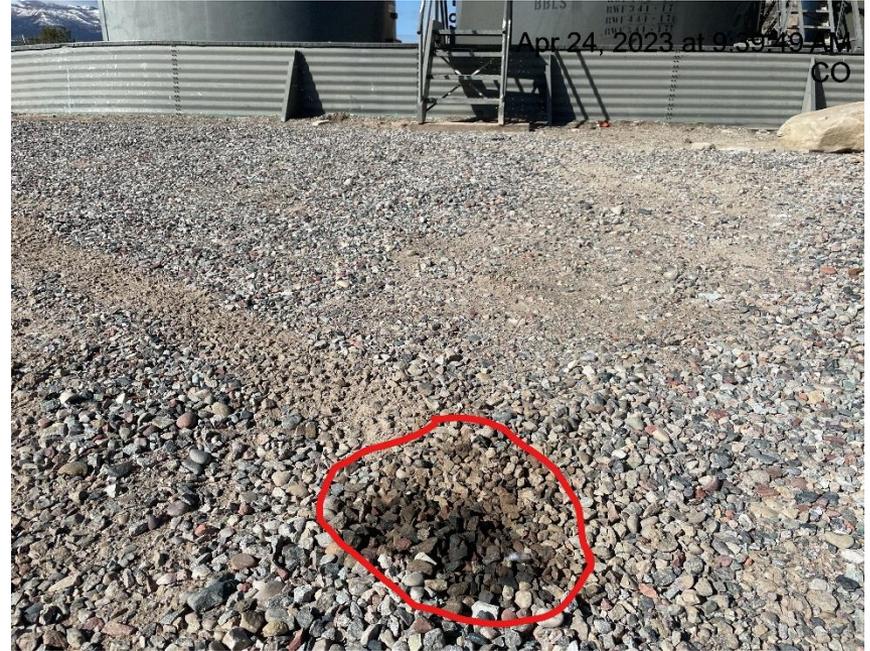
Photo # 6125 Stained soils & gravel

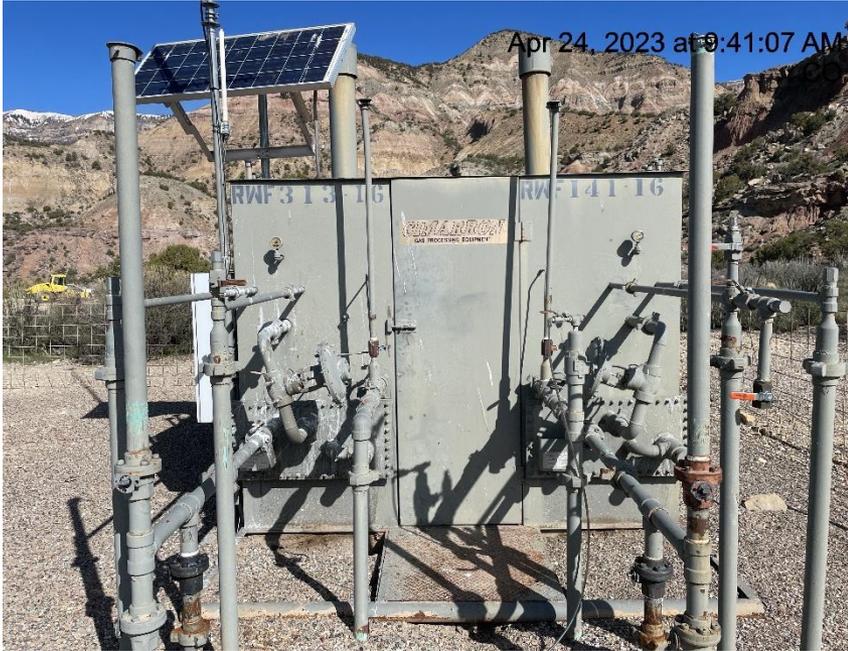
Photo # 6128 Meter calibration info not conspicuously posted

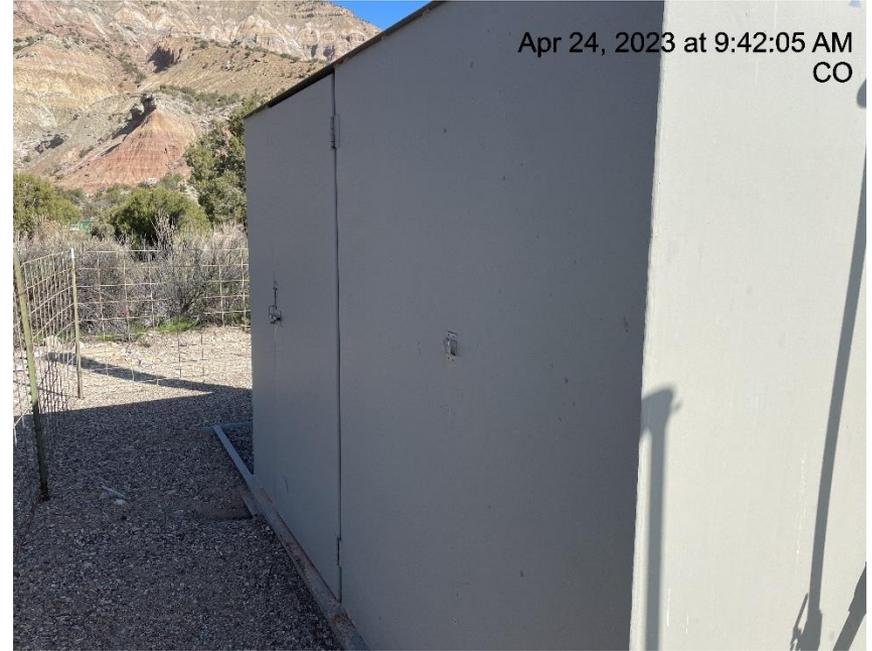
Photo # 6129 Meter calibration info not conspicuously posted

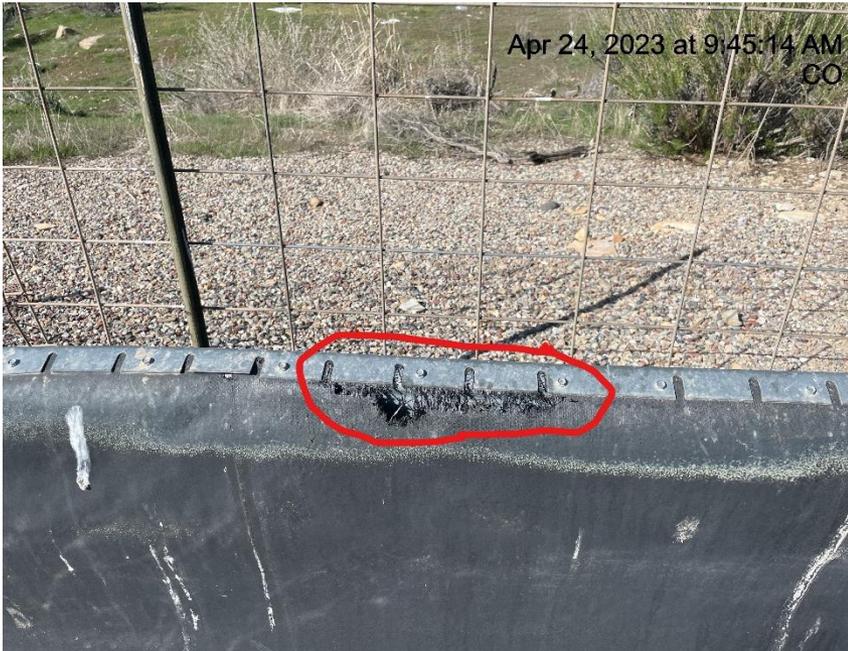
Photo # 6130 Containment liner needs maintenance

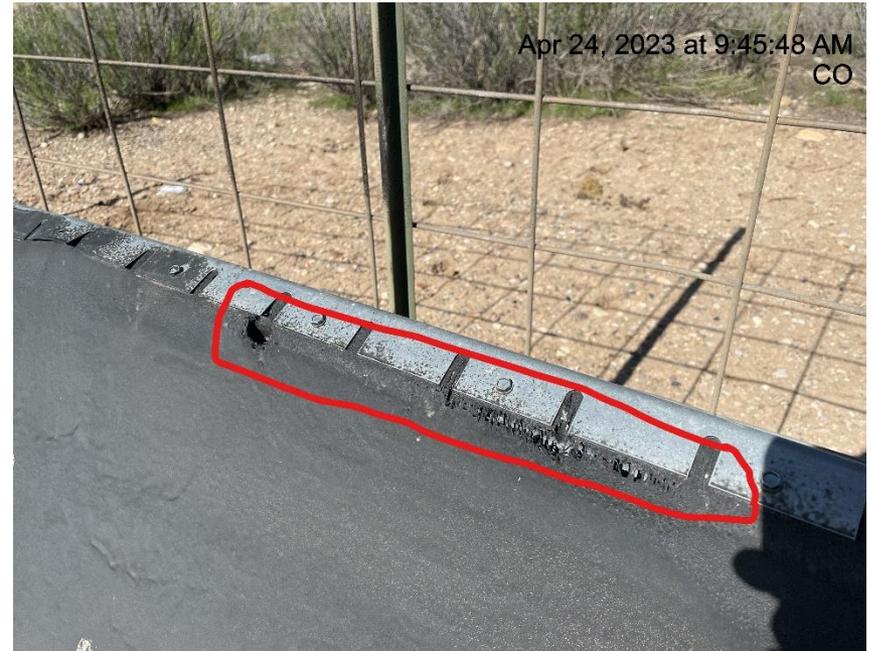
Photo # 6133 Containment liner needs maintenance

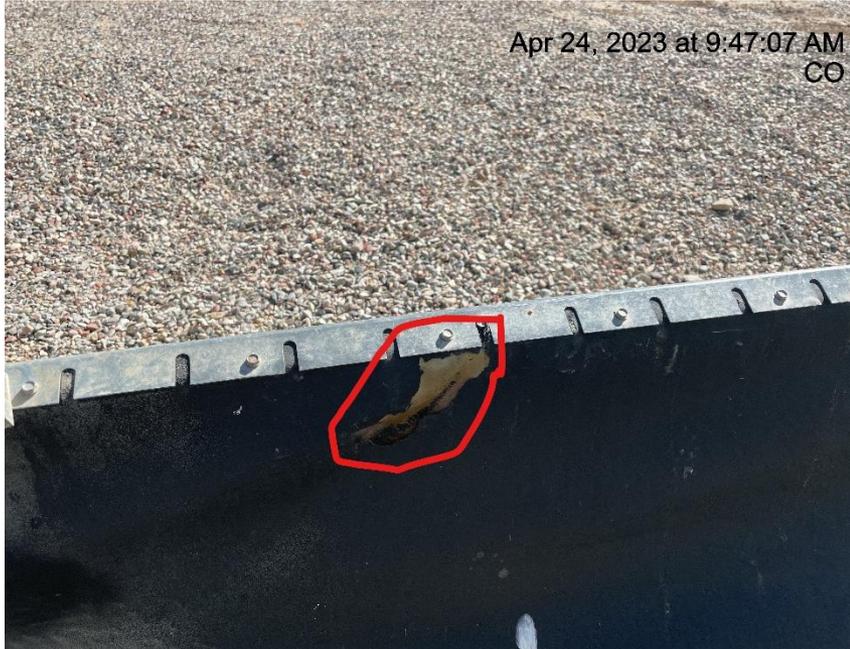
Photo # 6135 Containment liner needs maintenance

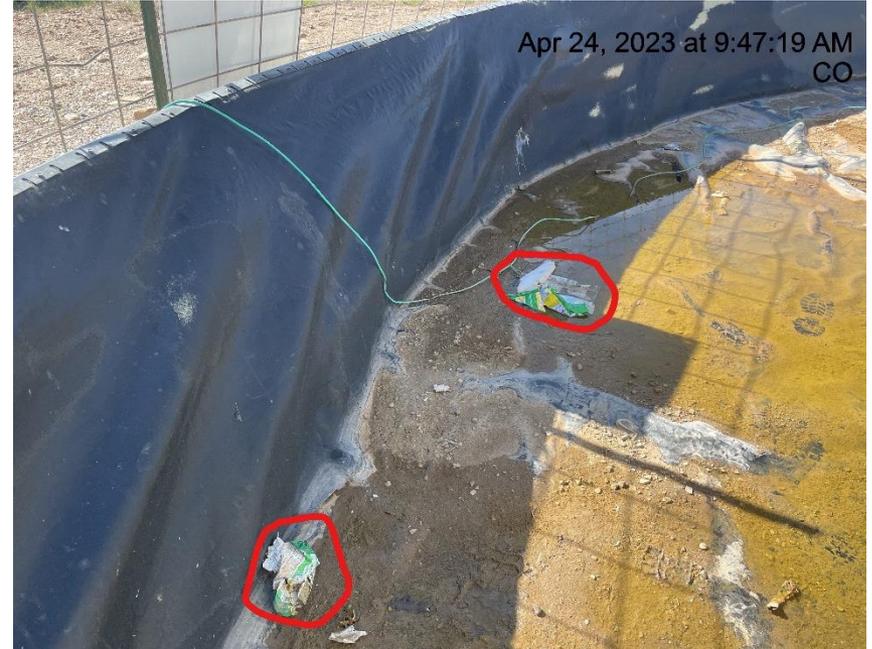
Photo # 6136 Debris

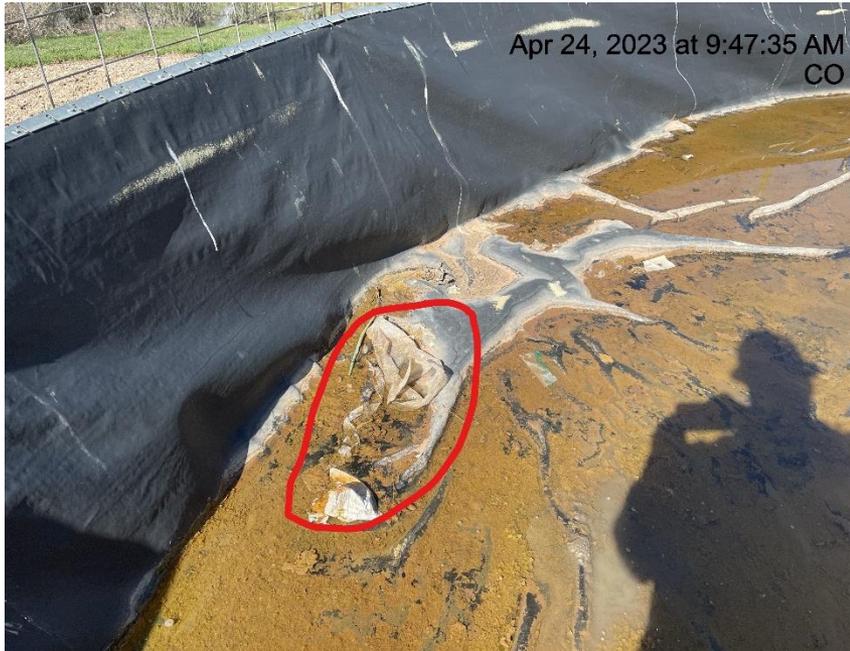
Photo # 6137 Debris

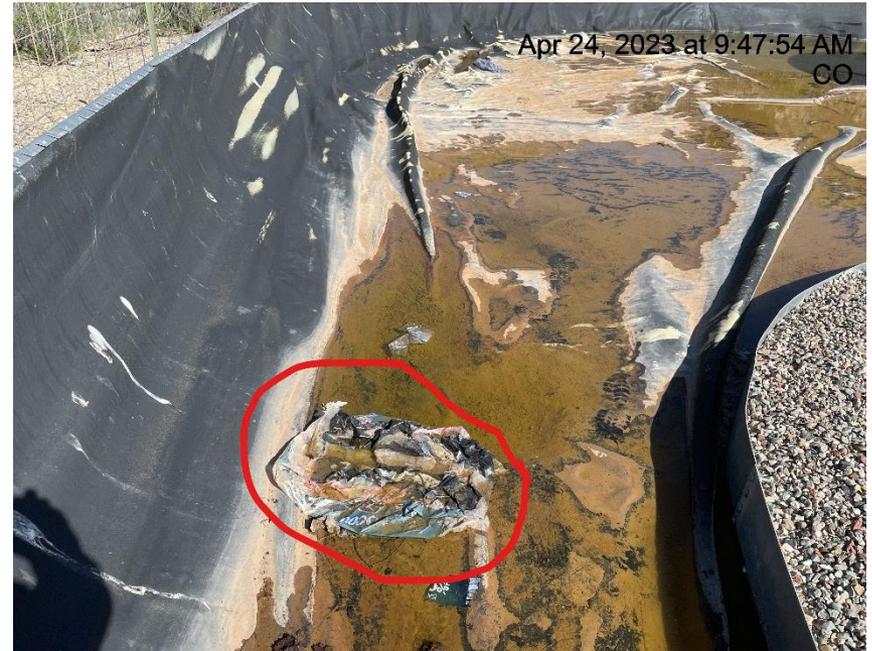
Photo # 6138 Debris

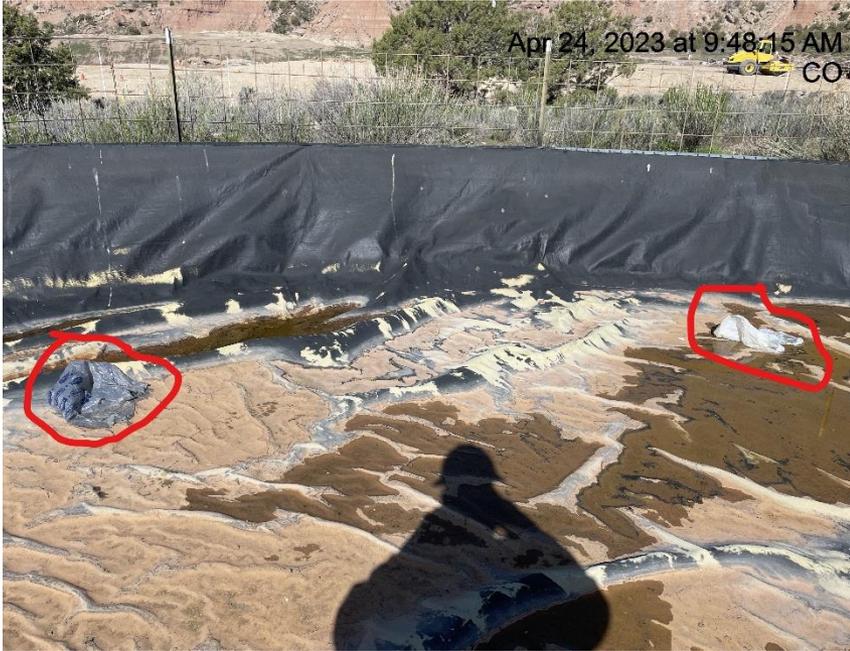
Photo # 6139 Debris

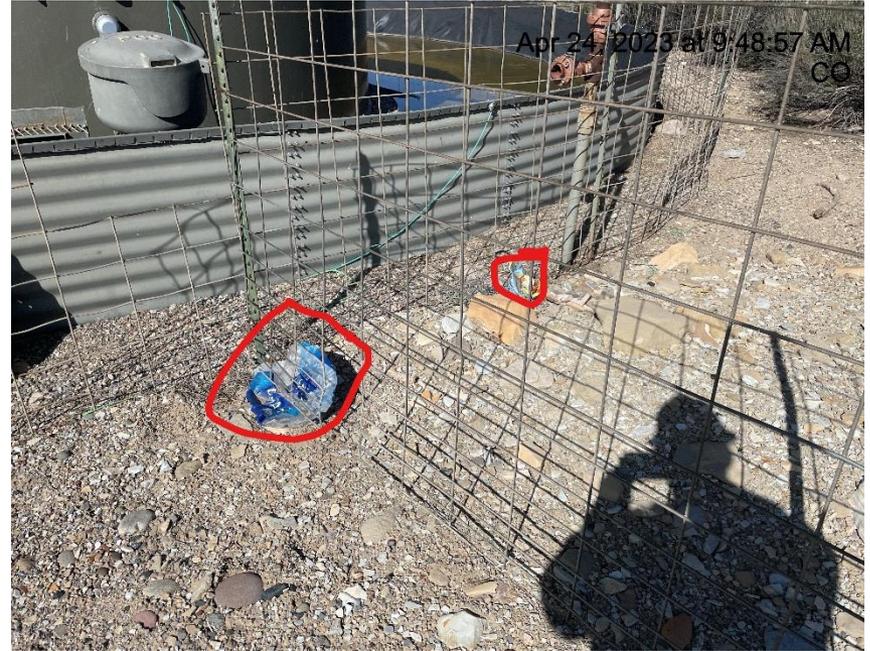
Photo # 6140 Debris

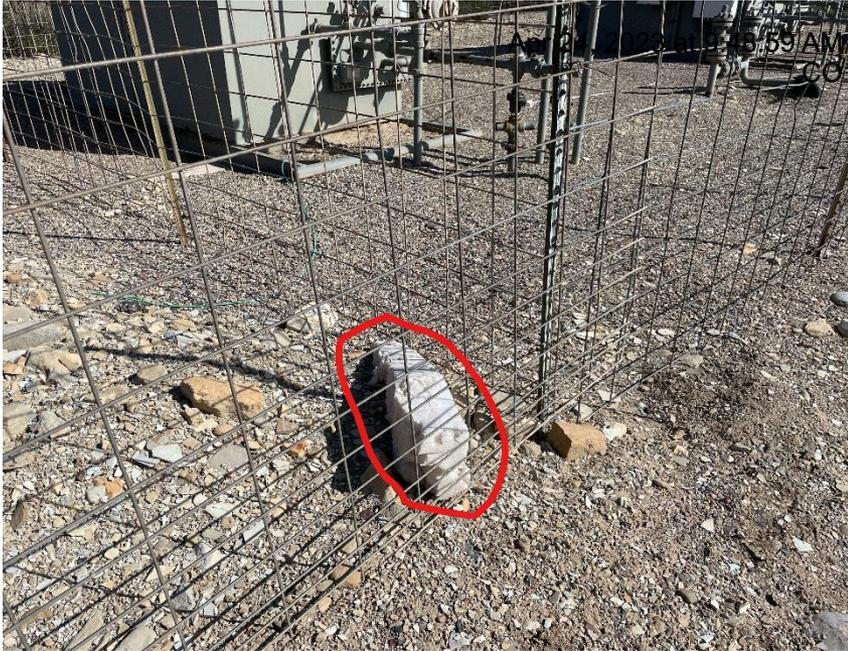
Photo # 6141 Debris

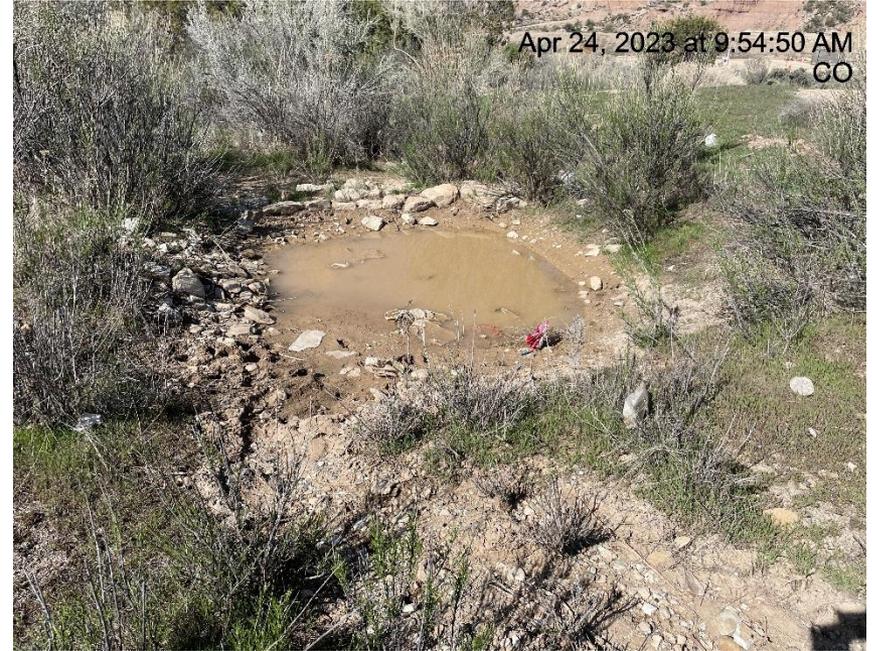
Photo # 6142 Sediment trap needs maintenance (West side of pad approximately 15-20 ft from tank battery)

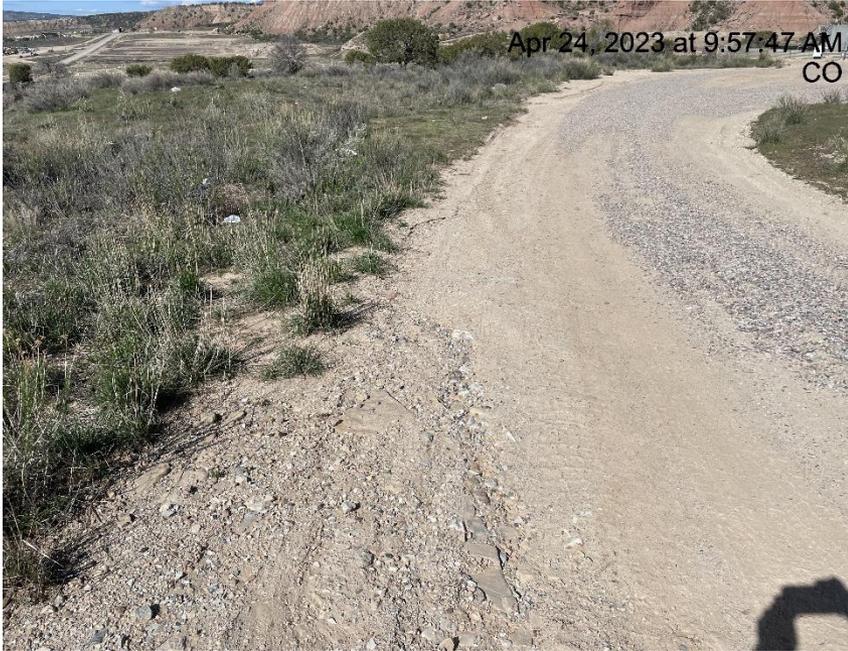
Photo # 6144 Erosion & transport of sediment on spur road near entrance to location

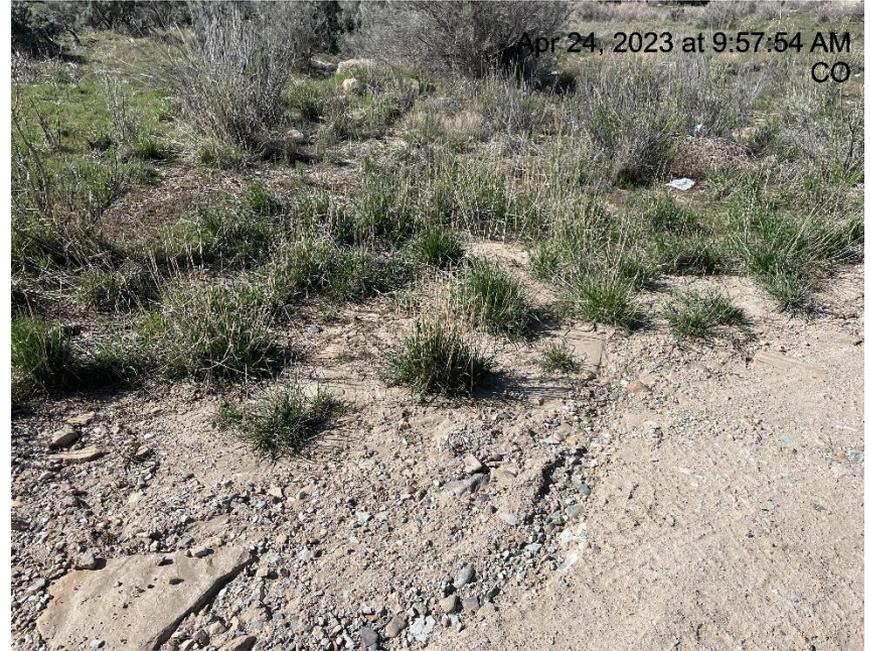
Photo # 6145 Erosion & transport of sediment on spur road near entrance to location

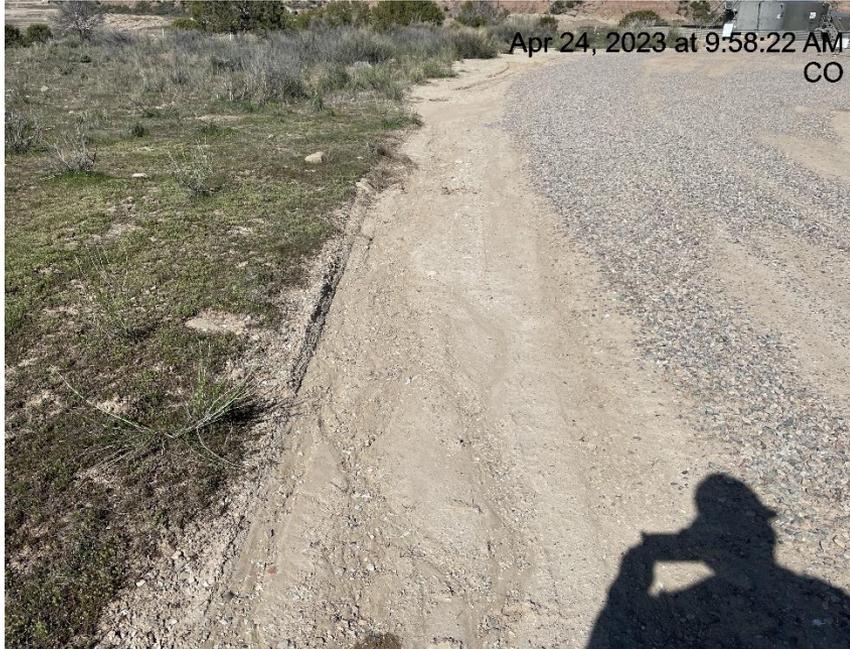
Photo # 6147 Erosion & transport of sediment on spur road near entrance to location

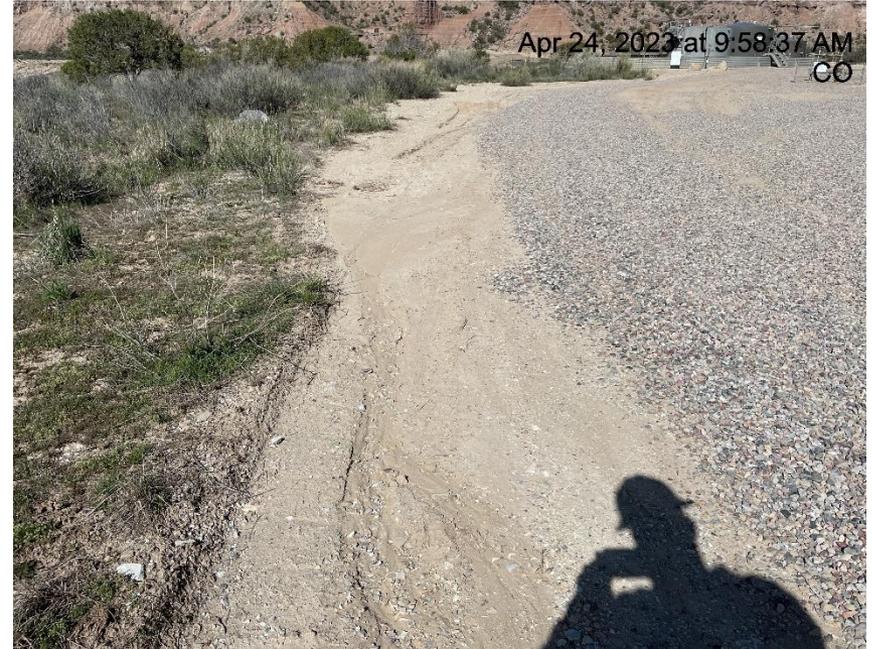
Photo 6149 Erosion & transport of sediment on spur road near entrance to location

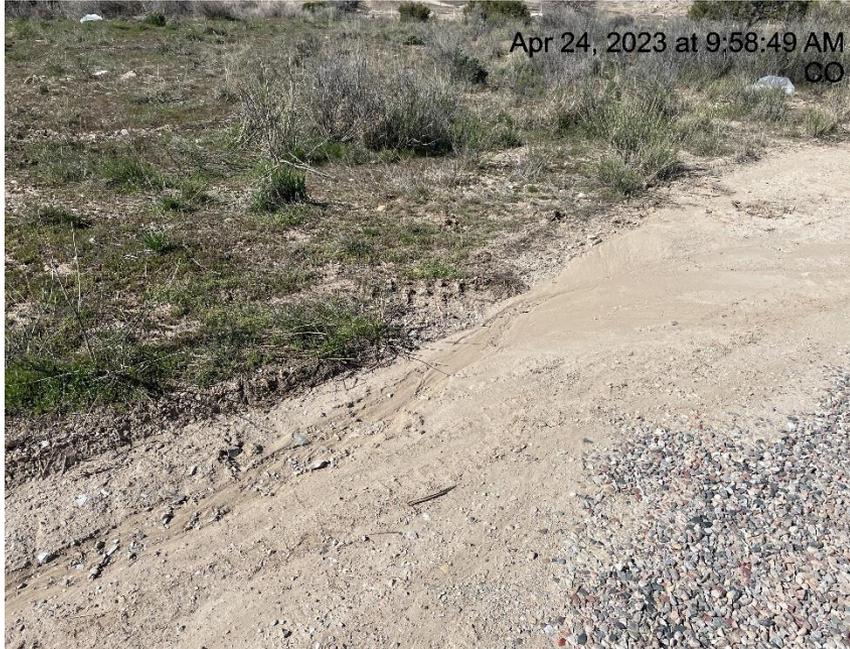
Photo # 6151 Erosion & transport of sediment on spur road near entrance to location
