Inspection Photos
Simcoe LLC. Evelyn Payne C1
API 067-06904

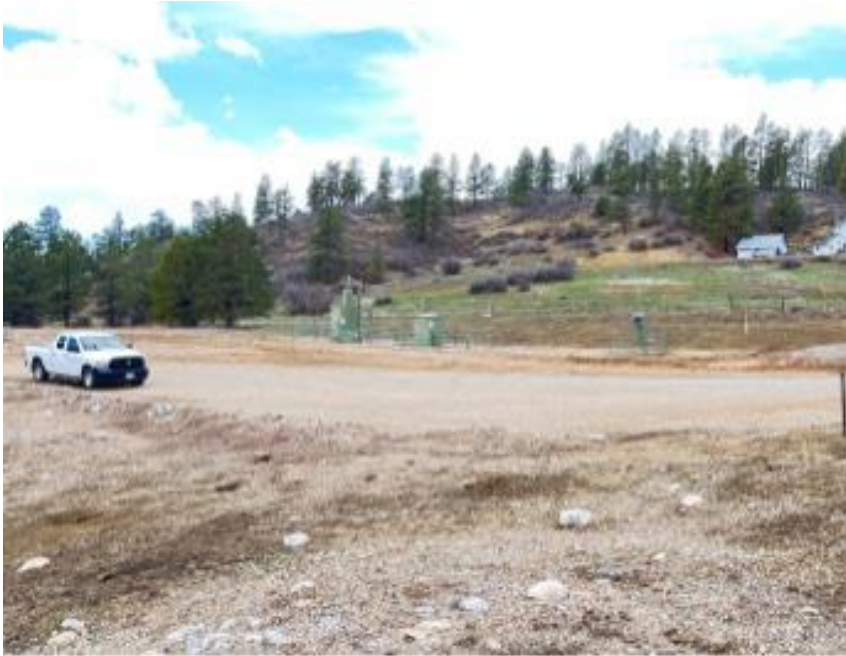
Photo #1. Overview of well location.

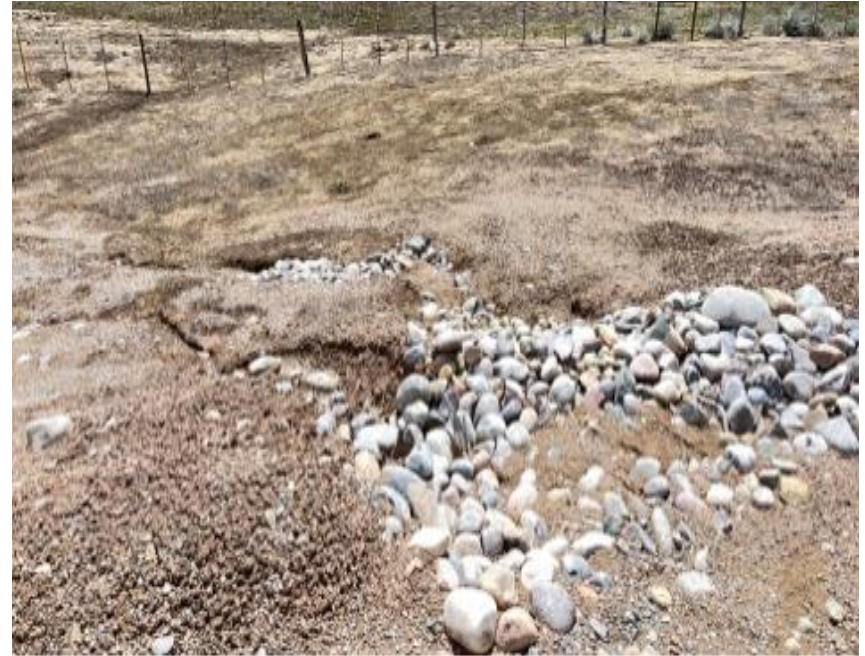
Photo #2. View of erosion on run-downs.

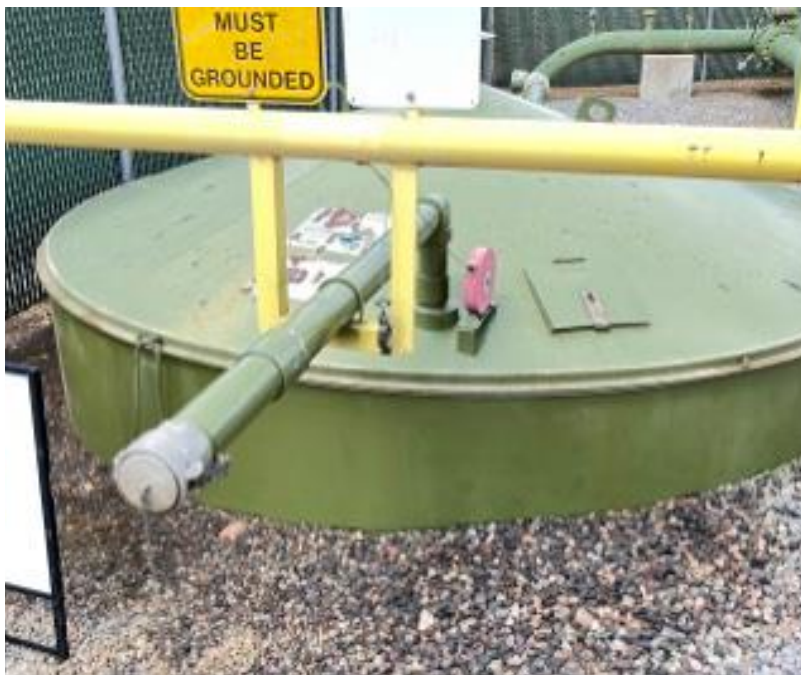
Photo #3. Produced water tank with impacted gravel.

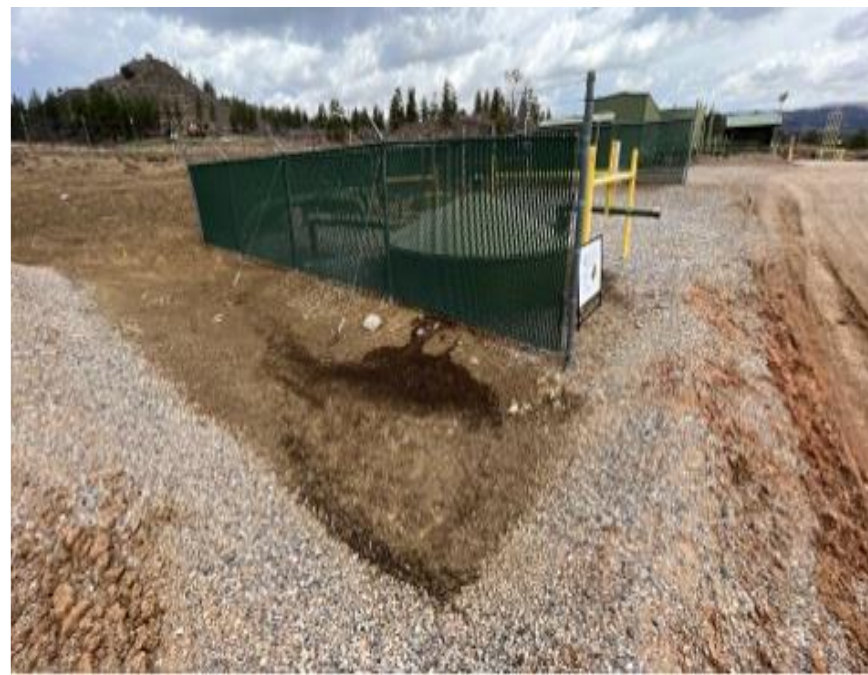
Photo #4. Impacted area from produced water tank spill.
