Inspection Photos

API: 071-06539

Operator: EVERGREEN NATURAL RESOURCES

Inspection Date: 4/27/2023

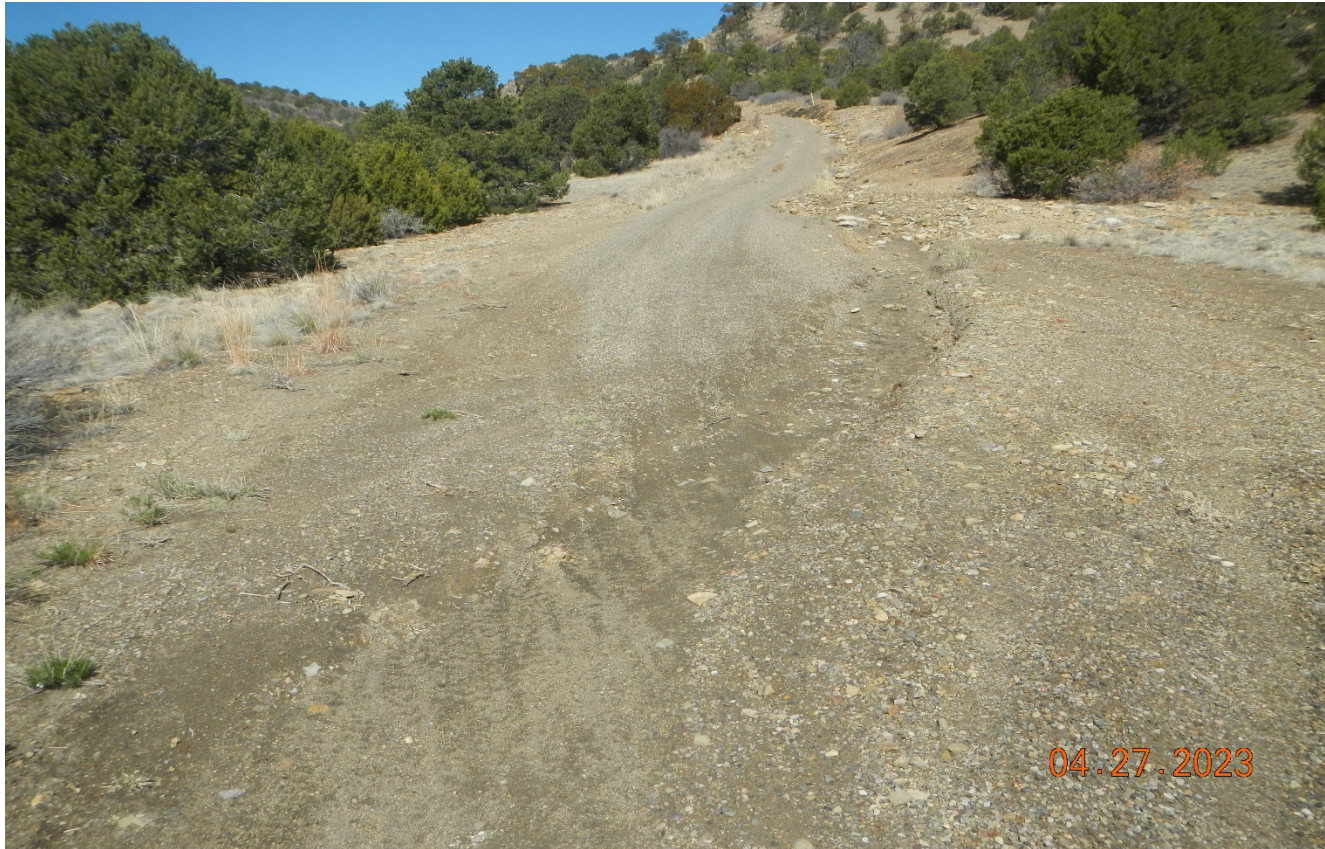
Photo 1. Facing northeast at the access road. Stormwater is directed all the way down the roadside causing erosion of the road.

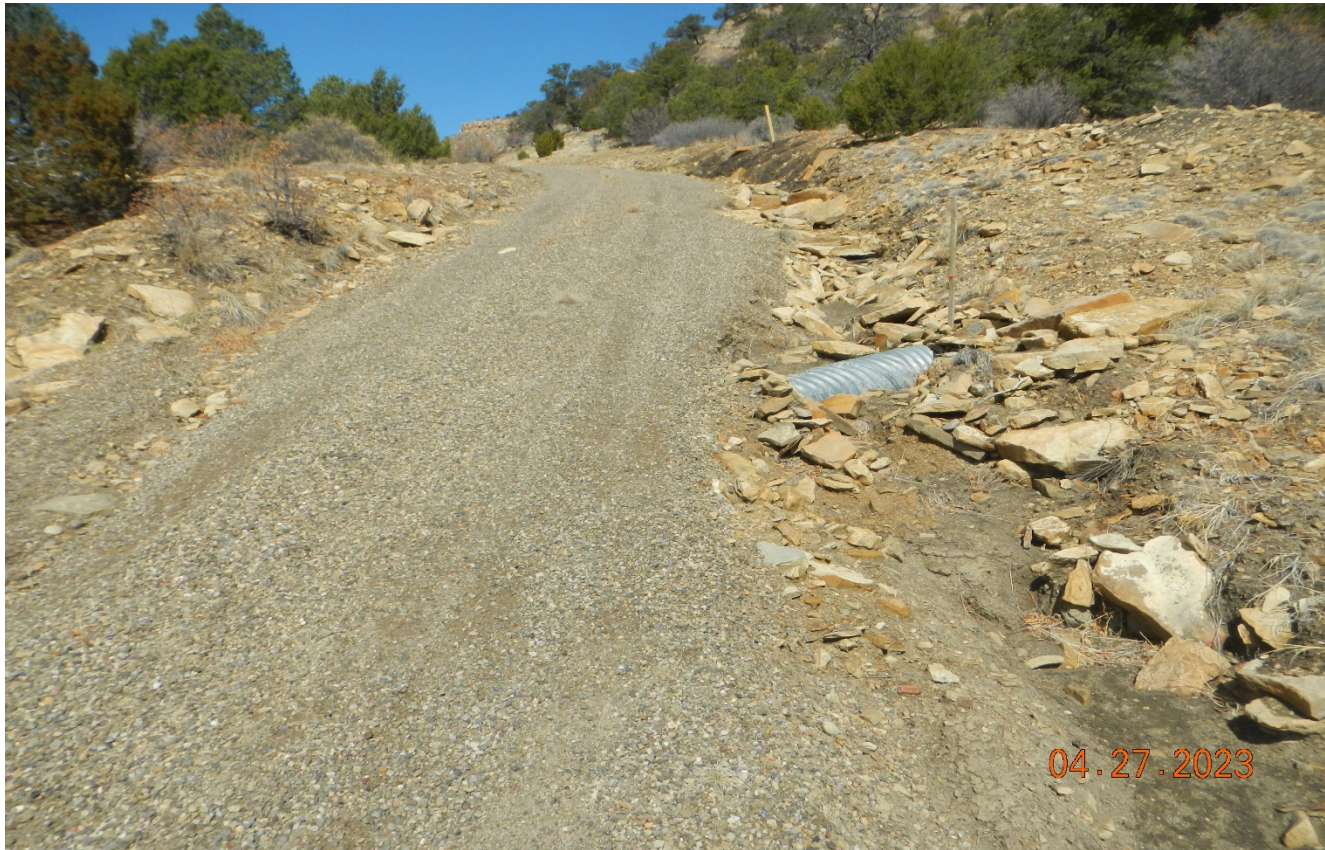
Photo 2. This culvert is filled in with sediment and there were no other culverts observed . Stormwater is all the way down the roadside causing erosion.

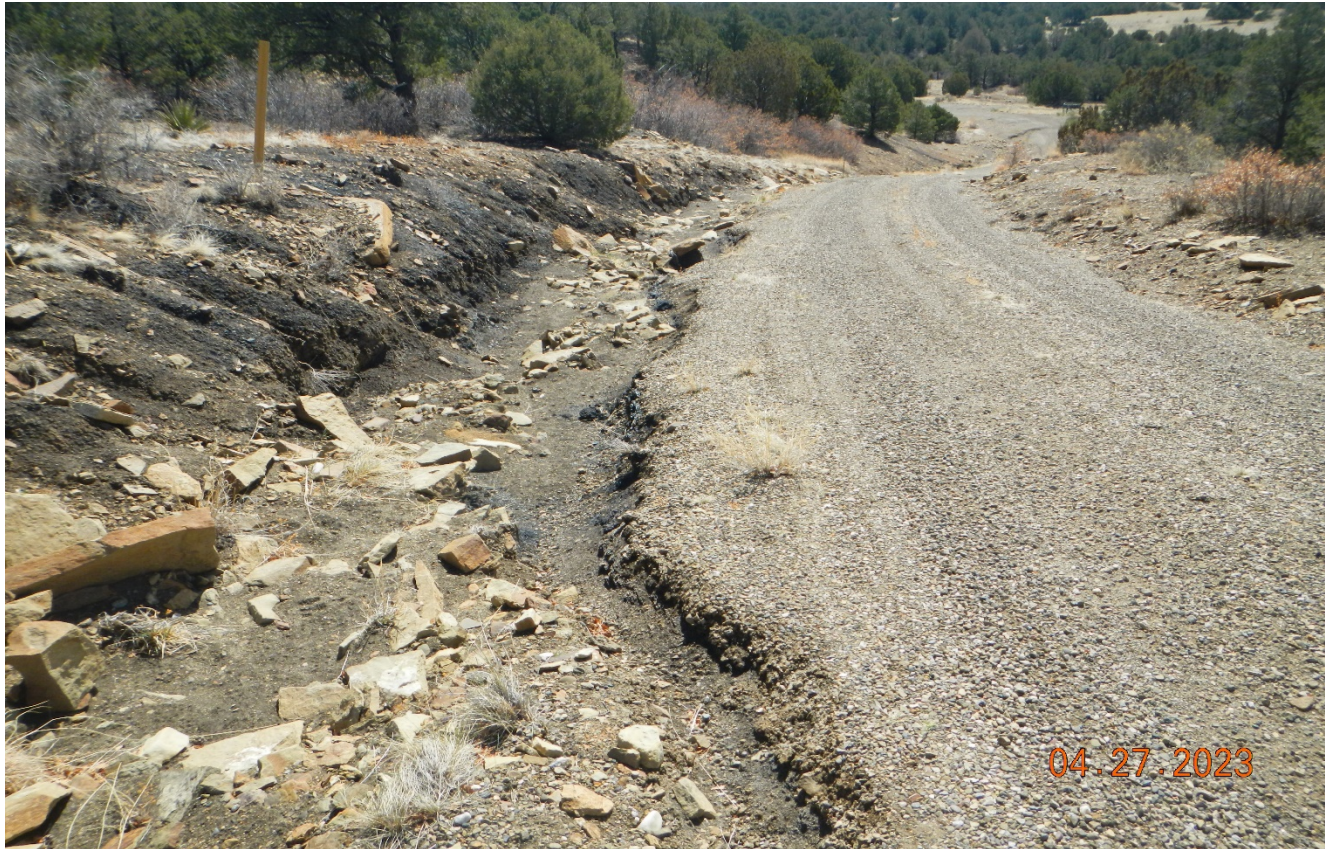
Photo 3. Facing back southeast along the access road. There is erosion along the roadside and stormwater is not diverted and runs down the entire length of the access road.

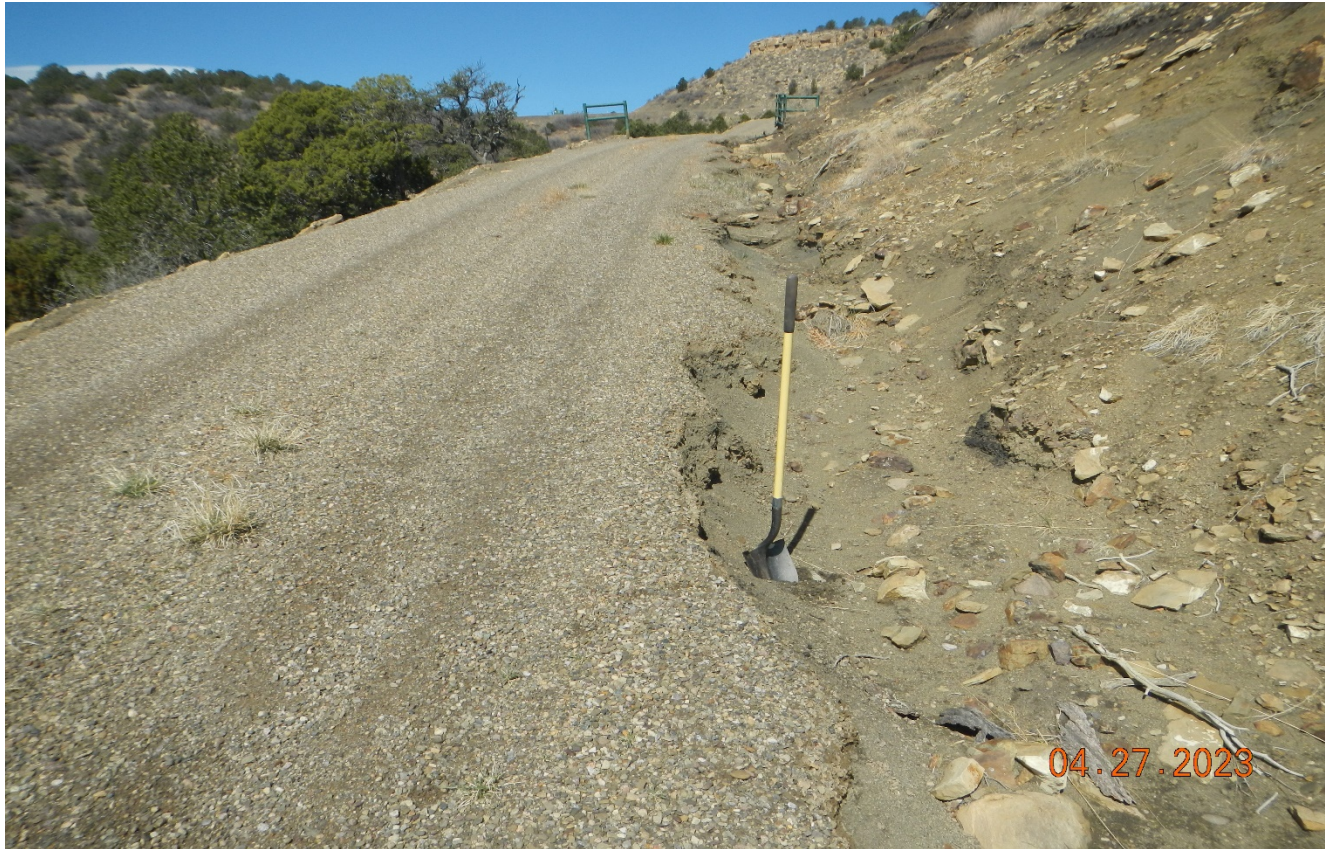
Photo 4. Facing northwest along the access road. Shovel placed in erosion channel for scale.

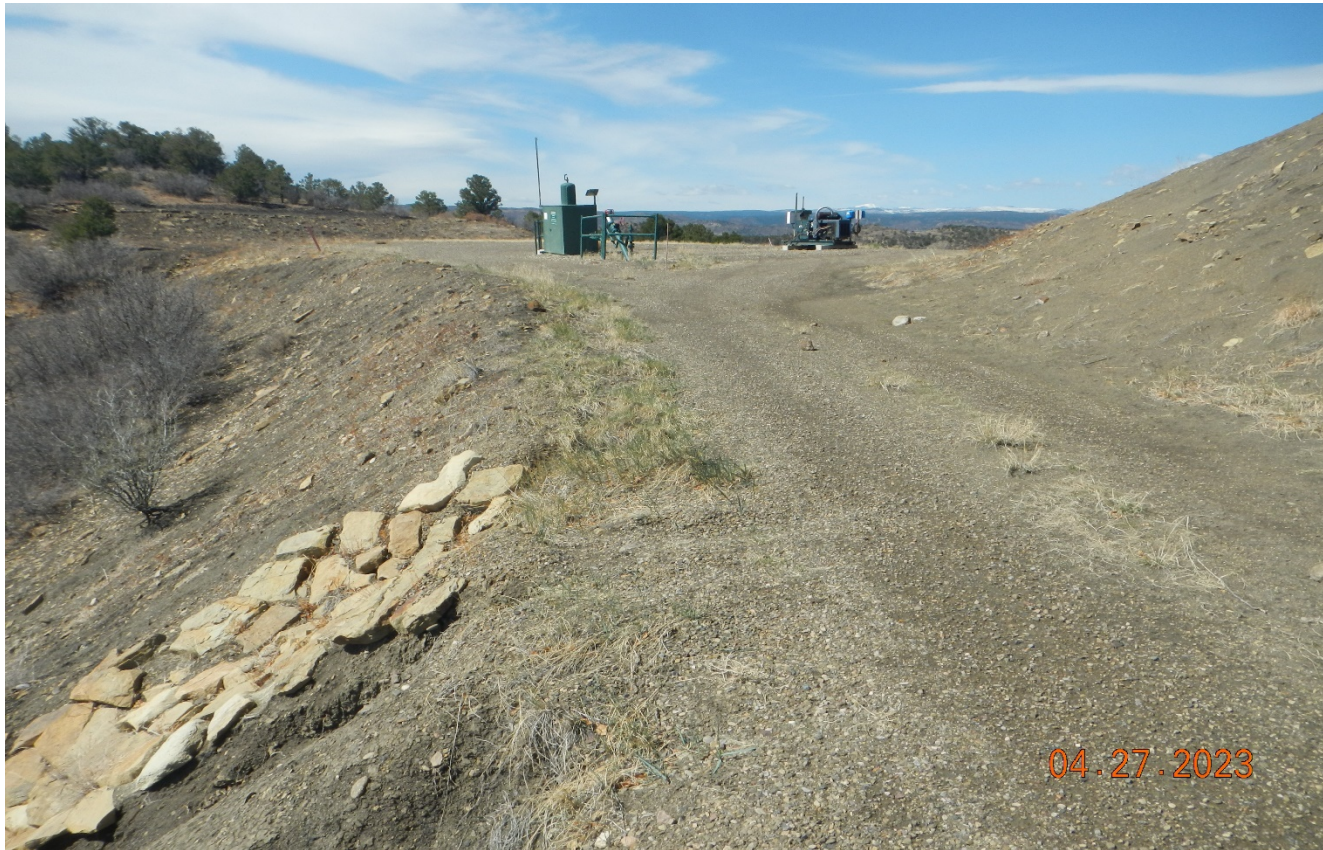
Photo 5. Facing southwest at the wellsite.

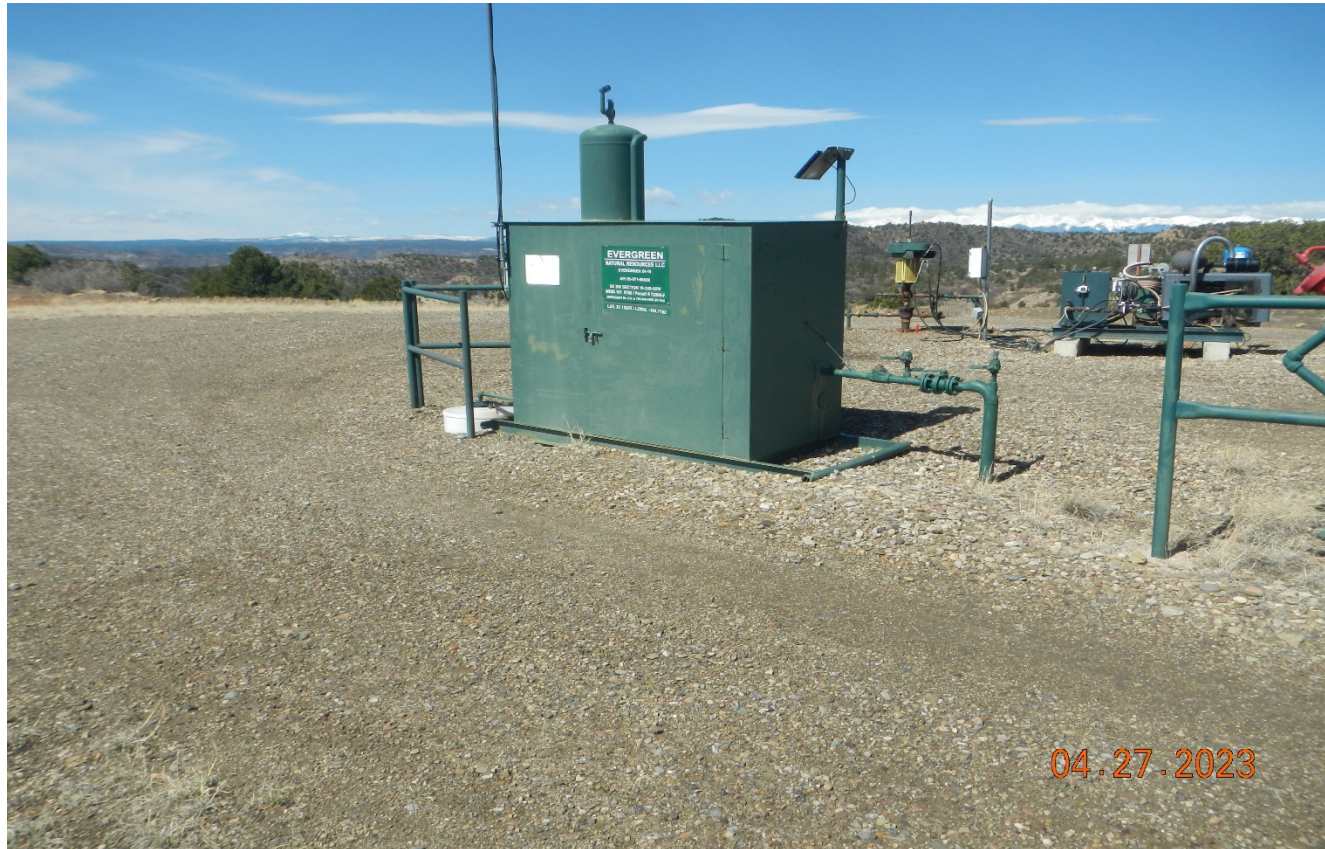
Photo 6. Facing west at the location. Sign is posted at meter shed.
