Interim Reclamation and Stormwater Inspection

Date: 04/20/2023

Operator: IMPETRO RESOURCES LLC -10690

Location ID: 317357

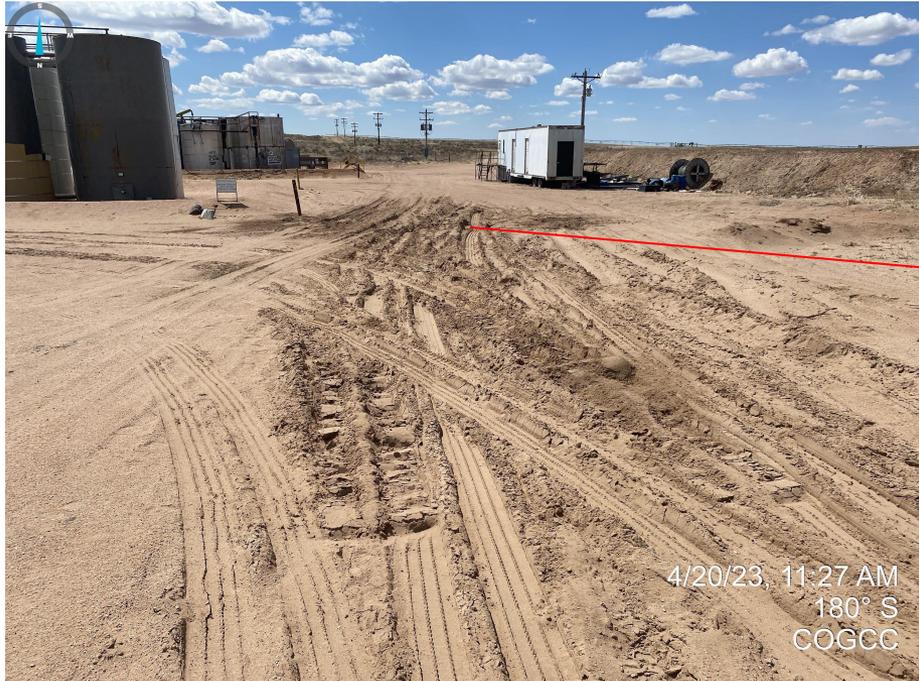
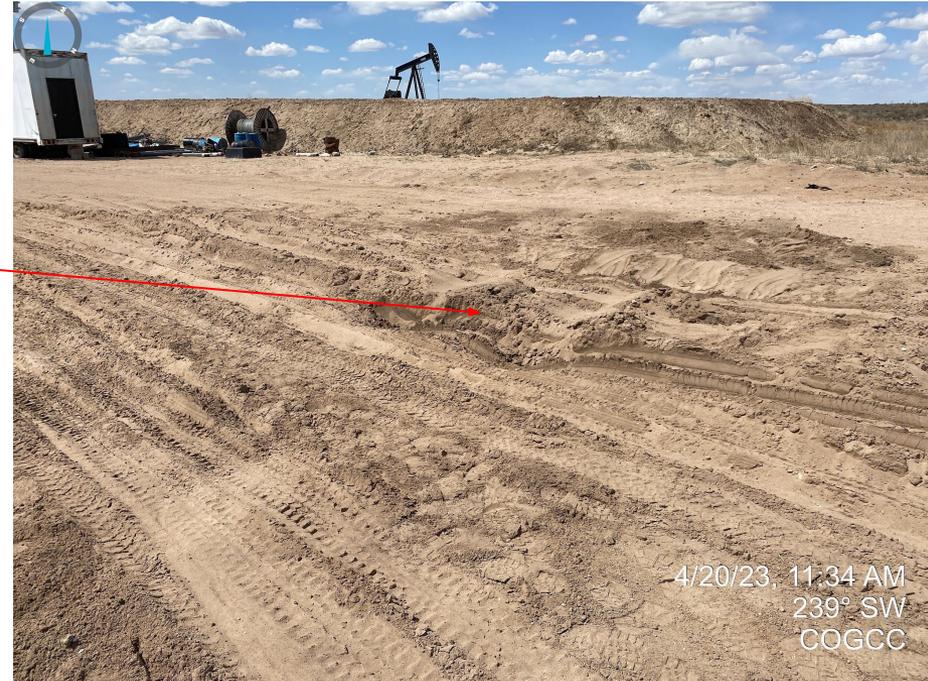
Photo 1. Production areas don't appear to be properly stabilized with evidence of deep rutting.

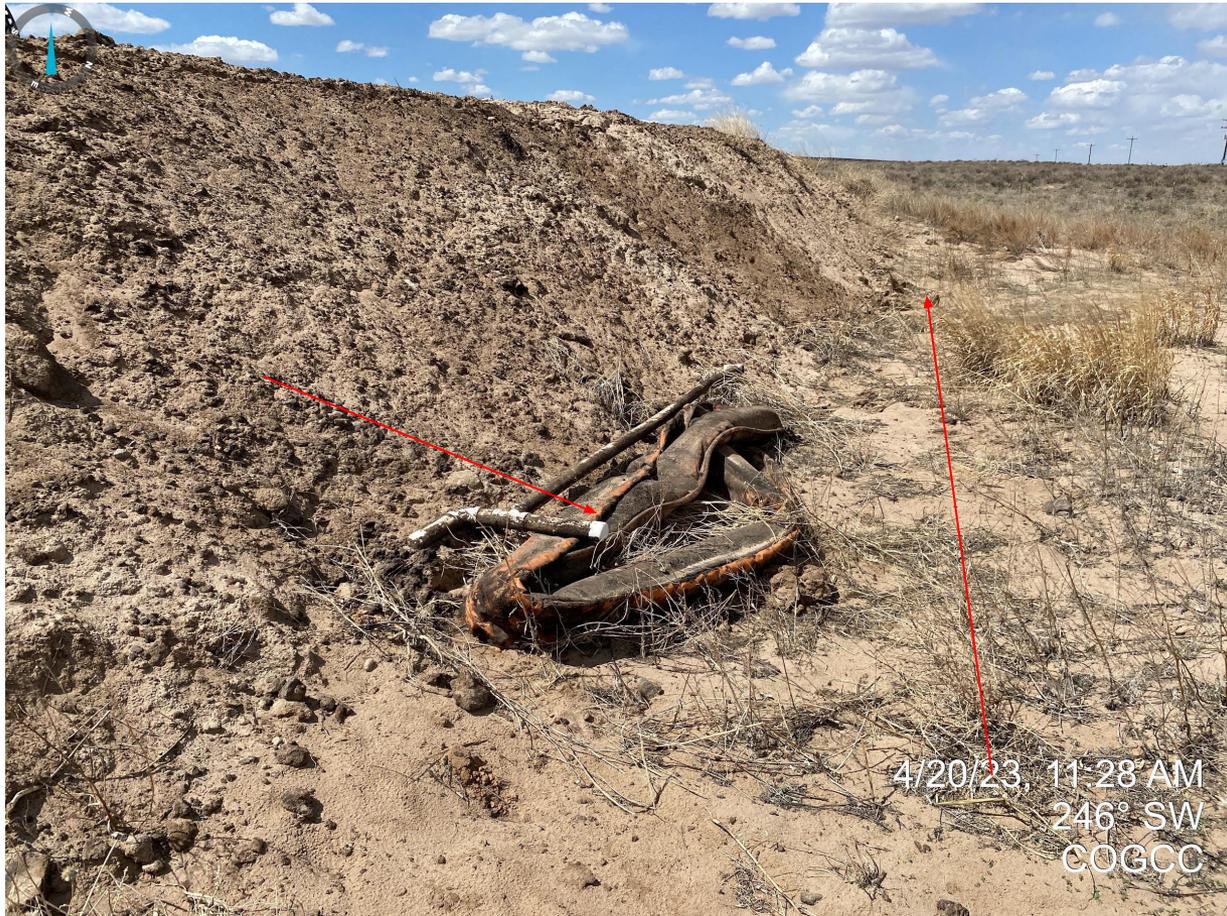
Photo 2. Hydrocarbon soaked filter media observed on the north side of the pit will need to be properly disposed of, including any stained soil. Also pictured, pit walls do not appear to be properly stabilized with evidence of unconsolidated material and sediment deposition at the foot of the wall.

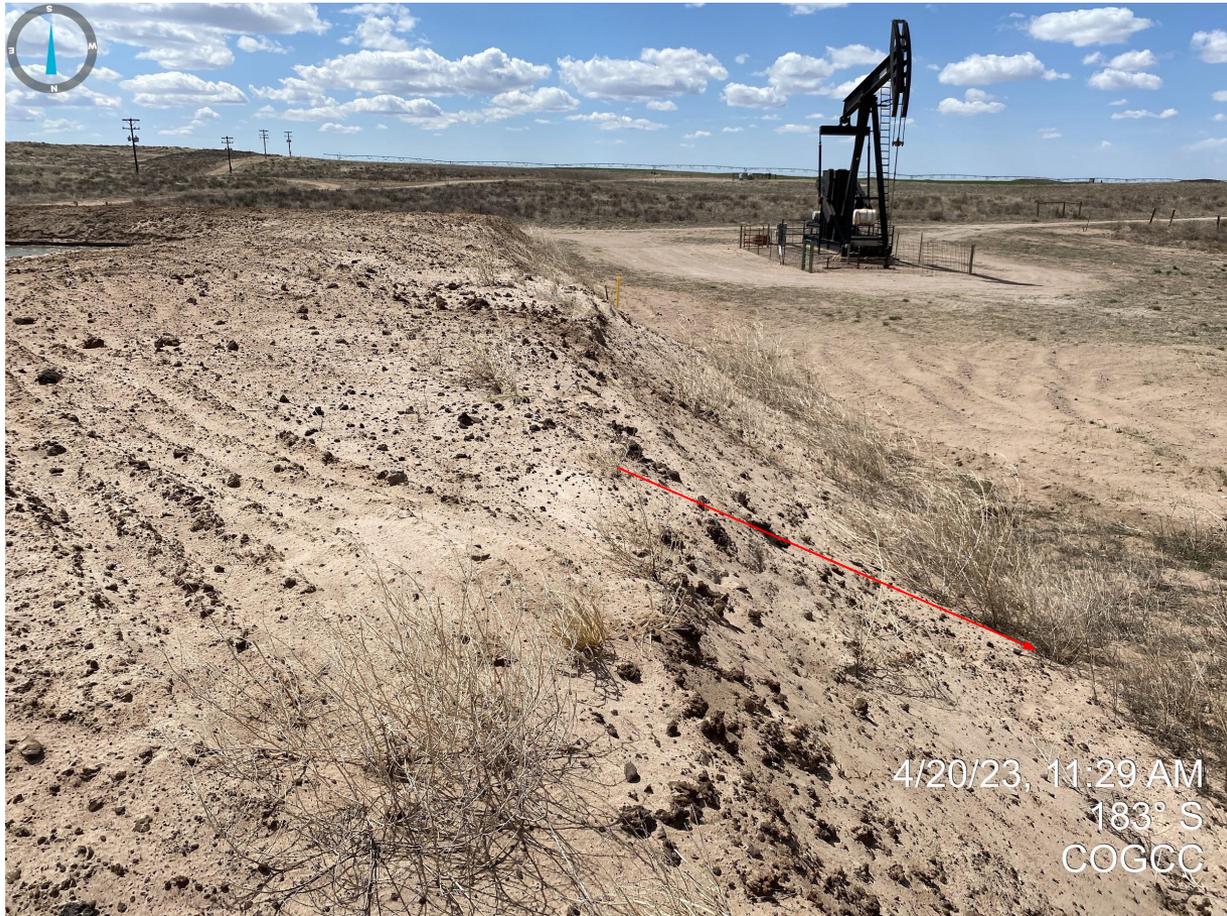
Photo 3. See comments in Photo 2.

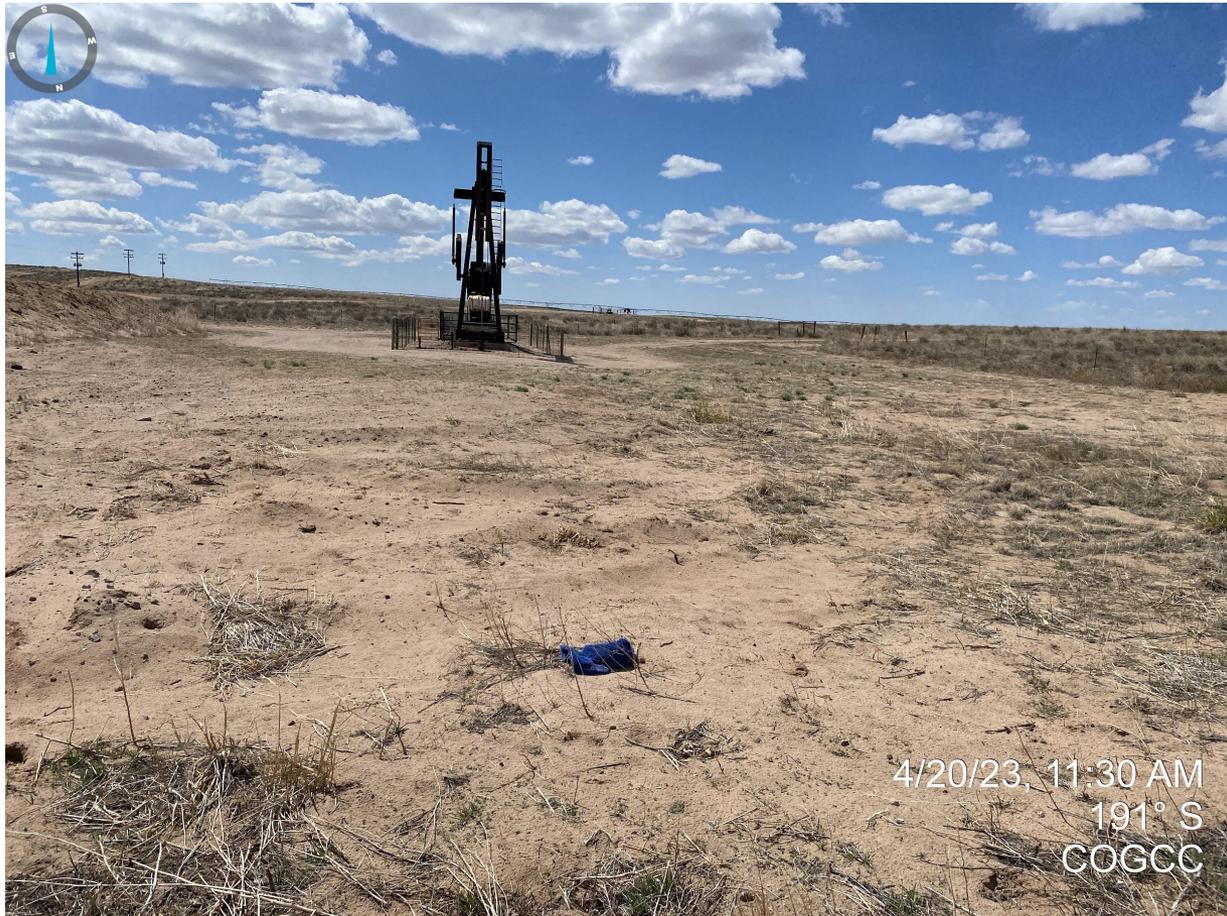
Photo 4. Interim areas around the well do not appear to be progressing towards reclamation standards. Non-uniform vegetation cover resulting in exposed/bare soil was evident in the areas north of the pumpjack. Soil will need to be properly stabilized with vegetation cover reflective of adjacent areas to prevent degradation and meet Rule 1003 standards

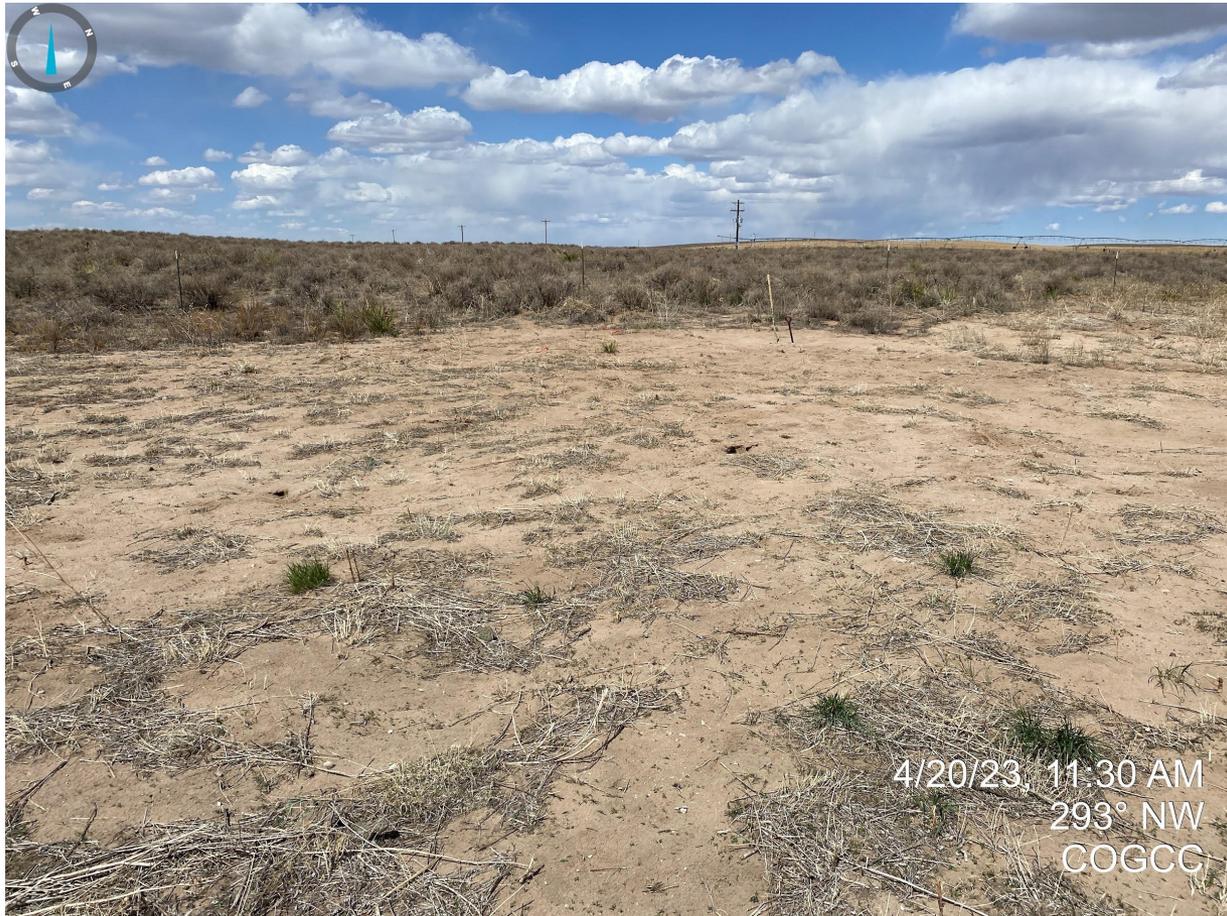
Photo 5. See comments in Photo 4.

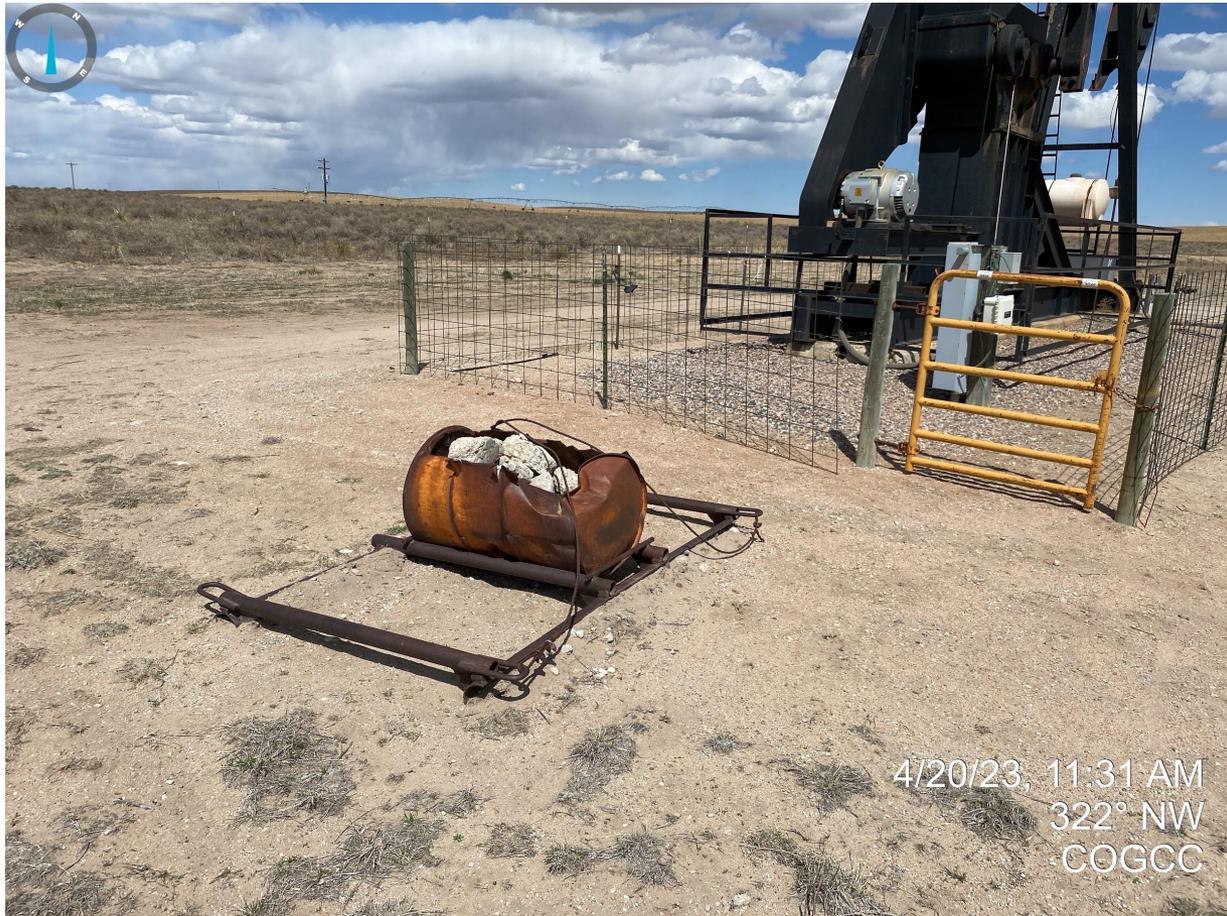
Photo 6. Road drag/maintainer being stored on location will need to be removed. Storage of equipment, supplies, etc is prohibited on location.

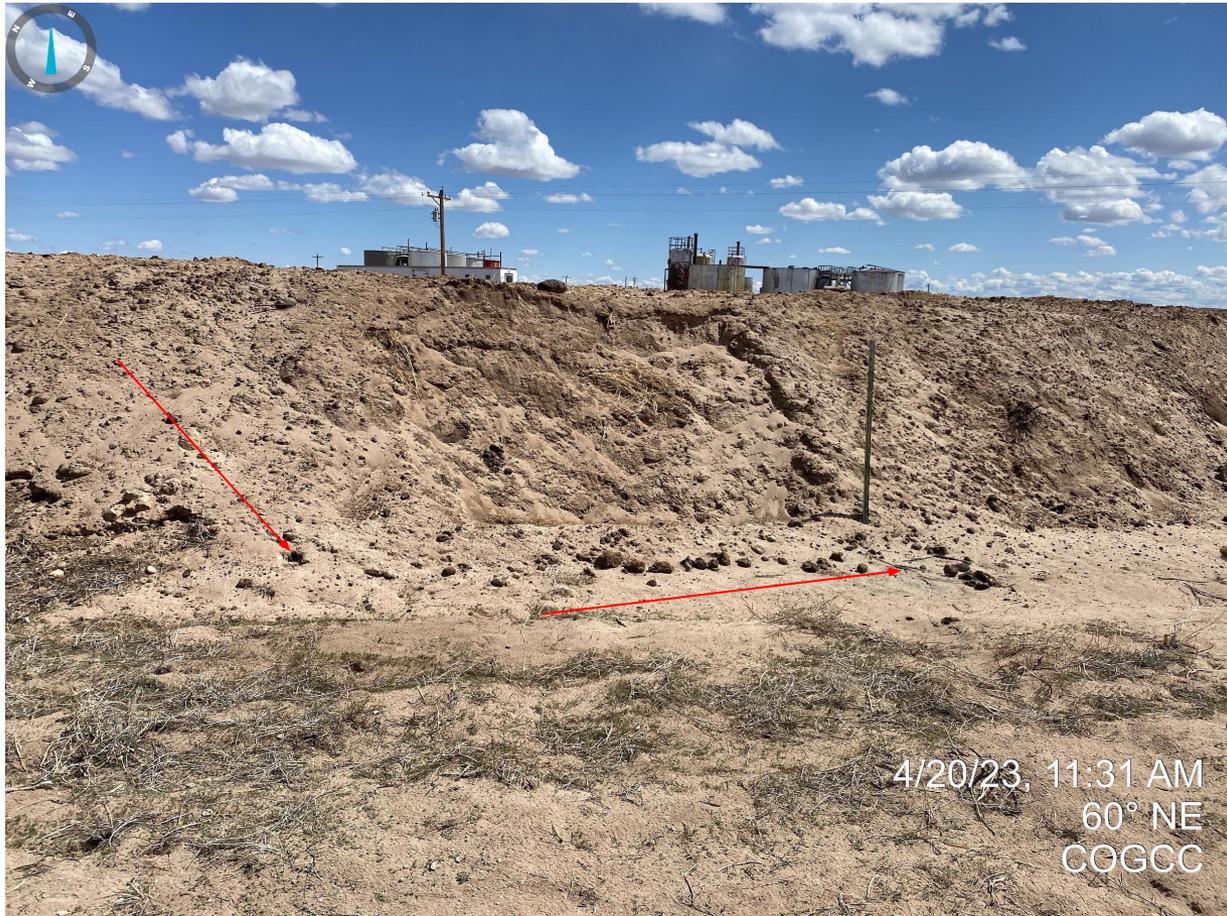
Photo 7. South pit walls do not appear to be properly stabilized with evidence of unconsolidated material and sediment deposition at the base of the wall.

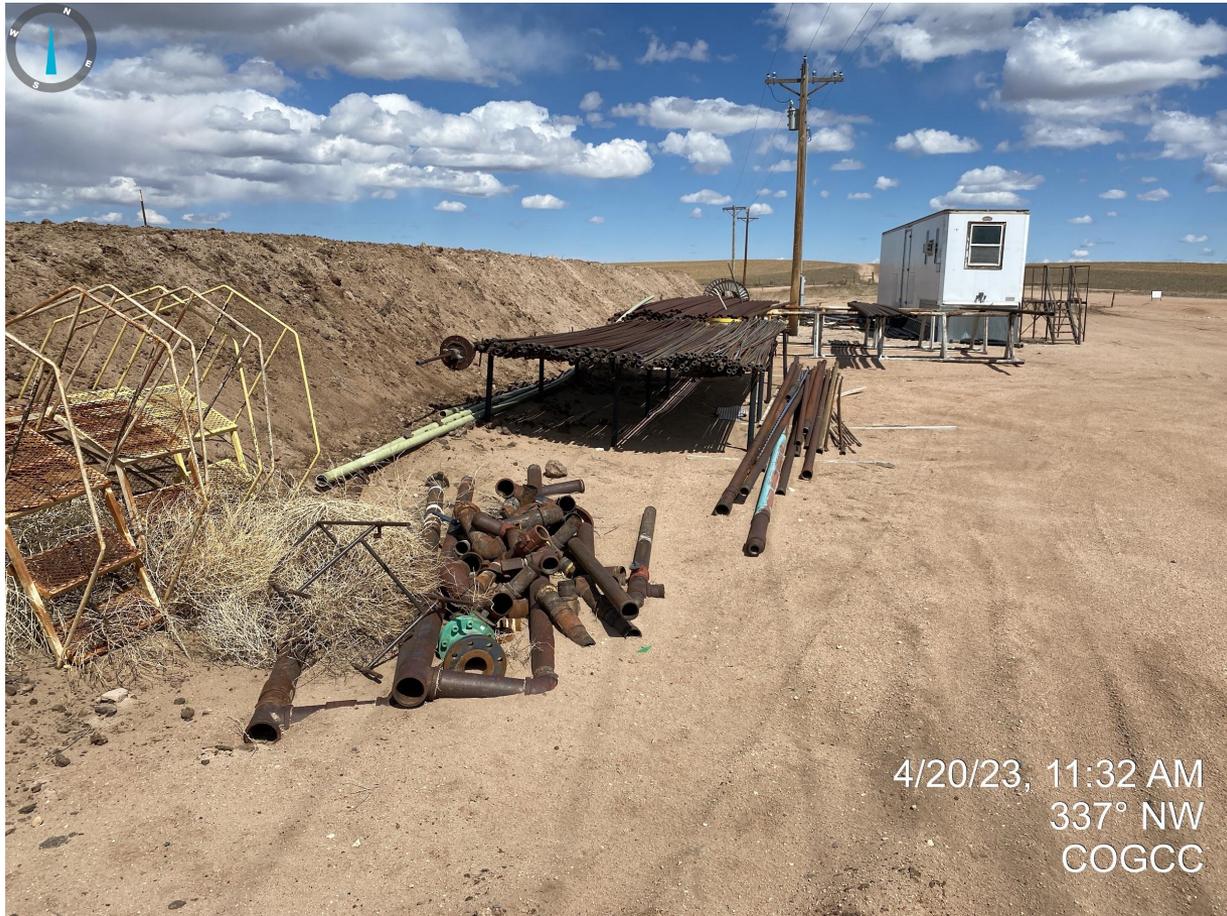
Photo 8. Appears the location is being used as a storage yard. Storage of equipment is prohibited on location.

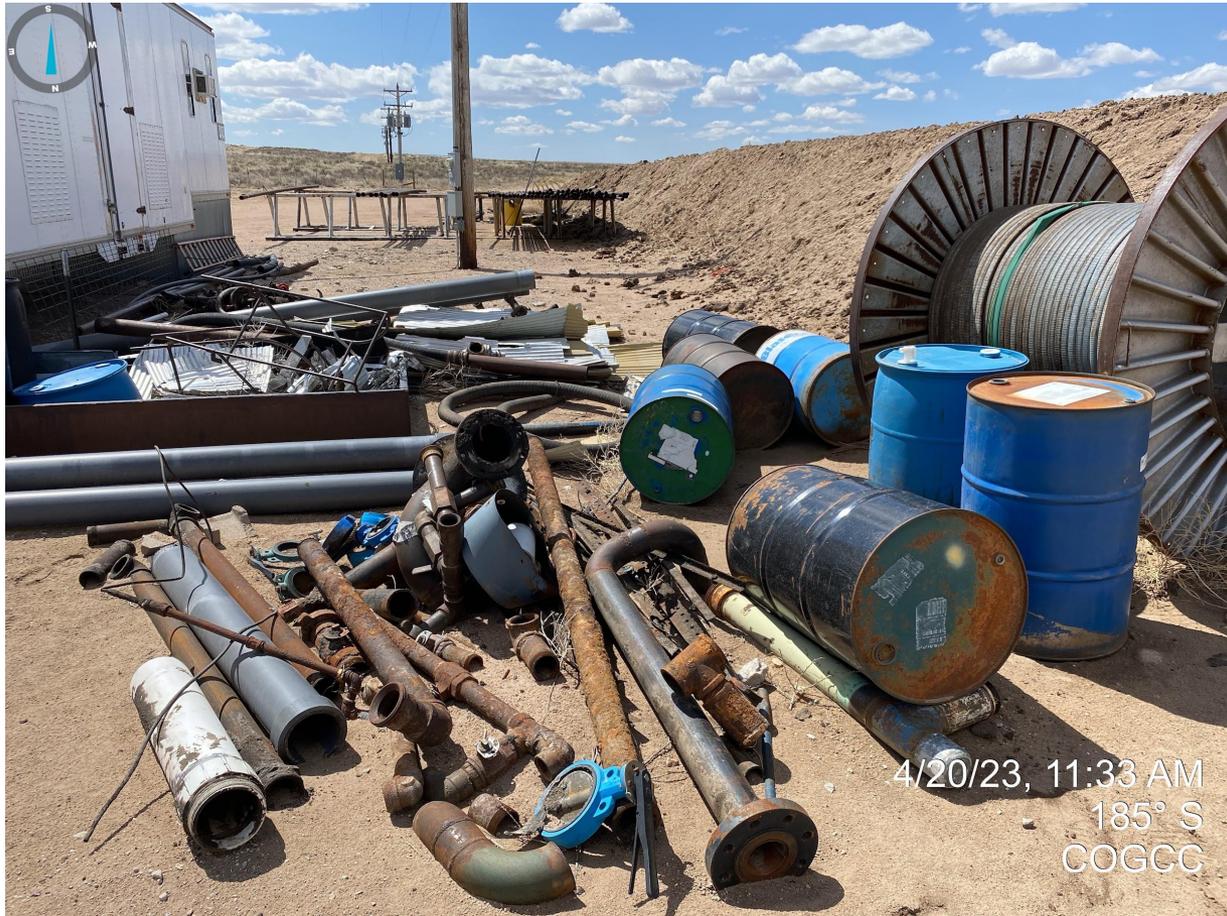
Photo 9. See comments in Photo 8. Barrels appear to be empty but are not upright or within secondary containment.

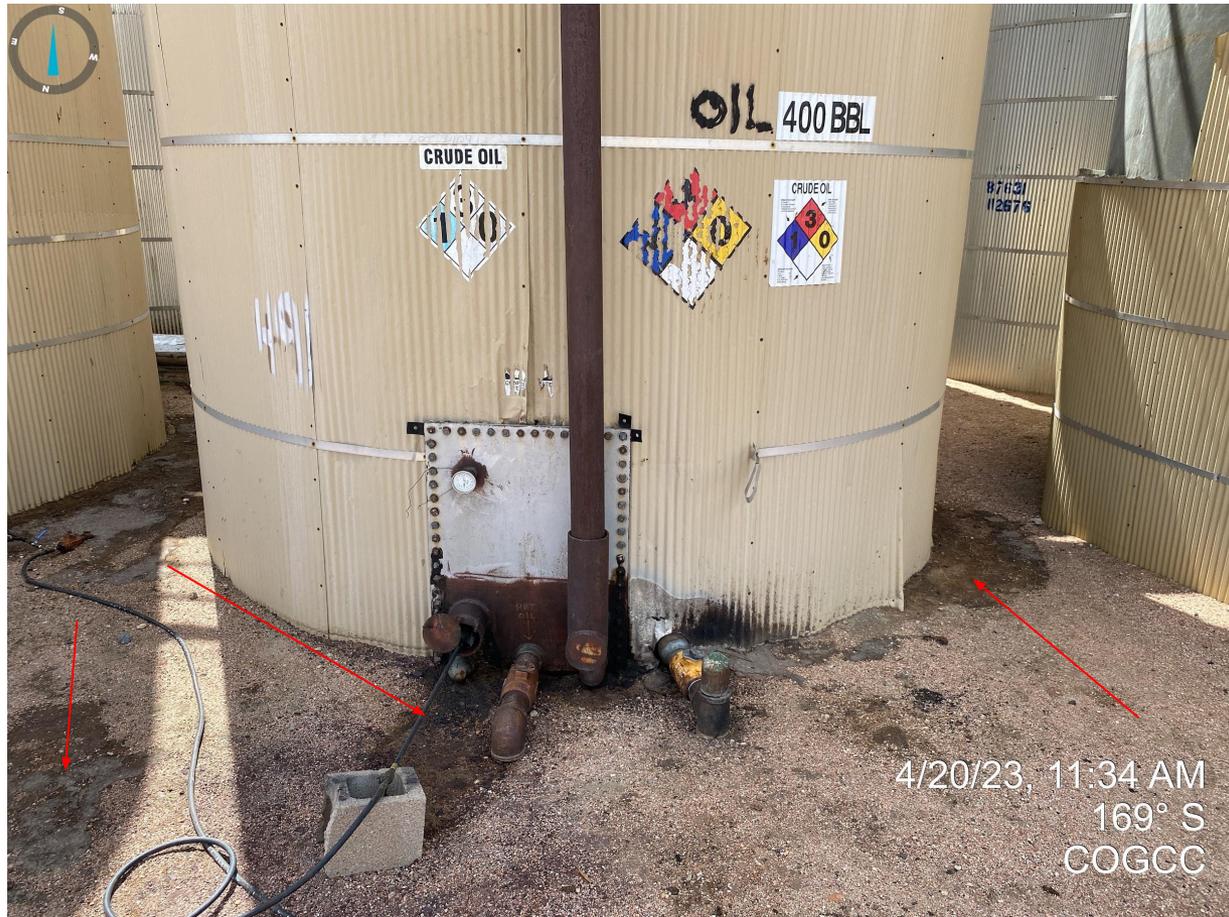
Photo 10. Stained soil observed around equipment. The operator is required to clean up all stained soil (including areas not identified in inspection photos) per Rule 912.b. Additionally, Operator shall perform maintenance on equipment, fittings, connections, etc to ensure good mechanical condition per Rule 608.e.

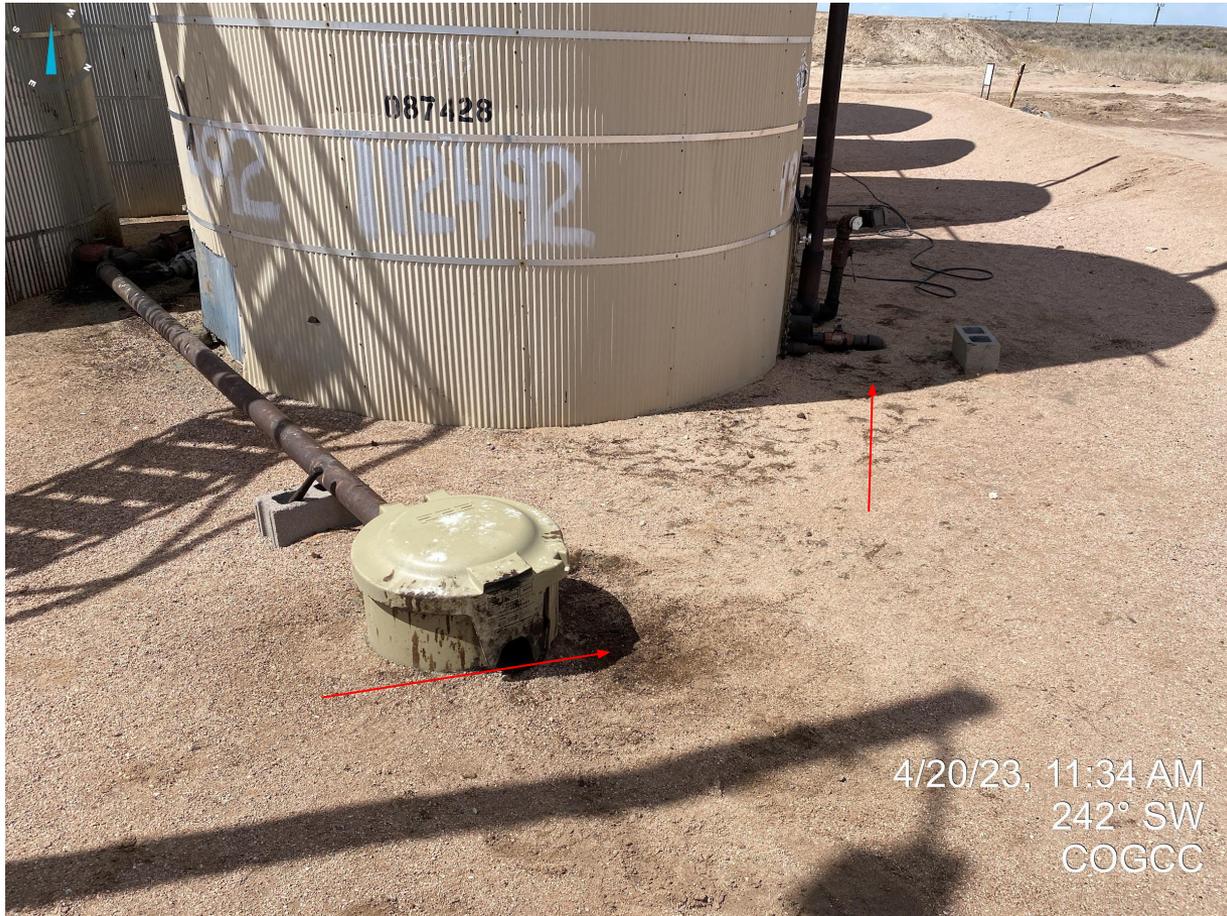
Photo 11. See comments in Photo 10.

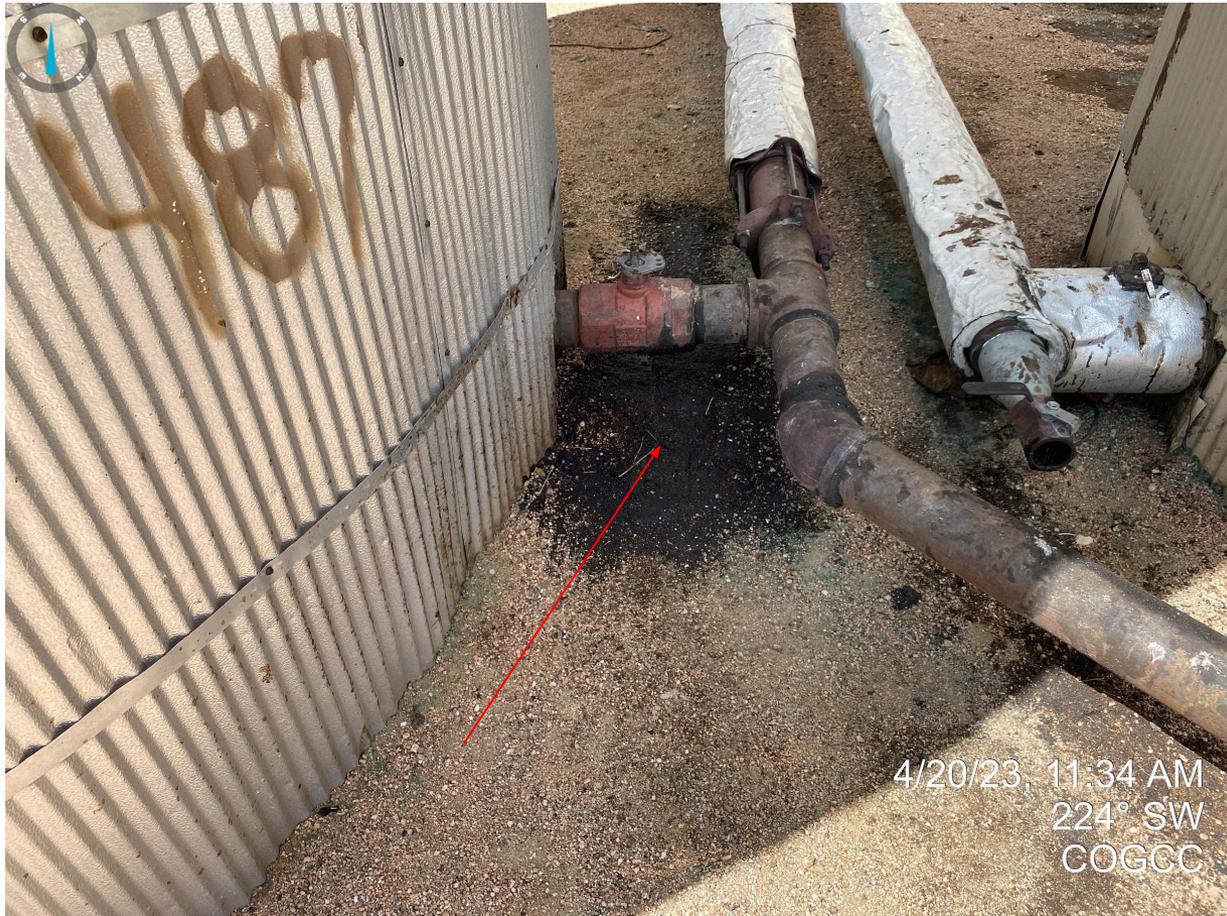
Photo 12. See comments in Photo 10.

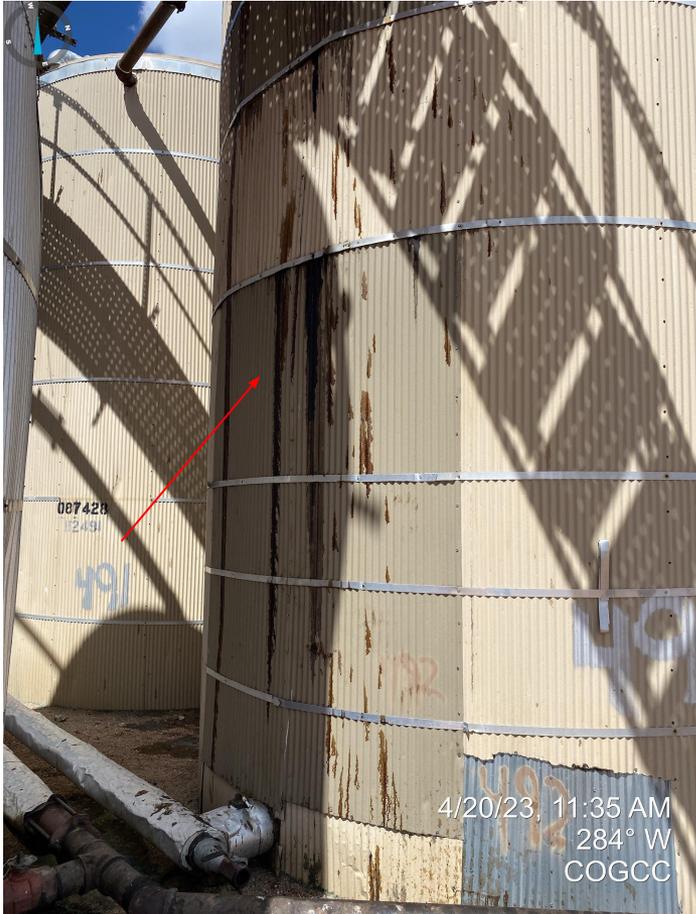
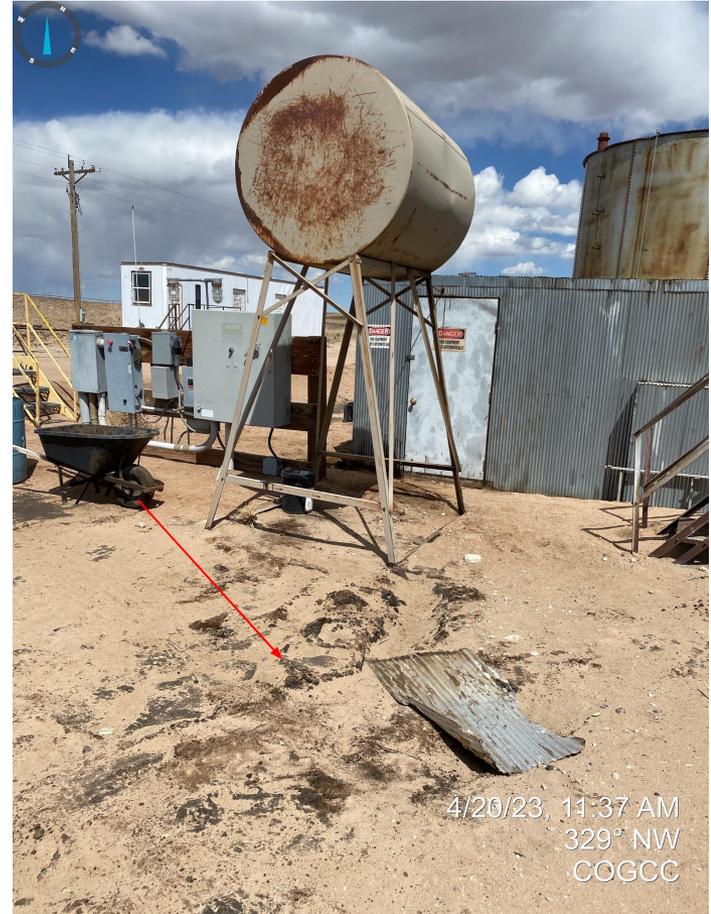
Photo 13. See comments in Photo 10

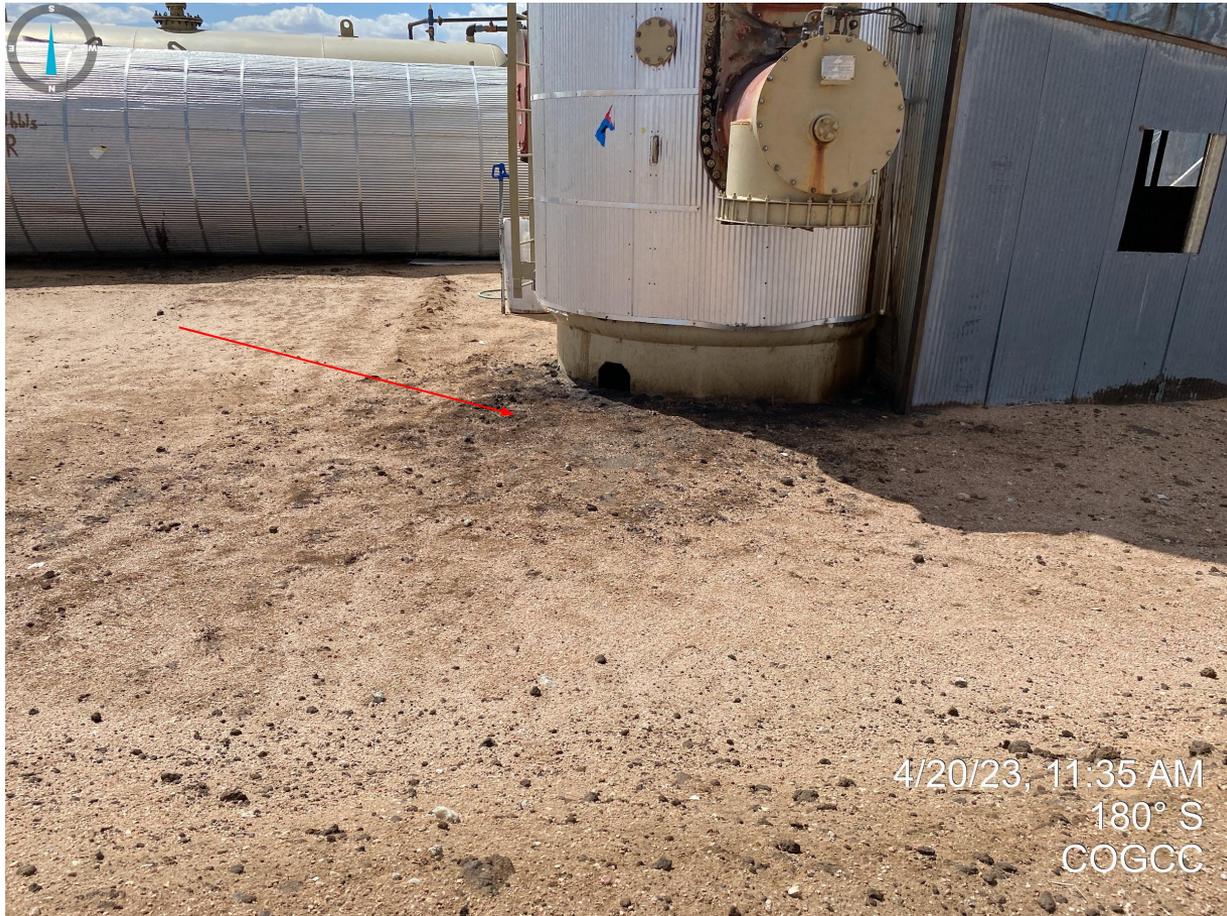
Photo 14. See comments in Photo 10.

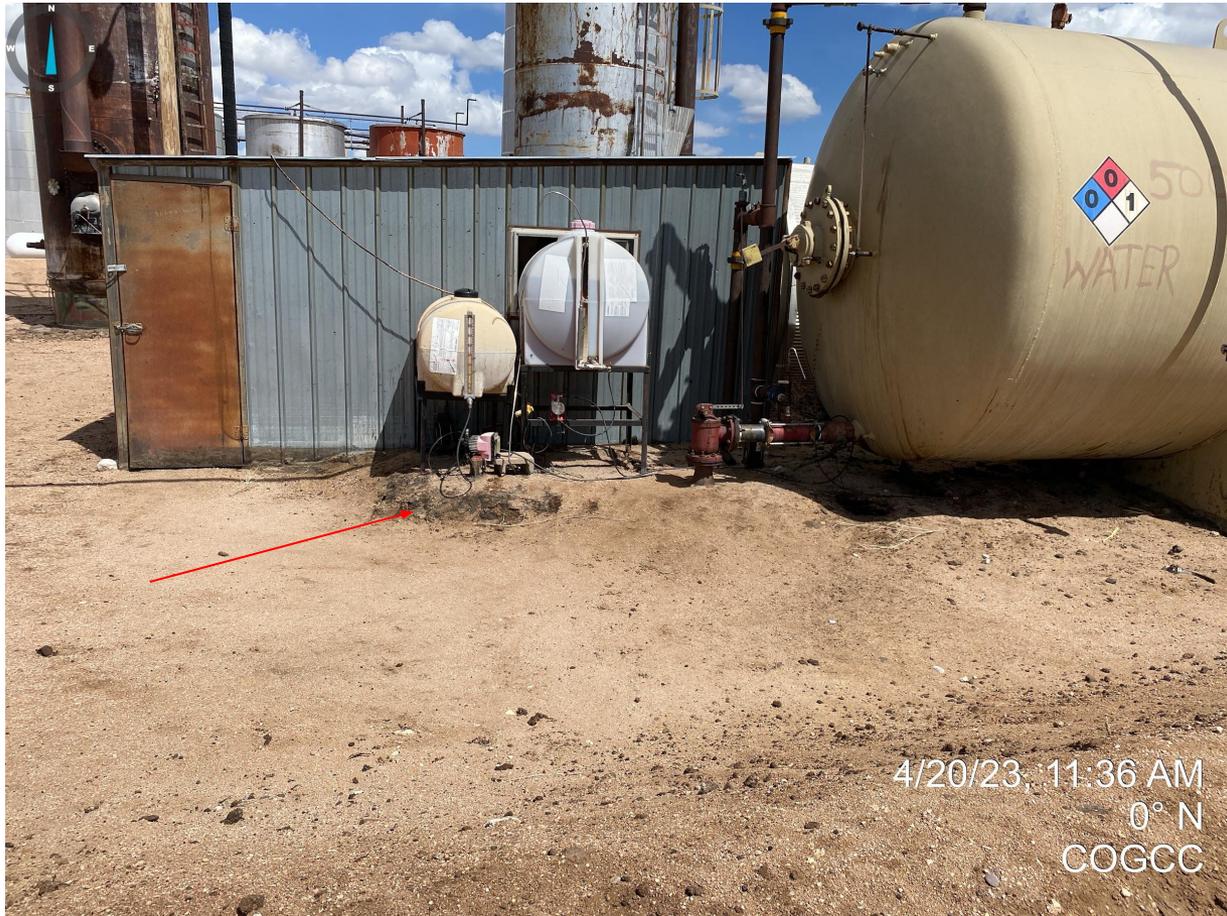
Photo 15. See comments in Photo 10.

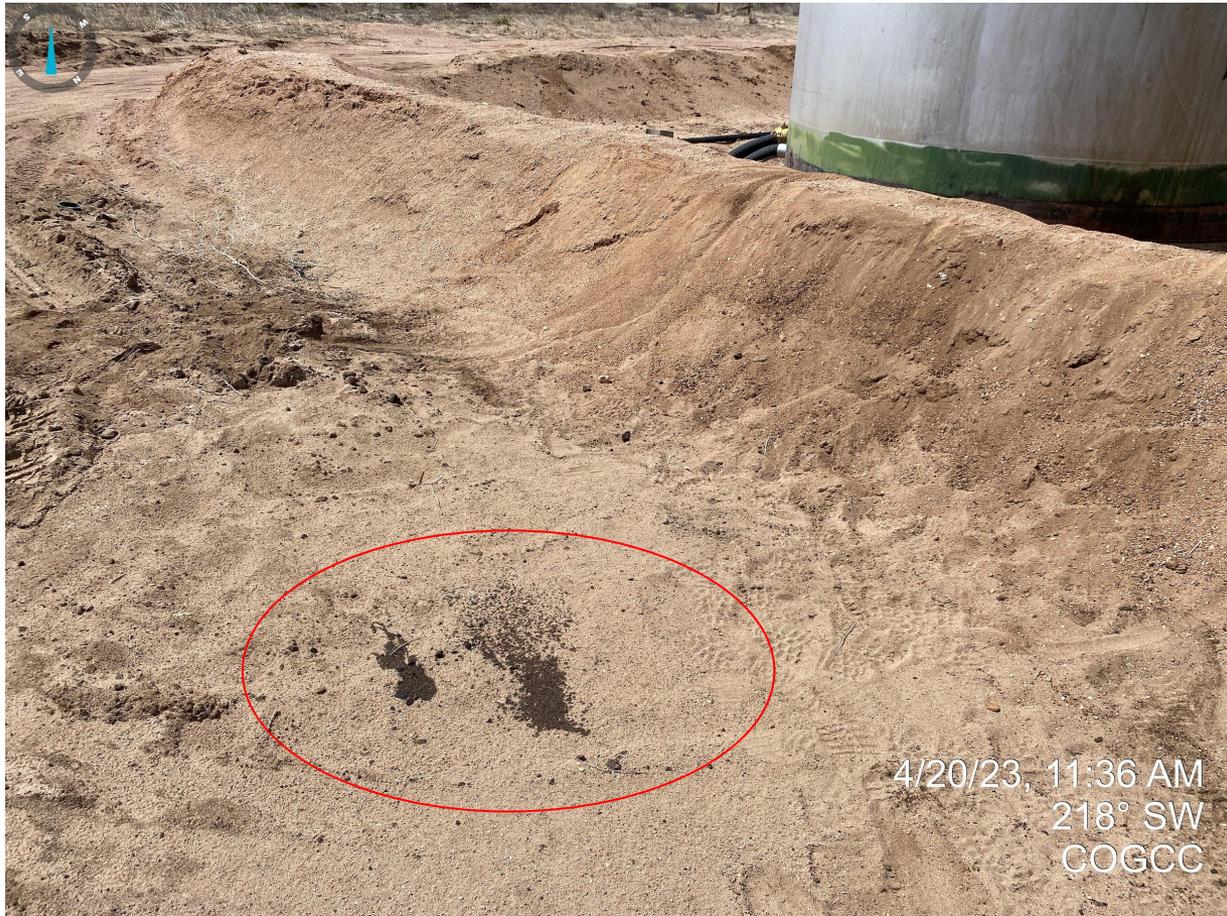
Photo 16. See comments in Photo 10.

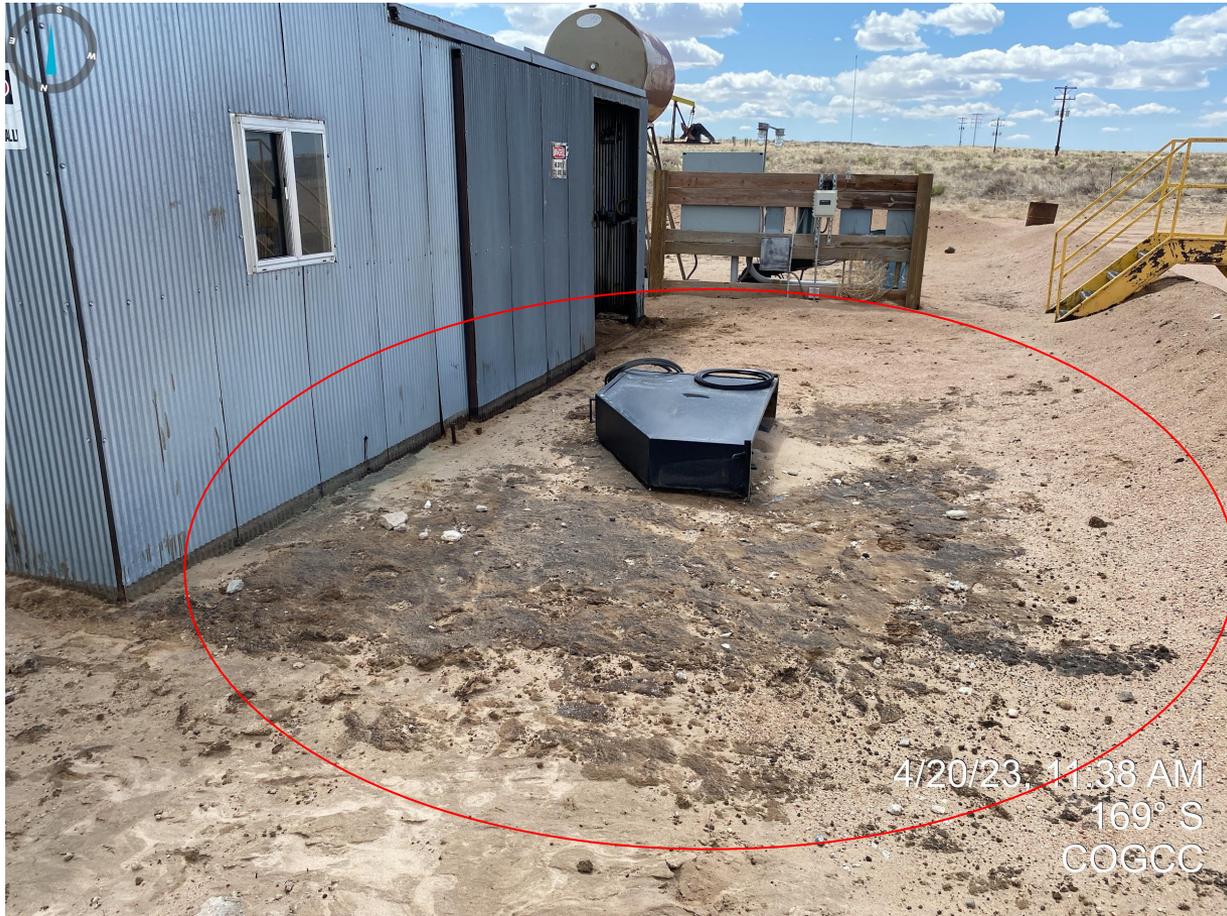
Photo 17. See comments in Photo 10.

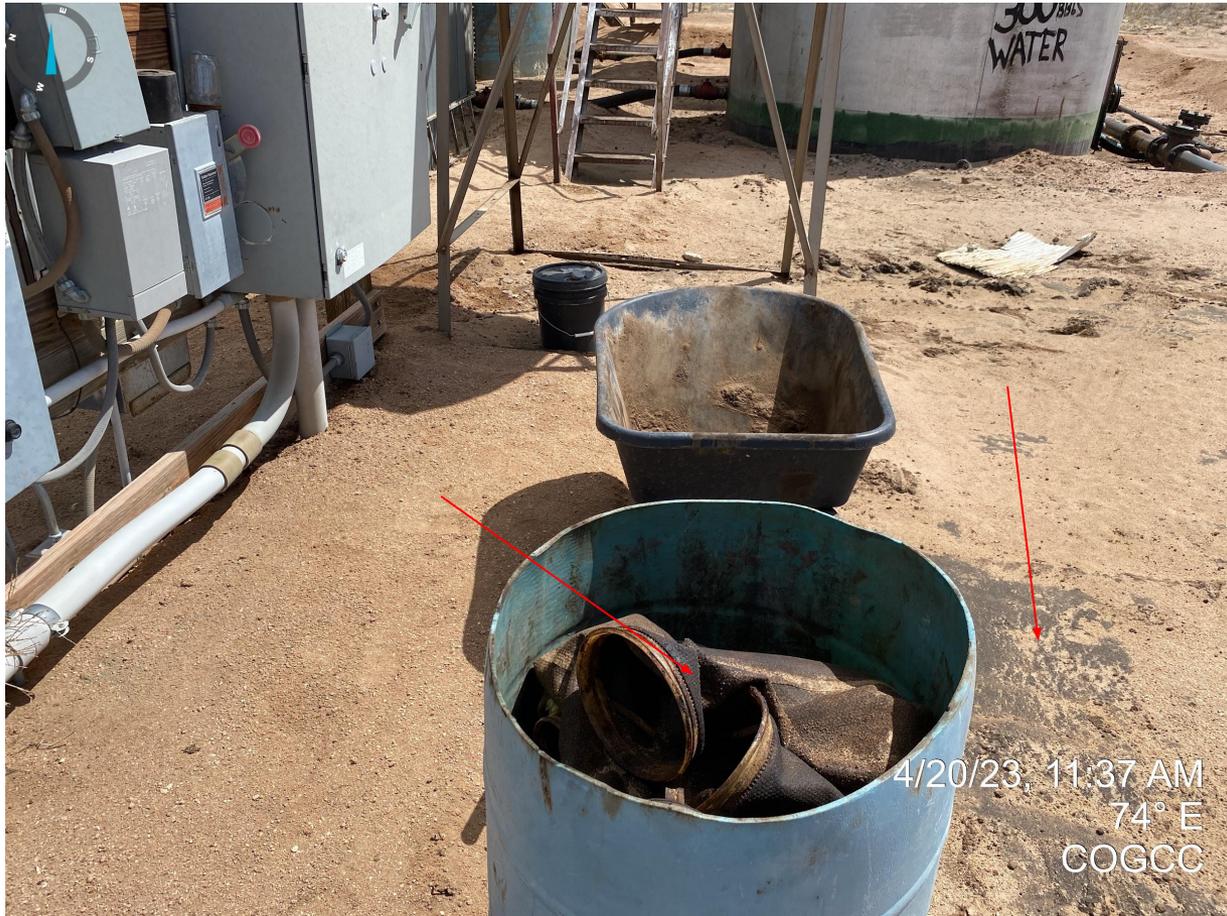
Photo 18. See comments in Photo 10.

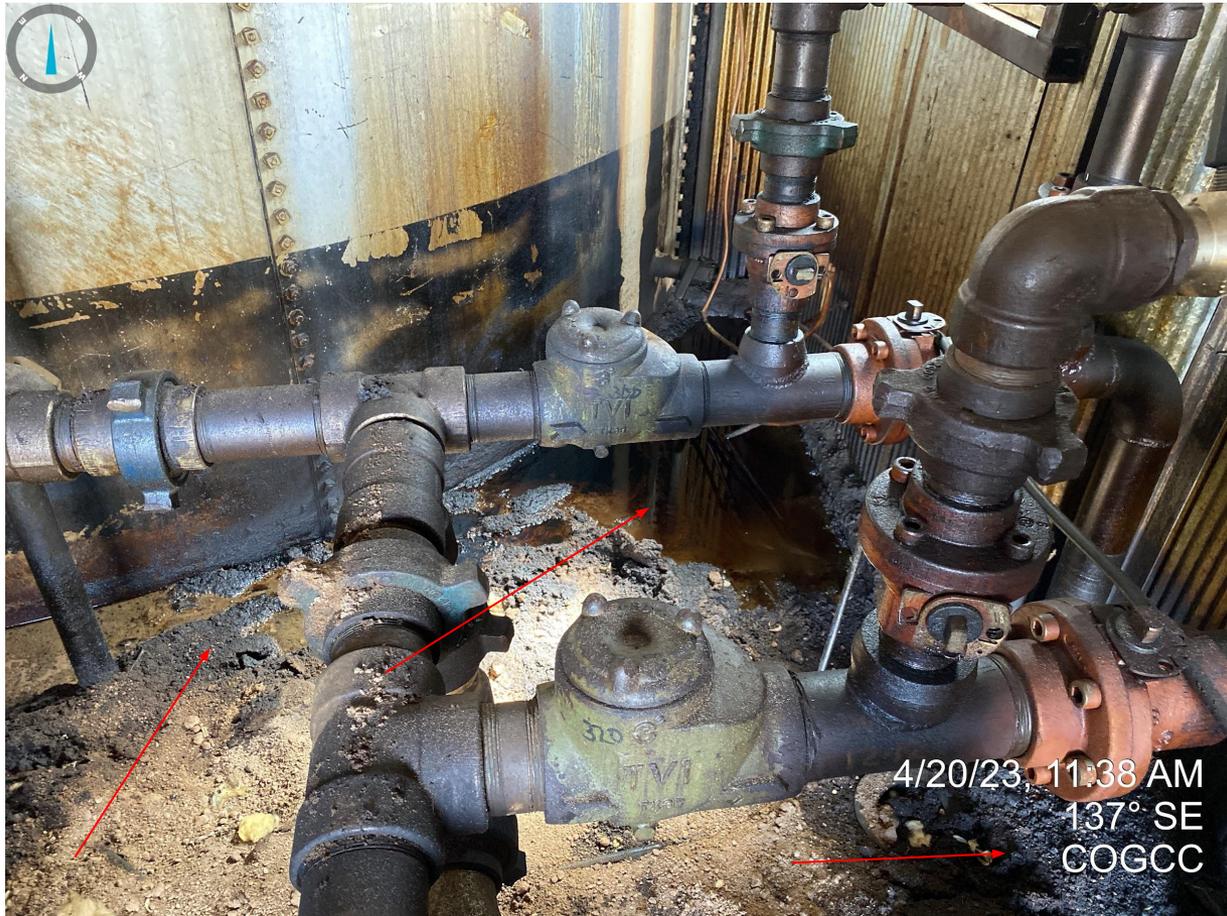
Photo 19. See comments in Photo 10.

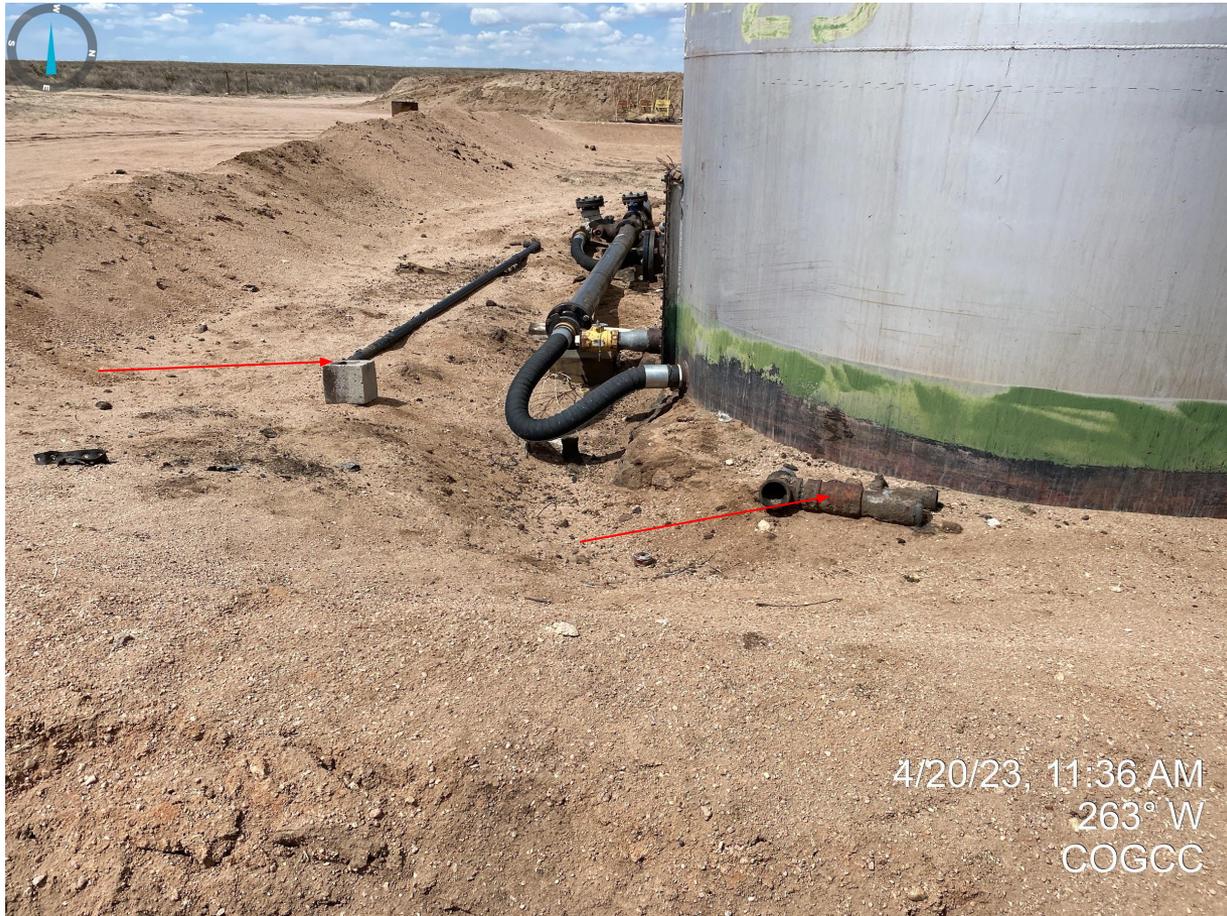
Photo 20. Unused equipment will need to be removed from the location.
