Interim Reclamation and Stormwater Inspection

Date: 04/20/2023

Operator: IMPETRO RESOURCES LLC -10690

Location ID: 317357

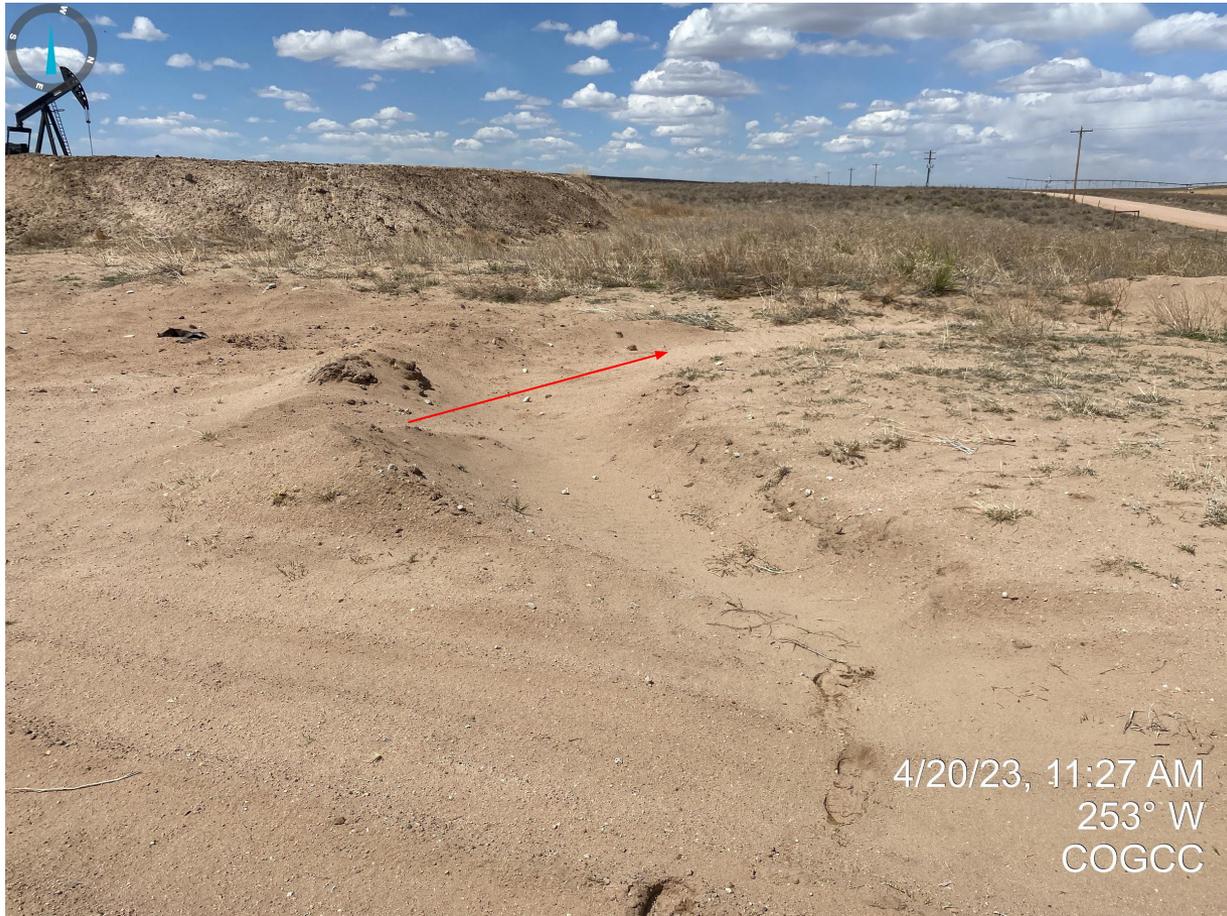
Photo 21. Stormwater ditch/diversion was constructed near the northwest portion of the location's entrance leading to off-site sediment transport into adjacent bar ditch. It does not appear that a properly engineered sediment basin was constructed in this area as it is a natural low point on the location. More robust stormwater BMPs must be implemented to manage stormwater run on and run off to prevent further degradation to adjacent land.

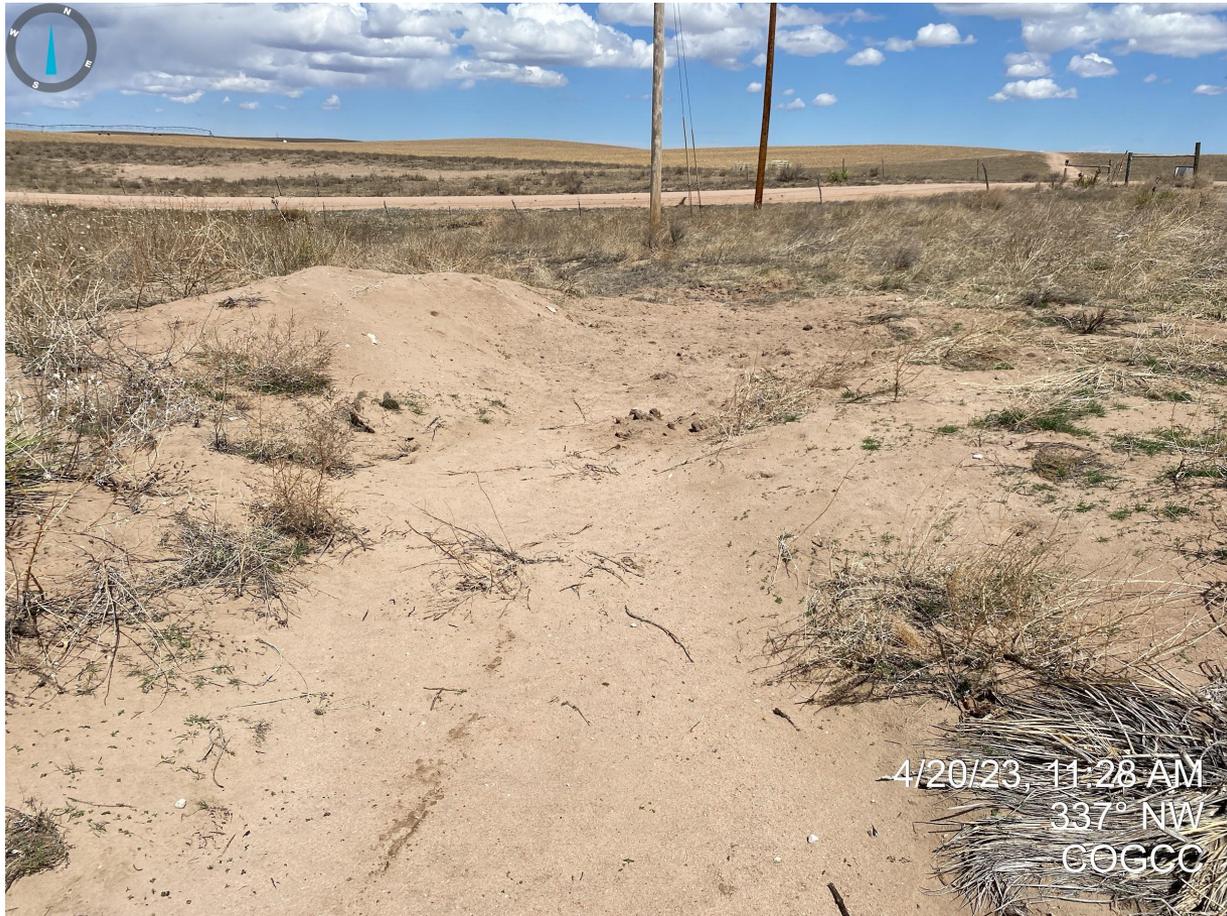
Photo 22. See comments in Photo 21.

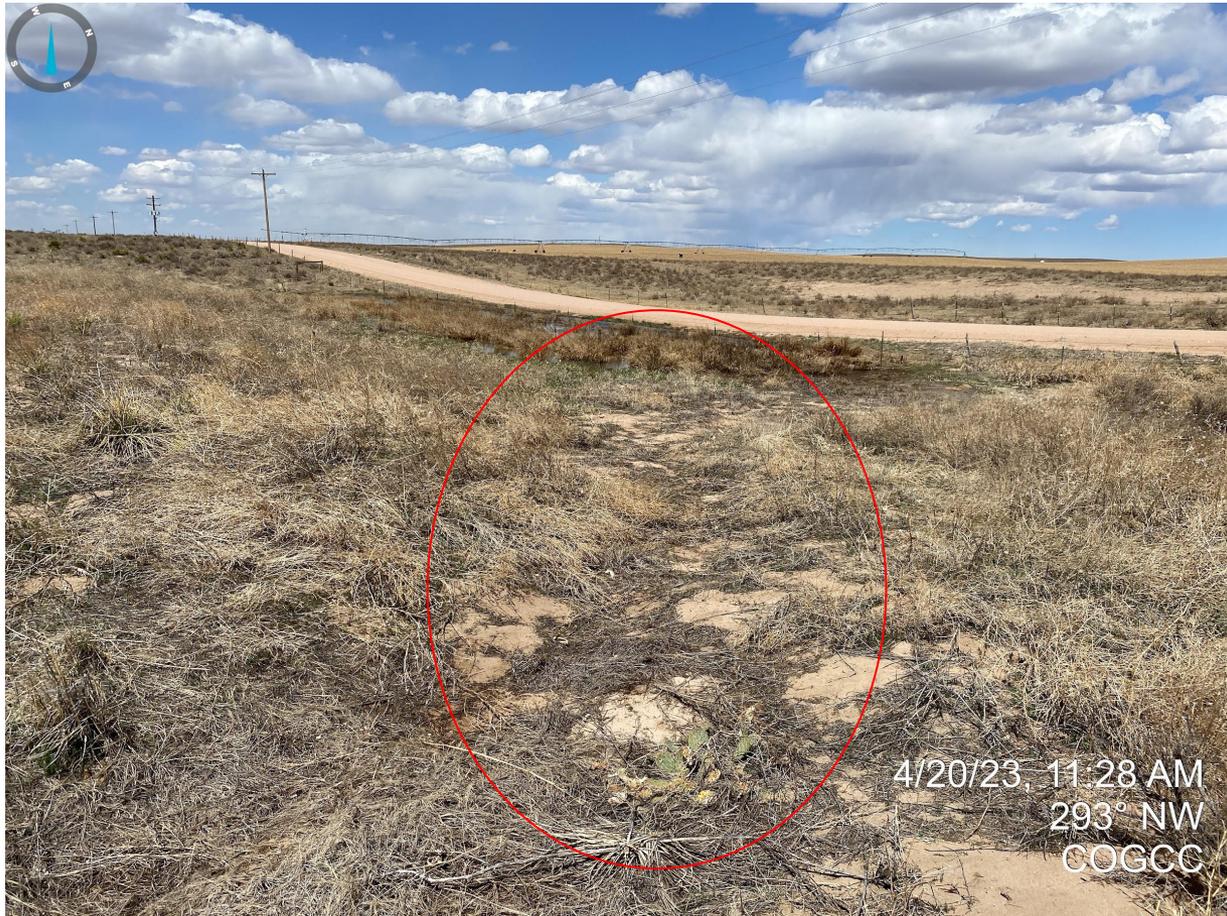
Photo 23. Photo illustrates sediment deposition into adjacent lands. See comments in Photo 21.

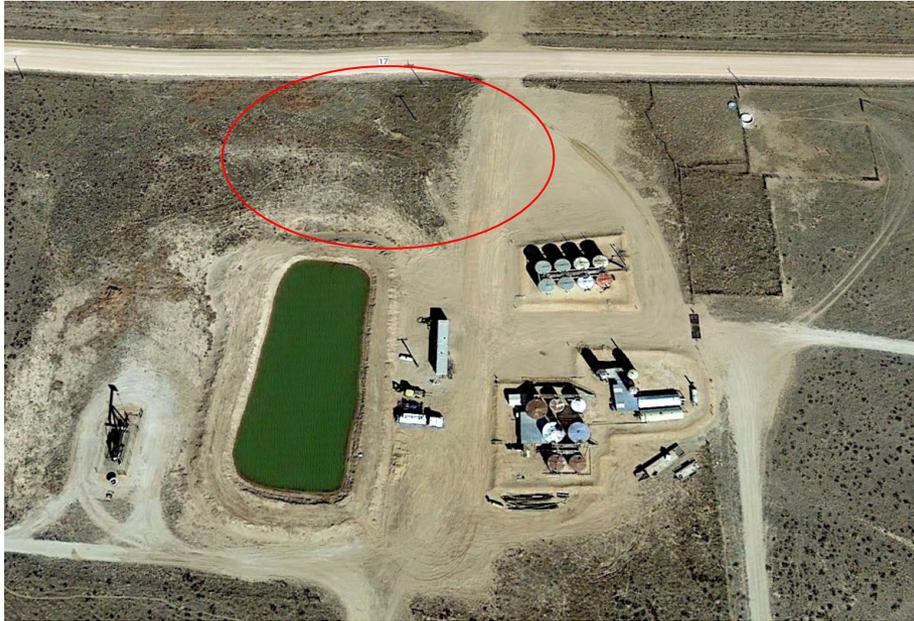
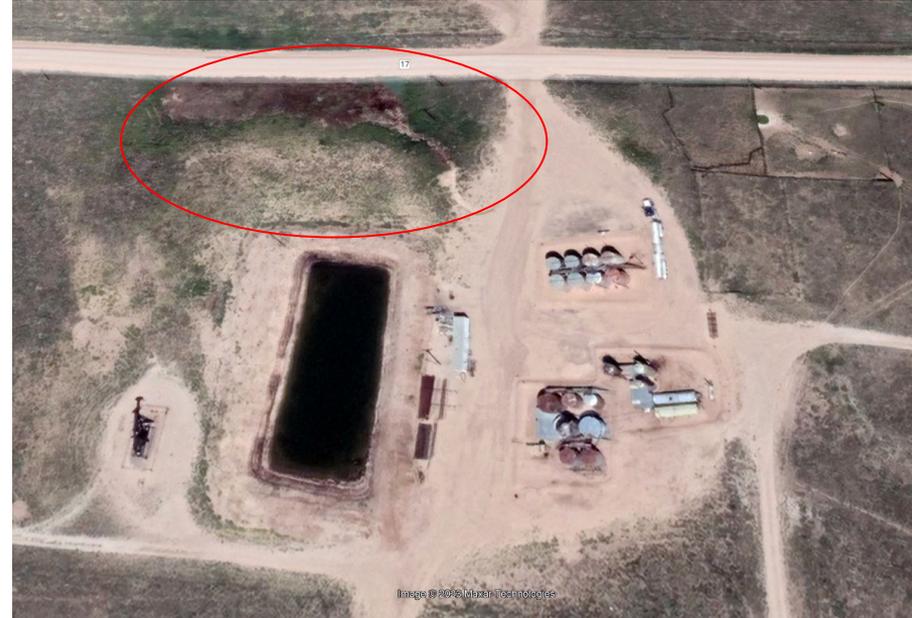
Photo 24 & 25. Google Earth aerial imagery illustrating progression of gully erosion occurring off of the production area. Left image is from 2016 and right is from 2022. More robust stormwater BMPs will need to be implemented to comply with Rule 1002.f.
