# Final Reclamation and Stormwater Inspection

Date: 04/20/2023

Operator: ST CROIX OPERATING INC - 81490

Location ID: 317374

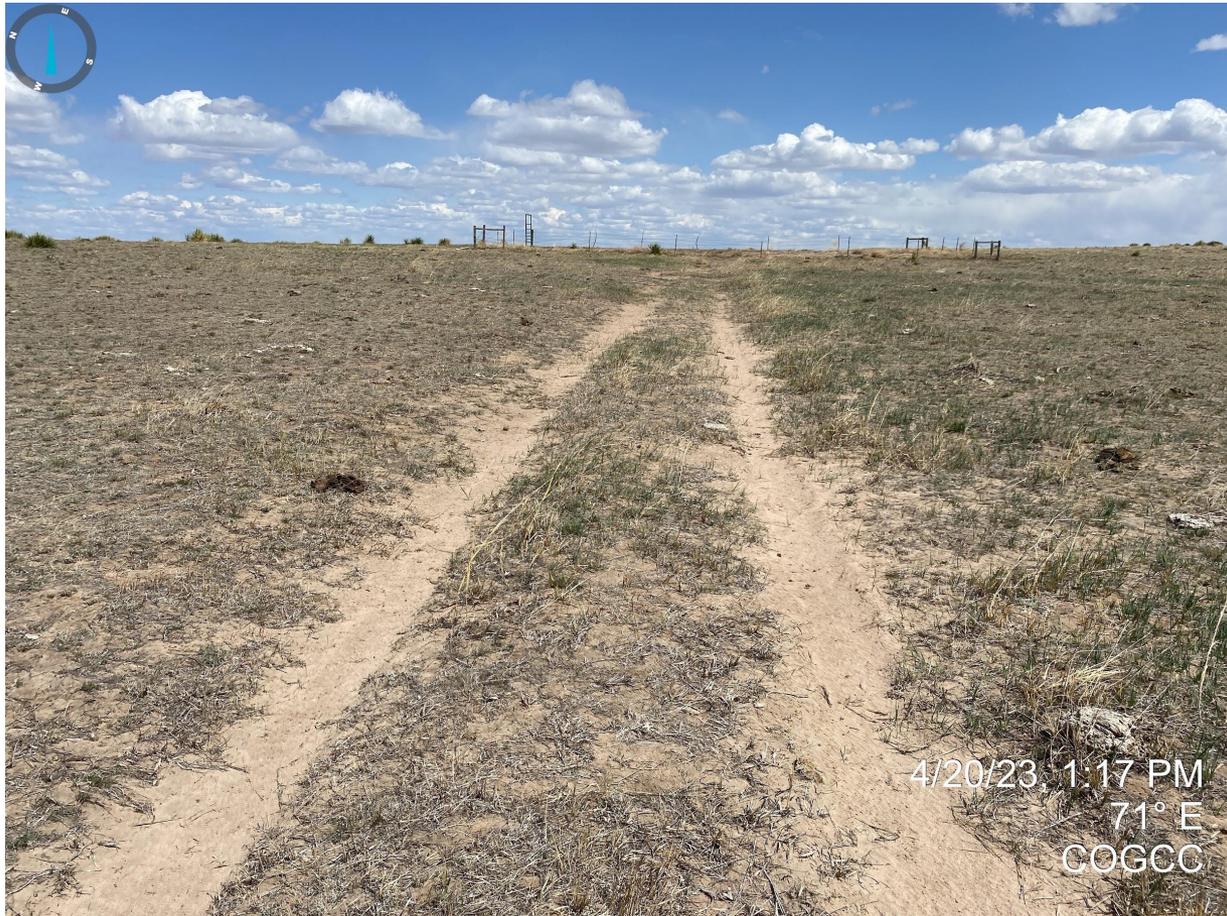
**Photo 1.** It does not appear the access/lease road has been reclaimed or contoured to reflect pre-disturbance conditions with rutting evident.

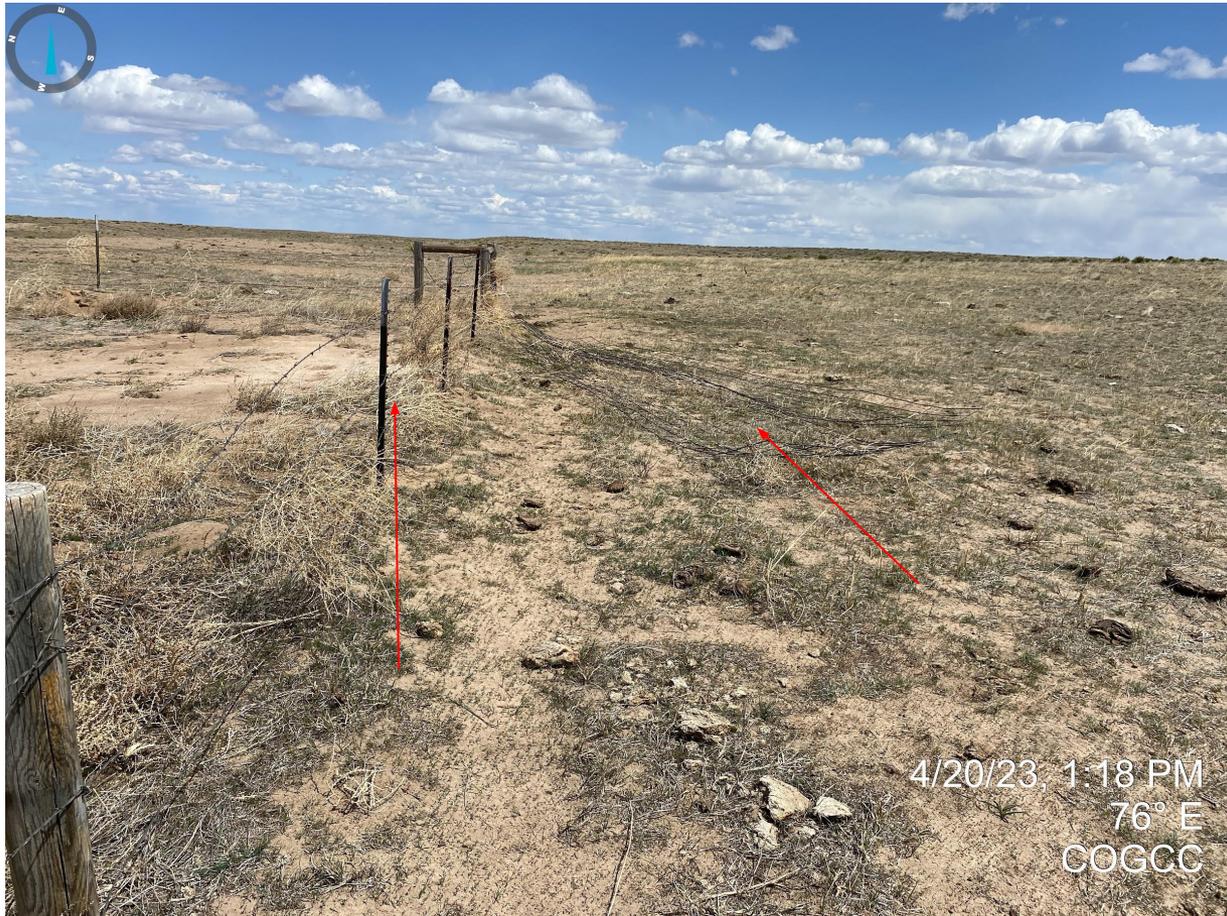
**Photo 2.** Debris and equipment remain on location and will need to be removed to meet Rule 1004 standards for final reclamation. Refer to inspection report for additional information.

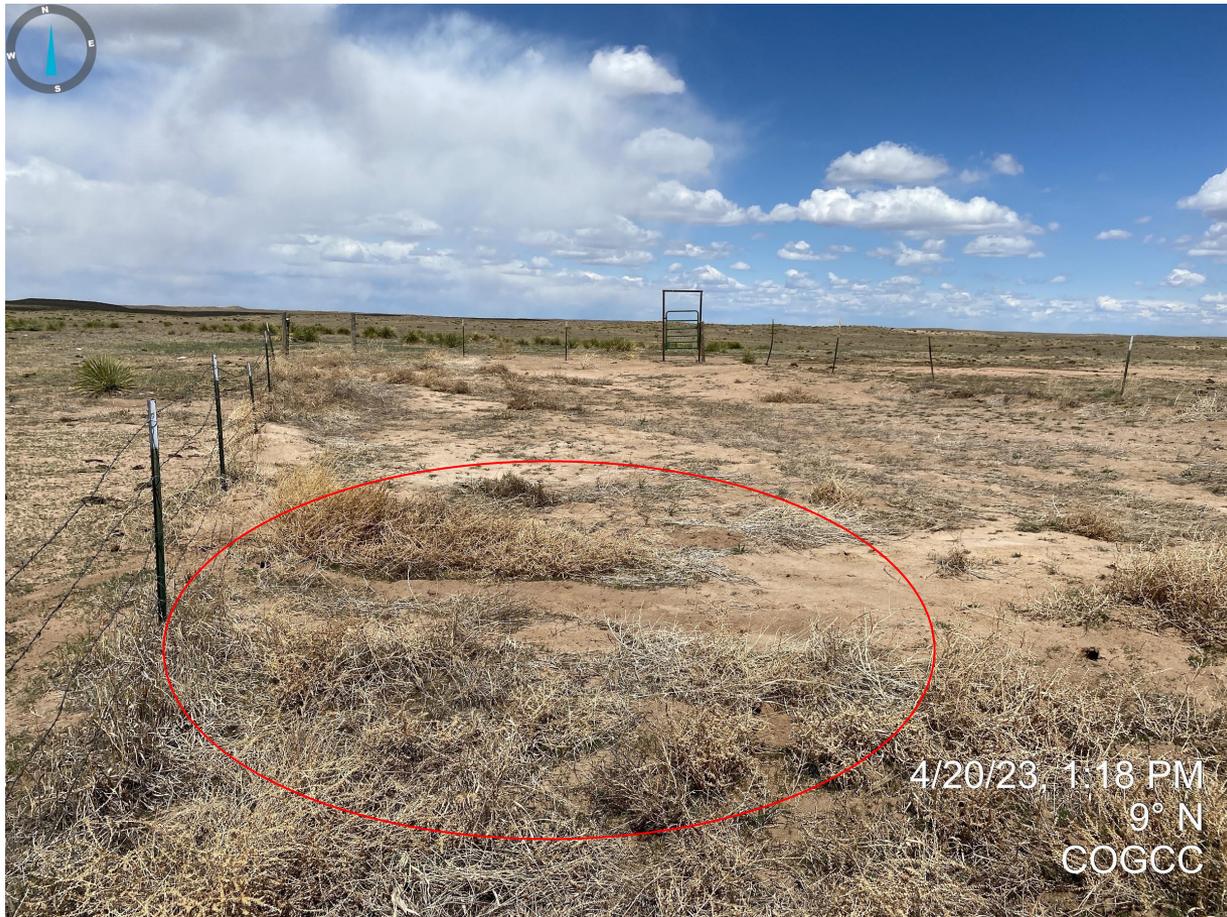
**Photo 3.** Russian thistle and kochia debris observed within the fenced off portion of the location. Red circle is only an example as undesirable plant species were observed throughout the location. Perimeter fencing around the former skim pit is considered debris and needs to be removed.

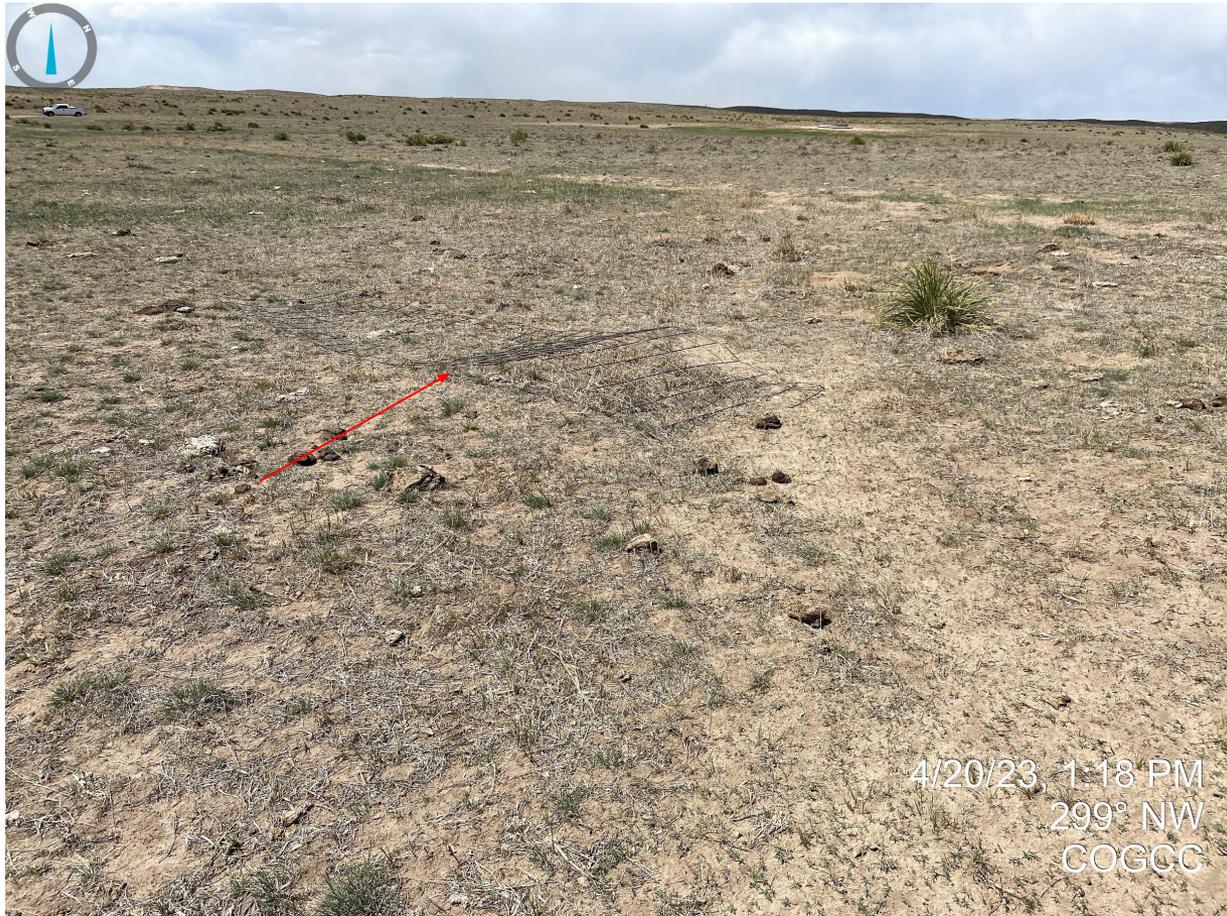
**Photo 4.** Cattle panel observed near the location; this is now considered debris and will need to be removed.

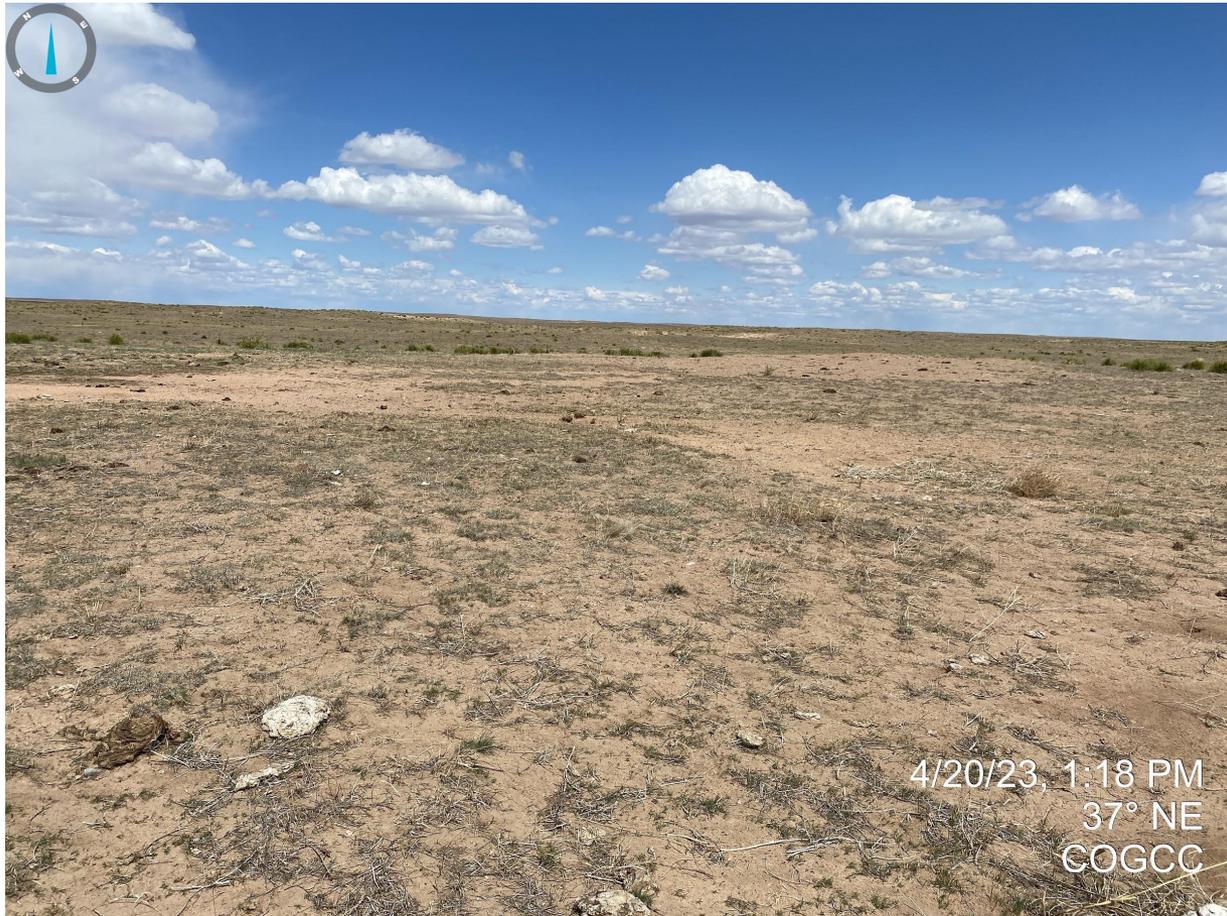
**Photo 5.** Final reclamation area does not appear to be progressing towards reclamation standards with evidence of non-uniform vegetation cover resulting in areas of exposed/bare soil. Additional reclamation activities will need to be performed to meet Rule 1004 standards.

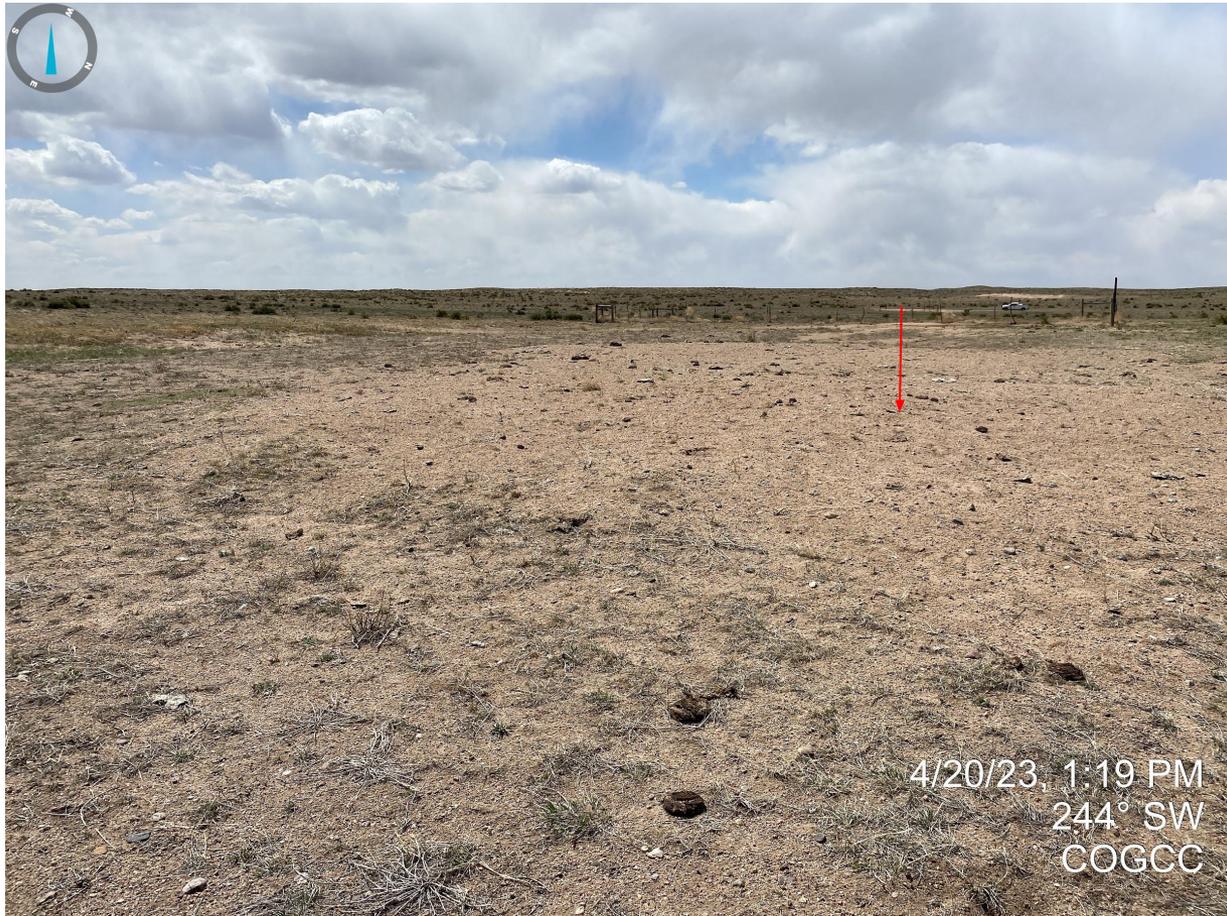
**Photo 6.** Red arrow illustrates approximate well location. See comments in Photo 5.

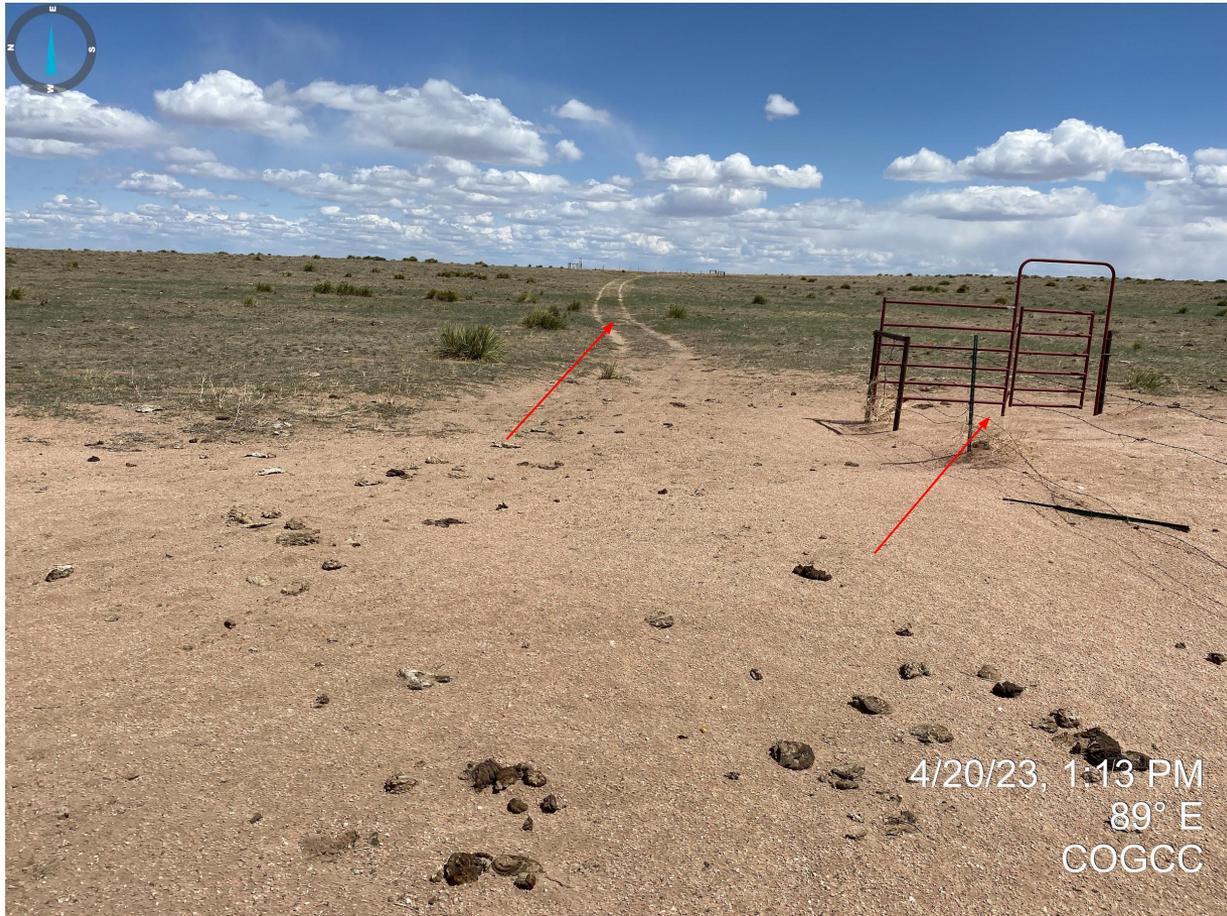
**Photo 7.** Facing east from the lease road entrance. Photo illustrates that the access road does not appear to have been reclaimed and is not progressing towards final reclamation standards. Also pictured, equipment (e.g. fencing) remains around the former tank battery location.

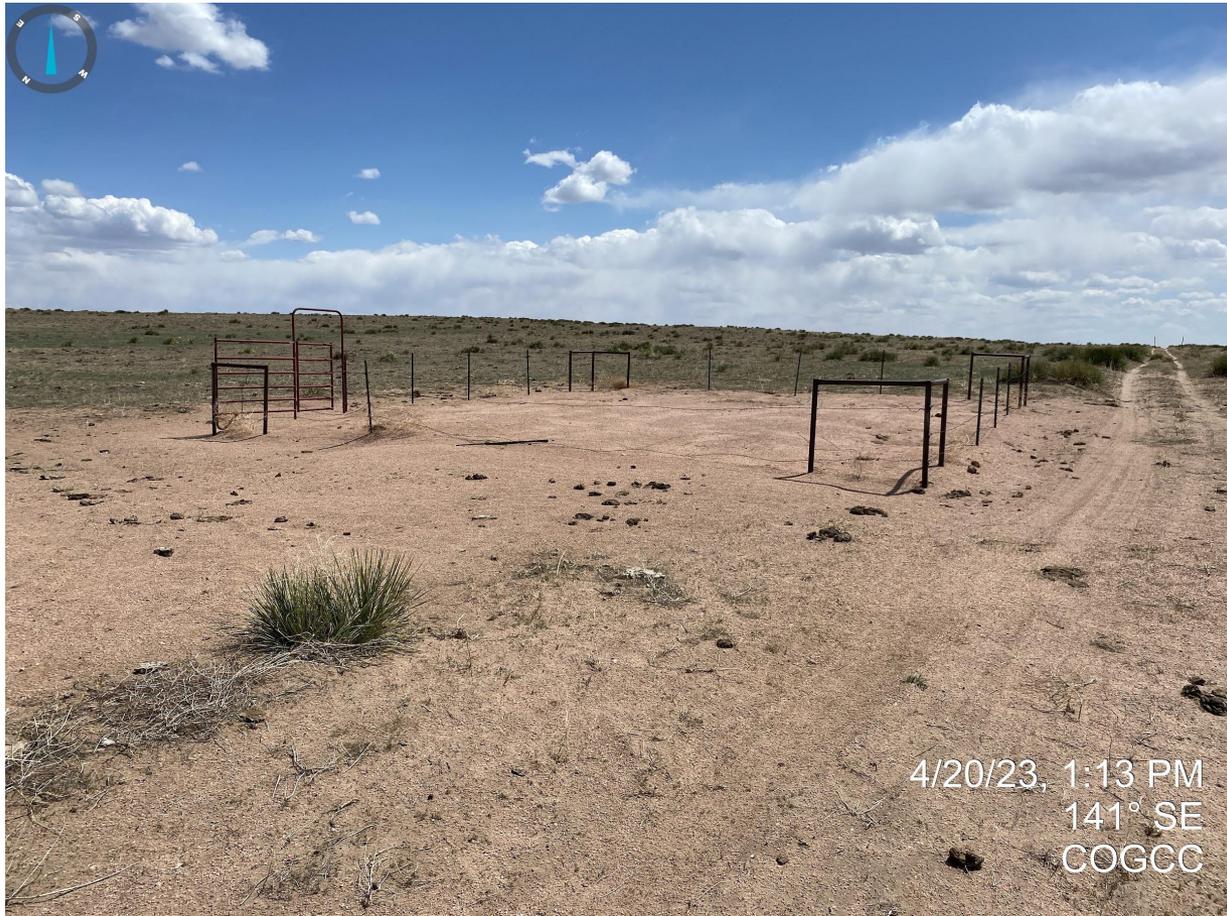
**Photo 8.** Facing southeast at the tank battery location. No evidence of germination was observed within the reclaimed area. Further reclamation activities will need to be conducted in order for the location to meet final reclamation requirements.
