CAERUS PICEANCE LLC, USA-68S97W/5SWNE

Location # 322468

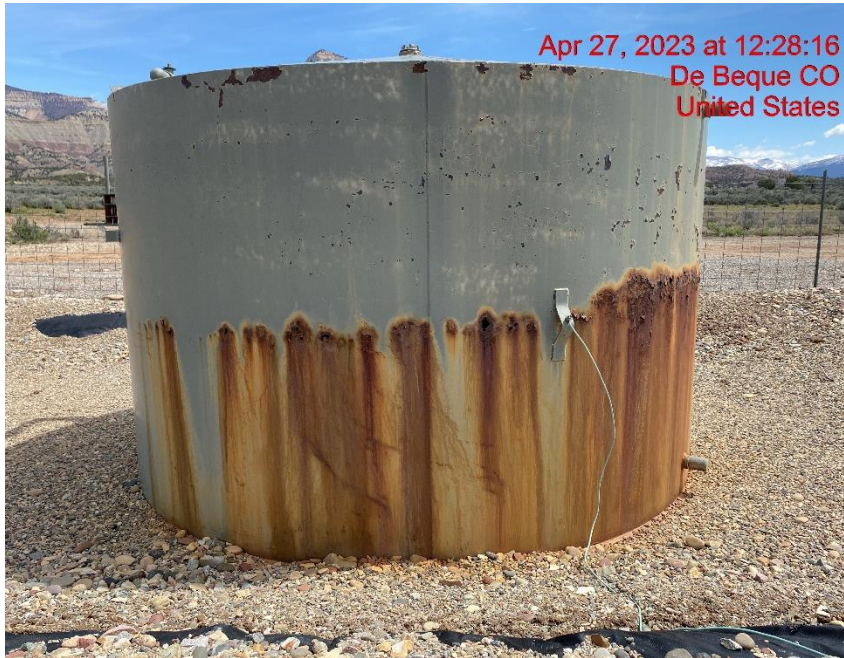
Holes in Produced Water Tank – Photo #02631

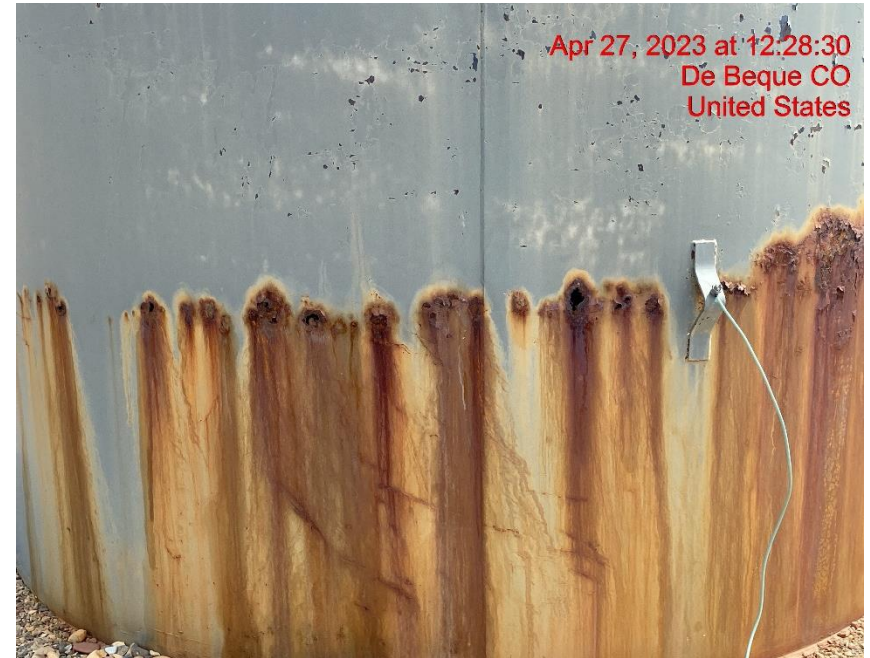
Holes in Produced Water Tank – Photo #02632

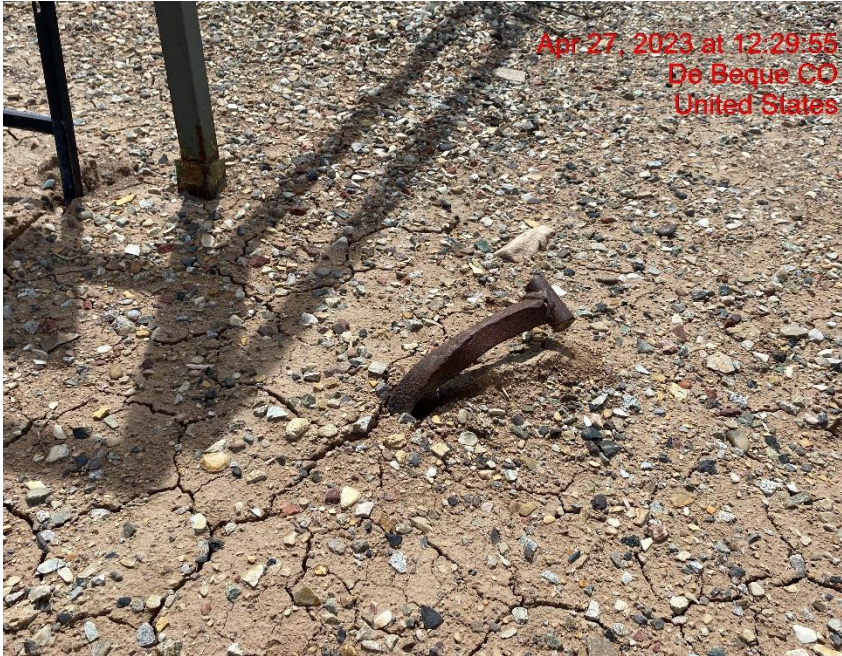
Unmarked Anchor – Photo #02637

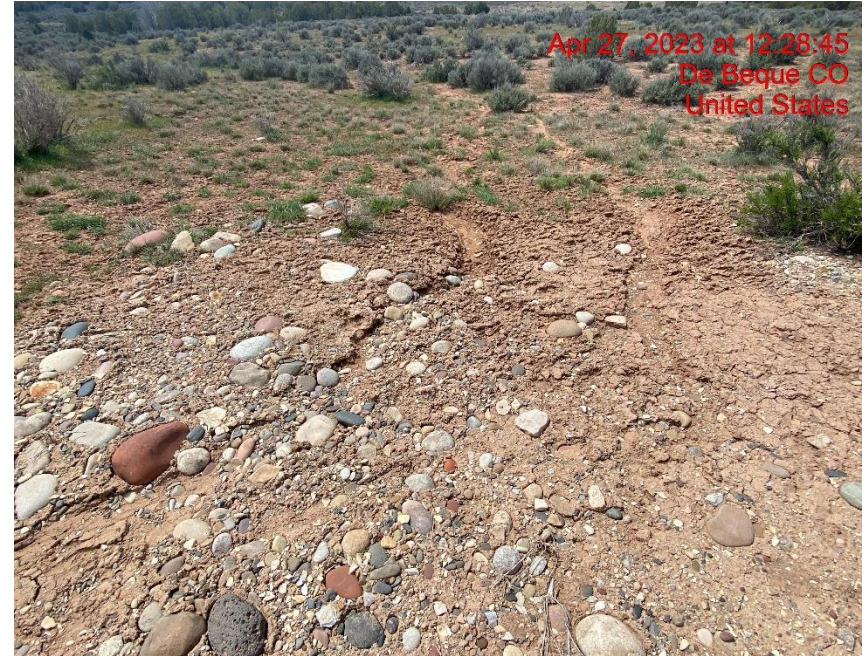
Rill Erosion/Transport of Sediment from Location – Photo #02633

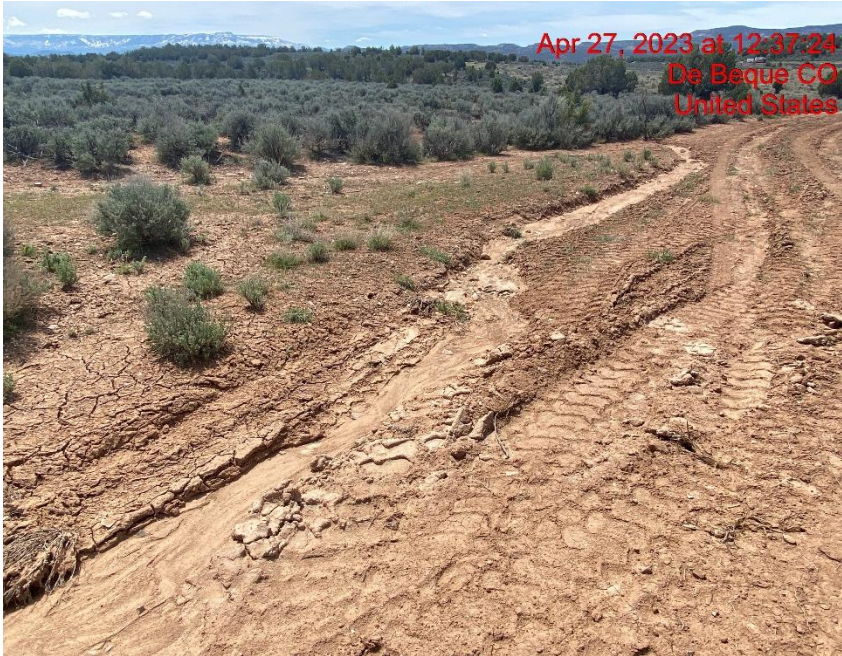
Erosion/Transportation of Sediment from Access Road – Photo #02642

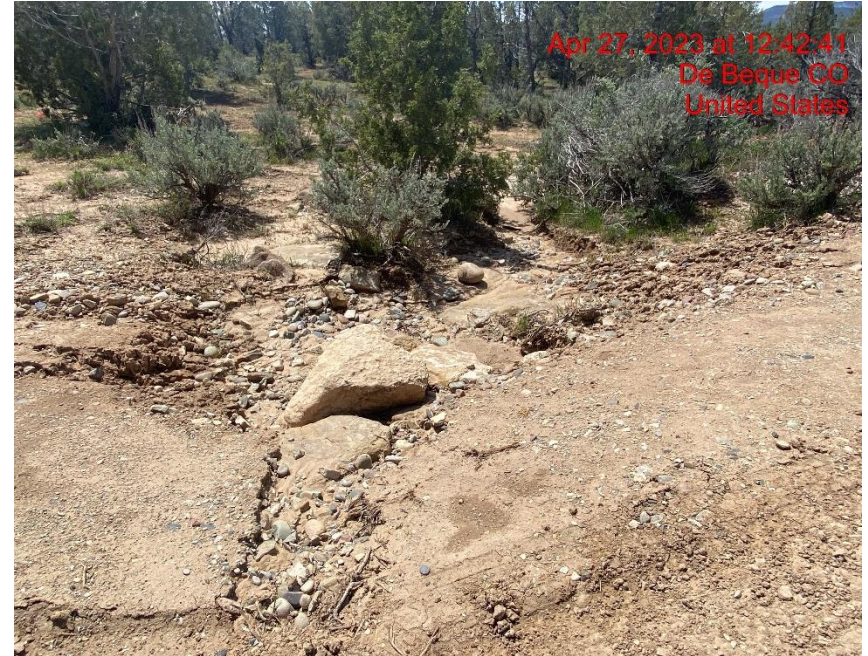
Insufficient BMPs to Minimize Sediment Transportation from Access Road – Photo #02647

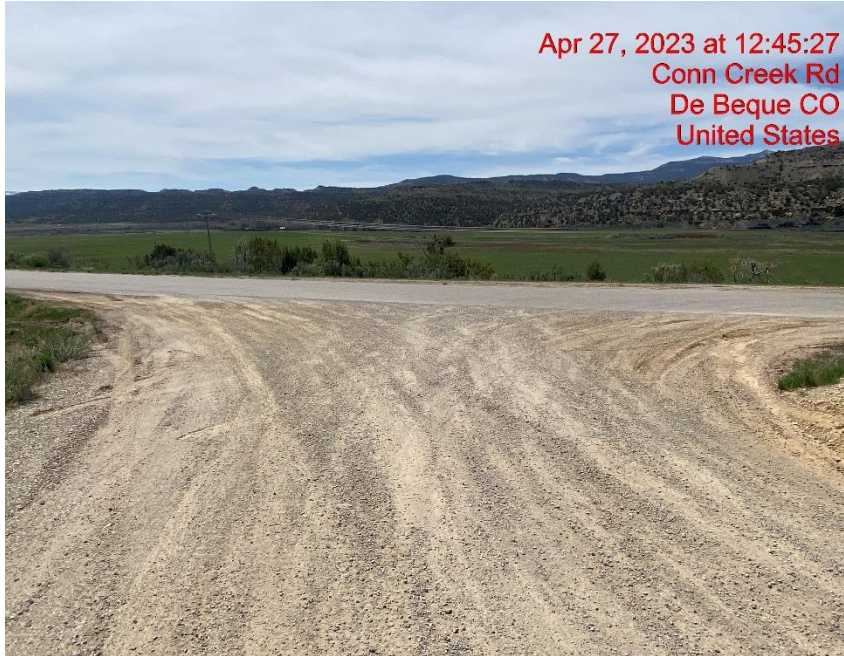
Insufficient Vehicle Tracking BMP – Photo #02648

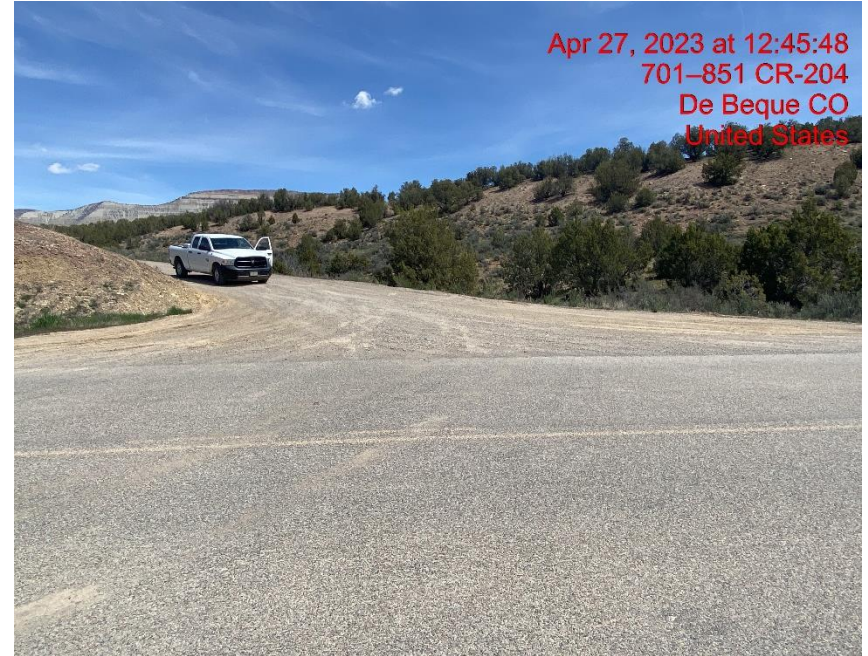
Insufficient Vehicle Tracking BMP – Photo #02649
