Stormwater Management and Erosion control

Location Name: CAERUS PICEANCE LLC HYRUP-68S95W /18NWSW

Location #: 312705

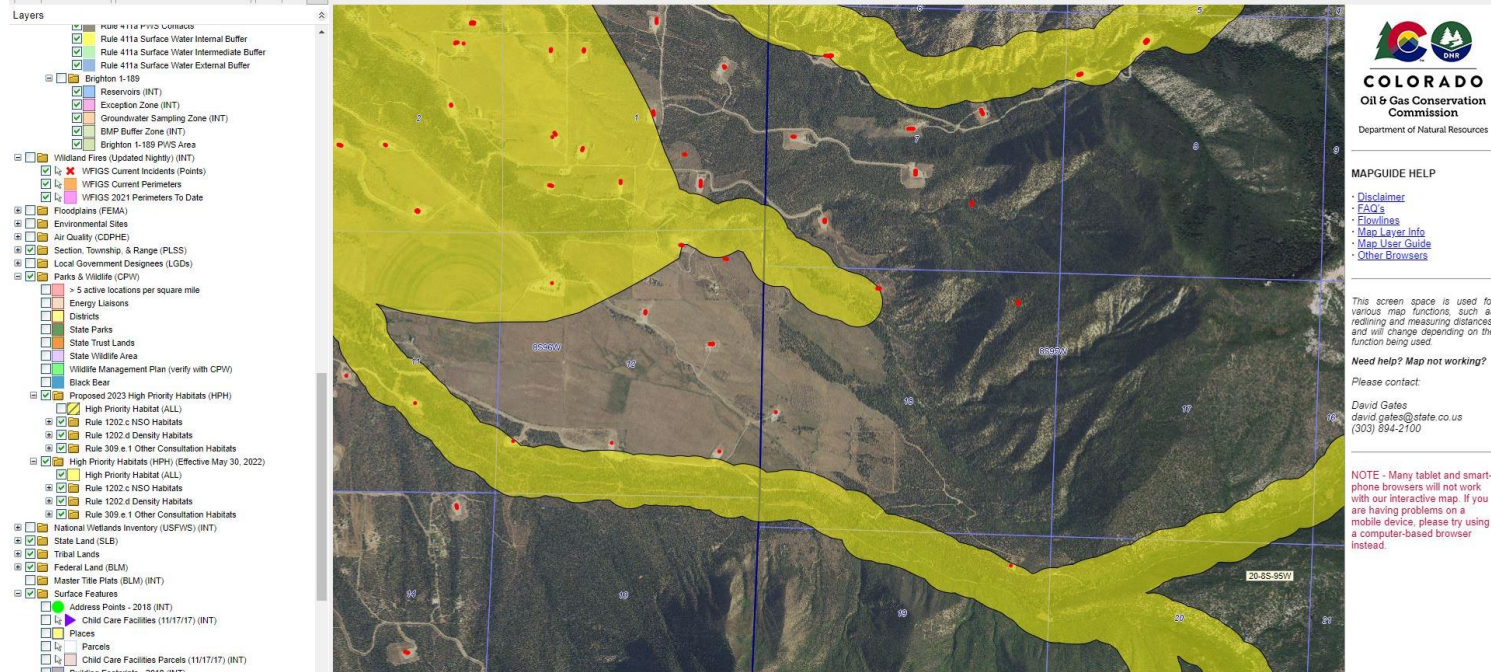
Location Overview: Location is located on the edge of a High priority habitat area.

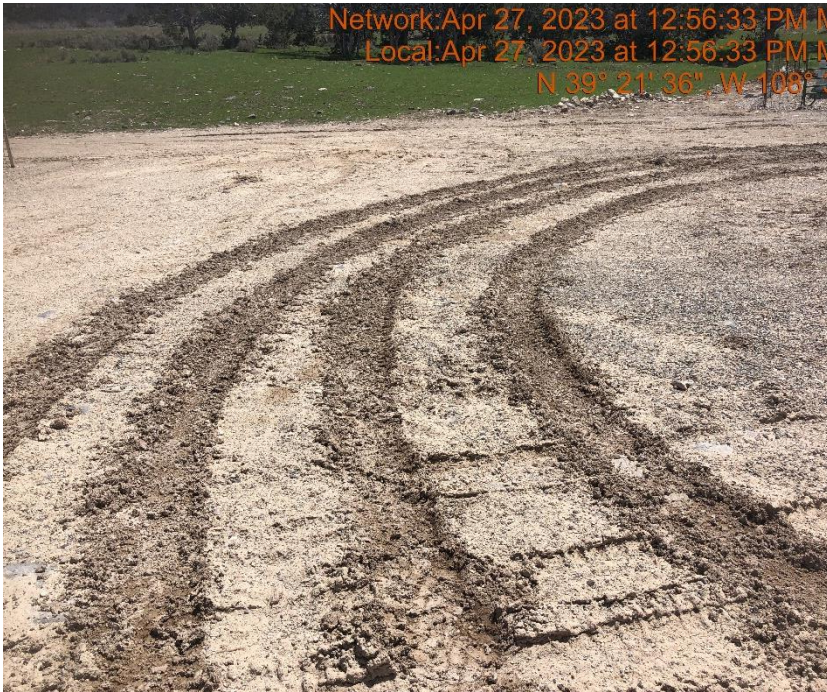
Photo #9760 Location lacks stabilization.

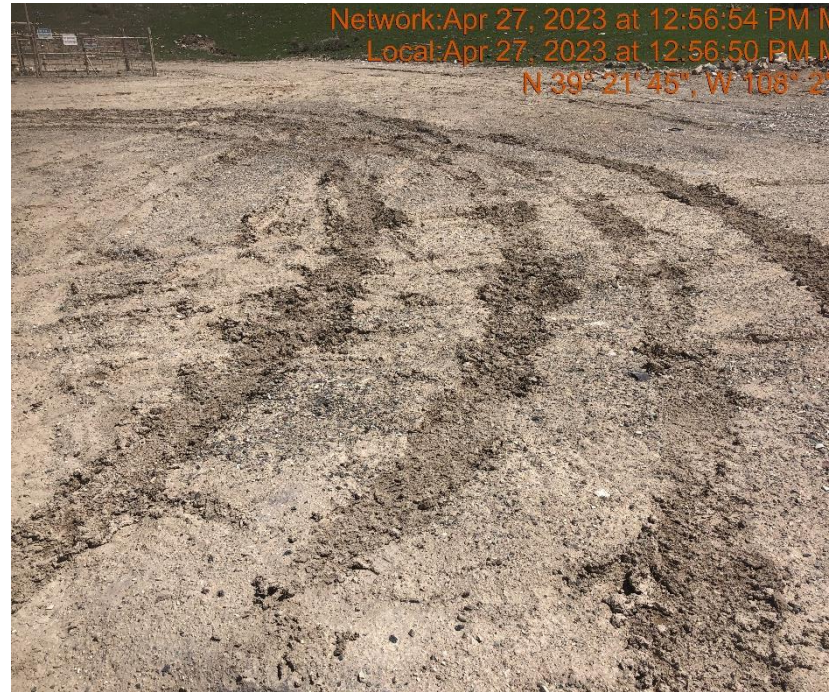
Photo #9761 Location lacks stabilization.

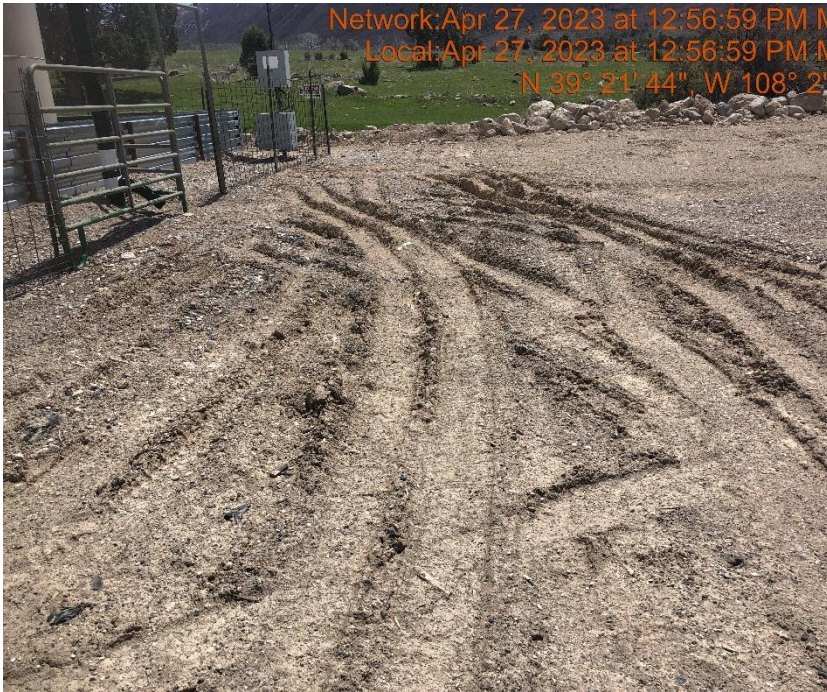
Photo #9762 Location lacks stabilization.

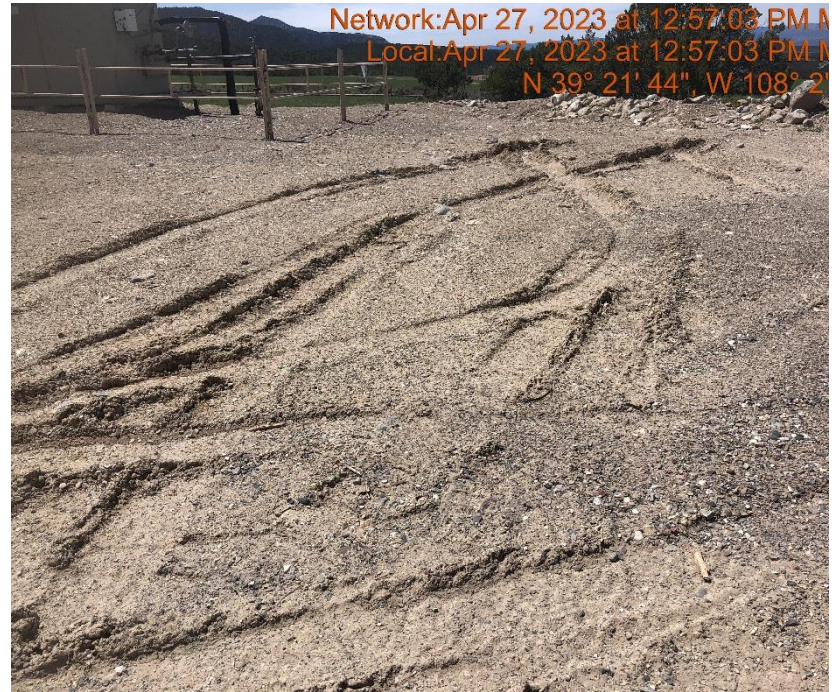
Photo #9763 Location lacks stabilization.

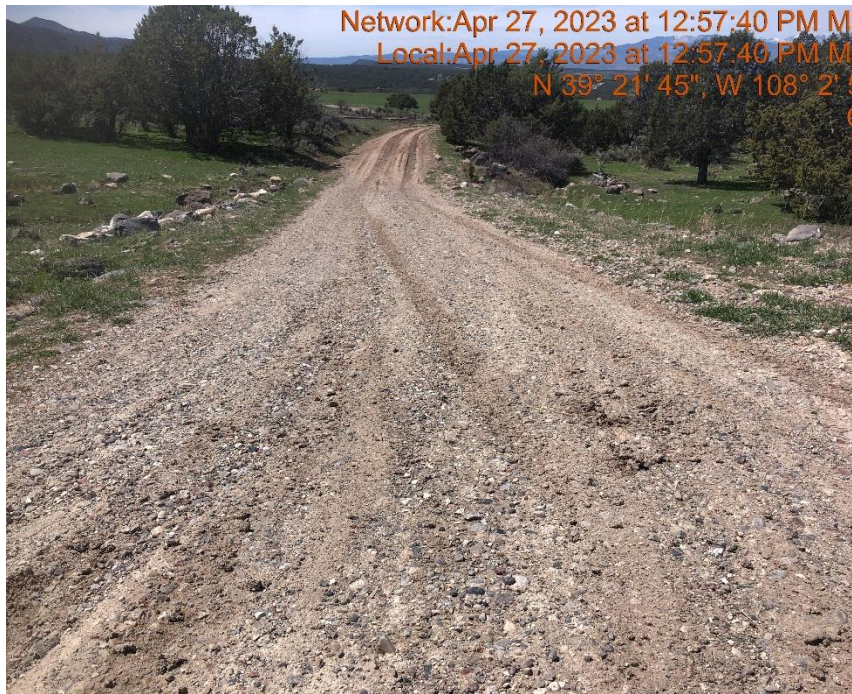
Photo #9766 Insufficient tracking BMP at entrance to location to minimize the transport of sediment off location.

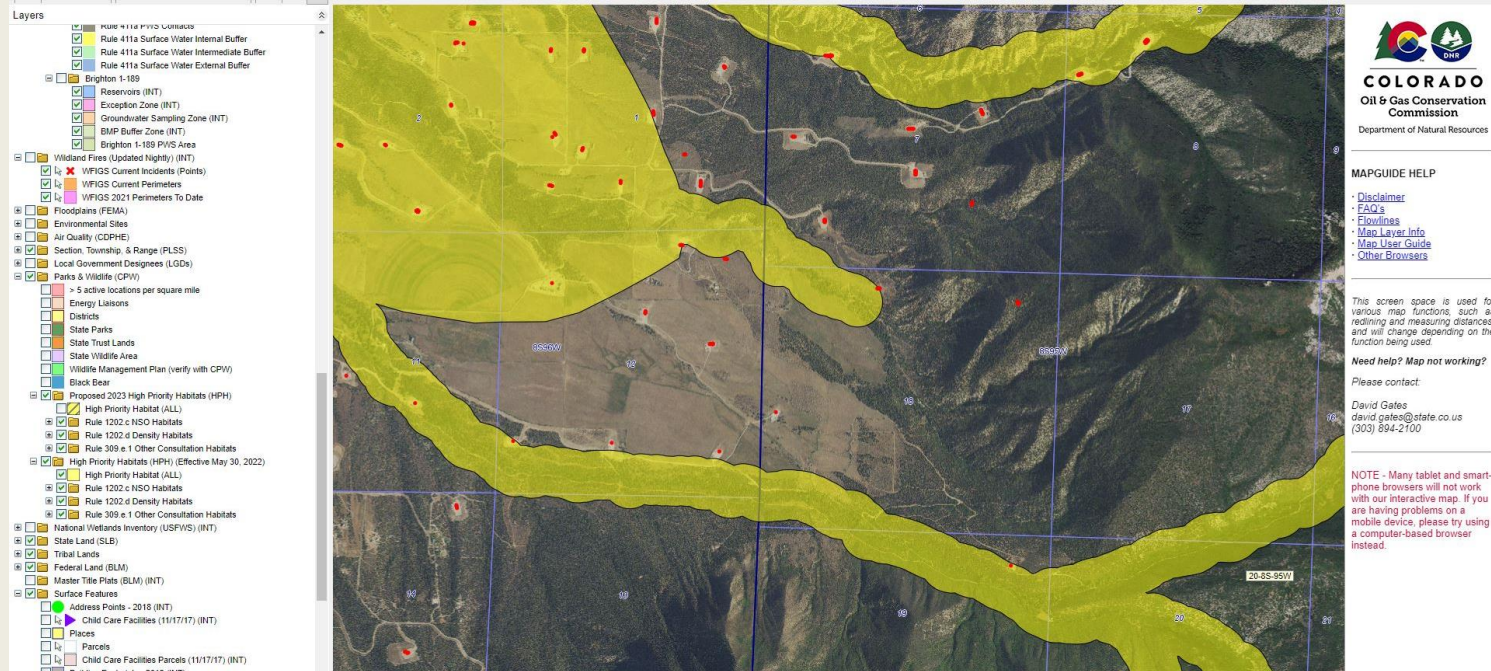
Access Road overview: Access road is located on the edge of a High priority habitat area.

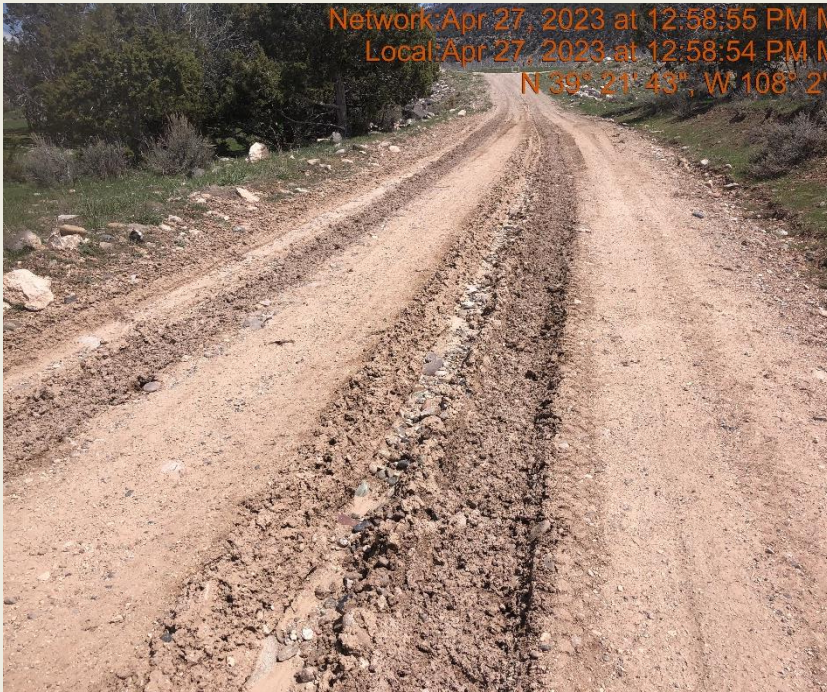
Photo #9767 Access road lacks stabilization.

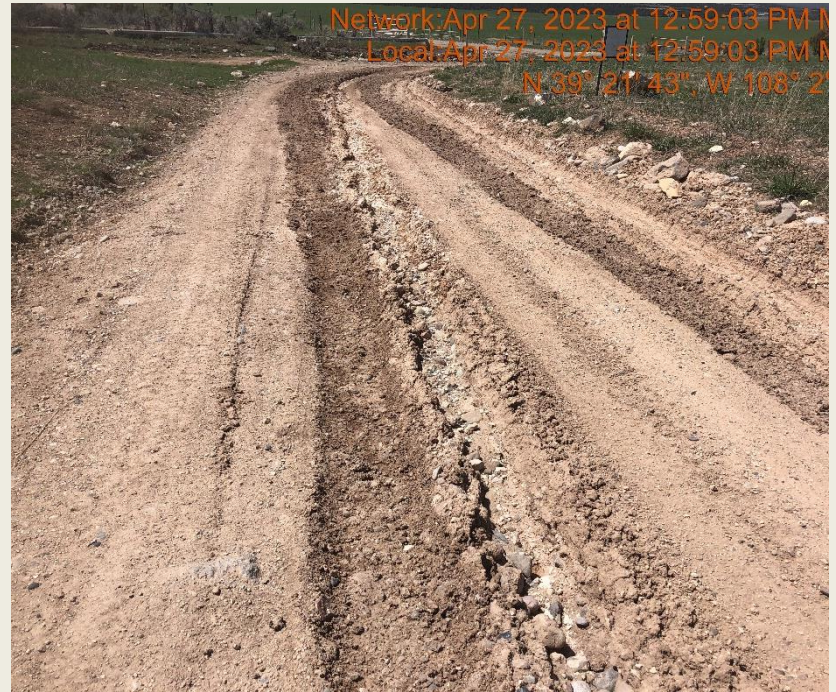
Photo #9768 Access road lacks stabilization.

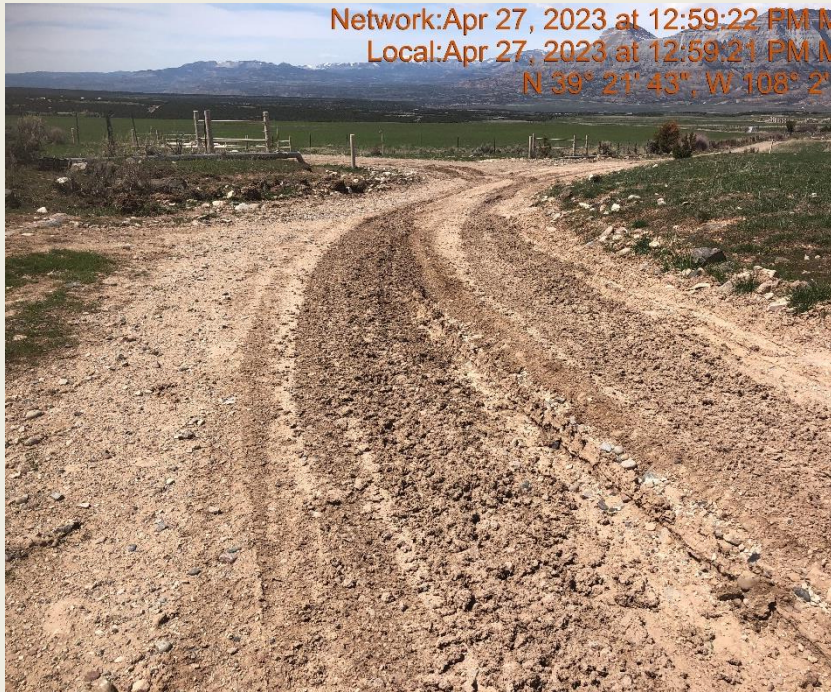
Photo #9769 Access road lacks stabilization.
