Stormwater Management and Erosion control

Location Name: CAERUS PICEANCE LLC HYRUP-68S96W /12SESW.

Location #: 312696

Section/Township/Range: 12 8S96W

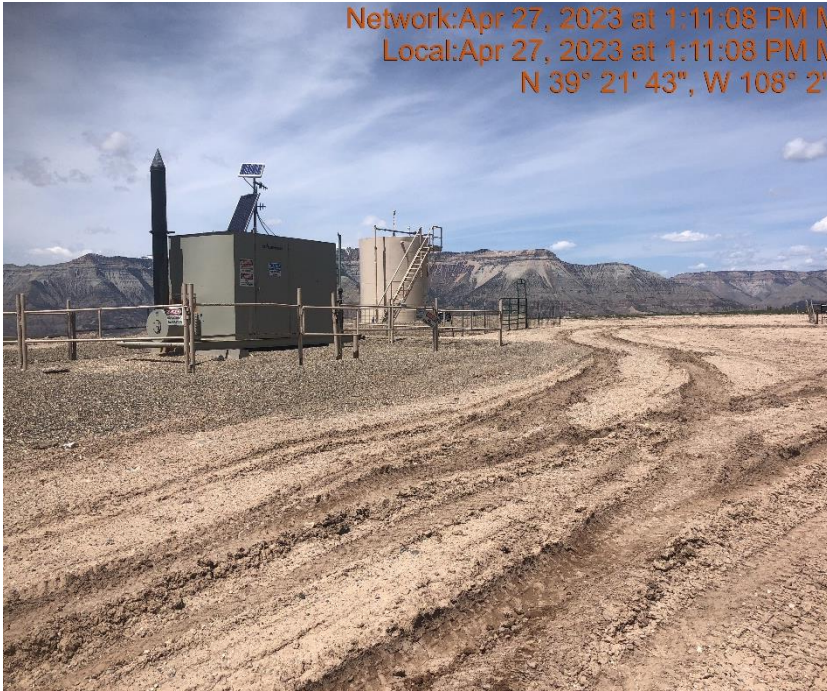
Photo #9770 From entrance to location.

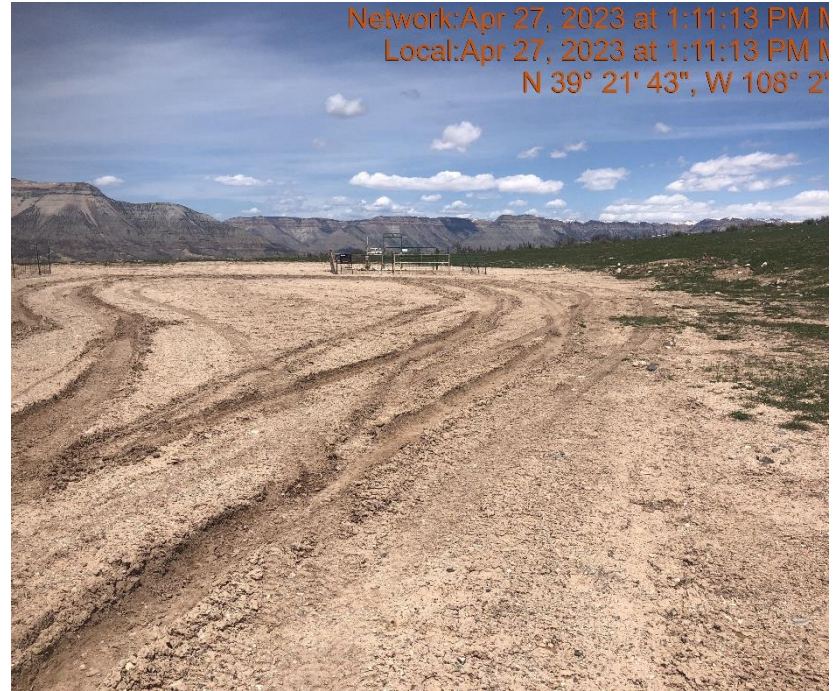
Photo #9771 From entrance to location.

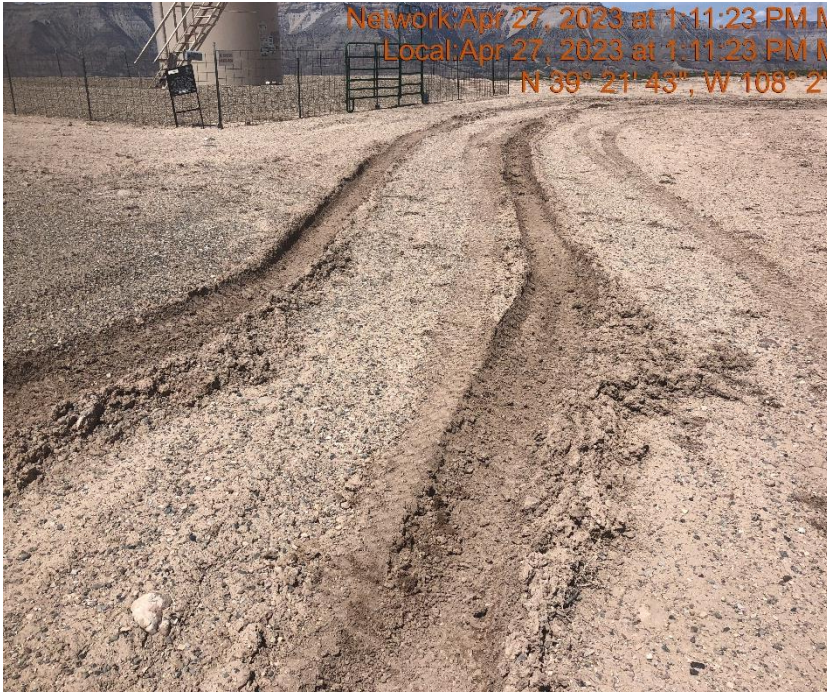
Photo #9772 Location lacks stabilization.

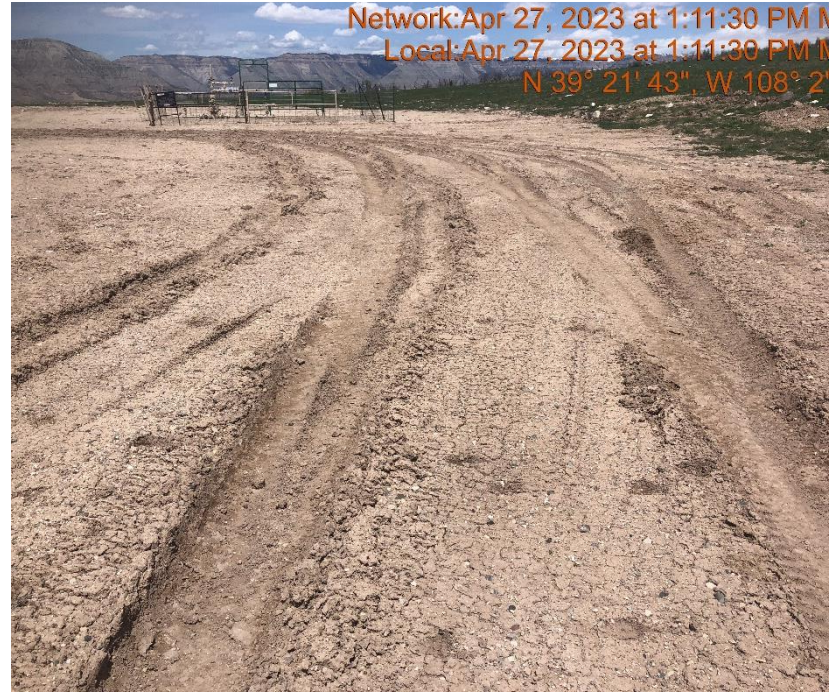
Photo #9773 Location lacks stabilization.

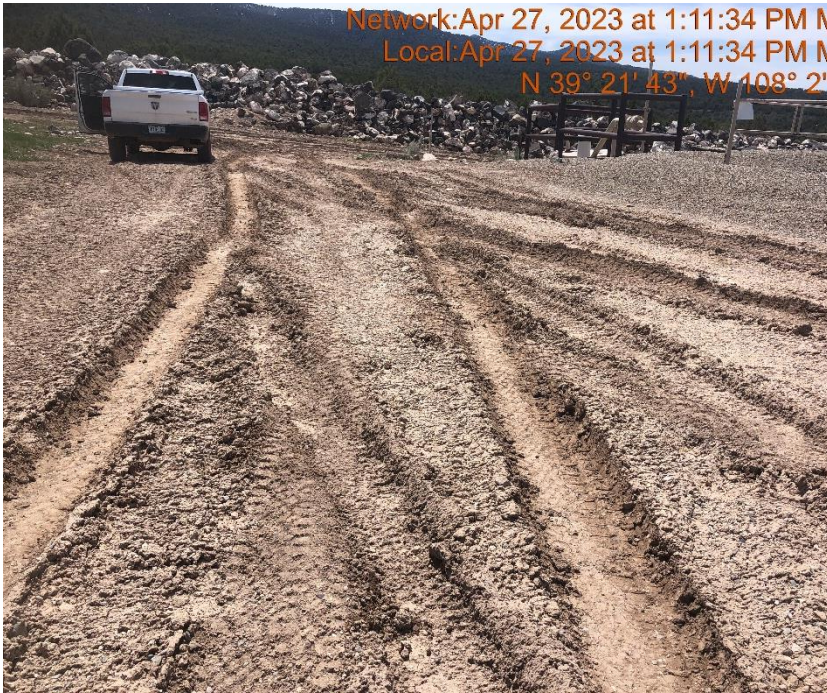
Photo #9774 Location lacks stabilization.

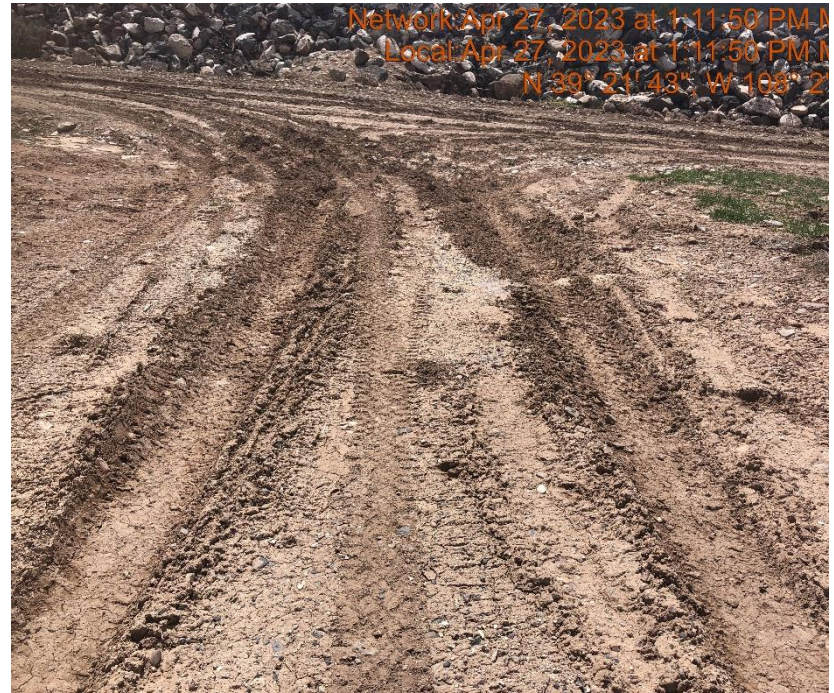
Photo #9775 Insufficient tracking BMP at entrance to location to Minimize the transport of sediment.

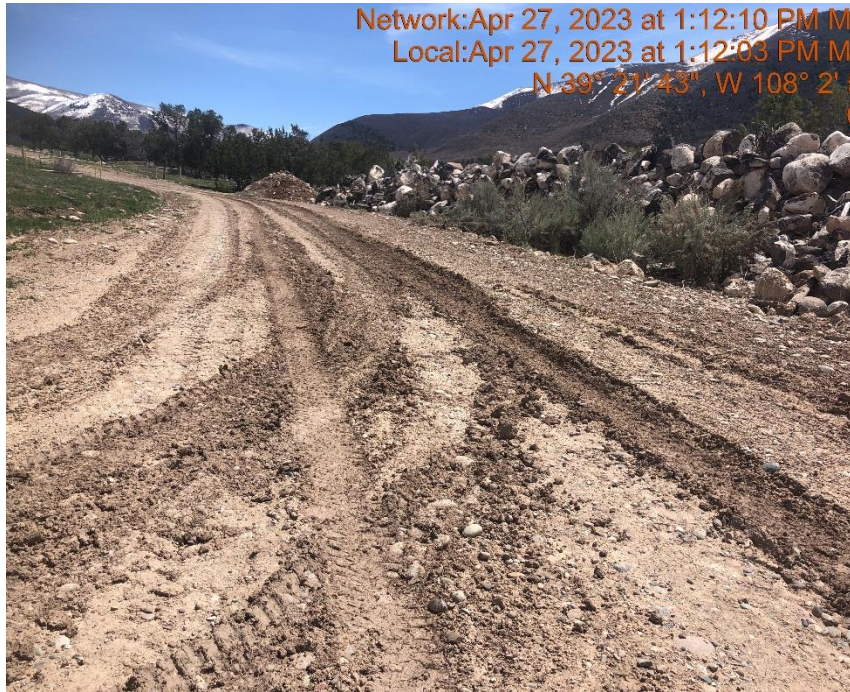
**Photo #9776 Insufficient tracking BMP at entrance
to location to Minimize the transport of sediment.**
