## Inspection Photos

Location Name: TEP ROCKY MOUNTAIN LLC CLOUGH RMV 62-29 Pad

Location ID: 335252

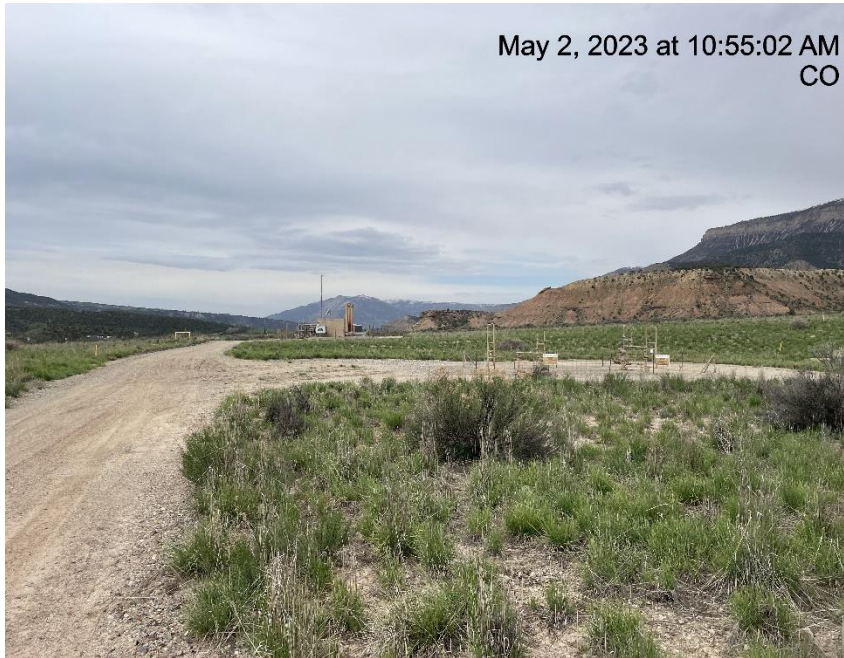
Photo # 6763 From entrance to location

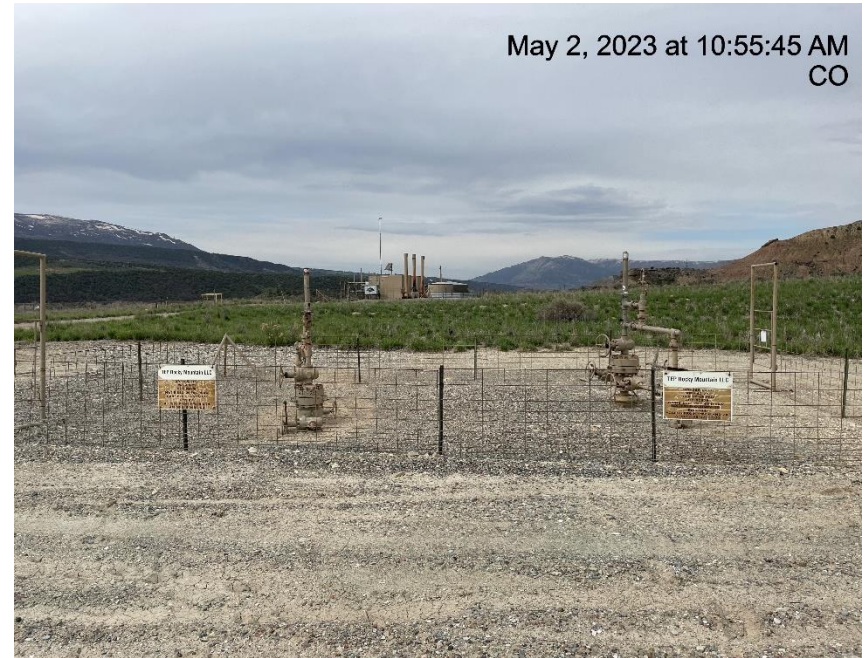
Photo # 6764 Location

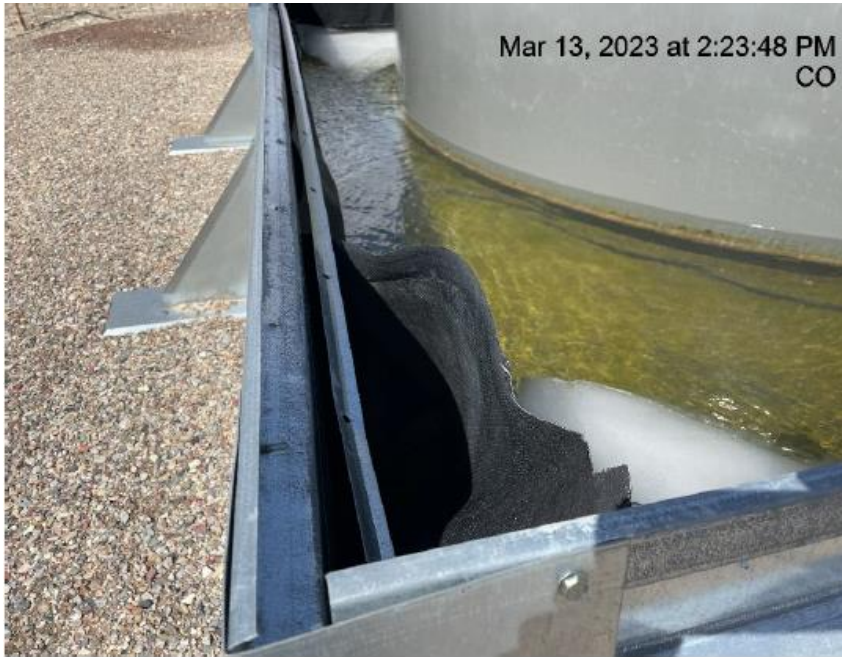
**Photo # 2311 From Inspection 708900114 conducted on 03/13/2023 Containment needs maintenance**

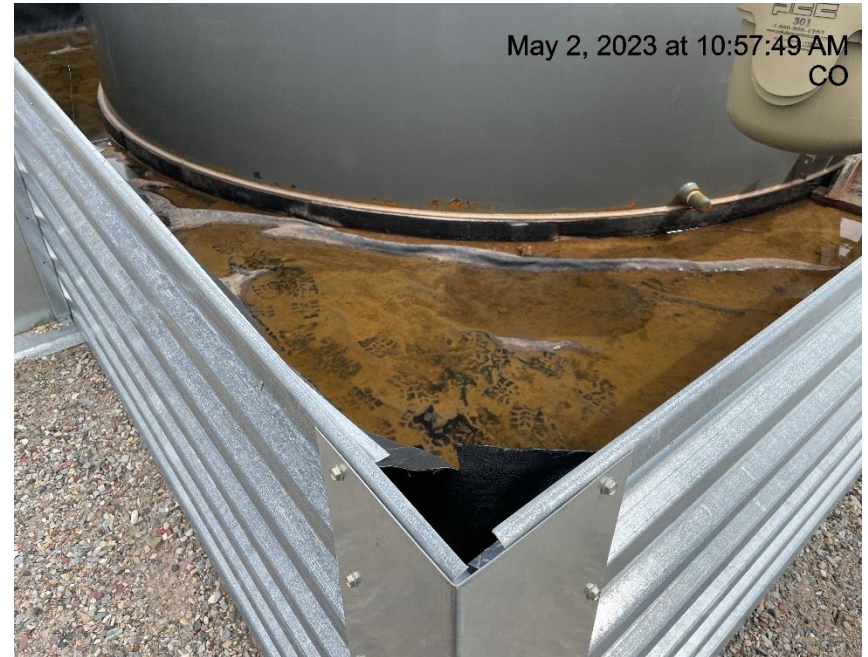
**Photo # 6770 Containment needs maintenance**

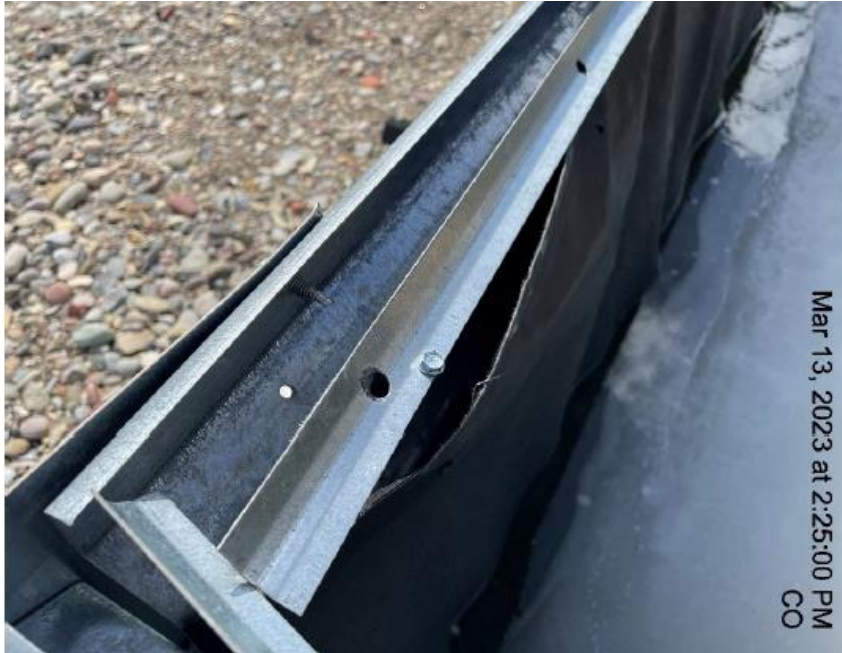
Photo # 2313 From Inspection 708900114 conducted on 03/13/2023 Containment needs maintenance

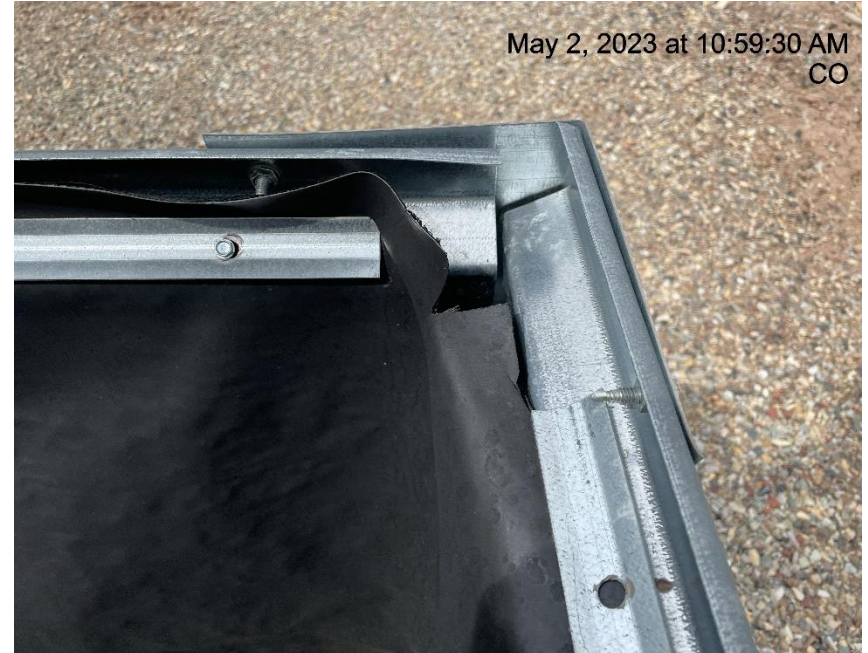
Photo # 6777 Containment needs maintenance

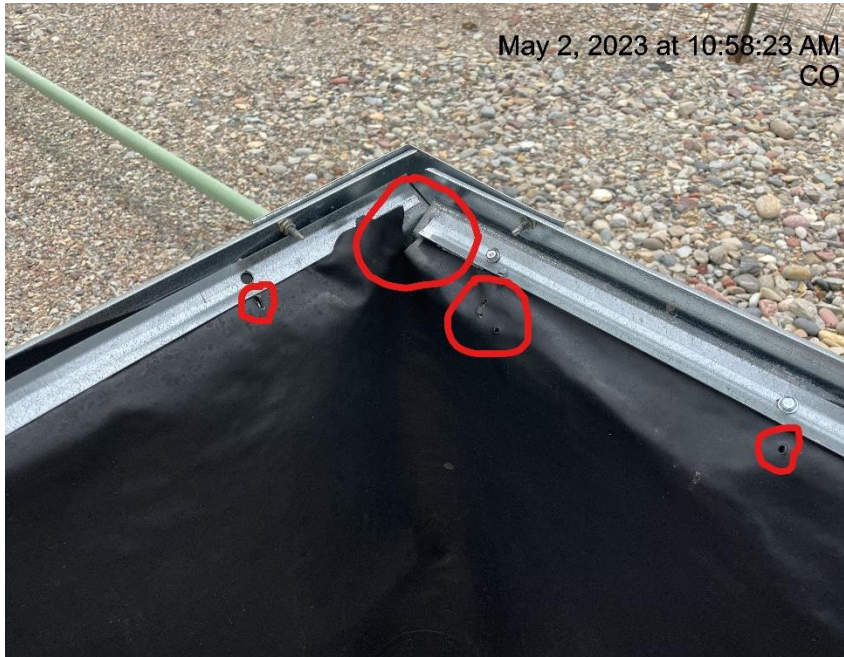
Photo # 6771 Containment needs maintenance

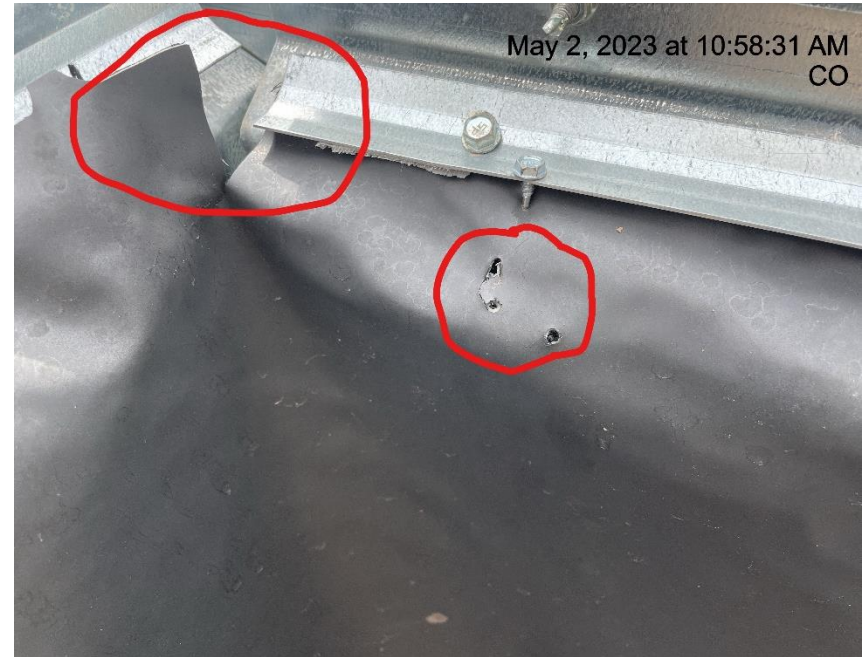
Photo # 6772 Containment needs maintenance

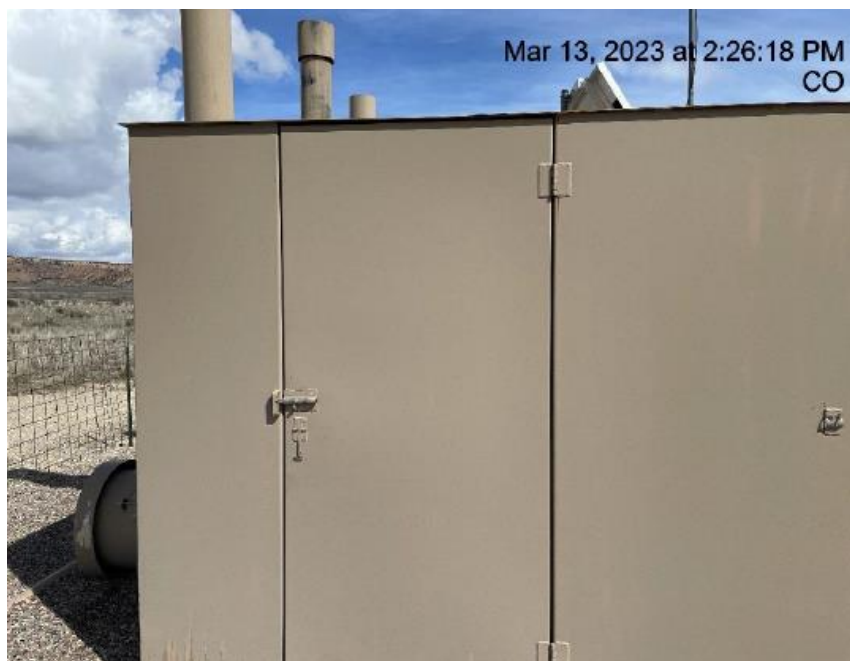
**Photo # 2316 From Inspection 708900114 conducted on 03/13/2023 Meter calibration info not conspicuously posted**

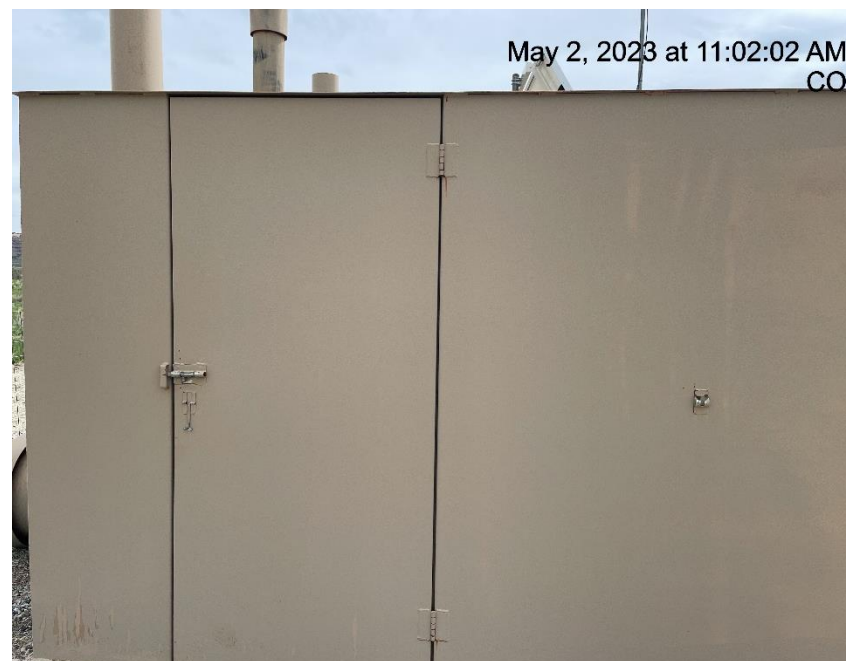
**Photo # 6787 Meter calibration info not conspicuously posted**

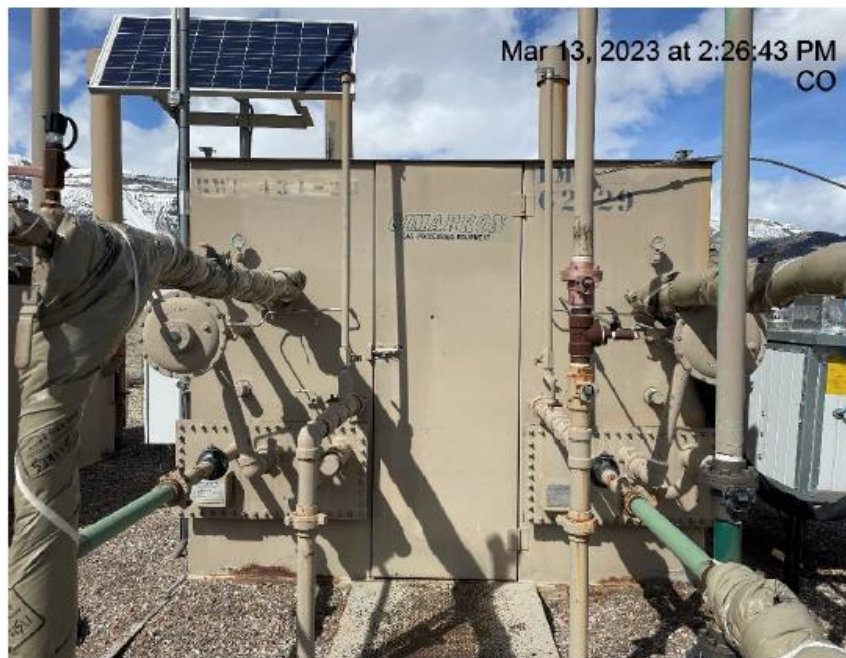
Photo # 2317 From Inspection 708900114 conducted on 03/13/2023 Meter calibration info not conspicuously posted

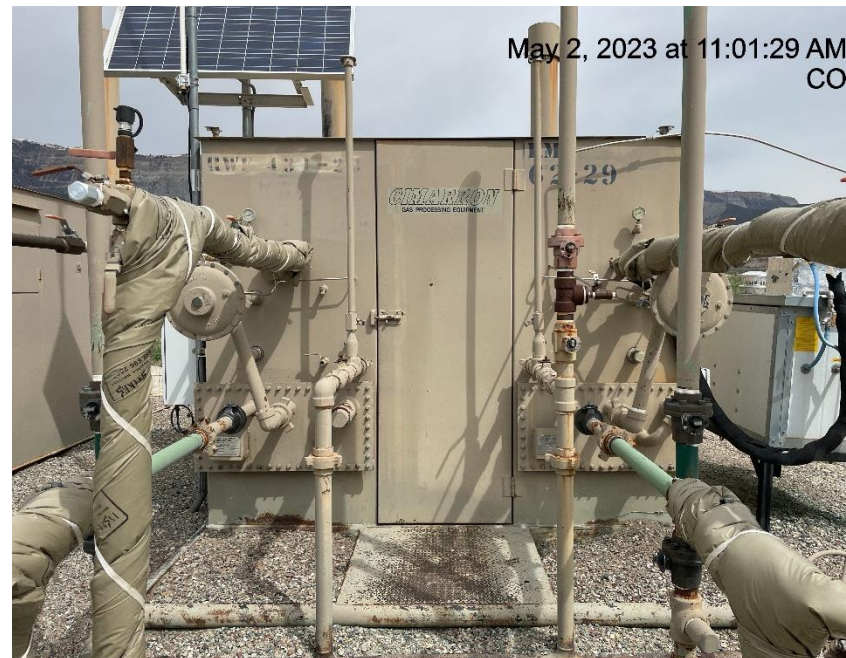
Photo # 6783 Meter calibration info not conspicuously posted

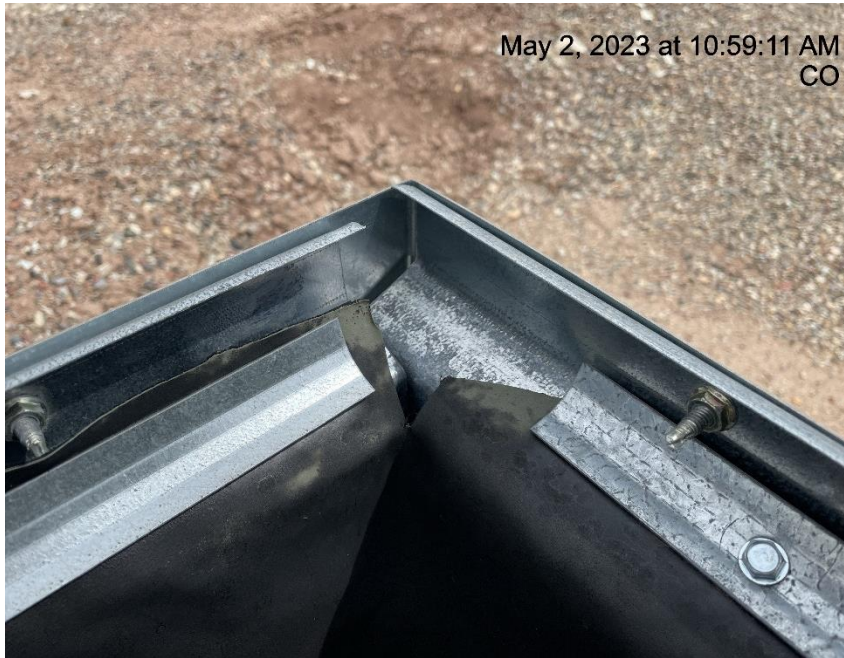
**Photo # 6776 Containment needs maintenance**
