Inspection Photos  
Location Name: Consolidation Unit 8 437627  
Facility ID: 437627

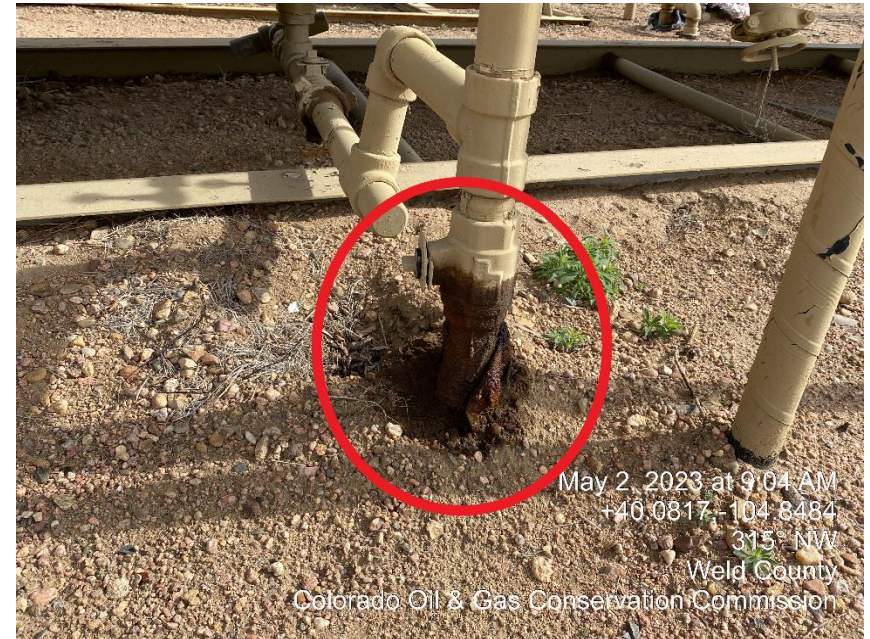
Photo #2 Mechanical Conditions & Oily Waste

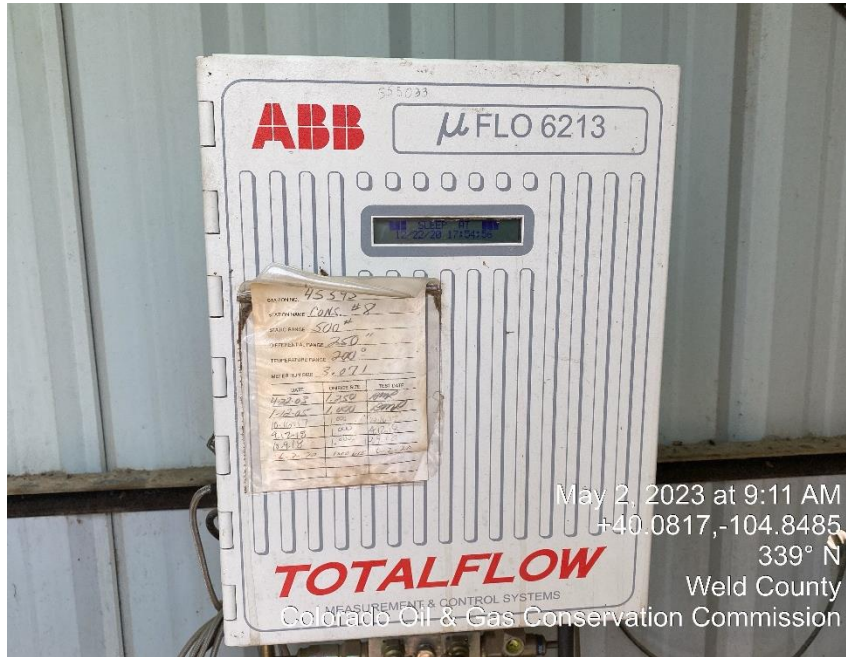
Photo #3 Mechanical Conditions & Meter not calibrated

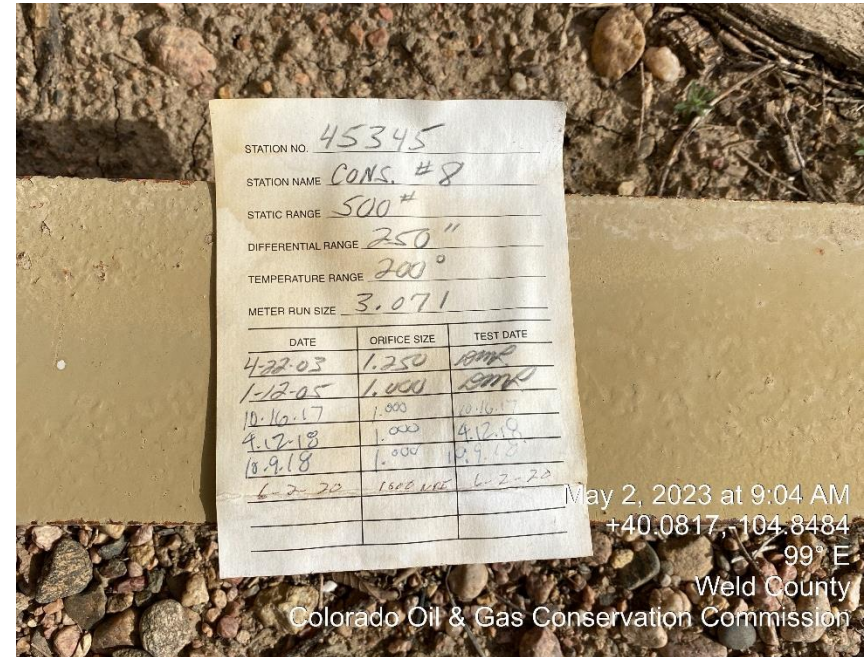
Photo #4 Gas Meter Card shows no annual calibration

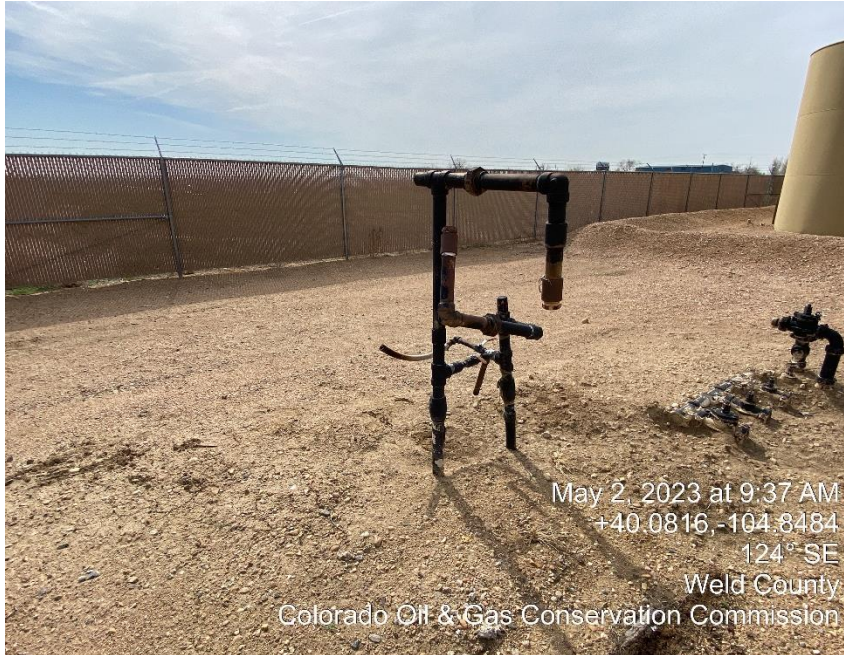
**Photo #5 Unmarked Riser**

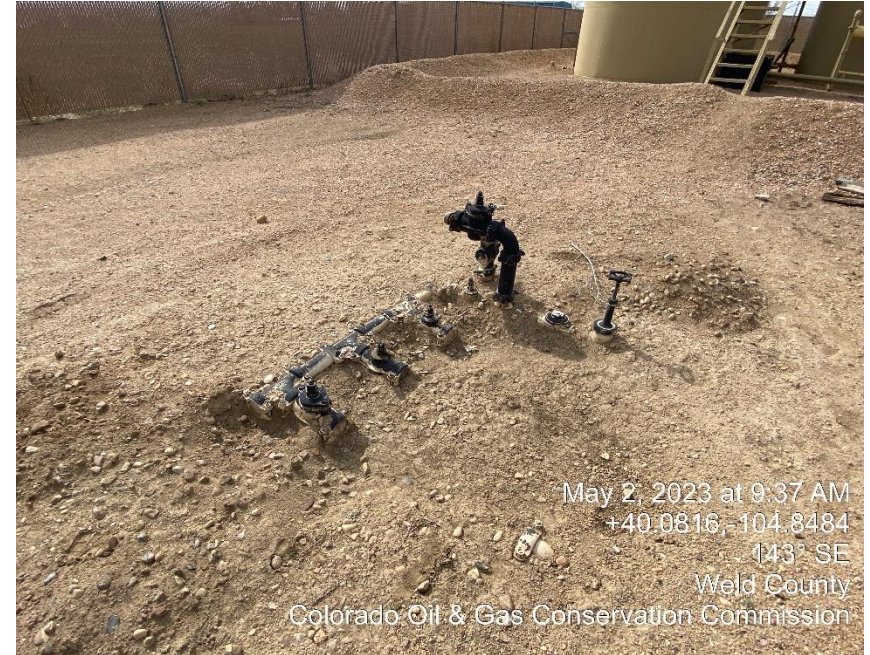
**Photo #6 Unmarked Riser**

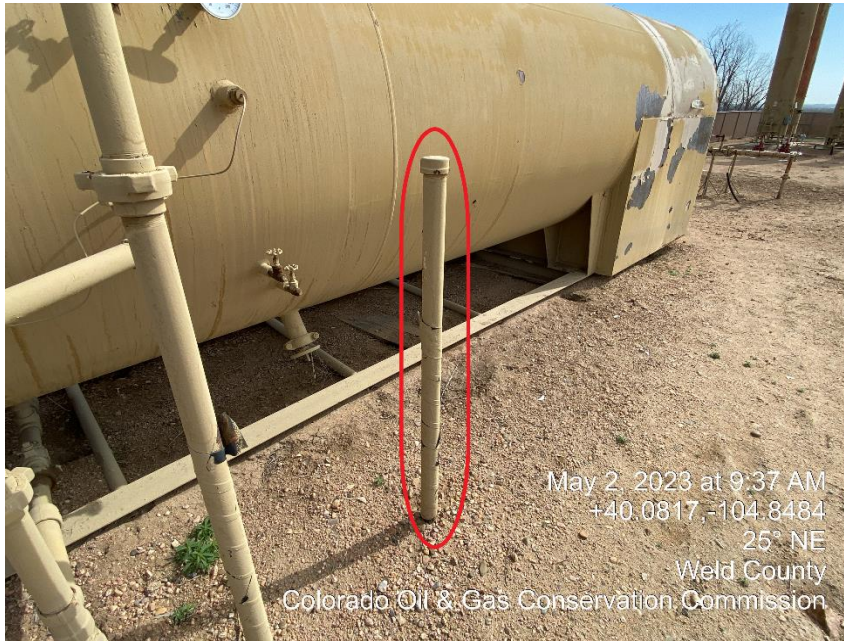
**Photo #7 Unmarked Riser**

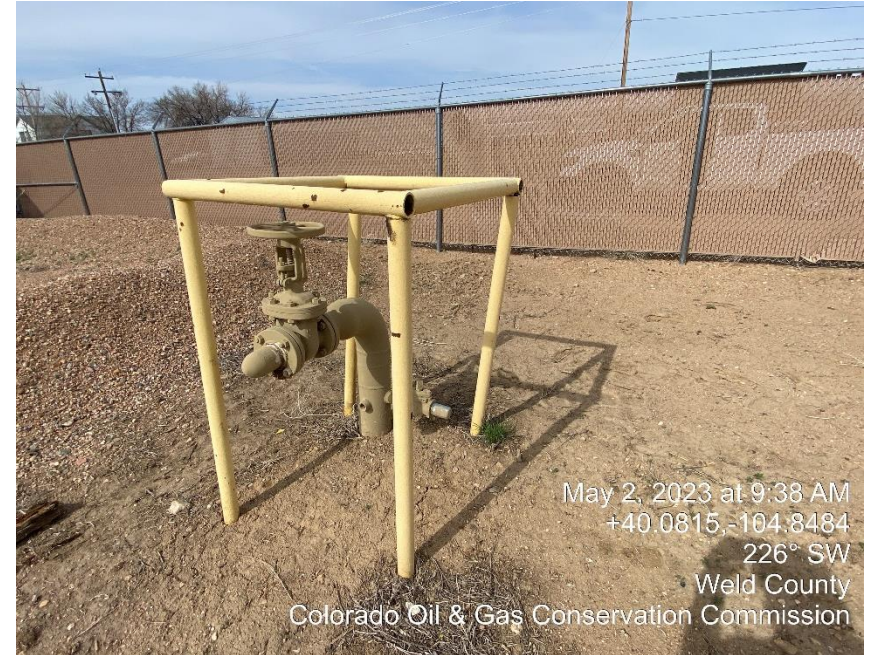
**Photo #8 Unmarked Riser**

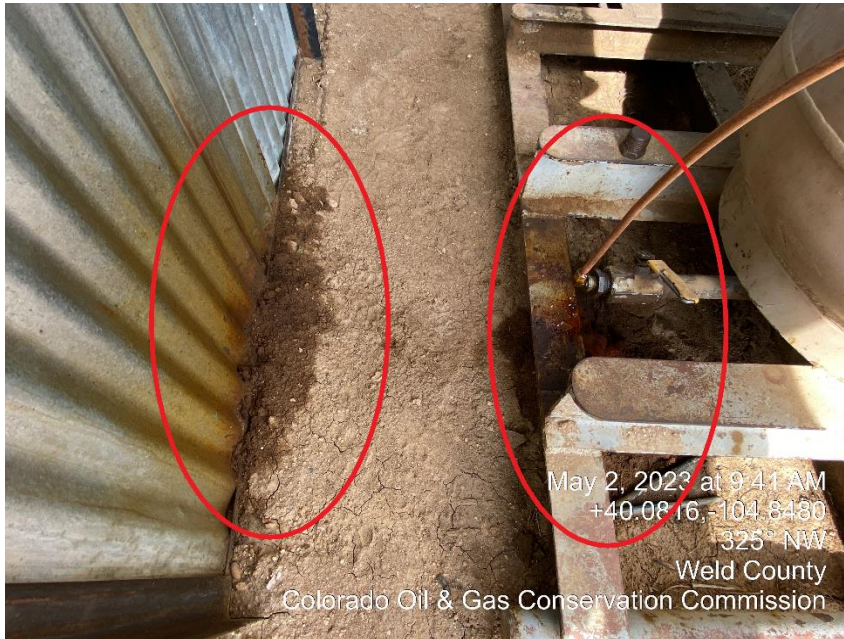
**Photo #9 Mechanical Conditions & Oily Waste**

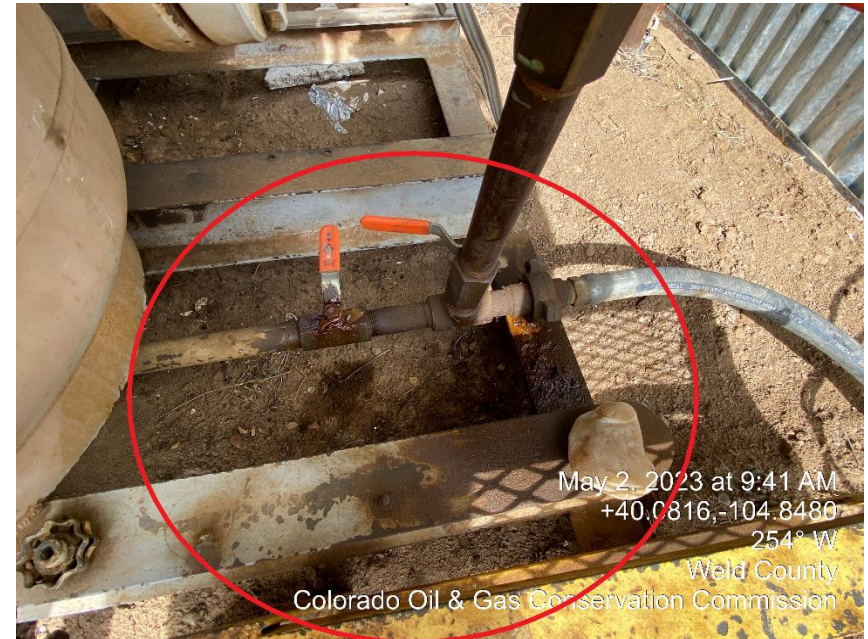
**Photo #10 Mechanical Conditions & Oily Waste**
