Inspection Photos

Location Name: TEP ROCKY MOUNTAIN LLC CLOUGH RWF 432-29 Pad

Location ID: 335494

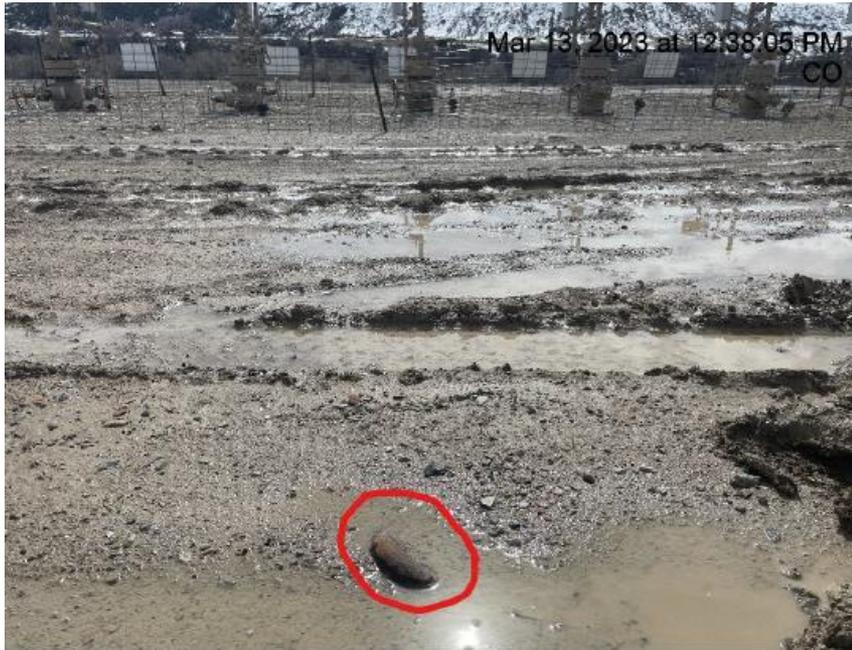
Photo # 2241 From Inspection 708900110 conducted on 03/13/2023 Unmarked deadman

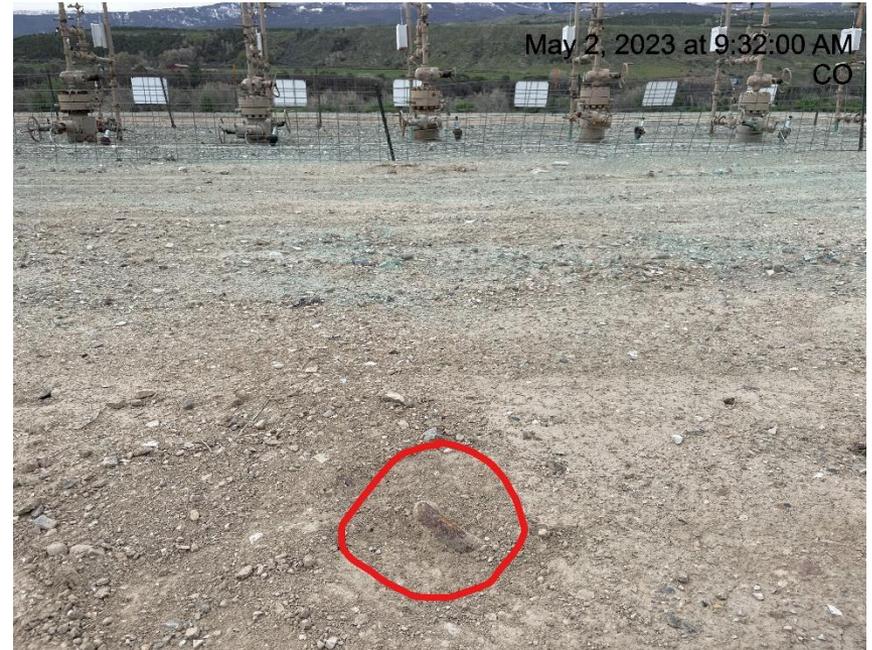
Photo # 6699 Unmarked deadman

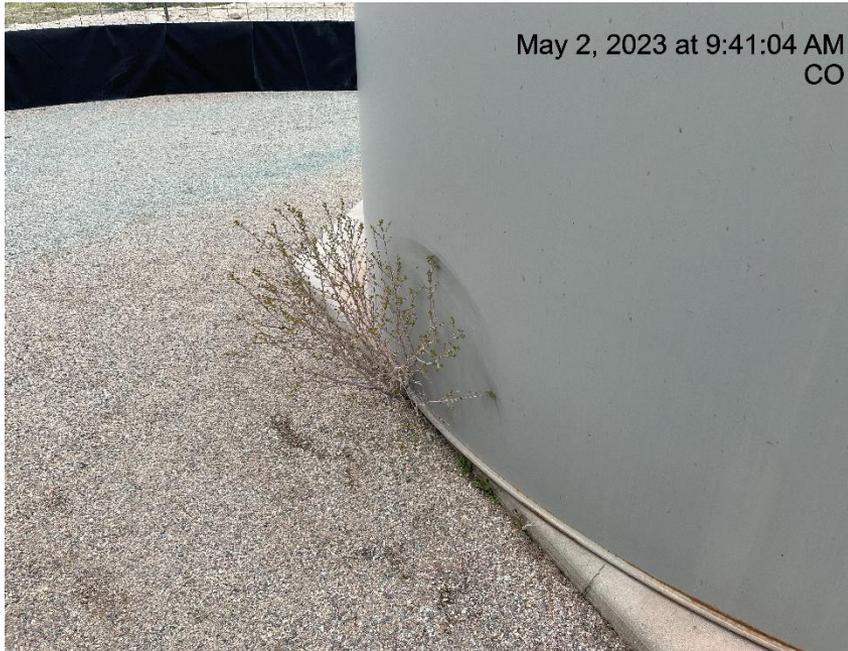
Photo # 6703 Weeds/sapling in containment

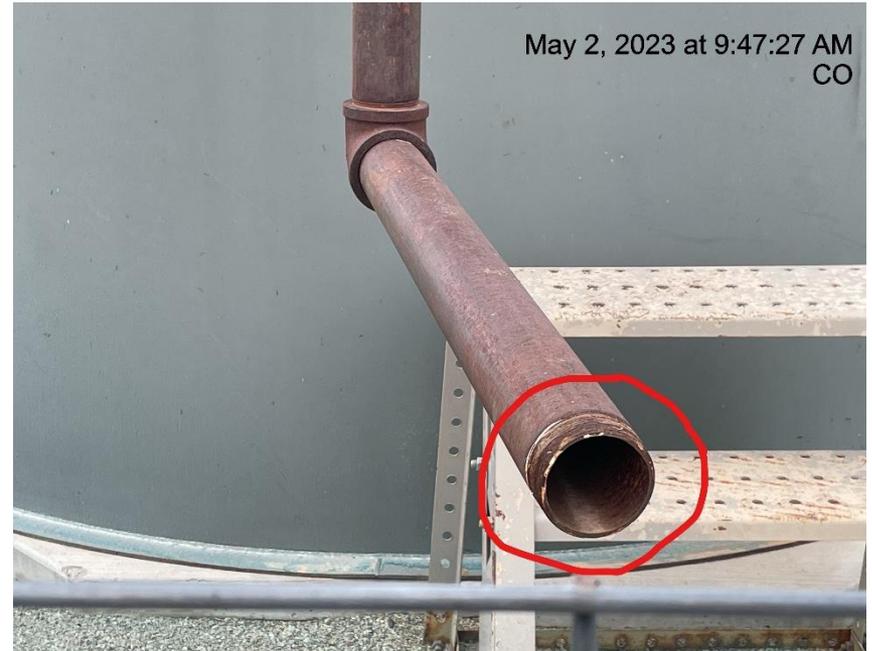
Photo # 6706 Open ended pipe/wildlife hazard

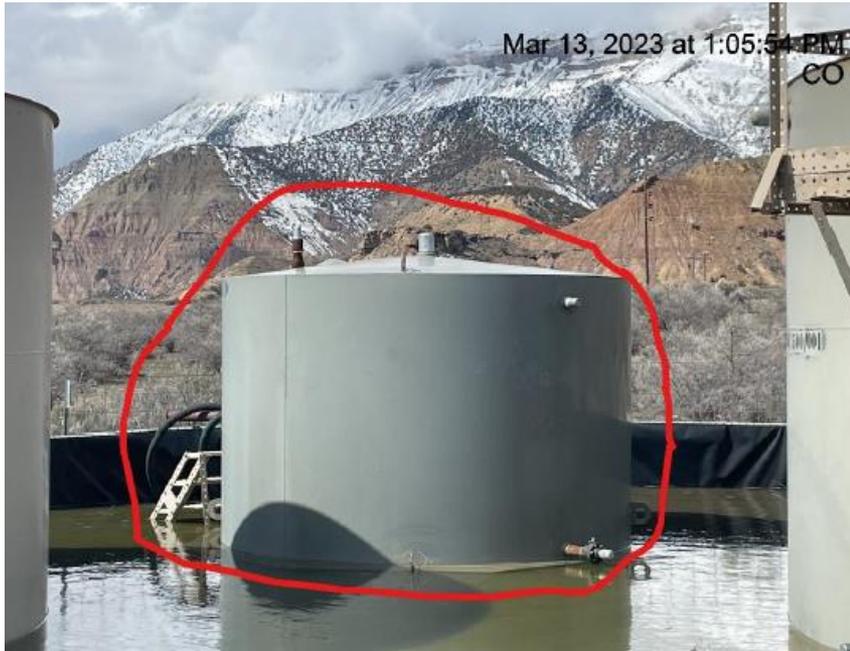
Photo # 2266 From Inspection 708900110 conducted on 03/13/2023 Unused equipment

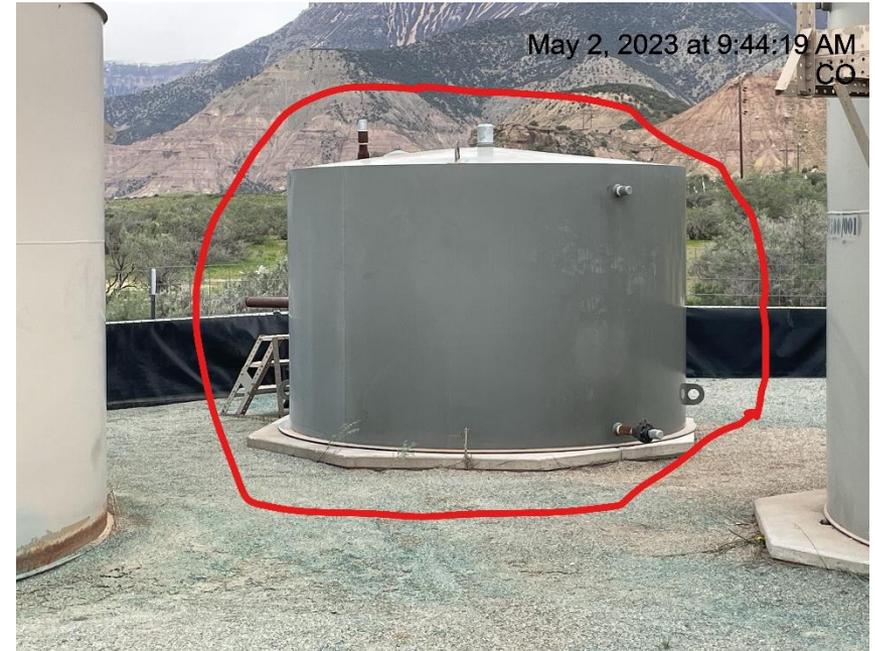
Photo # 6704 Unused equipment

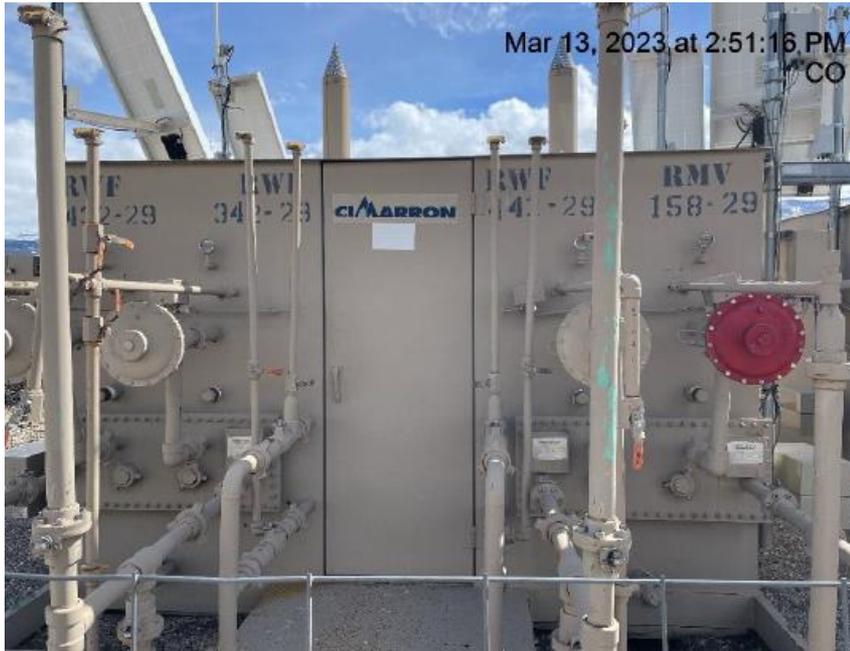
Photo # 2331 From Inspection 708900110 conducted on 03/13/2023 Meter calibration info not conspicuously posted

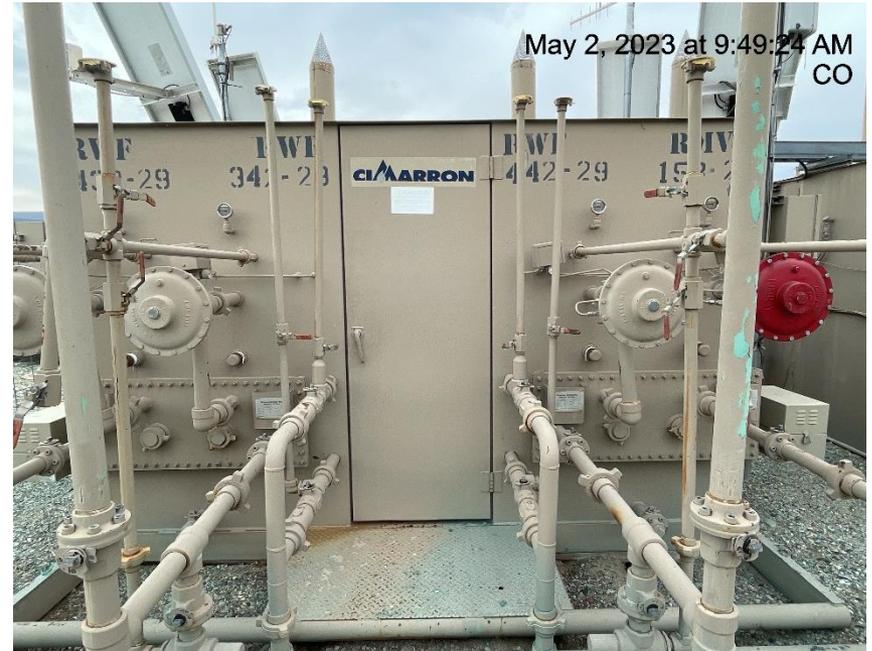
Photo # 6707 Meter calibration info not conspicuously posted

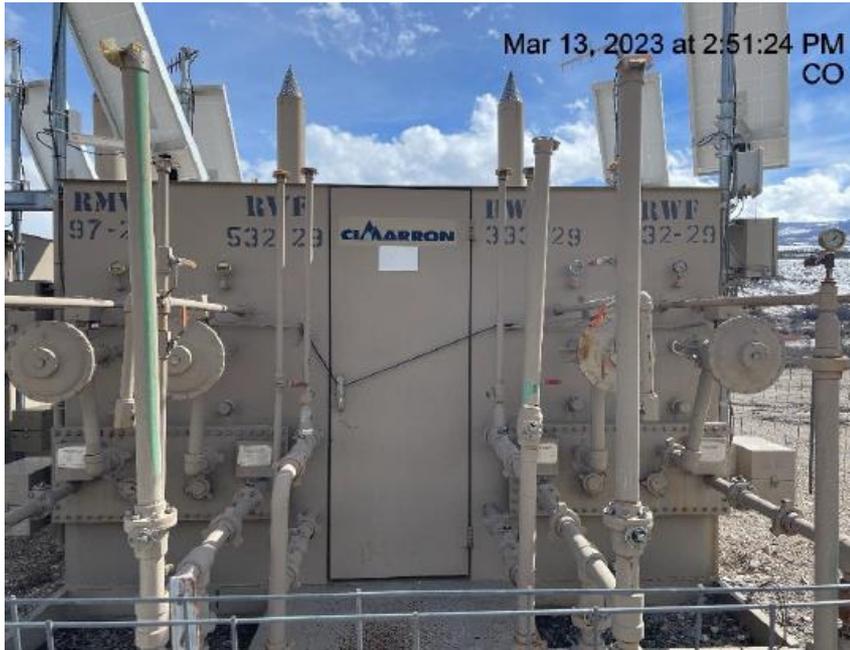
Photo # 2332 From Inspection 708900110 conducted on 03/13/2023 Meter calibration info not conspicuously posted

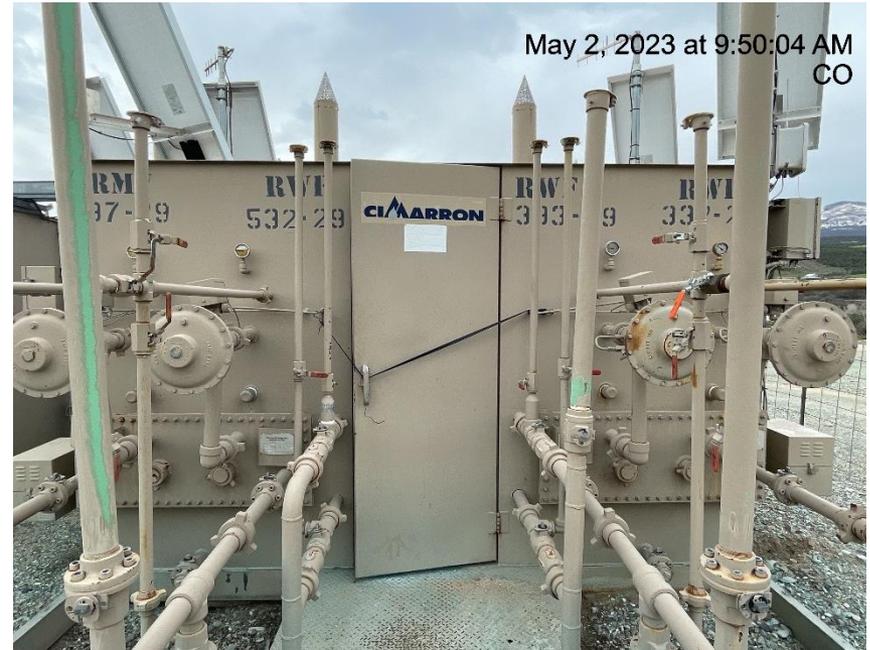
Photo # 6709 Meter calibration info not conspicuously posted

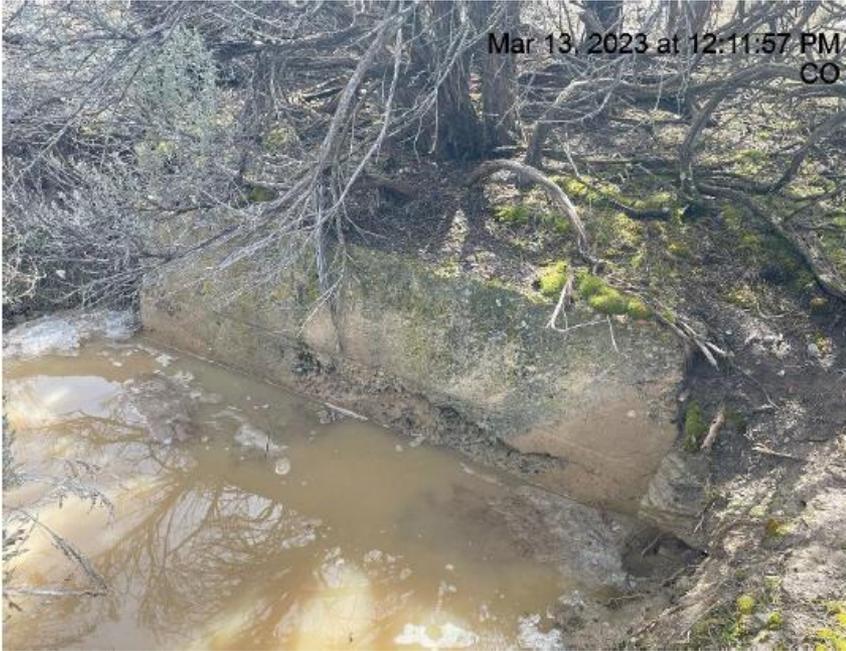
Photo # 2226 From Inspection 708900110 conducted on 03/13/2023 Culvert needs maintenance

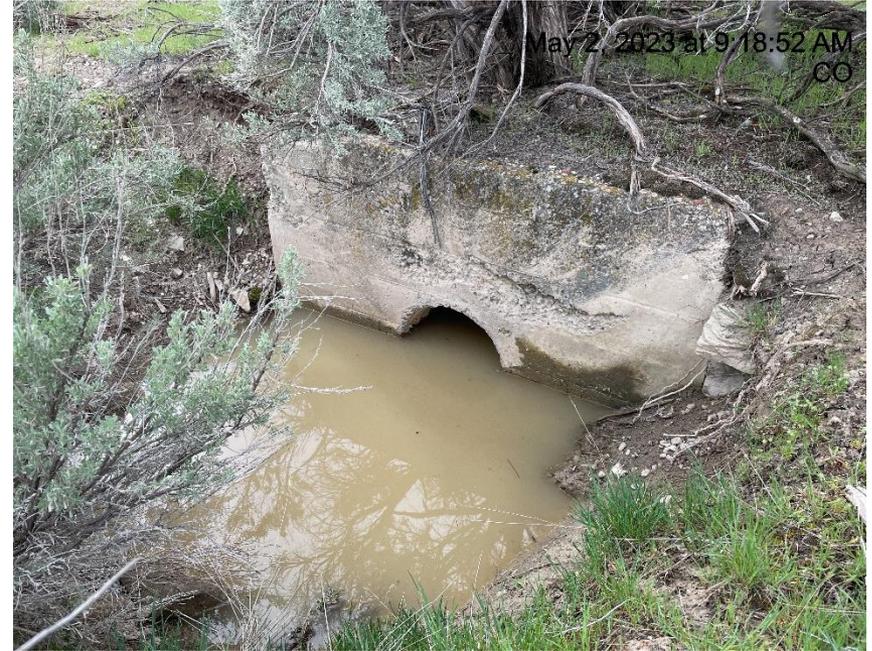
Photo # 6685 Culvert needs maintenance
