# Inspection Photos

API: 009-06134

Operator: SAMSON OIL COMPANY

Inspection Date: 5/3/2023

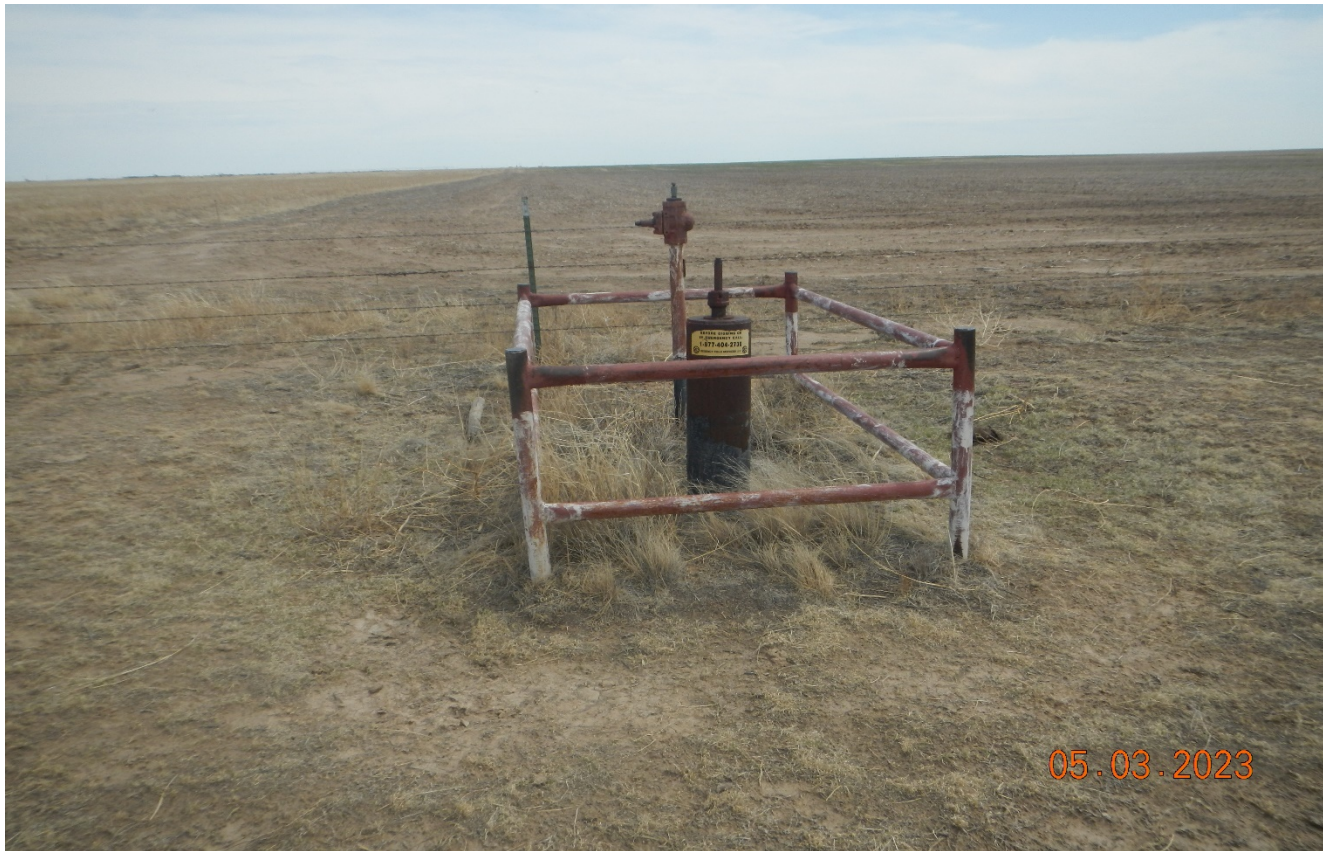
**Photo 1.** Approximately 100' northeast of the location is an abandoned pipeline user which must be removed.

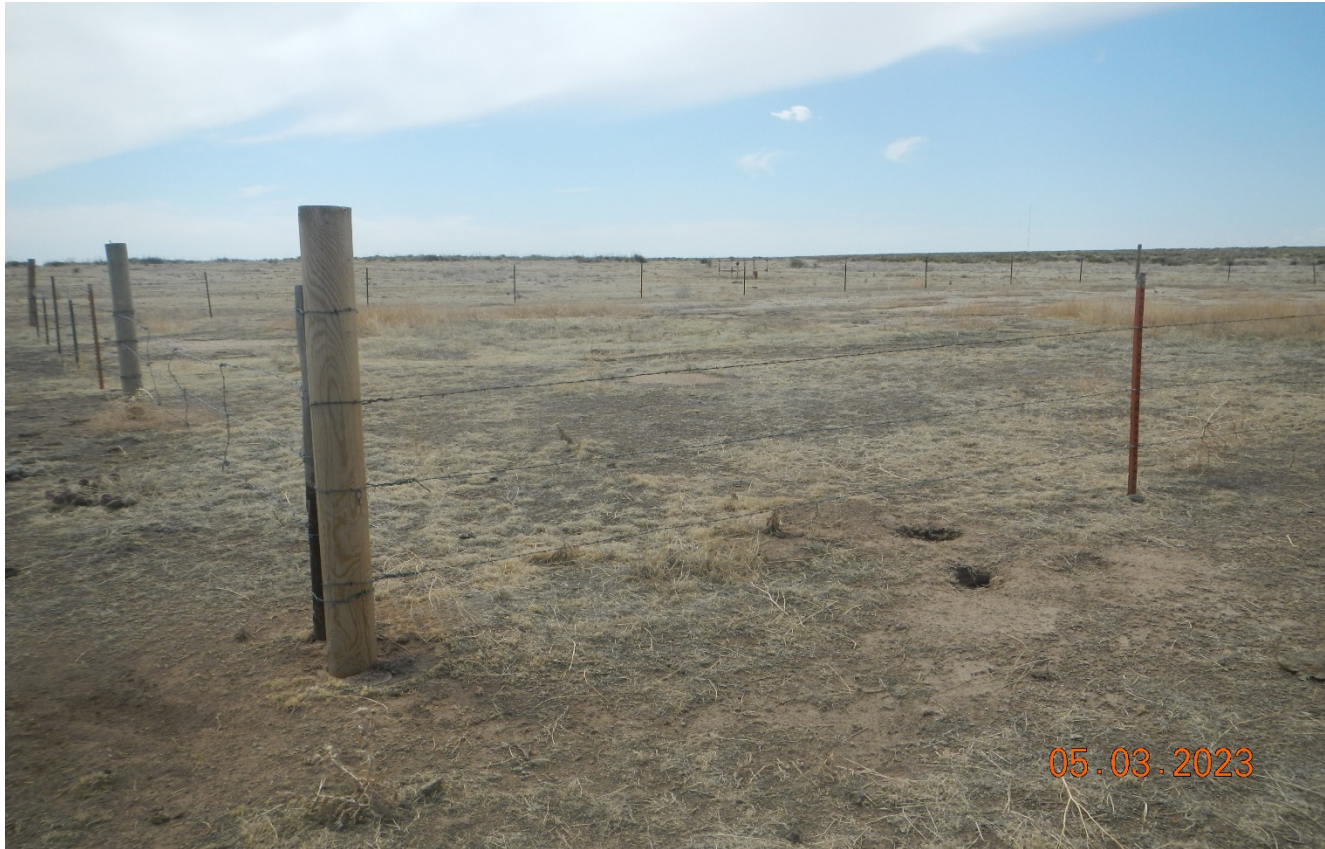
**Photo 2.** Facing southwest toward the location which has been fenced off. There are areas that are bare of vegetation. Soils may be impacted preventing vegetation growth.

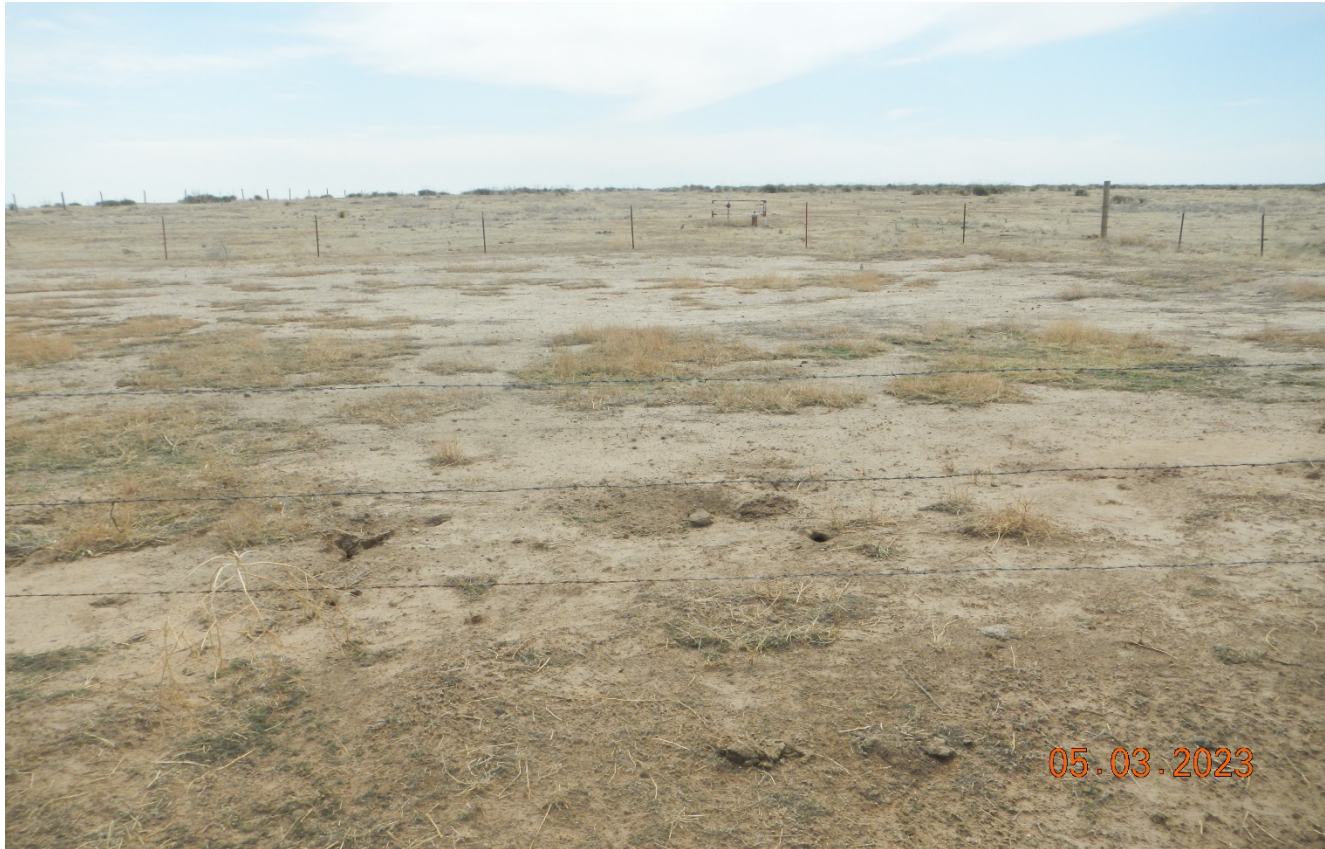
**Photo 3.** Facing south at the location. There are areas that are bare of vegetation. Soils may be impacted preventing vegetation growth.

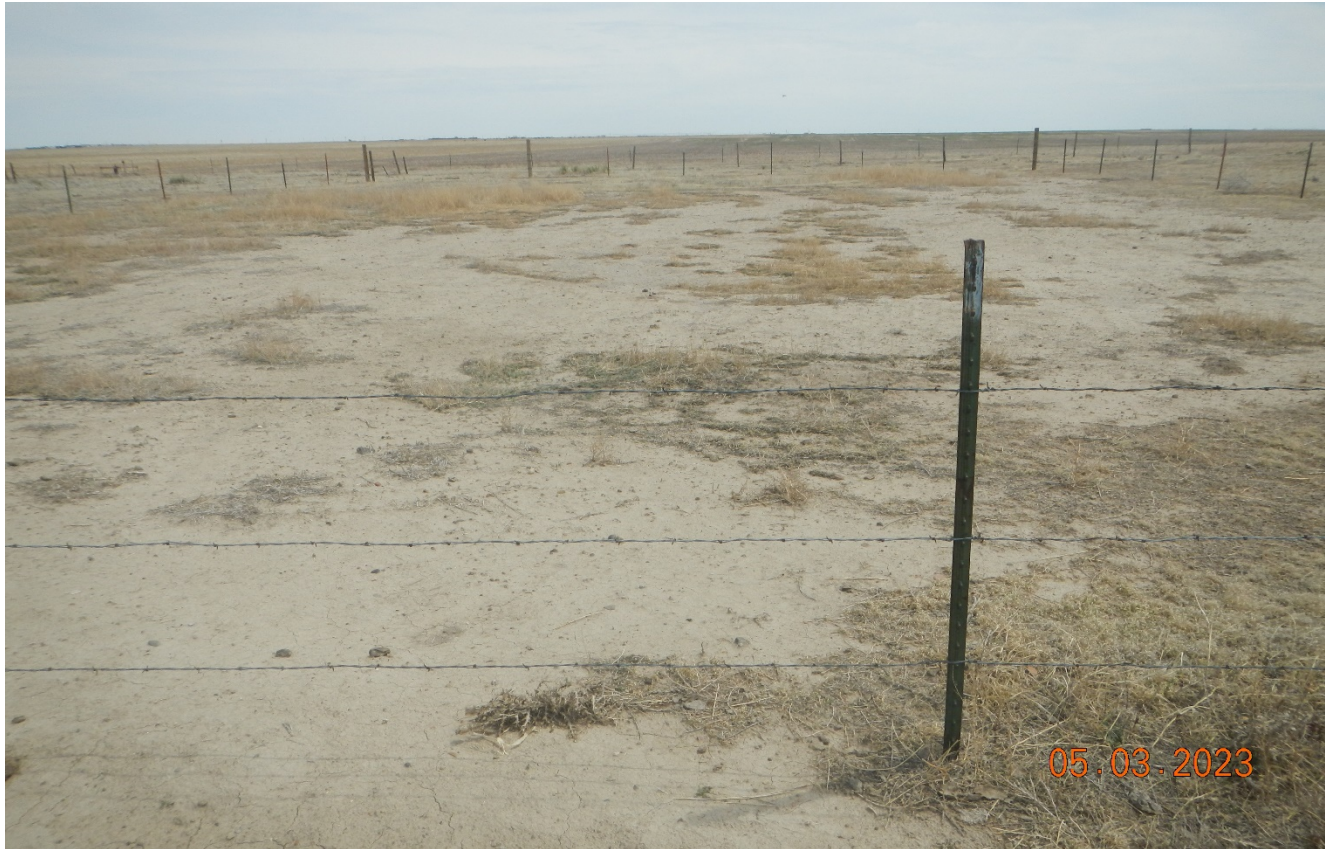
**Photo 4.** Facing east at the west side of the location. There are areas that are bare of vegetation. Soils may be impacted preventing vegetation growth.

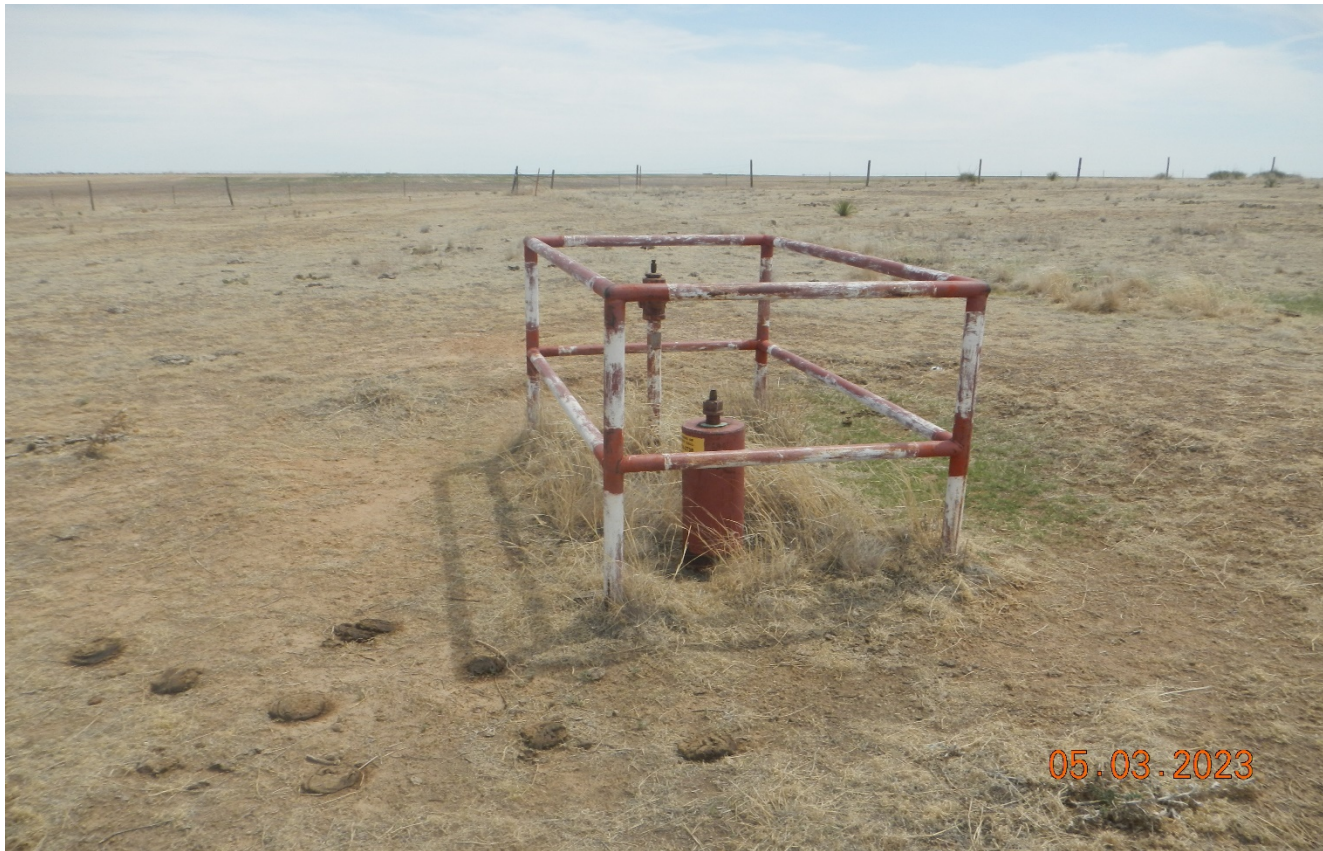
**Photo 5.** There is another pipeline riser that remains at the south side of the location that has not been removed
