Inspection Photos

API: 009-06268

Operator: DOVER ATWOOD CORPORATION

Inspection Date: 5/3/2023

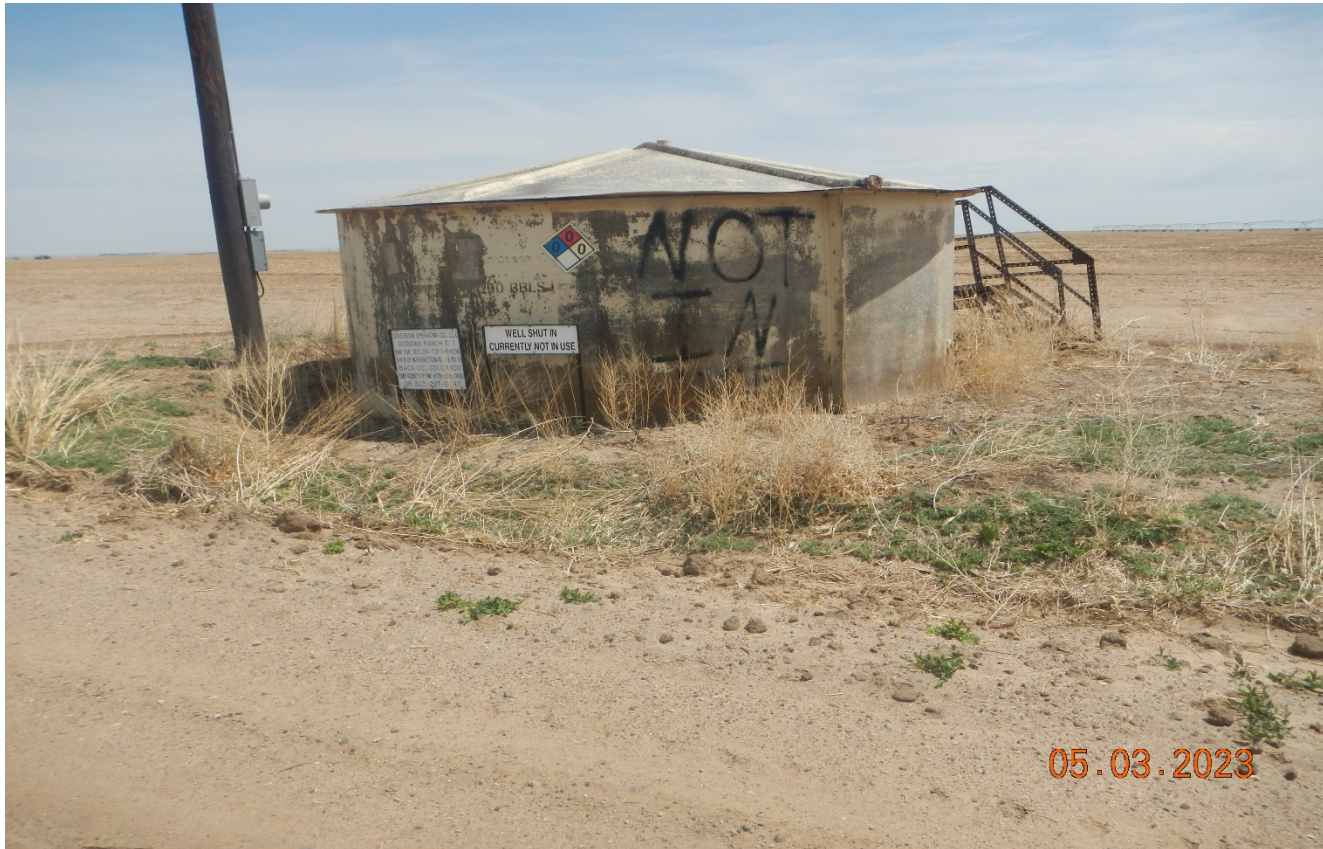
Photo 1. Facing east toward the tank battery along the access road. The sign at the tank does not reflect current Operator or emergency contact INFO. If tank is not in use it must be removed. Tank berm is inadequate.

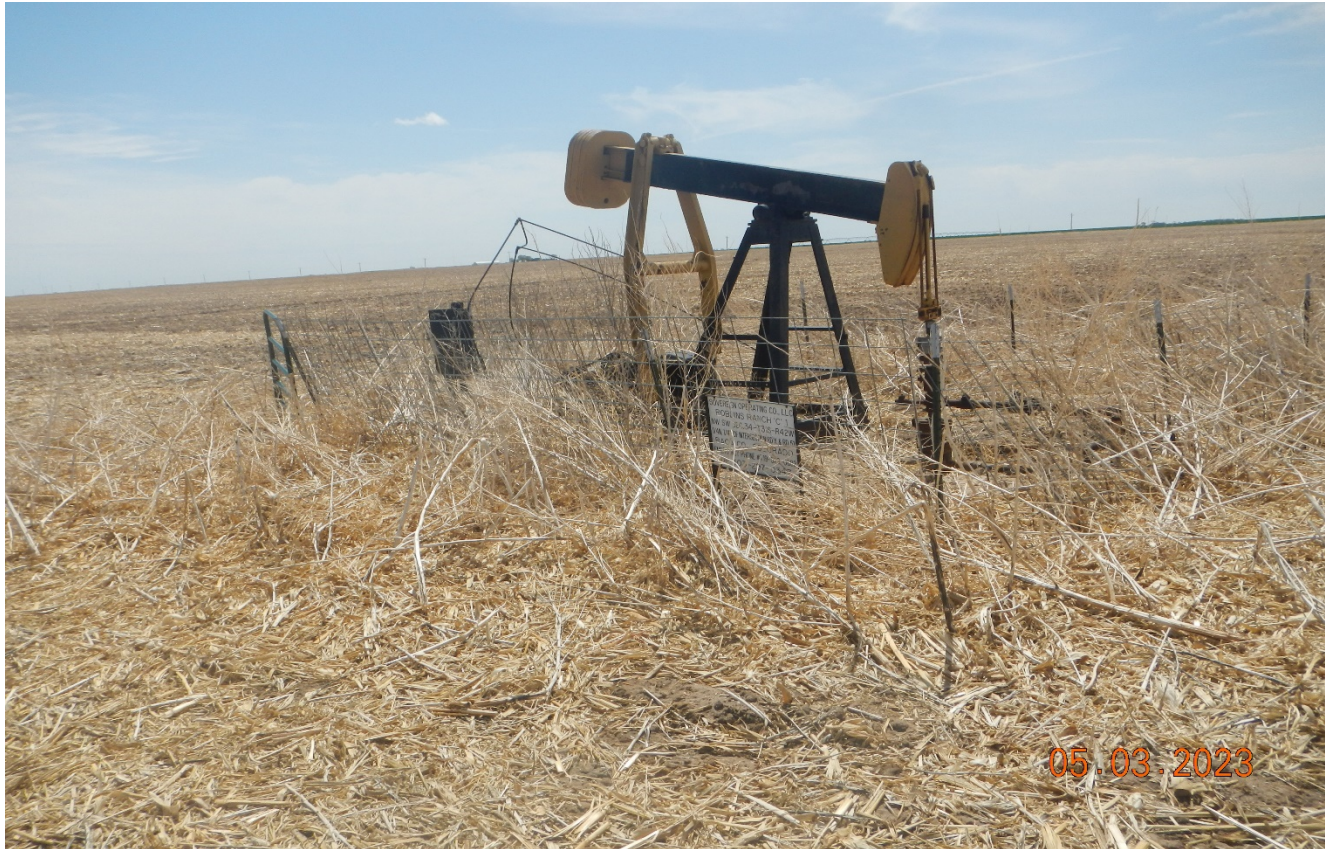
Photo 2. Facing toward the wellhead. There is vegetation debris around the equipment which is a fire hazard. The sign at the well does not reflect current Operator or emergency contact INFO.
