# Inspection Photos

API: 009-06081

Operator: DOVER ATWOOD CORPORATION

Inspection Date: 5/3/2023

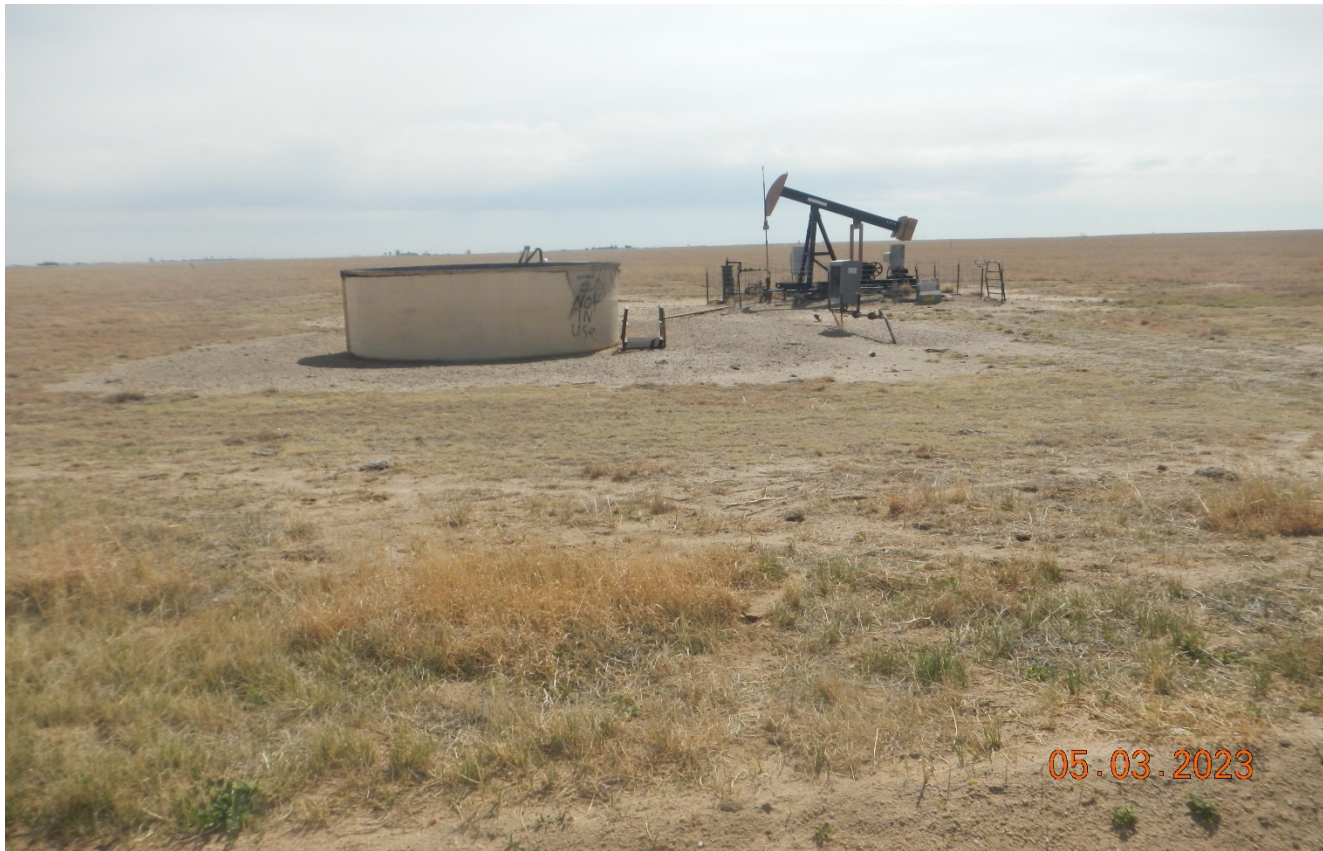
**Photo 1.** Facing toward the wellsite.

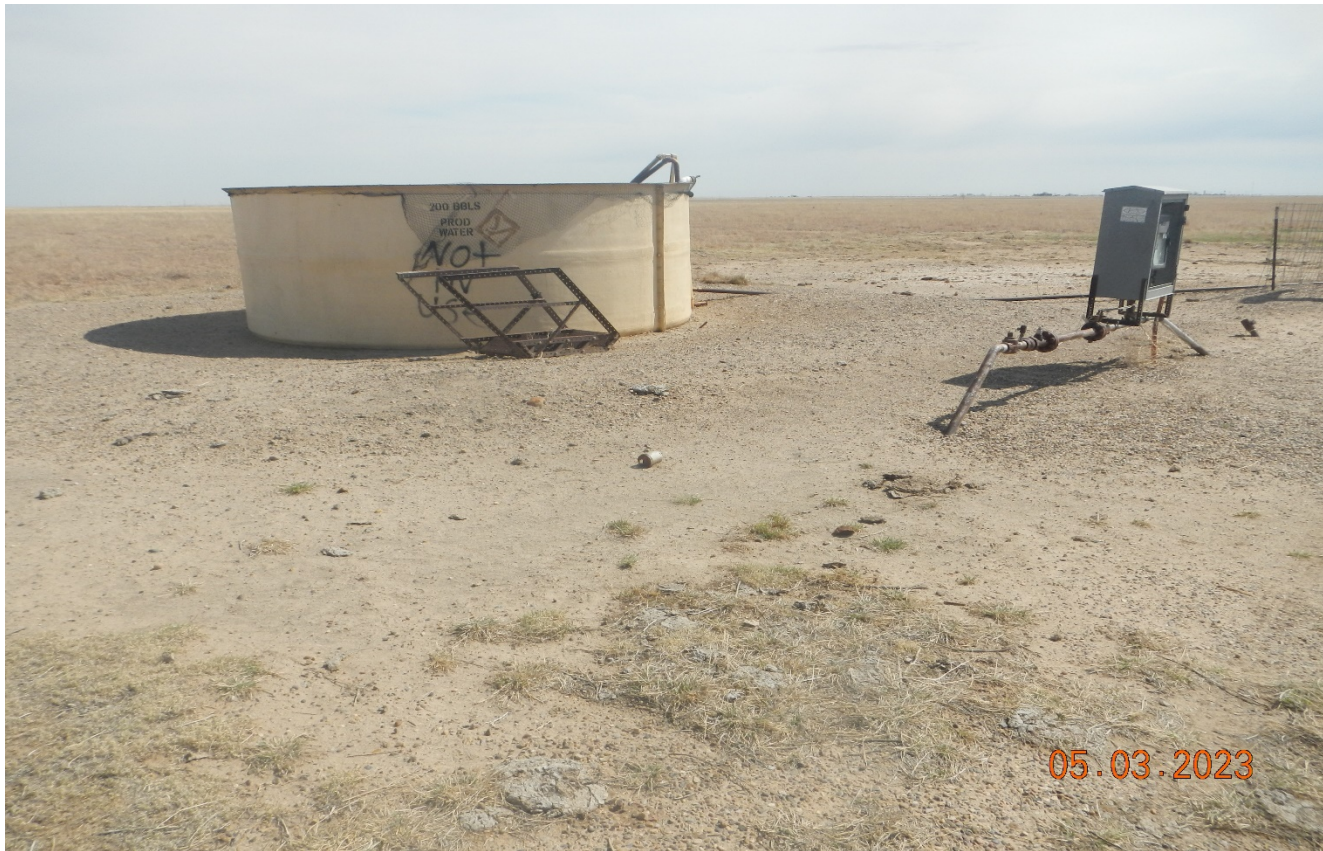
**Photo 2.** Facing toward the open top tank which still does not have secondary containment.

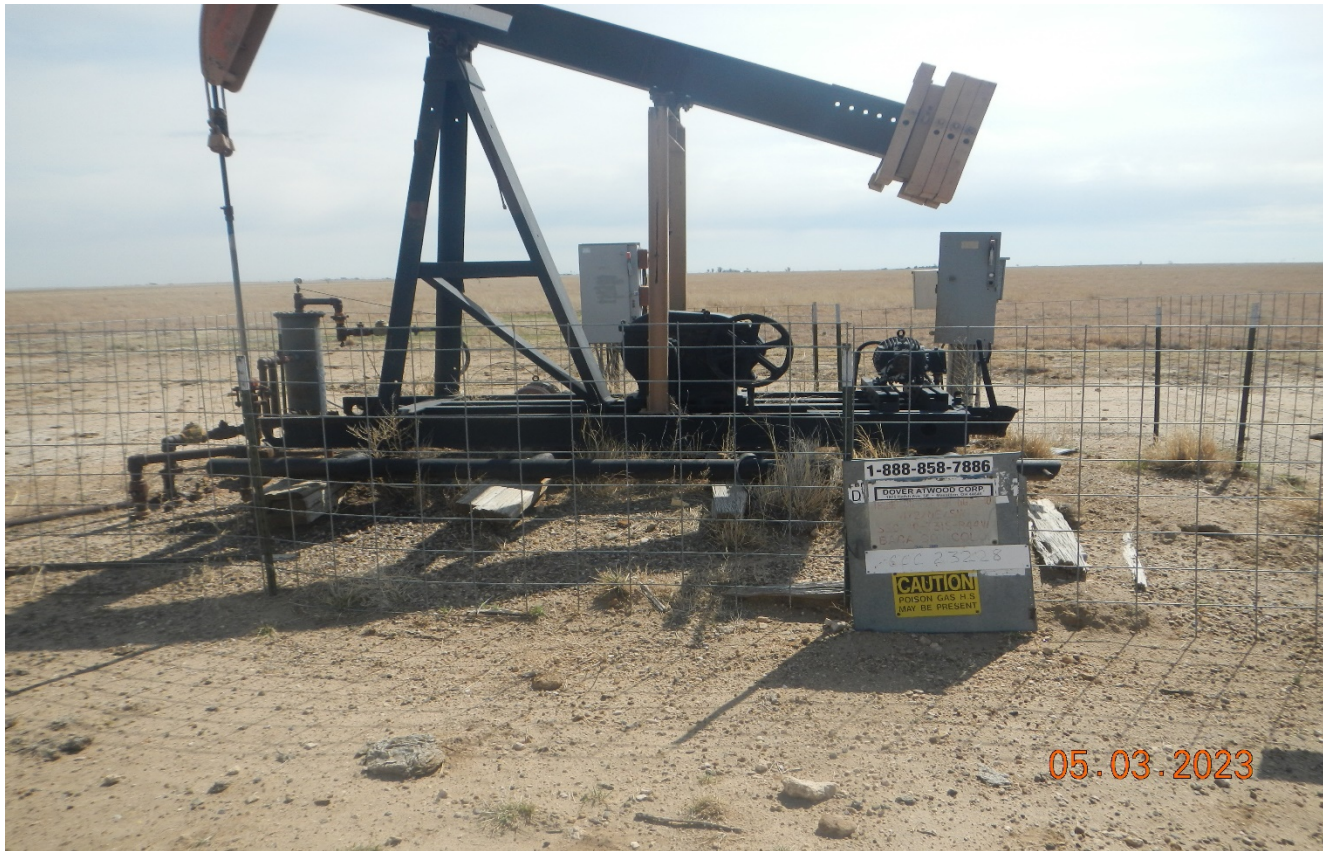
**Photo 3.** The well sign does not comply with 605. Incorrect Operator Emergency number and missing information.

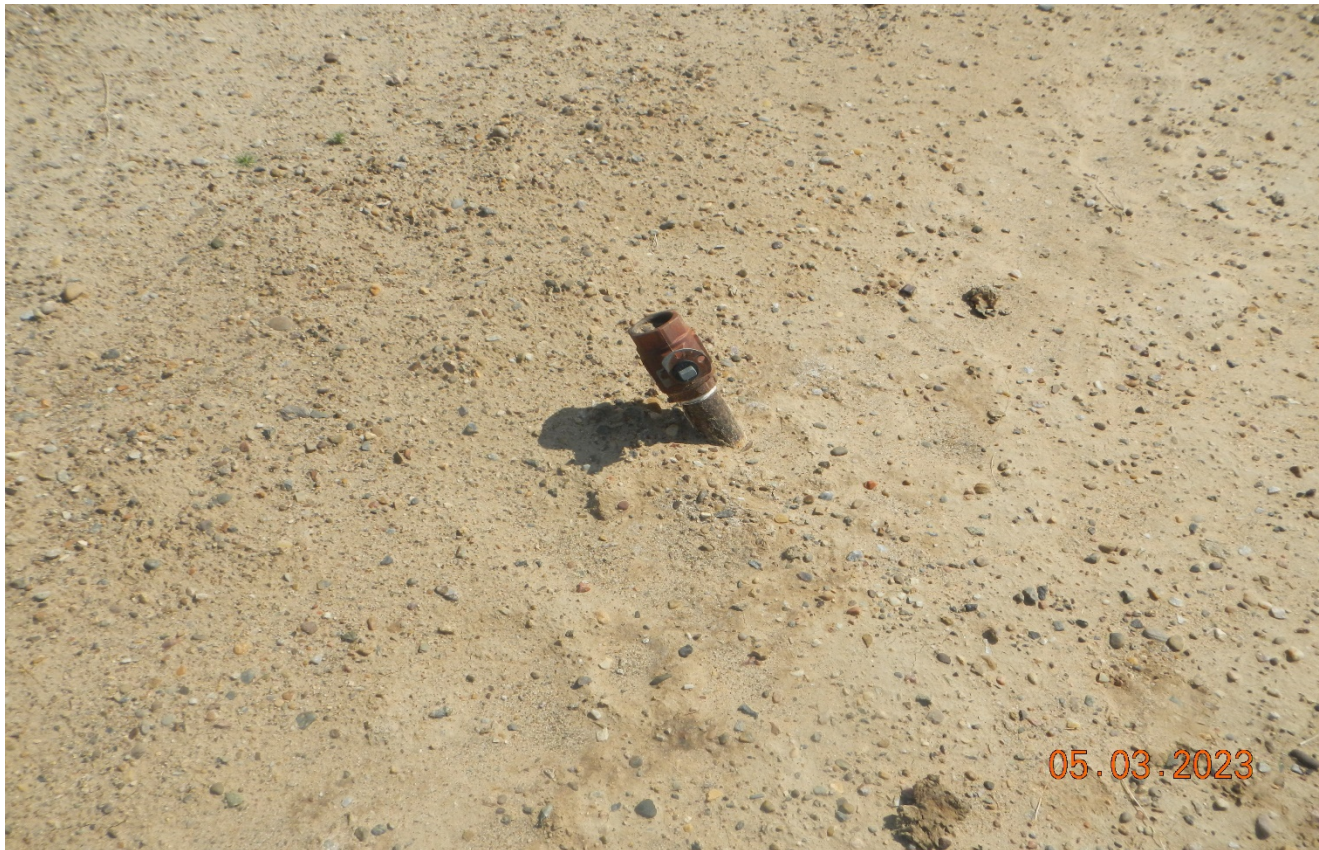
**Photo 4.** Unused pipe riser still remains with no OOSLAT.
