**Inspection Photos**  
**Well Name: Ocoma 31-18**  
**API #05-123-14803**

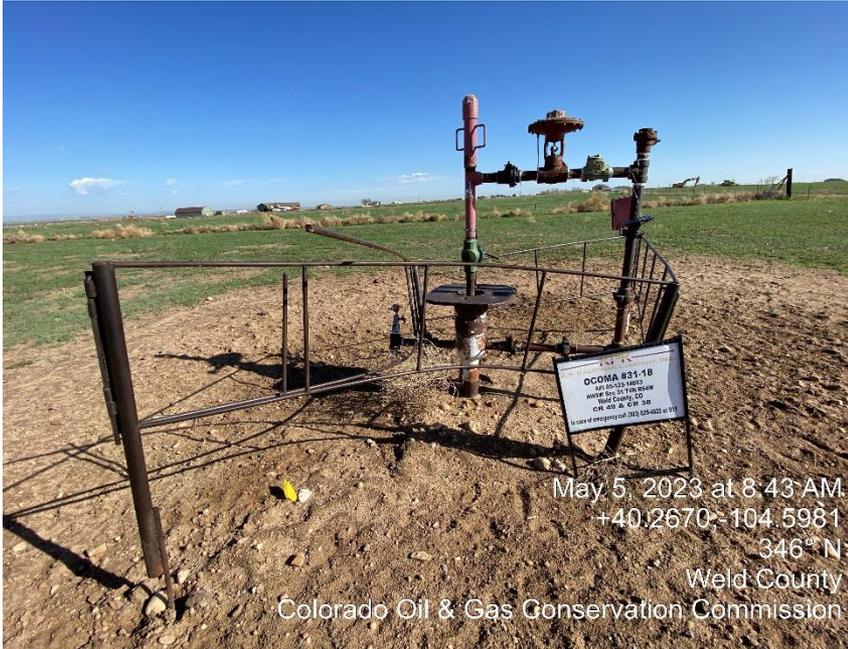
**Photo #1 Well and Mangled fence**

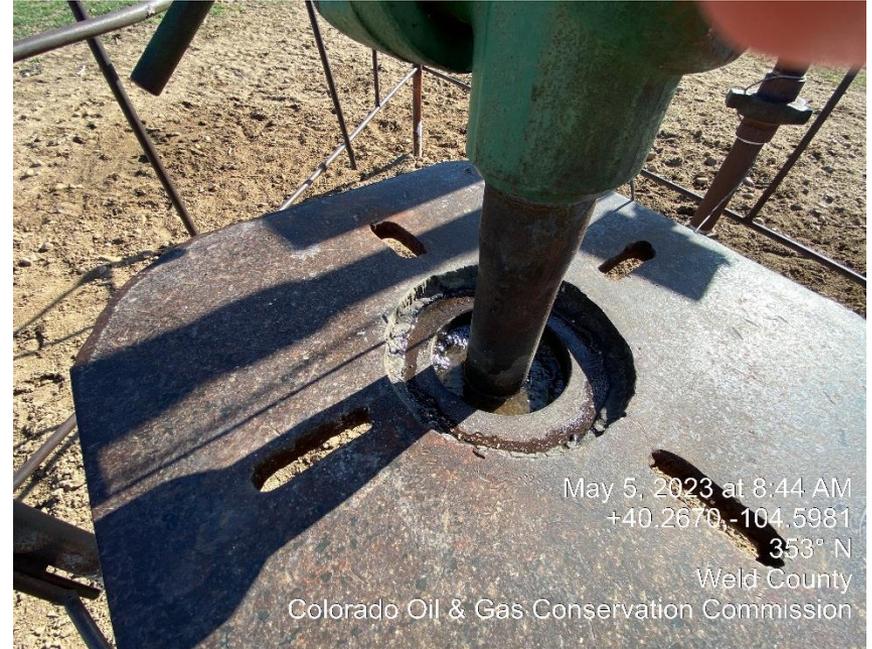
**Photo #2 packing leak**
