Stormwater Management and Erosion control

Location Name: CAERUS PICEANCE LLC N. PARACHUTE-66S96W /28NENW

Location #: 335200

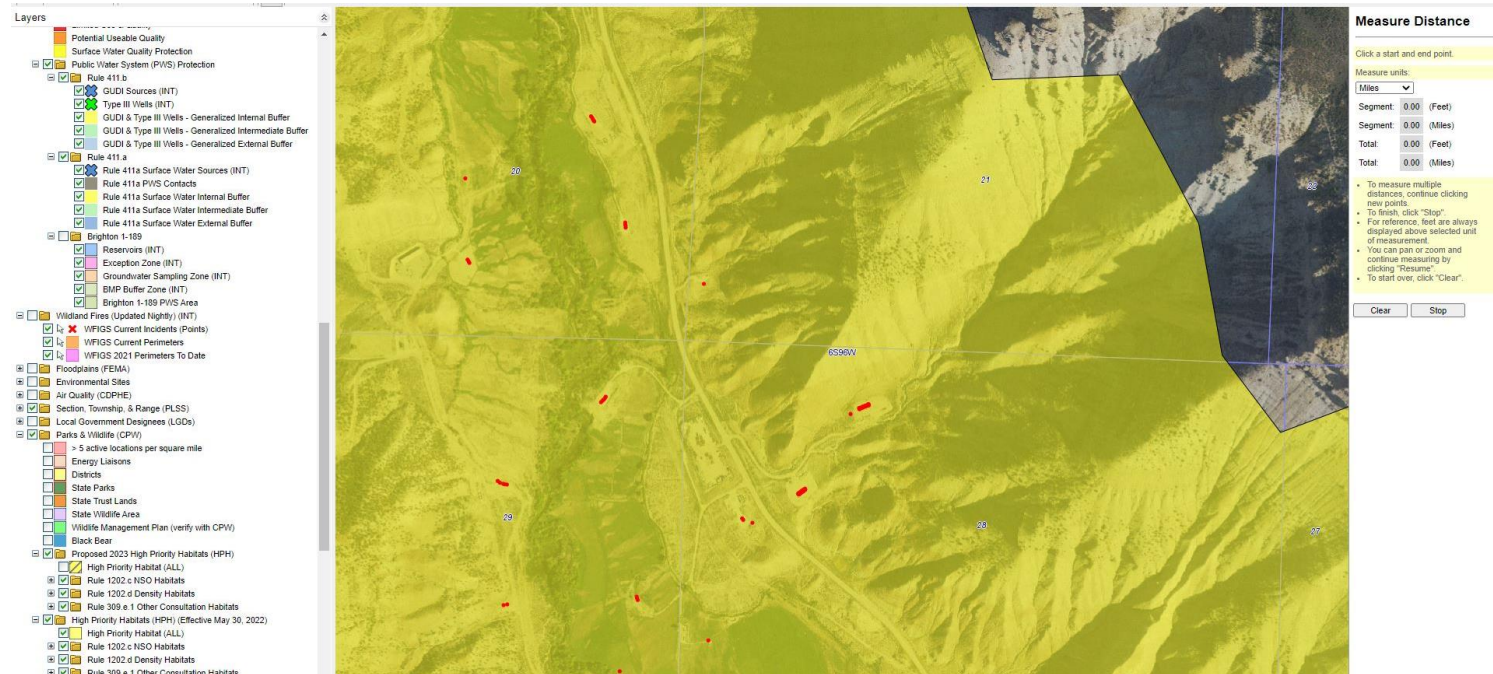
Location Overview: Location is located in a high priority habitat area.

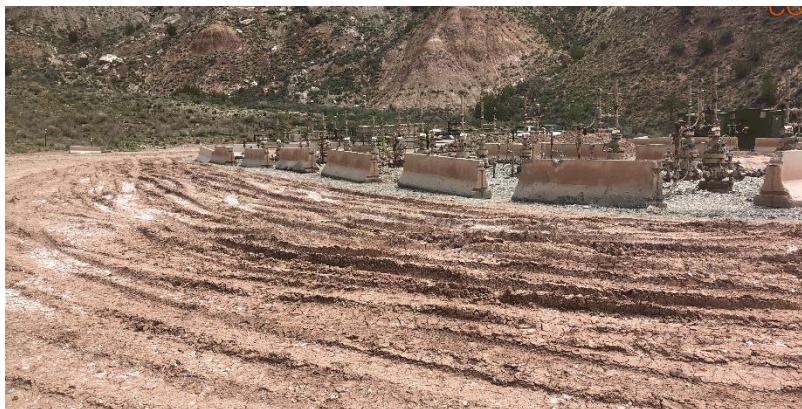
Northwest corner of location.

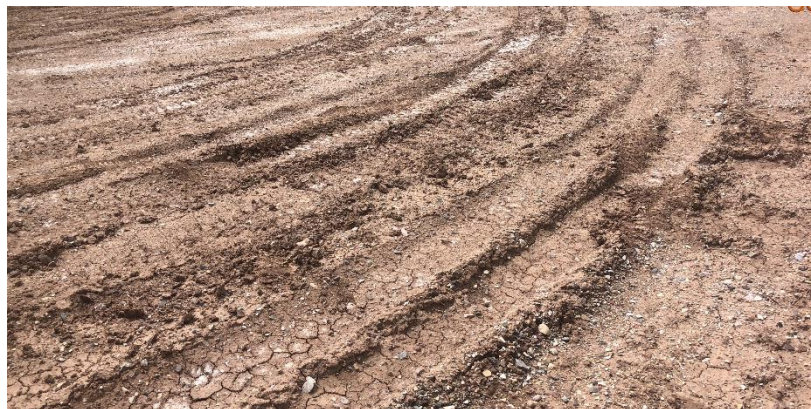
Northeast corner of location.

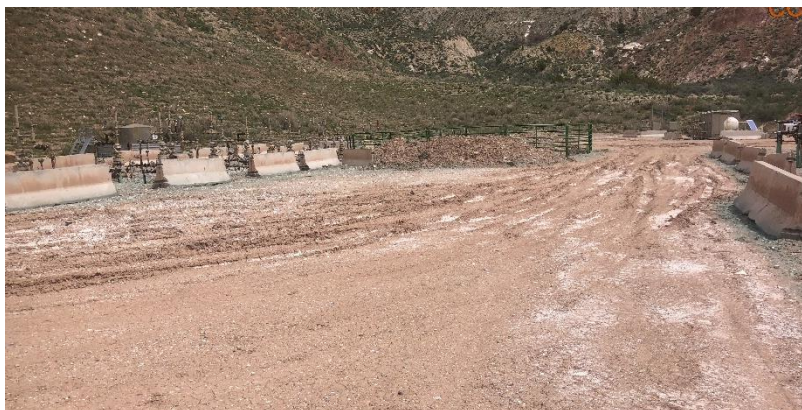
Southwest corner of location.

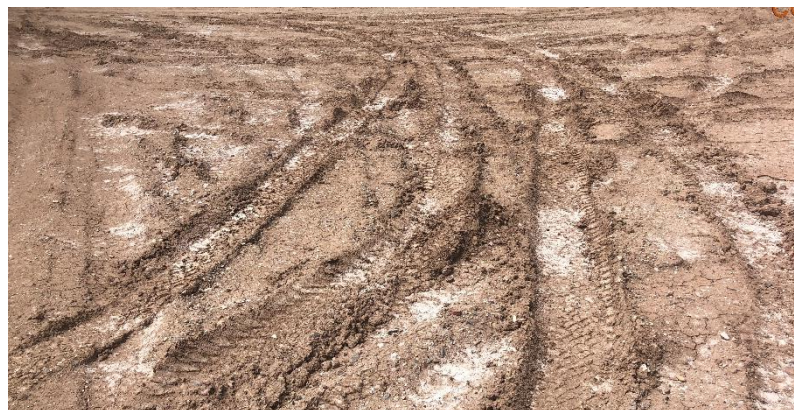
Southeast corner of location.

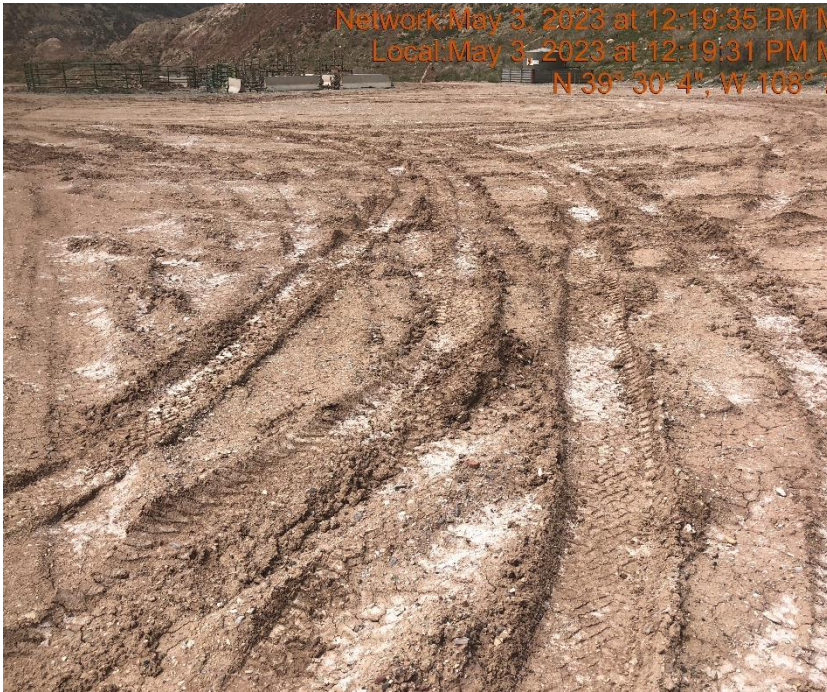
Photo #9840 Location lacks stabilization

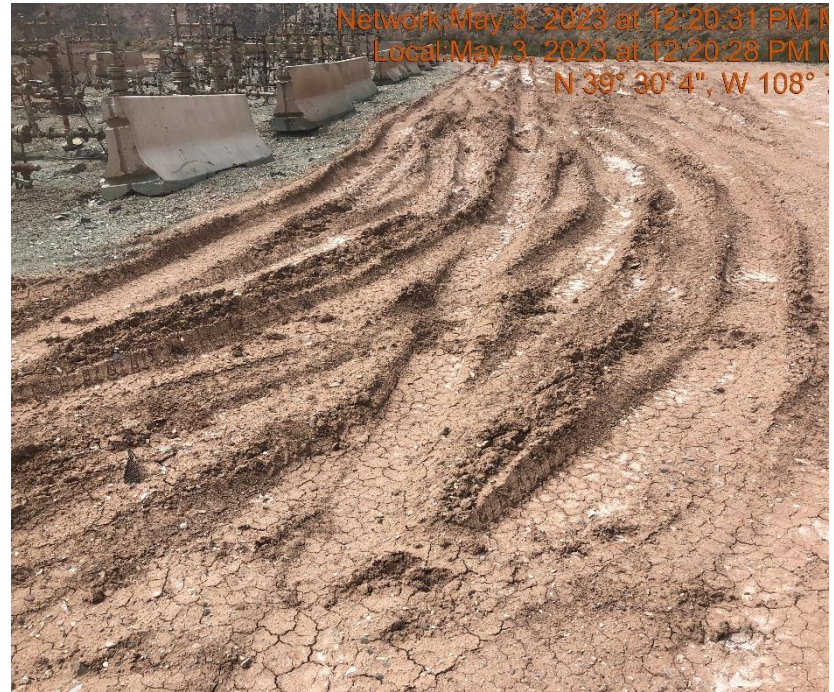
Photo #9844 Location lacks stabilization

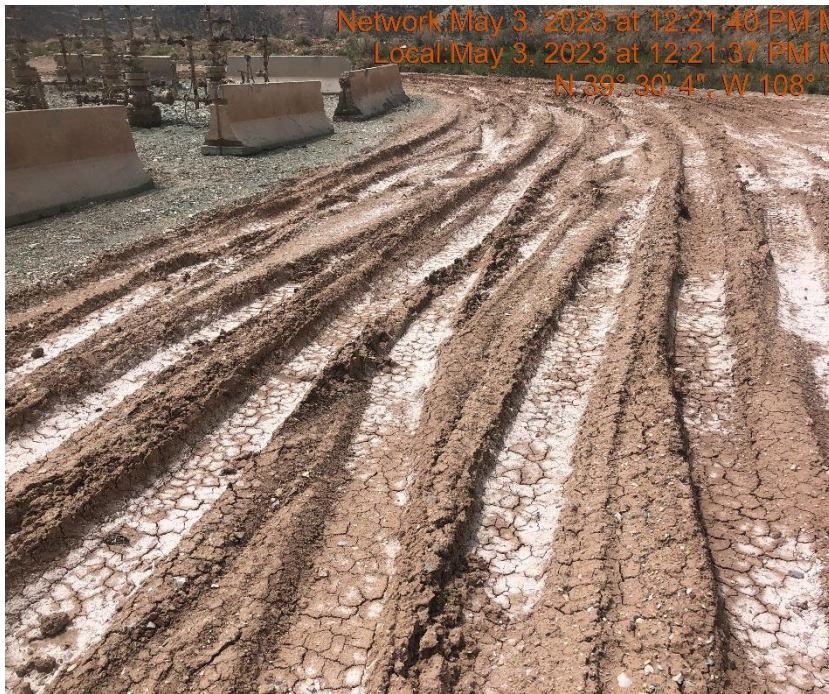
Photo #9848 Location lacks stabilization

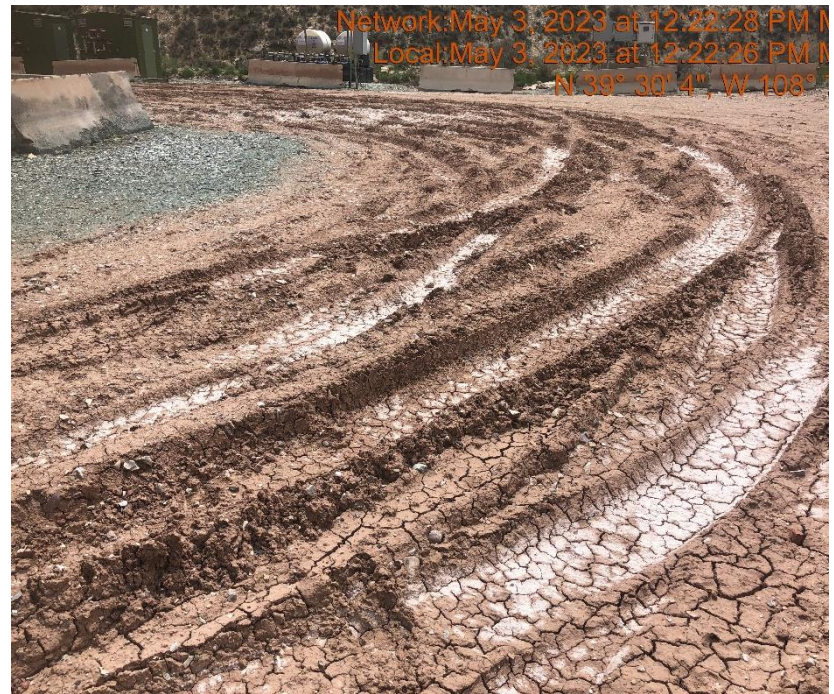
Photo #9850 Location lacks stabilization.

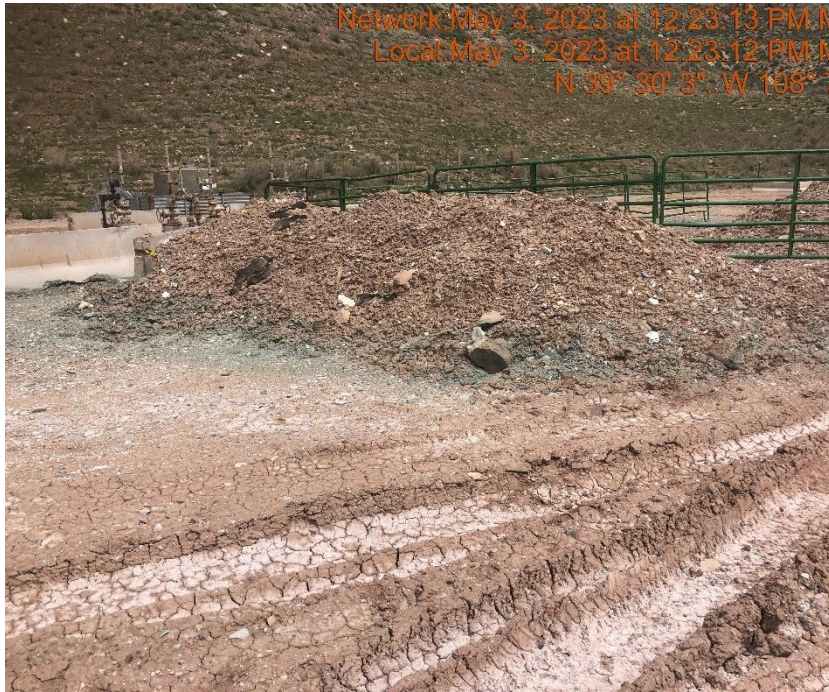
Photo #9853 Insufficient stock piled soils BMPs

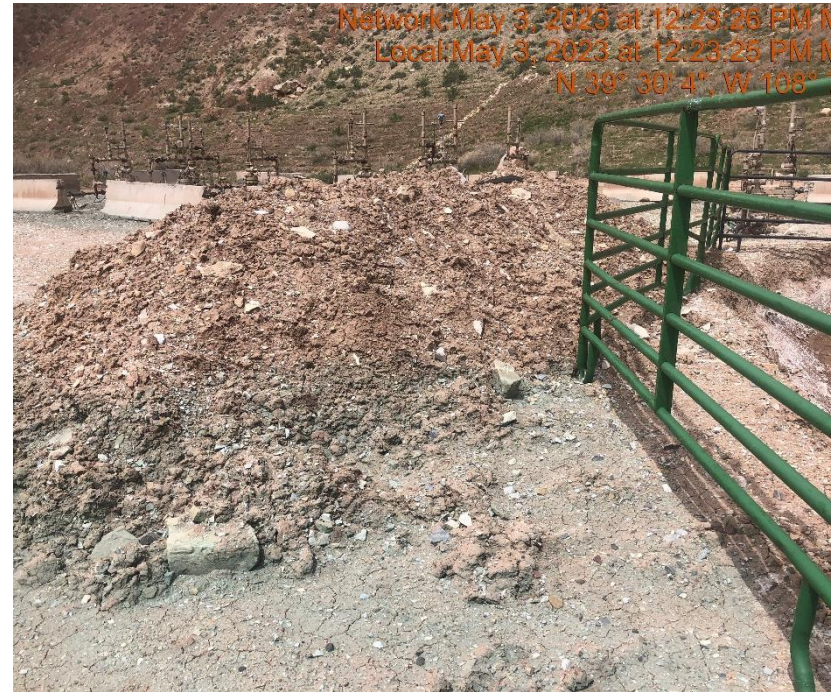
Photo #9854 Insufficient stock piled soils BMPs

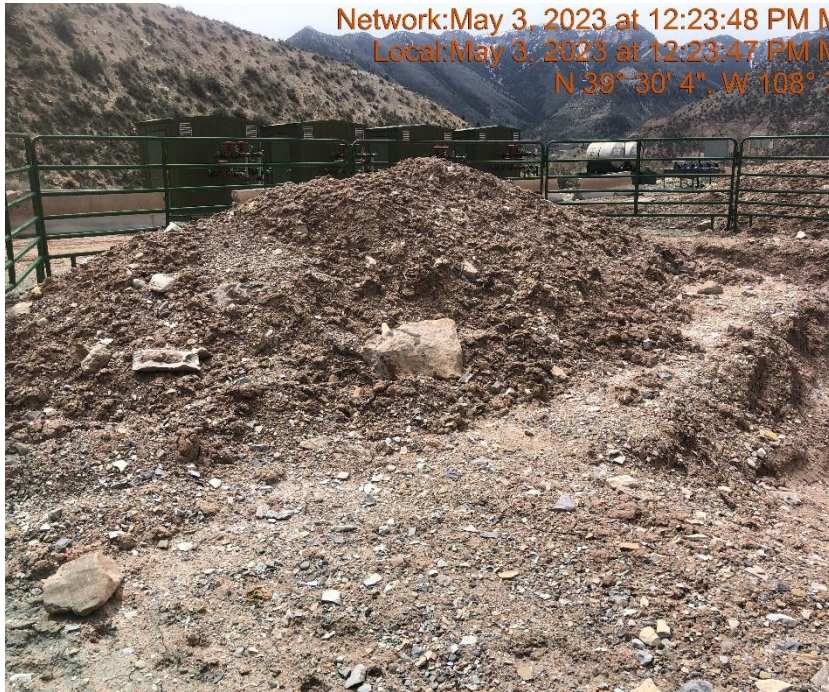
Photo #9855 Insufficient stockpiled soil BMPs

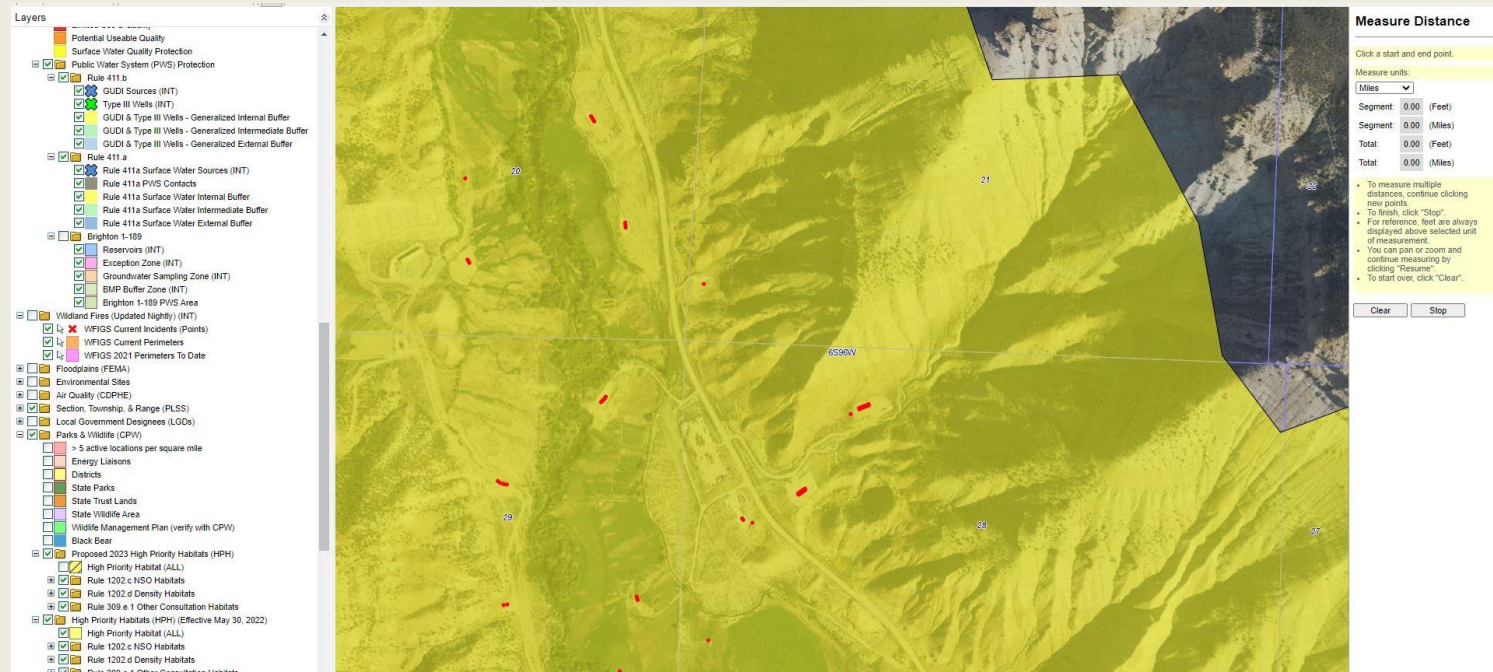
Access Road overview: Access road is located in a high priority habitat area.
Section/Township/Range: 28 6S96W

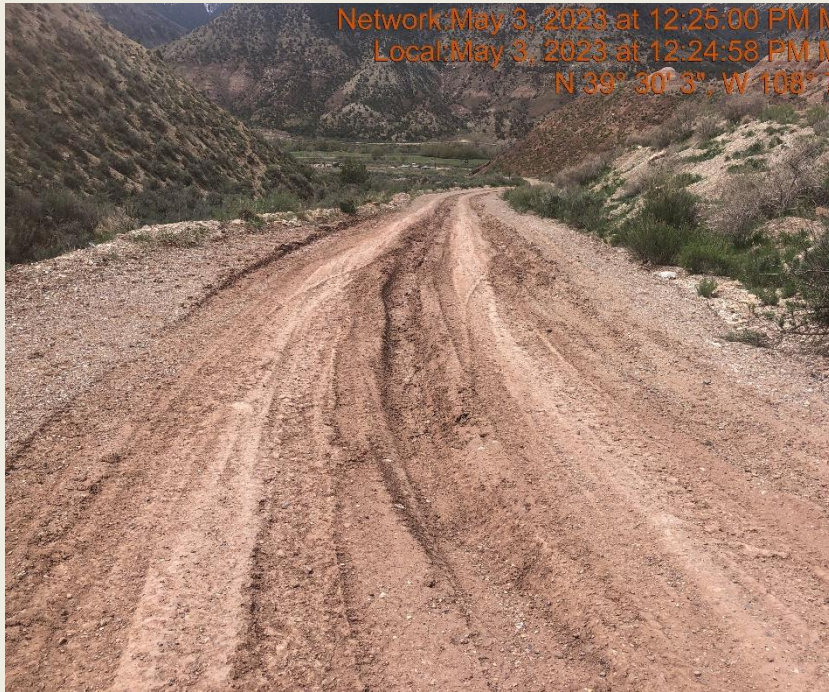
Photo #9859 Access road lacks stabilization

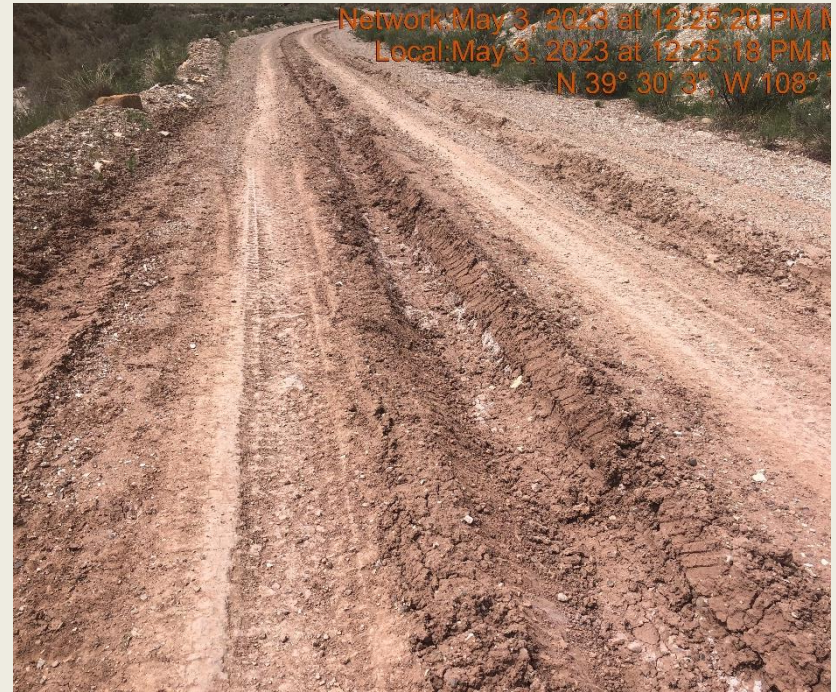
Photo #9860 Access road lacks stabilization

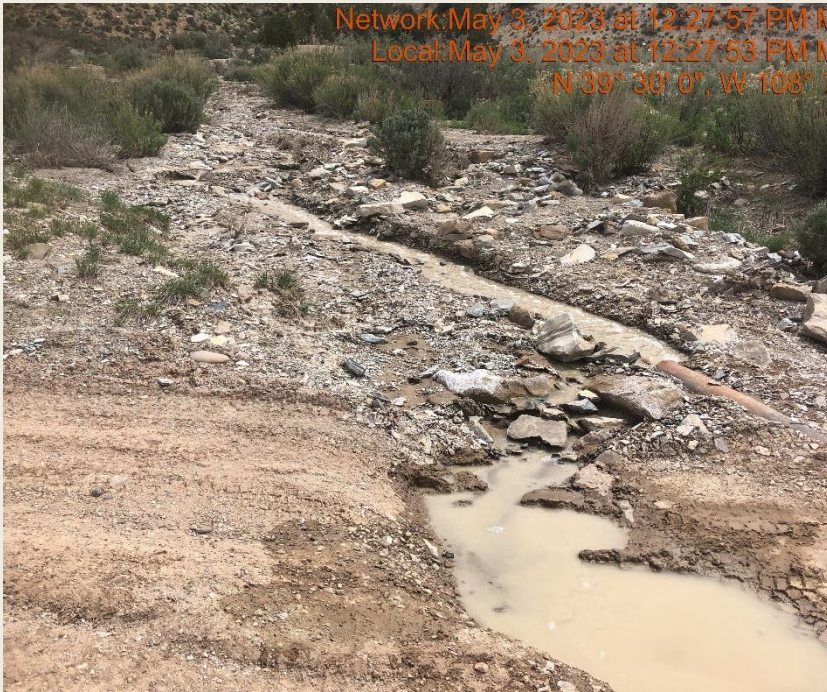
Photo #9862 Culvert capacity insufficient.

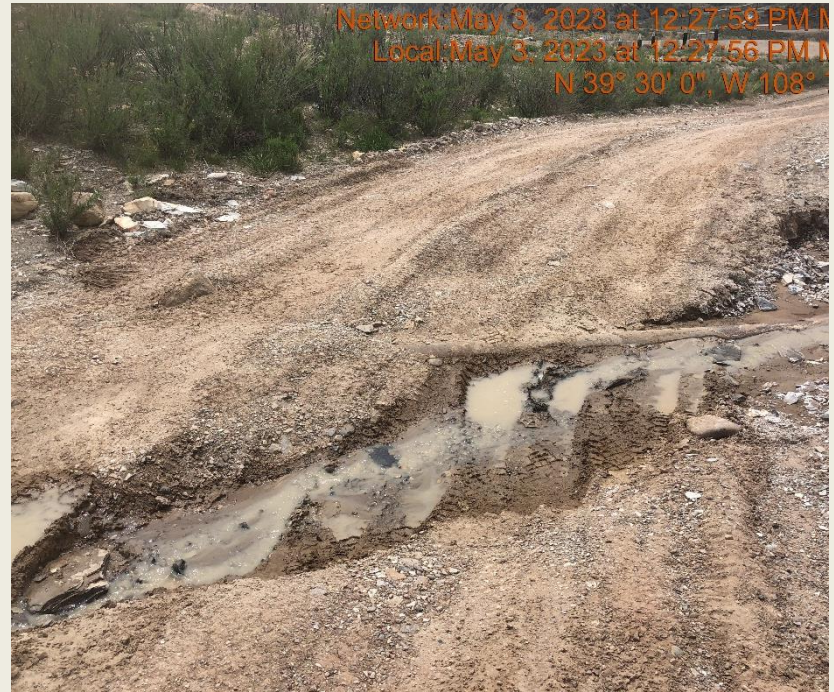
Photo #9863 Culvert capacity insufficient.

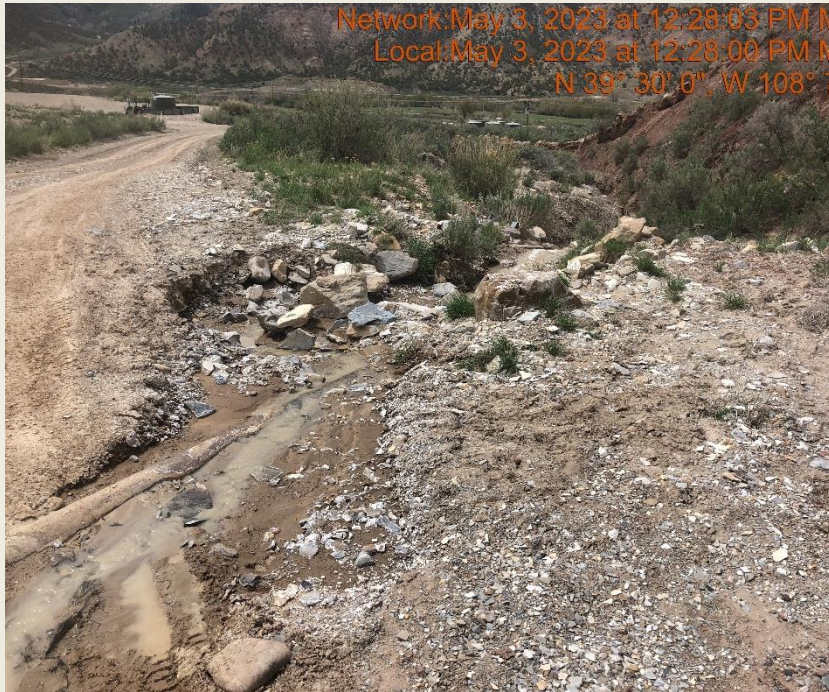
Photo #9864 -Culvert capacity insufficient.

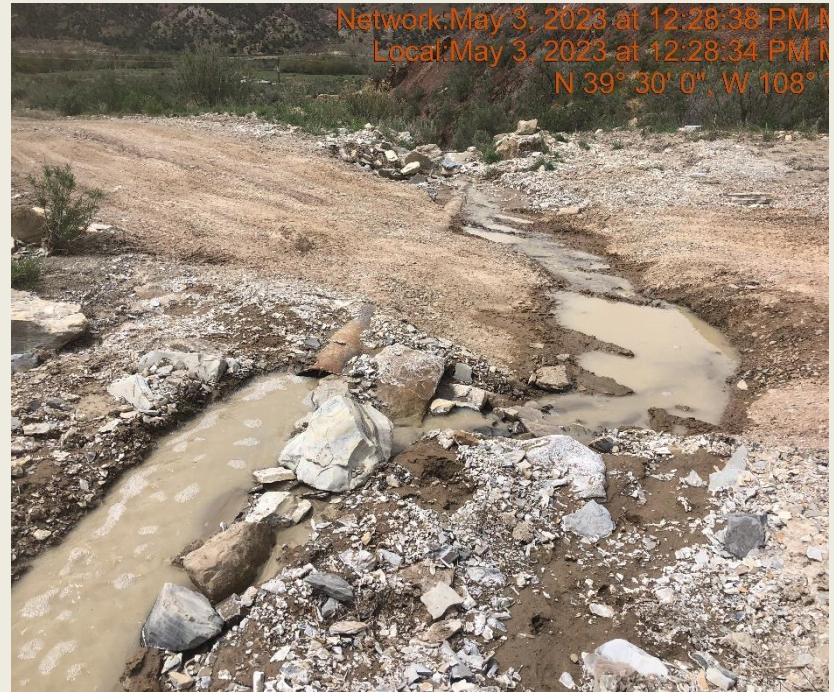
Photo #9866 -Culvert capacity insufficient.
