# Interim Reclamation and Stormwater Inspection

Date: 05/03/2023

Operator: FUNDARE RESOURCES OPERATING  
COMPANY LLC - 10773

Inspection Photos  
Location Name: Razor 30L Pad  
Location ID: 438806

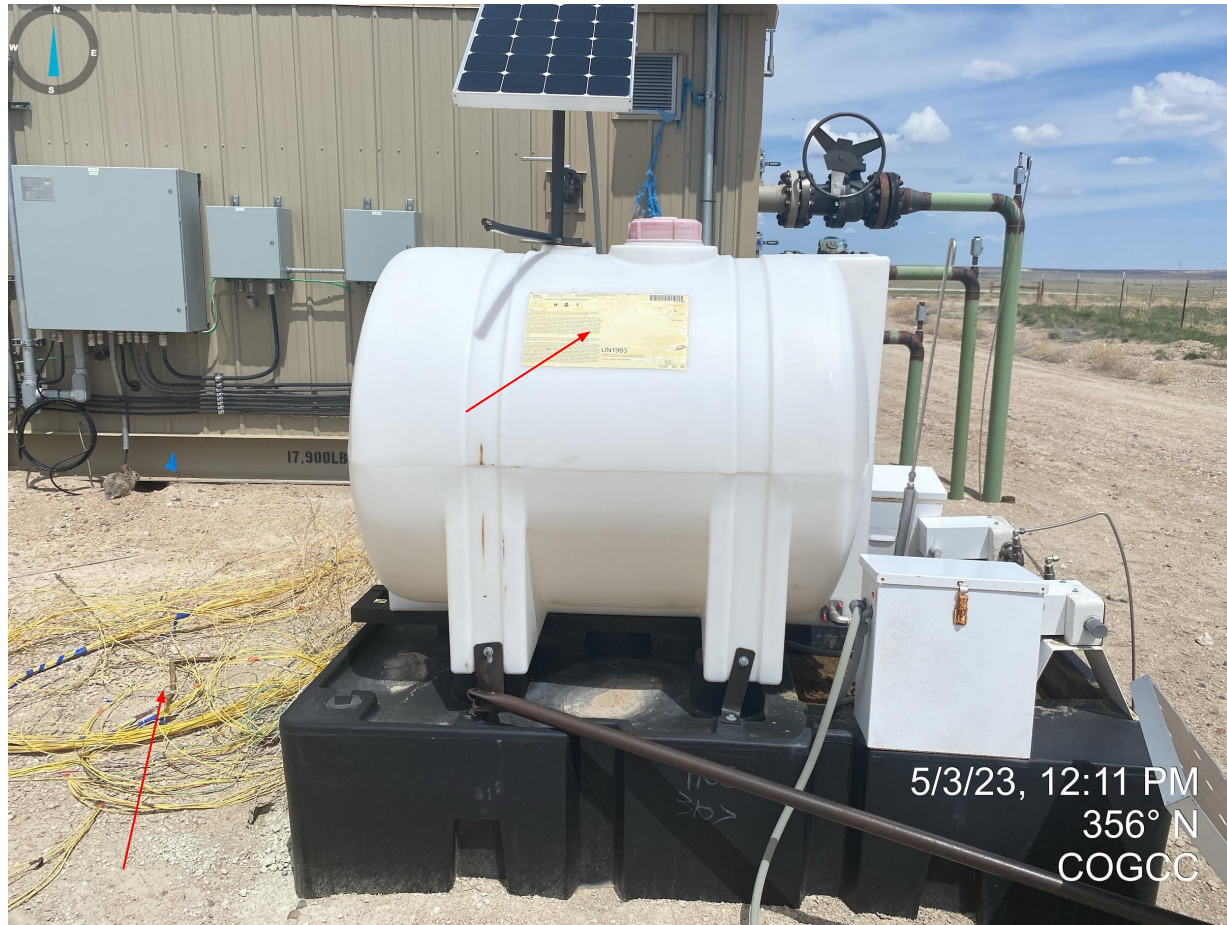
**Photo 1.** Faded/cracked/peeling tank label will need to be replaced. Additionally, unused wires were observed next to tank and are now considered trash and will need to be disposed of, or removed off location.

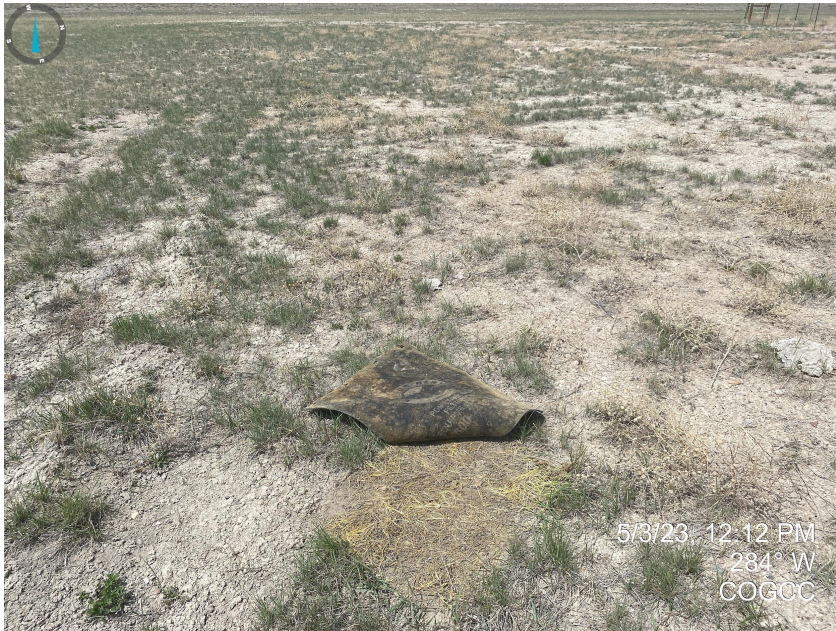
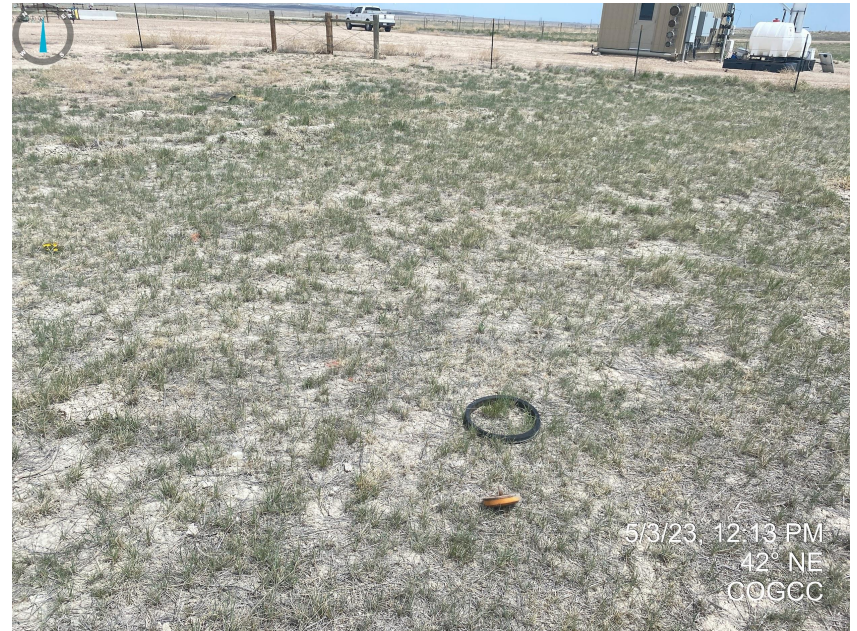
**Photos 2 & 3.** Trash was observed throughout the location and will need to be disposed of. Operator shall self inspect the entire location for trash as these photos are only examples of trash observed during this inspection.

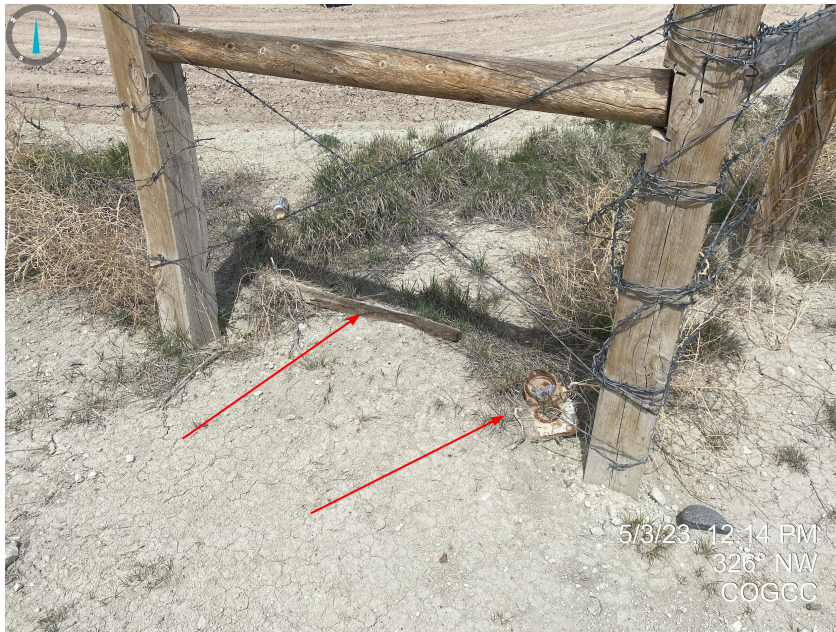
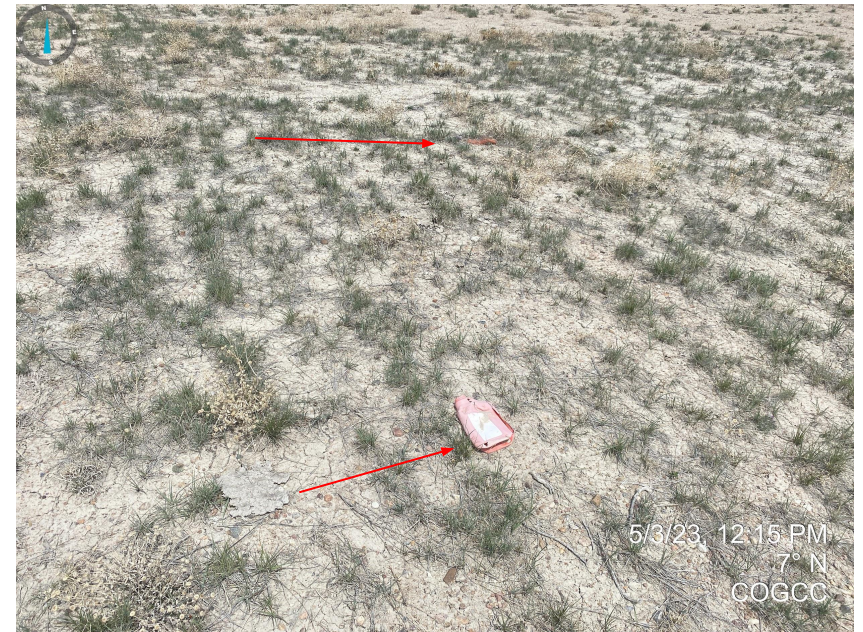
**Photos 4 & 5.** See comments in Photos 2 & 3.

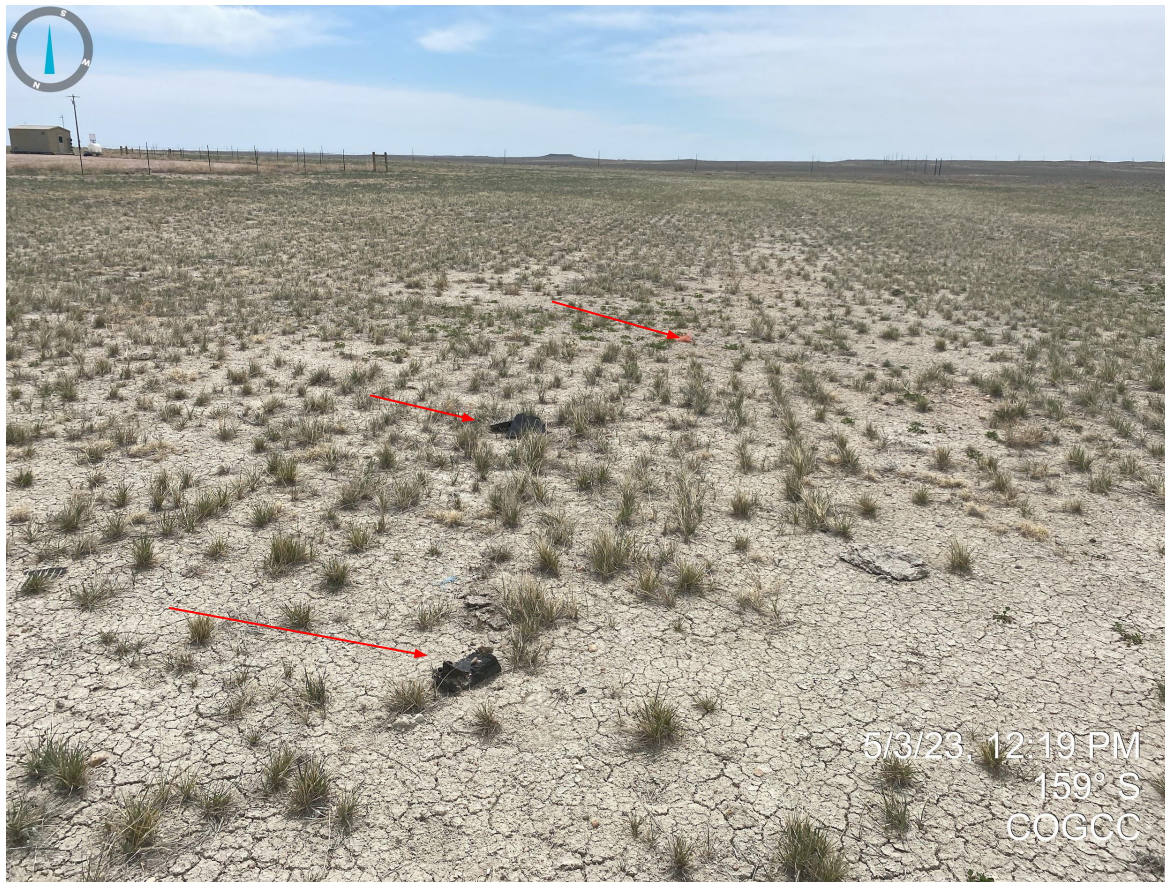
**Photo 6.** See comments in Photos 2 & 3.

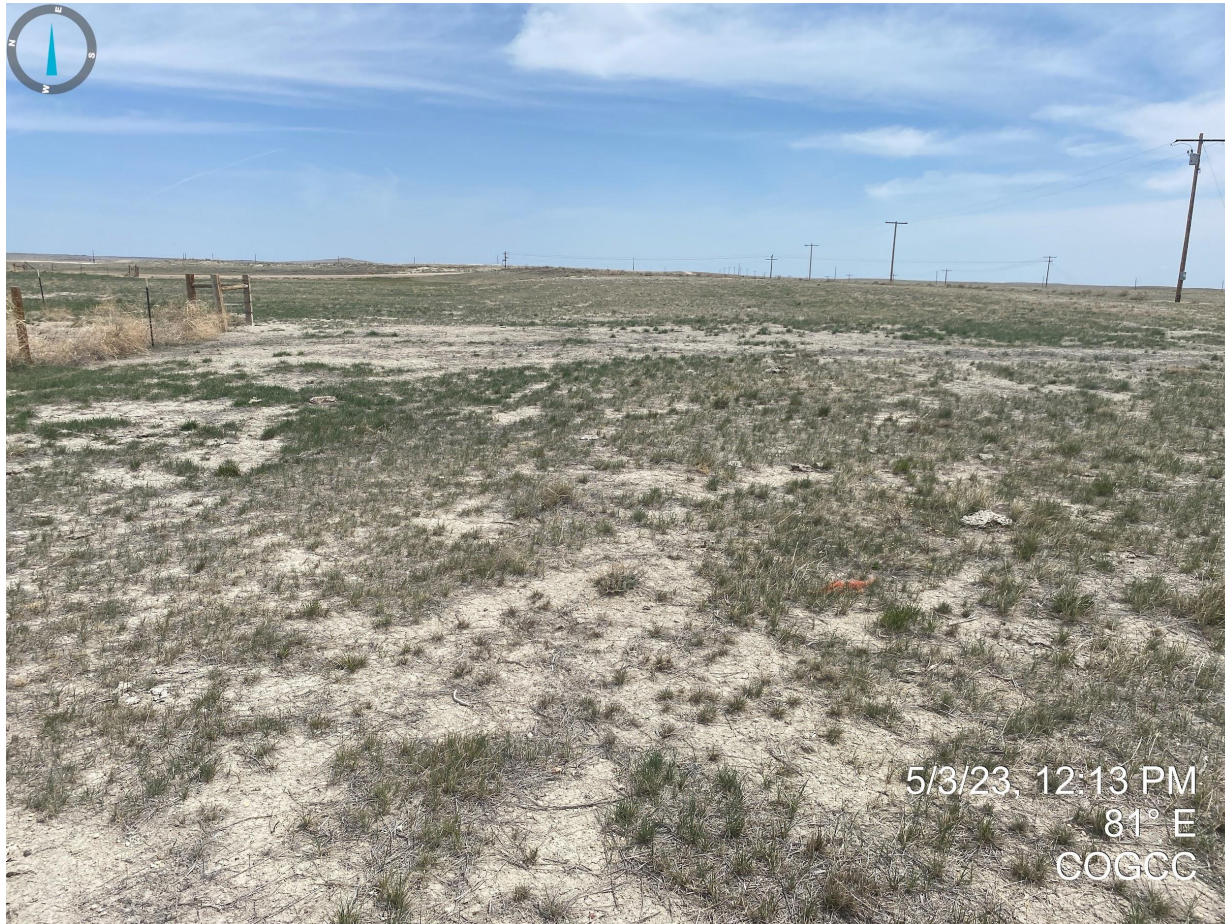
**Photo 7.** It appears the Operator has performed reclamation activities, however, the majority of the interim areas are not progressing towards Rule 1003 standards. Non-uniform vegetation cover resulting in areas of bare soil was observed throughout the location.

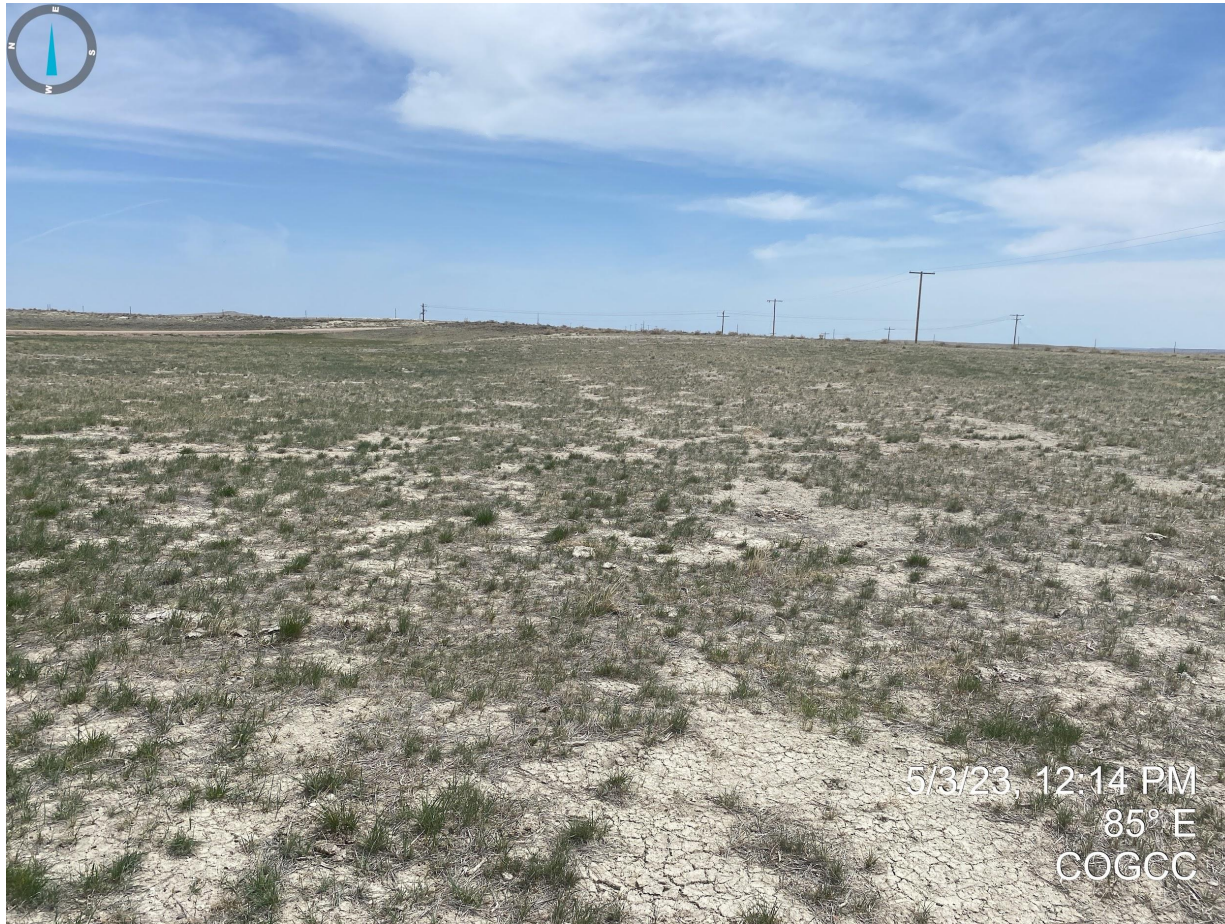
**Photo 8.** Facing east from the eastern side of the location; see comments in Photo 7.

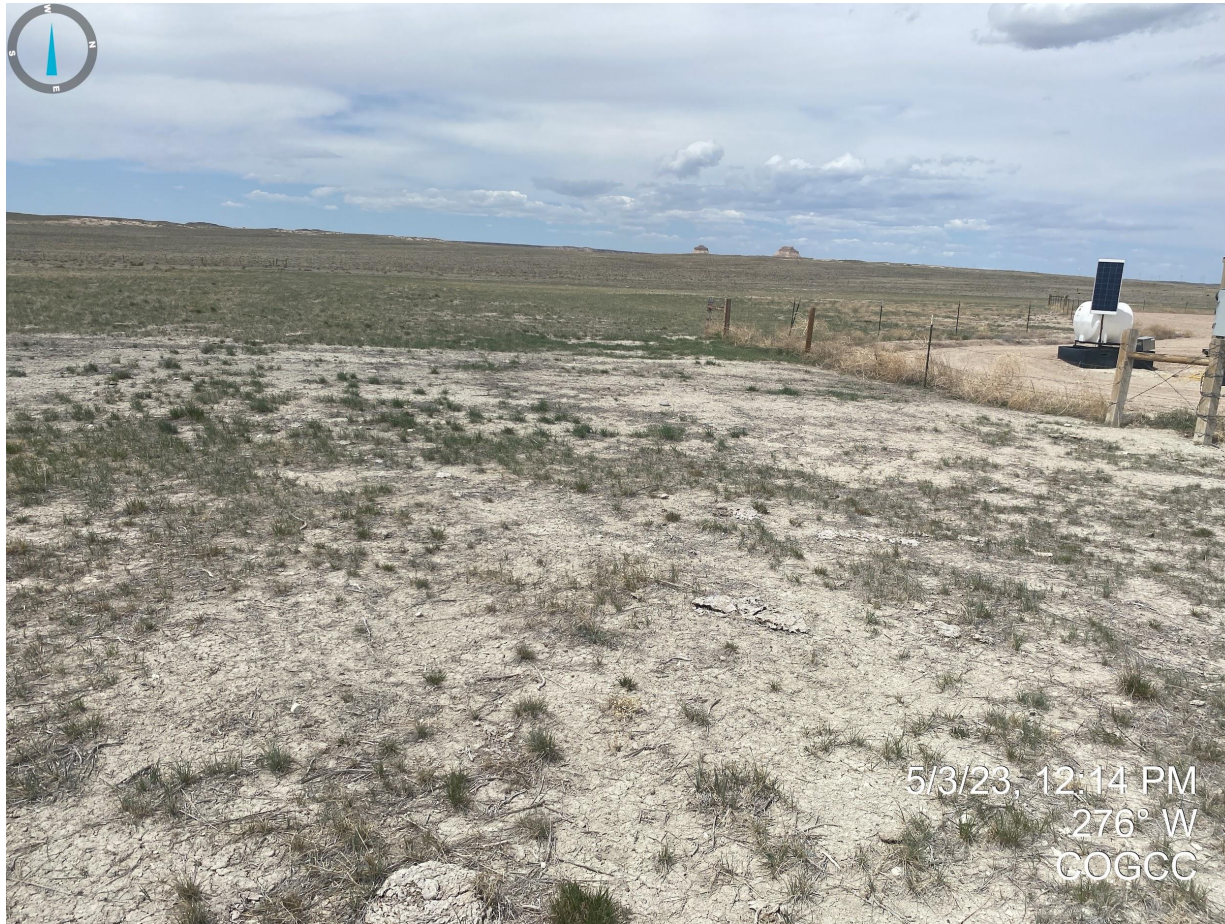
**Photo 9.** Facing west from the southern side of the location; see comments in Photo 7.

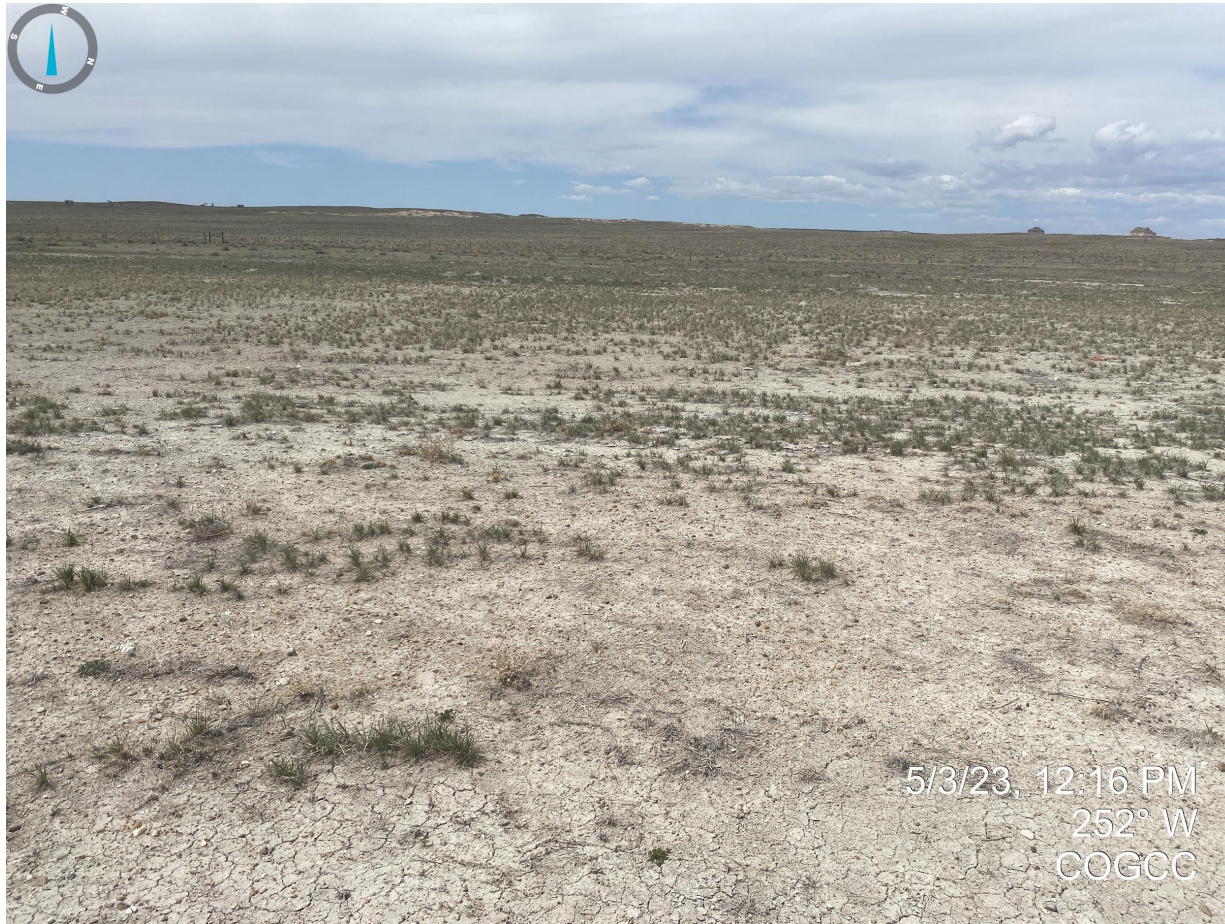
**Photo 10.** Facing west from the western side of the location; see comments in Photo 7.

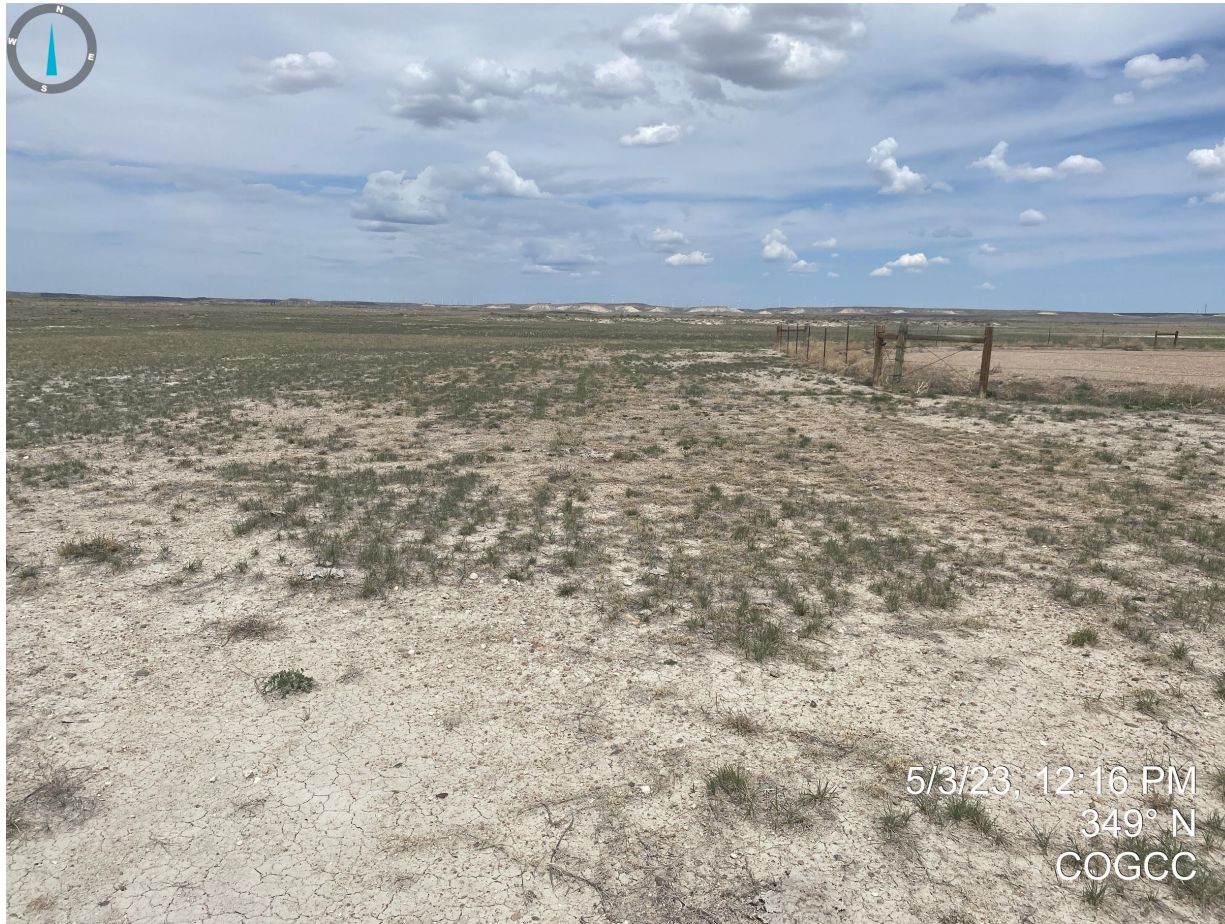
**Photo 11.** Facing north from the western side of the location; see comments in Photo 7.

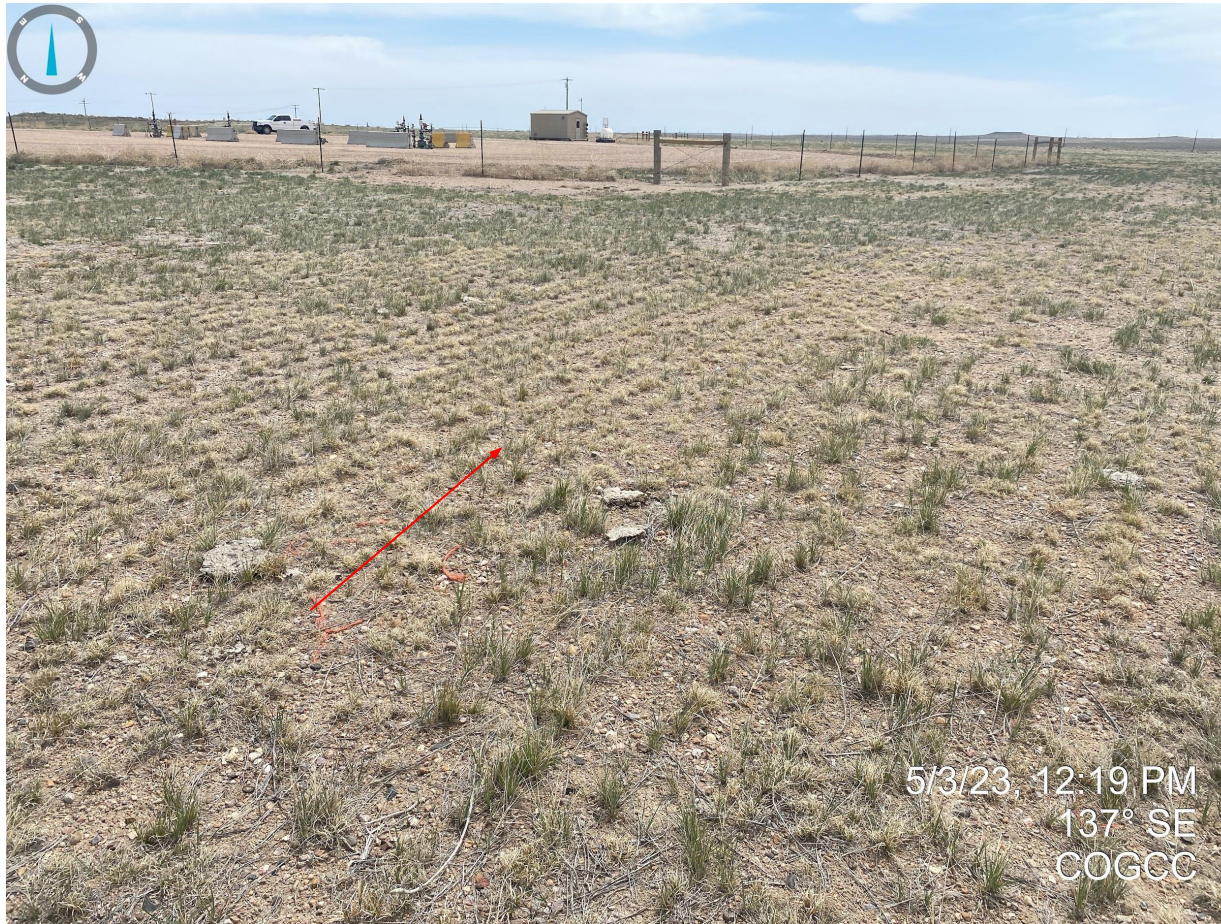
**Photo 12.** Facing southeast from the northwestern side of the location; see comments in Photo 7. Evidence of road base was seen in this northwestern corner of the interim areas (red arrow); all road base material shall be removed and voids filled with topsoil as part of the reclamation process.

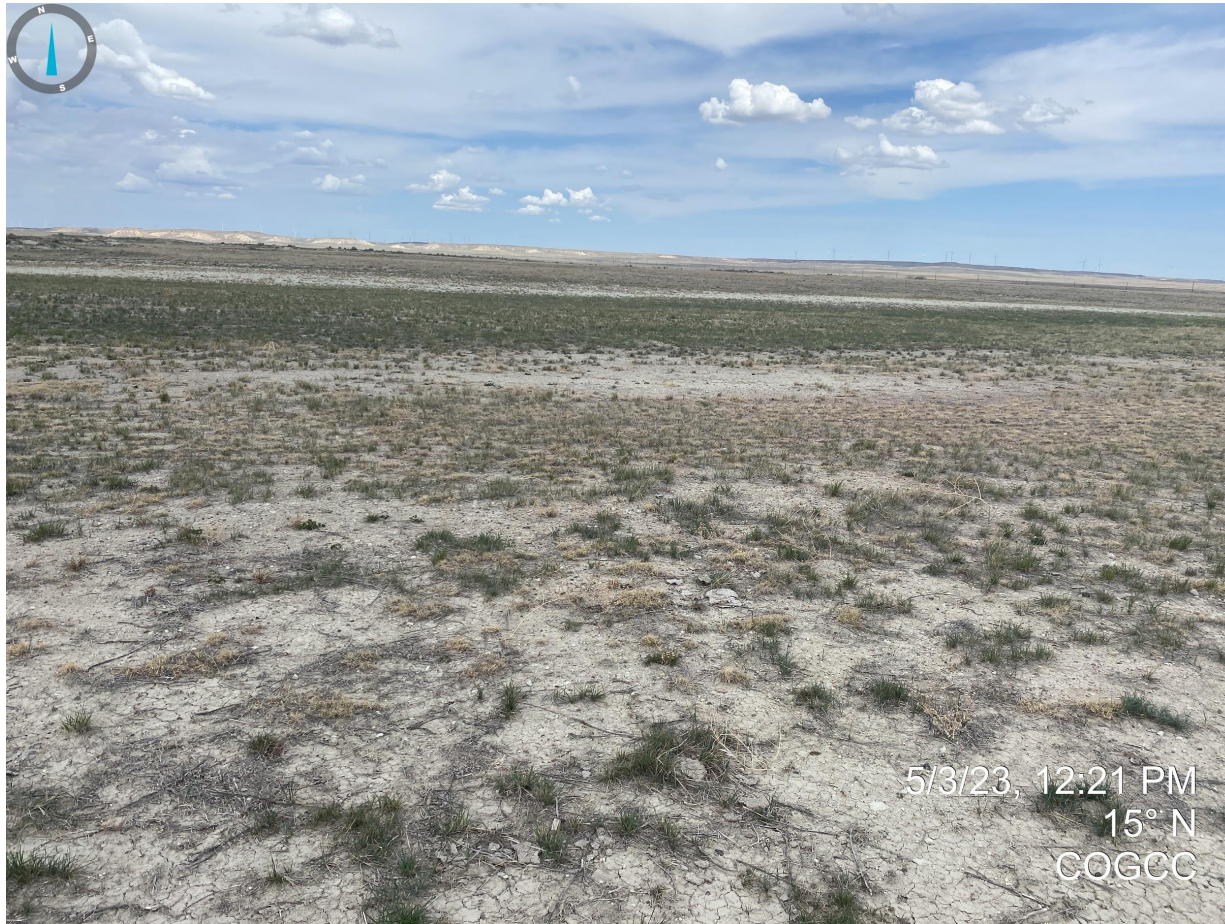
**Photo 13.** Facing north from the northern side of the location; see comments in Photo 7.

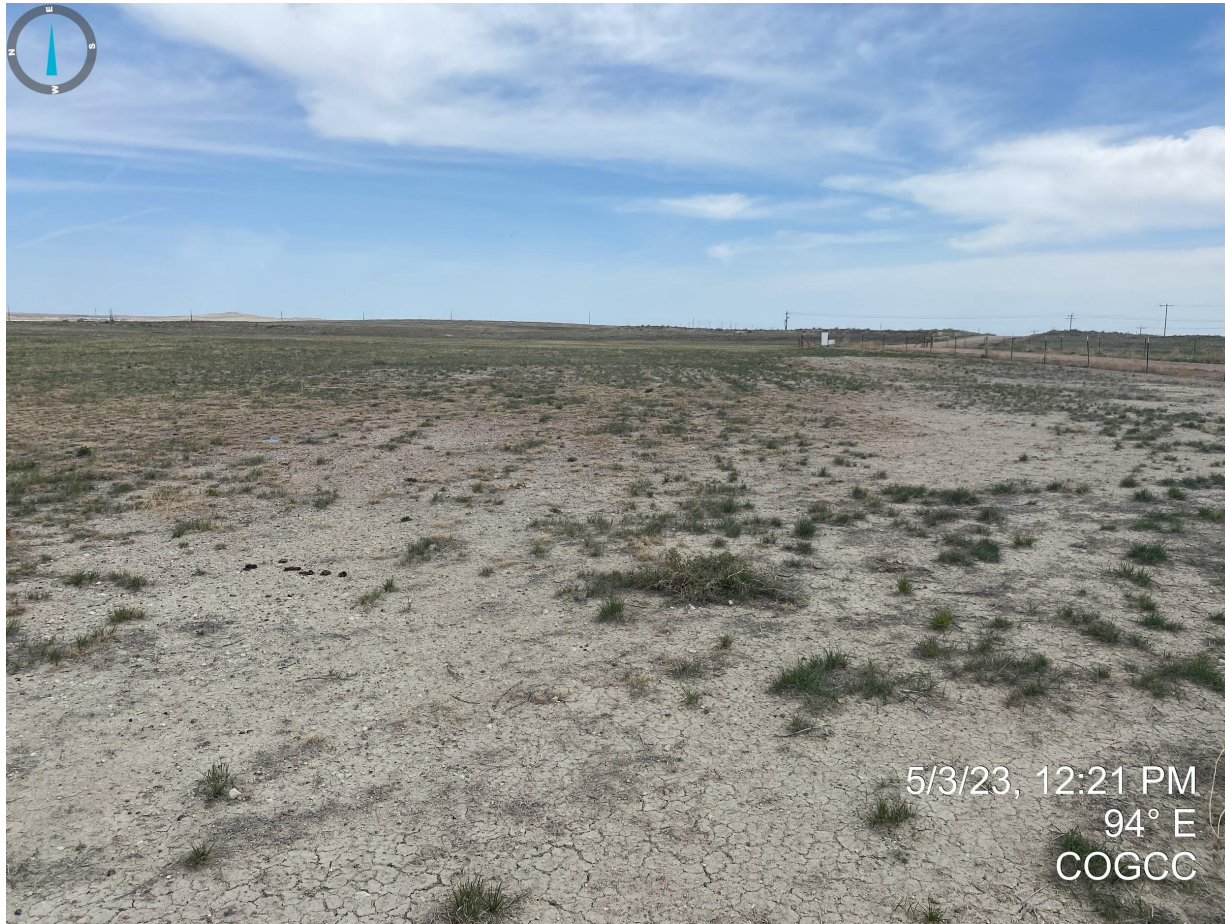
**Photo 14.** Facing east from the northern side of the location; see comments in Photo 7.

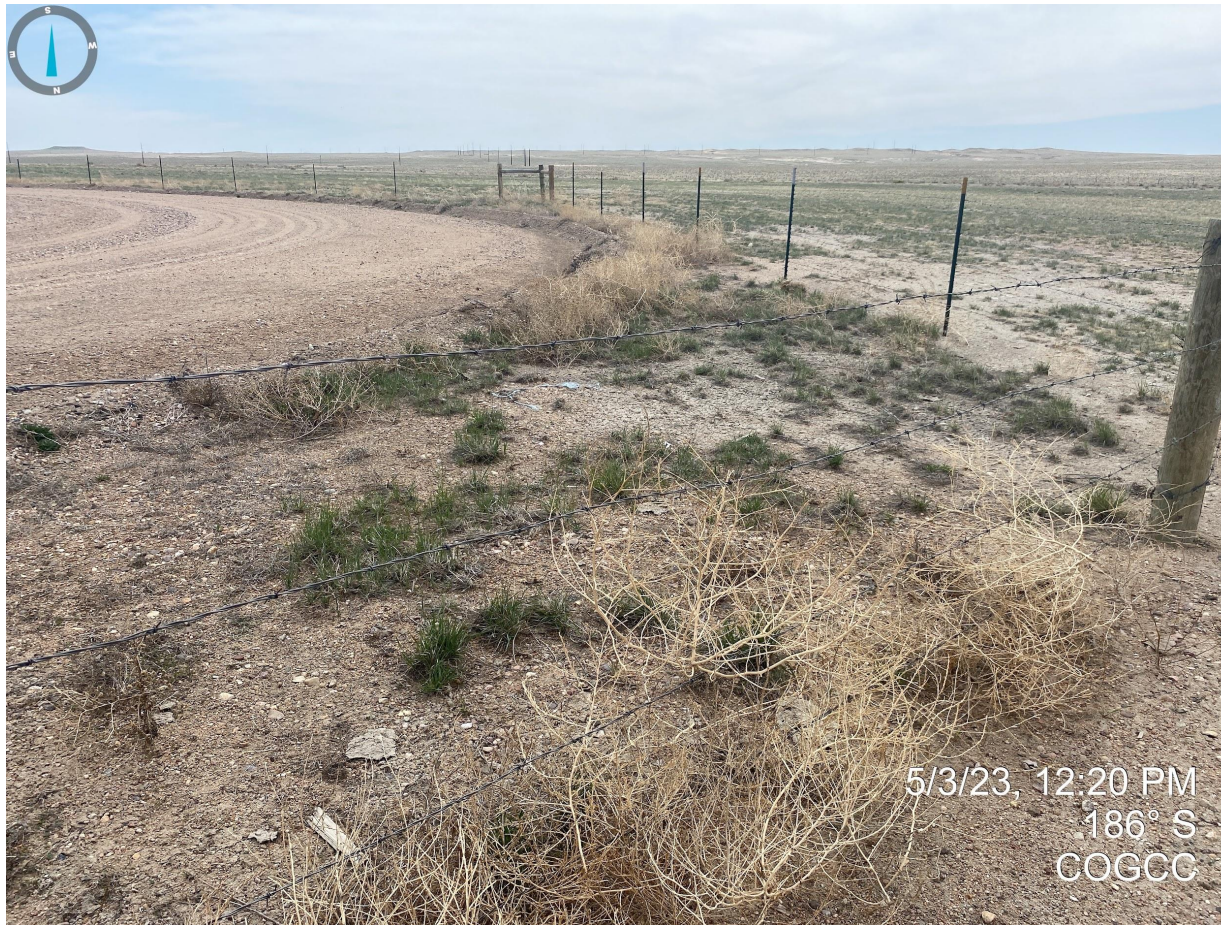
**Photo 15.** Tumbleweed debris and undesirable plant species observed on location; Operator shall implement a weed management program to control undesirable plant species during the next local growing season.

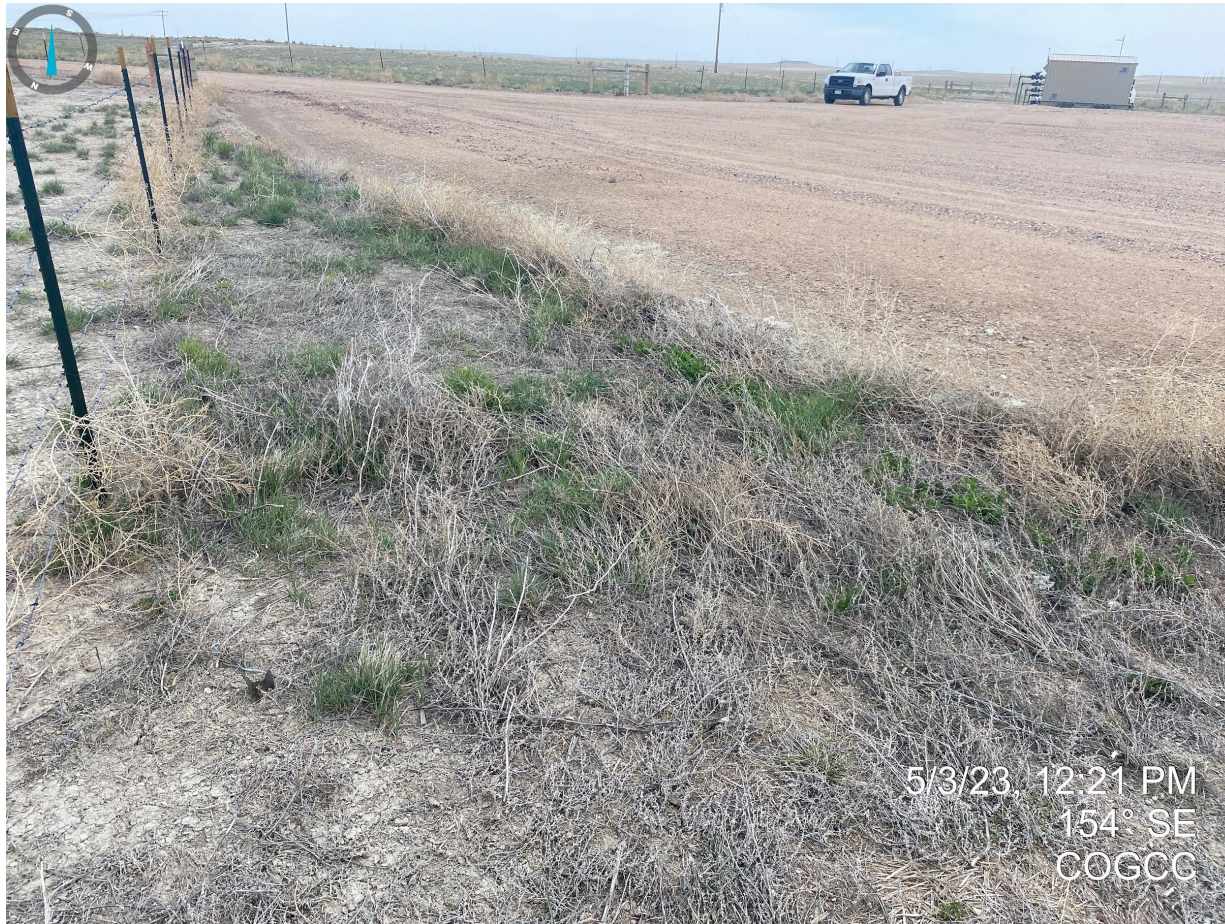
**Photo 16.** See comments in Photo 15.
