# Construction and Stormwater Inspection

Date: 05/03/2023

Location ID: 481827

Inspection Photos  
Location Name: Peanut Fed 3403  
Location ID: 481827

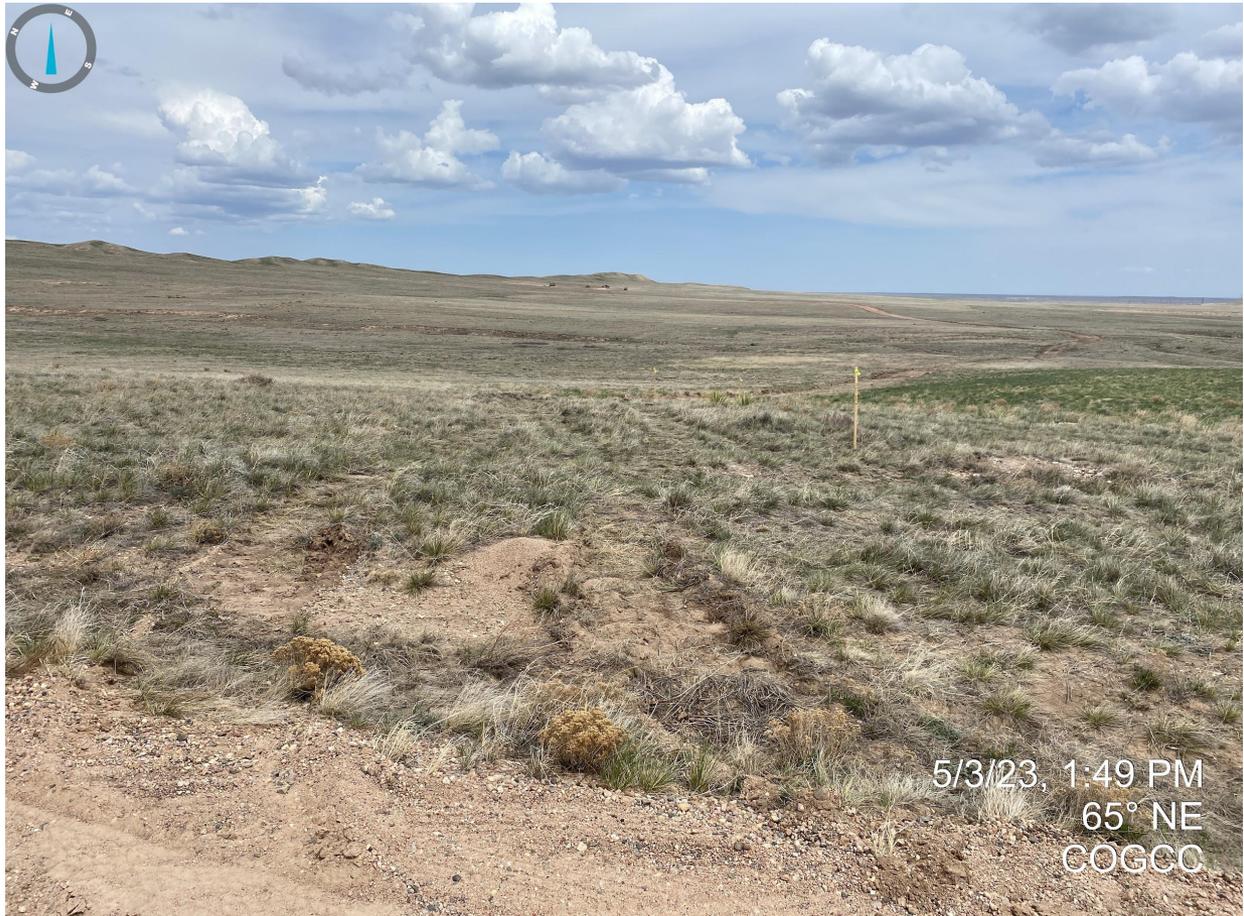
**Photo 1.** Facing northeast from the new access road entrance. At the time of this inspection, it did not appear topsoil had been salvaged from the access road with evidence of some grubbing having occurred. An approved copy of the From 2A was also not posted on location at the time of this inspection.

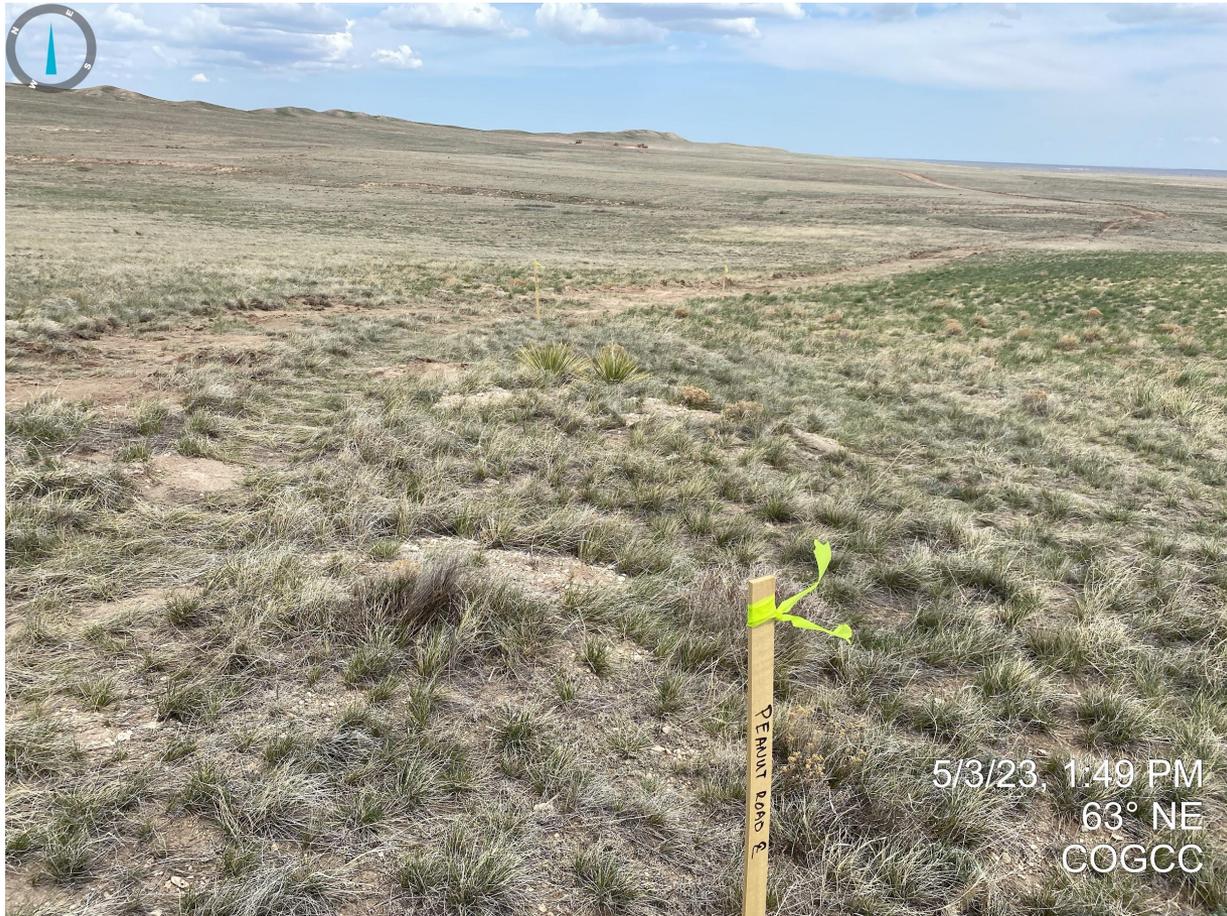
Photo 2. See comments in Photo 1.

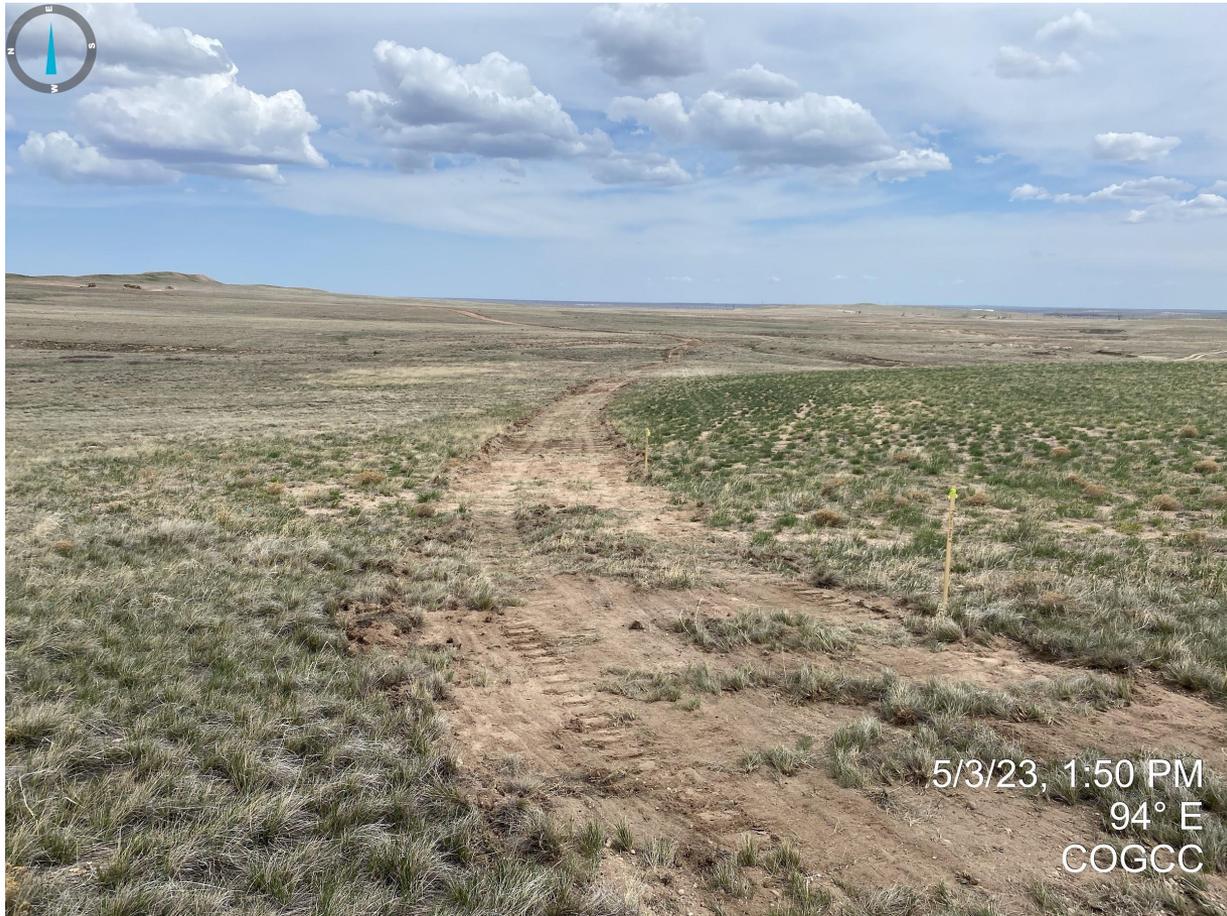
**Photo 3.** Grubbing pictured along the new access road portion; see also comments in Photo 1.

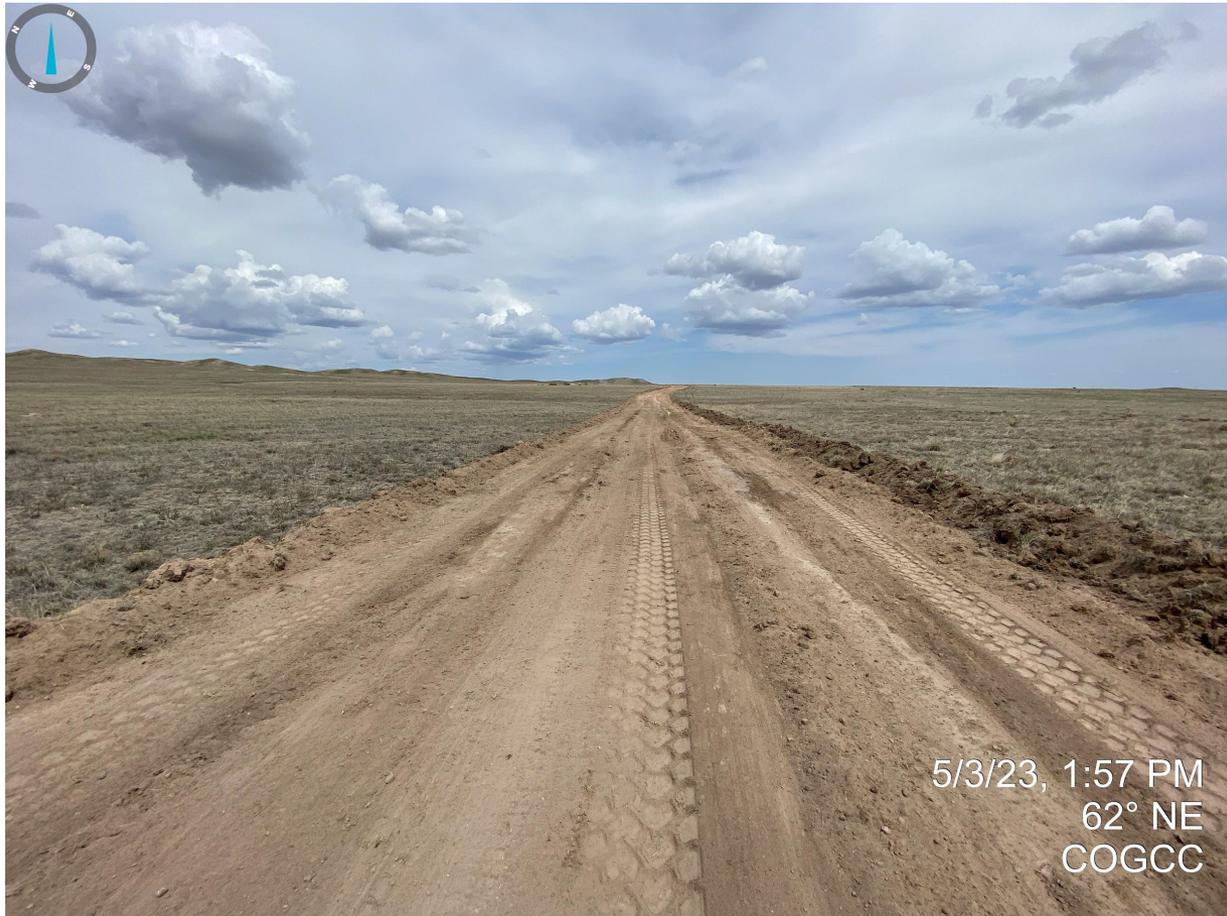
**Photo 4.** Facing northeast from an existing access road. The access road appears to have been grubbed and widened during the construction process.

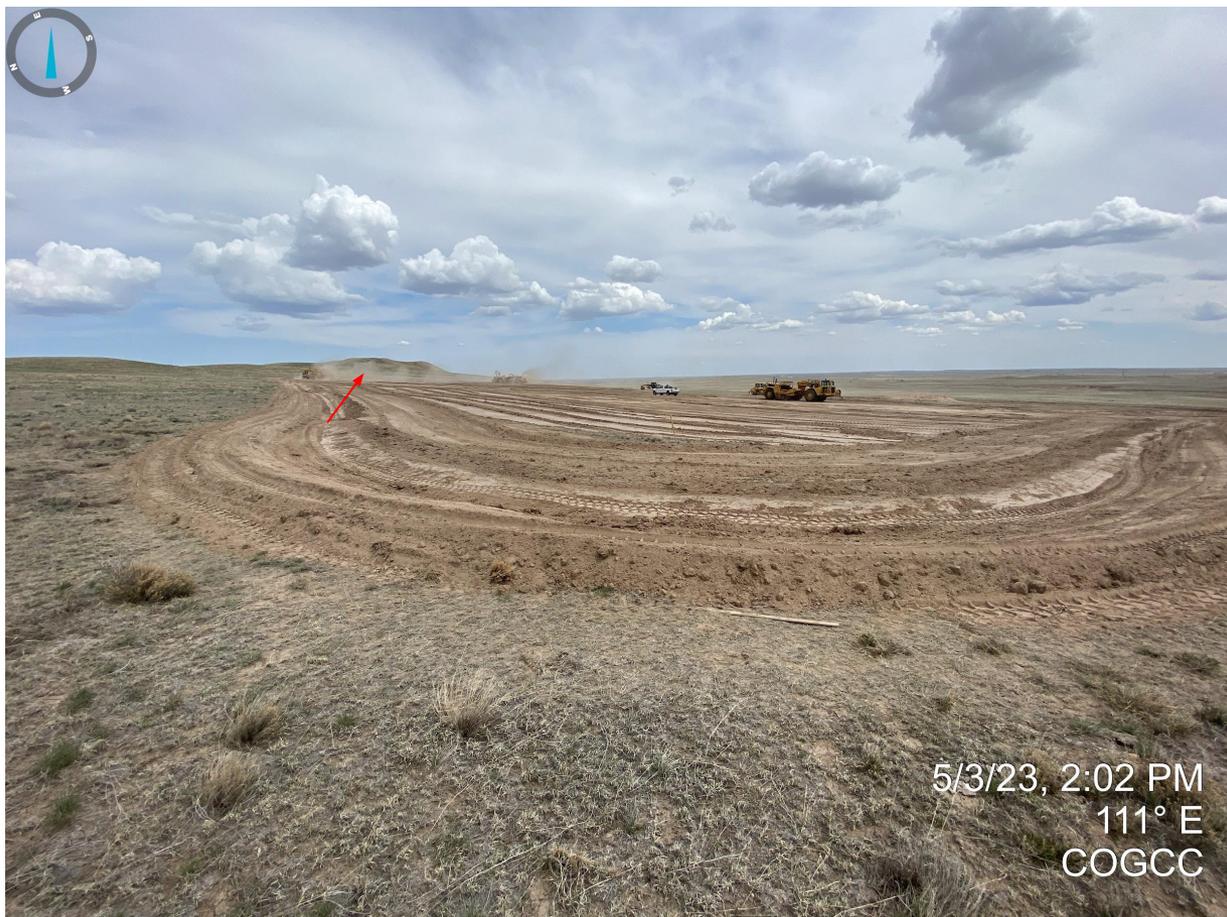
**Photo 5.** Facing east from the northwest corner of the pad construction. Photo illustrates topsoil salvage operations and fugitive dust (red arrow) that was observed at the time of this inspection. Also pictured, a temporary stormwater BMP (ditch and berm) appears to have been installed during the construction phase of the location.

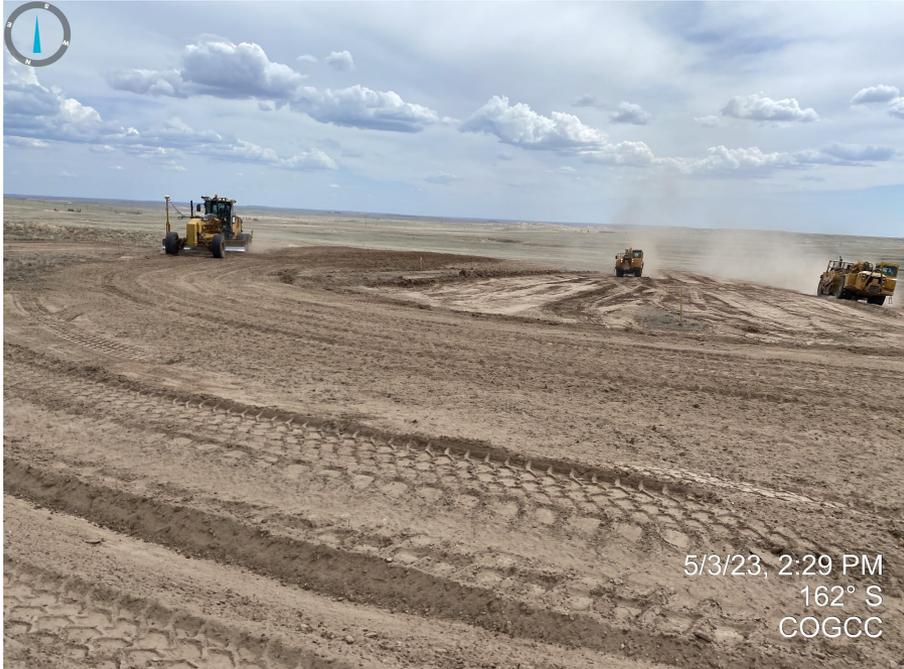
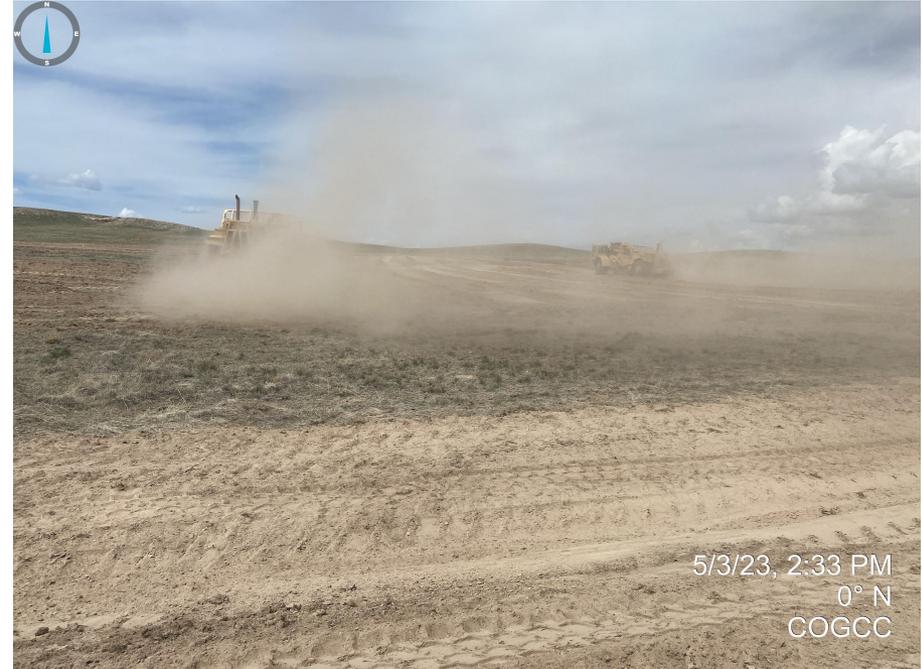
**Photo 6.** Close up photos of fugitive dust occurring from topsoil salvage.

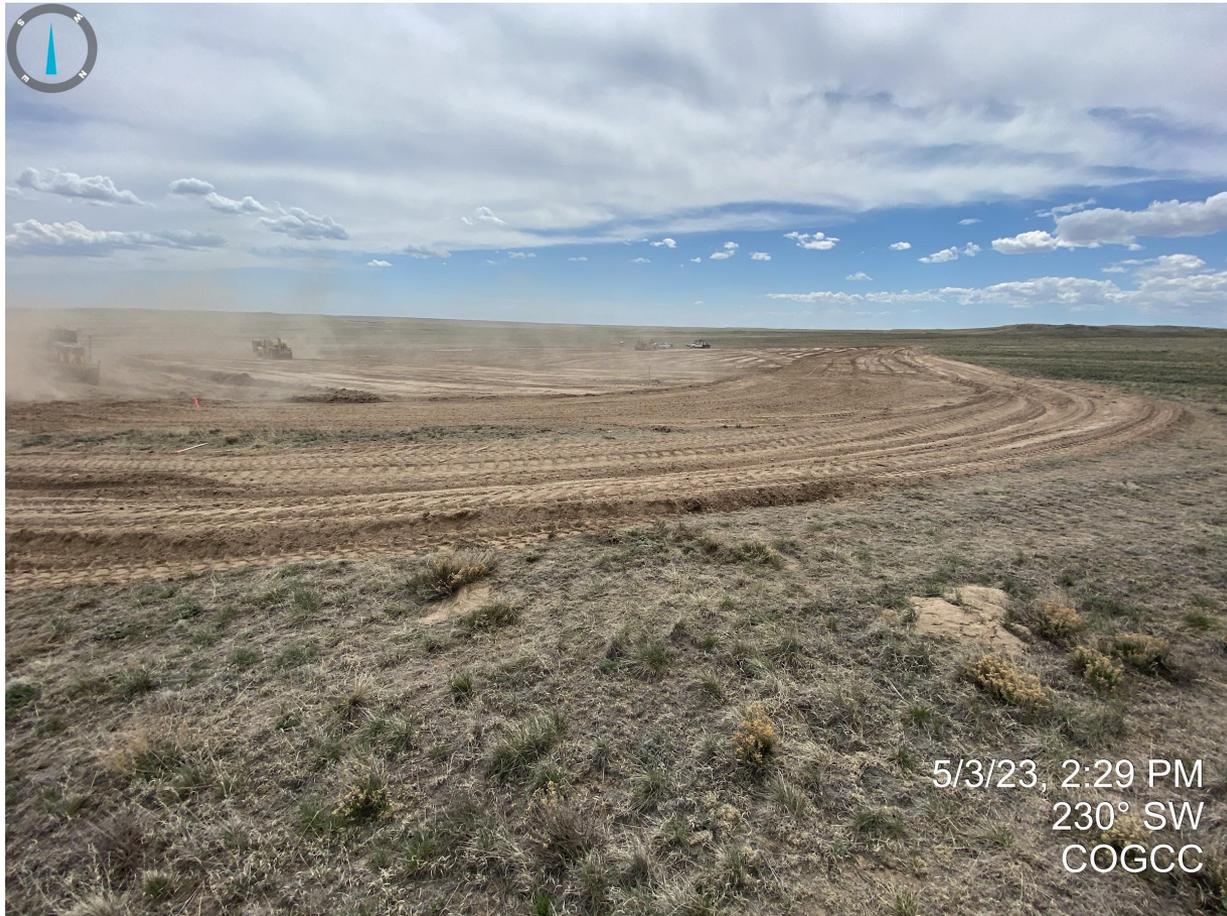
**Photo 7.** Facing southwest from the northeast corner of the location. See comments in Photo 5.

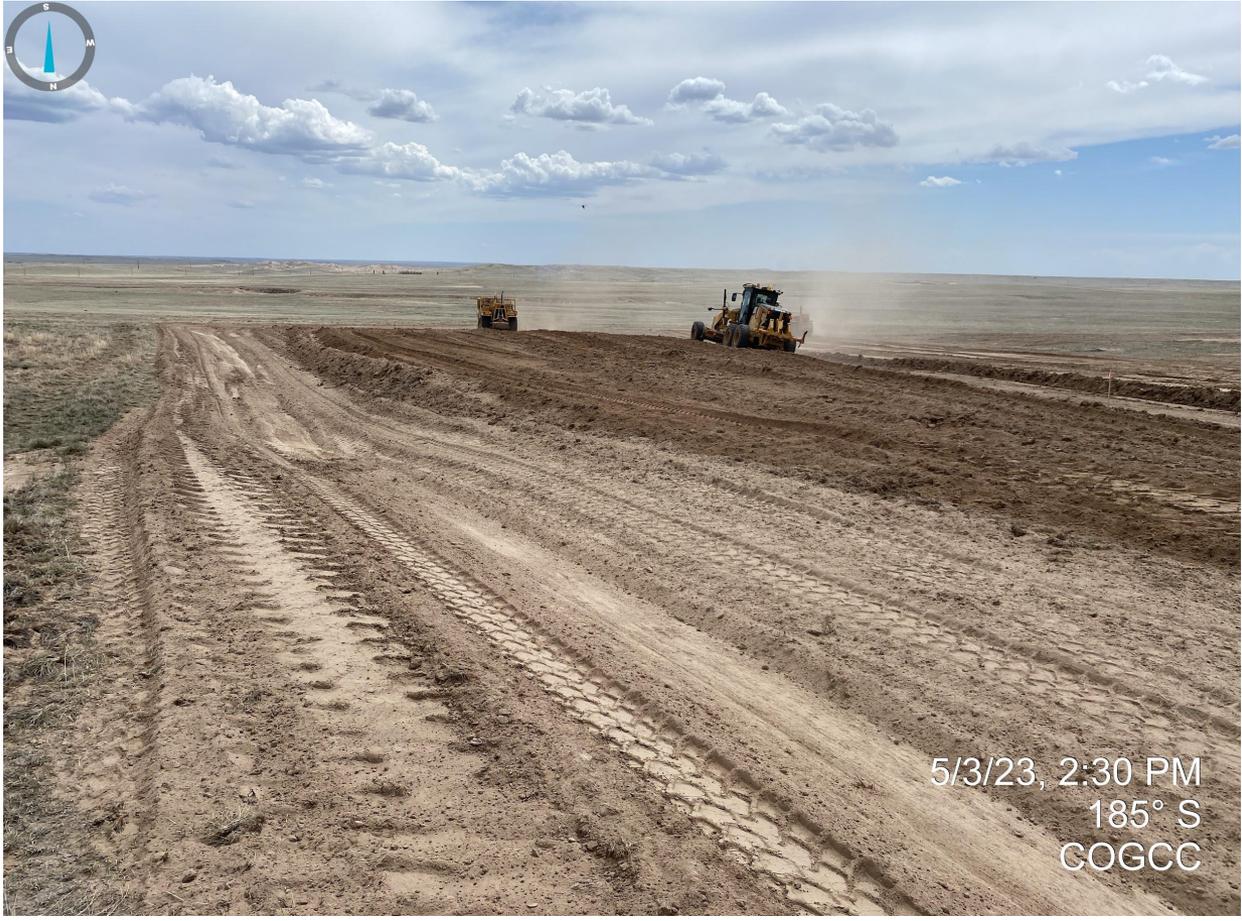
**Photo 8.** Facing south towards the topsoil stockpile. A future inspection will be conducted to ensure all topsoil has been salvaged from the location and that stockpiles are stabilized against wind and water erosion.

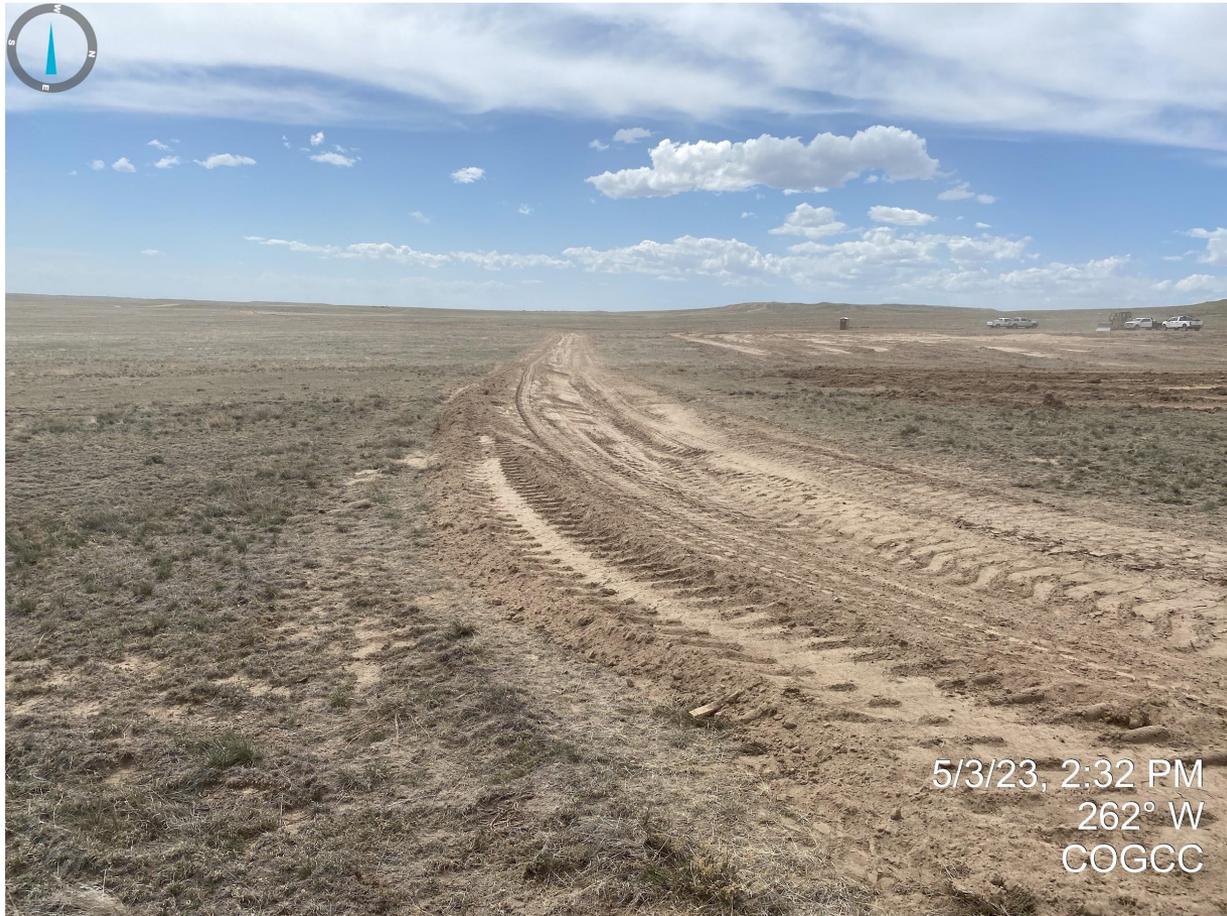
**Photo 9.** Facing west from the southeast corner of the location. See comments in Photo 5.

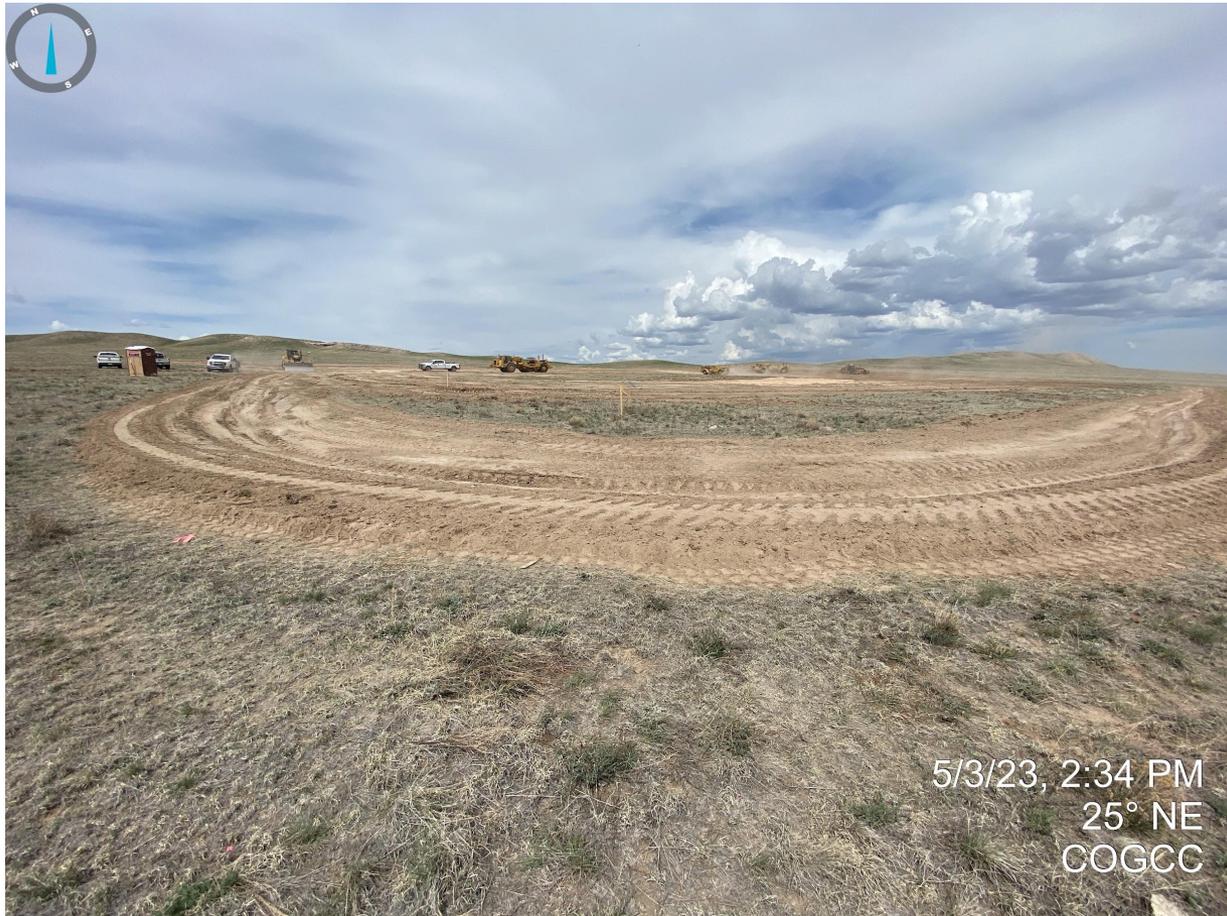
**Photo 10.** Facing northeast from the southwest corner of the location. See comments in Photo 5.
