LARAMIE ENERGY LLC, Horseshoe Canyon/4-28

Location # 312739

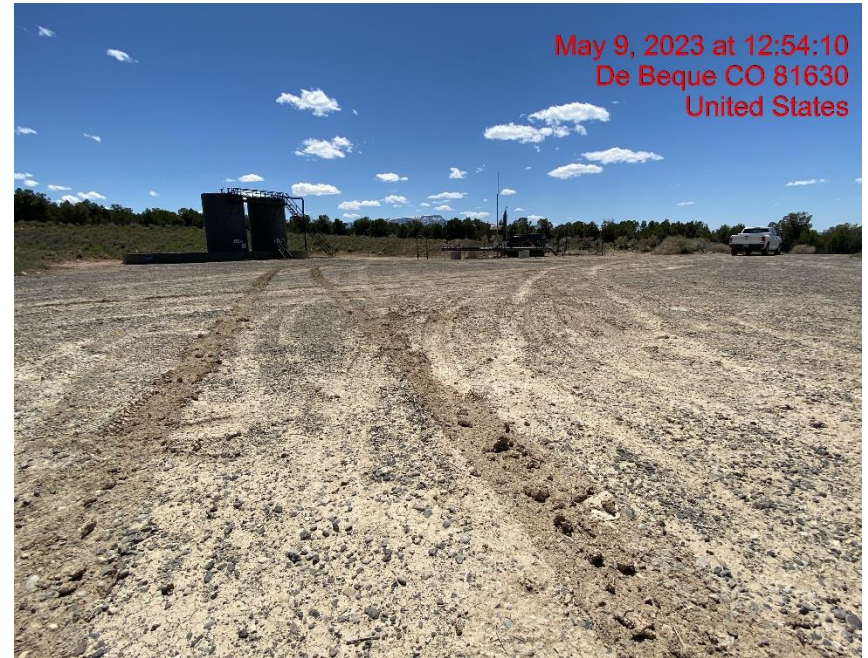
Location Lacks Stabilization – Photo #03117

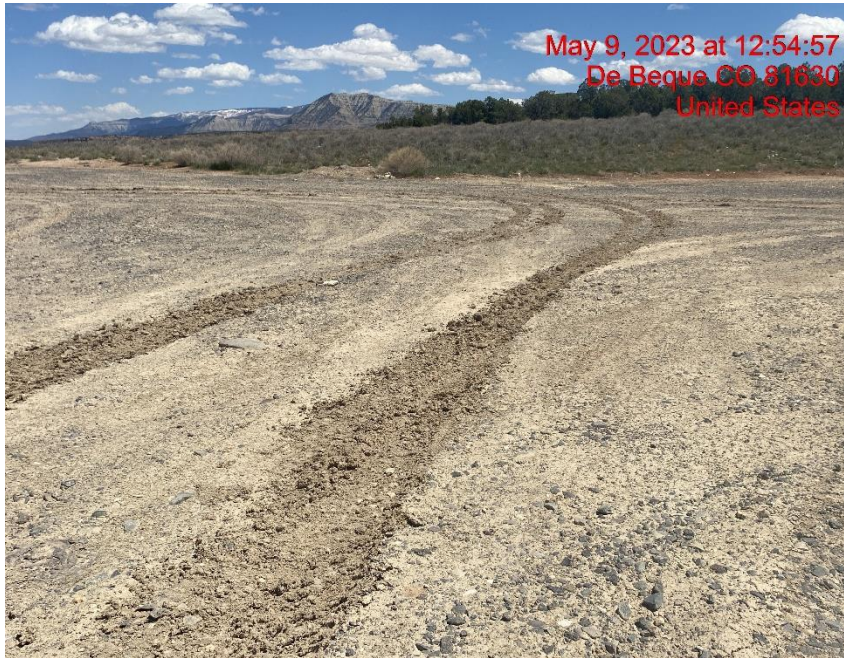
Location Lacks Stabilization – Photo #03119

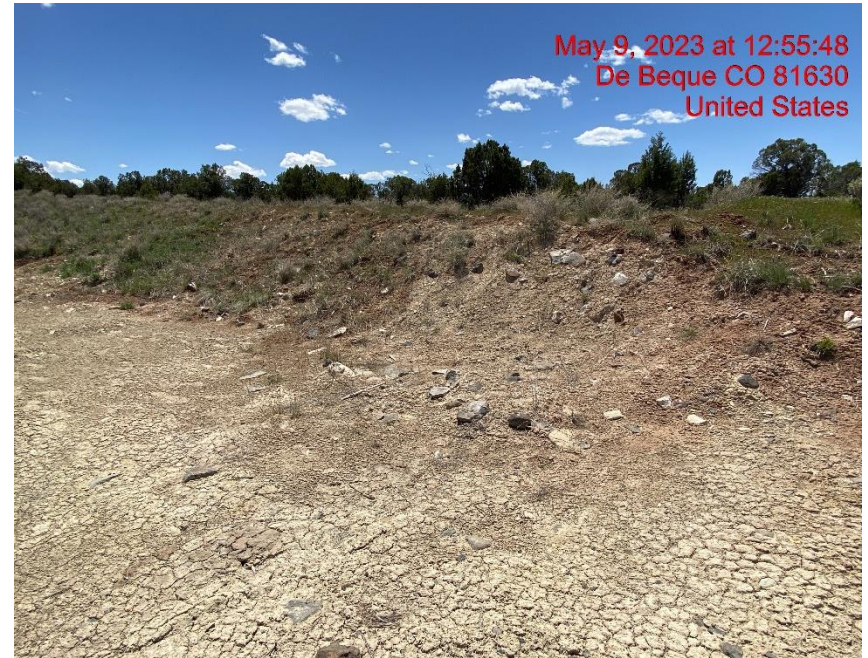
Cut Slope Eroding onto Location – Photo #03123

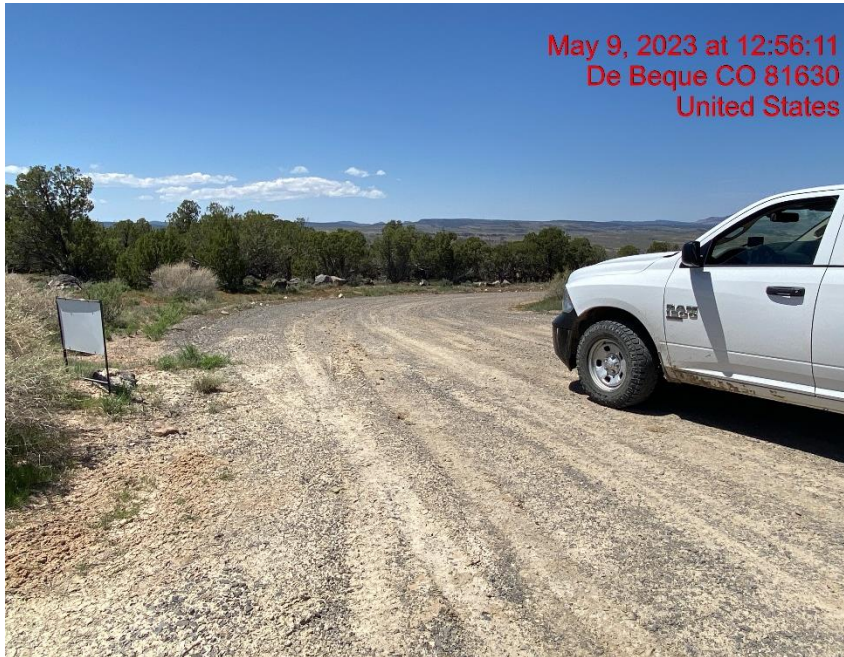
**Insufficient Vehicle Tracking BMPs at Location
Entrance/Exit – Photo #03124**

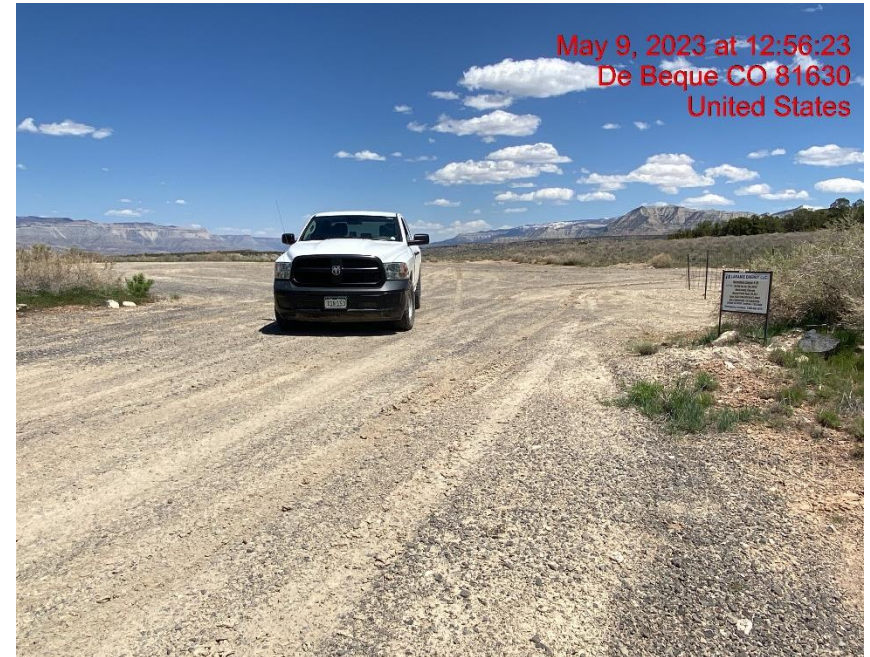
**Insufficient Vehicle Tracking BMPs at Location
Entrance/Exit – Photo #03125**

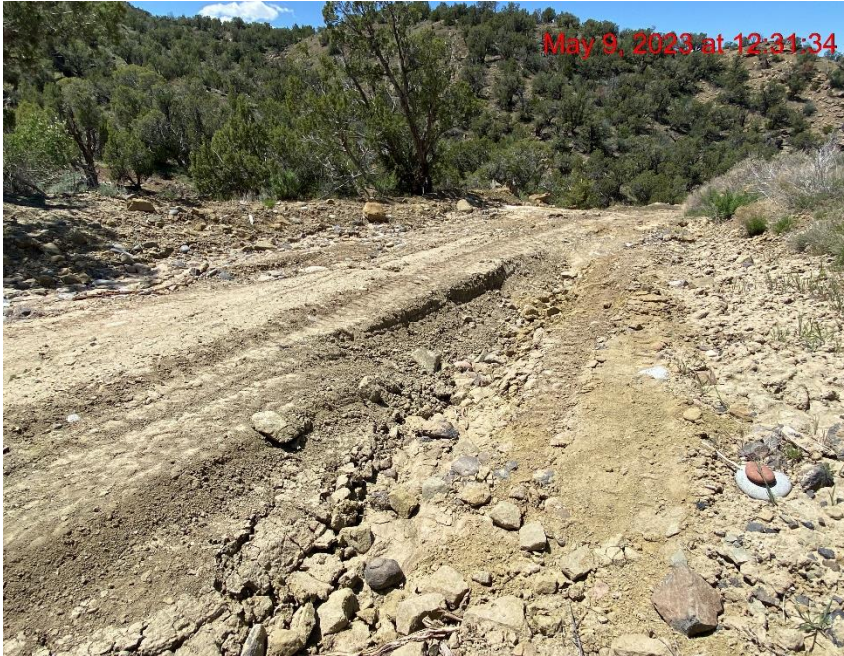
Access Road Degradation – Photo #03093

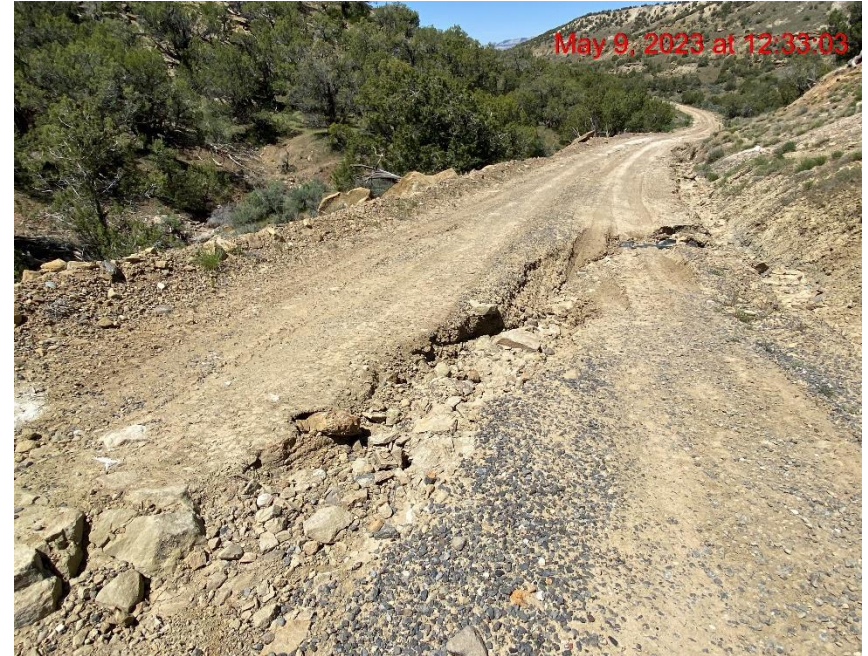
Erosion Through Access Road – Photo #03095

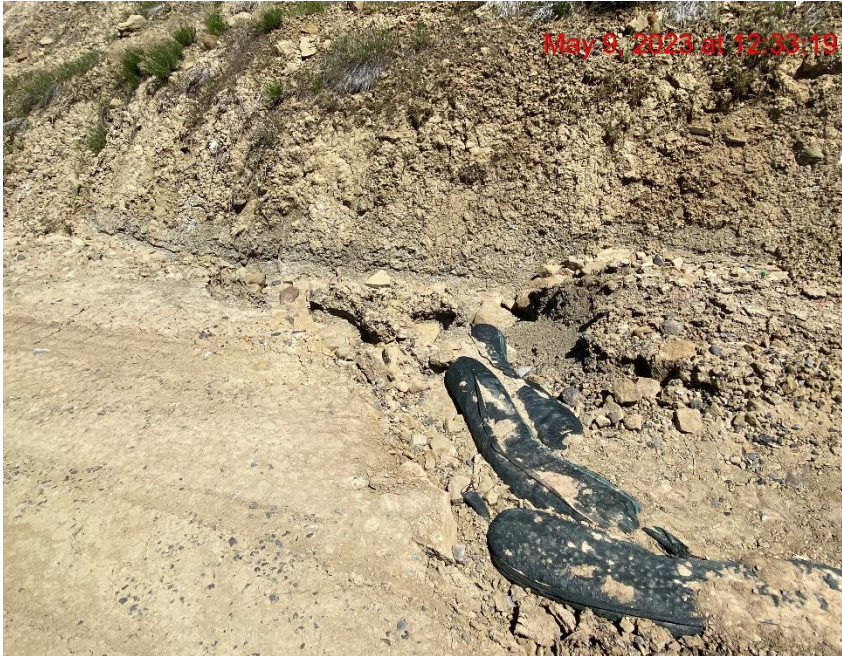
Insufficient BMP on Access Road – Photo #03096

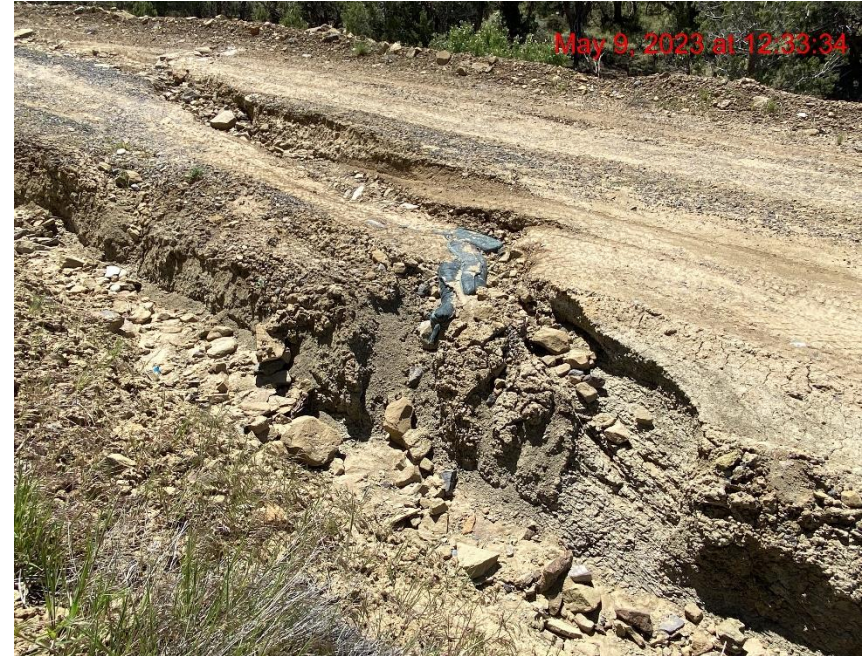
Access Road Erosion/Degradation – Photo #03097

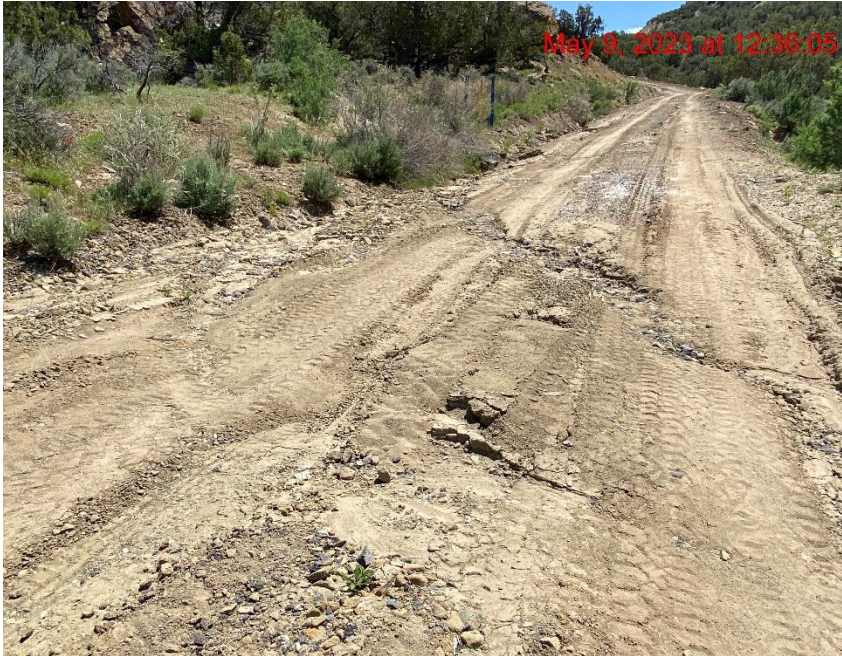
Rill Erosion Through Access Road – Photo #03103

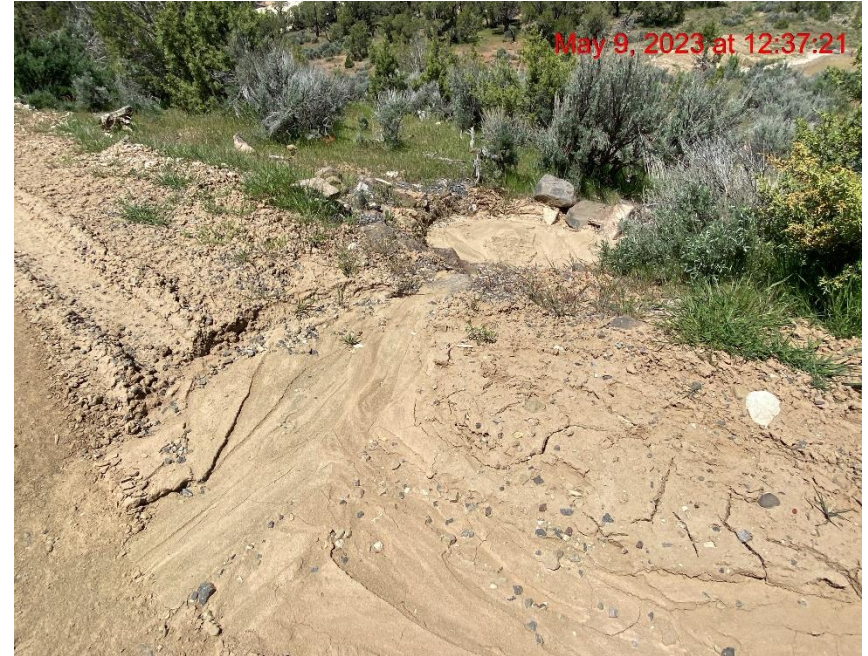
Erosion from Access Road/Sediment Trap Needs Maintenance – Photo #03104
