TEP ROCKY MOUNTAIN LLC, WILLIAMS-67S96W/1NENW

Location #334903

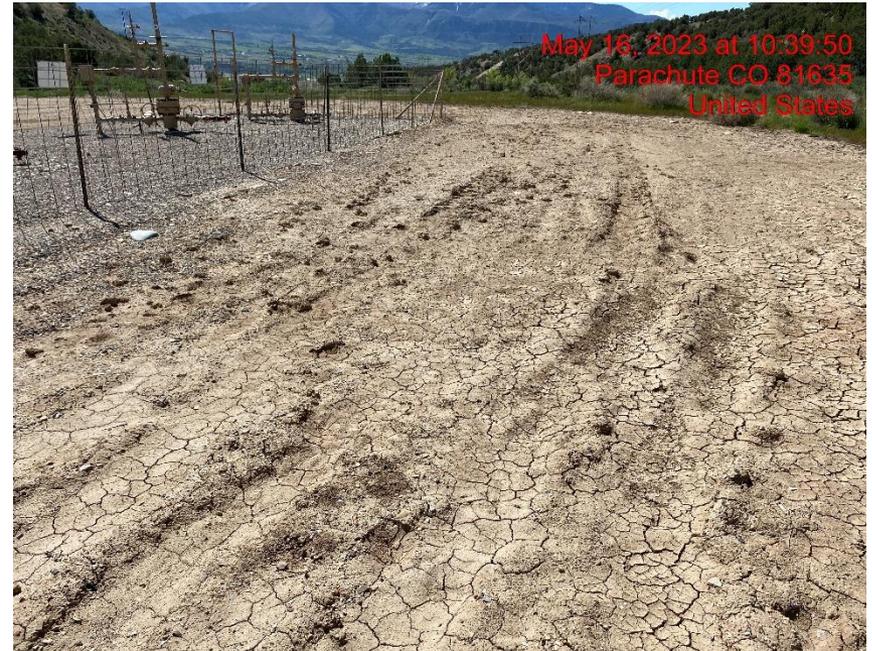
Location Lacks Stabilization – Photo #03368

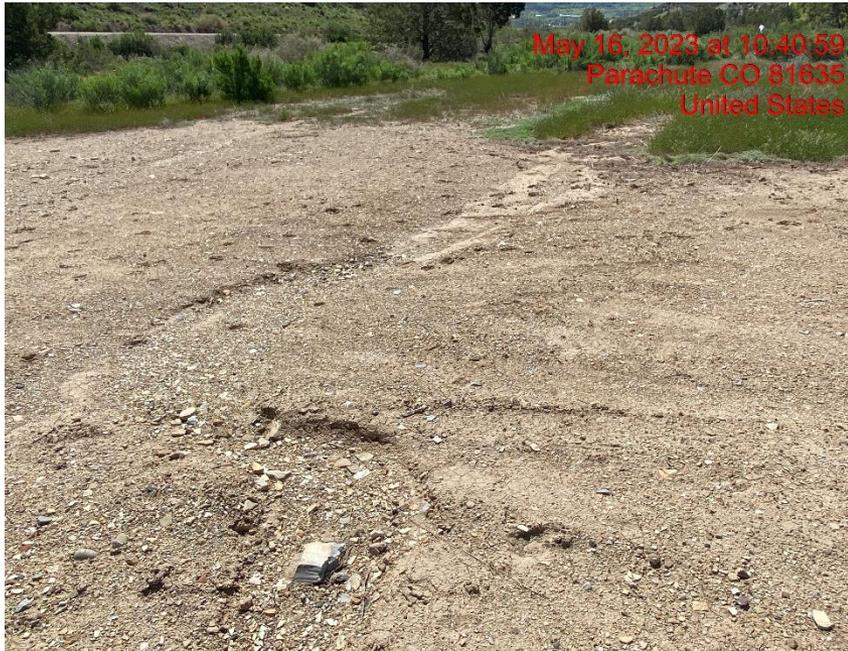
**Rill Erosion Transporting Sediment Off-Location –
Photo #03372**

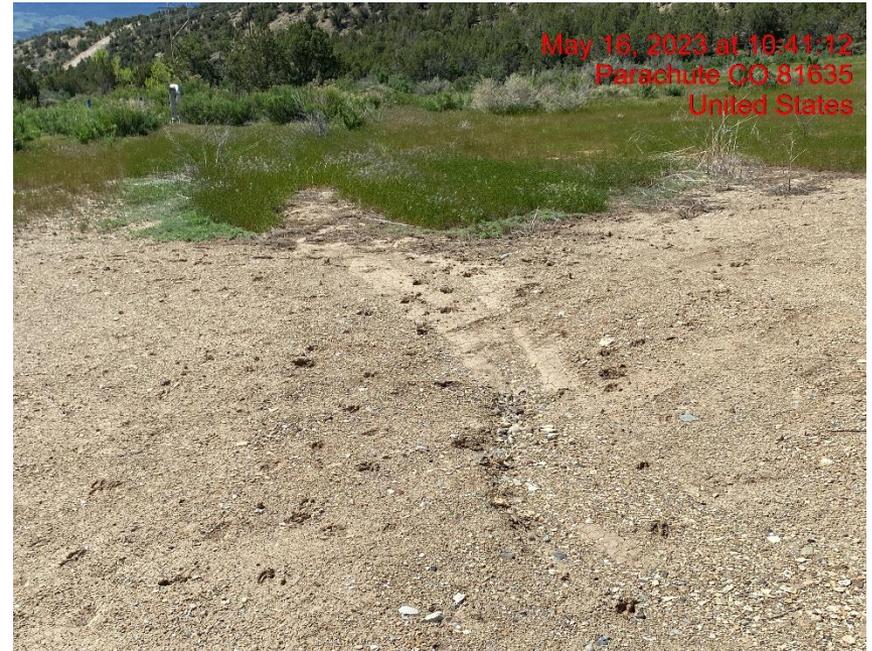
**Rill Erosion Transporting Sediment Off-Location –
Photo #03374**

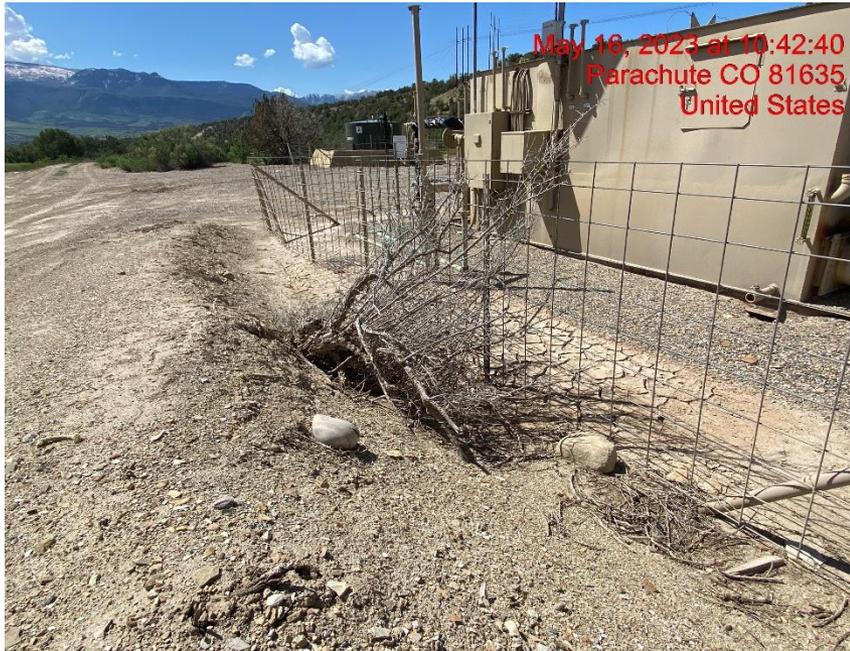
Site Degradation from Plow Causing Sediment Transportation and Lack of Stabilization – Photo #03376

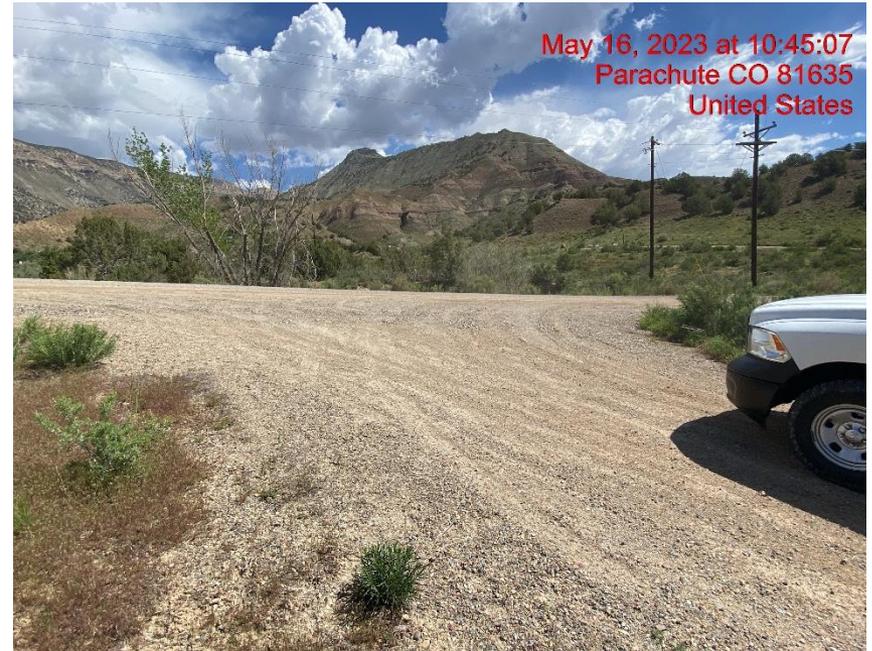
Insufficient Vehicle Tracking BMPs at Location Entrance/Exit – Photo #03381
