TEP ROCKY MOUNTAIN LLC, UNION-67S96W/2SENE

Location #334692

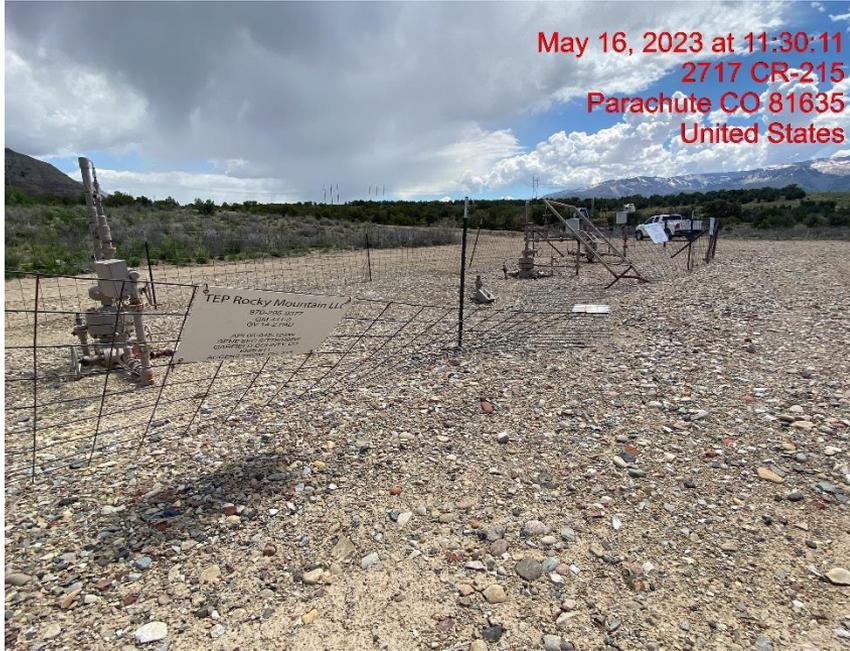
Wellhead Fencing Not Serviceable – Photo #03448

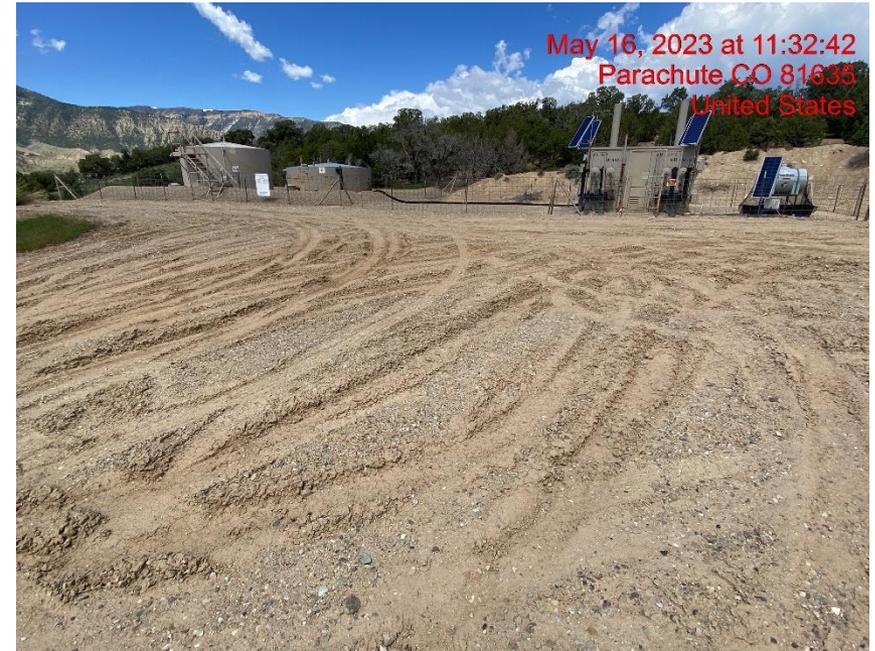
Location Lacks Stabilization – Photo #03453

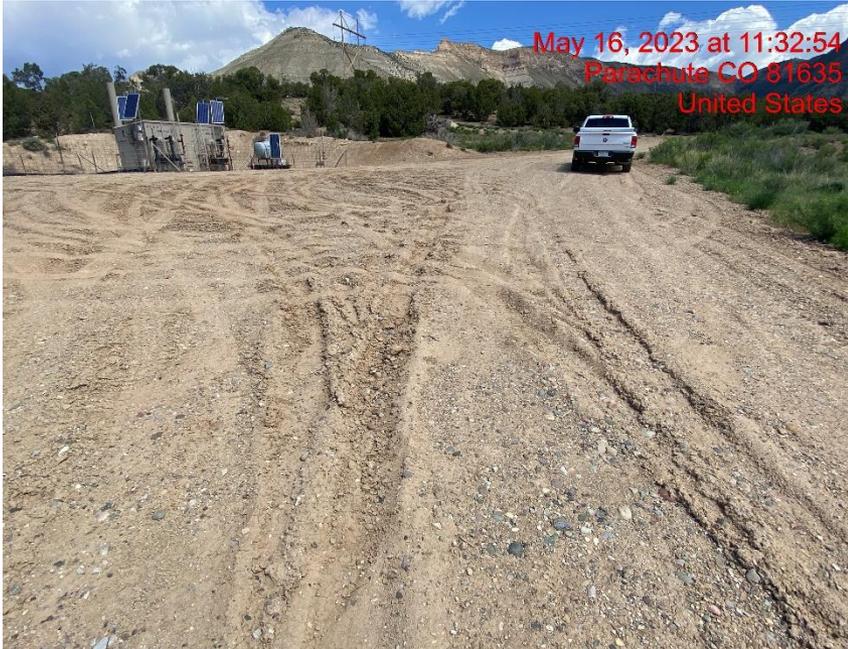
Location Lacks Stabilization – Photo #03454

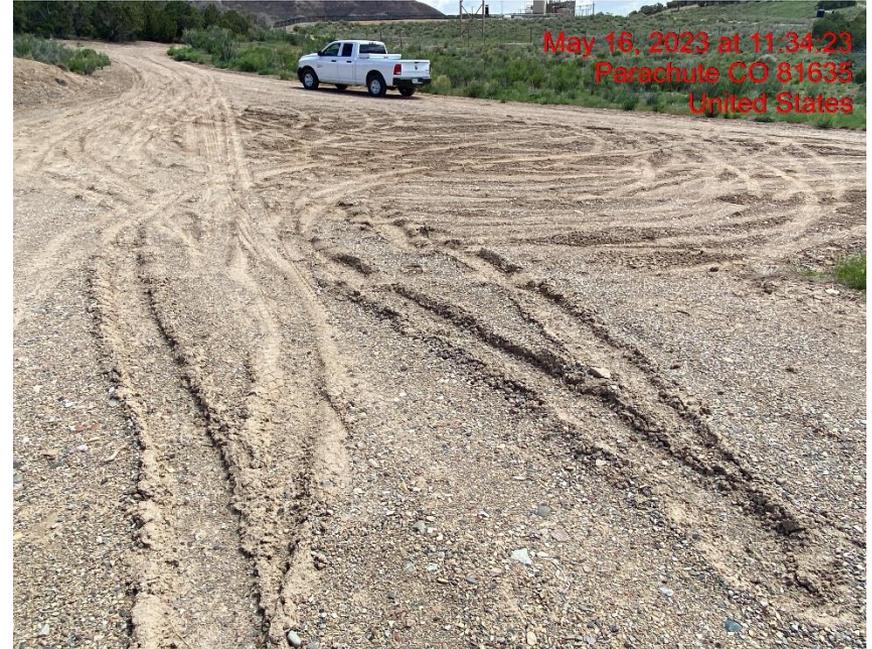
Location Lacks Stabilization – Photo #03460

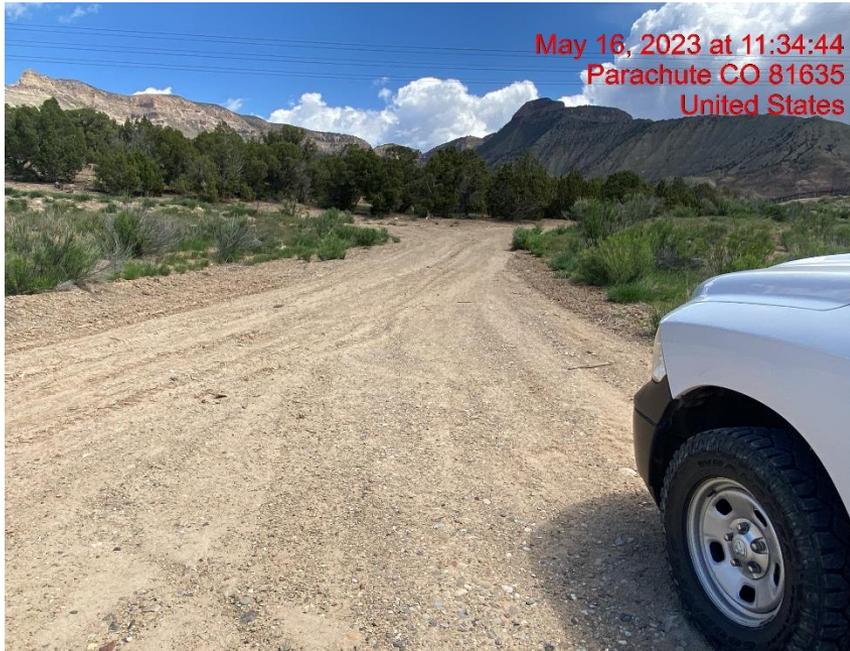
Insufficient Vehicle Tracking BMPs at Location Entrance/Exit – Photo #03461

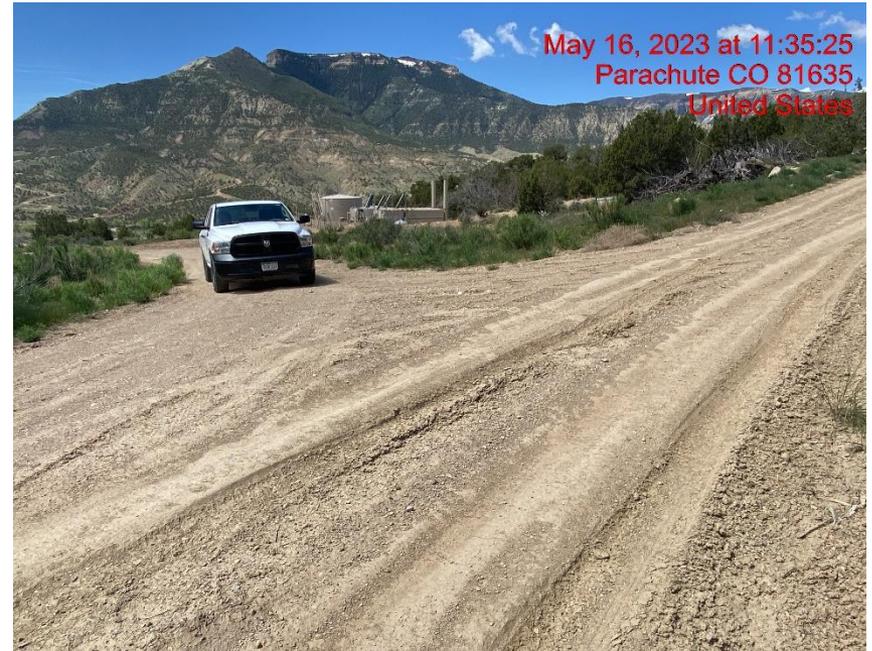
Insufficient Vehicle Tracking BMPs at Location Entrance/Exit – Photo #03462
