Construction and Stormwater Inspection

Date: 05/15/2023

Operator: ST CROIX OPERATING INC - 81490

Location ID: 484105

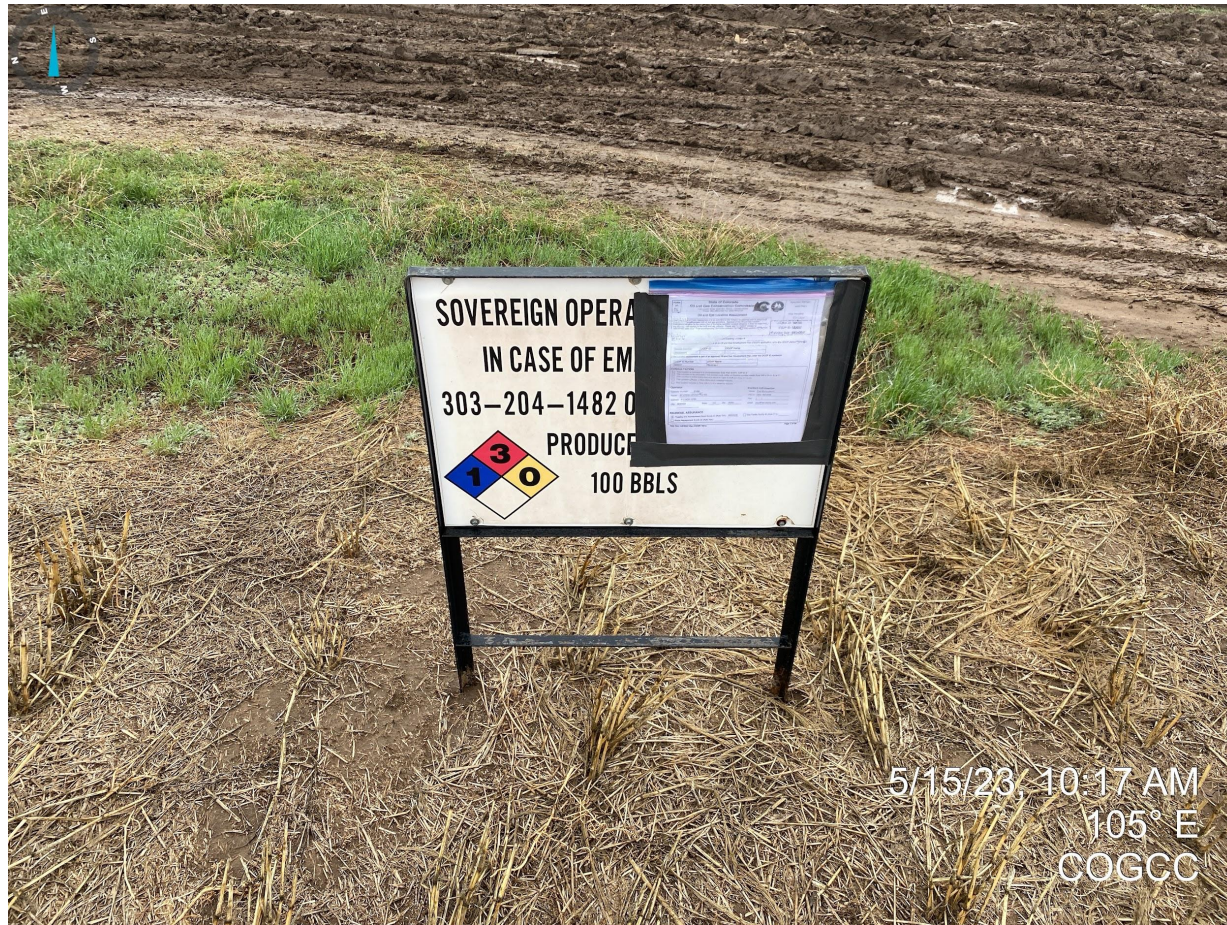
Photo 1. Appears the Operator has resolved the previous corrective action and posted the approved Form 2A on location.

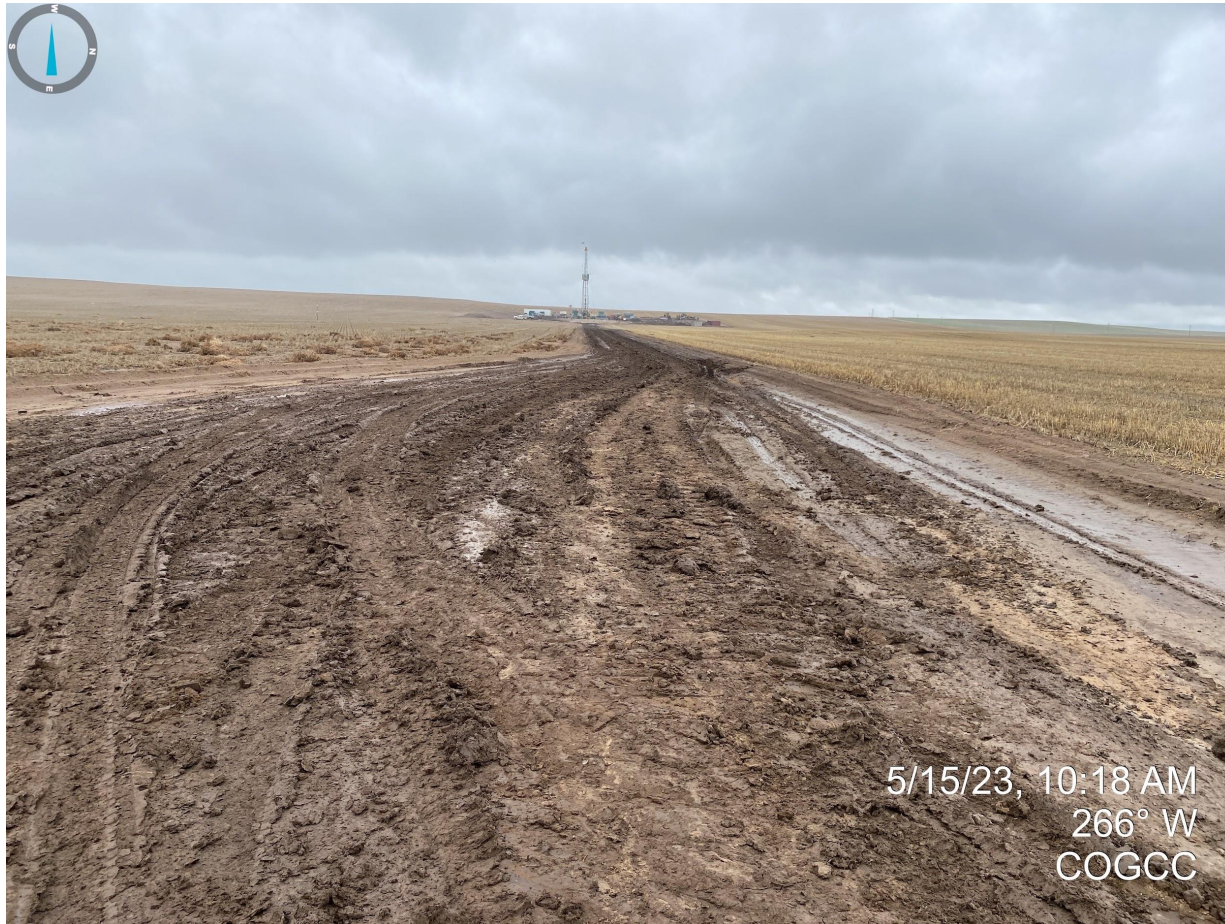
Photo 2. Facing west from the access/lease road entrance. Advise maintenance on lease road.

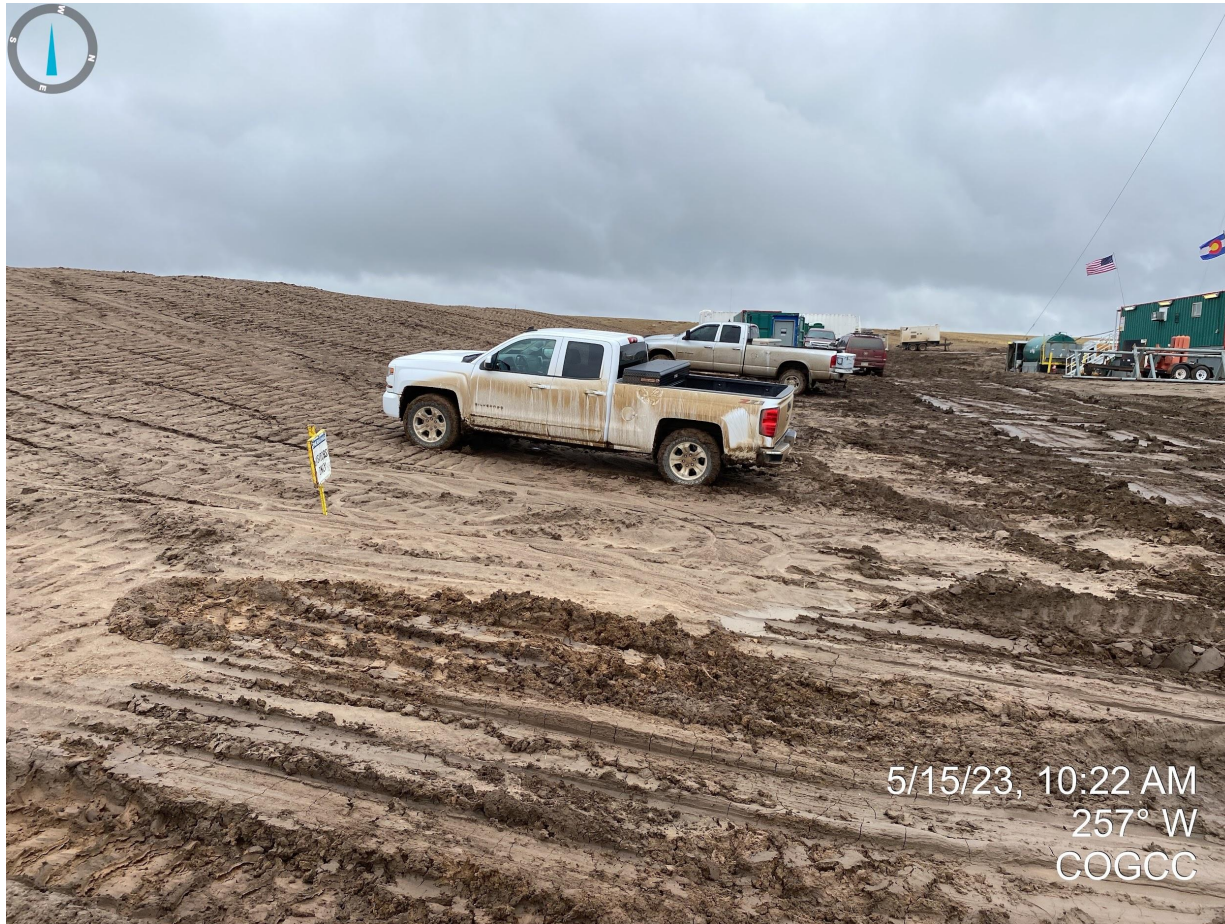
Photo 3. Facing west at topsoil stockpile. Vehicles and equipment were observed to be parked on the topsoil stockpile.

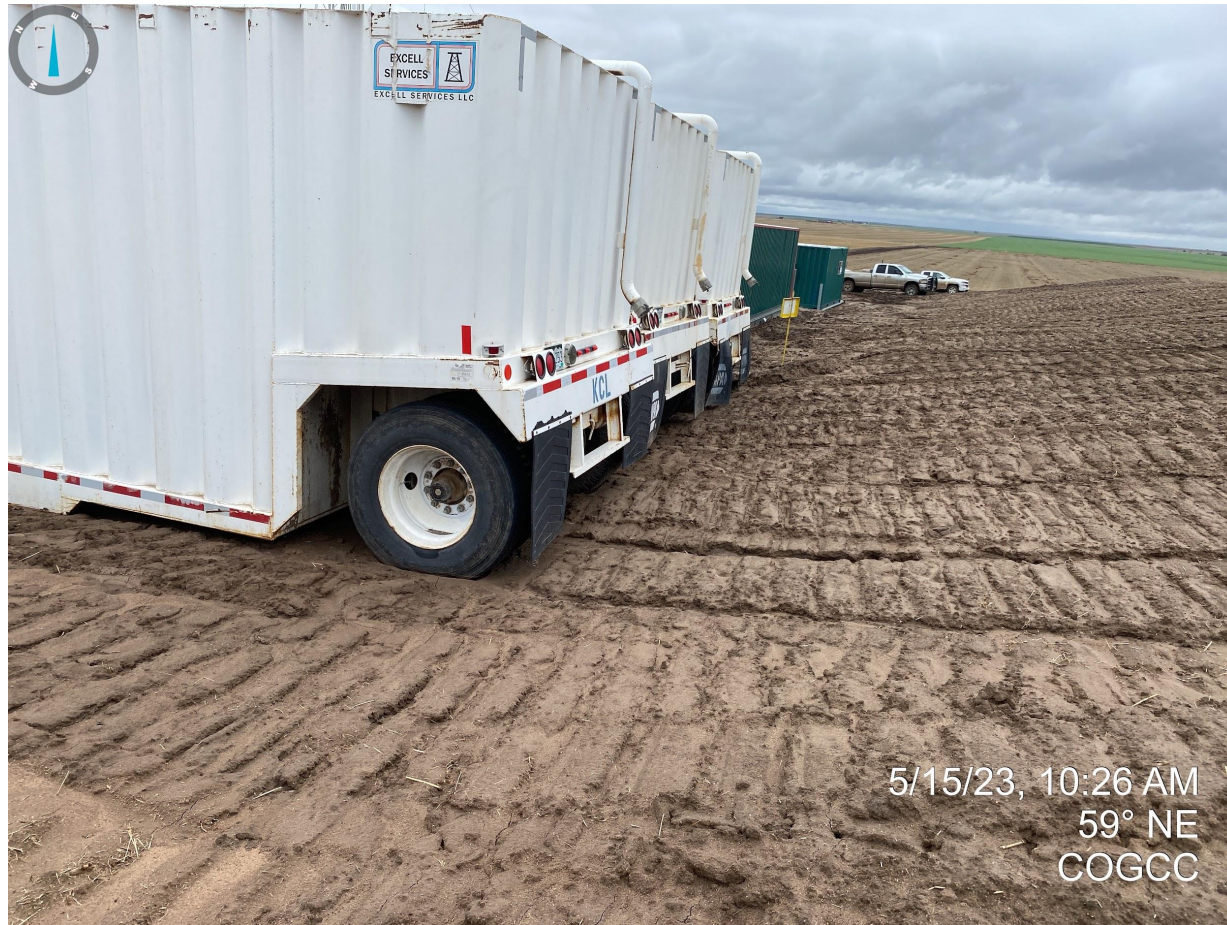
Photo 4. See comments in Photo 3.

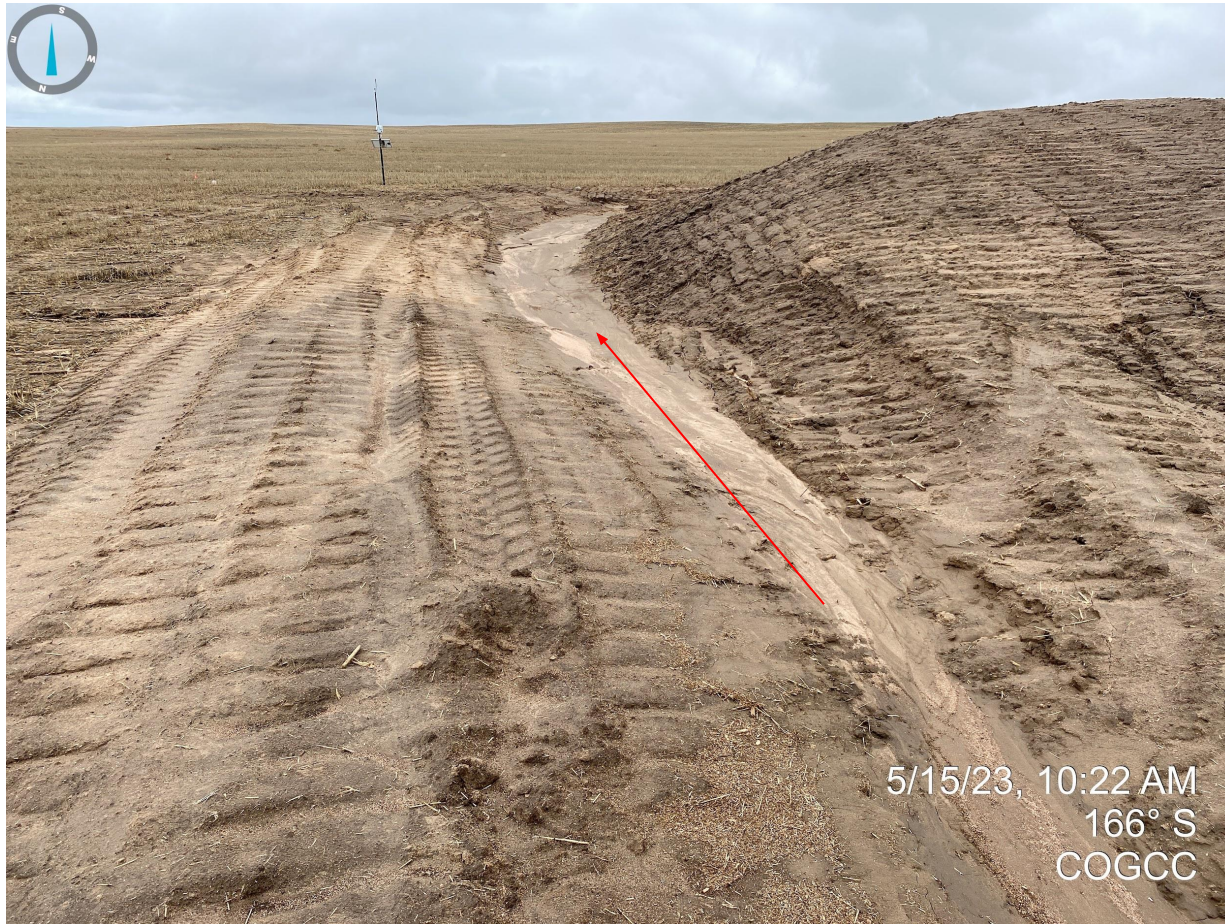
Photo 5. Ditch on the east side of the location appears to be filled with sediment; advise ditch maintenance in order to handle/control future stormwater events.

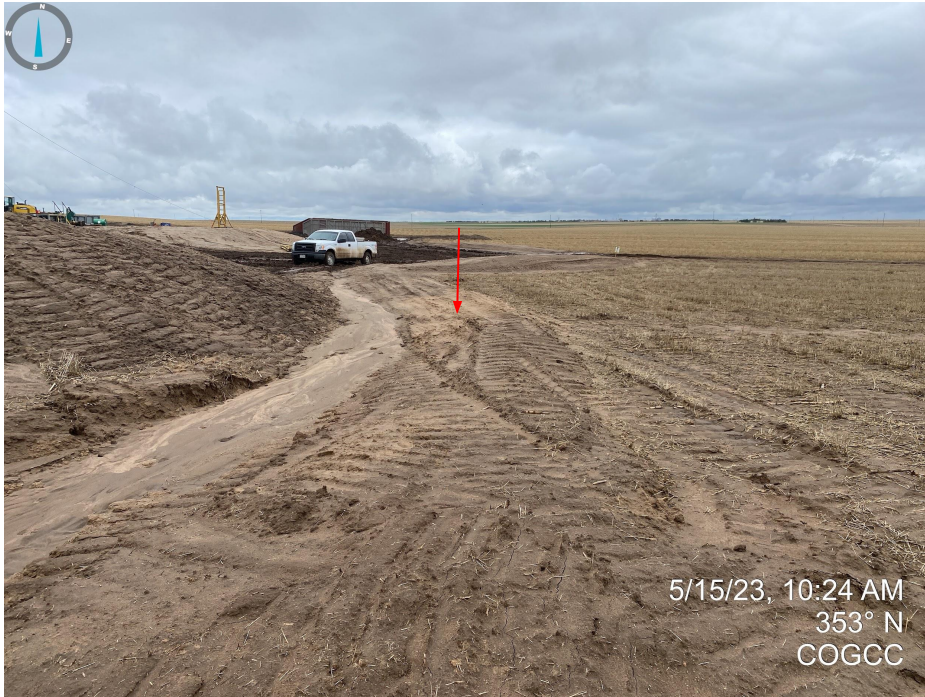
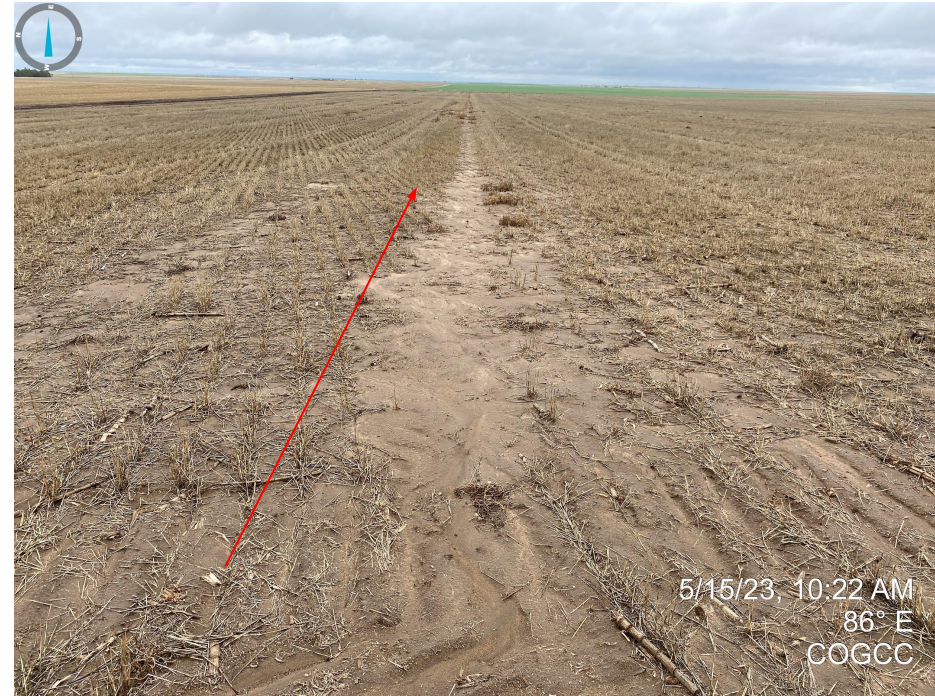
Photos 6 & 7. Photos illustrate apparent offsite sediment transport onto adjacent lands; Left photo shows position (red arrow) where right photo was taken. Stormwater BMPs appear to be inadequate and not installed per good engineering practices. More robust BMPs should be implemented to prevent further degradation to adjacent lands.

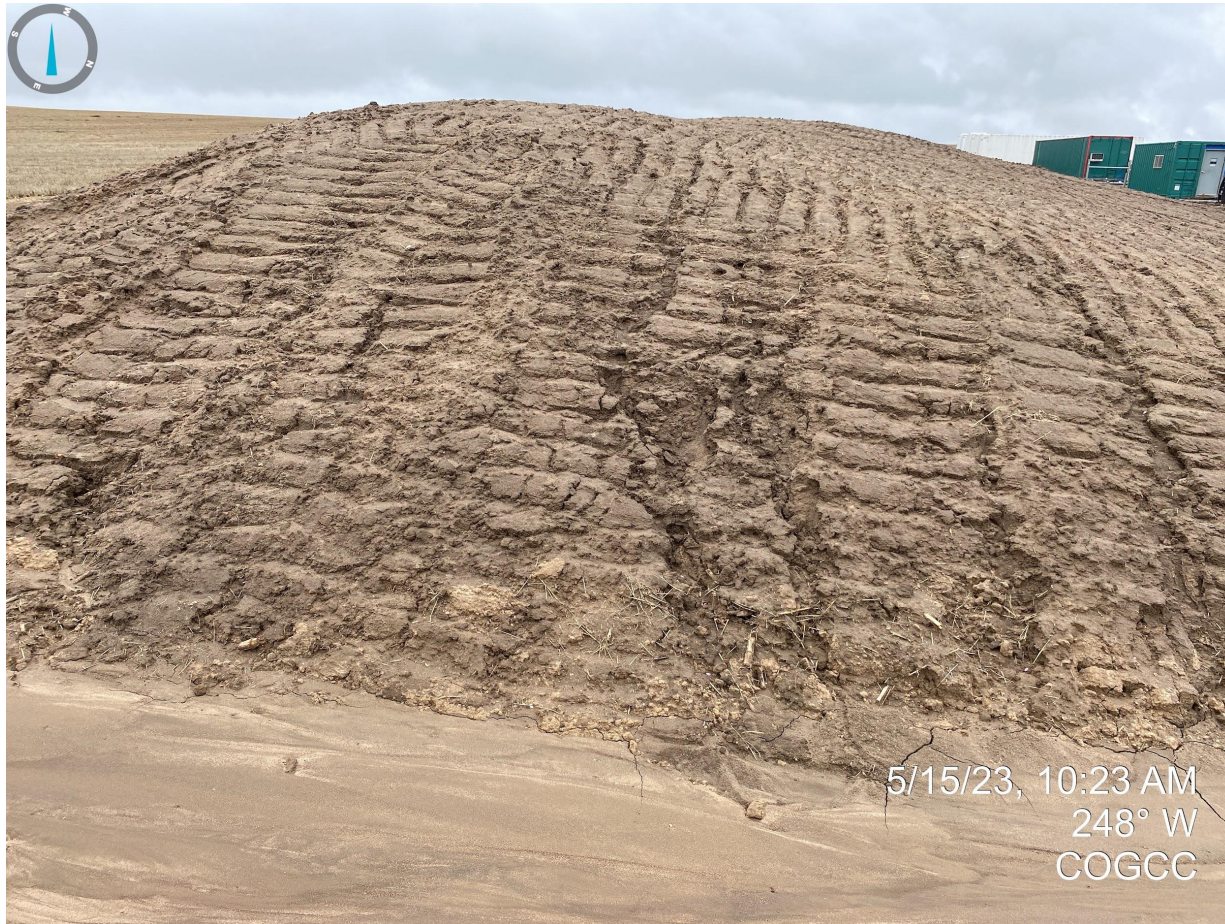
Photo 8. Facing west at the east end of the topsoil stockpile. Rill erosion evident on the walls of the stockpile. While equipment tracking appears to have been performed previously, additional short term stabilization work will need to be performed to prevent further erosion from occurring.

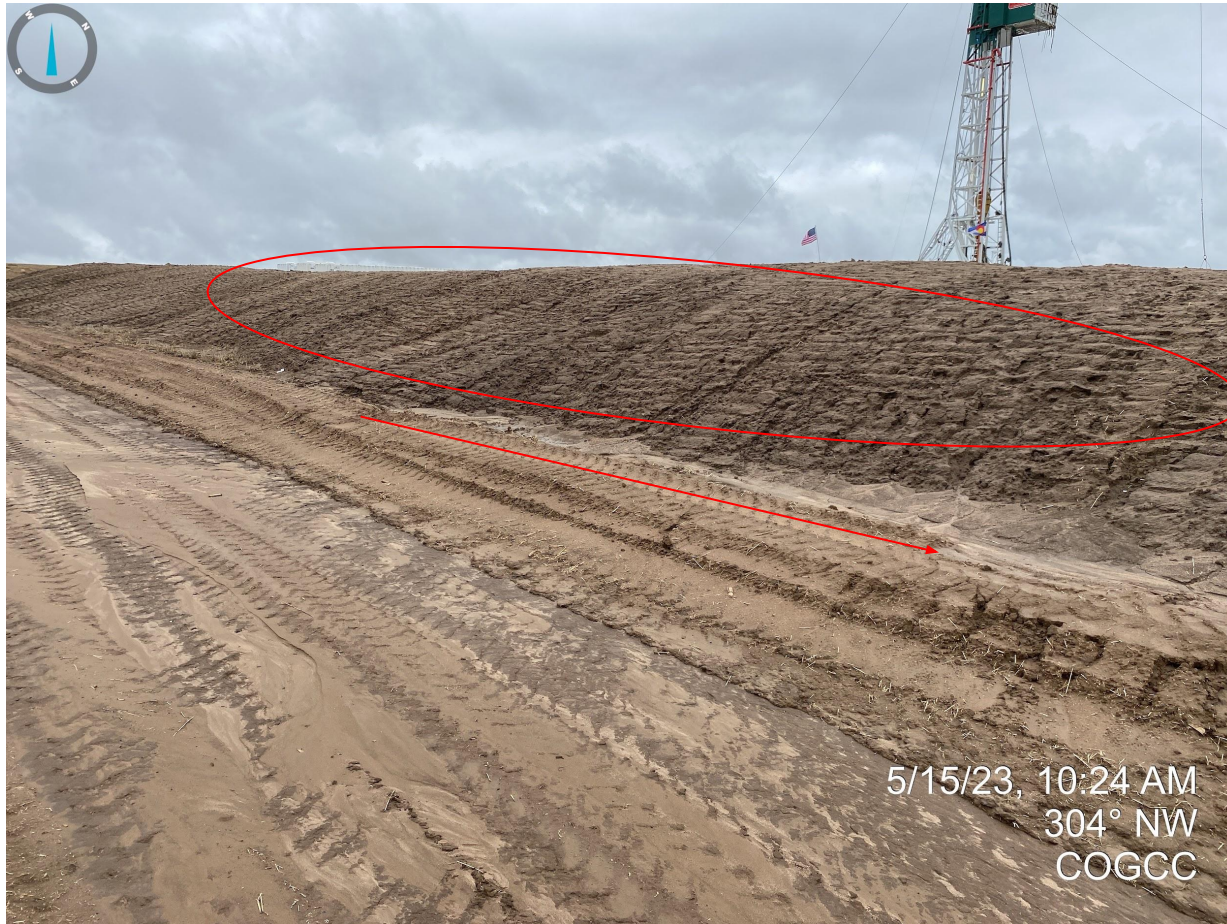
Photo 9. Taken from the eastern end of the stockpile. See comments in Photo 8. Circle identifying rill erosion and arrow illustrating sediment deposition.

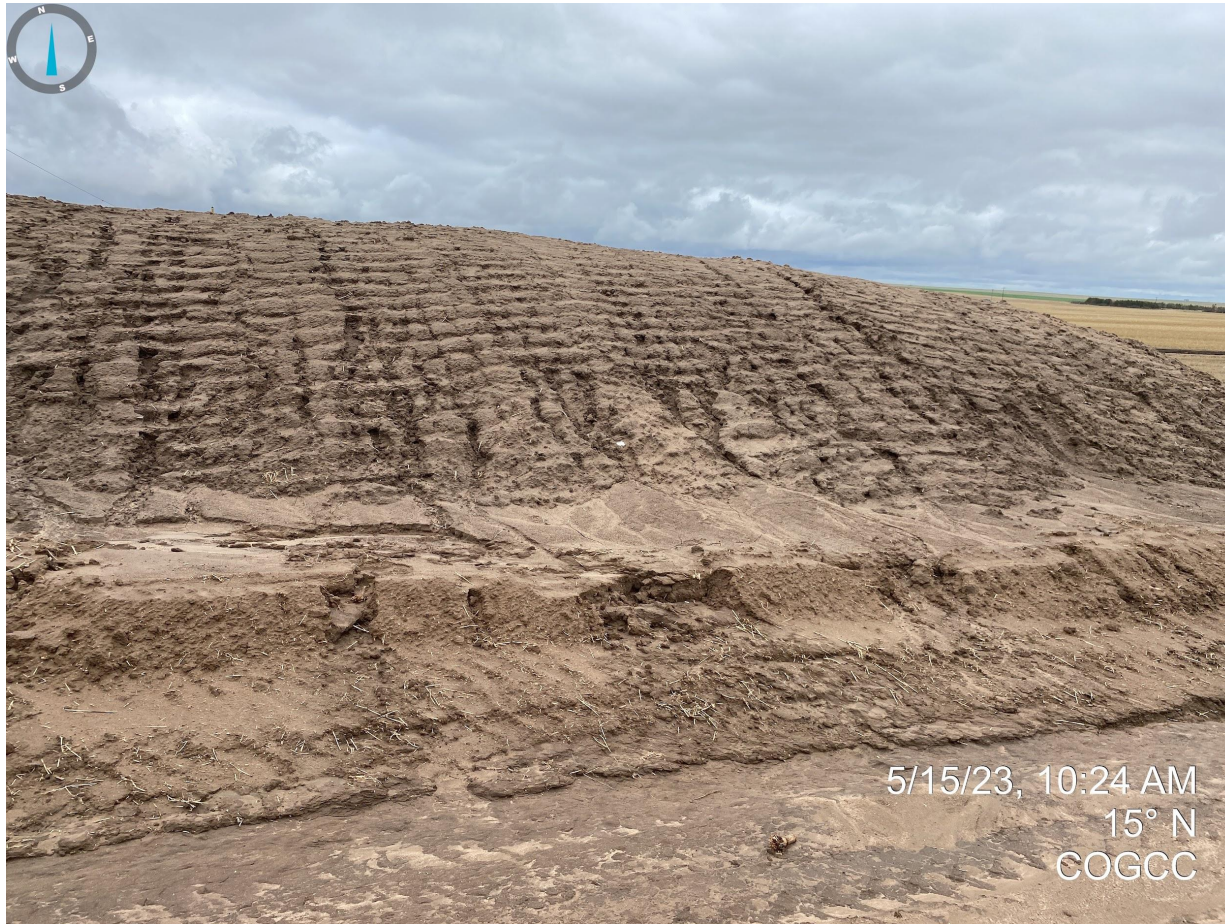
Photo 10. See comments in Photos 8 & 9.

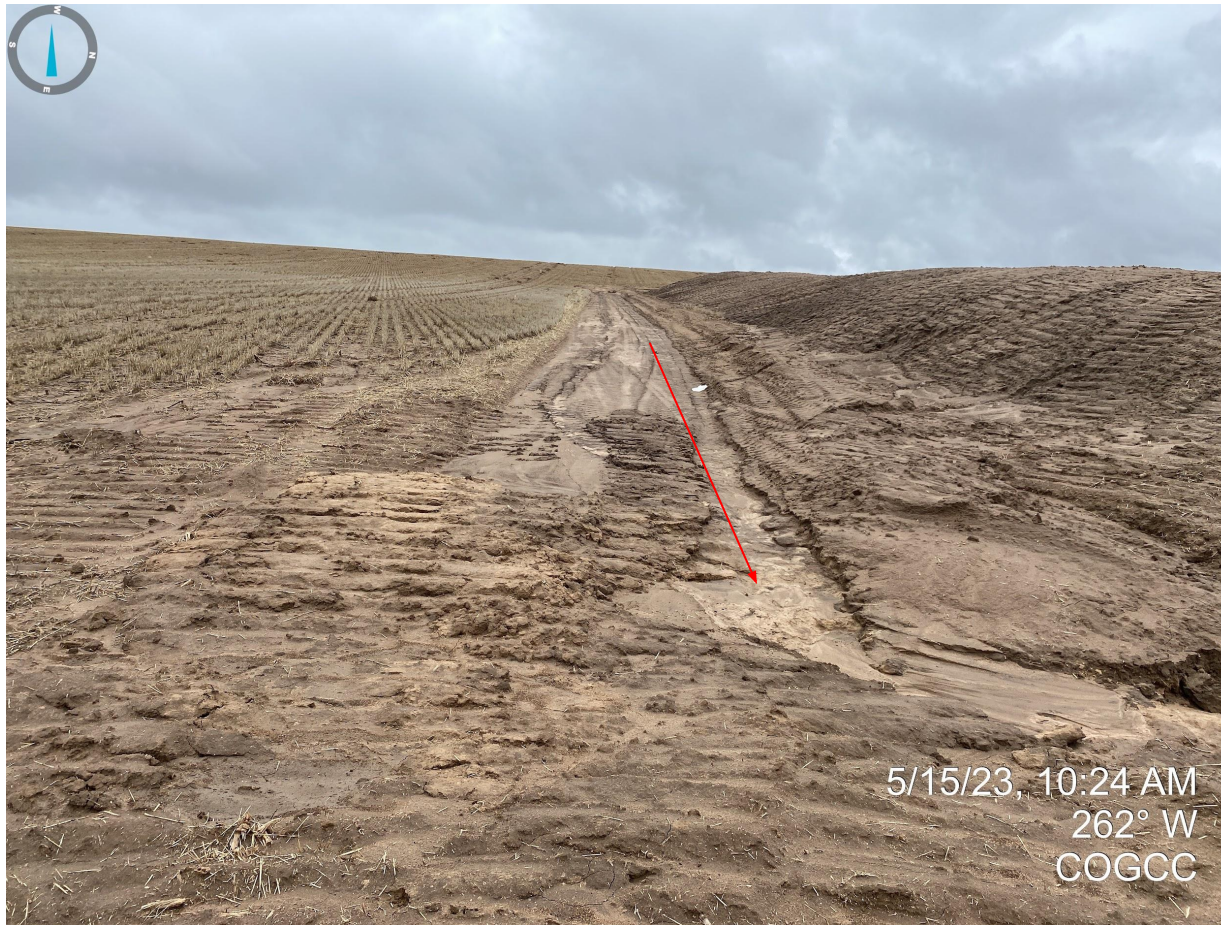
Photo 11. Facing west on the southern edge of the location. Photo illustrates rill erosion occurring on areas grubbed, with no apparent stormwater BMPs observed. More robust stormwater BMPs will need to be implemented to control stormwater run-on and run-off, and prevent further site degradation.

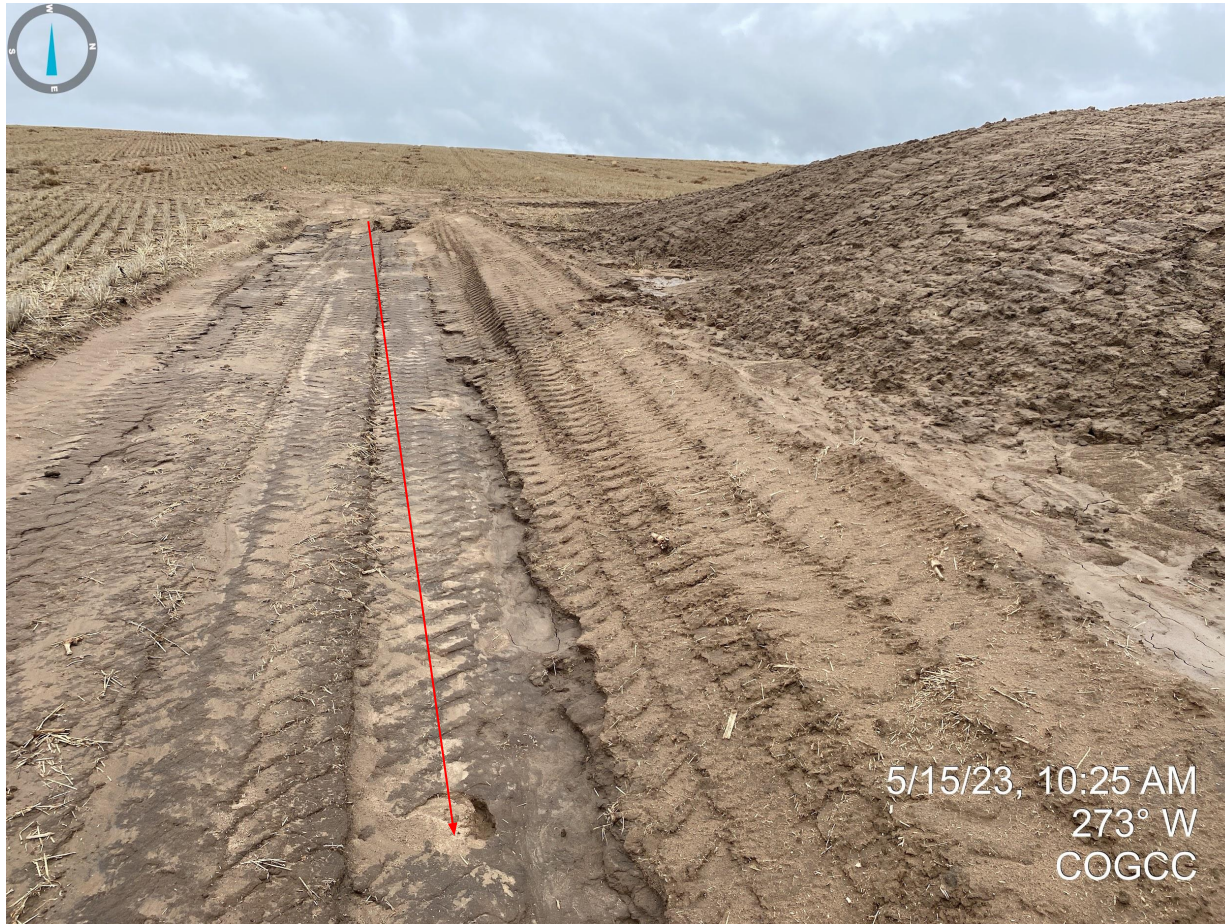
Photo 12. Continued from Photo 11.

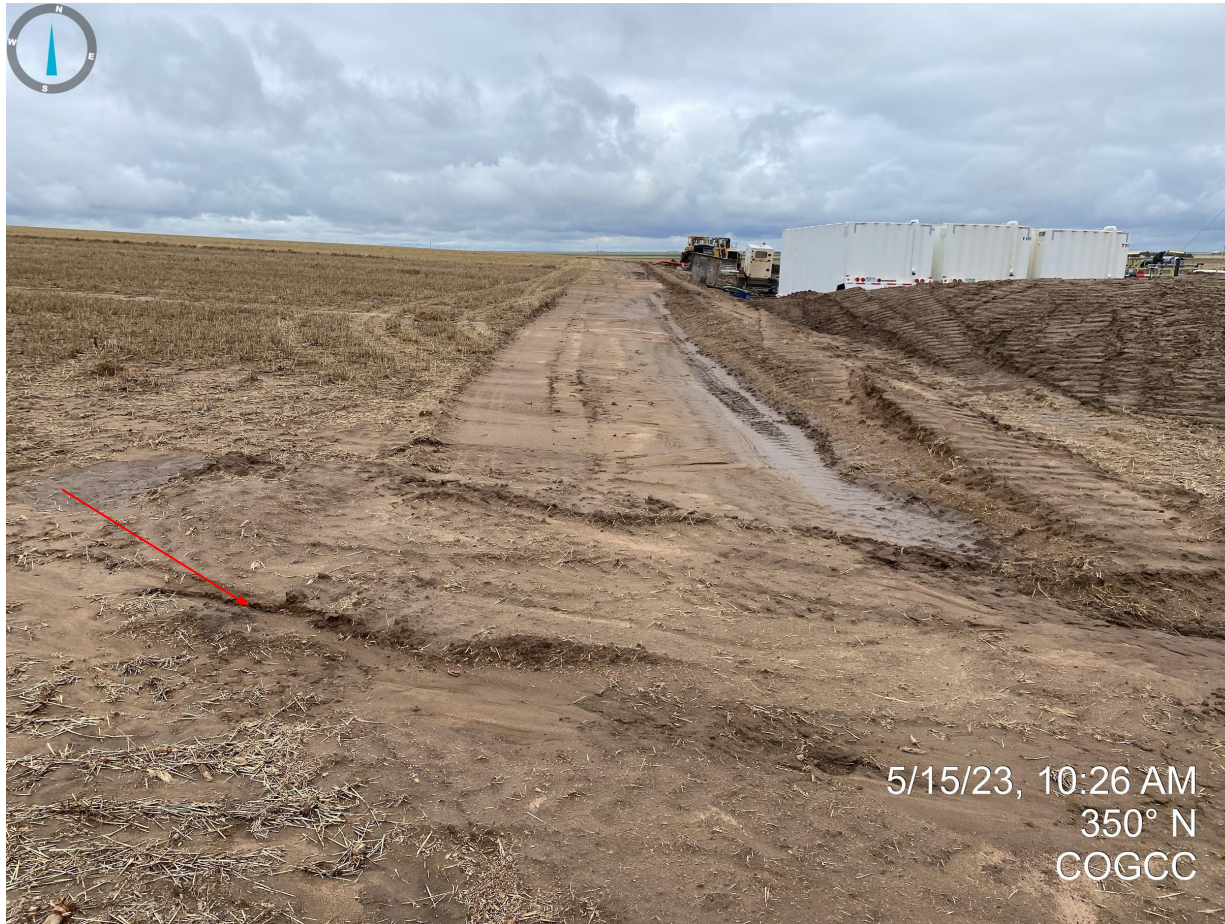
Photo 13. Taken from the southwest corner, facing north. See comments in Photo 11.

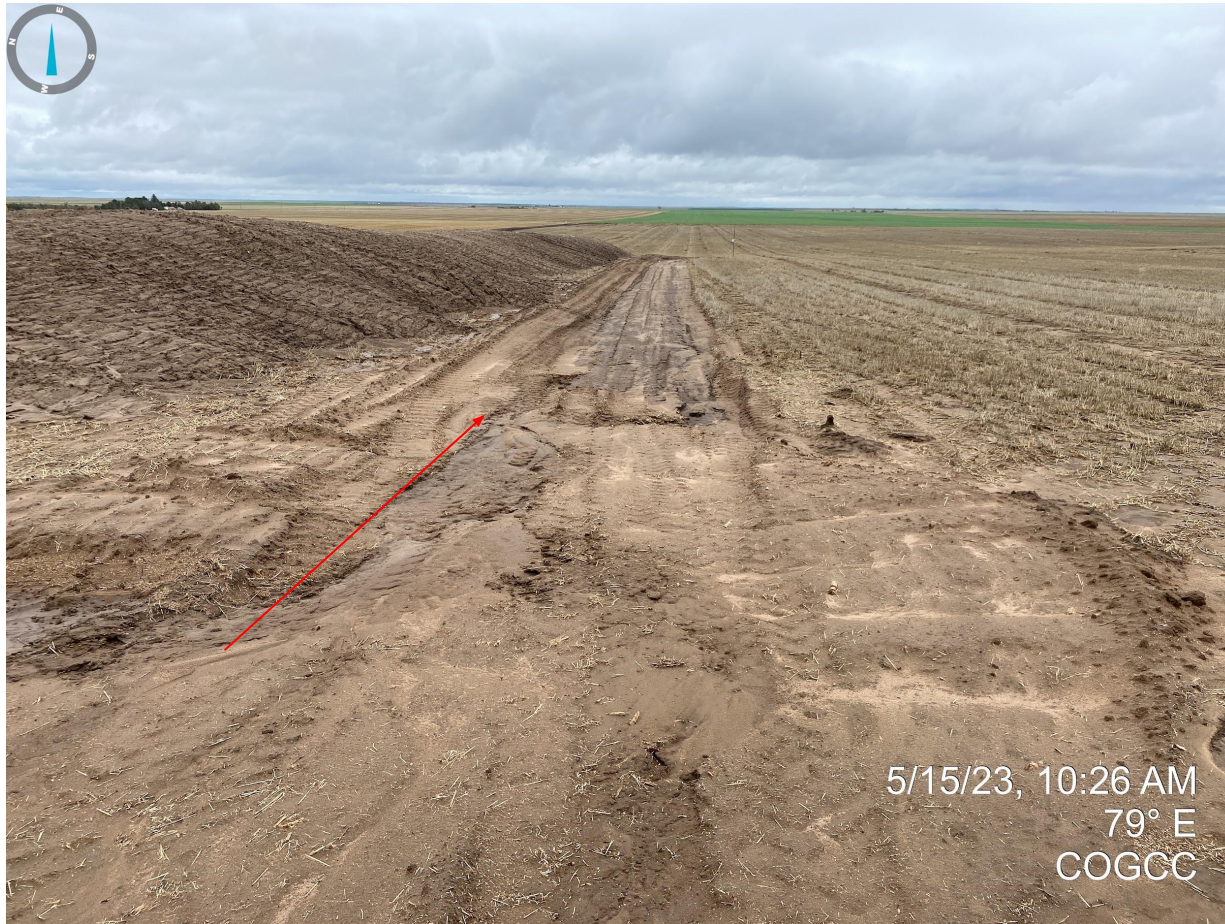
Photo 14. Facing east from the southwest corner; see comments in Photo 11.

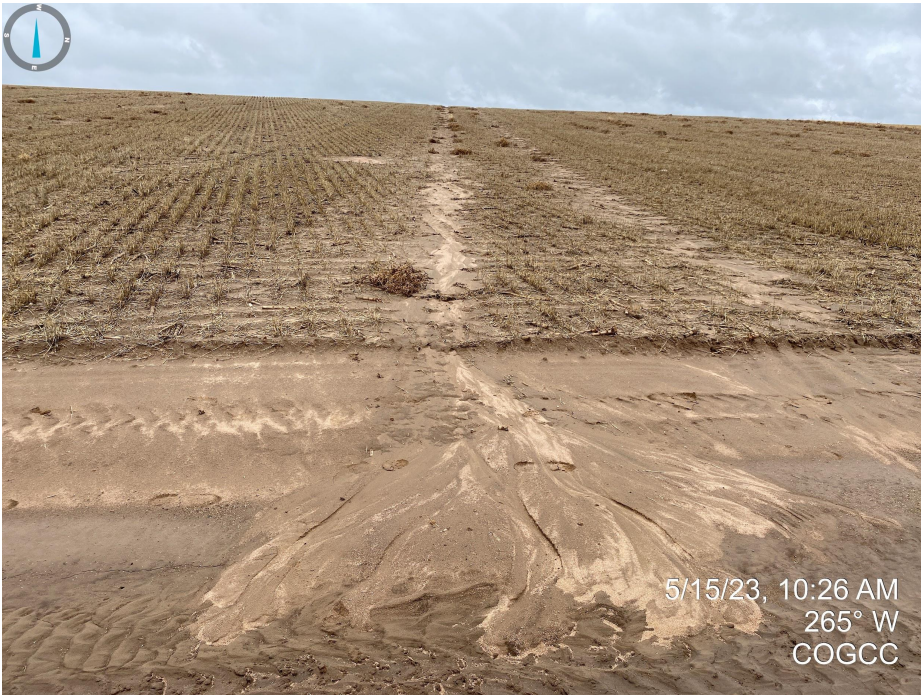
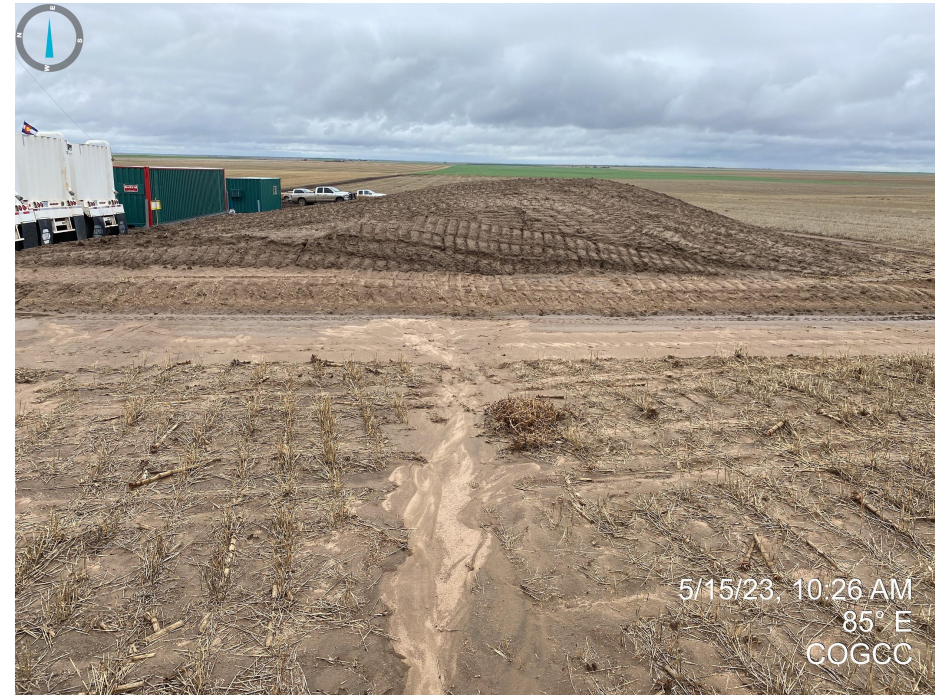
Photos 15 & 16. Taken from the southwestern portion of the location. Photo illustrates that no apparent stormwater BMPs have been implemented to prevent sediment laden stormwater from running onto the location.

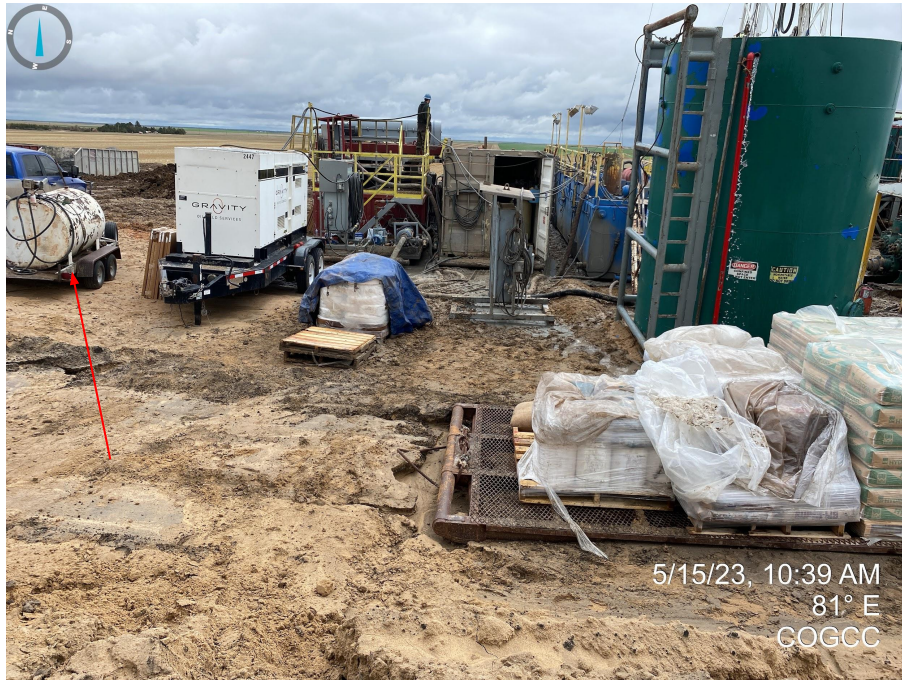
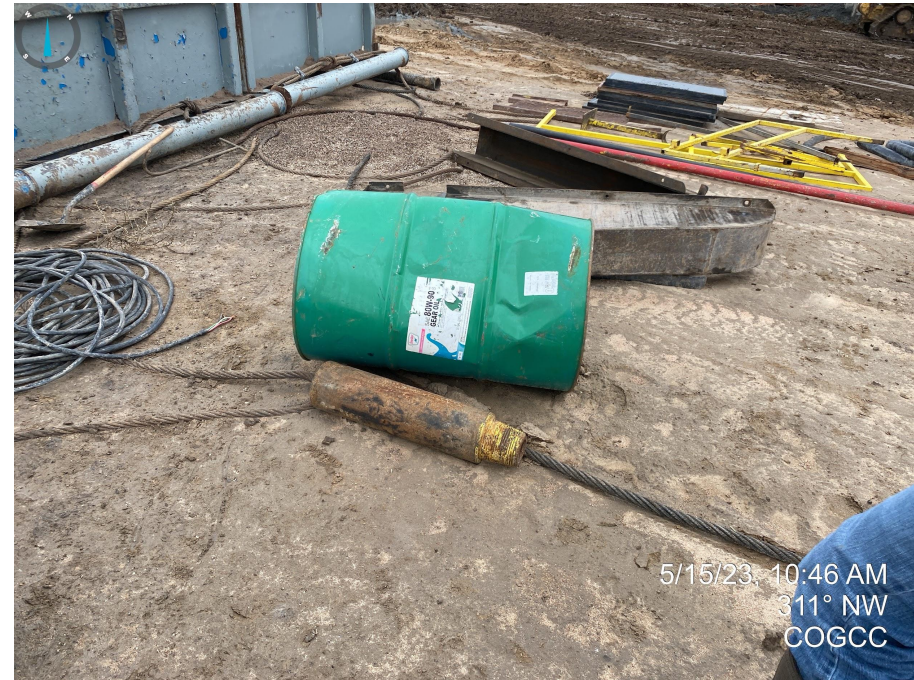
Photos 17 & 18. Left photo illustrates that fuel tank is not placed within secondary containment; and right photo illustrates oil drum was not upright, or in secondary containment, at the time of this inspection. This is not in compliance with Rule 1002.f.(2)B.

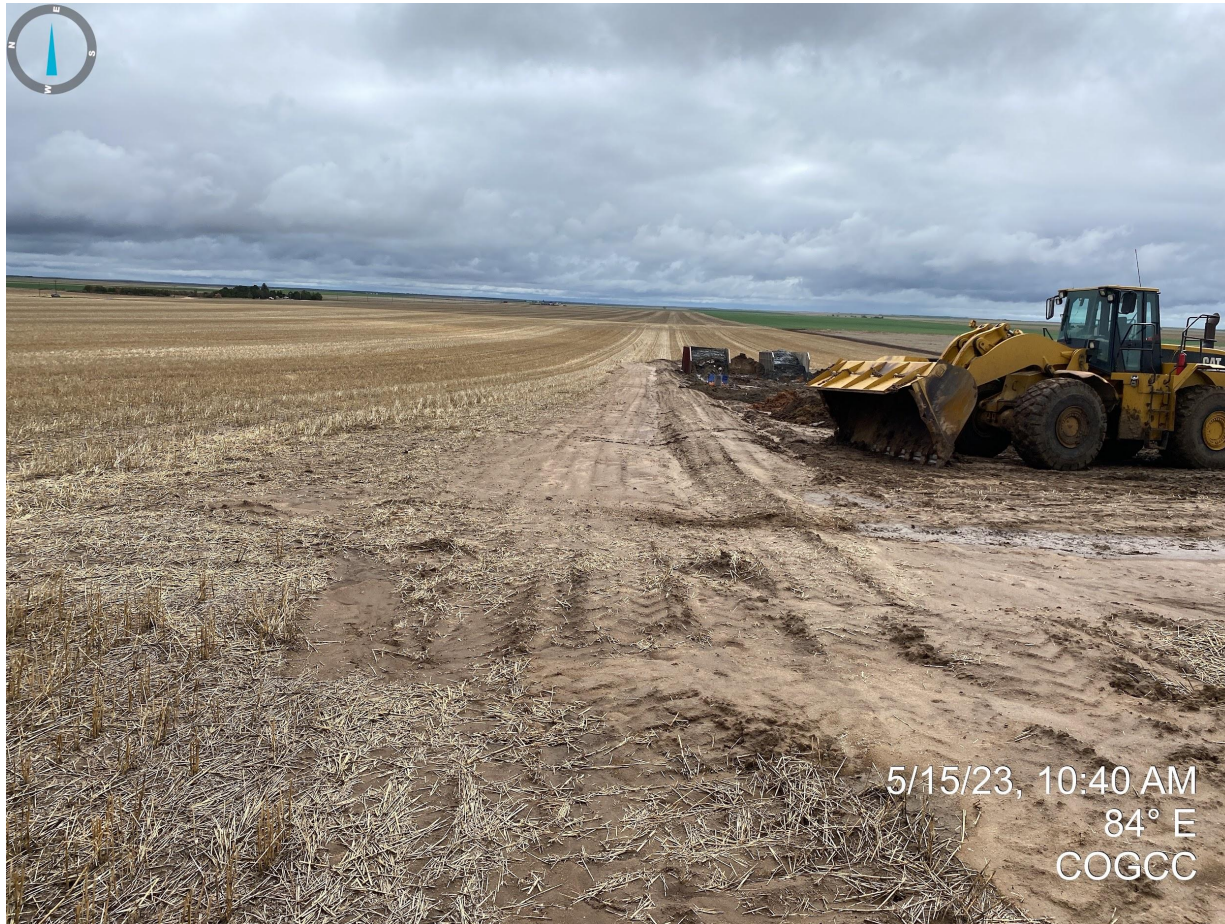
Photo 19. Facing east from the northwest corner of the location. Photo illustrates that stormwater BMPs appear to be inadequate for this location. Grubbed areas have no apparent stormwater/erosion controls to prevent sediment transport.

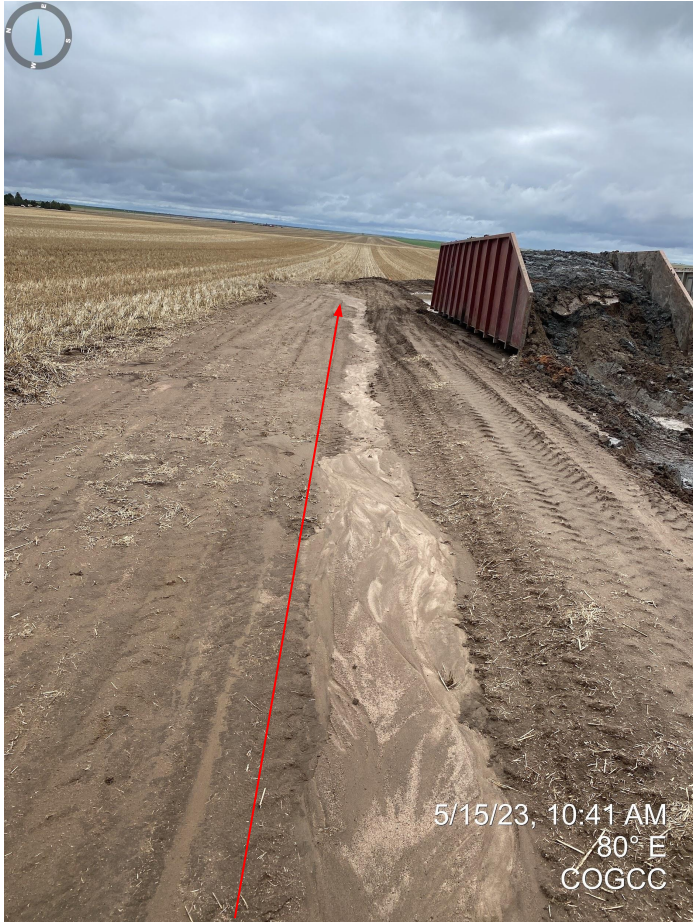
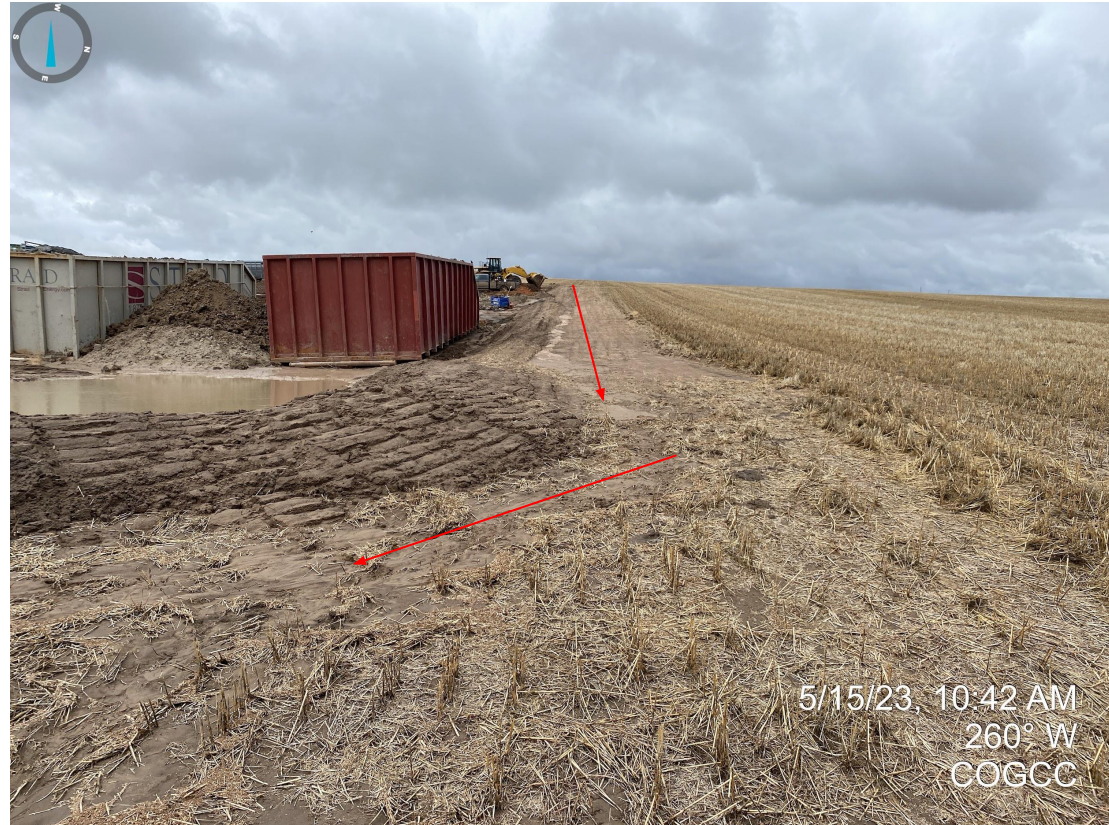
Photos 20 & 21. See comments in Photo 19.

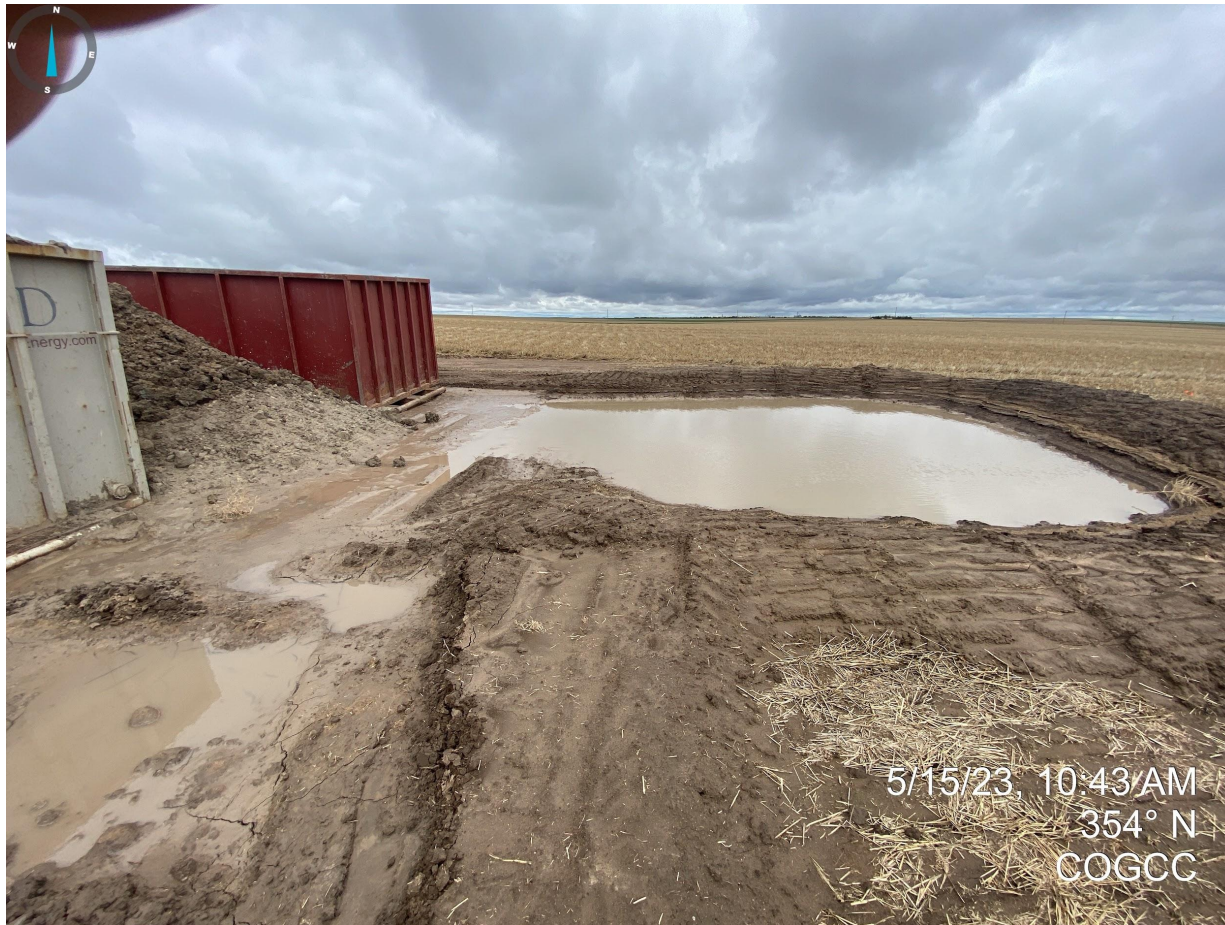
Photo 22. Sediment trap placed on the northeast corner of the location appears to be properly functioning.

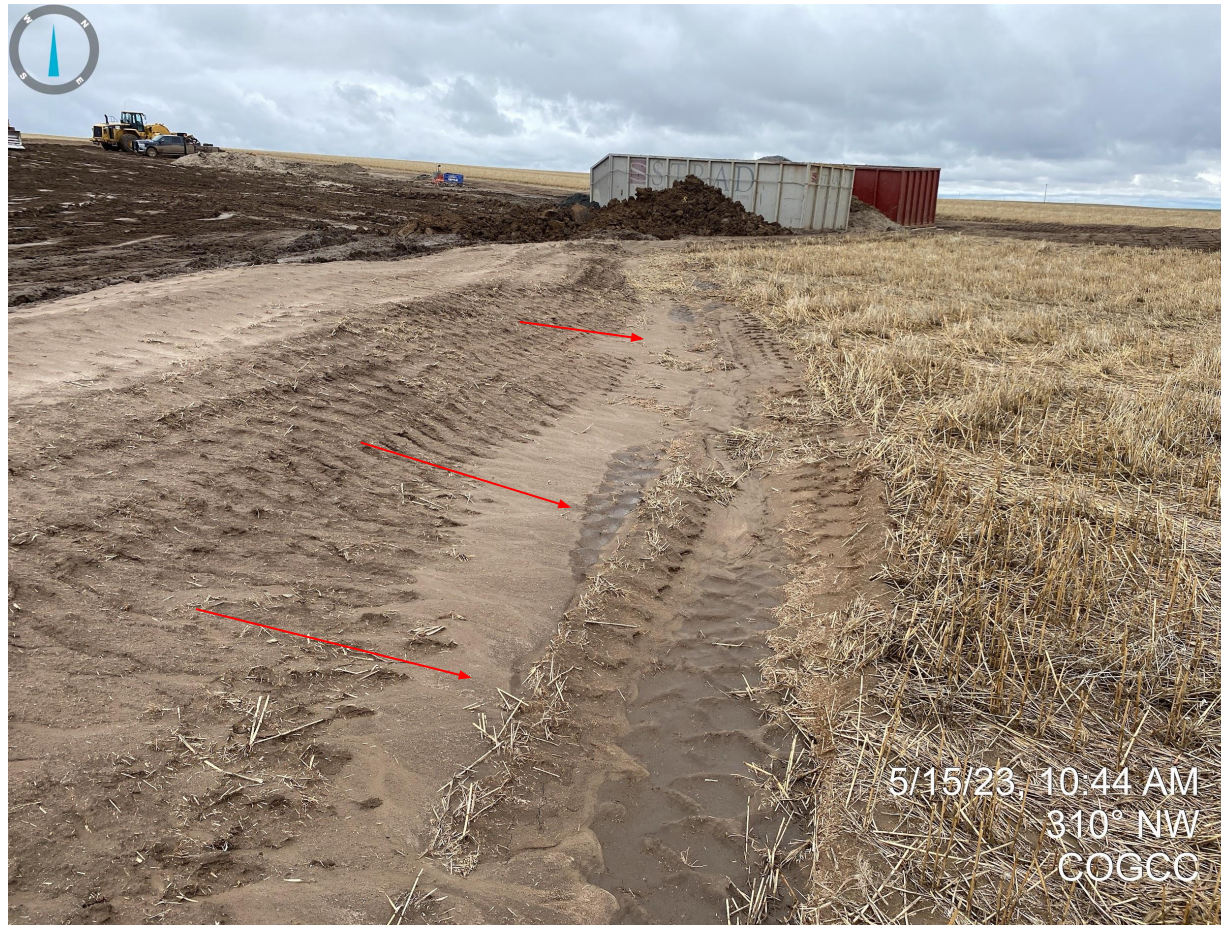
Photo 23. Taken from the eastern portion of the location, near the entrance. Berm material does not appear to be properly stabilized with evidence of sediment deposition.
