# Interim Reclamation and Stormwater Inspection

Operator: VERDAD RESOURCES LLC - 10651

Location ID: 432694

Inspection Document #: 708200264

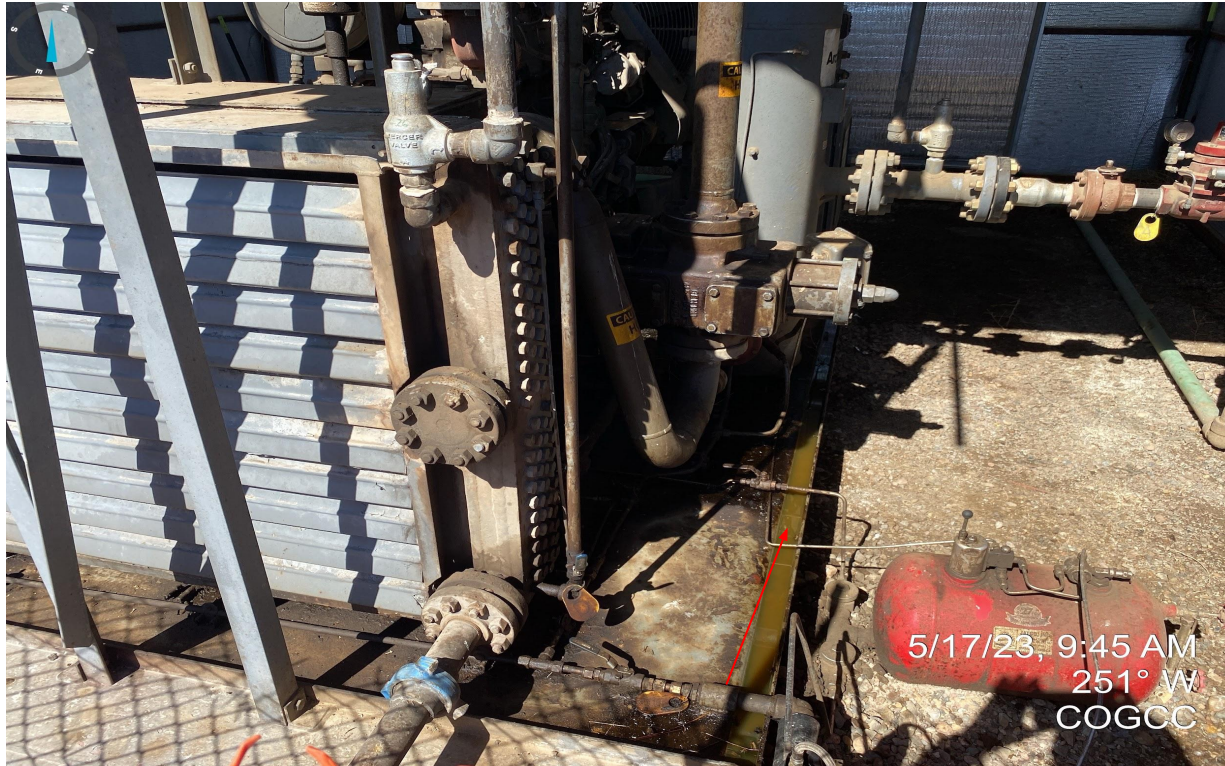
**Photo 1.** Facing west at compressor station. Unknown fluid observed within the engine skid; previous inspections required the Operator to contain and clean up antifreeze within the skid and perform maintenance on the equipment to ensure mechanical integrity (e.g. fix origin of leak). Based on documentation in FIRR (doc#403379517) the operator cleaned up the antifreeze (and drained it) but did not indicate if equipment was worked on/repaired. Staff is uncertain if rainfall mixed with residual chemicals on the skid or if the equipment has a mechanical failure elsewhere.

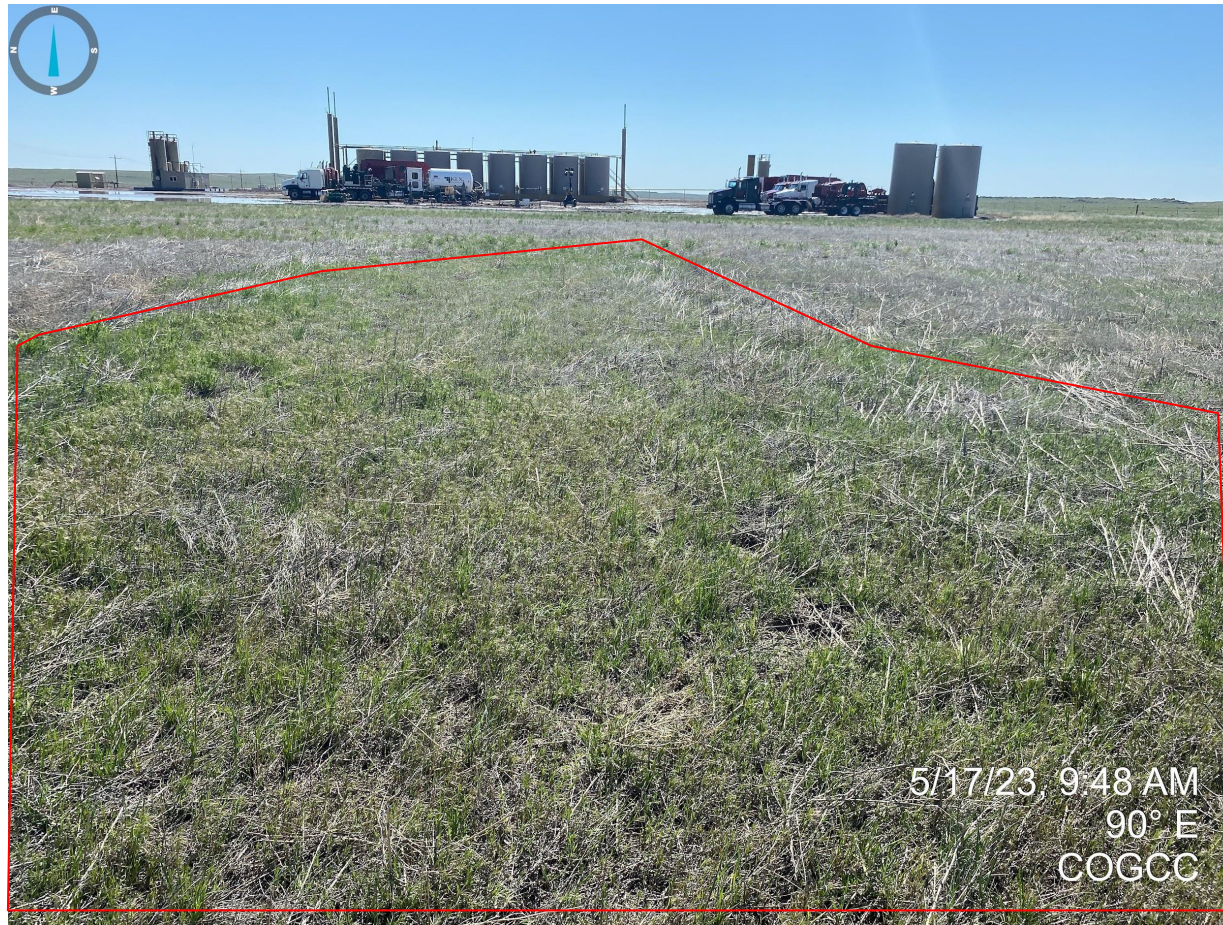
**Photo 2.** During this inspection, Staff observed that the interim reclamation areas do not appear to be progressing towards 1003 standards. Undesirable vegetation (e.g. kochia) and Colorado List B Noxious Weed (e.g. canada thistle) and a List C (e.g. cheatgrass; outlined in red) was observed growing throughout the interim areas and will need to properly managed for during the local growing season to prevent spread onto adjacent lands.

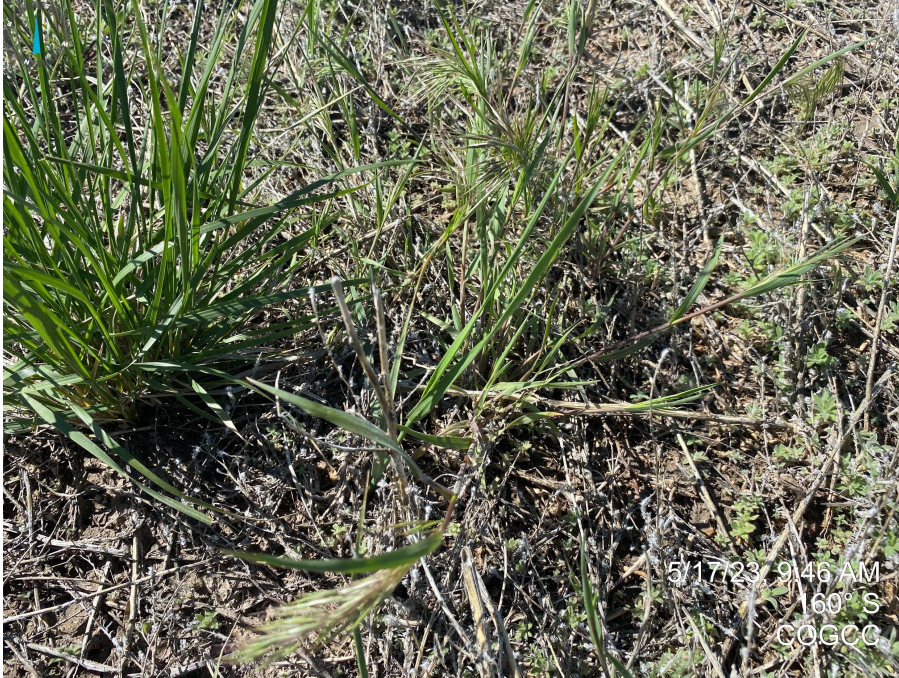
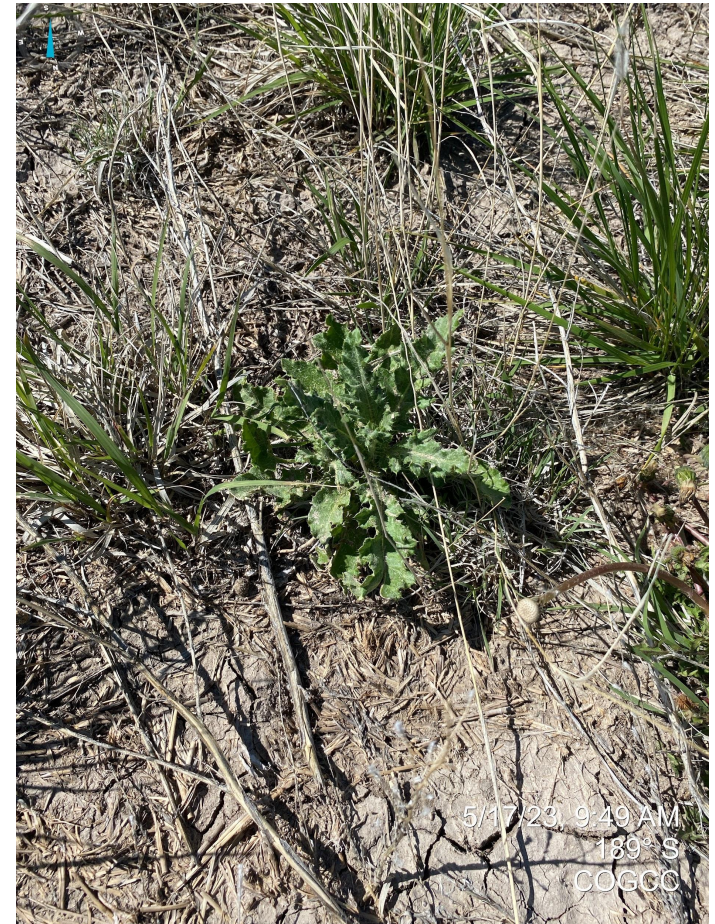
**Photos 3 & 4.** Close up photos of Colorado List C Noxious Weed (e.g. cheatgrass; left) and List B Noxious Weed (e.g. Canada thistle; right).

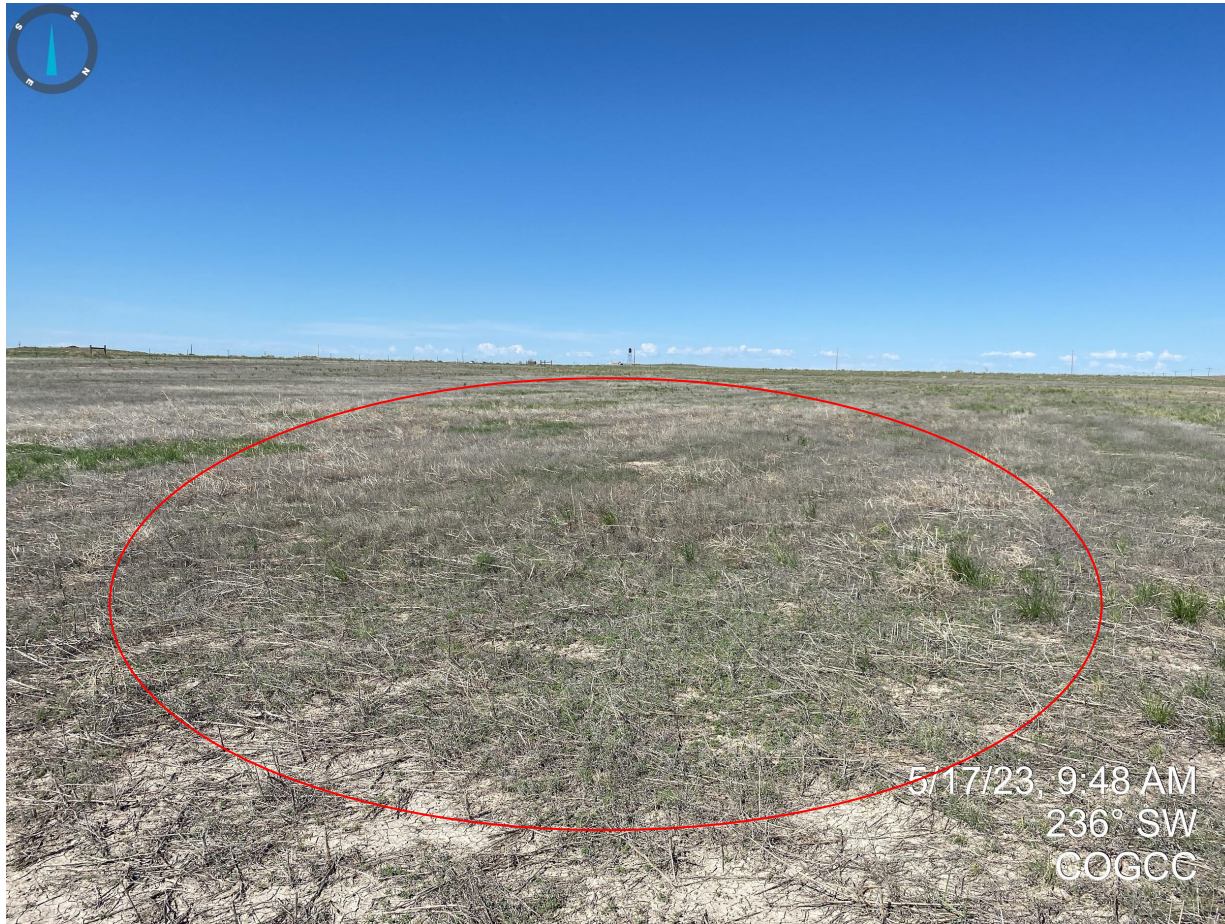
**Photo 5.** Facing southwest near the center portion of the interim areas which were observed to be predominantly undesirable vegetative cover (e.g. kochia).

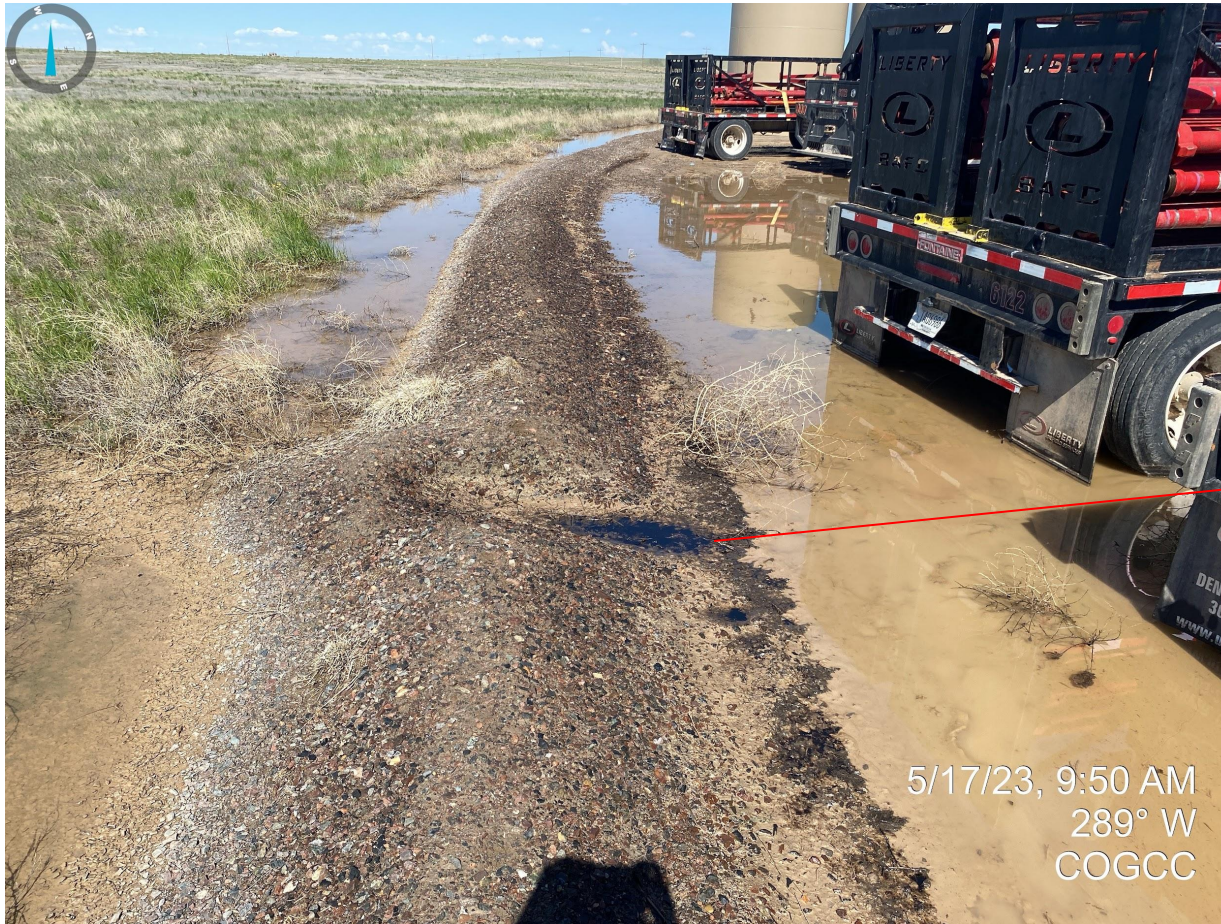
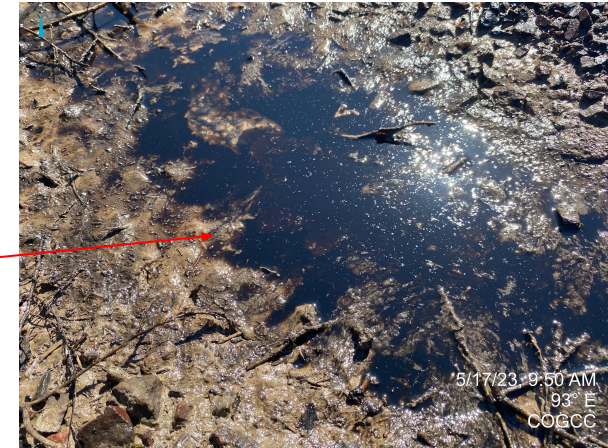
**Photo 6.** Facing west near the southern portion of the production area. Staff observed hydrocarbons mixed with stormwater and was unable to determine how much material was onsite. The berm material also had a noticeable sheen and chemical odor, which will need to be properly cleaned up and removed. After review with Environmental Staff this is a reportable spill per Rule 912.b.

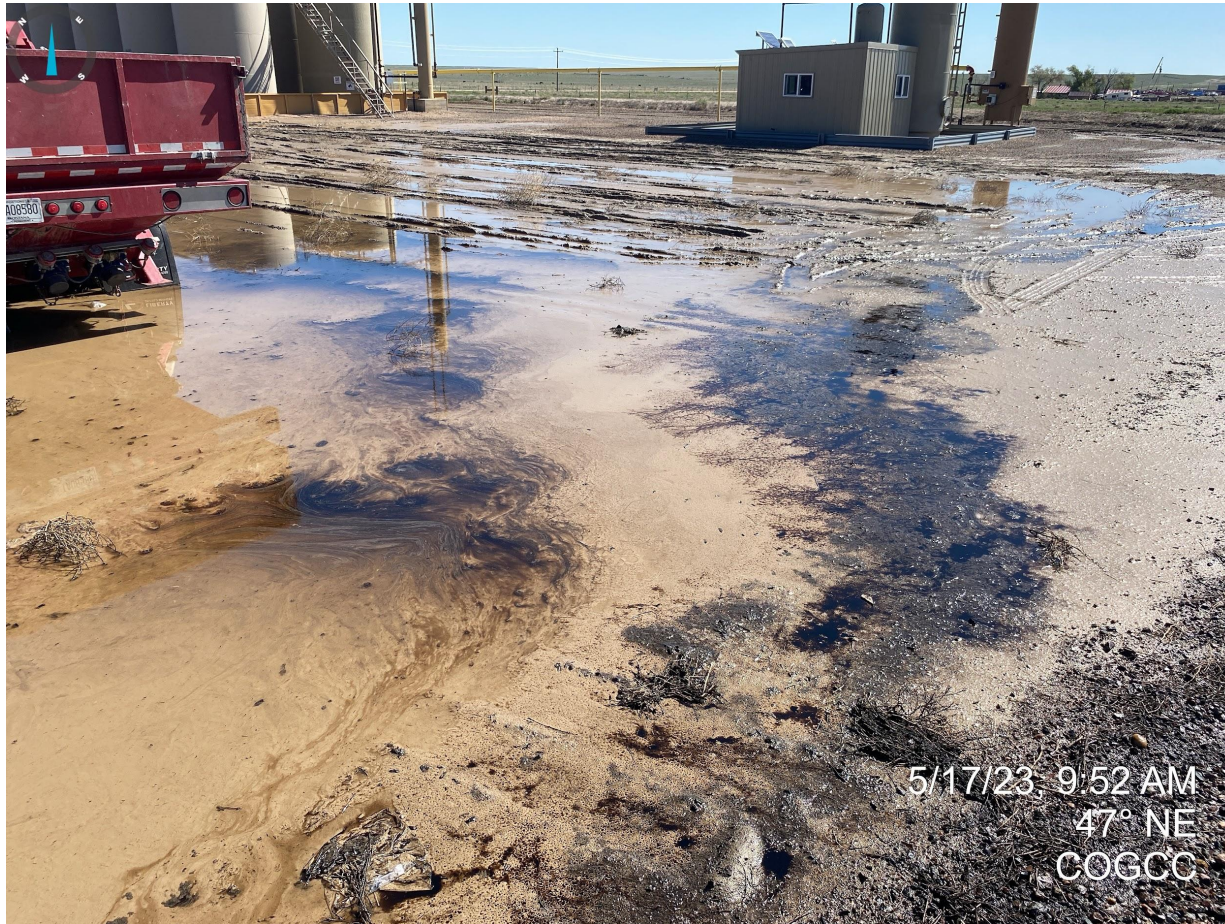
**Photo 7.** See comments in Photo 6.

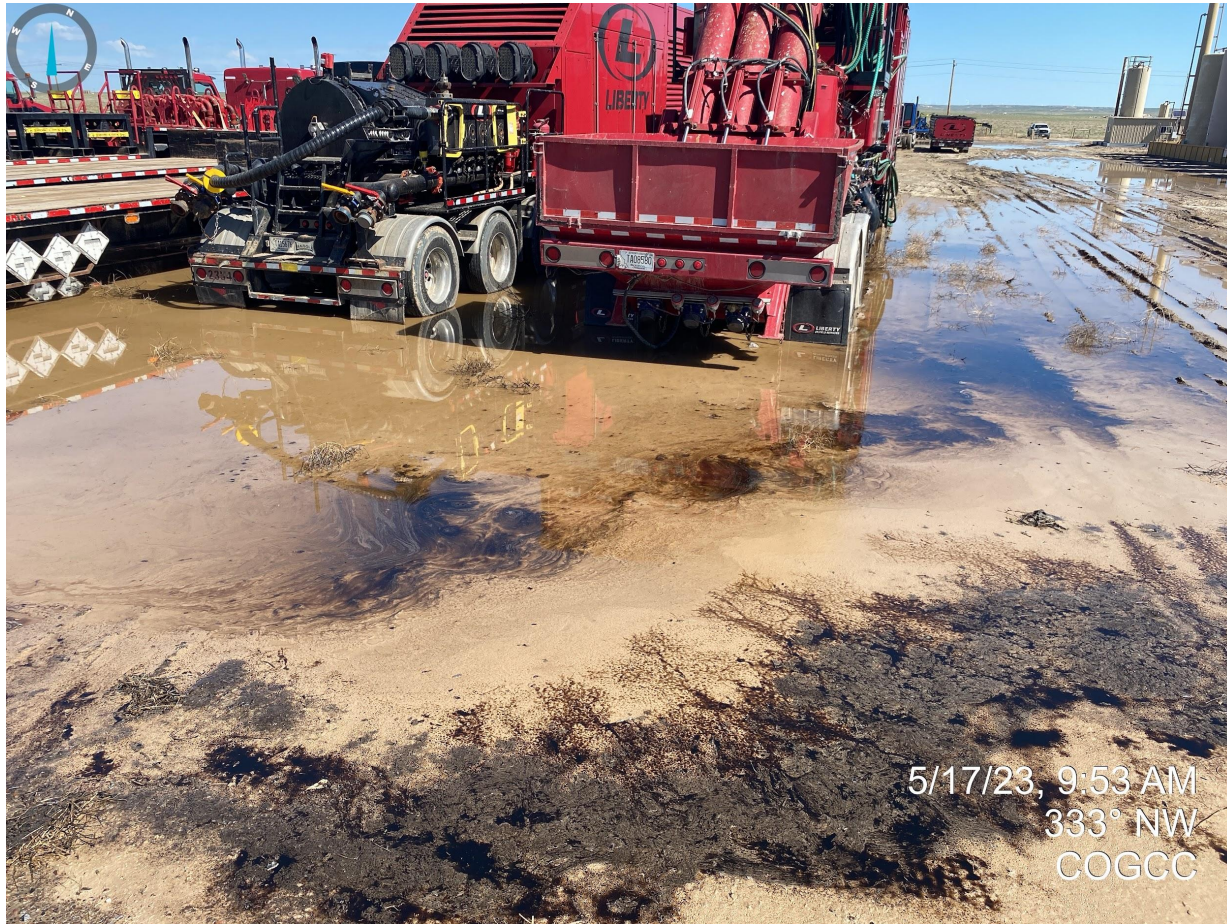
**Photo 8.** See comments in Photo 6.

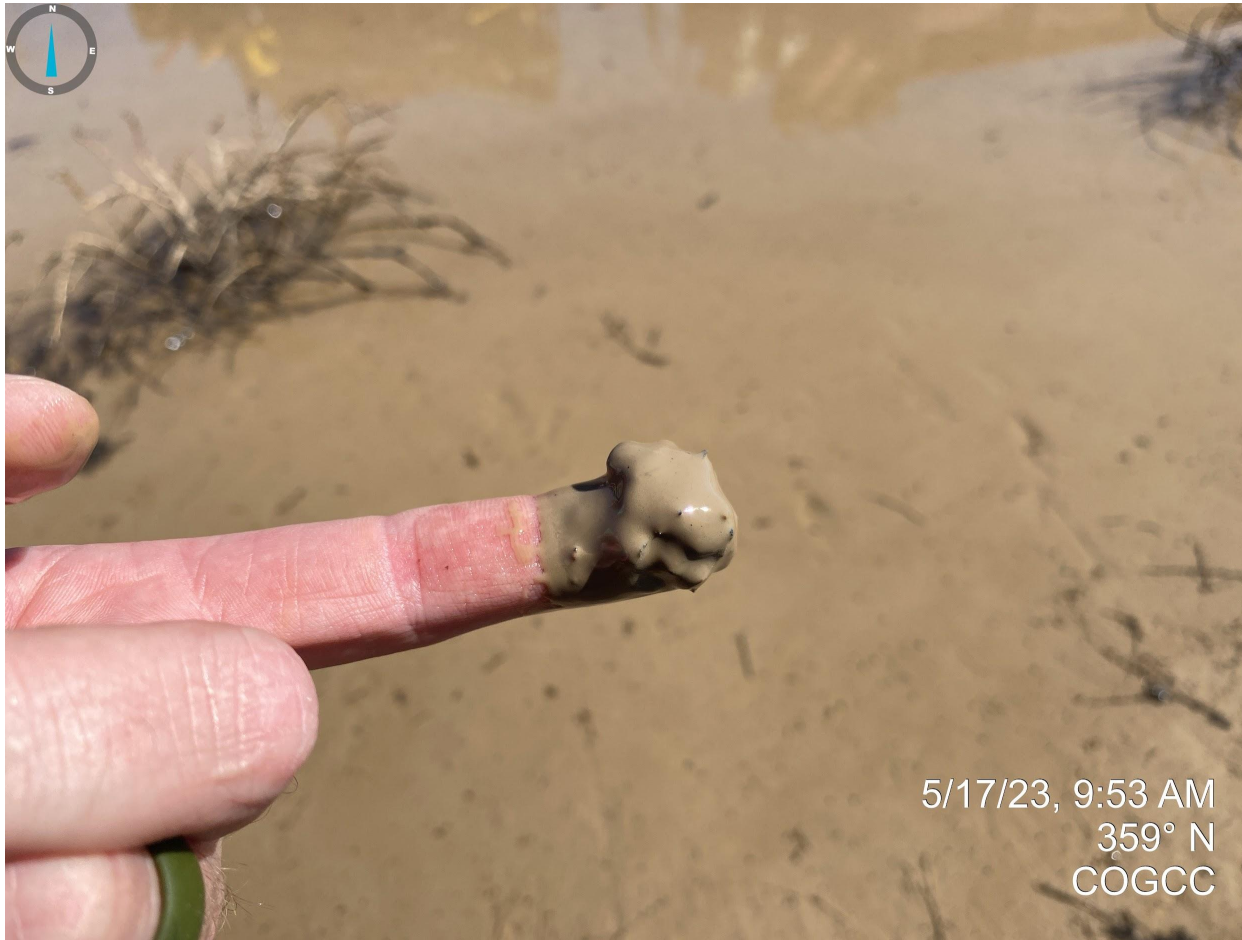
**Photo 9.** See comments in Photo 6. Unknown fluid did not appear to be the consistency of dirt/soil/stormwater and had noticeable chemical odor and sheen.

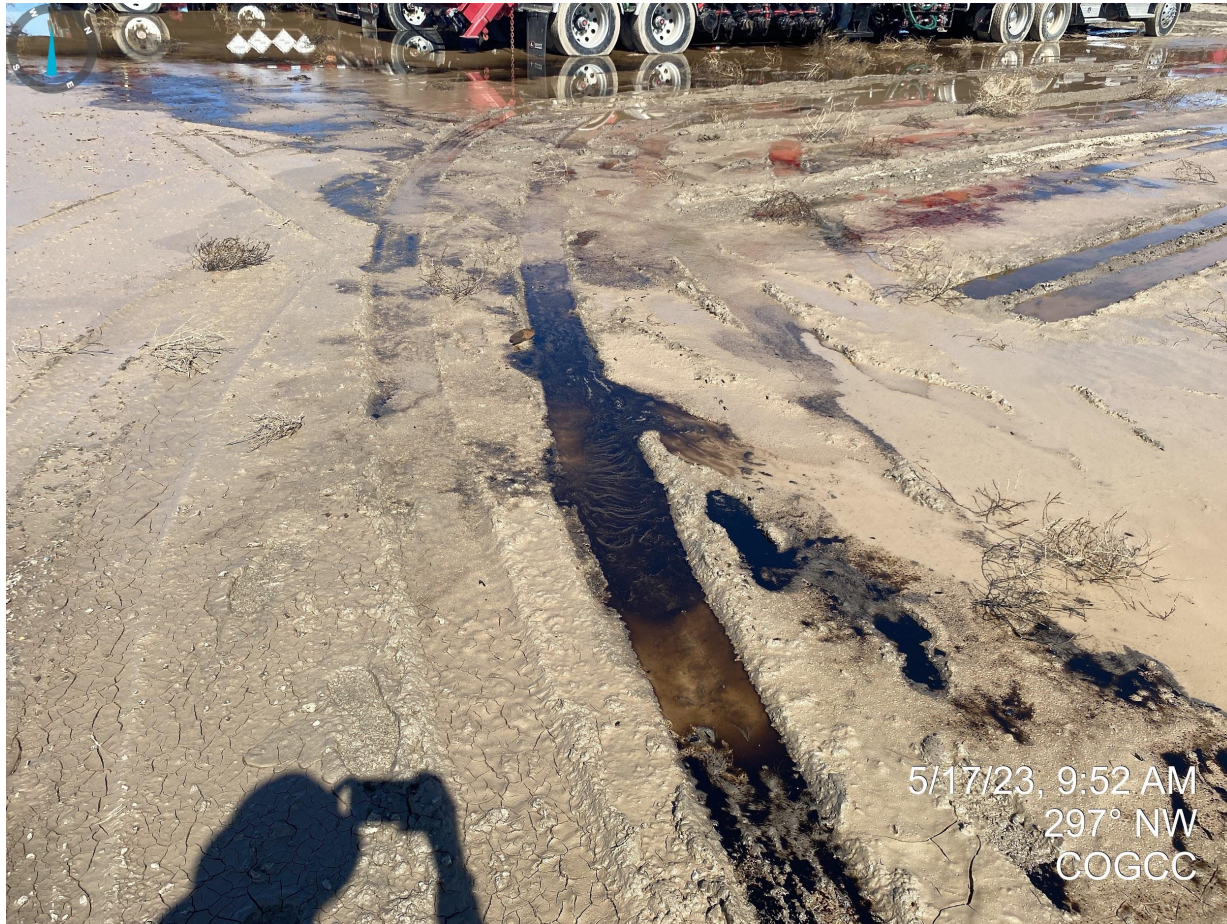
**Photo 10.** See comments in Photo 6.

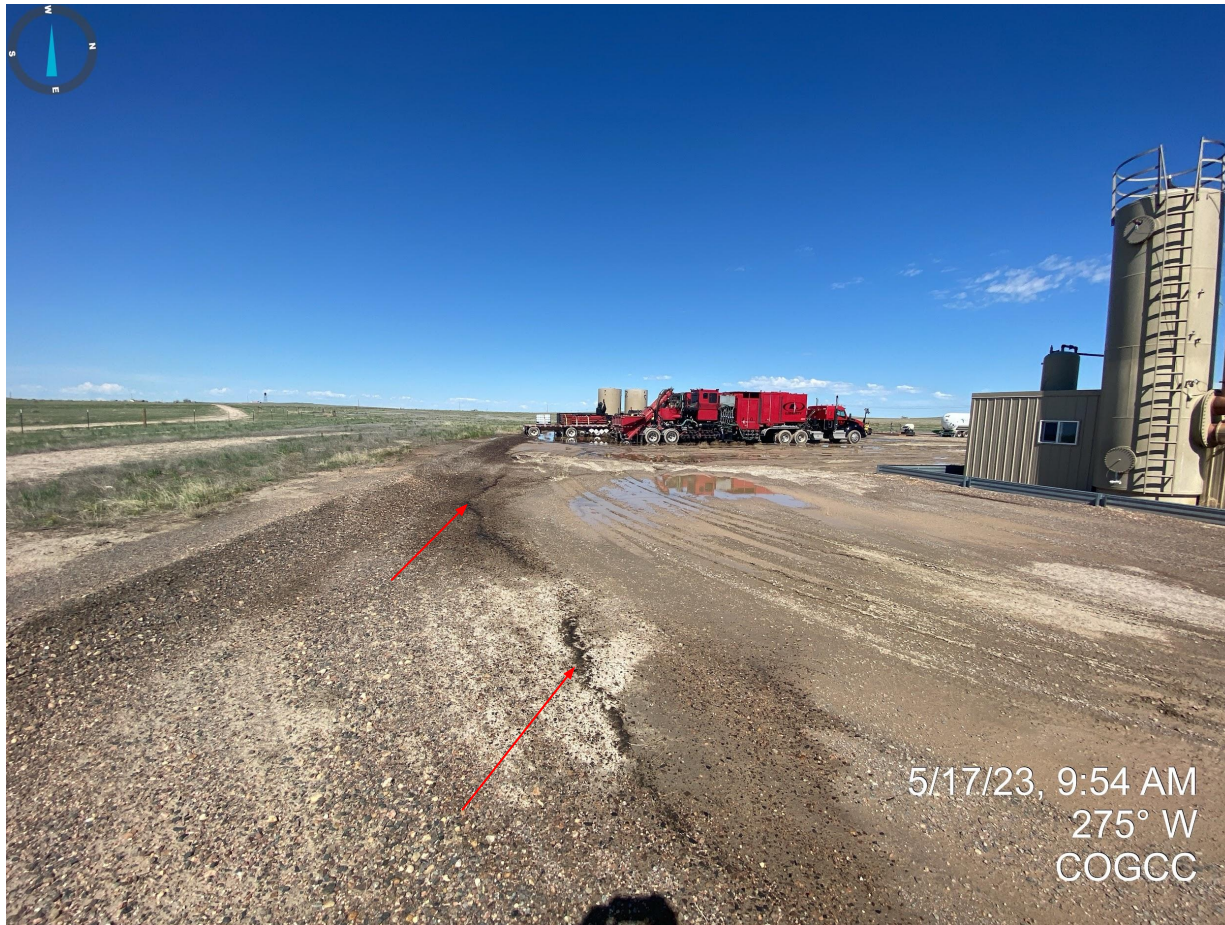
**Photo 11.** See comments in Photo 6.

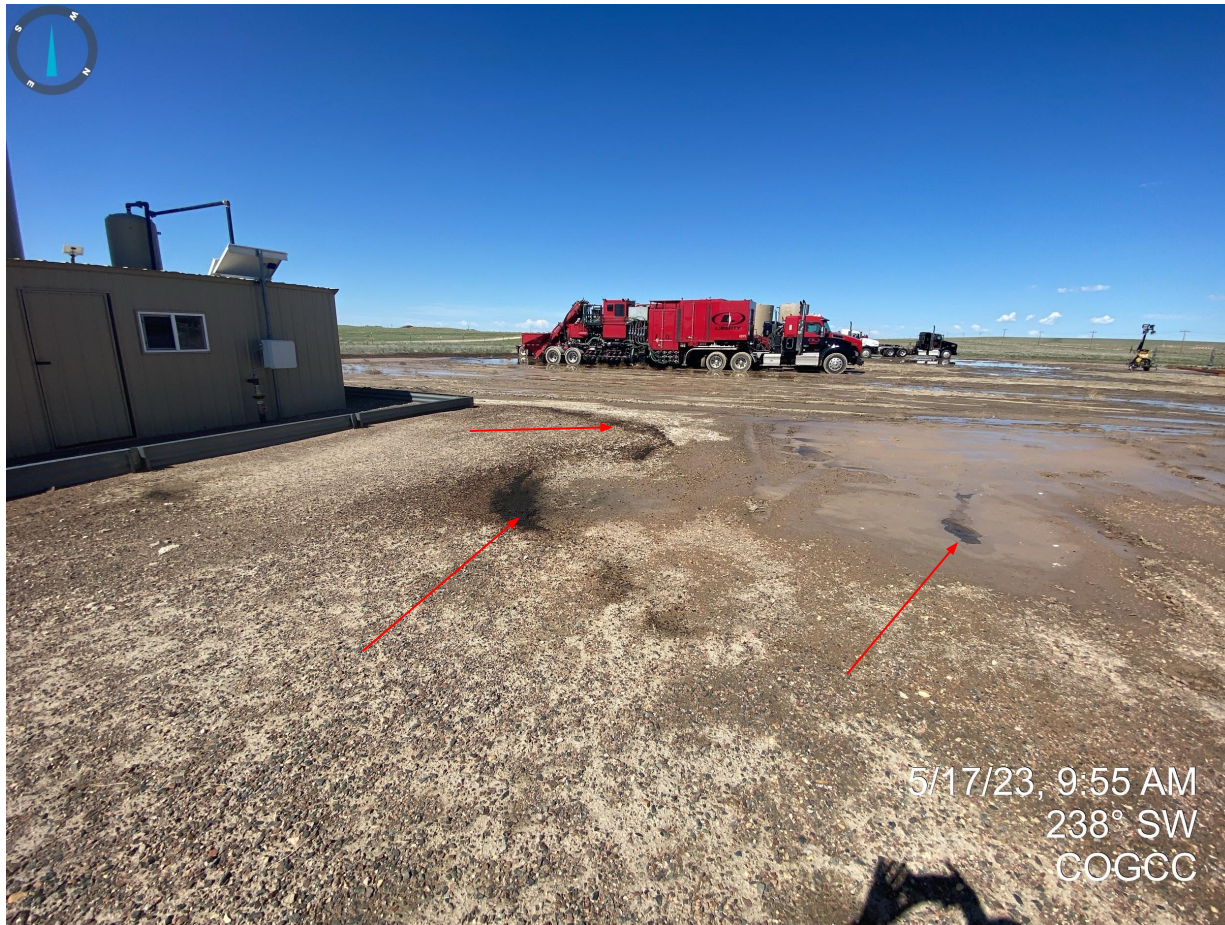
**Photo 12.** See comments in Photo 6.

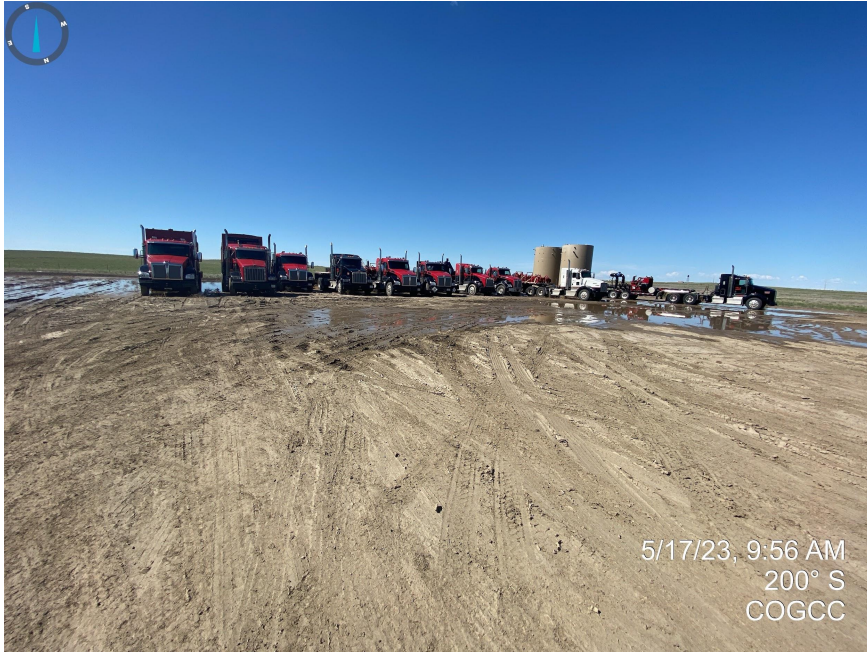
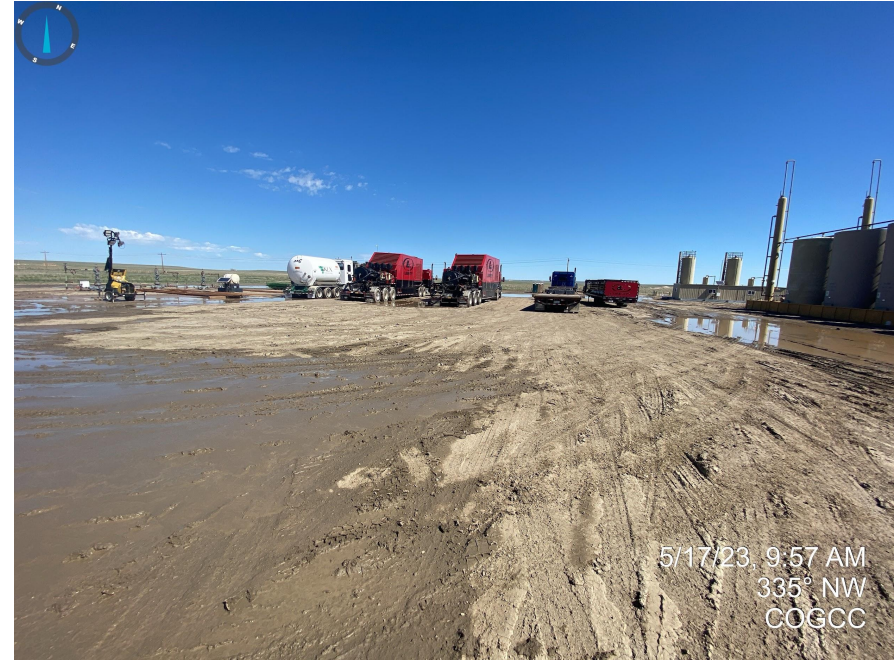
**Photos 13 & 14.** Staff observed multiple vehicles parked on location. Verdad personnel (D. Wagoner) informed Staff that vehicles were temporarily parked on location due to a safety concern at a nearby location (462872) that was in the process of fracking wells. Staff acknowledges the safety concern and also wants to remind the Operator that locations are not to be used for equipment storage; relocate vehicles/equipment when conditions allow safe operation.
