TEP ROCKY MOUNTAIN LLC, UNOCAL-67S96W/1SWSE

Location #334905

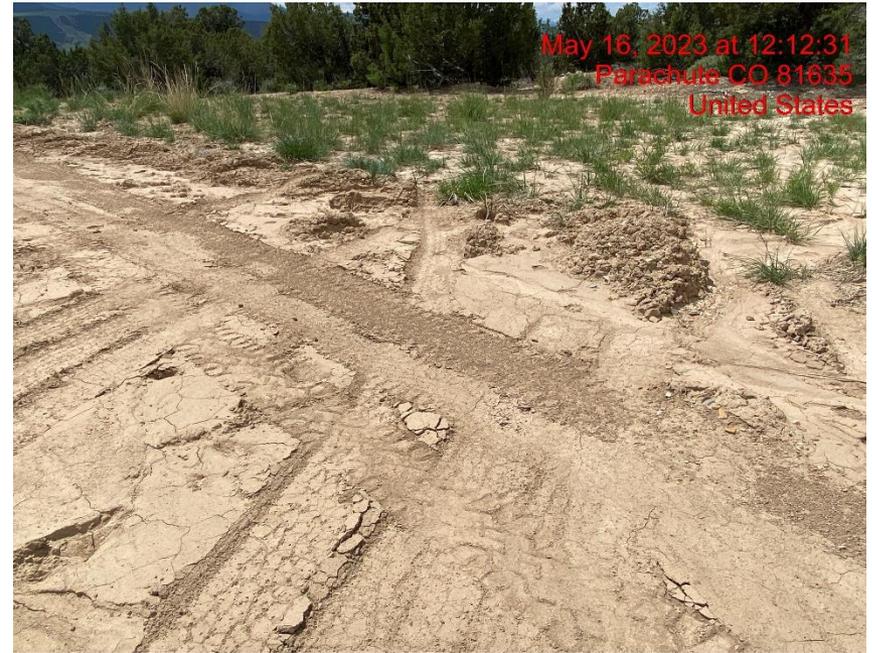
Lease Road Degradation/Transportation of Sediment from Lease Road – Photo #03534

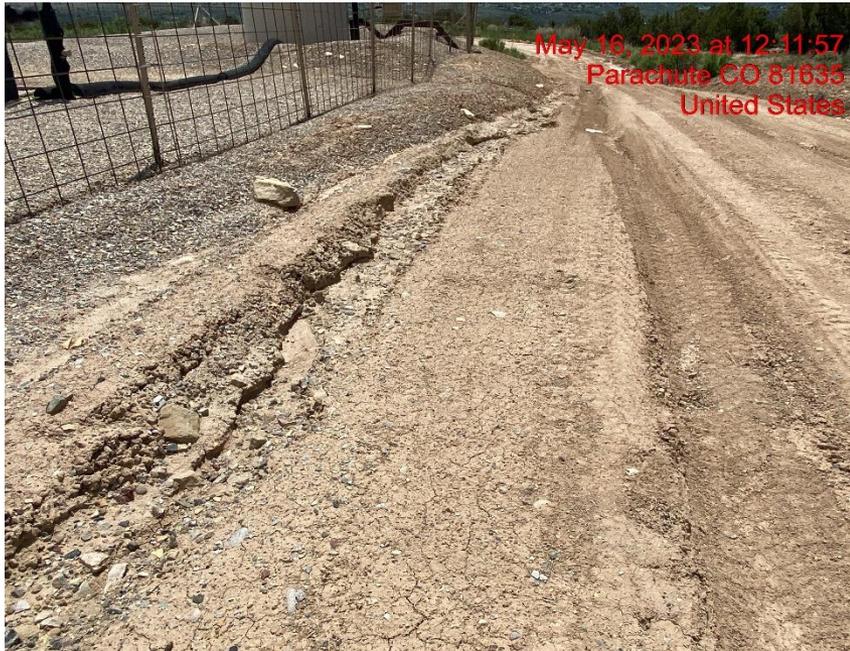
Rill Erosion On Lease Road – Photo #03533

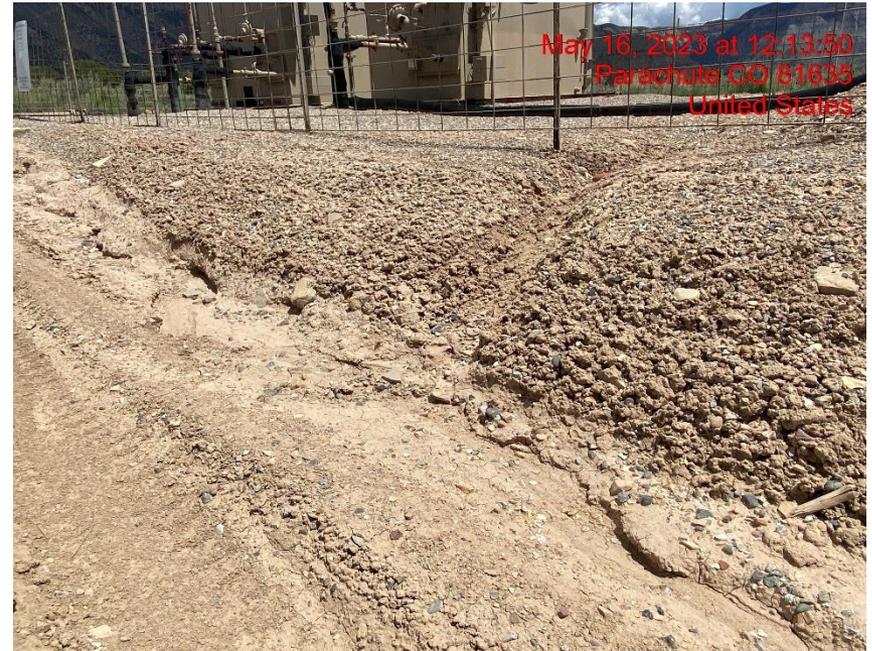
Rill Erosion Transporting Sediment from Location – Photo #03538

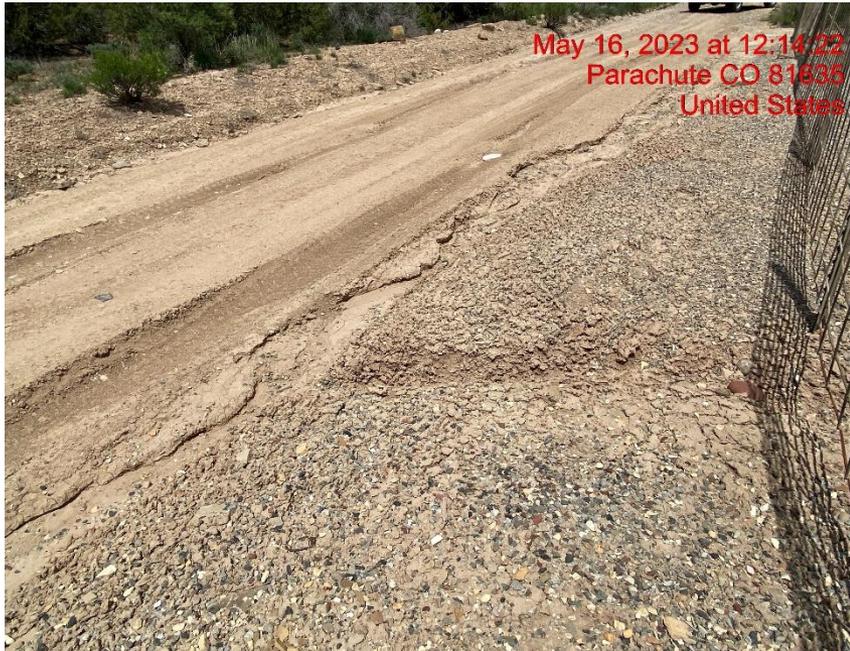
**Rill Erosion Transporting Sediment from Location –
Photo #03541**

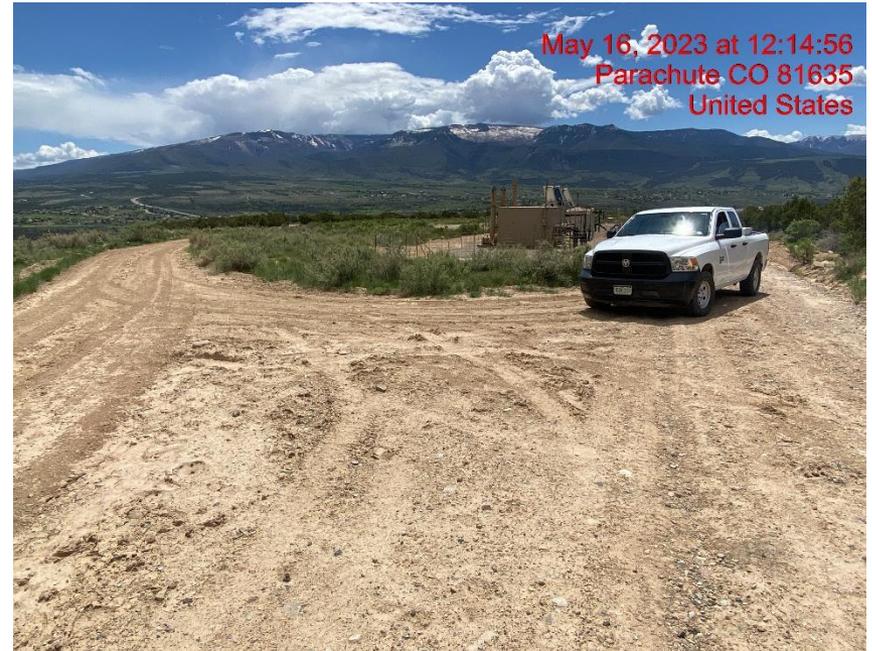
**Insufficient Vehicle Tracking BMPs at Location
Entrance/Exit – Photo #03542**
