TEP ROCKY MOUNTAIN LLC, UNOCAL-67S96W/1SWNW

Location #324021

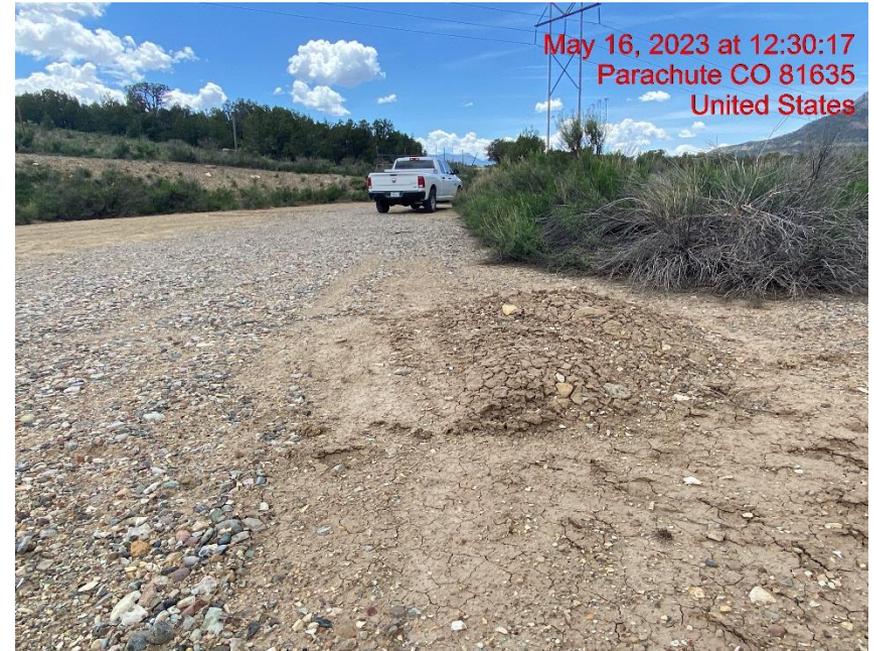
Unprotected Soil Stockpile – Photo #03571

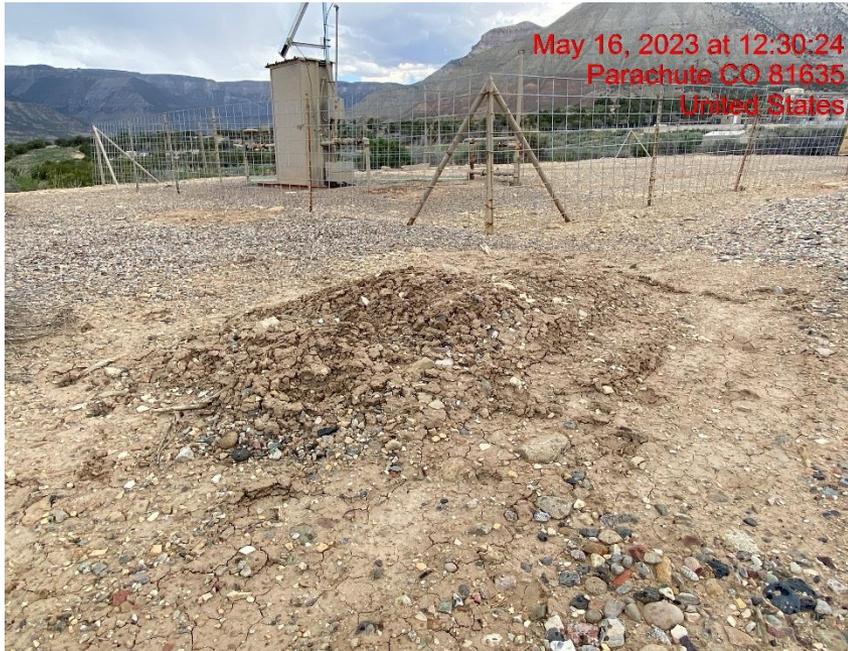
Unprotected Soil Stockpile – Photo #03572

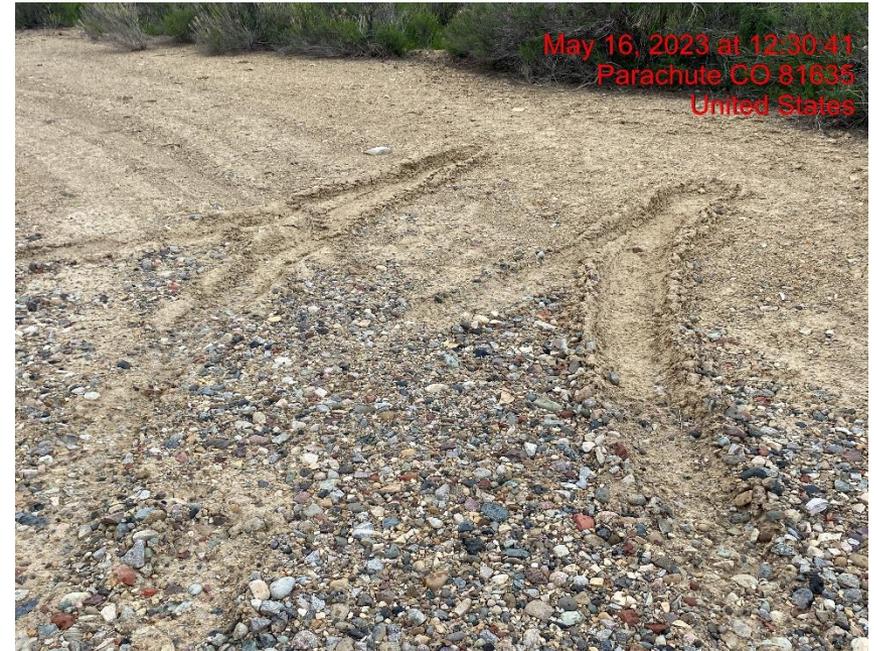
Location Lacks Stabilization – Photo #03573

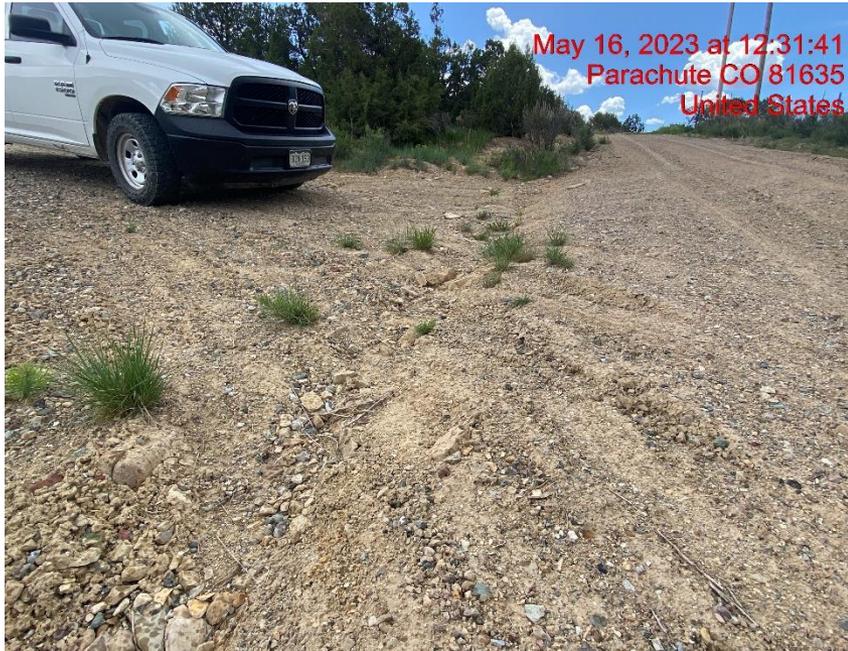
Rill Erosion Transporting Sediment Across Access Road – Photo #03575

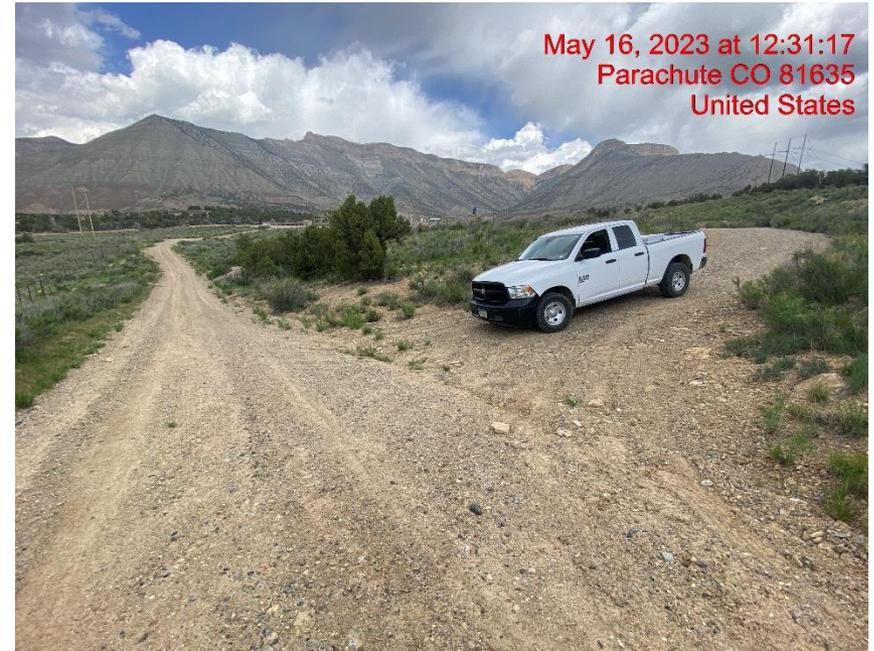
Insufficient Vehicle Tracking BMPs at Location Entrance/Exit – Photo #03574
