TEP ROCKY MOUNTAIN LLC, BARRETT ET AL-66S96W/35SESE

Location #334743

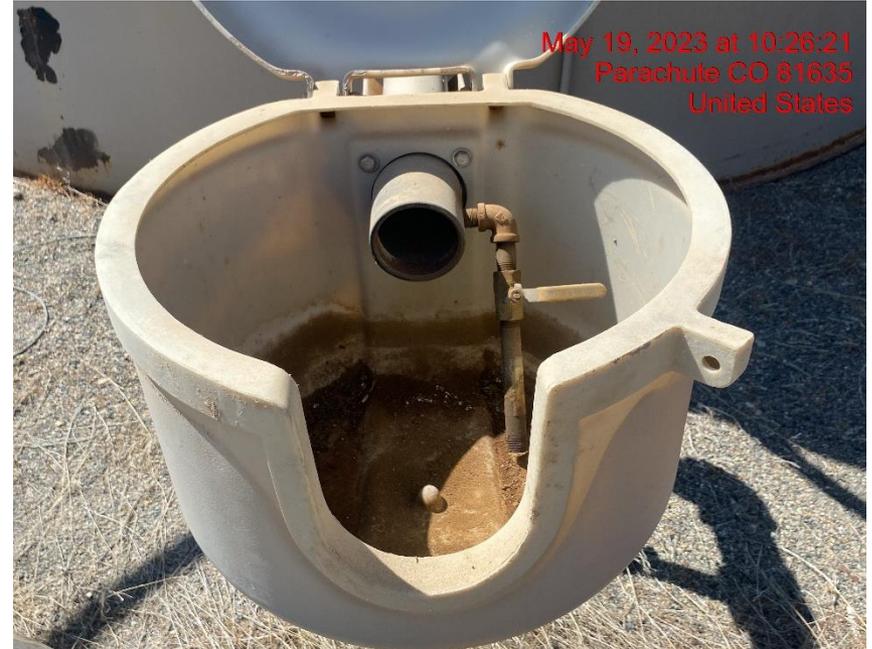
Open-Ended Load Line – Photo #03591

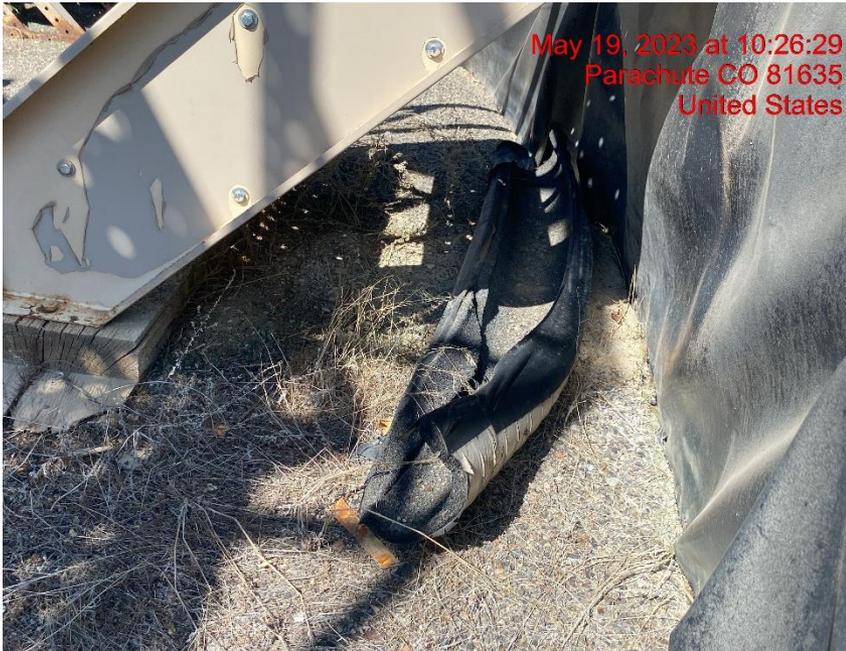
Debris in Tank Battery – Photo #03592

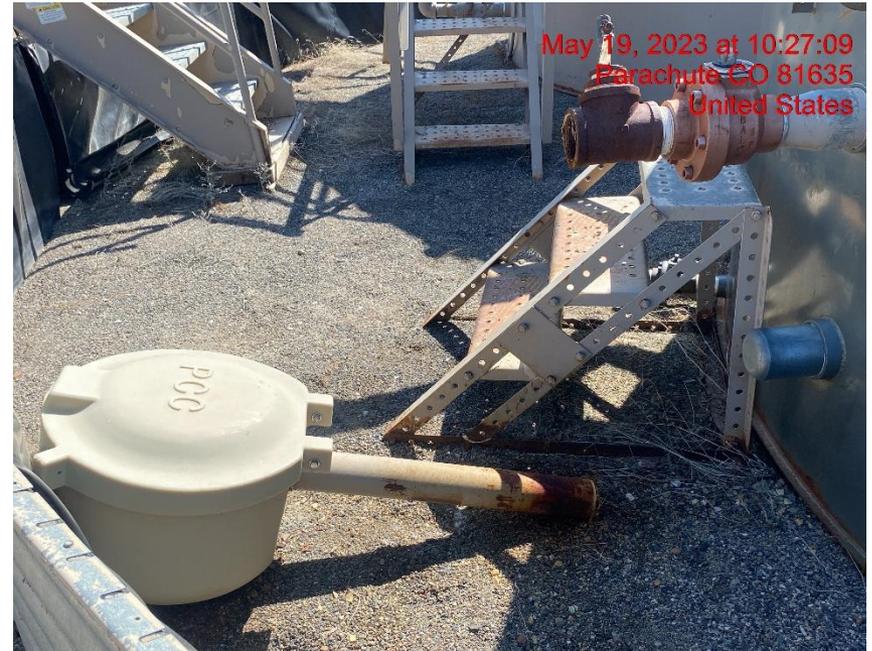
Unsecured Load Line – Photo #03593

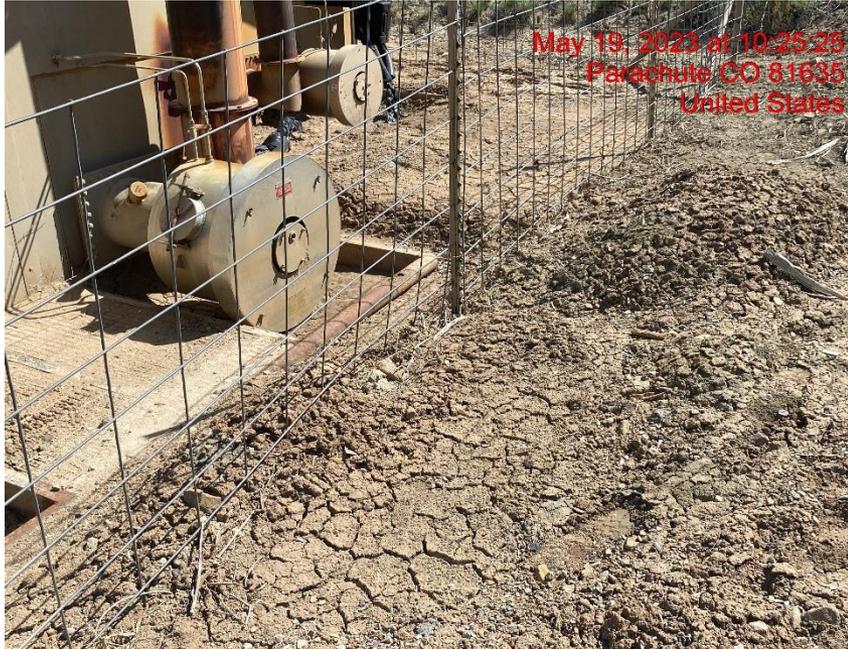
Sediment Encroaching on Equipment – Photo #03589

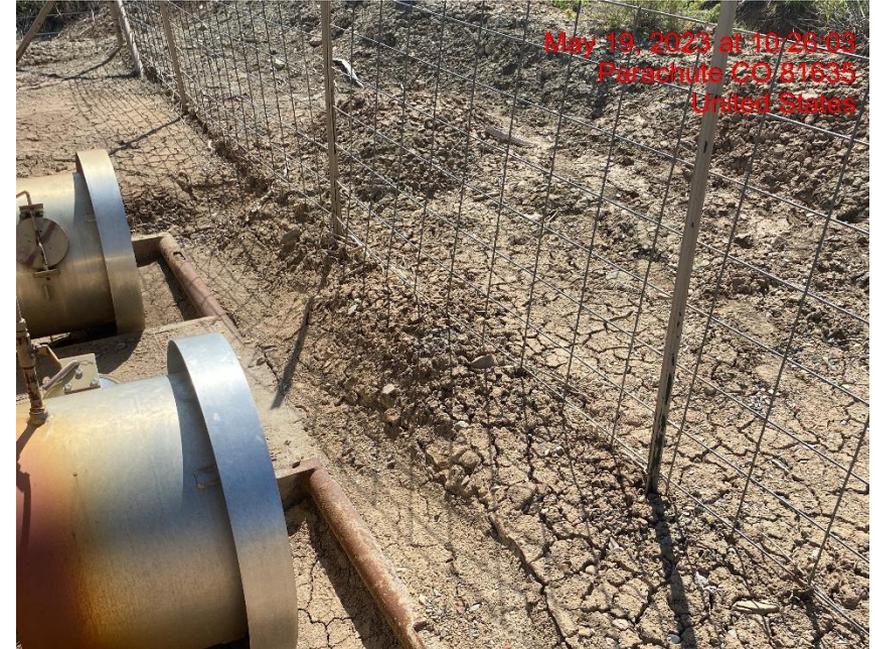
Sediment Encroaching on Equipment – Photo #03590

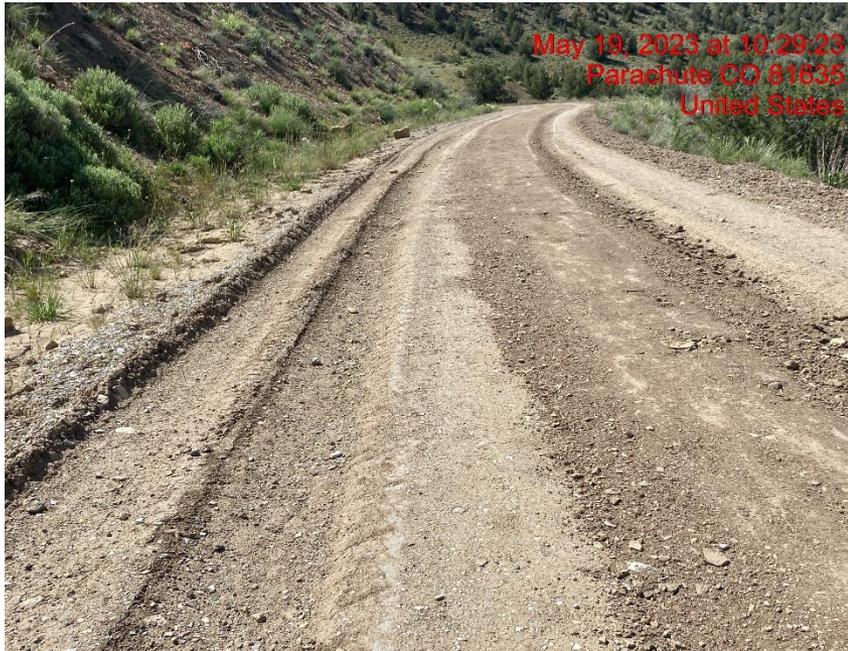
Lease Road Lacks Stabilization – Photo #03595

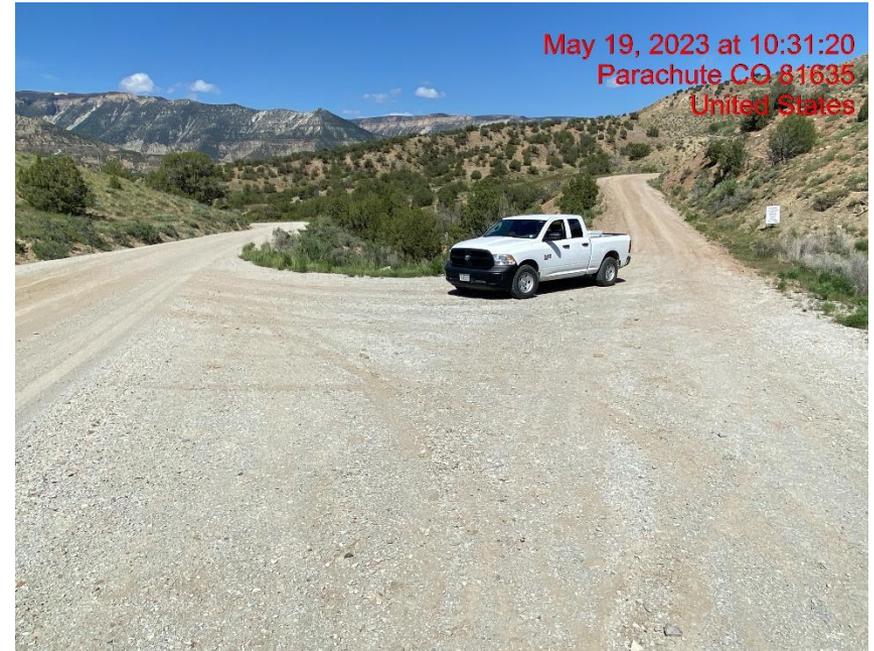
Insufficient Vehicle Tracking BMPs at Location Entrance/Exit – Photo #03598
