Inspection Photos
Spill REM 29154
Inspection
Date:5/18/2023

All Photos taken
by Kris Neidel

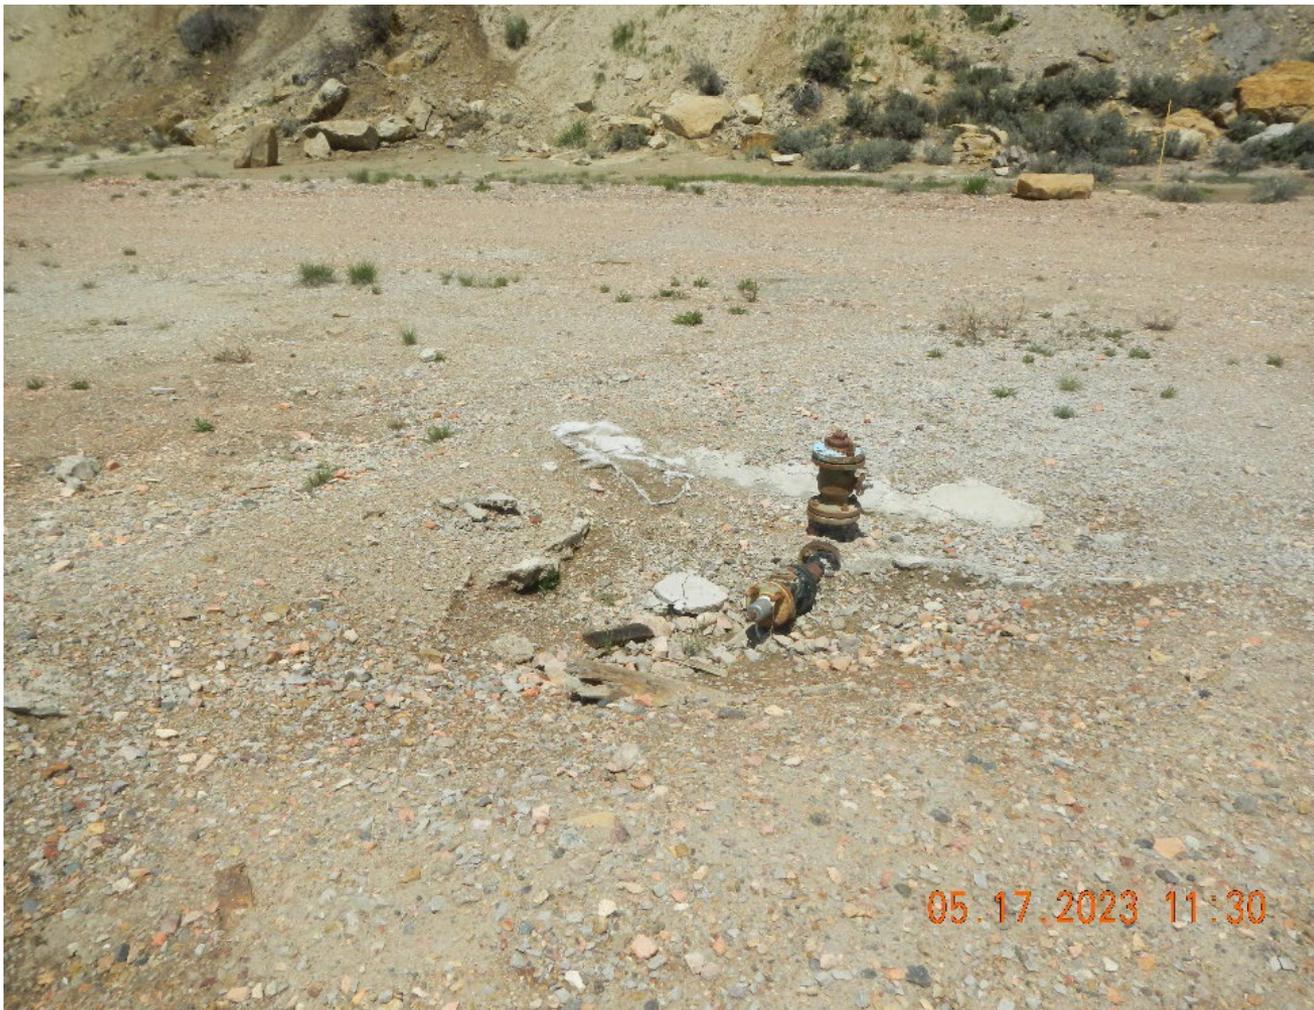
Photo #1 COGCC staff was told that this is a remaining flowline. Staff was told that Form 44 was in process for this line. The area below this line should be sampled as a part of REM 29154, in addition to where the line is cut and abandon.

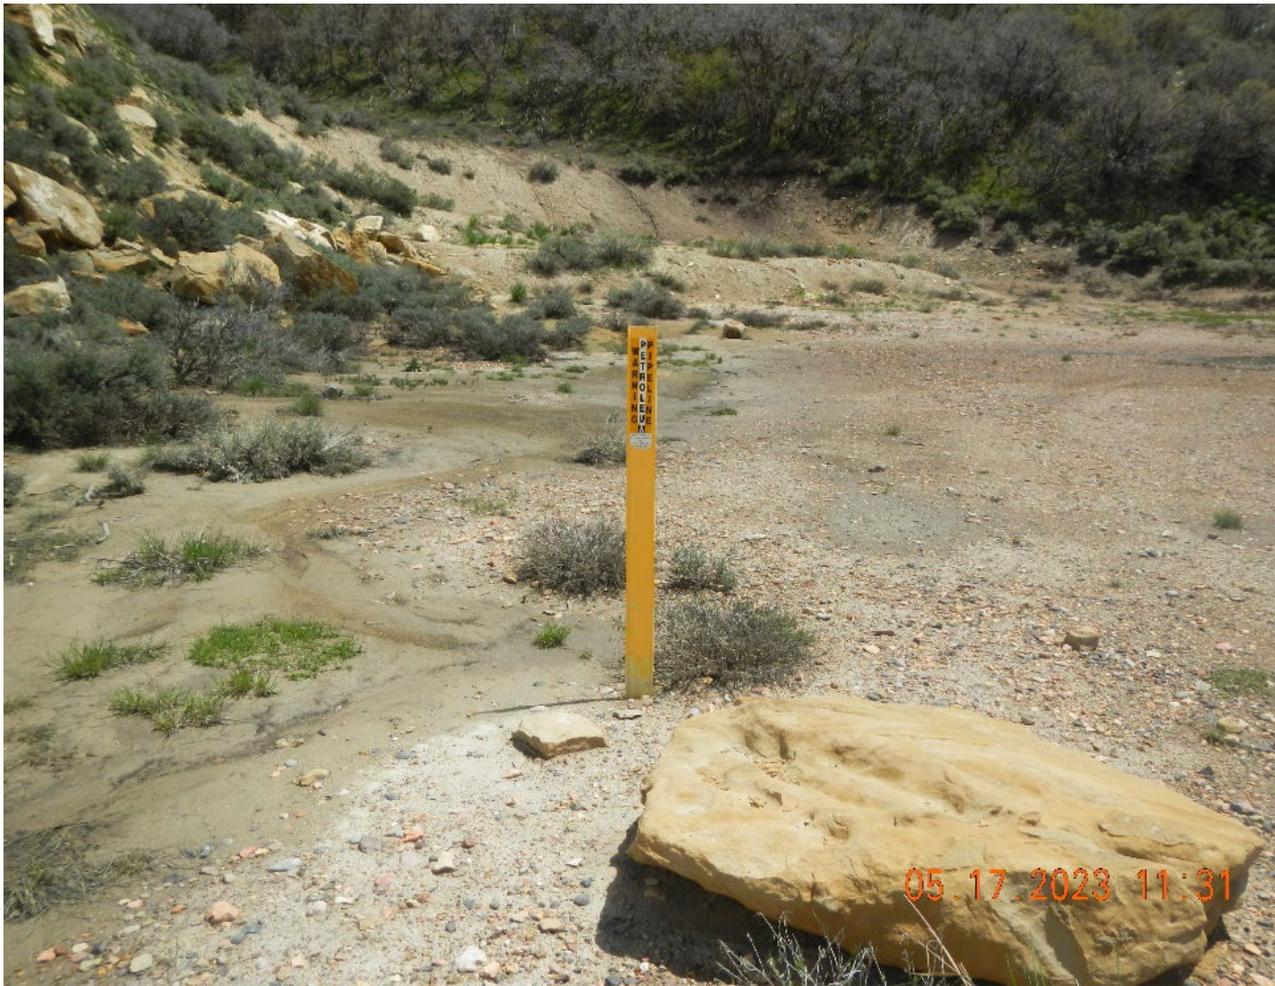
Photo #2 looking east, at the northeast corner of location.

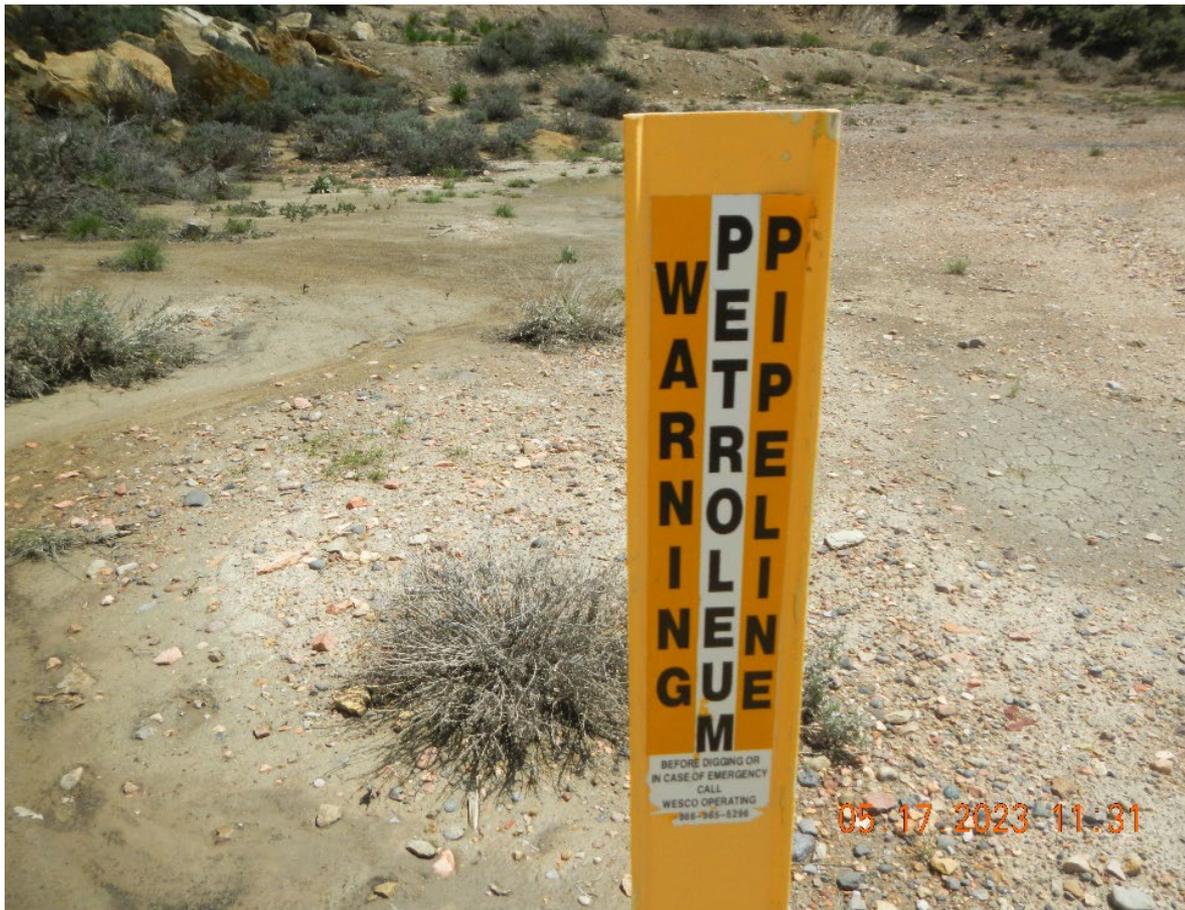
Photo #3 close up of photo #2 showing pipeline marker.

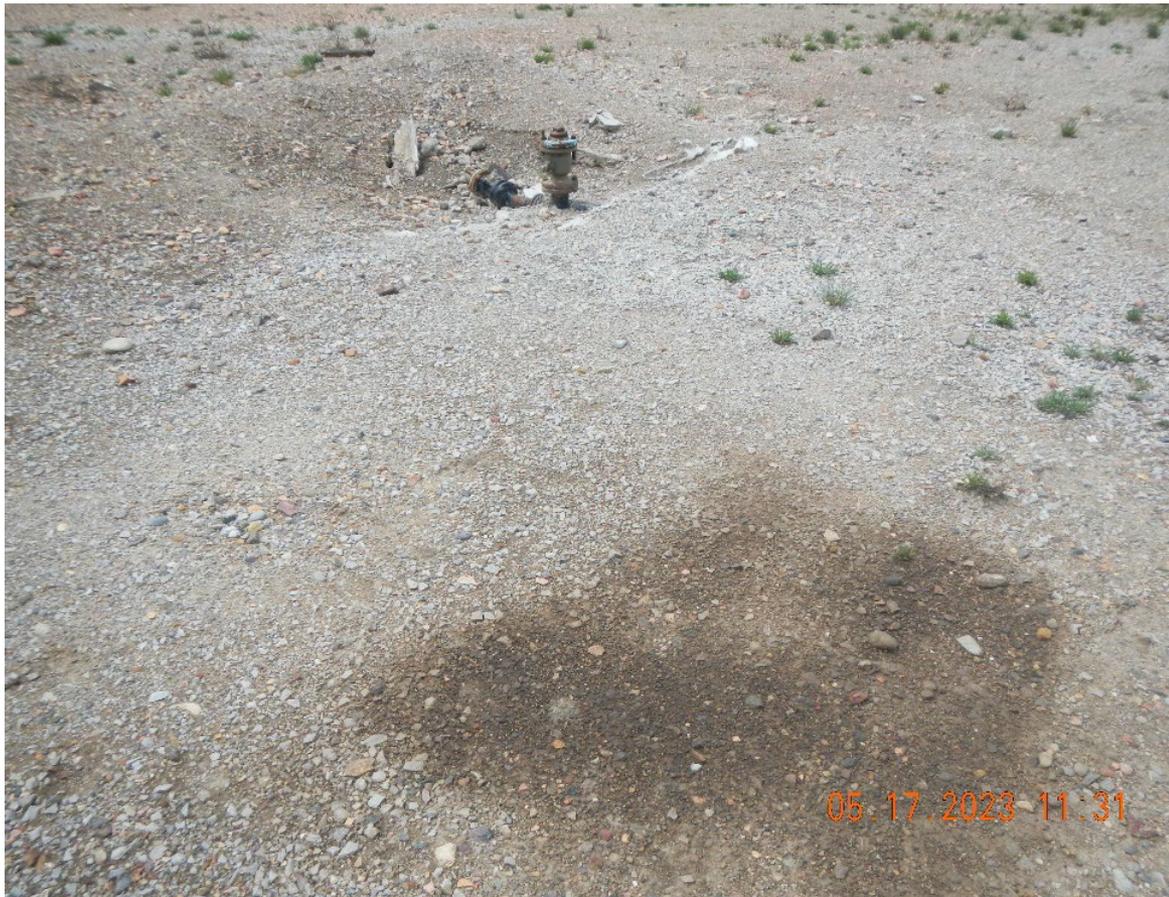
Photo #4 some staining on the ground near flowline riser, at wellhead.
