**POC-I LLC
Iles Dome Unit 24
Location #312848**

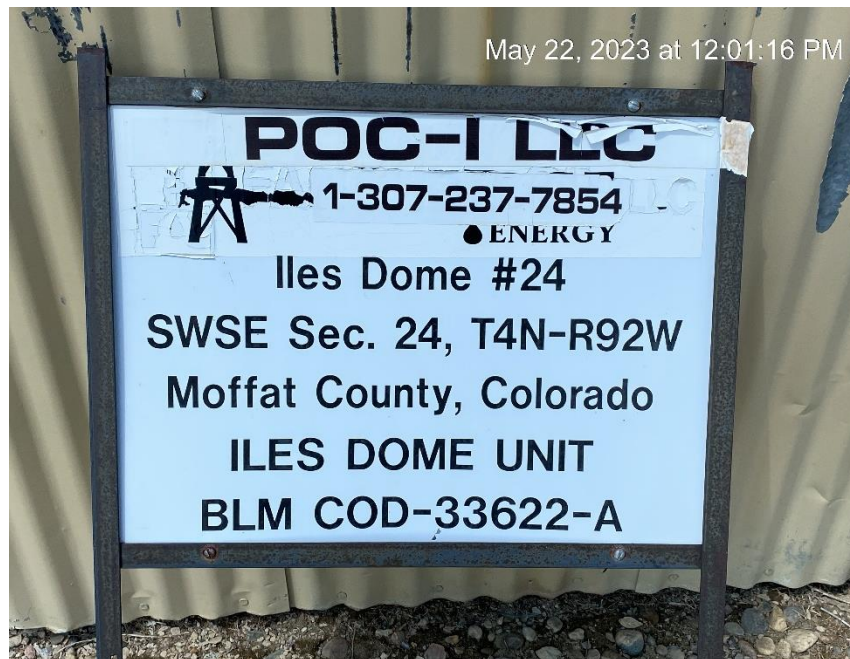
Need API Number, Emergency contact and access information

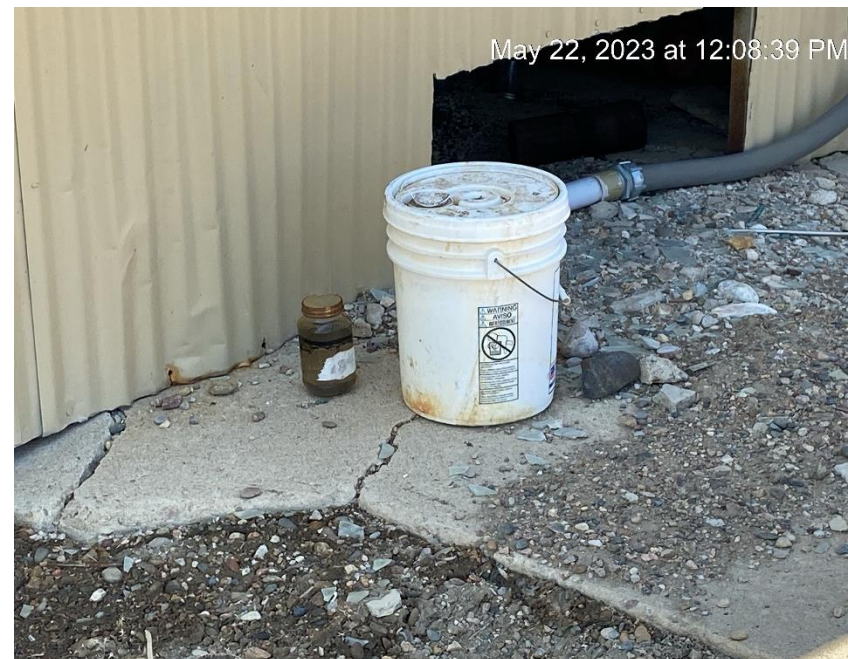
Random debris

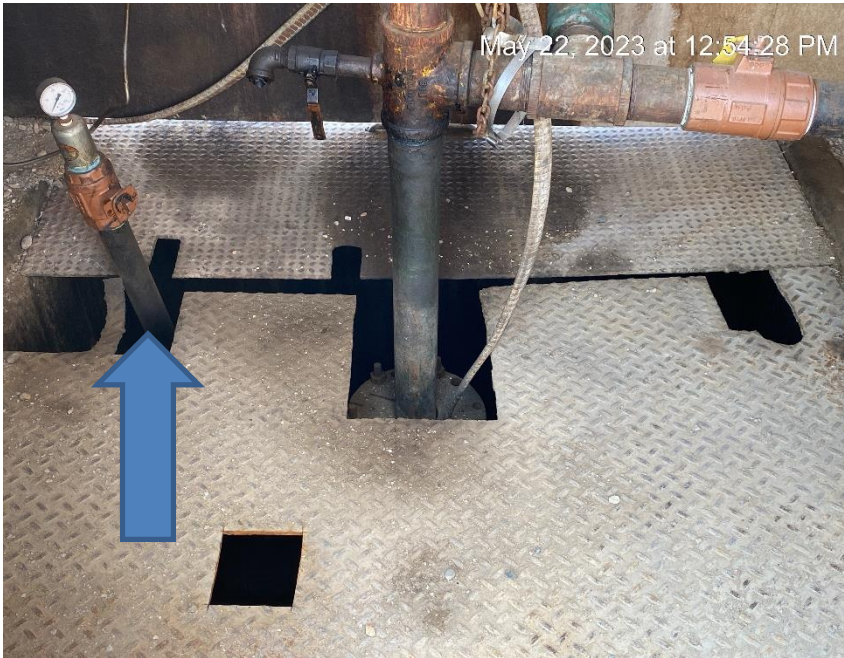
Production casing? No visible Bradenhead valve.

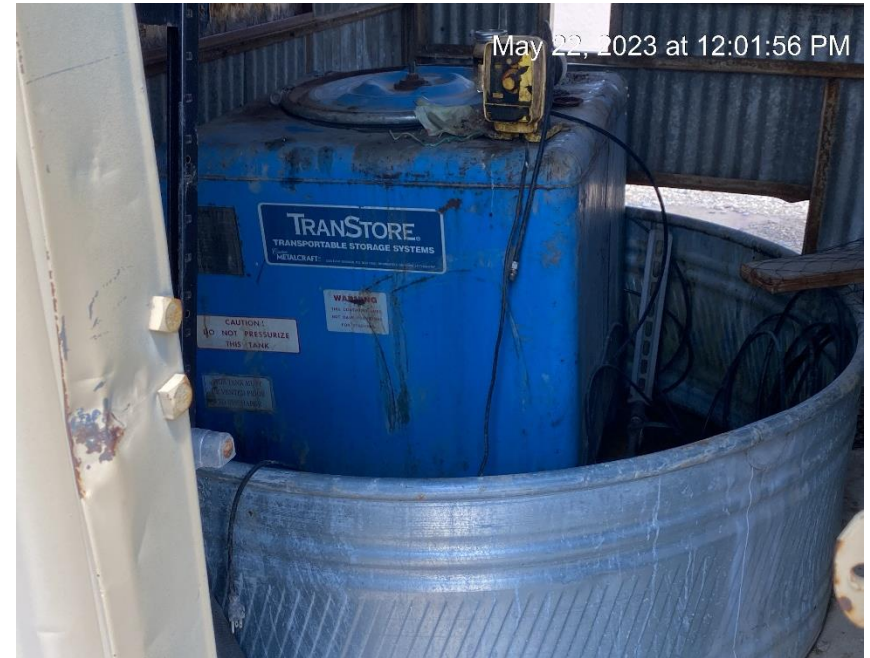
No labels or wildlife protection

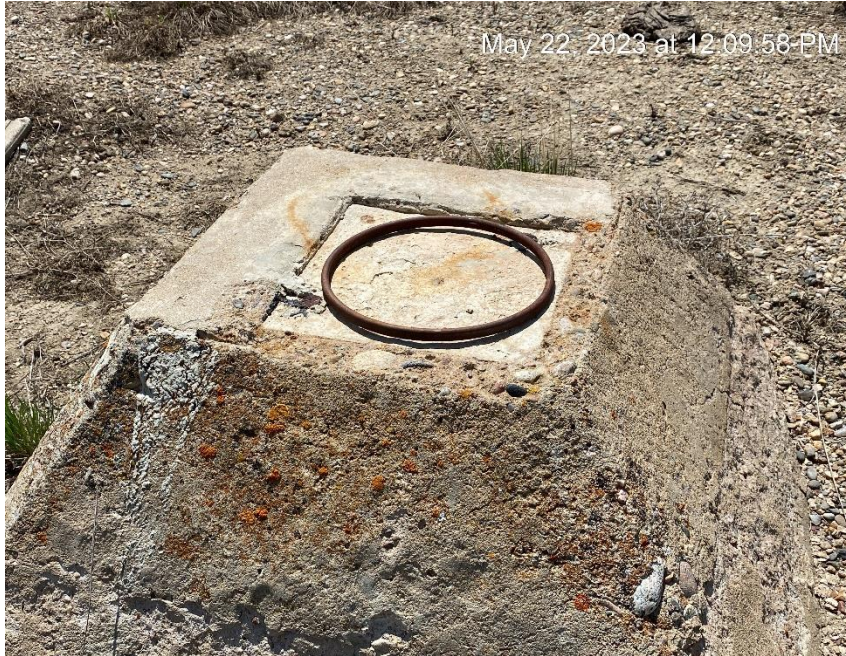
Random debris

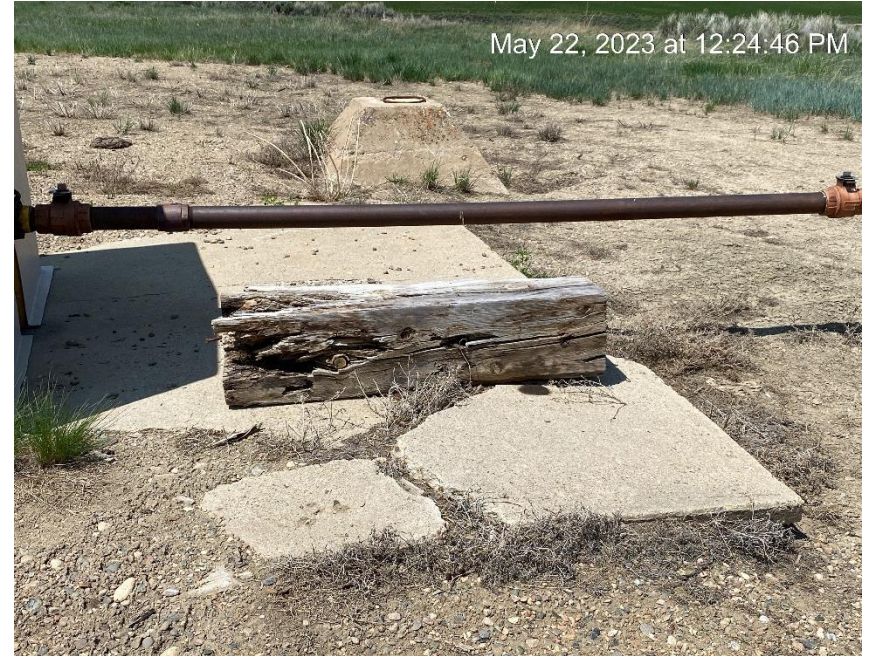
Random debris

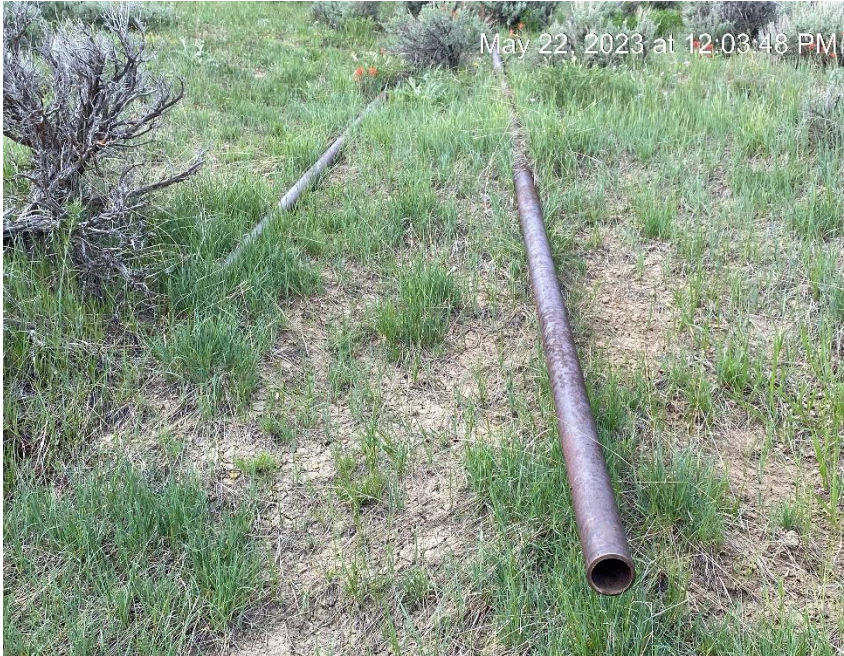
Random debris

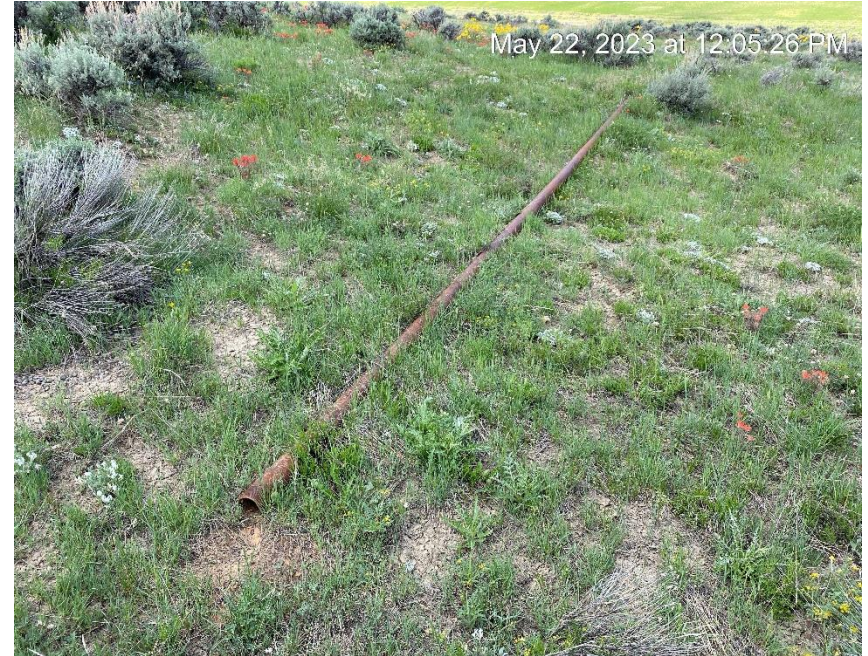
Random debris

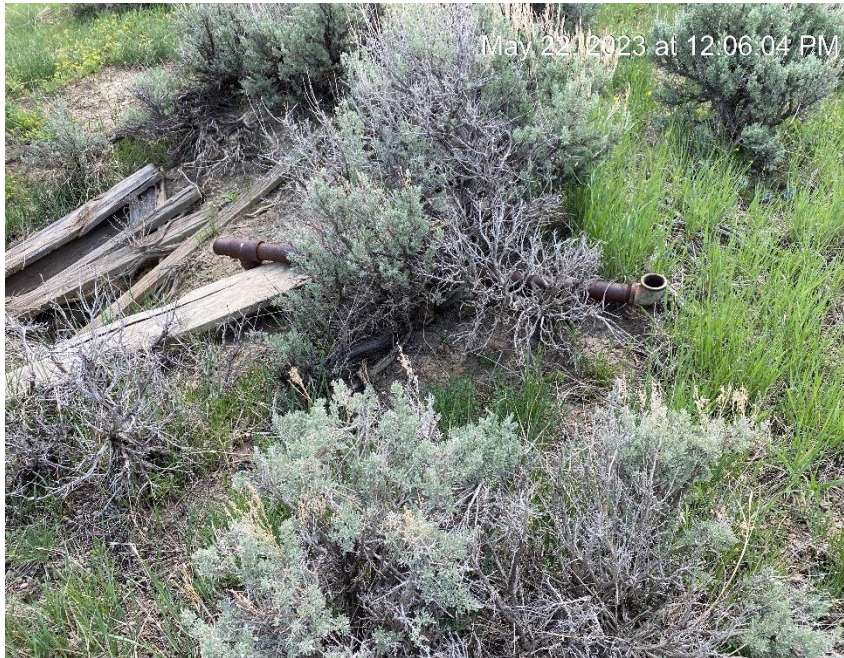
Random debris

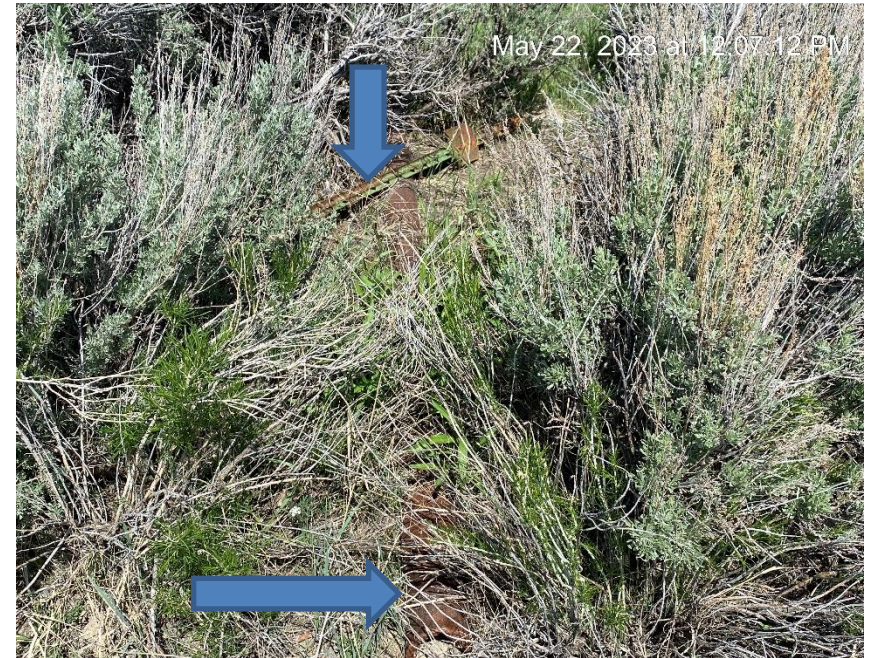
Random debris

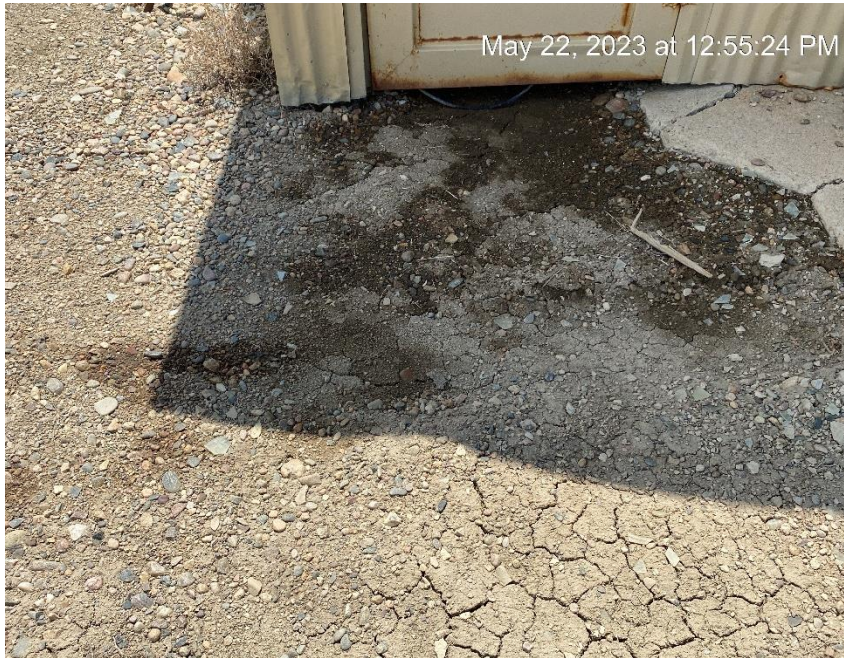
Stained soil

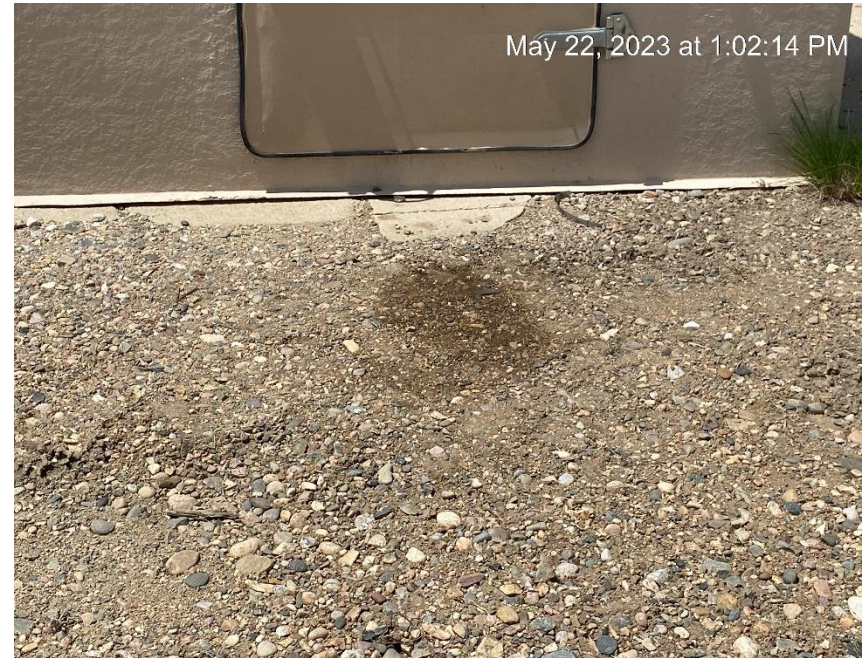
Stained soil

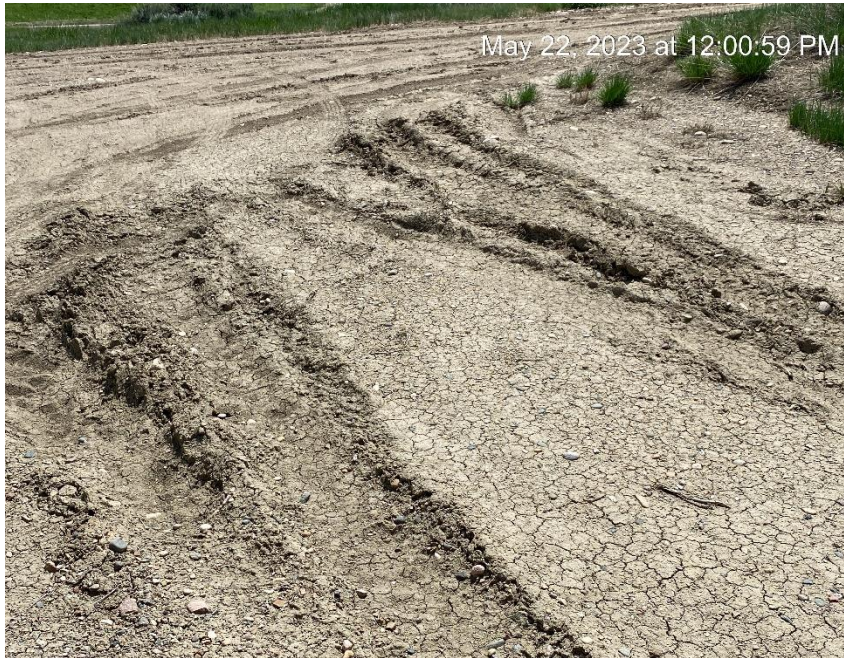
Lack of stabilization and sediment migration

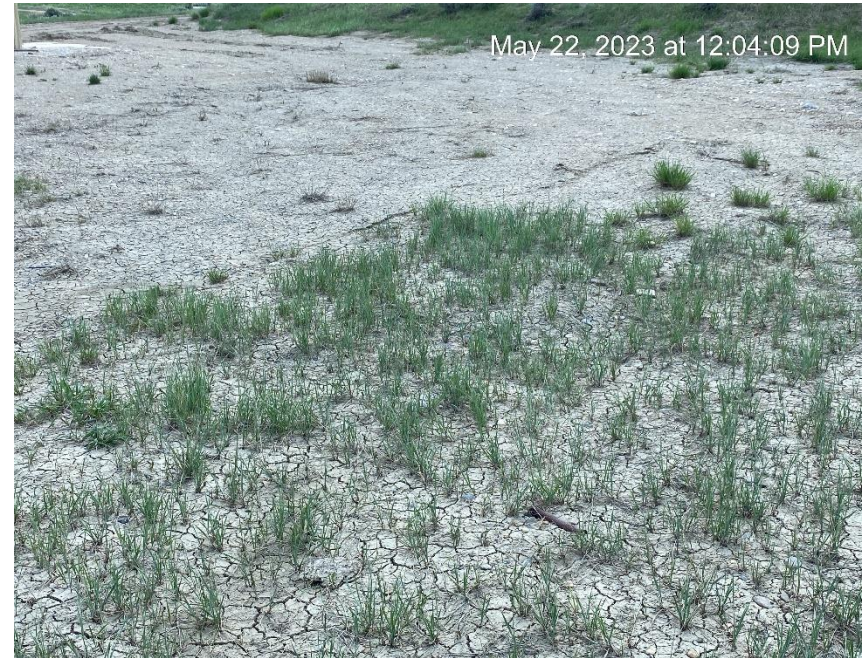
Location erosion and sediment migration

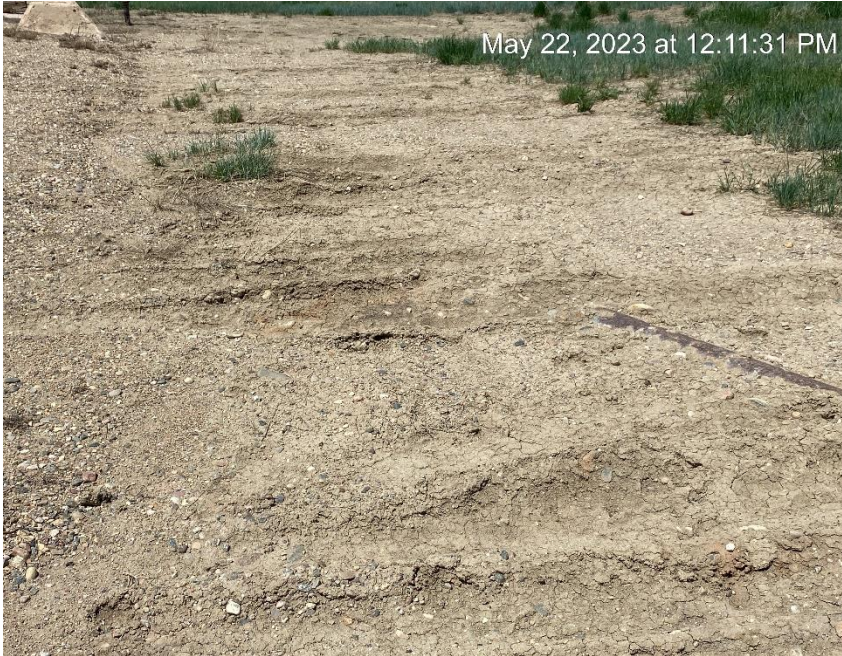
Lack of stabilization

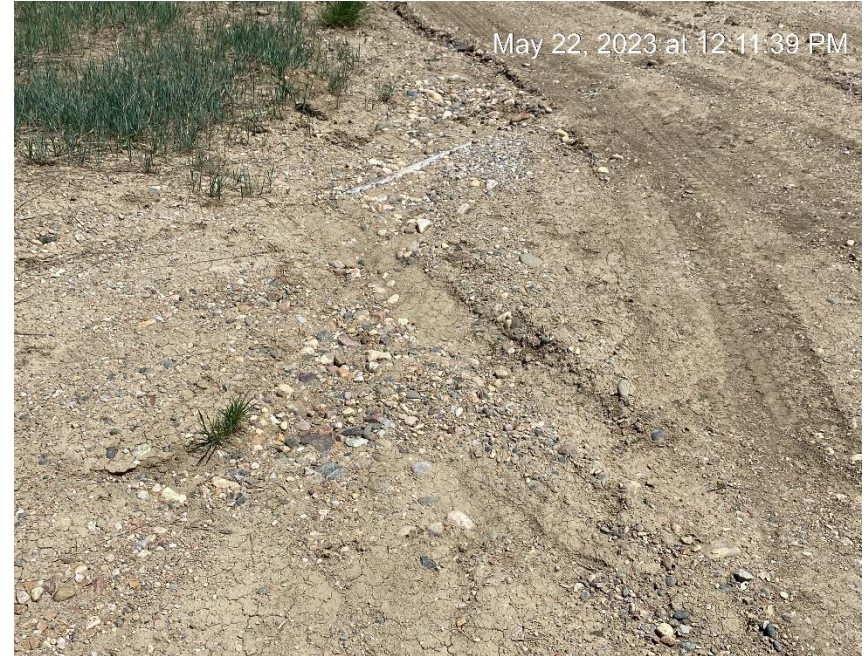
Location erosion at access road entrance
