# Final Reclamation and Stormwater Inspection

Operator: VERDAD RESOURCES - 10651

Location ID: 406429

Inspection Document #: 708200263

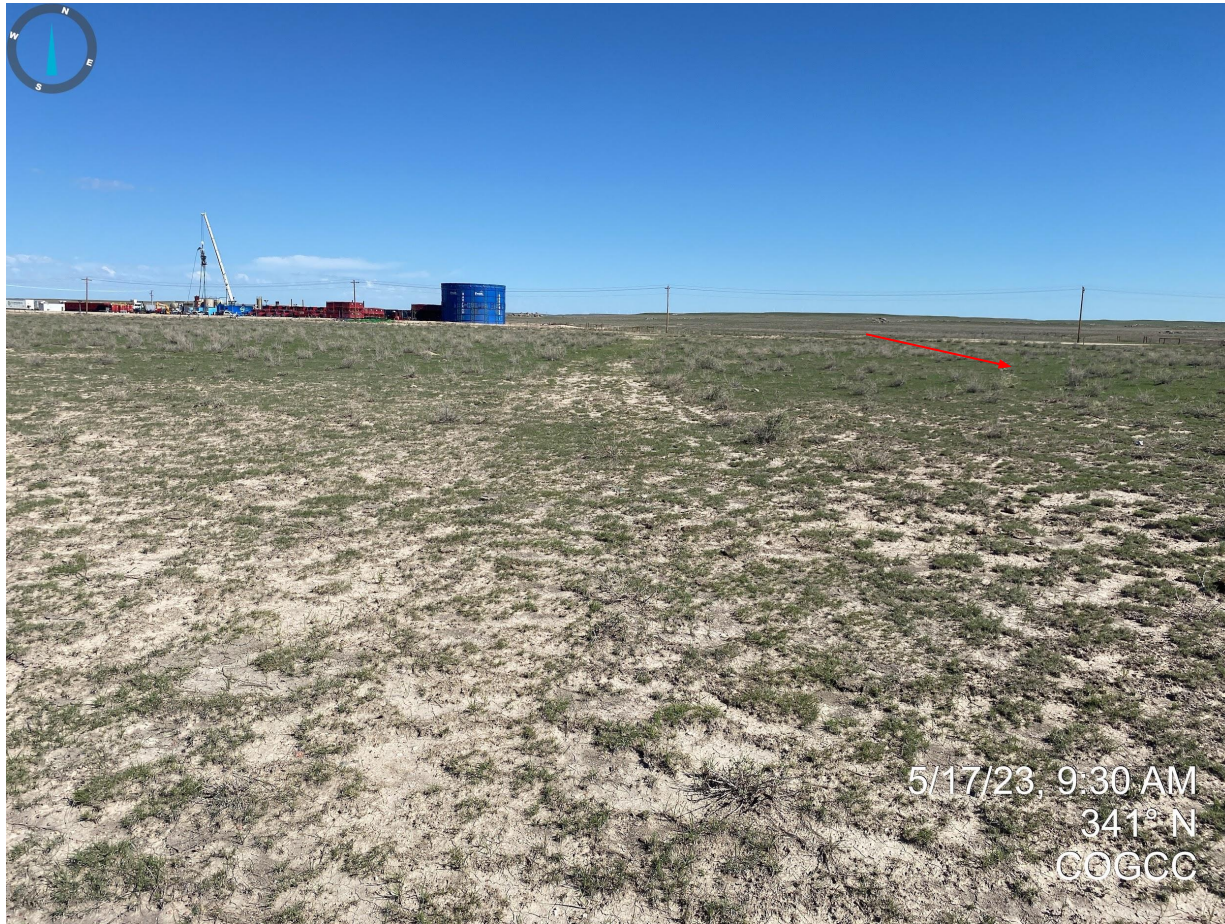
**Photo 1.** Facing north towards the former access road. Reclaimed portions of the replugging area do not appear reflect of adjacent reference areas with evidence of non-uniform vegetation cover resulting in areas of bare soil. Additional reclamation activities are required to meet Rule 1004 standards. Note: reference areas have uniform cover of desirable perennial vegetation (red arrow); see subsequent photos for examples.

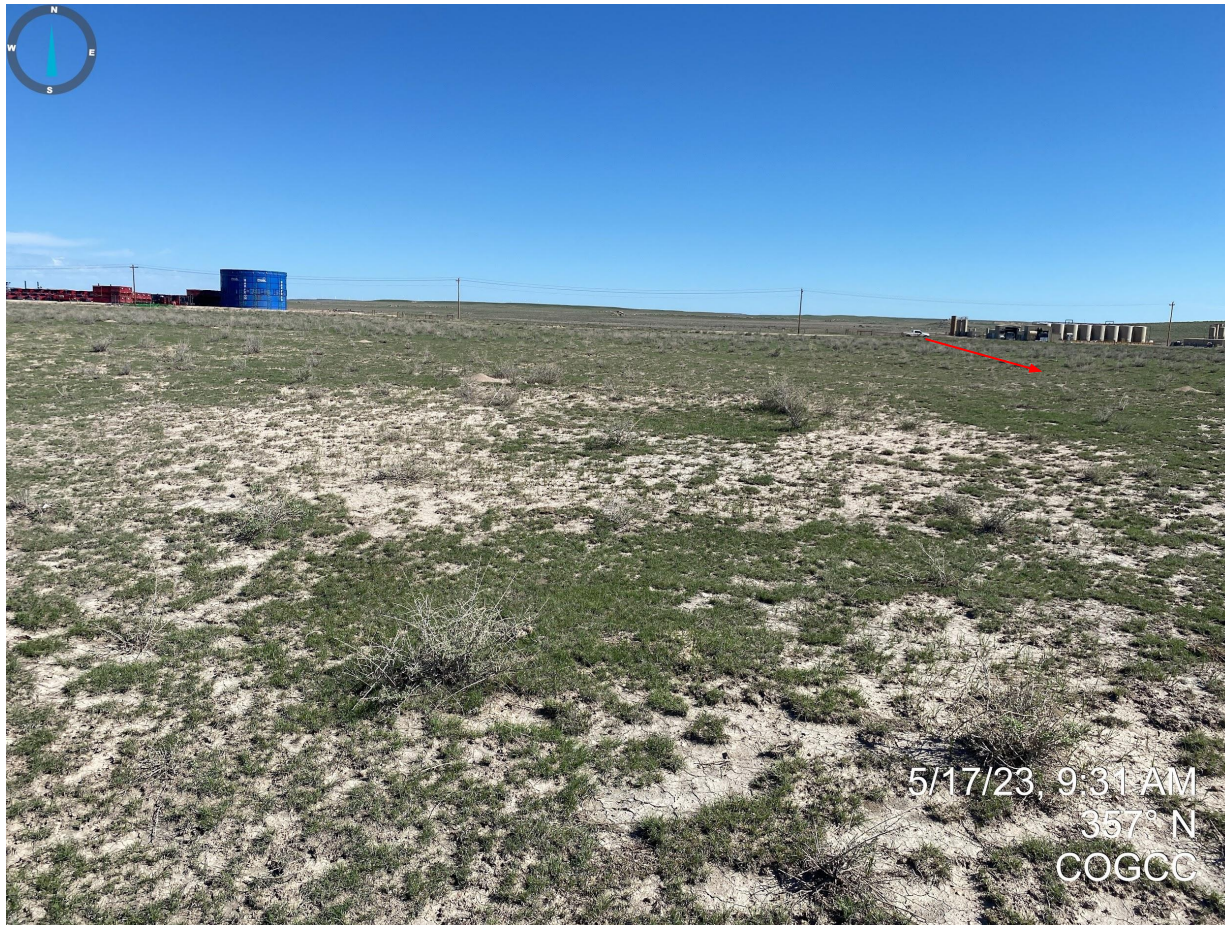
**Photo 2.** Facing north near former wellhead; see comments in Photo 1.

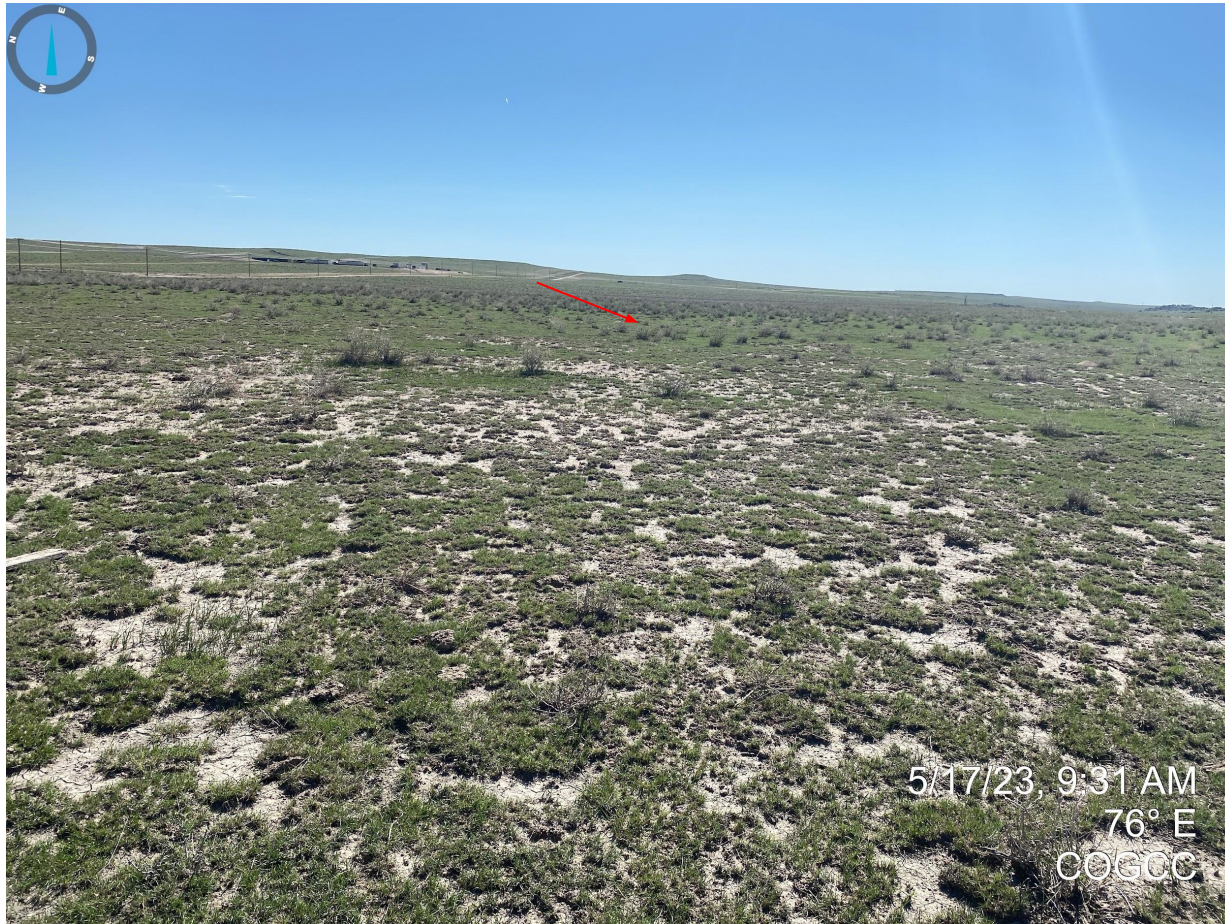
**Photo 3.** Facing east; see comments in Photo 1.

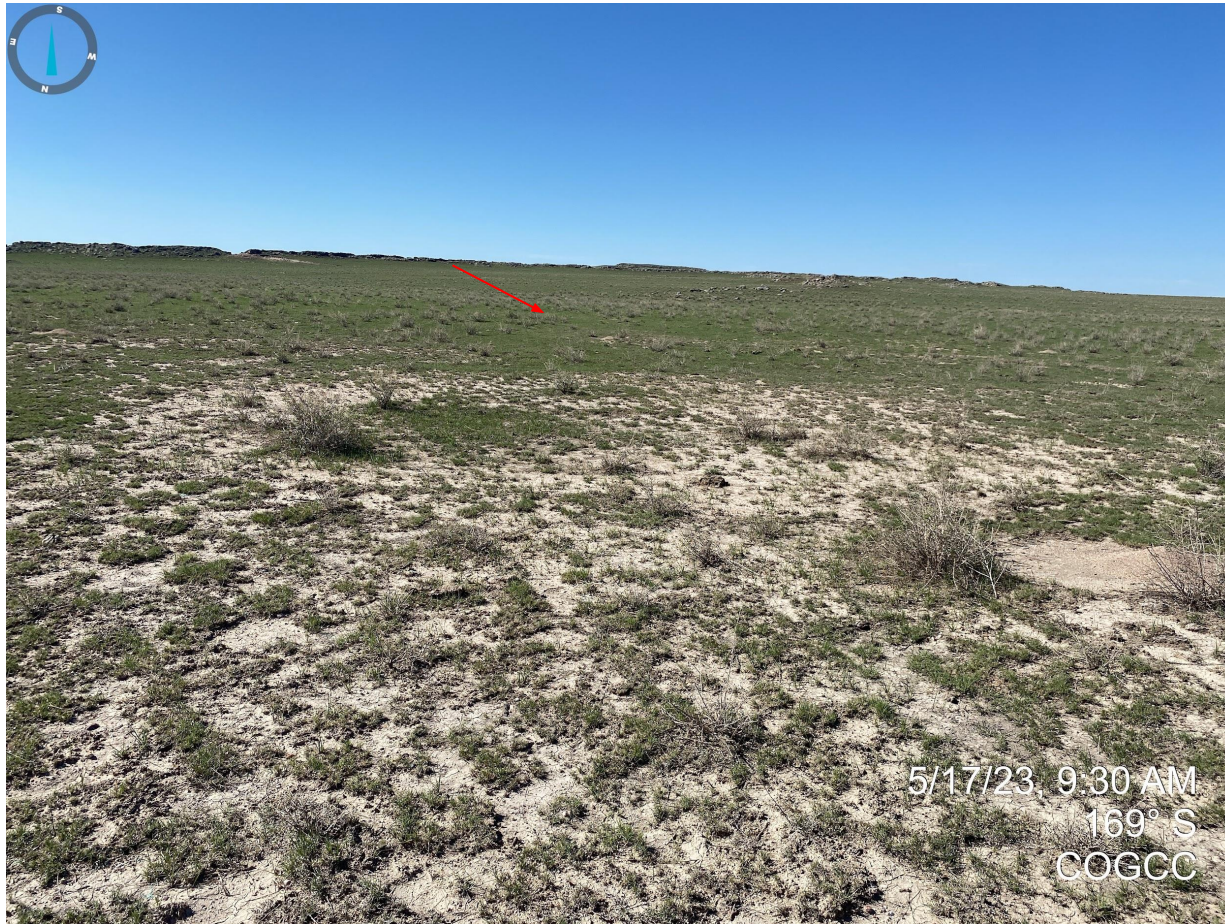
**Photo 4.** Facing south; see comments in Photo 1.

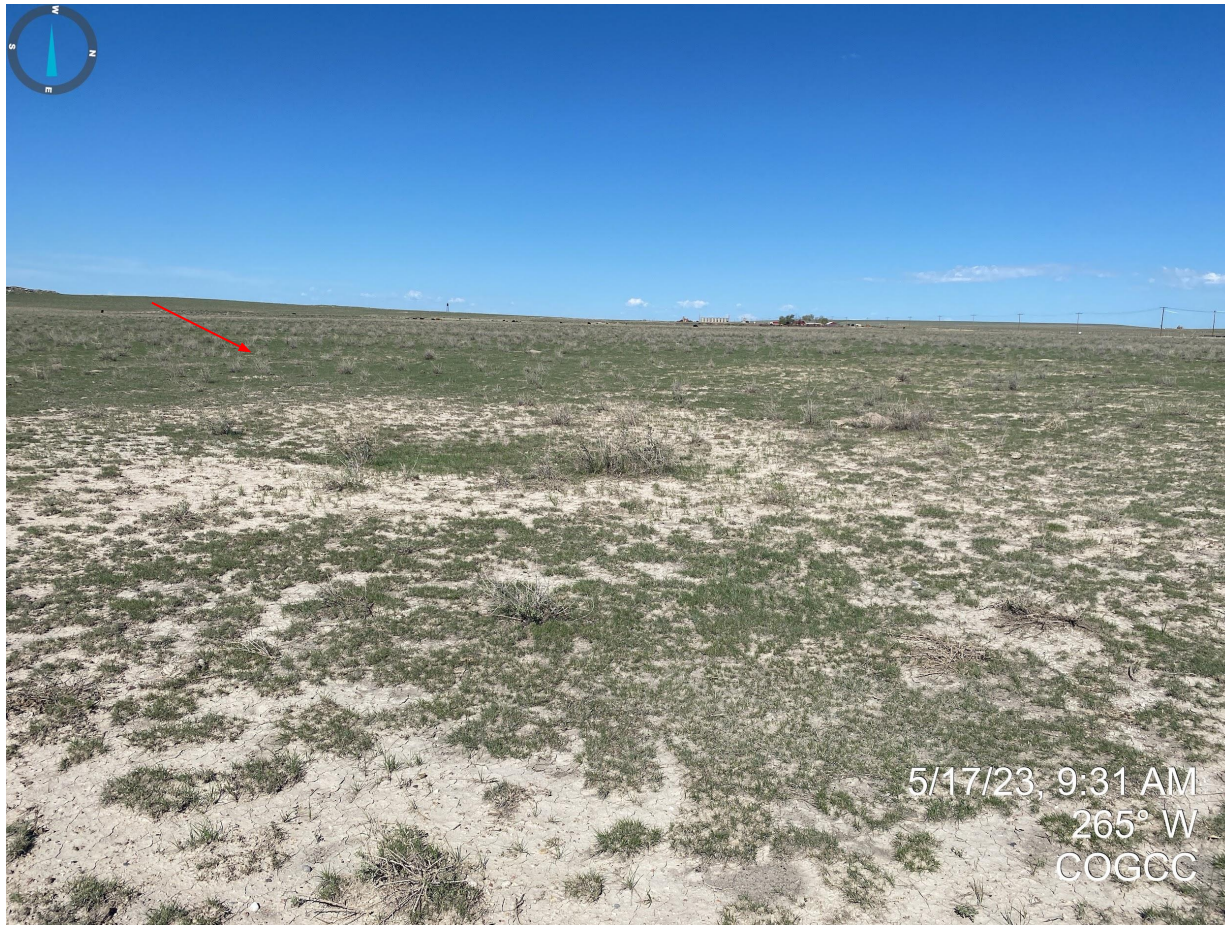
**Photo 5.** Facing west; see comments in Photo 1.

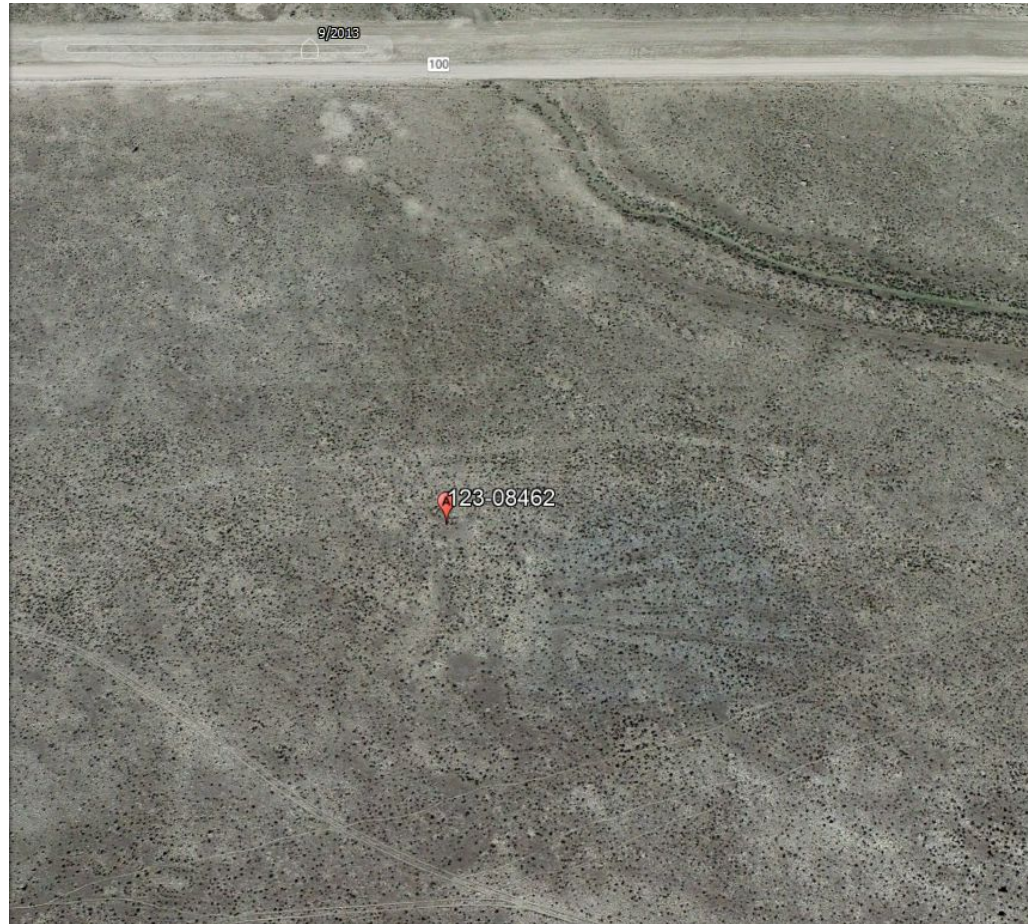
**Photo 6.** Google Earth aerial imagery (circa 2013) showing state of the site prior to replugging operations.

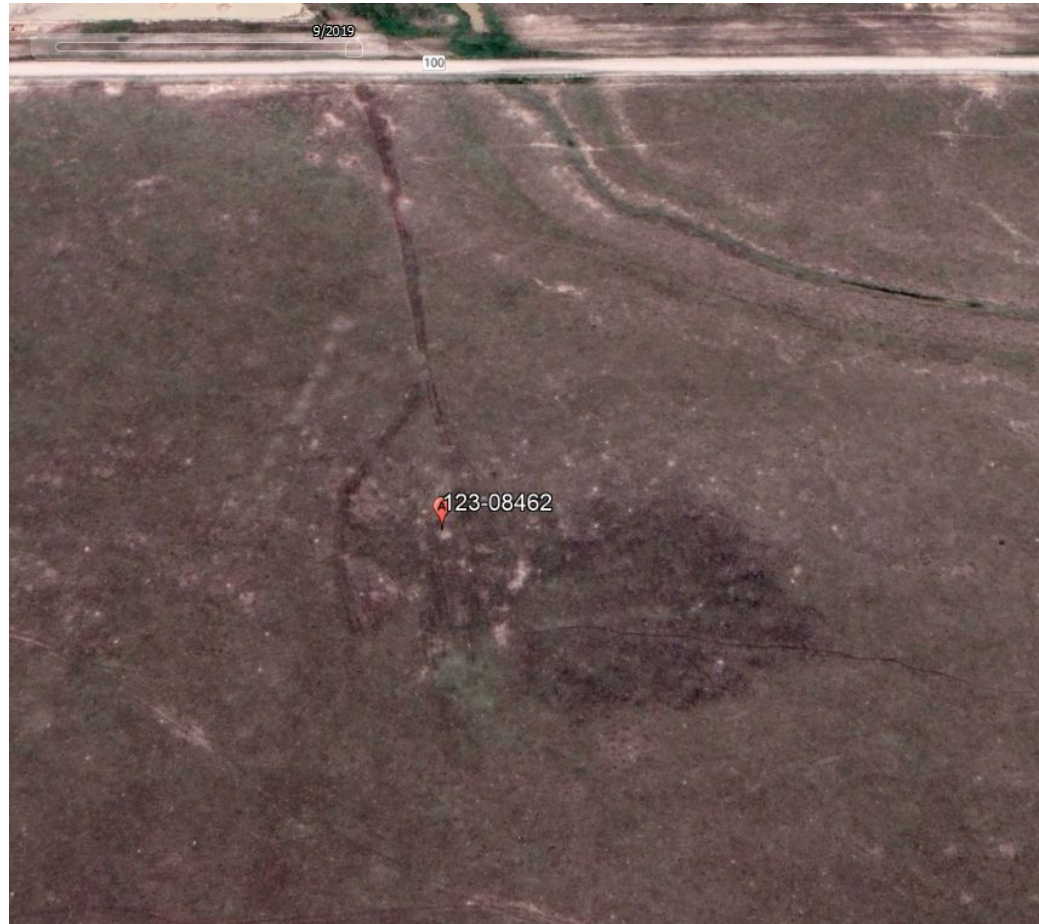
**Photo 7.** Google Earth aerial imagery (circa 2019) showing site conditions after replugging on 03/14/2014.  
Note: 2019 aerial imagery was the most recent after plugging date.
