Interim Reclamation and Stormwater Inspection

Date: 05/17/2023

Operator: VERDAD RESOURCES LLC - 10651

Inspection Photos
Location Name: Timbro 1717
Location ID: 468967

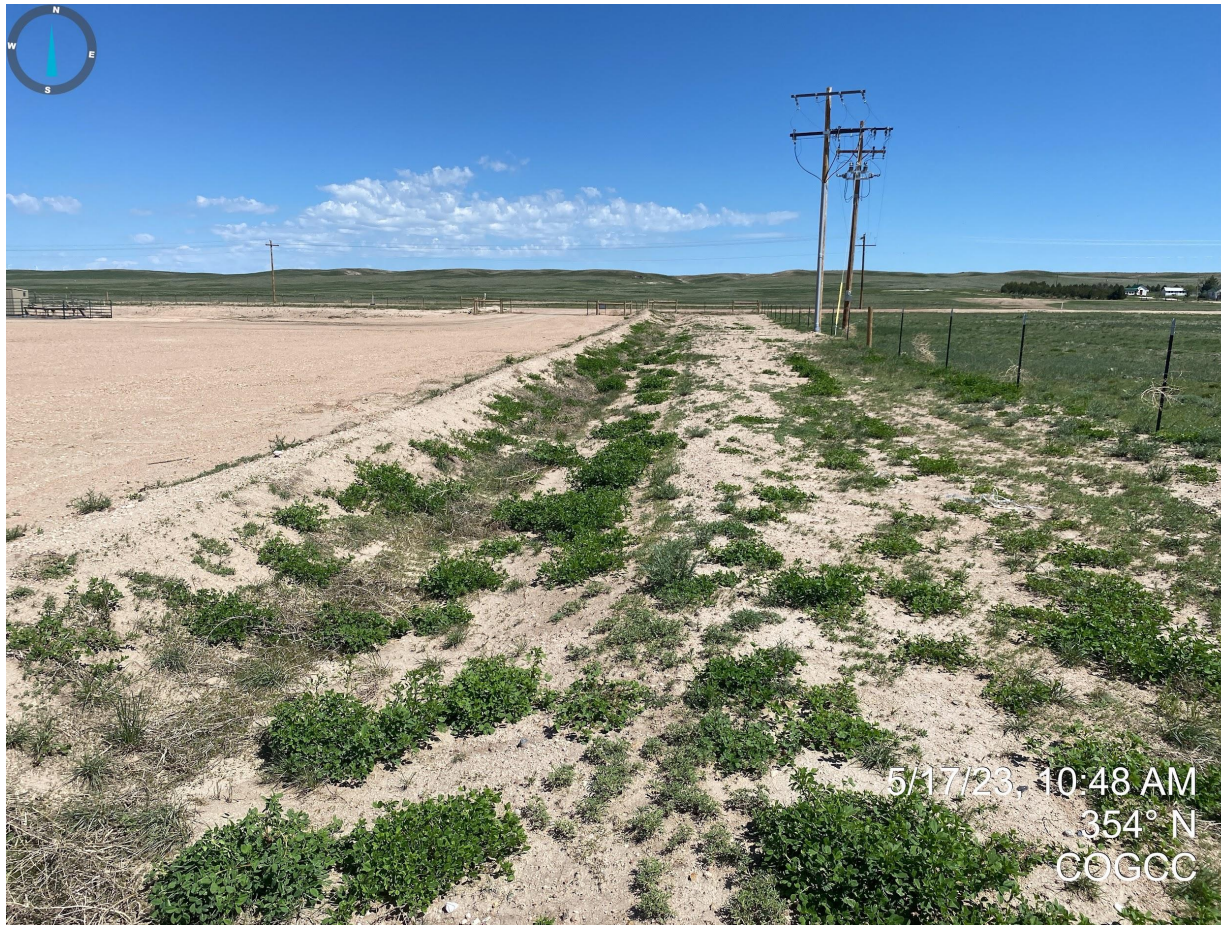
Photo 1. Facing north from the eastern side of the location. Undesirable weedy vegetation (e.g. kochia and russian thistle) was observed to be growing throughout the perimeter of the location in the stormwater ditch system. Management of undesirable vegetation is required to prevent spread to adjacent lands.

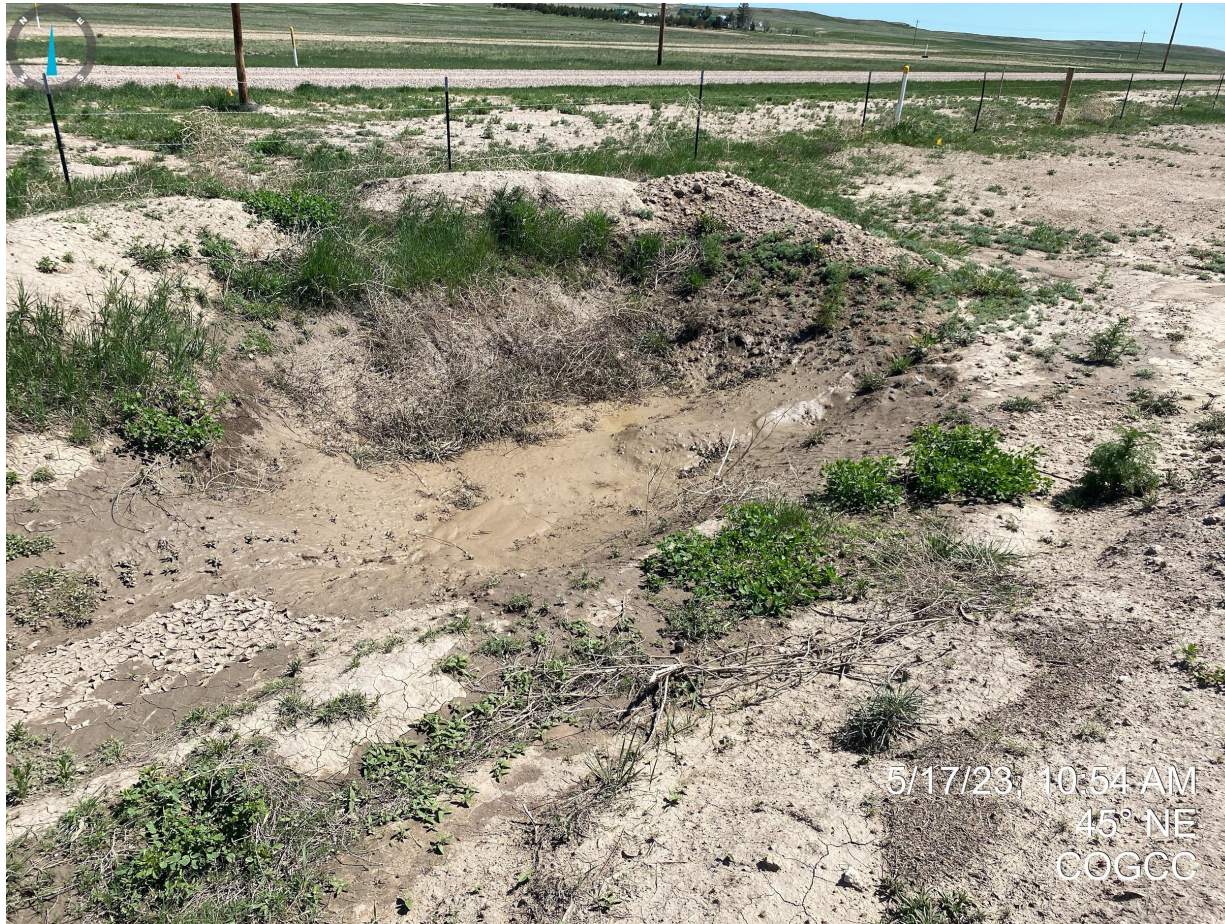
Photo 2. Facing northeast at sediment trap on the northern end of the location. See comments in Photo 1.

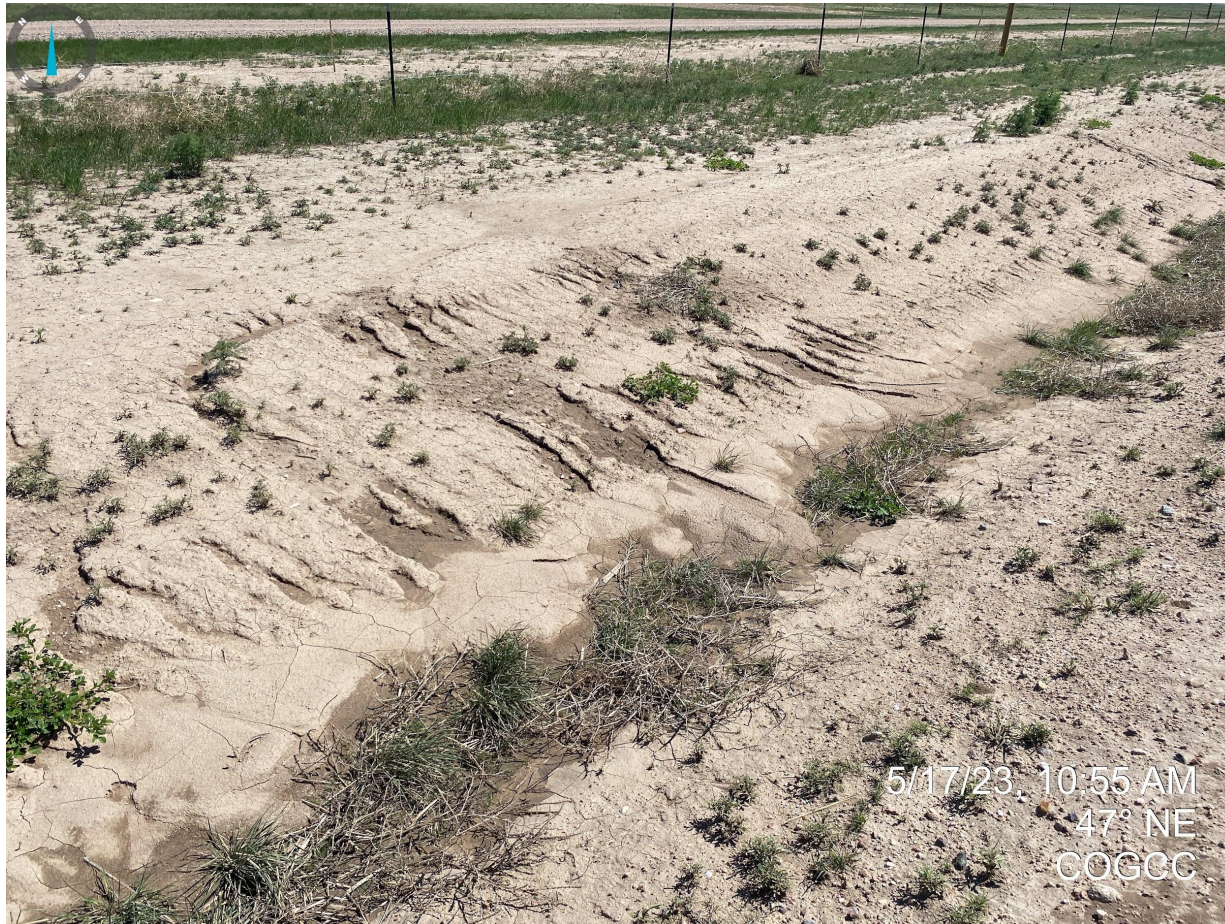
Photo 3. North side of location; rill erosion and undesirable weedy vegetation observed. See comments in Photo 1.

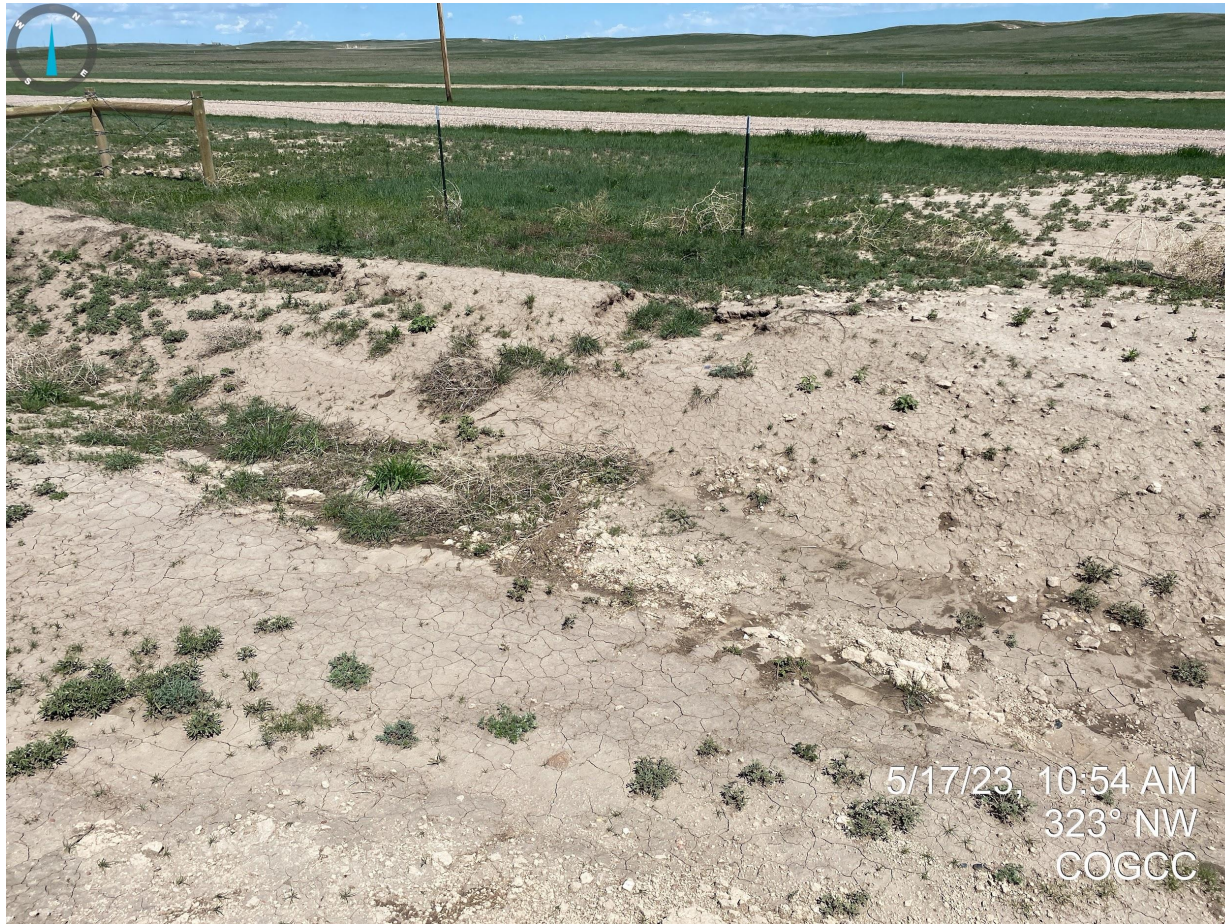
Photo 4. Facing northwest at the northwest corner. See comments in Photo 1.

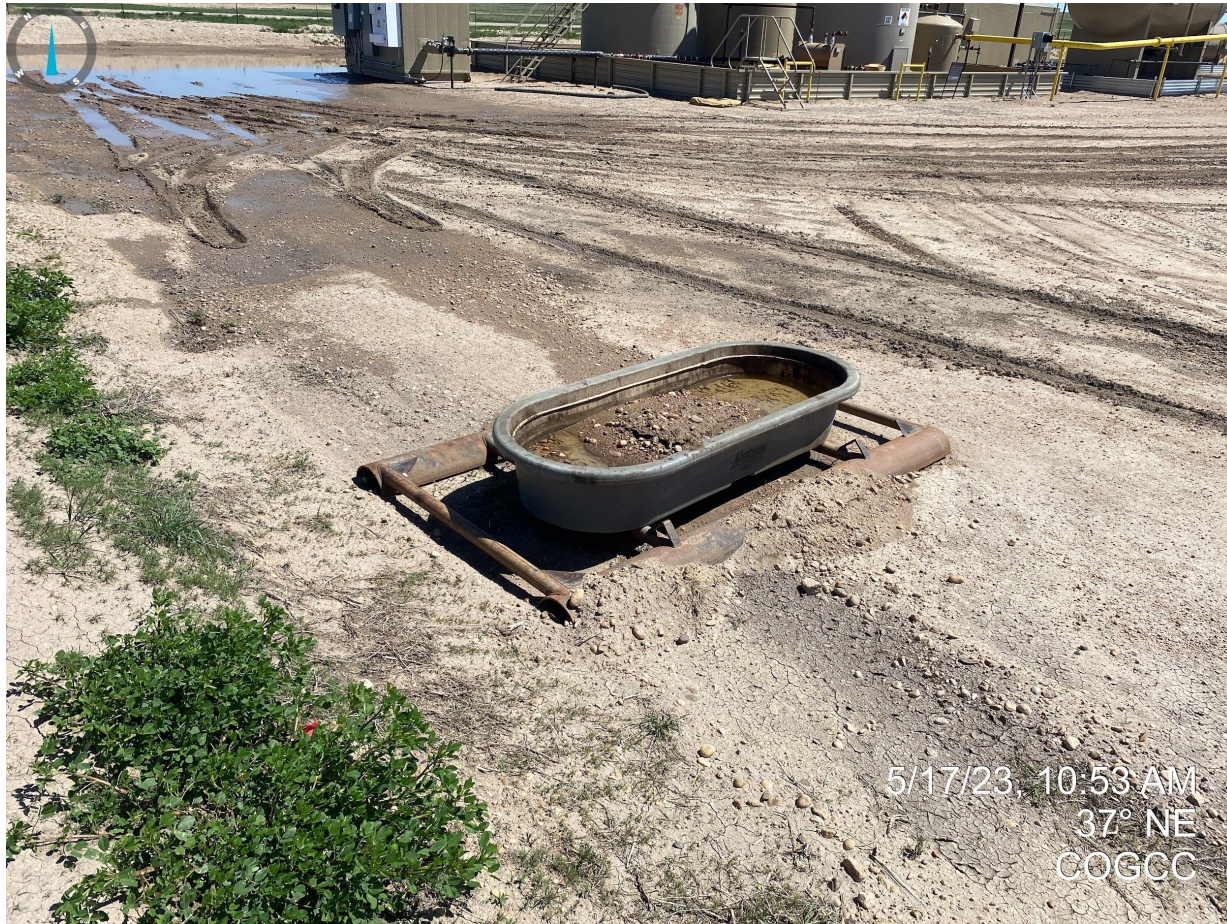
Photo 5. Road drag/maintainer stored on location. Storage of equipment, supplies, etc on location is prohibited.

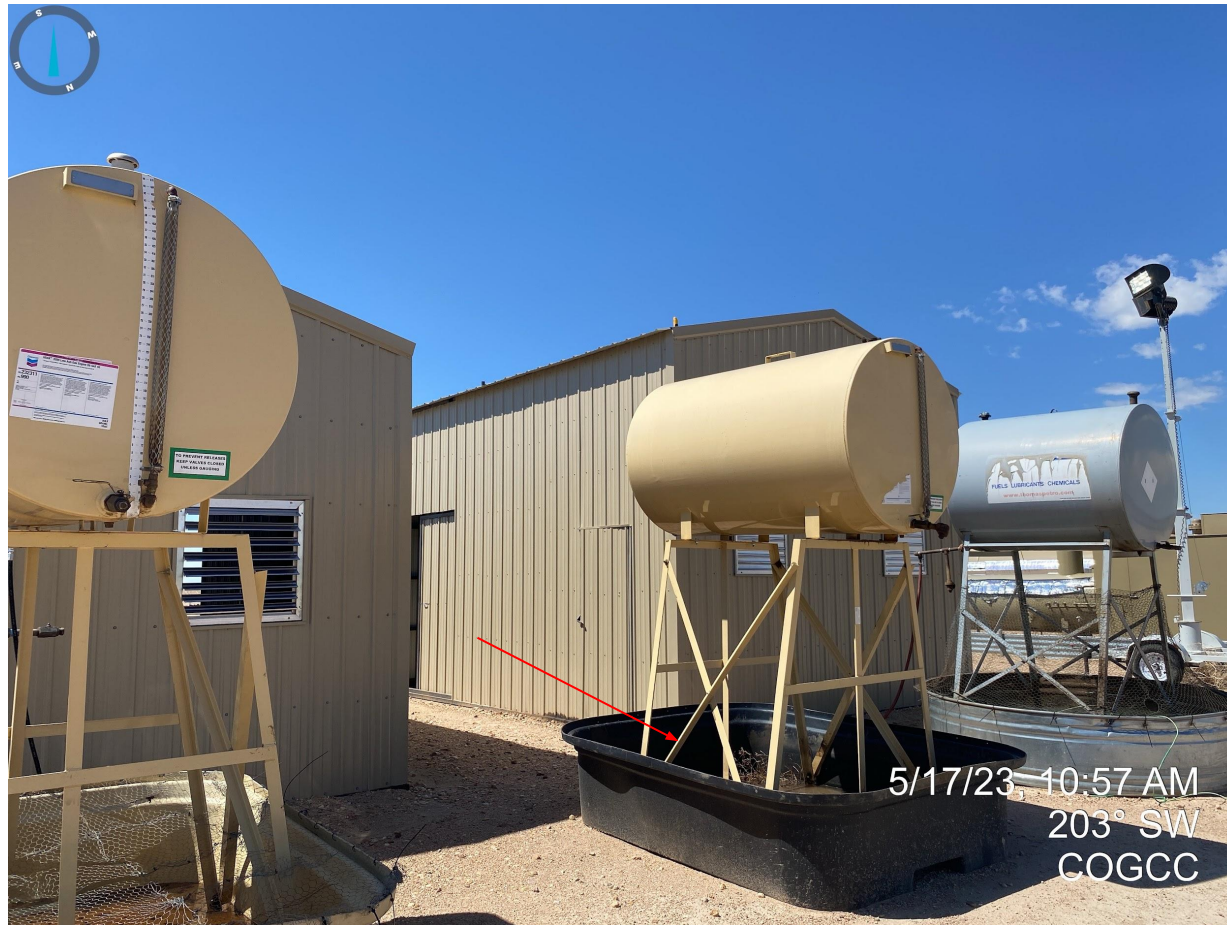
Photo 6. Middle tank did not have any netting installed to prevent wildlife entry.

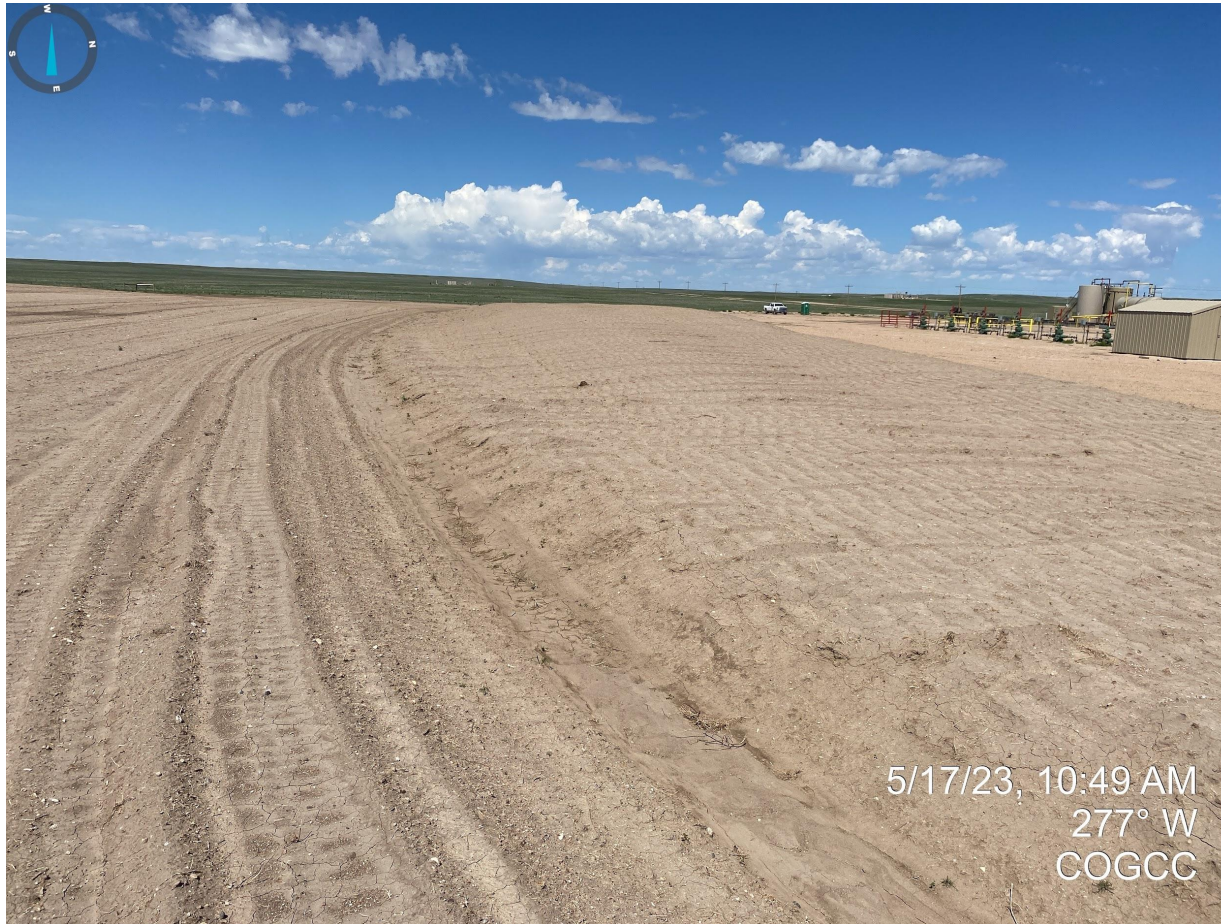
Photo 7. Facing west at the interim reclamation area and topsoil stockpile. Stockpile had evidence of equipment tracking for short term stabilization. The Operator shall continue to comply with interim reclamation timing requirements.

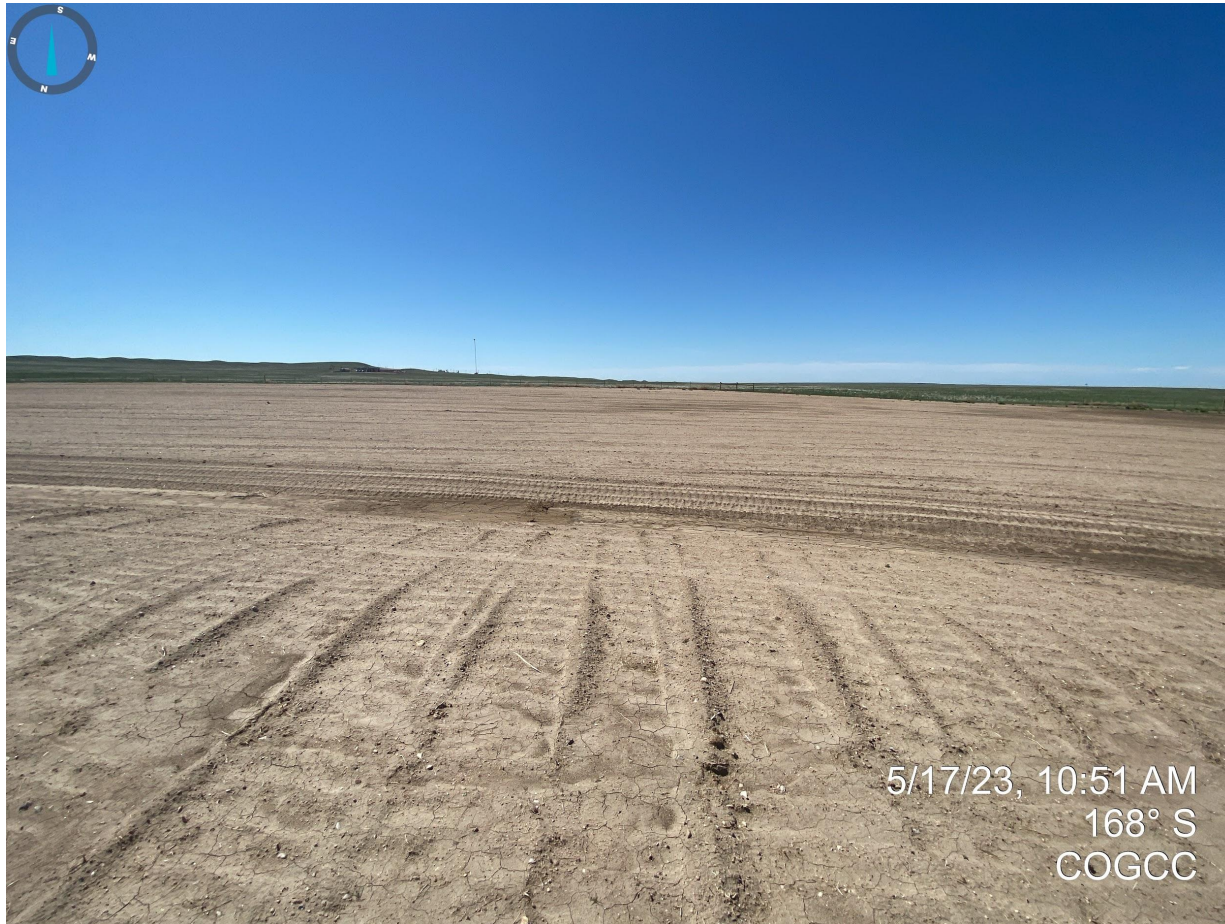
Photo 8. Facing south towards interim areas; see comments in Photo 7.

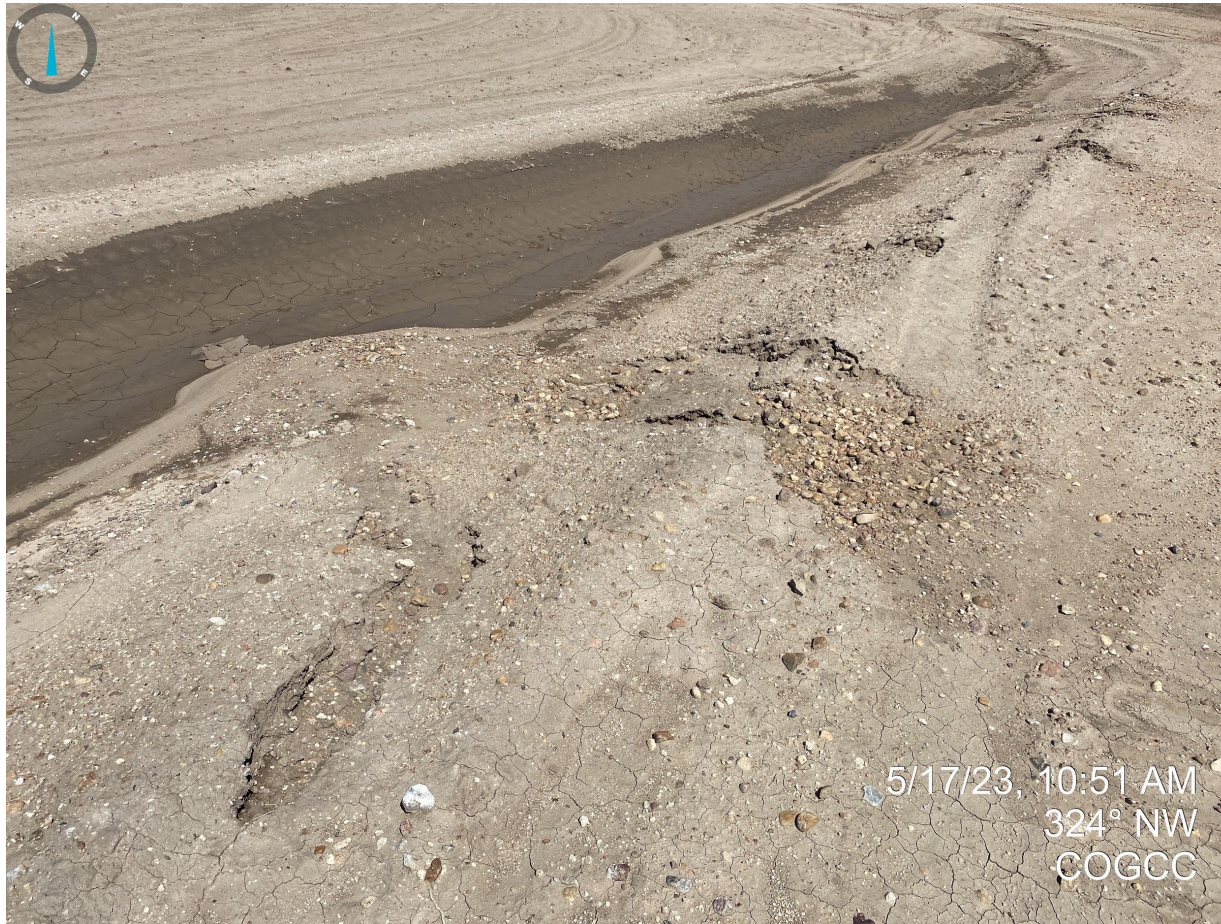
Photo 9. From the western portion of the production area. Portions of the production area do not appear stabilized with evidence of rill erosion and sediment deposition in the stormwater ditches. Additional stormwater BMP maintenance will need to be performed.

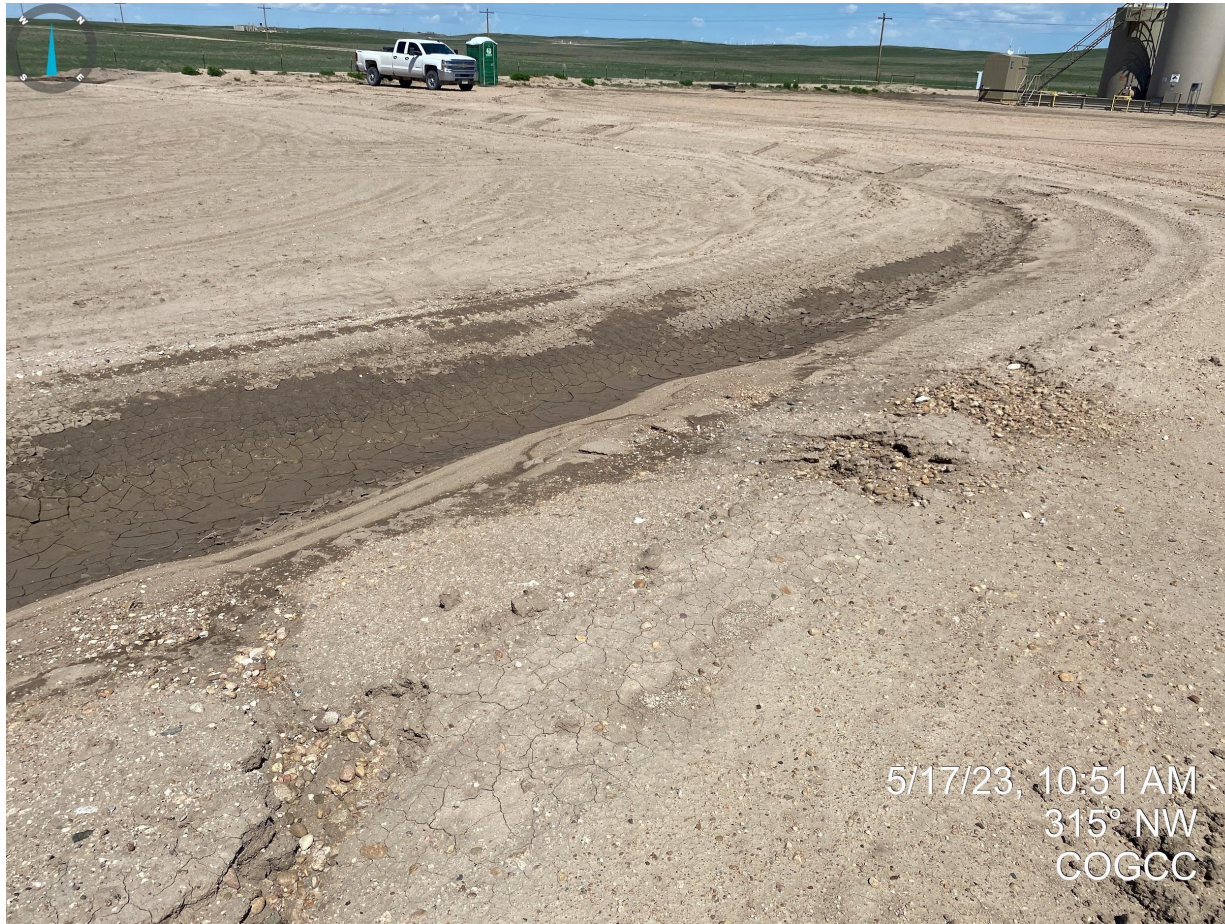
Photo 10. See comments in Photo 9.

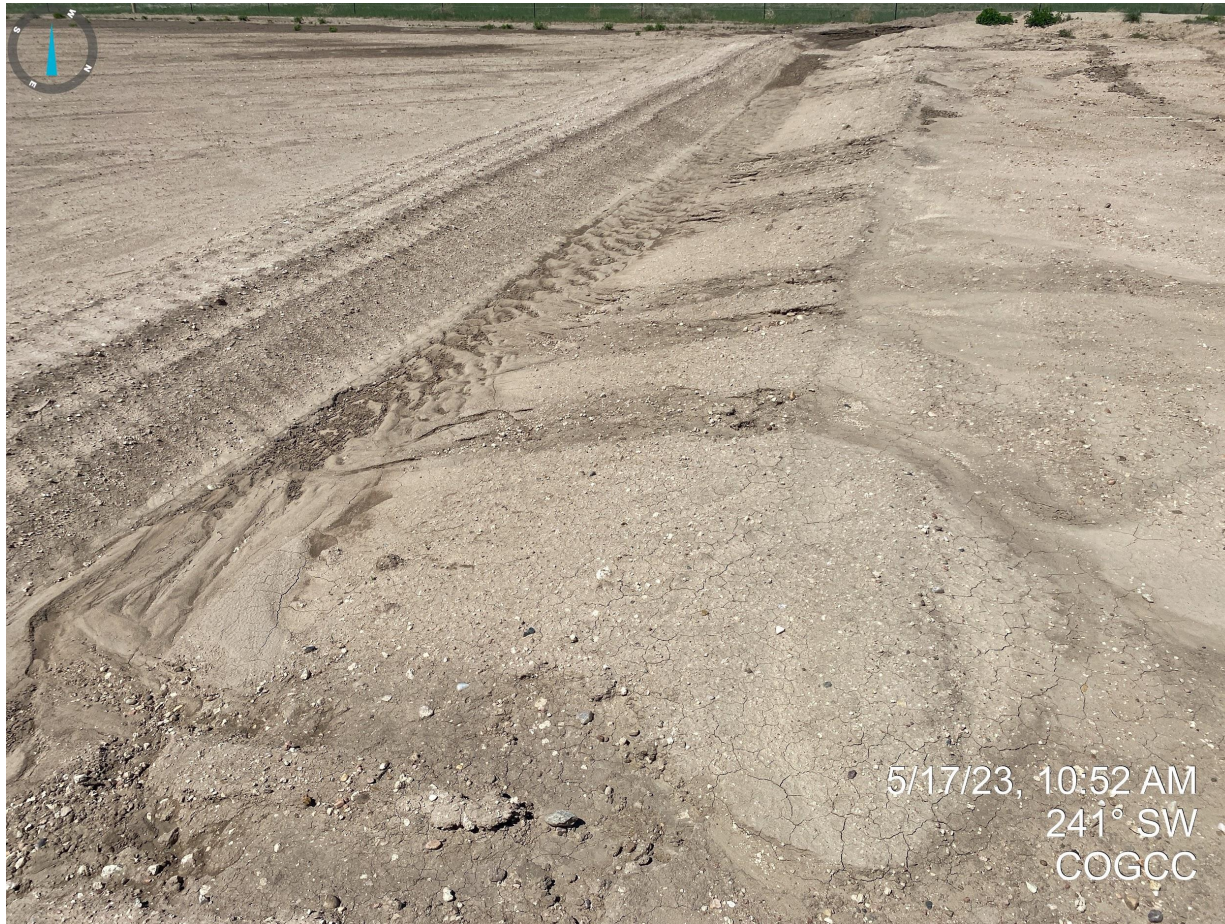
Photo 11. See comments in Photo 9.

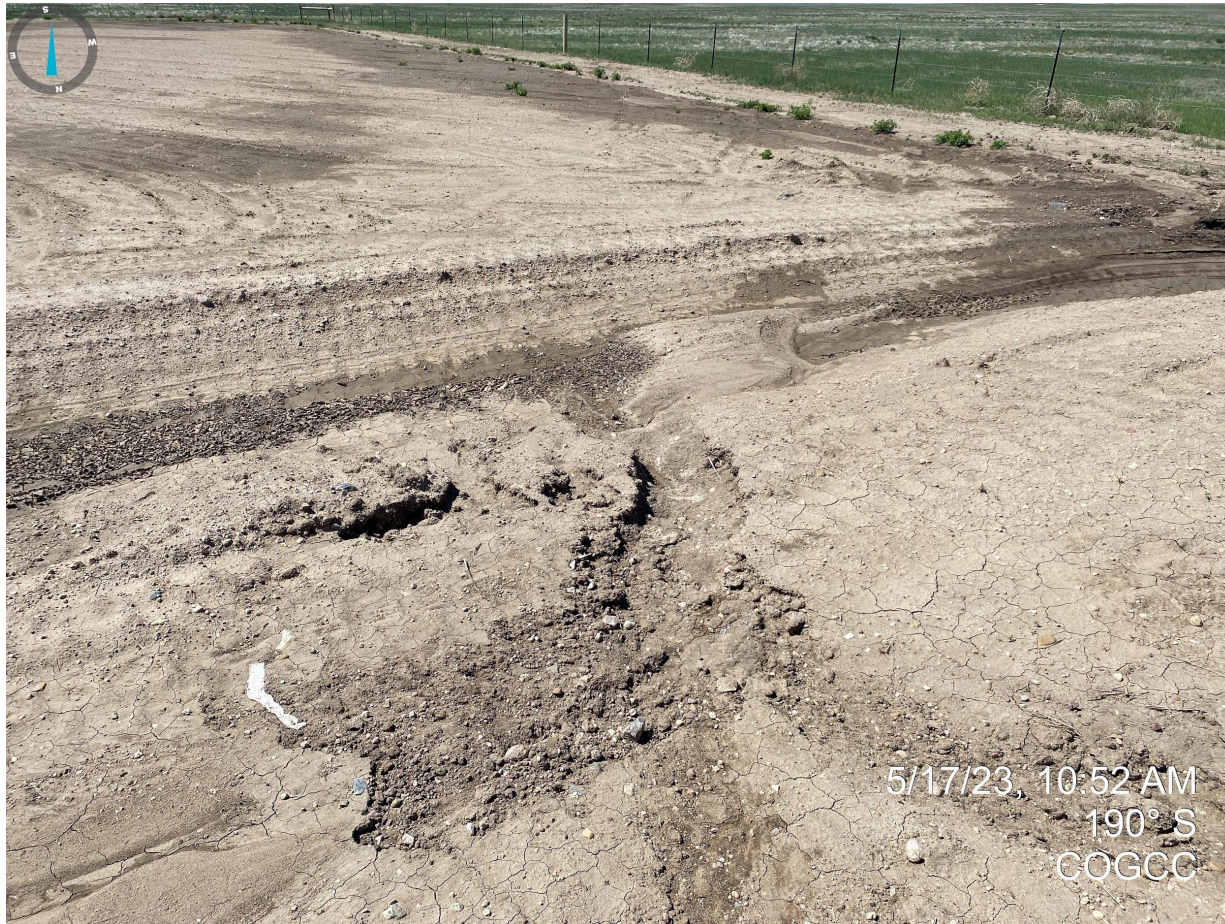
Photo 12. See comments in Photo 9.

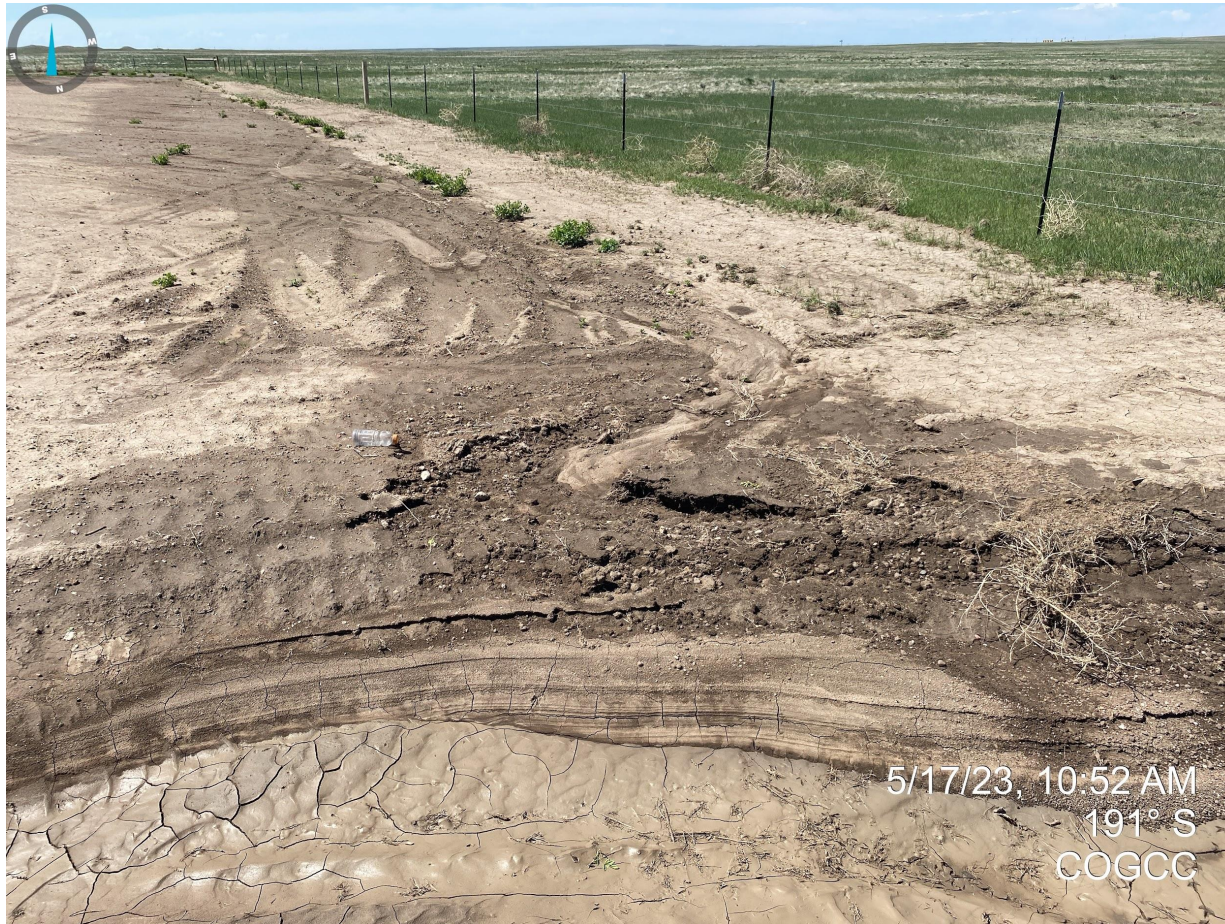
Photo 13. See comments in Photo 9.
