Inspection Photos

Location Name: ILES DOME UNIT/38

Inspection Document #: 702801533

COLORADO
**Oil & Gas Conservation
Commission**

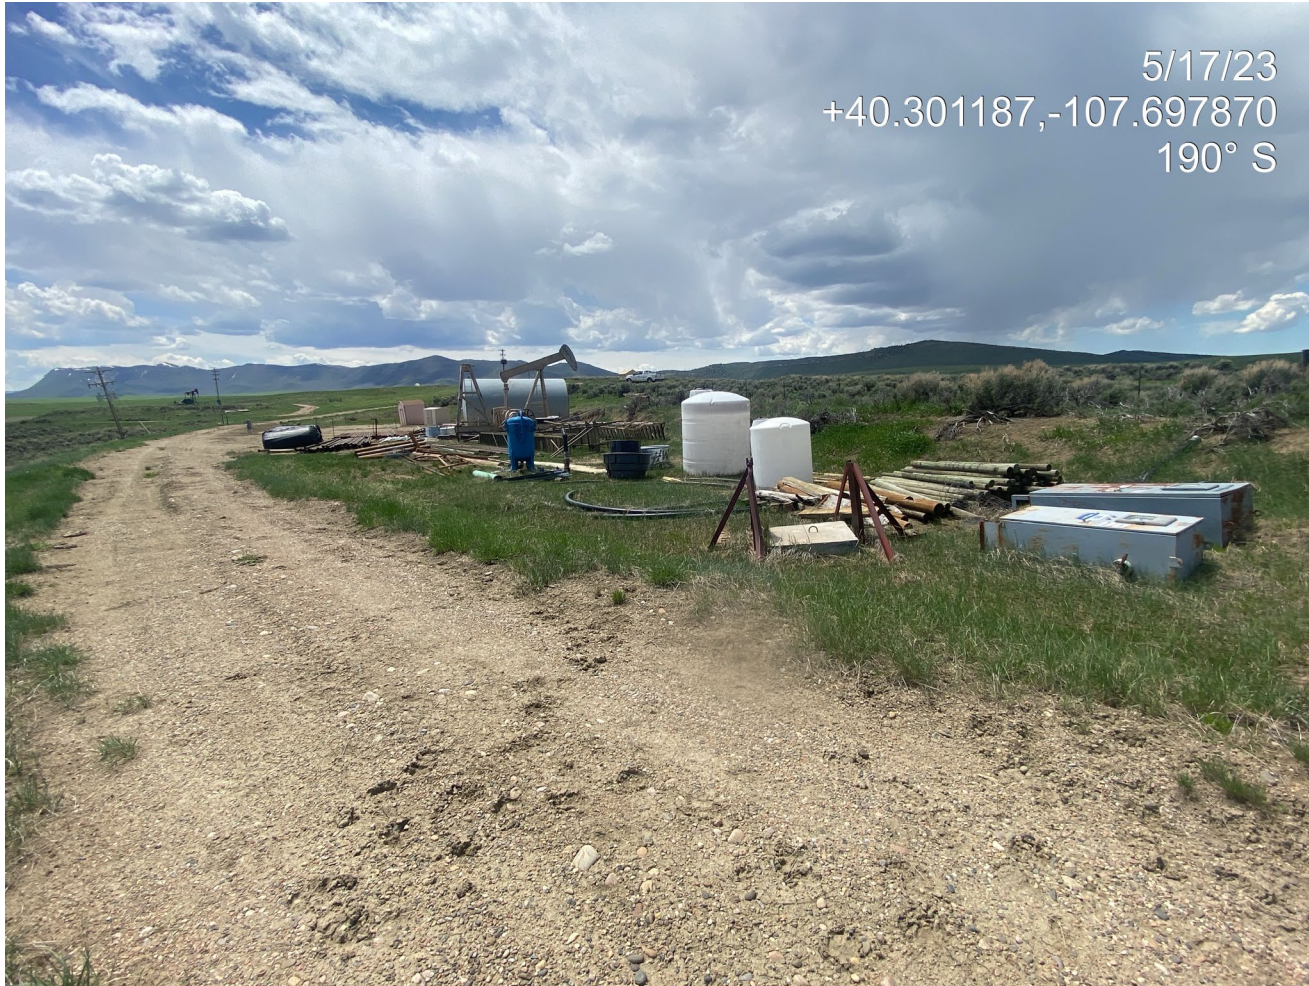
Photo 1. Photo taken from the location entrance to the north shows an overview of the location. Note storage of supplies, equipment and debris.

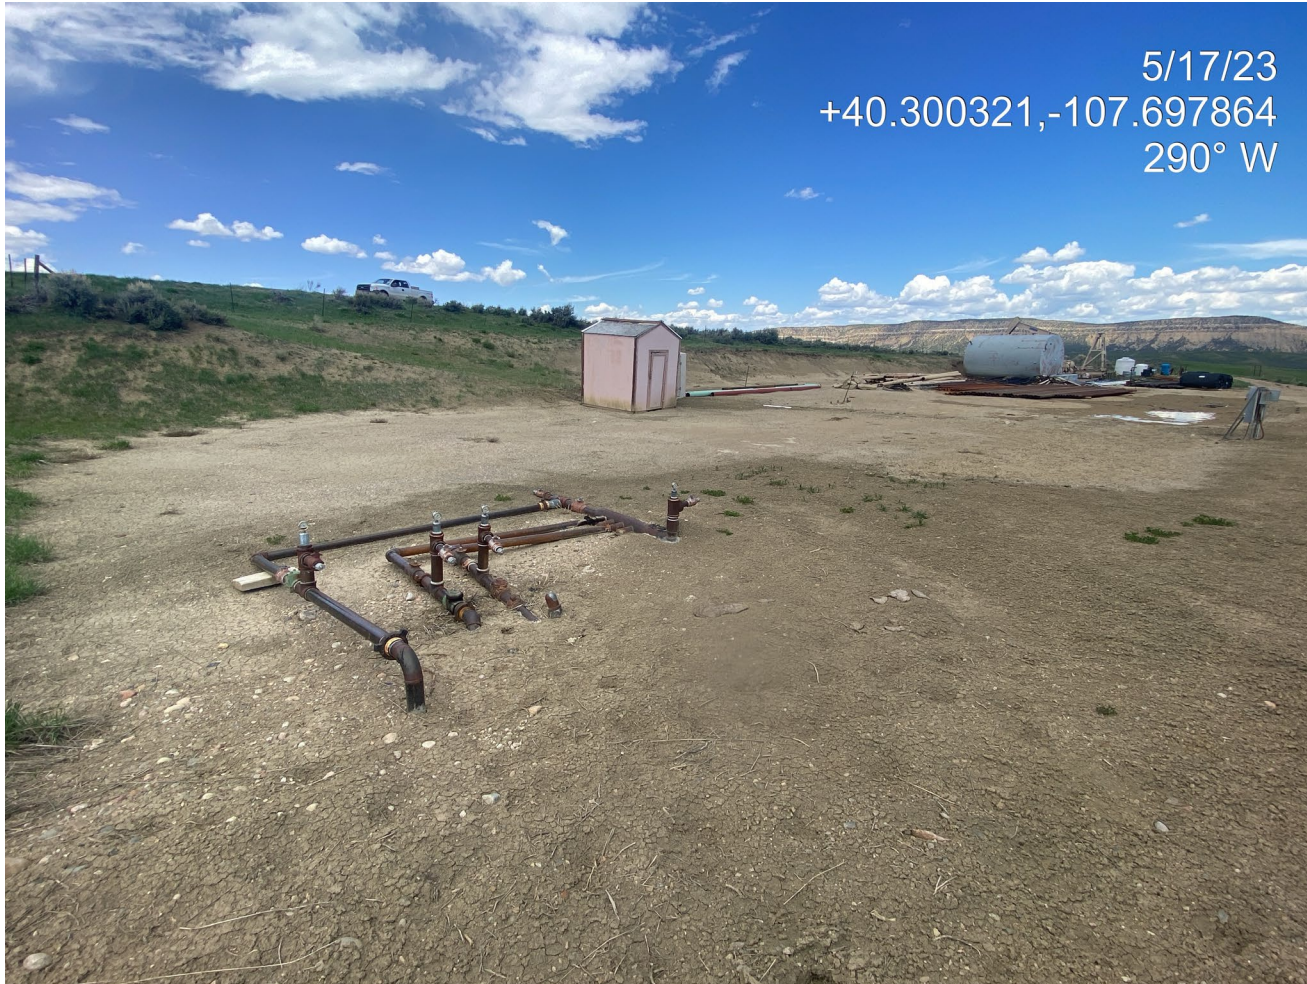
Photo 2. Photo taken from the location entrance to the south shows an overview of the location. Note storage of supplies, equipment and debris.

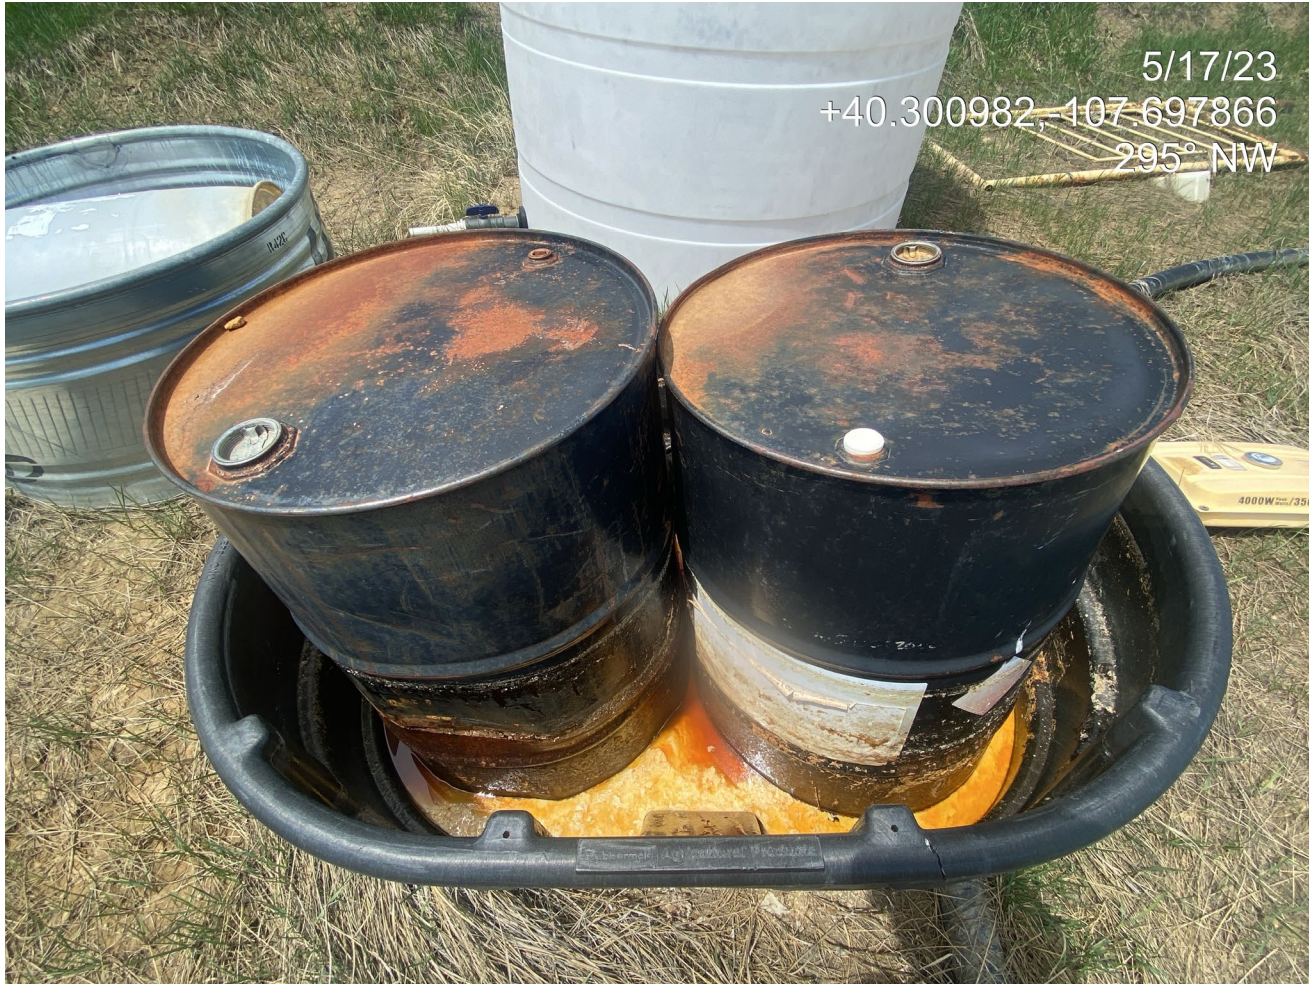
Photo 3. Photo shows storage of leaking chemical drums. No wildlife protection BMPs present to prevent entry into secondary containment.

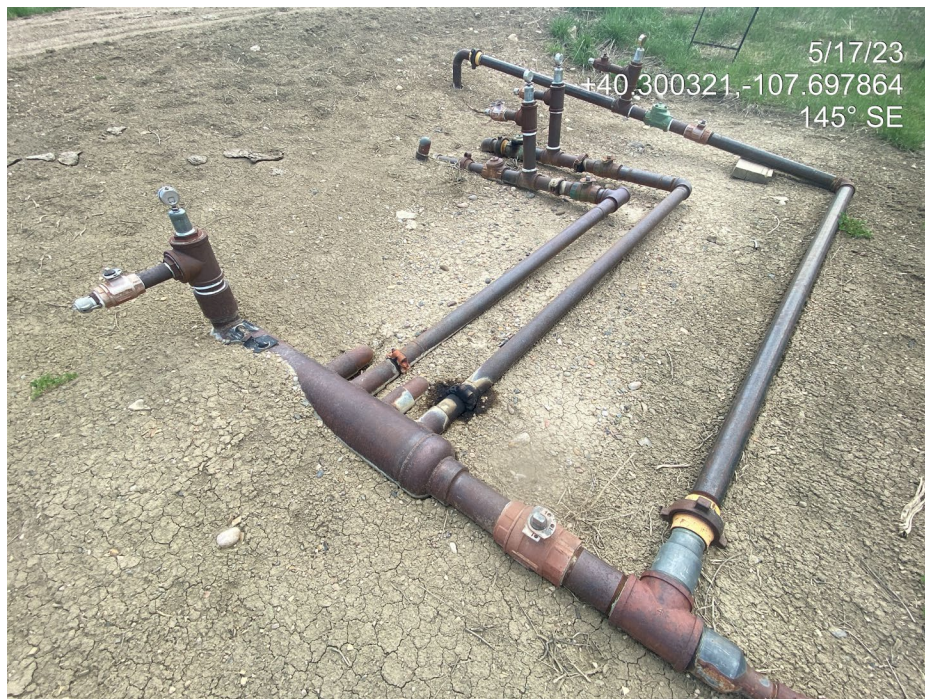
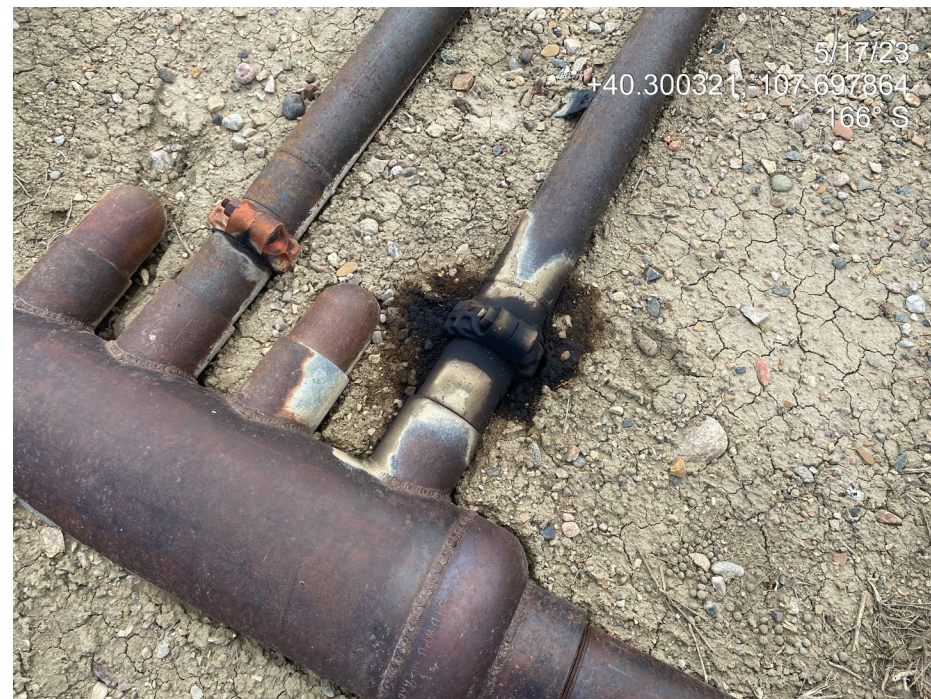
Photo 4. Photos show staining at the cathodic protection unit.

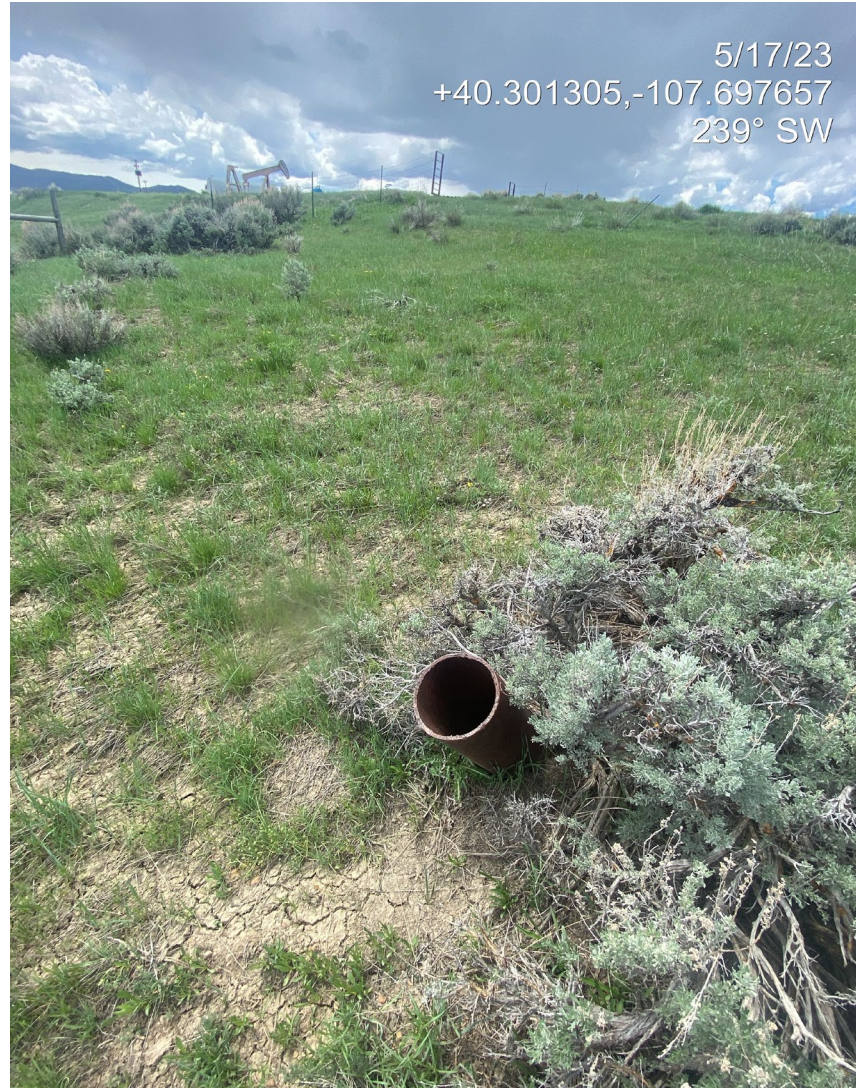
Photo 5. Photo shows an anchor to the northeast of the location. All equipment, both on and offsite must be removed.

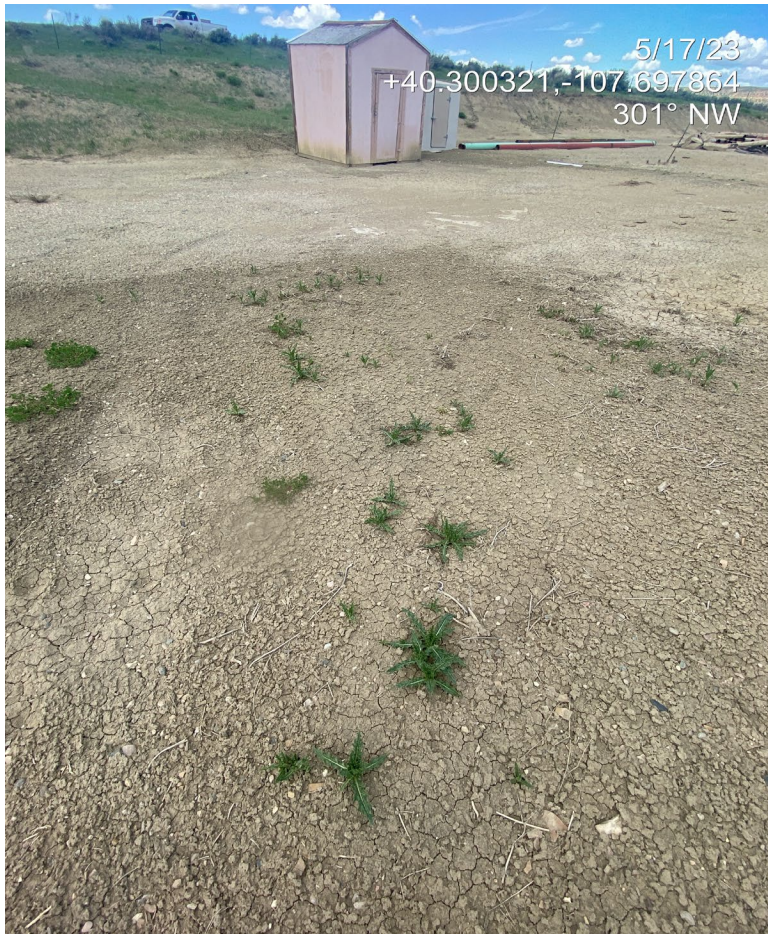
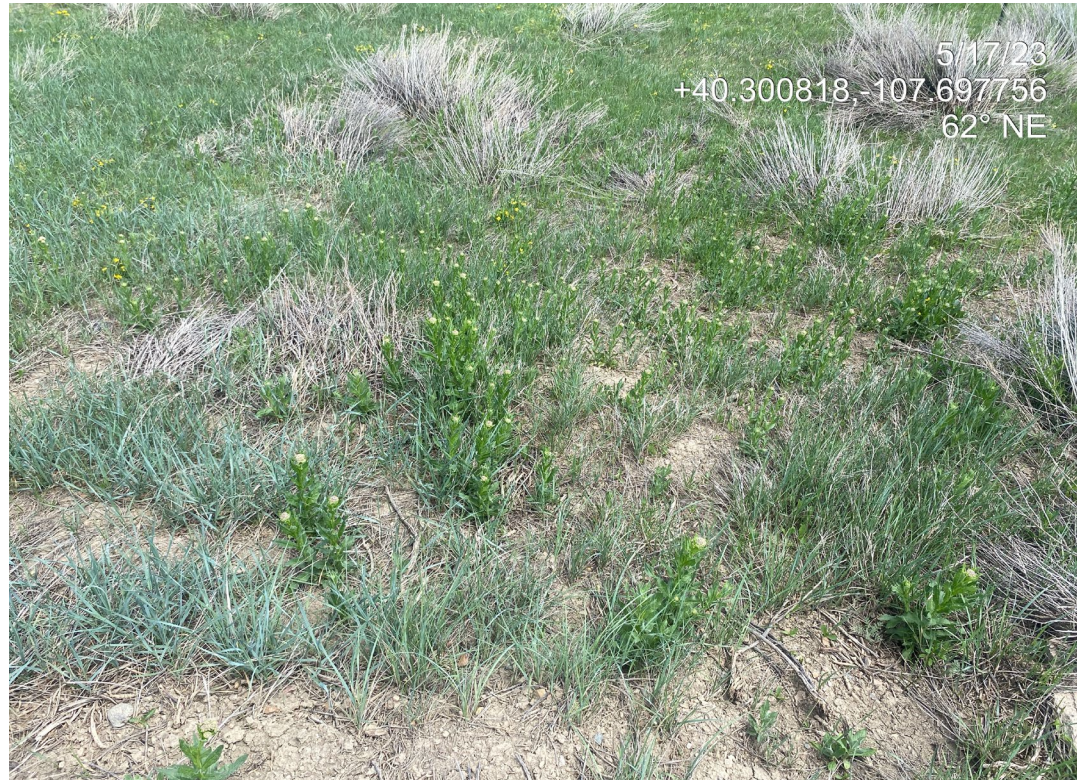
Photo 6. Photos show list B noxious weeds Canada thistle (left) and whitetop/hoary cress (right).

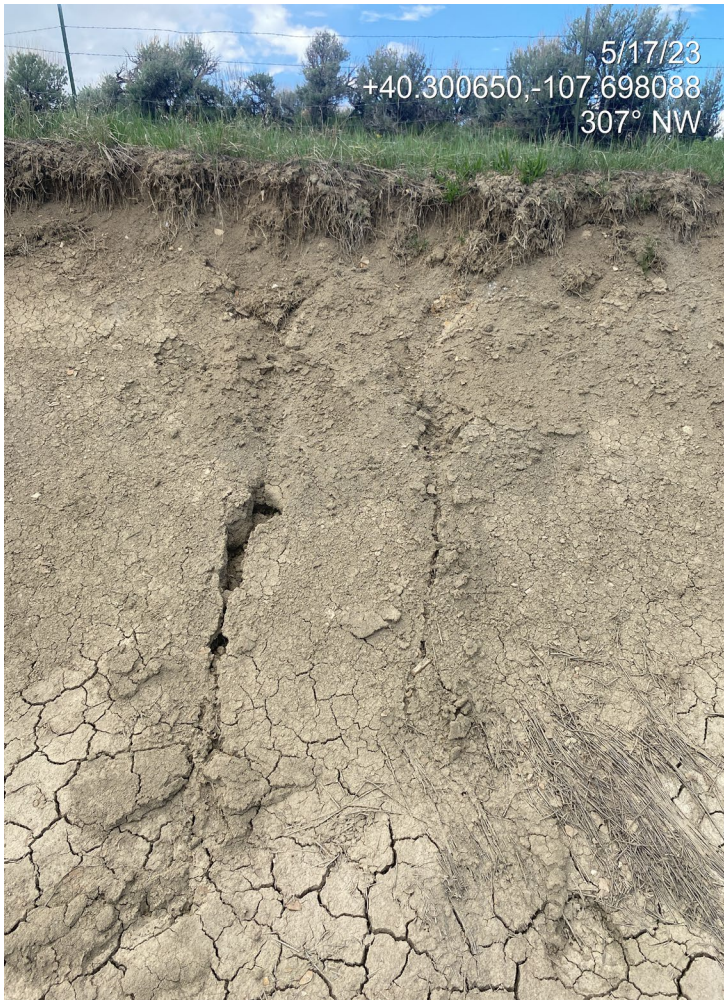
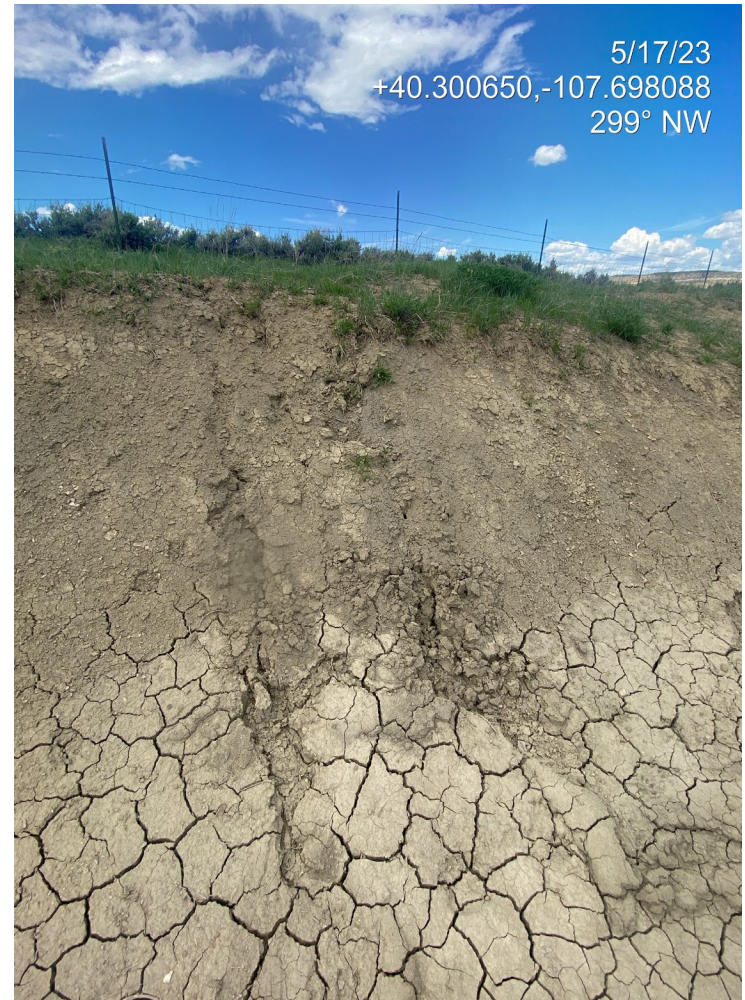
Photo 7. Photos show the cut slope is unstable. Vegetation is pedestaled with exposed roots. Erosion appears to be migrating upslope/backwards, undercutting into undisturbed reference areas. Rill erosion is occurring.

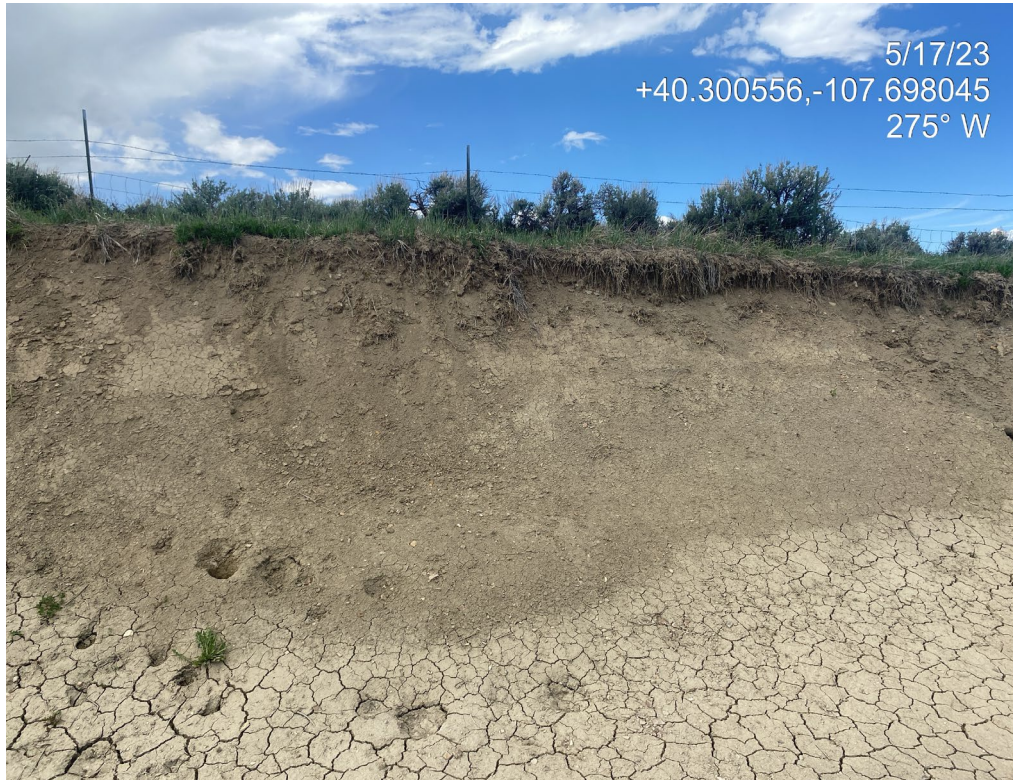
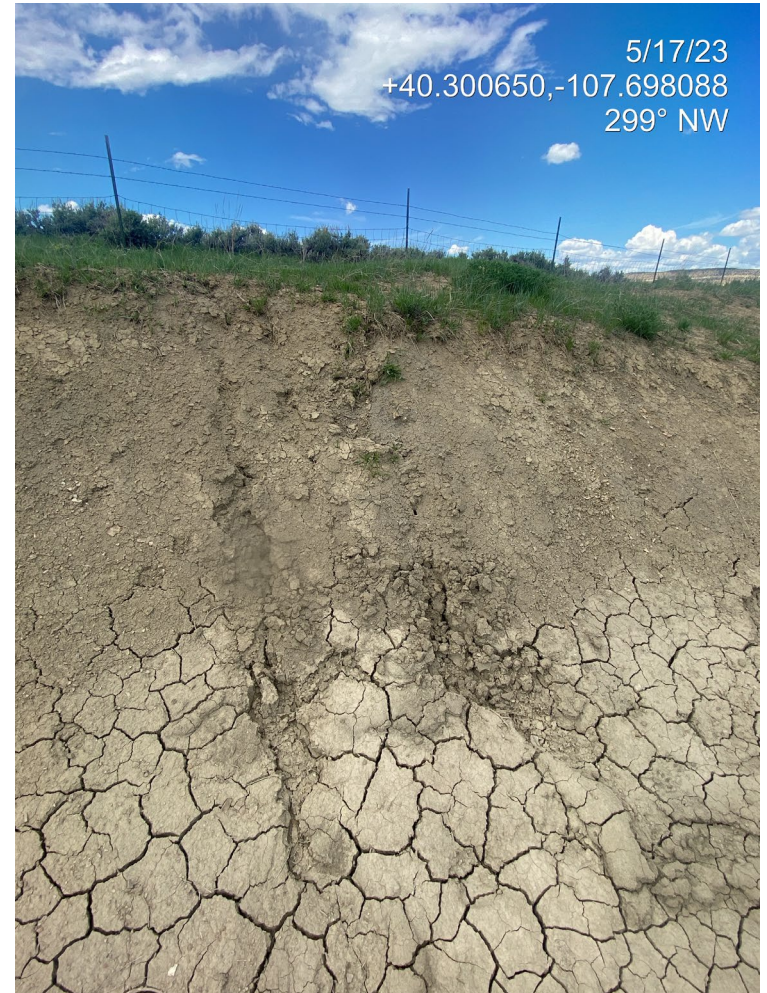
Photo 8. Photos show the cut slope is unstable. Vegetation is pedestaled with exposed roots. Erosion appears to be migrating upslope/backwards, undercutting into undisturbed reference areas. Rill erosion is occurring.
